429 Indiana Street, March 21, 2006

429 Indiana 3/21/06 (document 2)

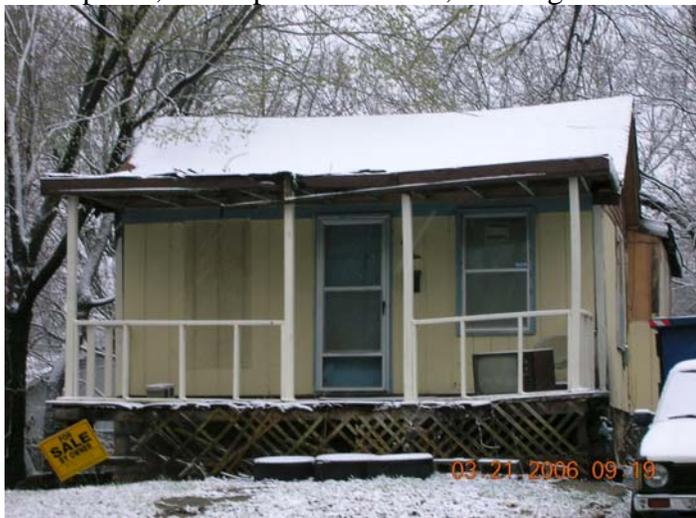
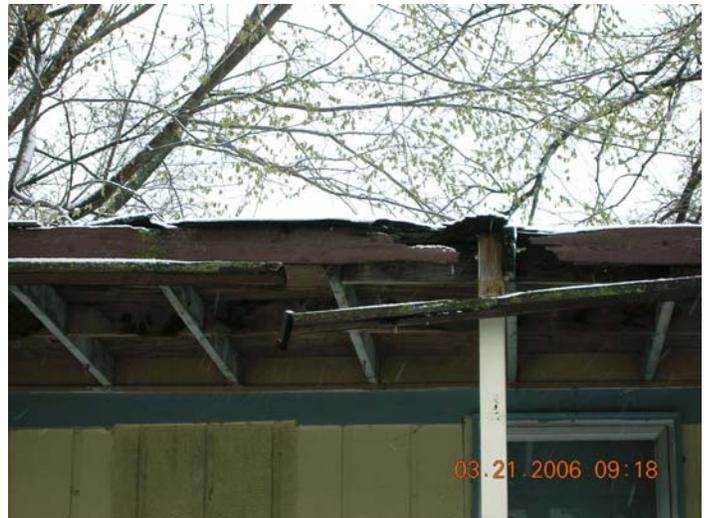
Front porch, rotted porch structure, flooring and roof:

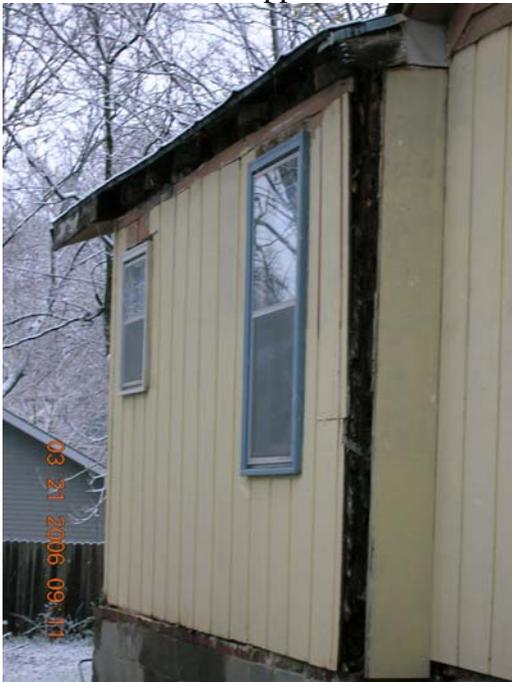
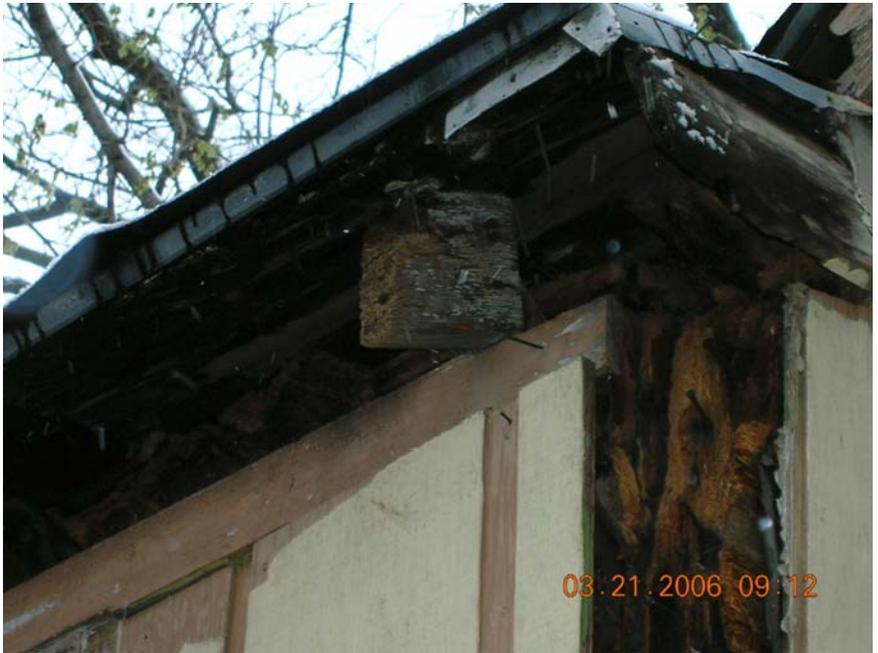
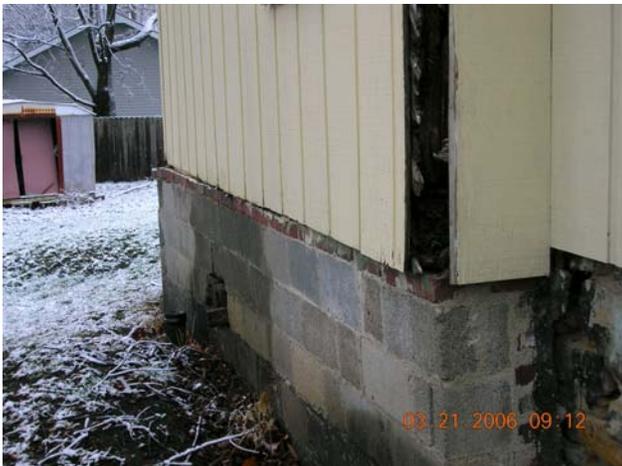
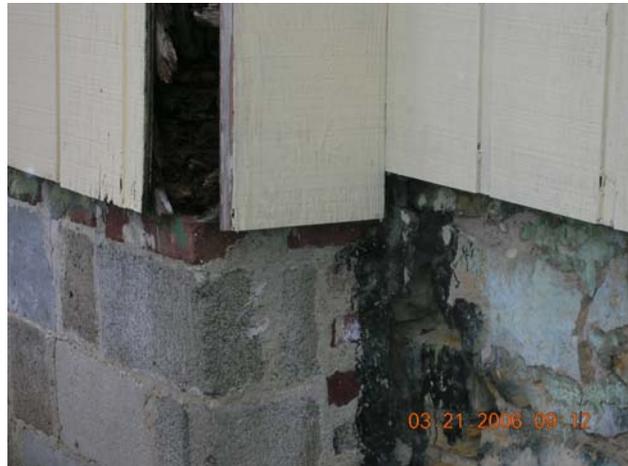
Rotted – roof and supports:

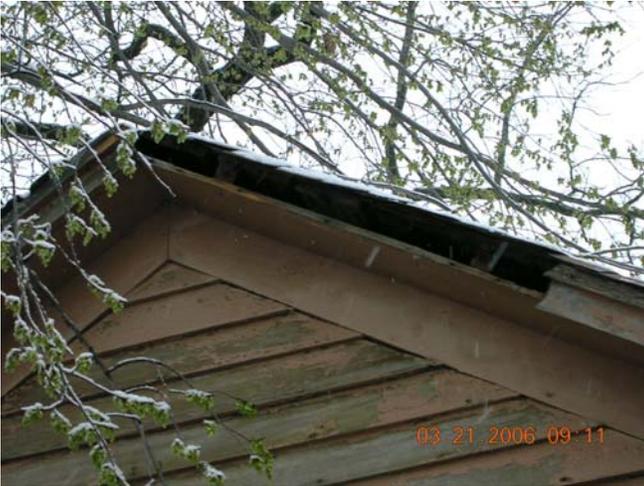
South side, rotted roof structure:

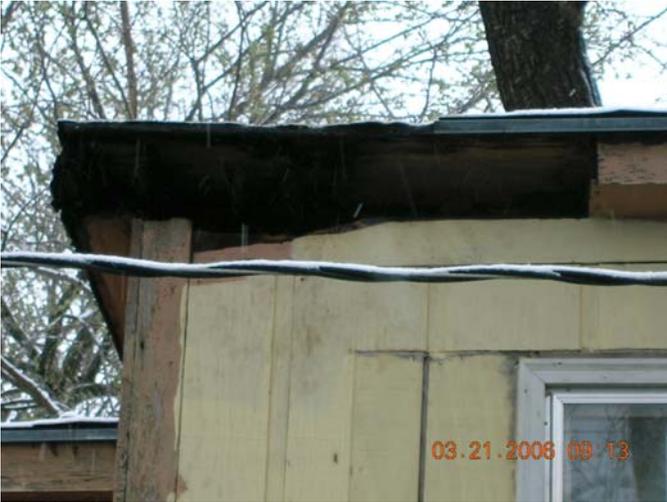
Southwest corner, rotted roof

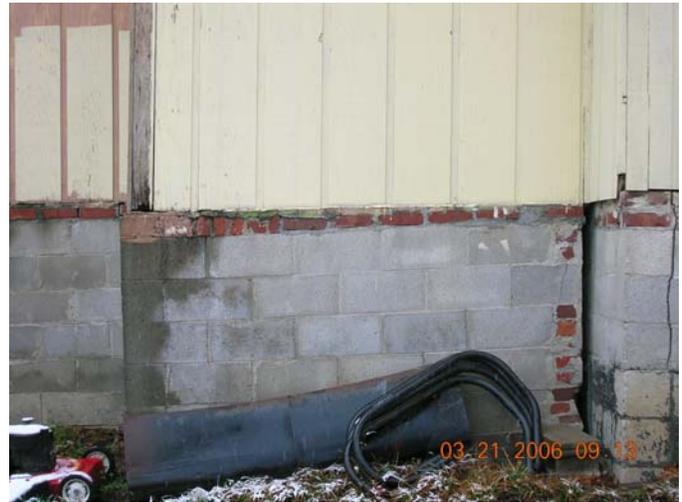
Deteriorated Foundation, South side – rear of structure

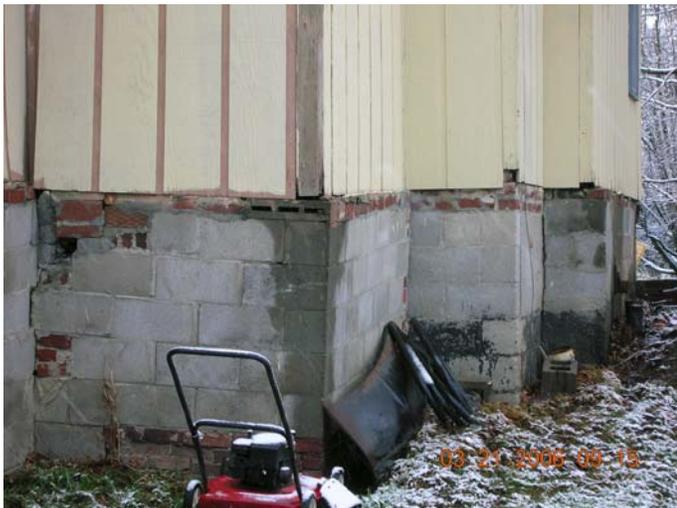
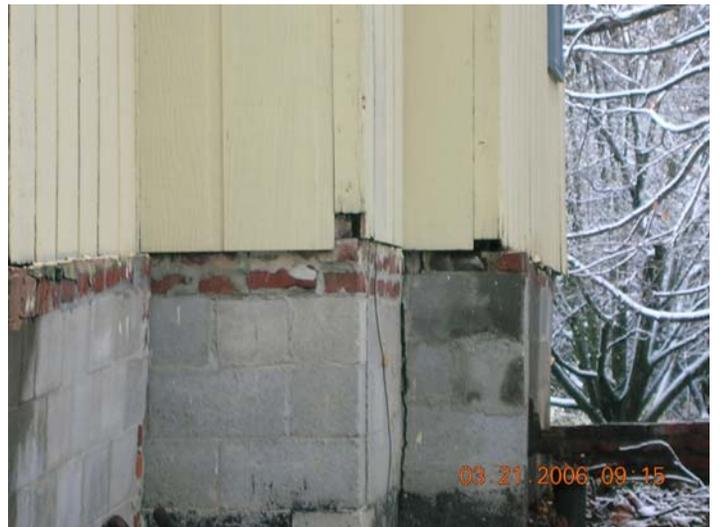
Deteriorated foundation, south wall:

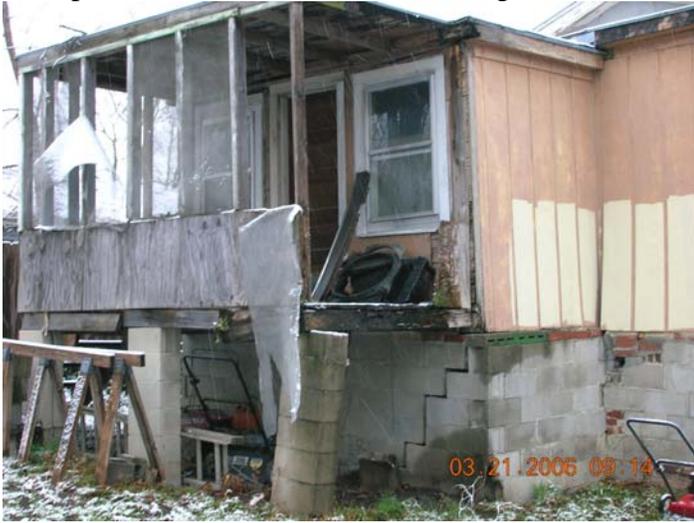
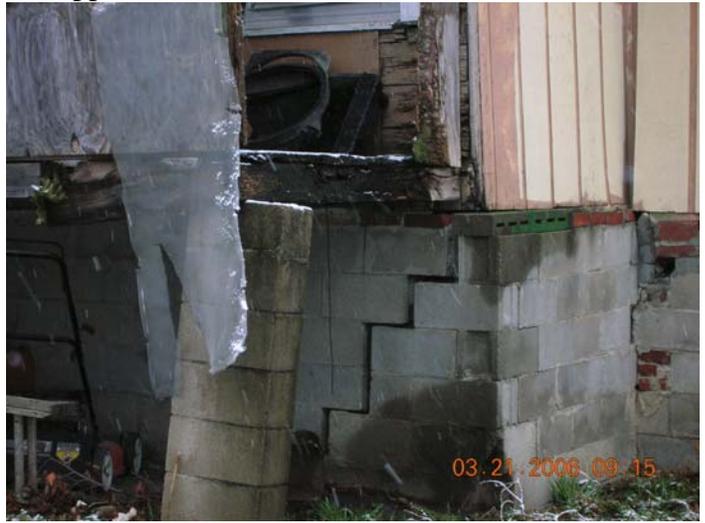
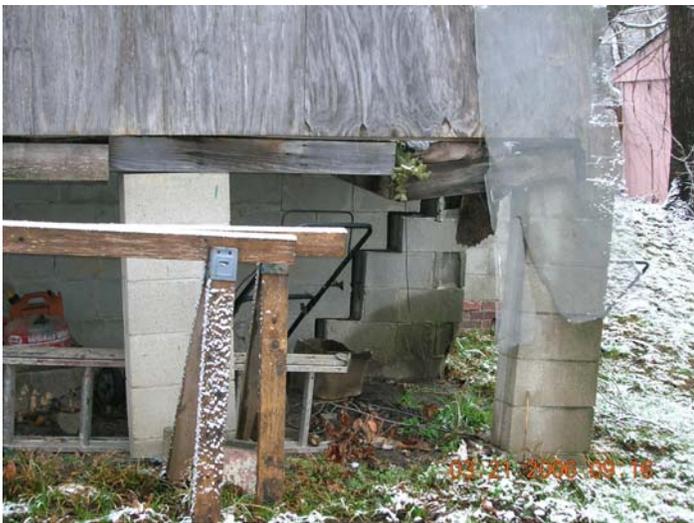
Rear porch – rotted, deteriorated/damaged foundation and supports:

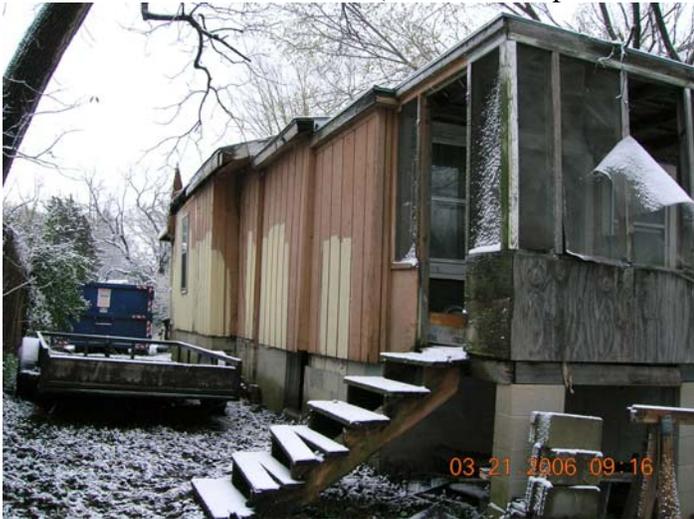
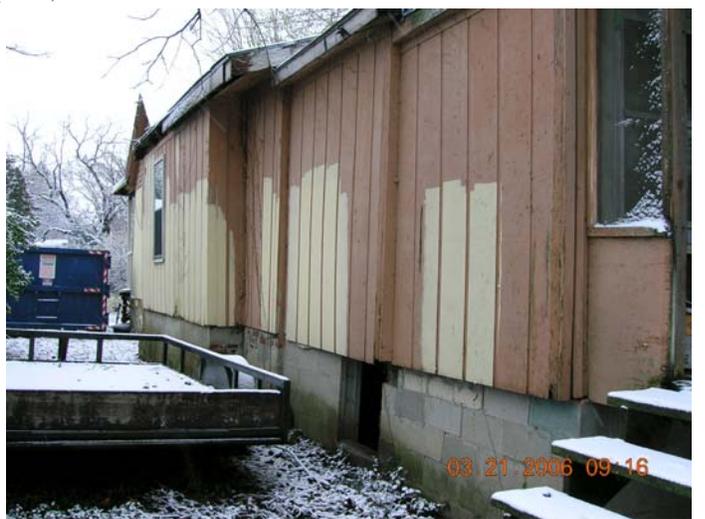
North side, view from rear: (rotted roof, open crawl space)
