Memorandum  
City of Lawrence  
Public Works Department

**TO: Dave Corliss, City Manager**  
**FROM: Dena Mezger, Assistant Public Works Director**  
**CC: Cynthia Boeker, Asst. City Manager; Diane Stoddard, Asst. City Manager; Charles Soules, Public Works Director; Steve Lashley, Project Engineer – Infrastructure Management**  
**Date: December 5, 2007**  
**RE: 2007 Pavement Maintenance Program Summary Report**

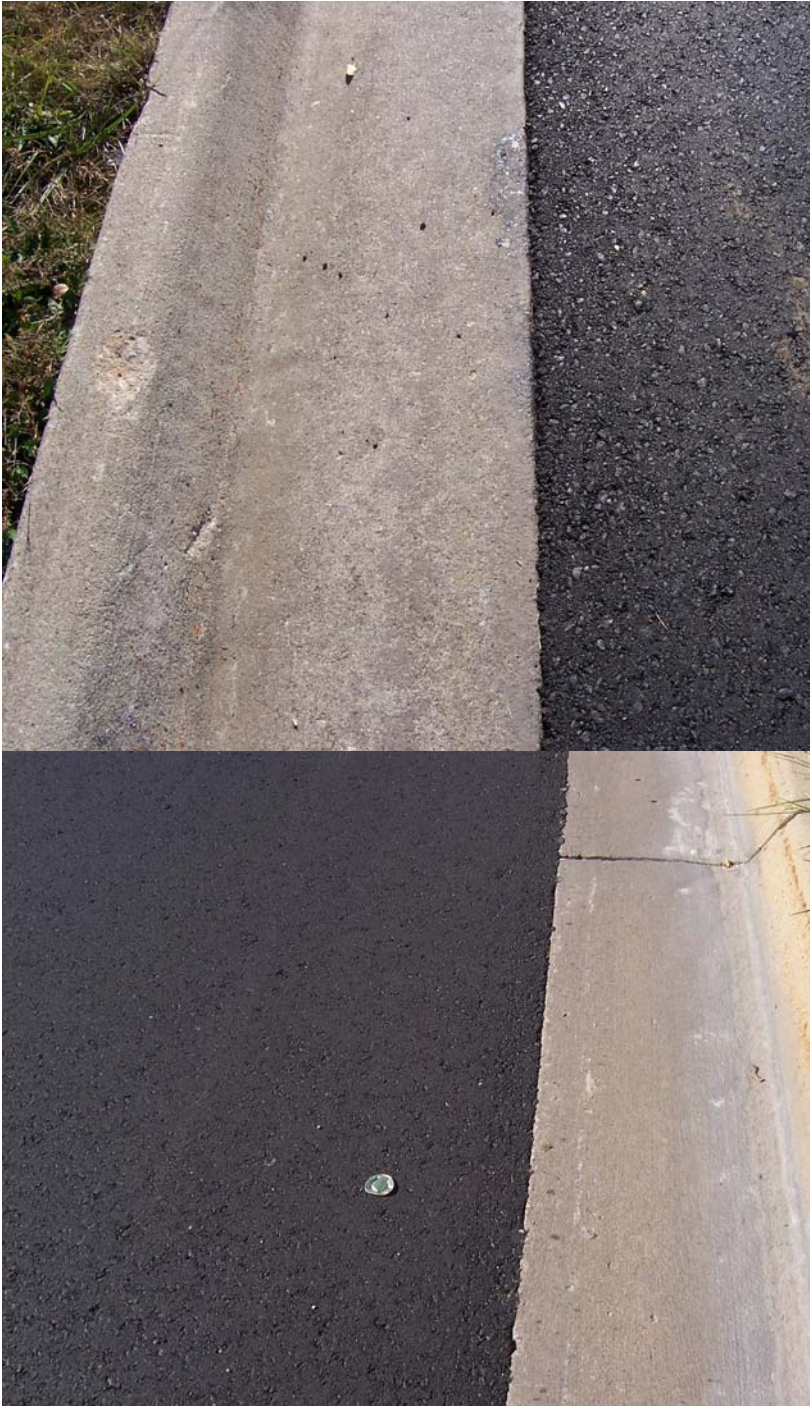
Properly finished pavement edges should abut tightly against the gutter and be level with the top of the concrete. No ragged edges or loose material should be left along the joint.

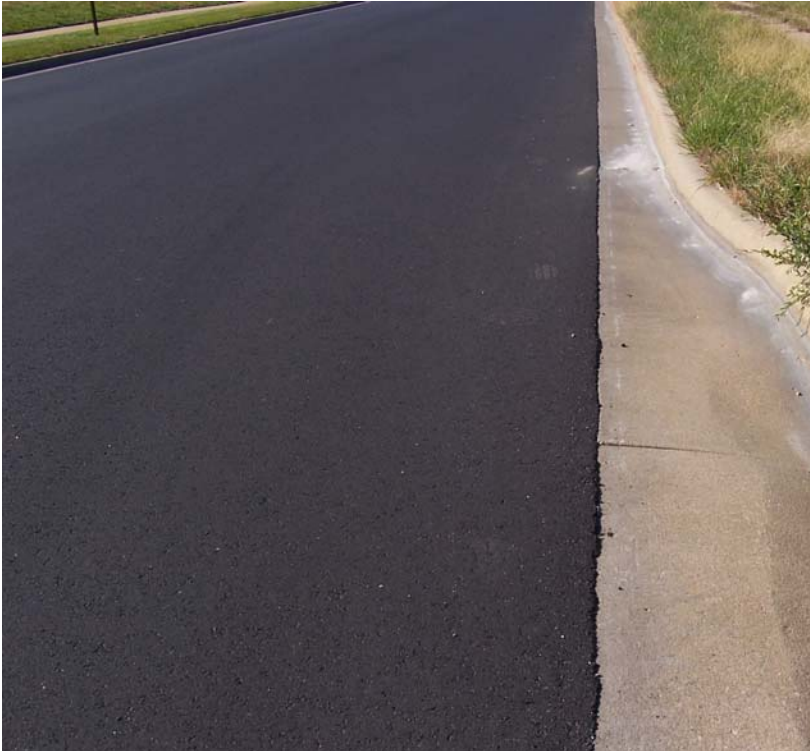
Pavement surface should be relatively "tight" without areas of large aggregate on the surface or very porous appearance.

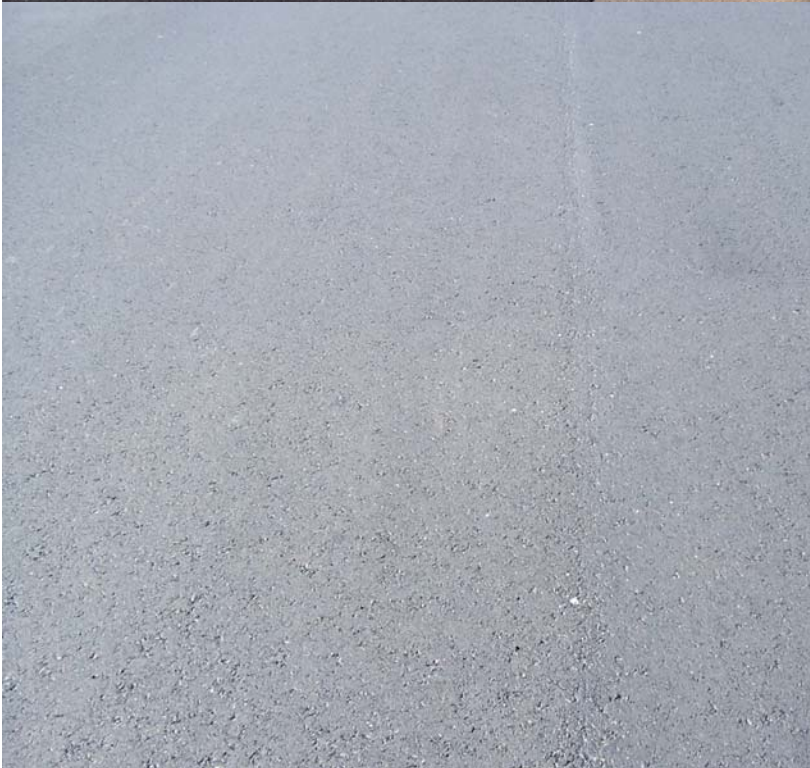
Surface should appear smooth. Seams and roller marks should be generally unnoticeable.

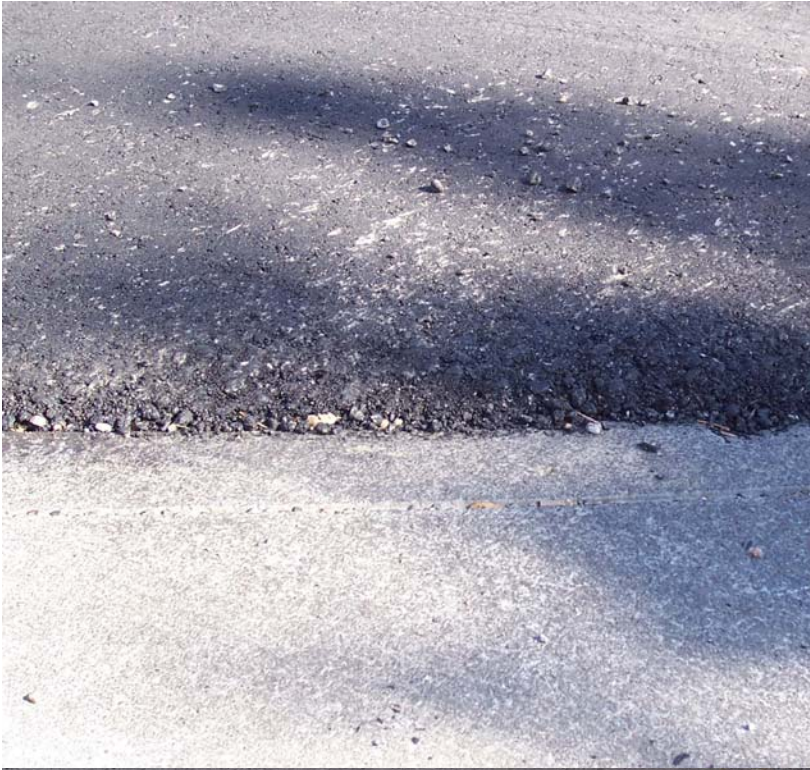
Edges that are raised above the adjacent gutter, and have ragged edges with loose material exposed are vulnerable to raveling and damage resulting in potholes and loss of pavement along the edges of the roadway.

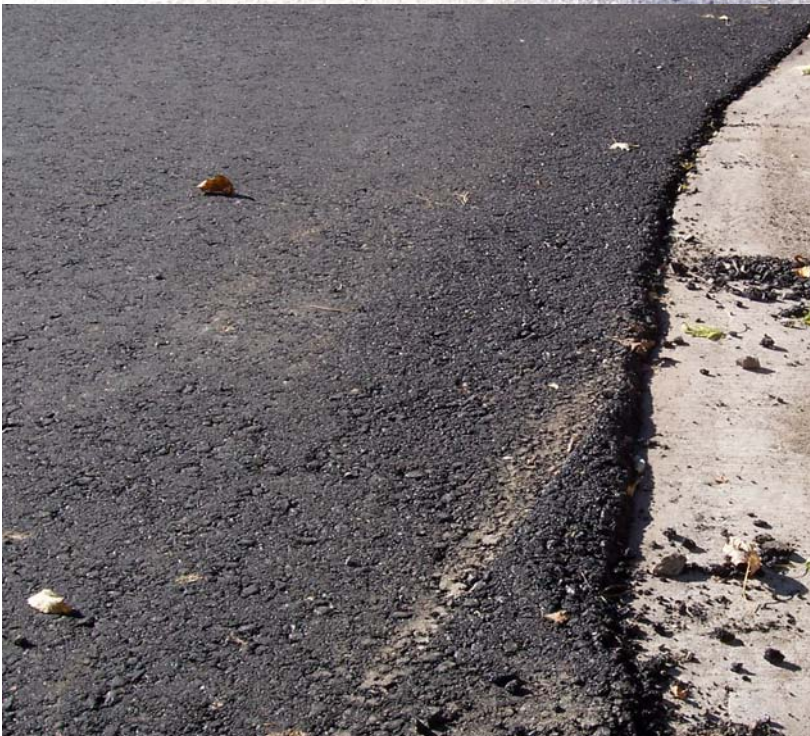
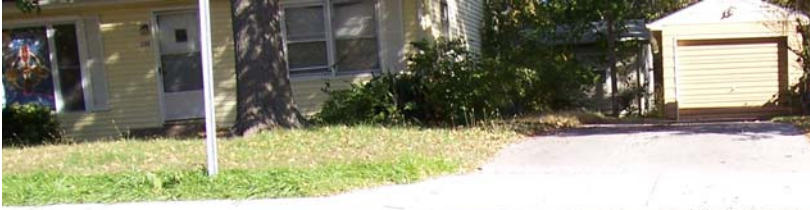
Noticeable roller marks and joints with loose material and porous surface.

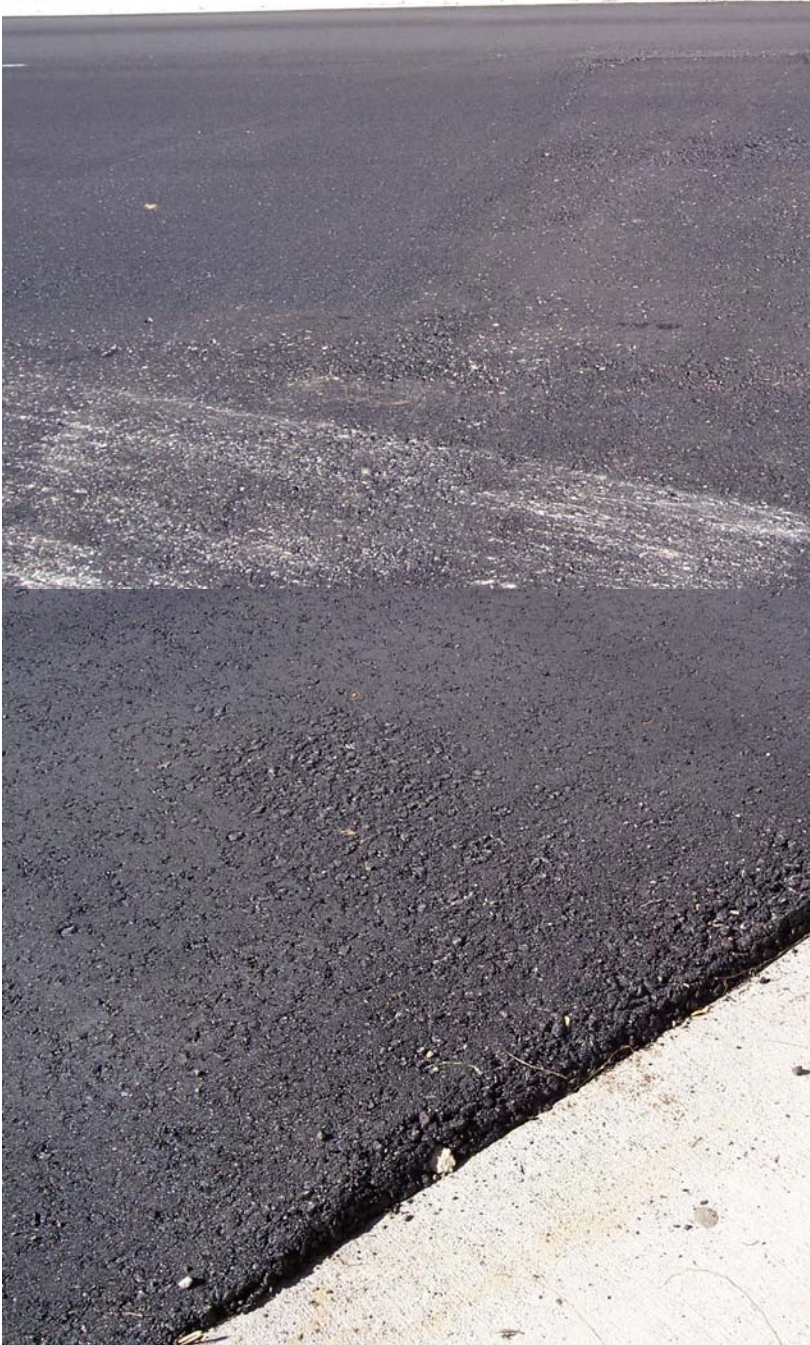
Gaps between the edge of the asphalt and the gutter allow water to infiltrate into the subgrade creating a greater potential for future base failures which require major patching. (This joint was sealed but that is not considered the best long-term solution.)

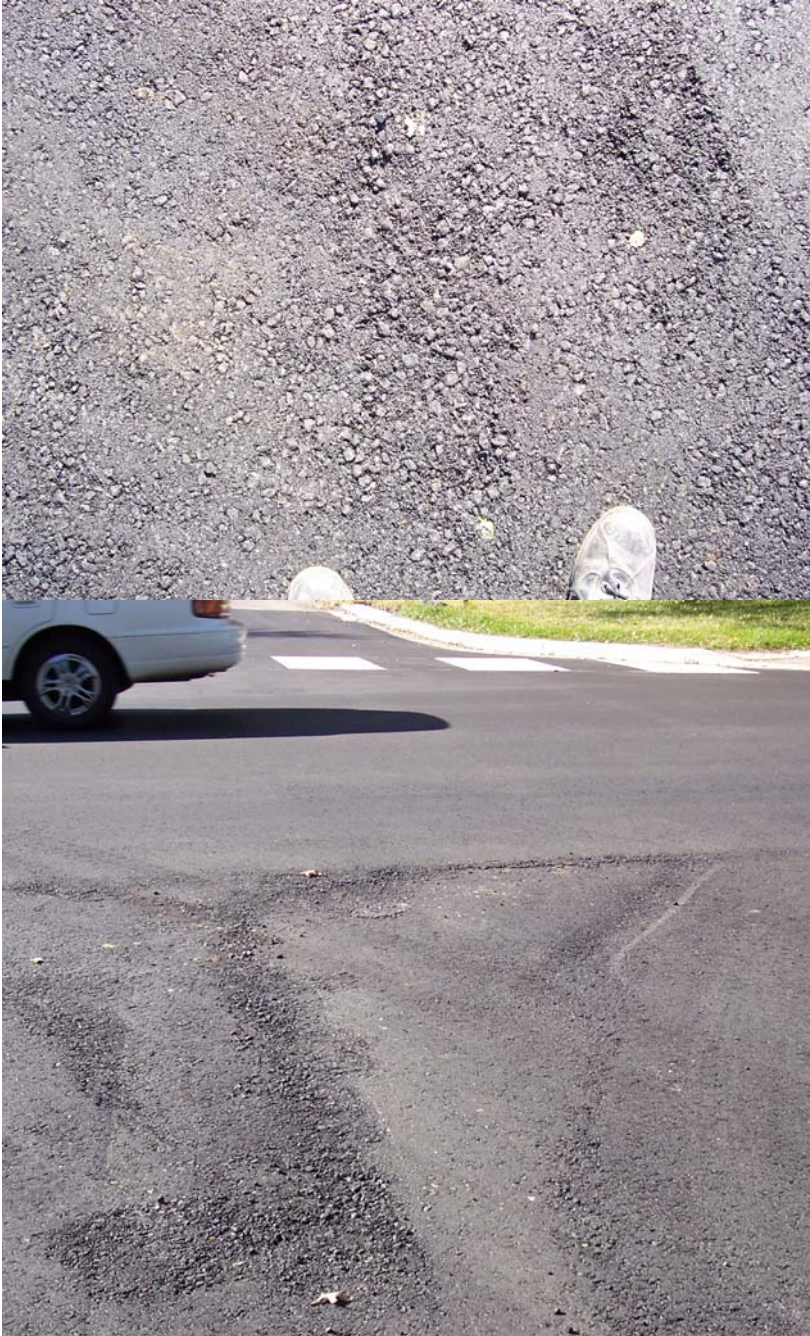
Very porous surface can result in the large aggregate pieces popping out. The holes can fill with water and freeze-thaw cycles can result in larger potholes.

Inadequate rolling and compaction, loose aggregate and porous surface result in rough surface areas like this which will deteriorate faster and can be easily damaged by snow plows.

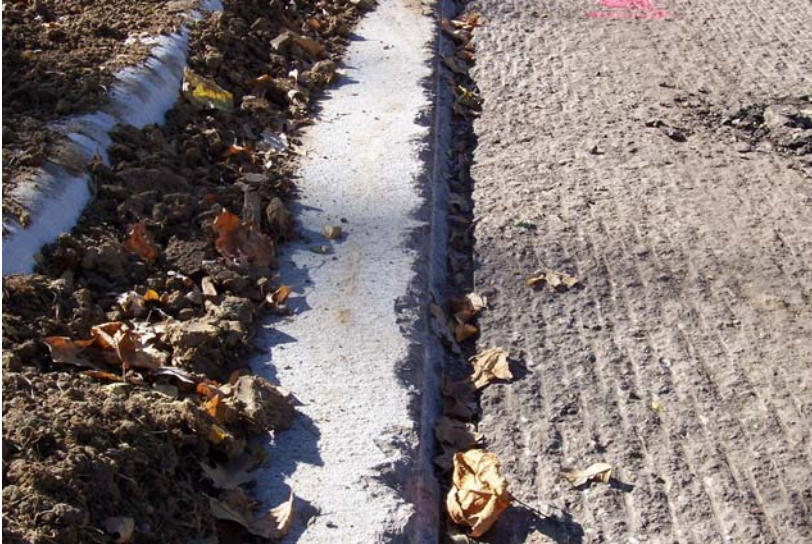
Edge of new curb & gutter damaged by milling machine is vulnerable to more rapid deterioration.

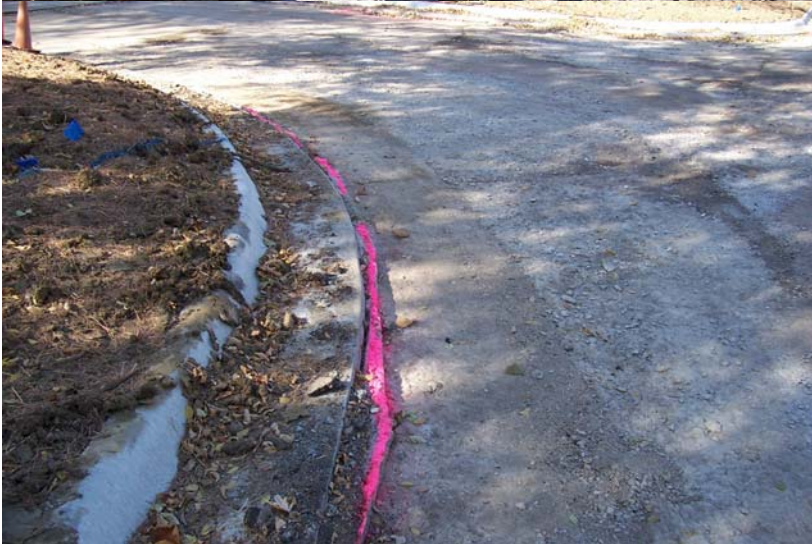
Area marked in pink is excess concrete ("slobbers") that prevent adequate depth of overlay at the edge of the pavement.

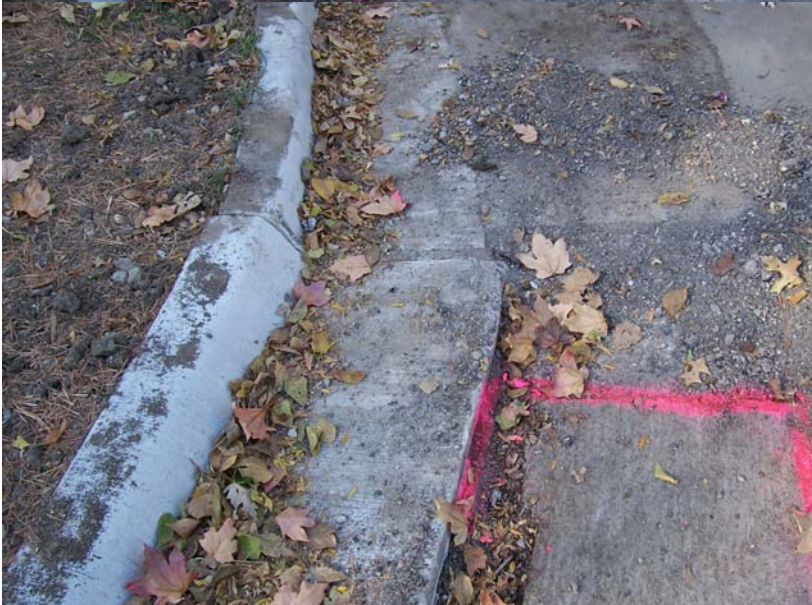
Back of curb and front edge of gutter do not align on each side of joint.

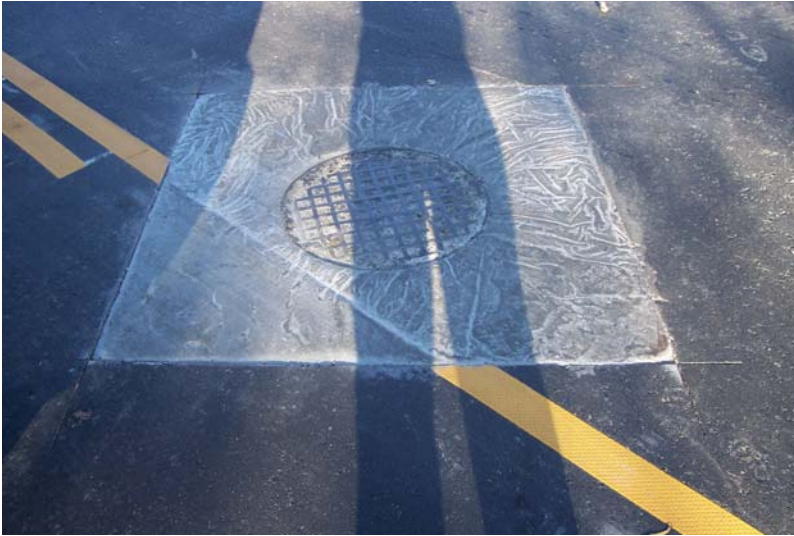
Concrete slab around manhole has imprints of creases in plastic sheeting used for protection from weather. (Example of aesthetic rather than functional issue.)
