Architectural Condition Survey

Santa Fe Railroad / AMTRAK Depot, Lawrence. Kansas

for the City of Lawrence, 2002

Survey: Lindsay Marion (student)

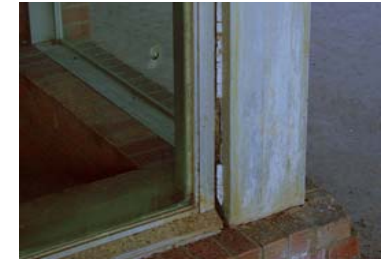
P85

- W8 – cracked glass in two panes. Caulking has come away from corner joint along entire right side to form 1/2in. gap at the edge of the frame. (P85)
- W9, 10, 11, 12, and 13 – good condition of frames with no cracked or broken glass. Stonework above and below windows shows minor gaps in mortar at joints. (P86)
- W10 – glass is missing from right half of windows, and the opening has been covered with wood. (Repaired between 6.24.2002 and 7.8.2002) (P87)

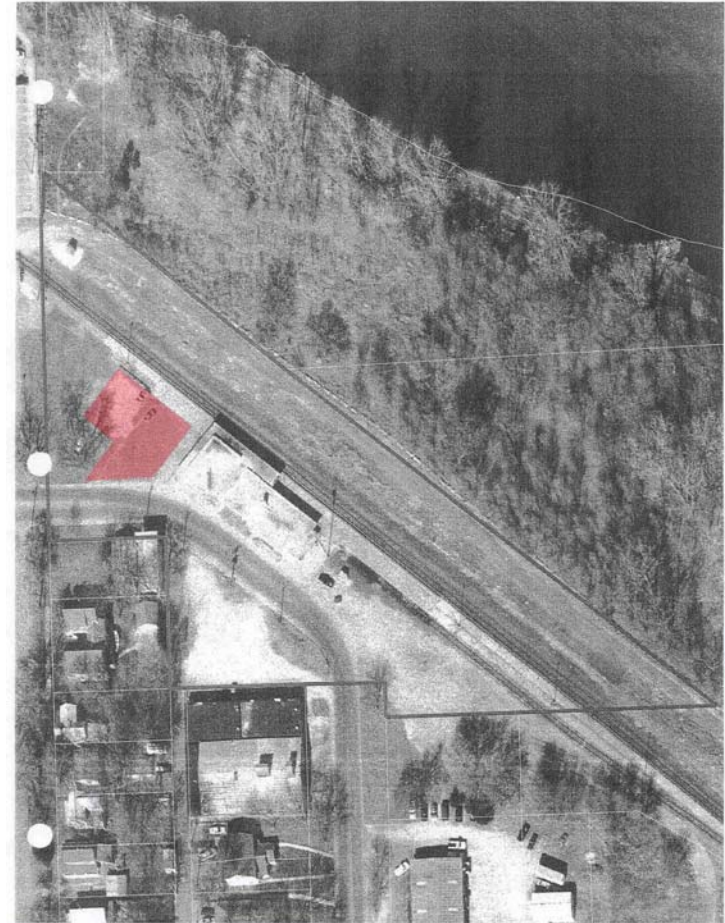
- Two parking lots on Northwest side of the building.
- The farthest from the station is asphalt with several cracks that run the length of the lot but do not show a great amount of deterioration.
 - This lot has room for approximately eight cars
 - The curb along the Northeastern half of the lot is deteriorated or missing
 - Bordered by wooden rail on the Northeast side that shows some deterioration of the wood
- The lot bordering the station is of brick and shows significant deterioration to the surface. The majority of the brick has some sand on it, and a strip along the Southeast side of the lot varying in width from 5-10ft. is almost entirely covered in sand.

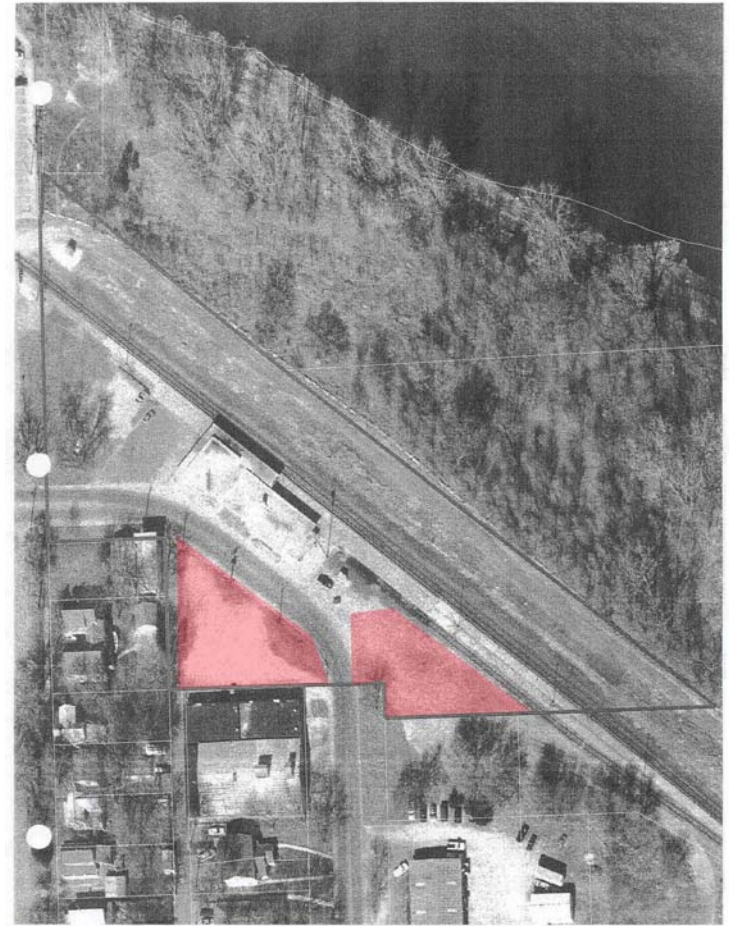
- The area to the Southeast of the station is mainly gravel and sand, with the exception of small grass areas on the South near the road and bordering the secondary tracks.
- Several large depressions where water has accumulated exist in the lot.
- Concrete driveway on the Southeast side of the station shows surface deterioration along the edges with shallow cracks.

- Gravel lot on the opposite side of 7th St., currently used by Van GO Mobile Arts. The triangular lot borders the street on the Northeast, and alley on the West, and the arts building on the South. In addition to the gravel, there are areas of weeds and grass around each telephone pole.

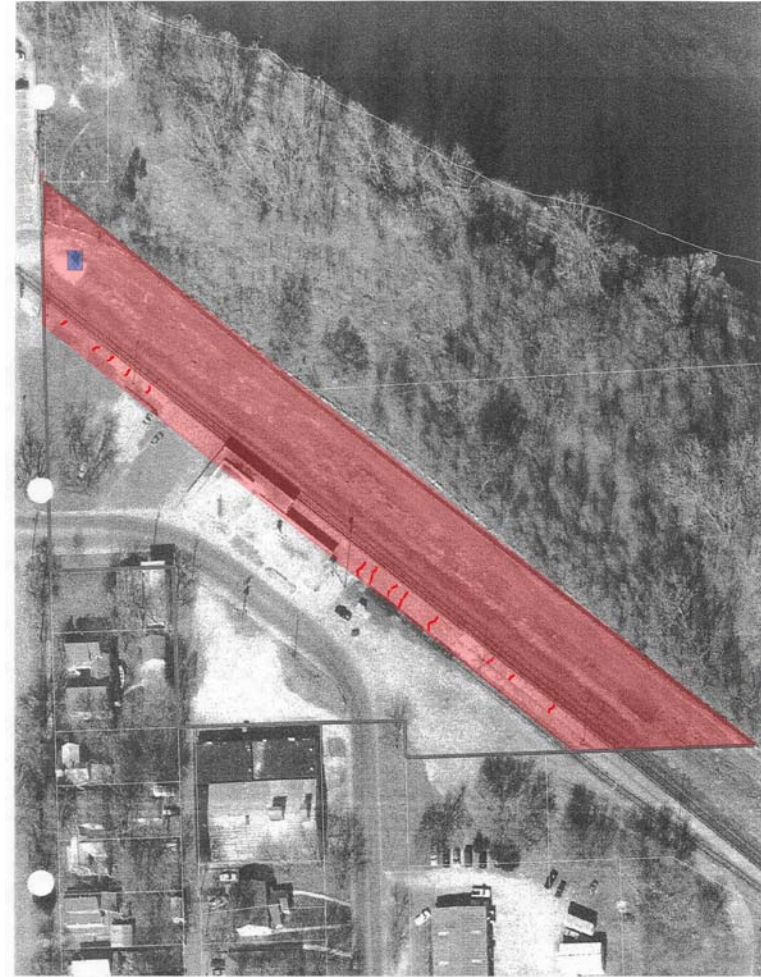
- Train platform/access sidewalk along Southwest side of the tracks shows several large cracks running perpendicular to the edge. Five sidewalk cracks exist to the Northwest of the station, all showing deterioration at edge bordering the tracks.
- Portion of the sidewalk Southeast of the station is asphalt as far as the first light pole from the station, changes to concrete, and continues as such until the property line. Asphalt has 5-10 cracks. Concrete shows deterioration along the Southwest side of the sidewalk near weed vegetation, and three major cracks, which show increasing deterioration near the tracks.
- The platform directly in front of the station is in good condition, but the remainder shows deterioration of the surface and edge.

- A private (?) gravel road runs along the Northeast side of the tracks, separated from them by a screen of weed vegetation. The road appears in fairly good condition with no potholes. The Northeast side of the road borders a Habitat Restoration Area near the river.
- Electrical box near the railroad crossing at northernmost corner of property line.

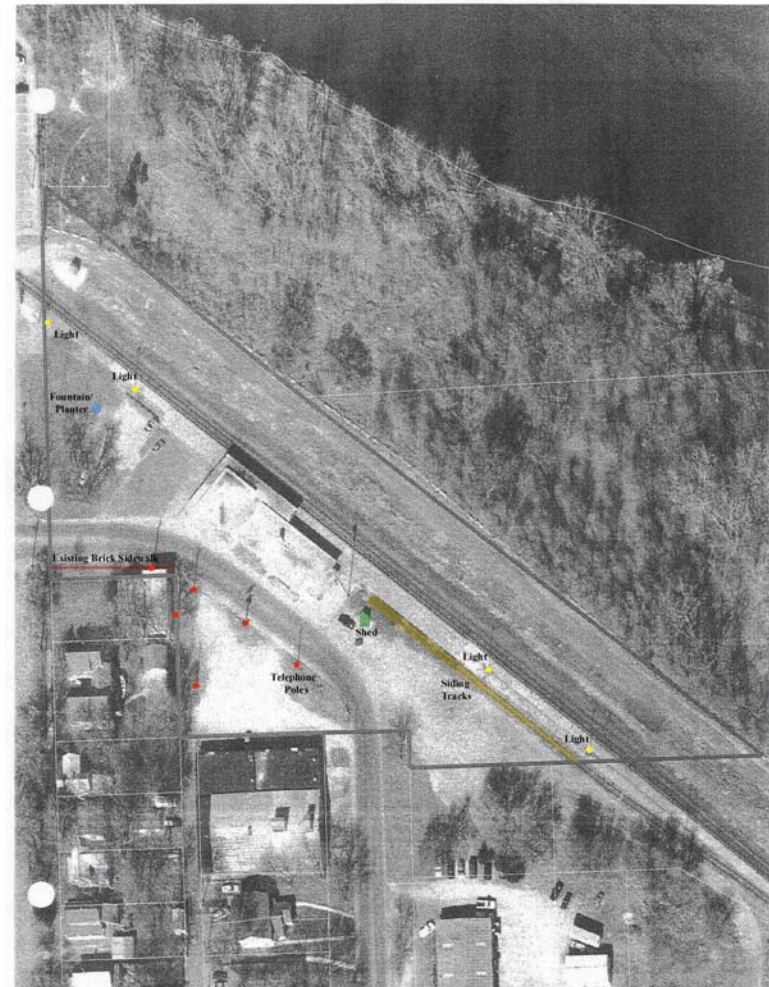
- The grass lawn to the Northwest of the station has a circular concrete structure, one foot high, possibly once a fountain or planter, and of potential historic interest.
- An existing brick sidewalk runs in front of the upholstery shop and continues to the end of the block. It is in good condition in front of the shop and almost entirely covered in grass on the other half.
- A railroad crossing lies just beyond the Northernmost corner of the property.
- The edge of the concrete patio bordering the siding tracks is deteriorated to the rebar in two spots.
- All four of the platform light poles show surface corrosion.
- A shed and pit are located to the South of the intersection of the siding tracks and Southeast patio.
- There are six telephone poles located within the property line.
