# LAWRENCE LIBRARY

## MECHANICAL AND ELECTRICAL STUDY

NO VEMBER 2008

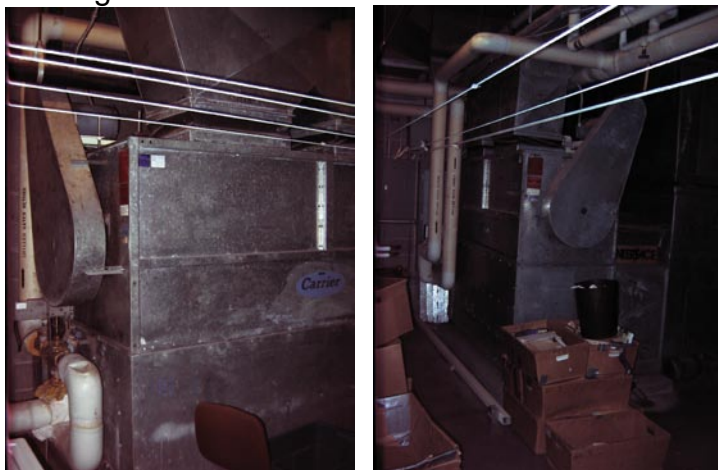
The existing air handling units for the basement that should be replaced due to efficiency and condition.

The second priority we would recommend is to replace the three basement air handling units because of their age, and condition.

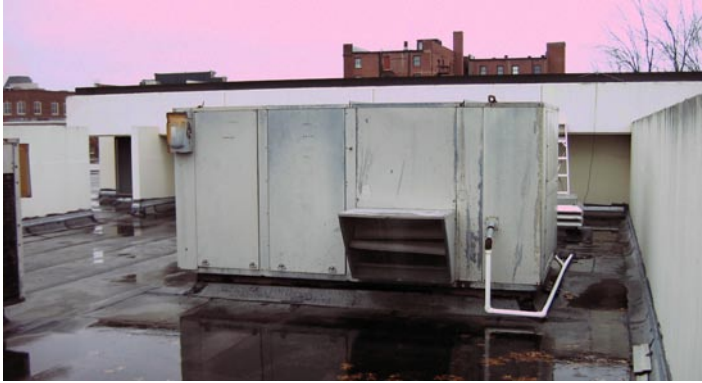
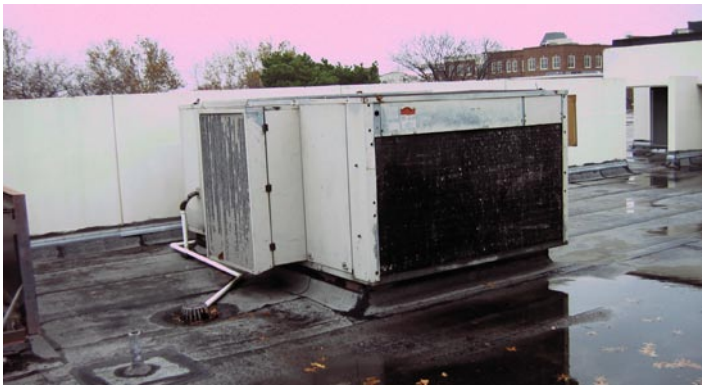
The existing 1972 Rooftop Units that need to be replaced for efficiency and condition.

The first priority we would recommend is to replace the two west roof top units and the chiller because of their age, condition, and energy usage. Along with this we would recommend installing a new building HVAC control system to increase comfort and better control energy usage. Also a part of this would be to add more air conditioning capacity for the Adult Services Lower Level area.

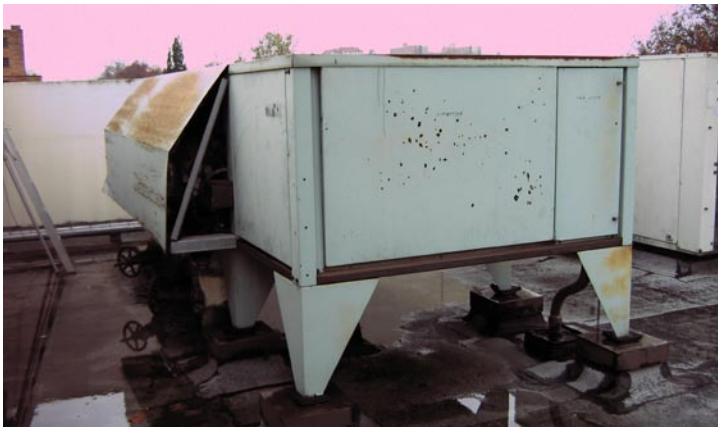
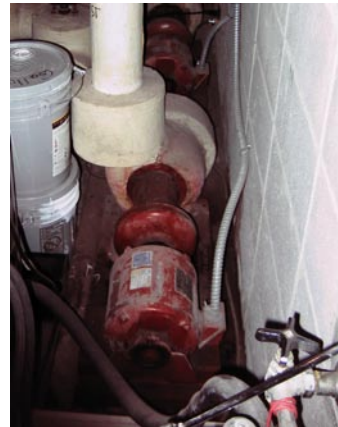
The existing 1972 chiller and its related pump that need to be replaced for improved efficiency and because of age and condition.

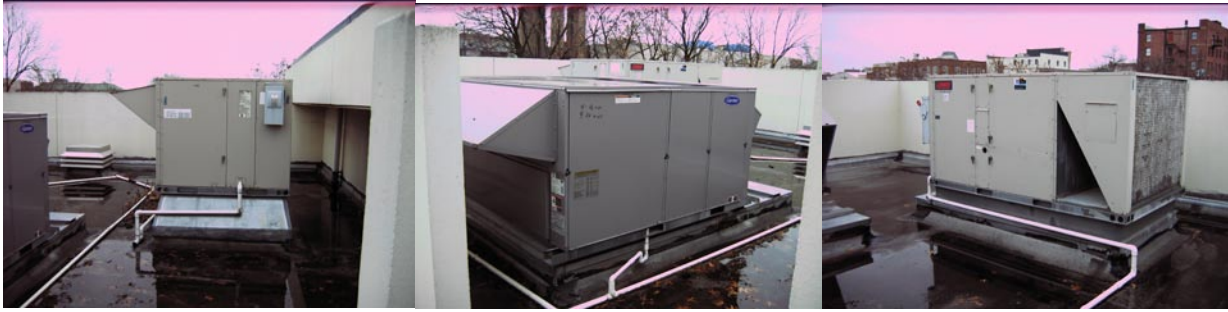
The three east roof top units have been replaced in the past several years with newer units that are in good condition.

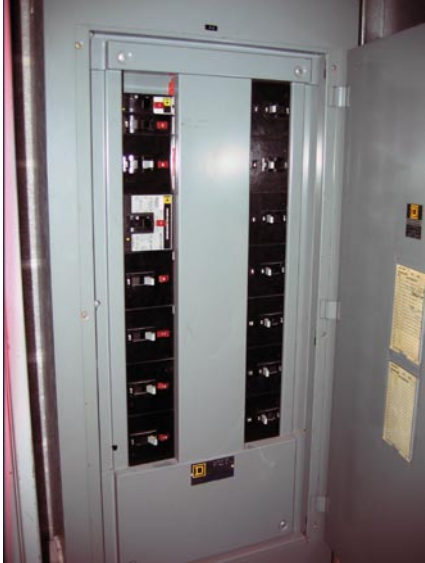
The electrical service is a 1,000 amp, 277/480 volt, service that is original but appears to be in relatively good condition.

Existing main distribution panel board.

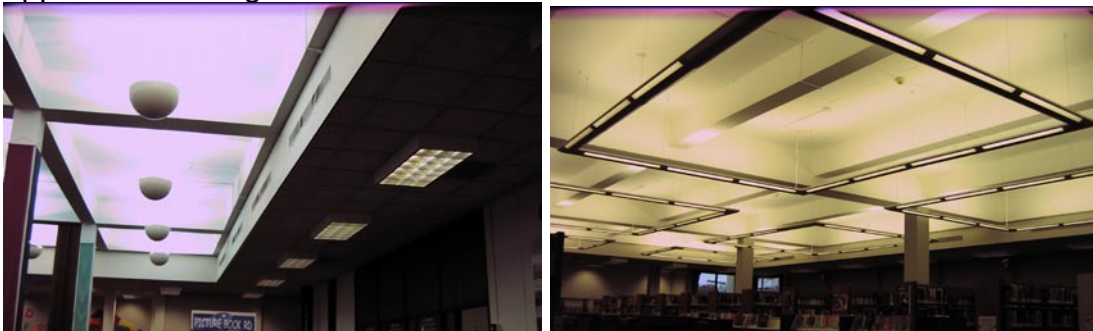
The lighting in a portion of the public spaces on the upper floor has been updated and appears to be in good condition.

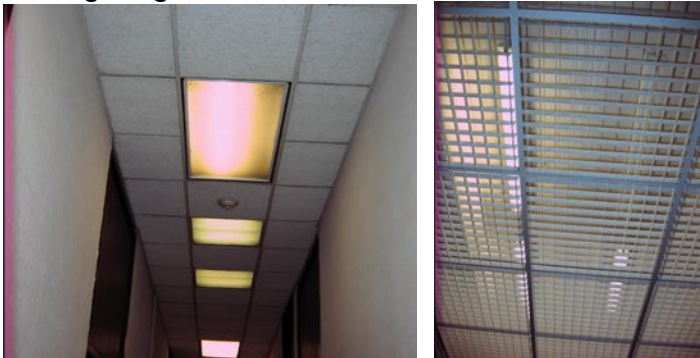
The lighting in the office areas and basement should be updated
