Lawrence, Kansas
Bowersock Dam Inspection 2006

B&V Project 146136
B&V File B-1.1
February 14, 2007

On October 30, 2006 an inspection of the Bowersock Dam in Lawrence, Kansas was performed to assess the condition of the dam. This report summarizes the visual observations made of the dam's condition and provides a phased recommendation for corrective actions for the City of Lawrence's consideration.

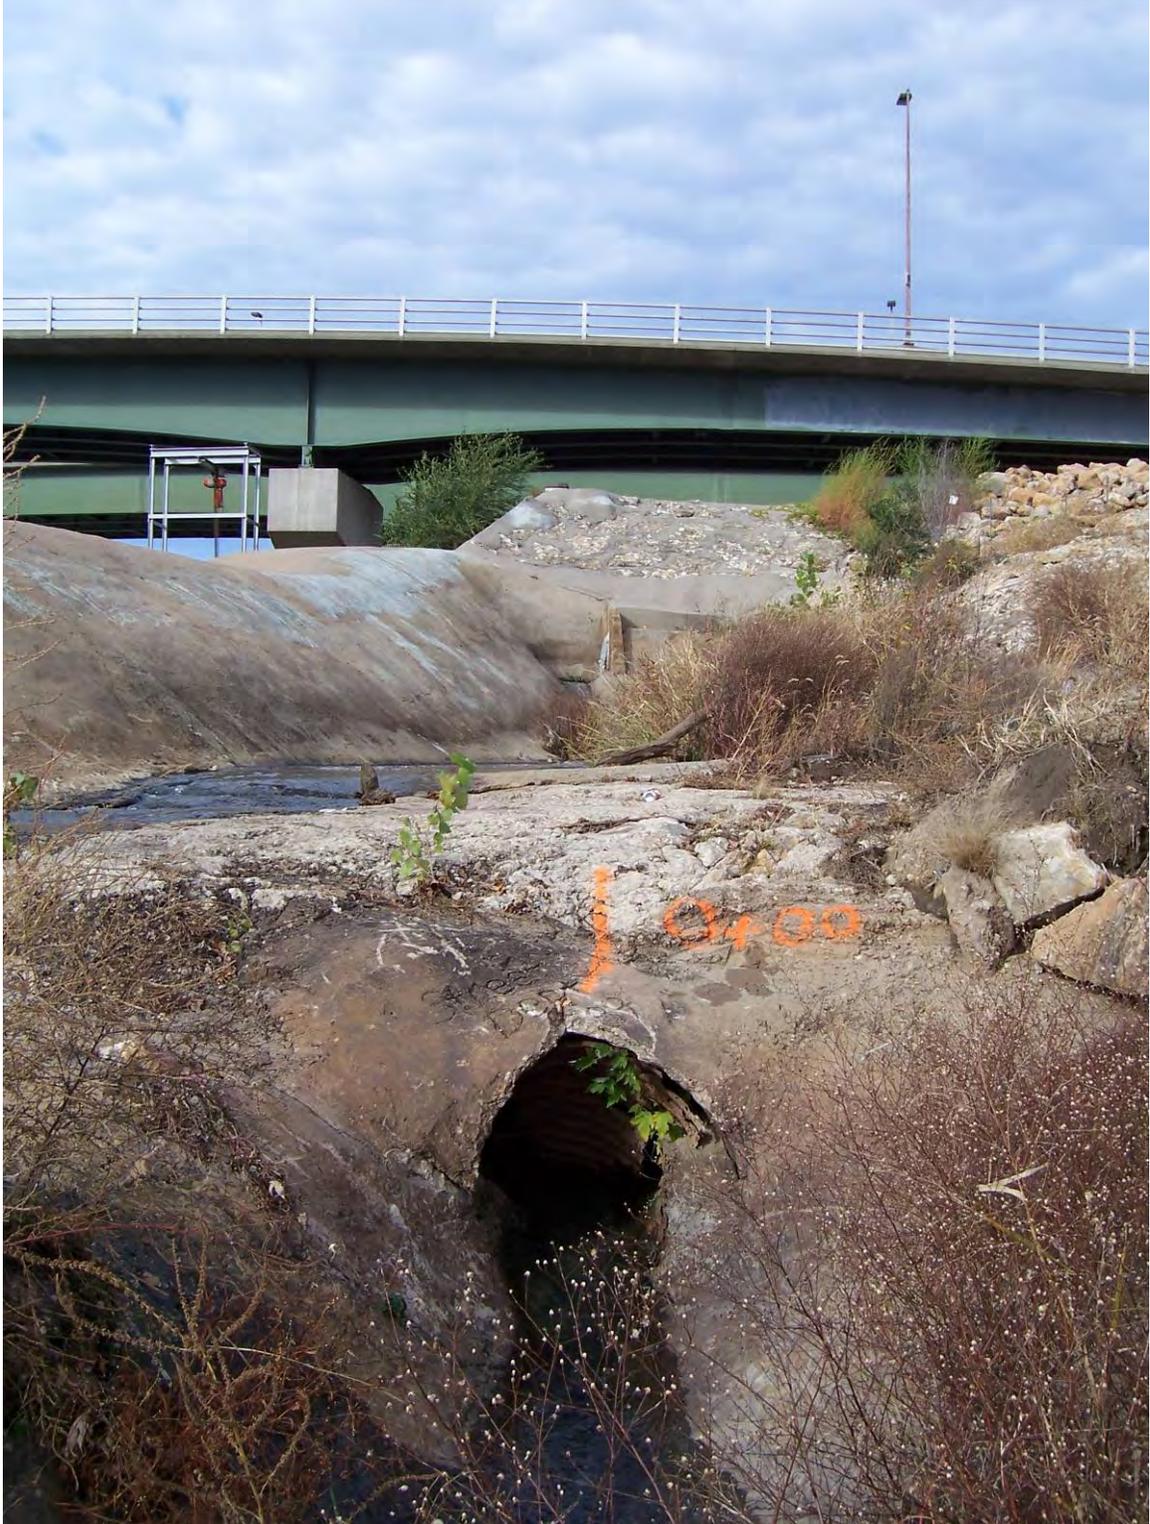
- Between Station 0+00 and 1+25, there are areas of spalled, cracked, and deteriorated concrete near the storm drain piping and along the northern spillway flume. Refer to pictures 1 through 4, and 6 through 18.
- The apron repairs completed in 2002 appear to be in excellent condition. The bond between the new and existing concrete appears to be sound, as little to no separation of the surface was identified. The sheet piling installed also appears to be protected by the apron caps and the riprap installed in the river appears have remained in place. See photographs 5, 7, 51, 75, 84, 144, and 146.
- Bowersock staff has installed a jetty of riprap parallel to and downstream from the dam near Station 2+00 to maintain a minimum pool elevation for the turbines to reduce cavitation

1. Station 0+00, North end of dam, storm drain, deteriorated concrete along storm drainage flume

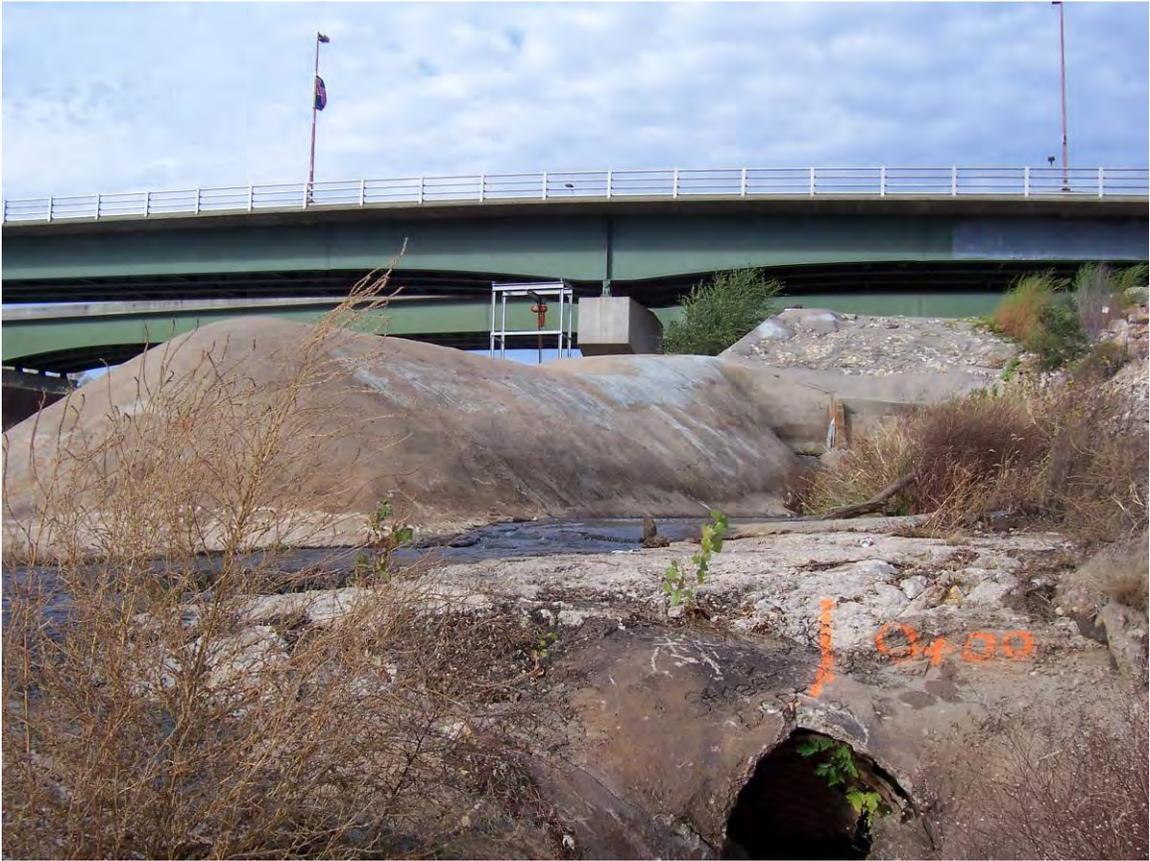
2. Station 0+00, Storm drainage flume, north wall of spillway

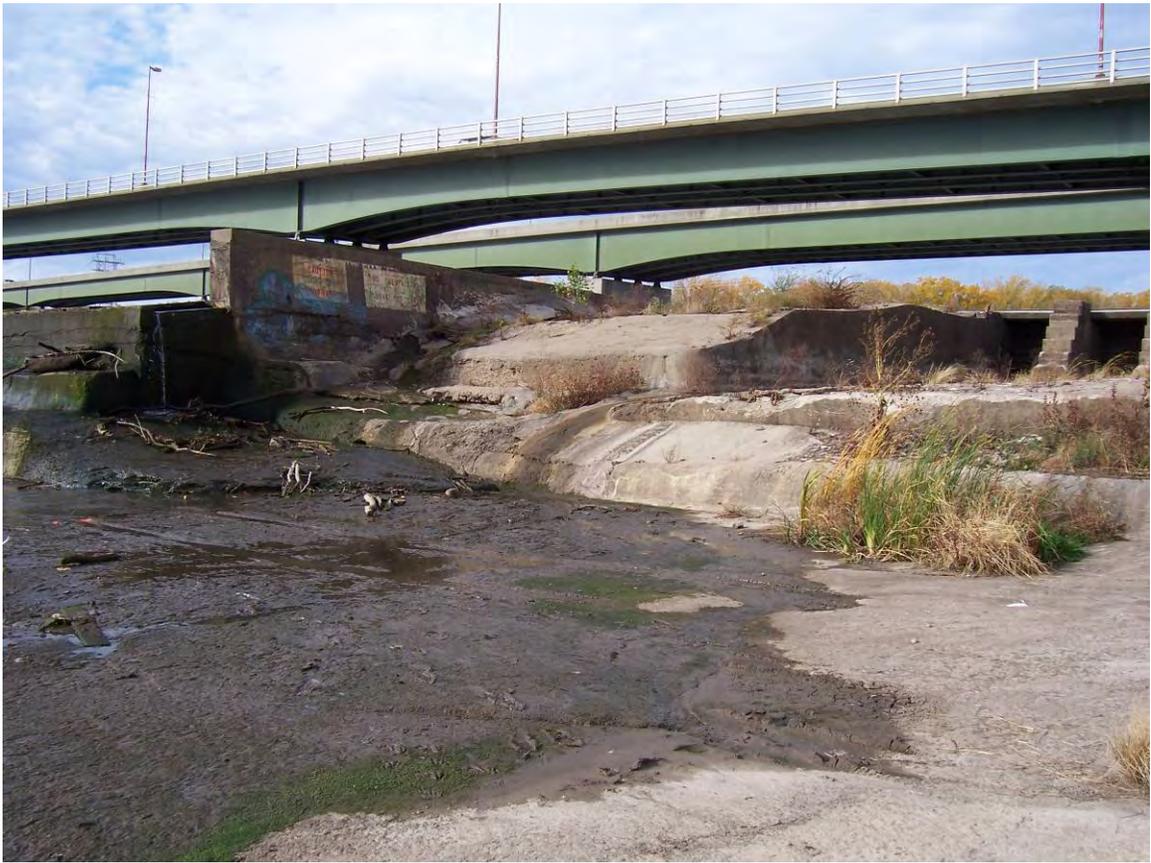
12. Sta 0+50 to Sta 0+00. Spillway. Eroded and cracked concrete.

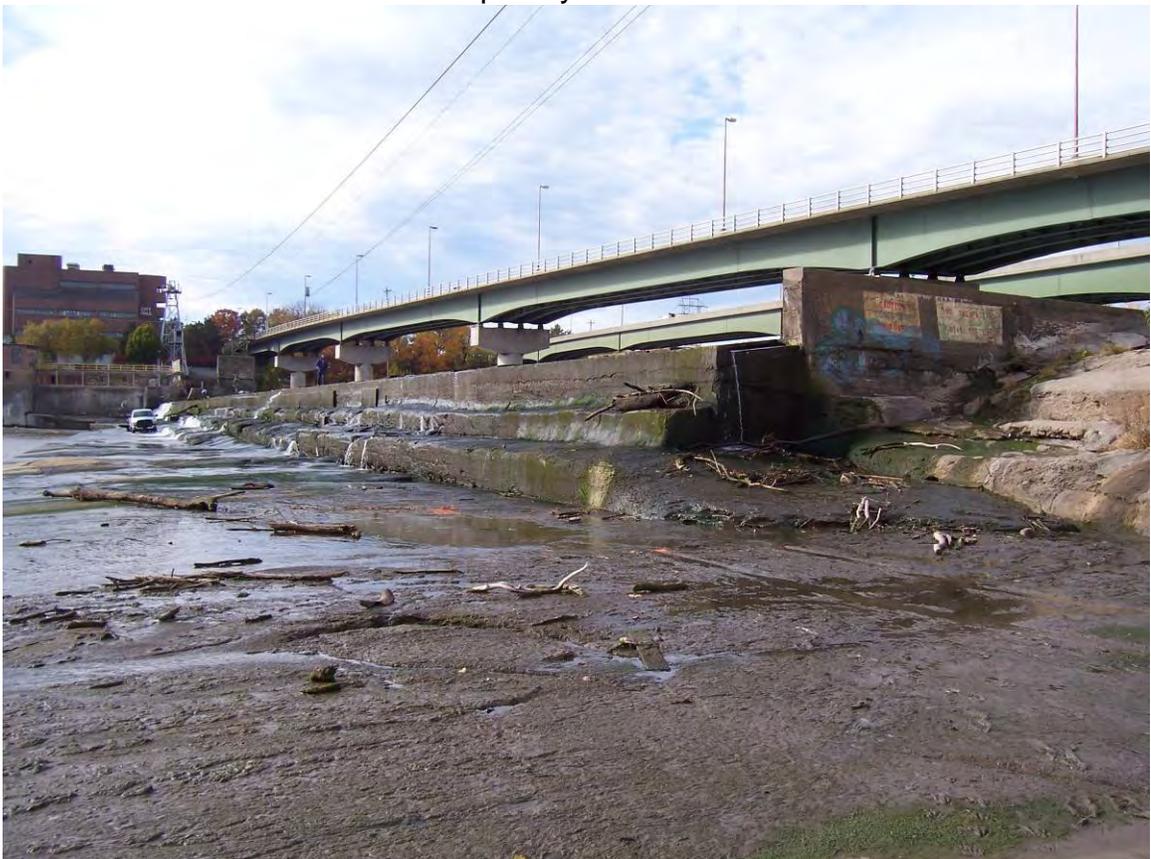
13. Sta 0+50 to Sta 1+50. North end of dam and flashboards. Eroded and cracked concrete on old apron.

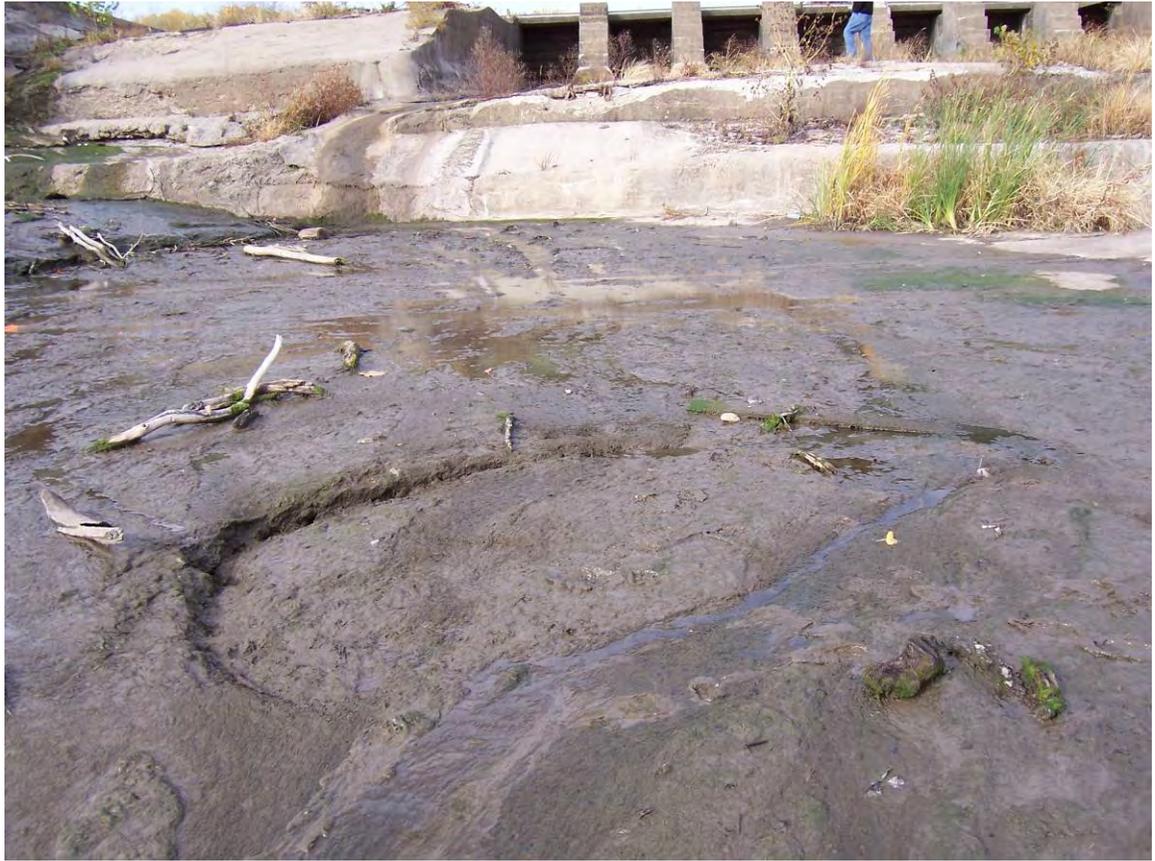
14. Sta 0+75. Eroded concrete in spillway.

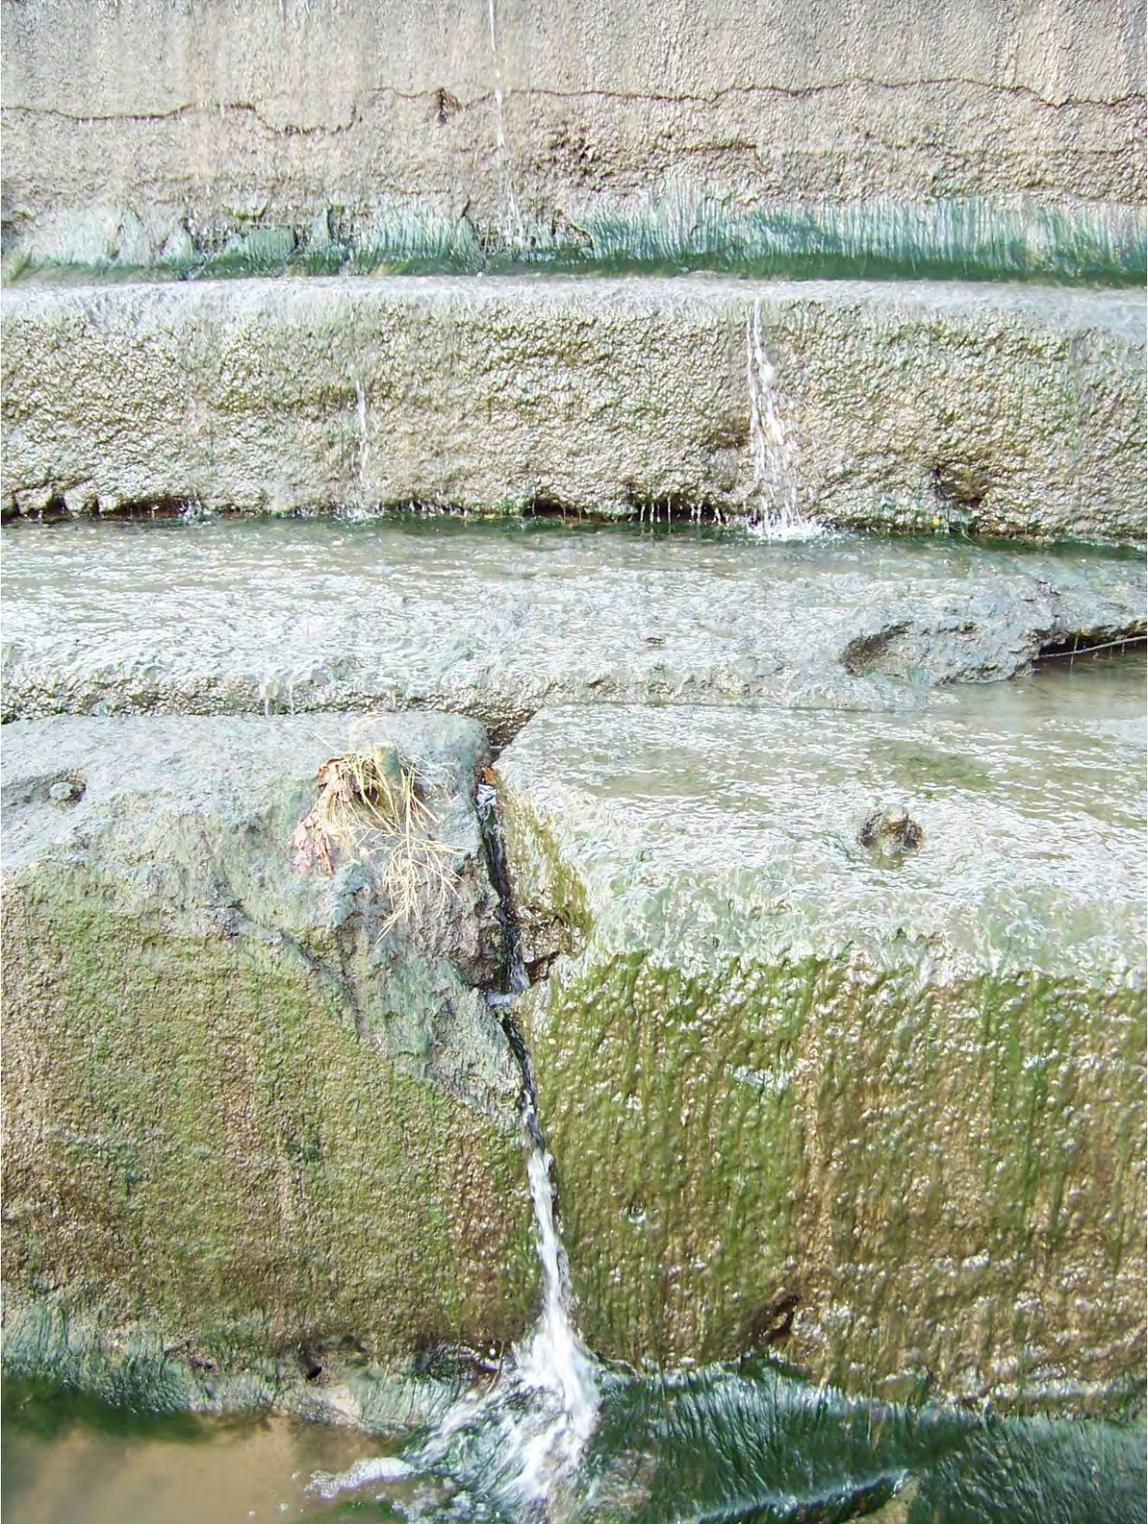
- Between Stations 2+00 and 2+50, there is a significant triangular piece of concrete approximately 25' by 8' that is separated from the lowest step of the dam. Refer to photographs 26 through 28 and 106 through 108.

- Between Stations 2+00 and 2+50, there is significant erosion of the top of the steps of the concrete dam exposing rebar. Refer to photographs 24 through 27.

26. Sta 2+10. Crack in lower step. Exposed joint between steps. Eroded shotcrete with exposed wire mesh. Triangular crack beginning.

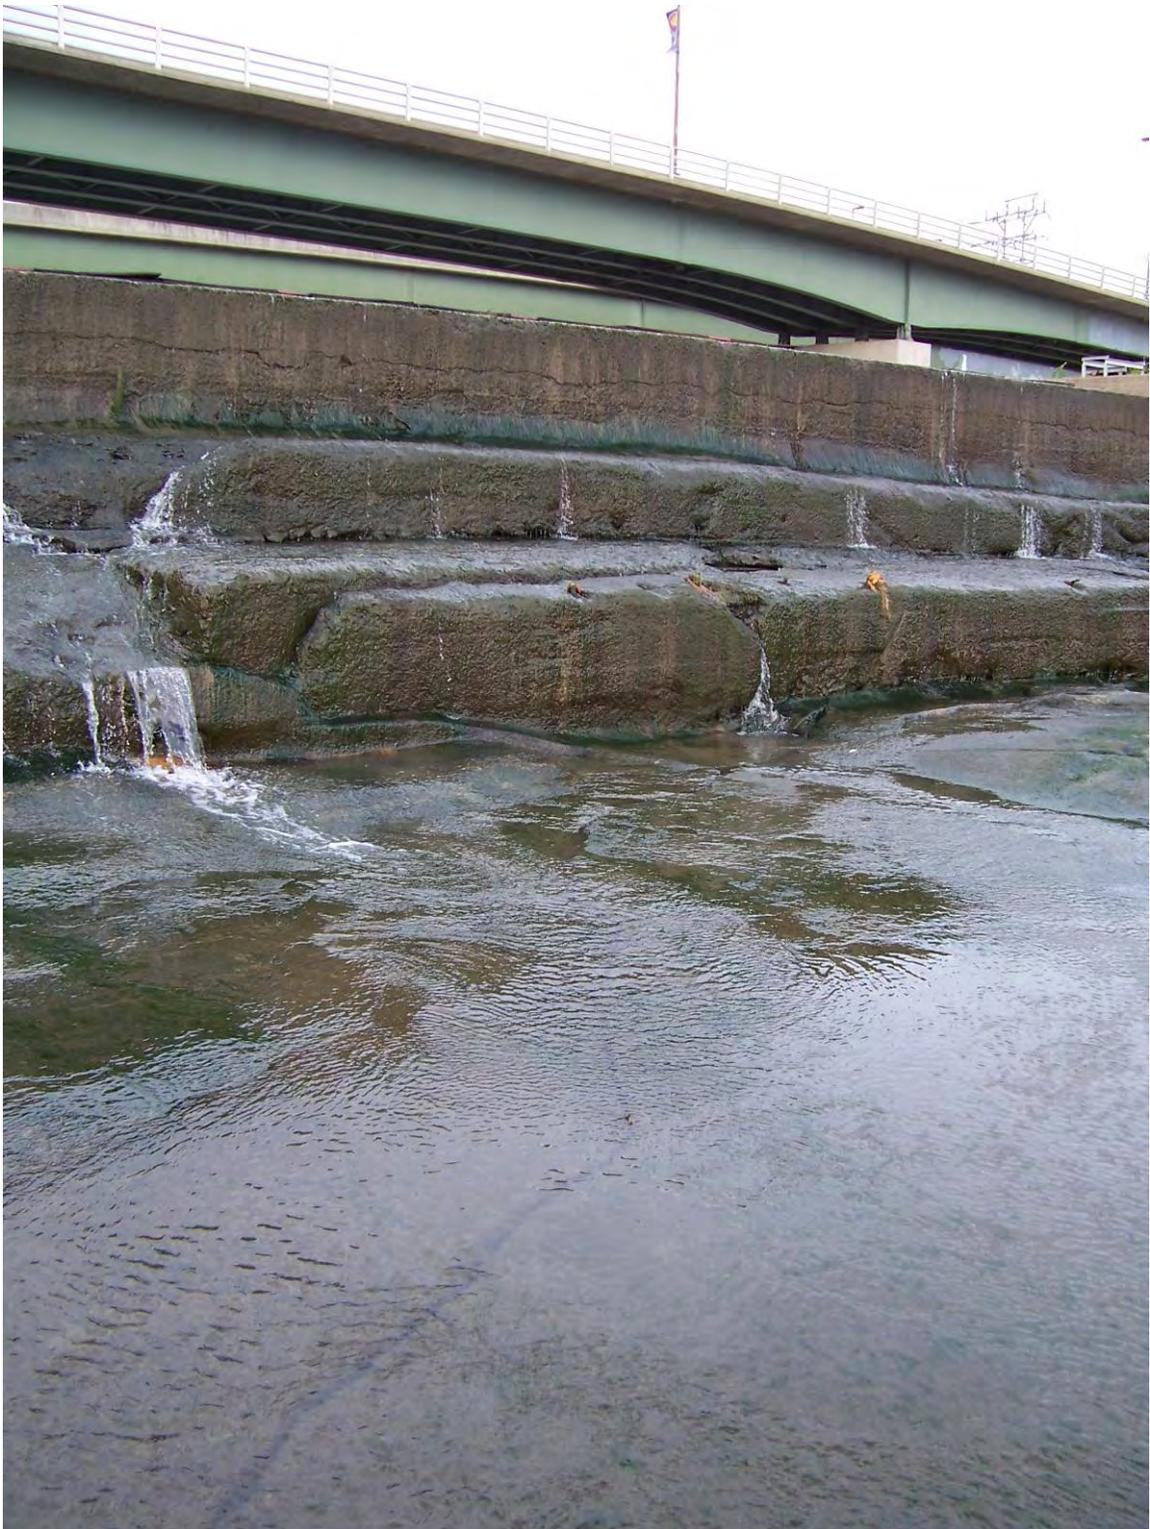
- Between Stations 2+00 and 2+50, there was evidence of flow through the apron represented by bubbling action on the water surface and rings of waves. In addition, there is a crack that runs from the lower step of the dam to the face of the apron. Refer to photographs No. 27 and 28, and video beginning at timestamp 9:46 a.m.

27. Sta 2+25±. Triangular section broken away in bottom step. Crack in apron that extends to edge of apron. Exposed joints between steps. Deteriorated steps.

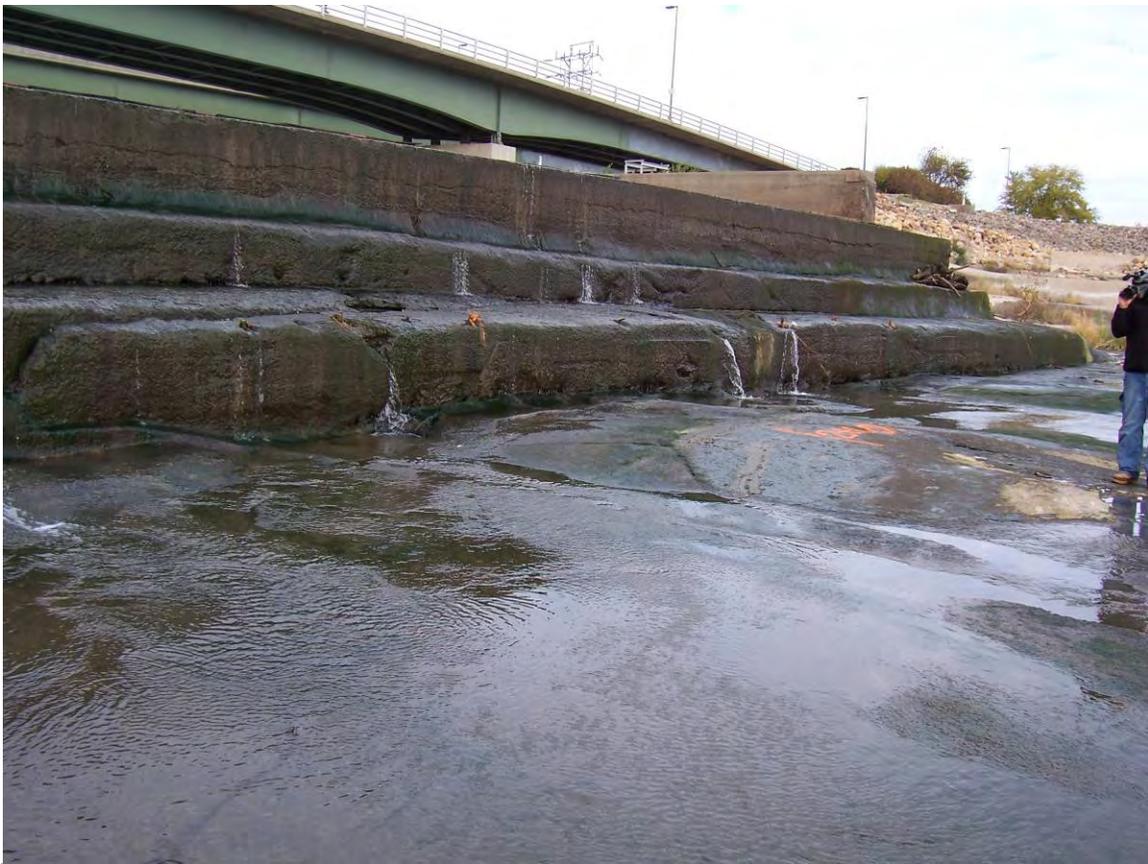
28. Sta 2+25. Back to Sta 2+00. Triangular section in bottom step.
Crack in apron.

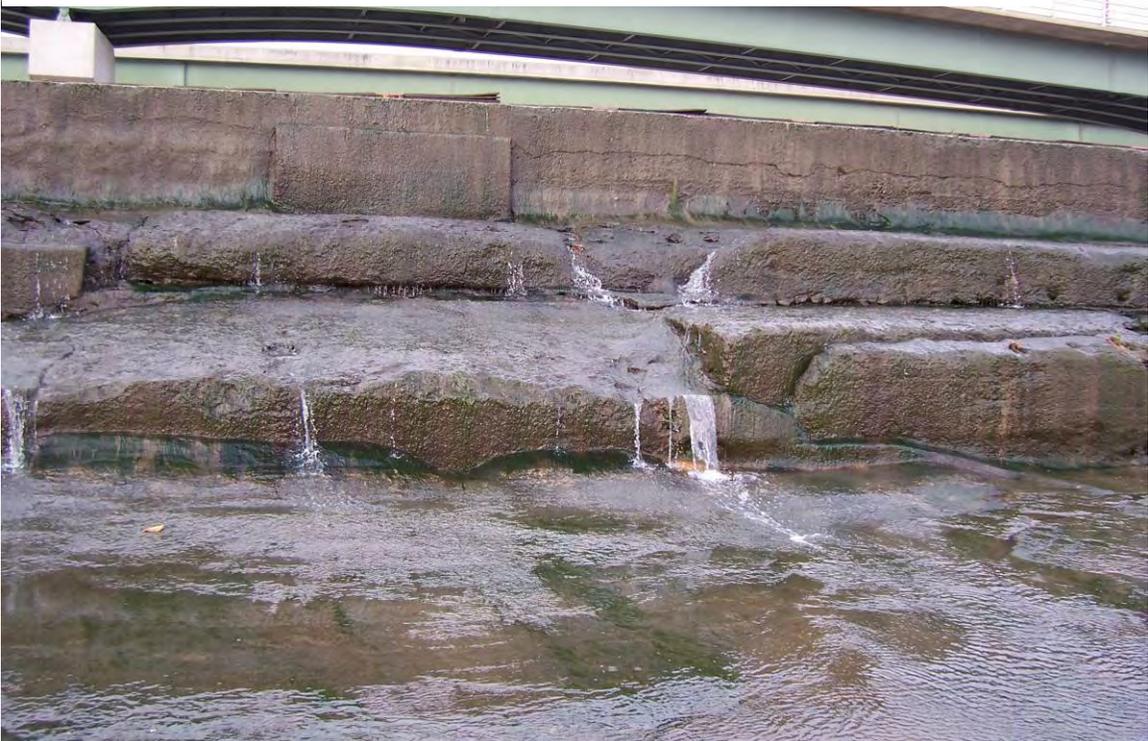
29. Sta 2+40±. Deteriorated steps. Exposed joints.

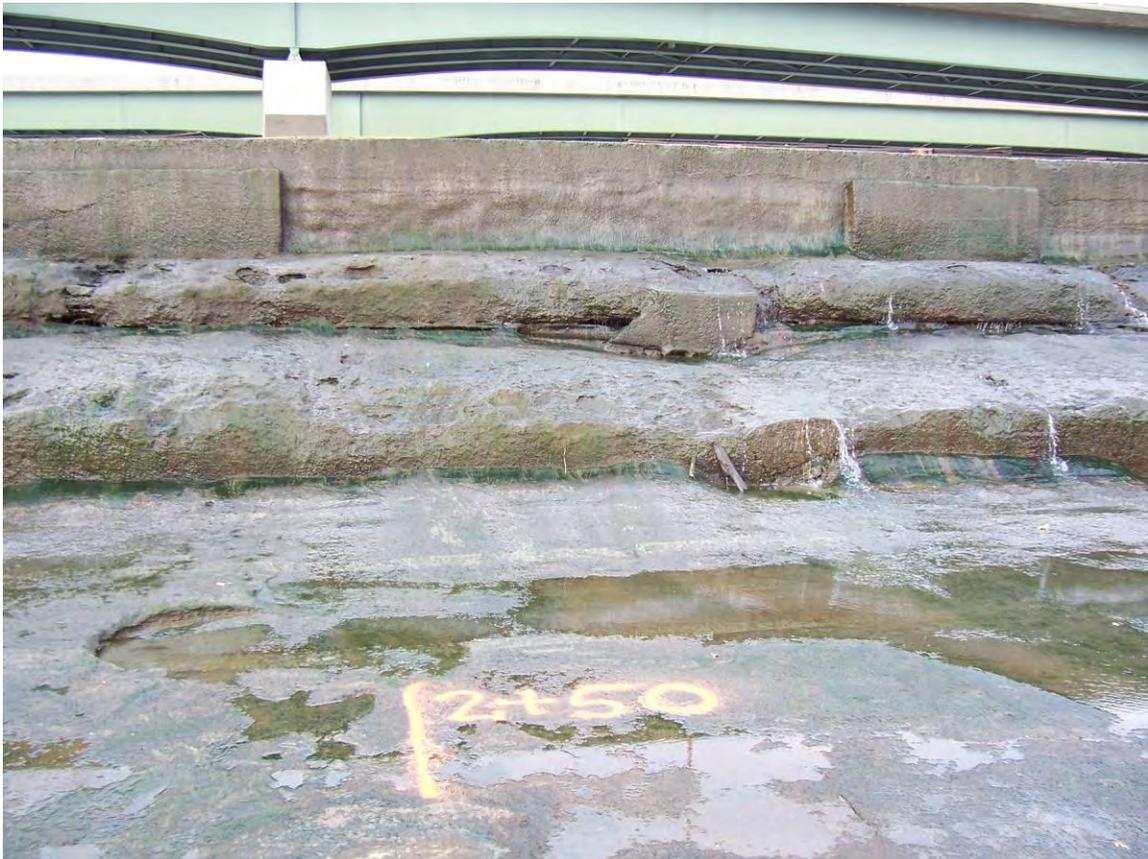
- Between Stations 2+50 and 3+50, the concrete has eroded to expose the timbers. Refer to photographs 30, 31, 33, 35 through 49, 104 and 105.
- Between Stations 2+75 and 3+50, all three steps in the dam are in poor condition. Refer to photographs No 37 through 49, 52, and 102 through 105.

30. Sta 2+50. Exposed joints between steps. Eroded concrete in top step. Exposed rebar at old timbers.

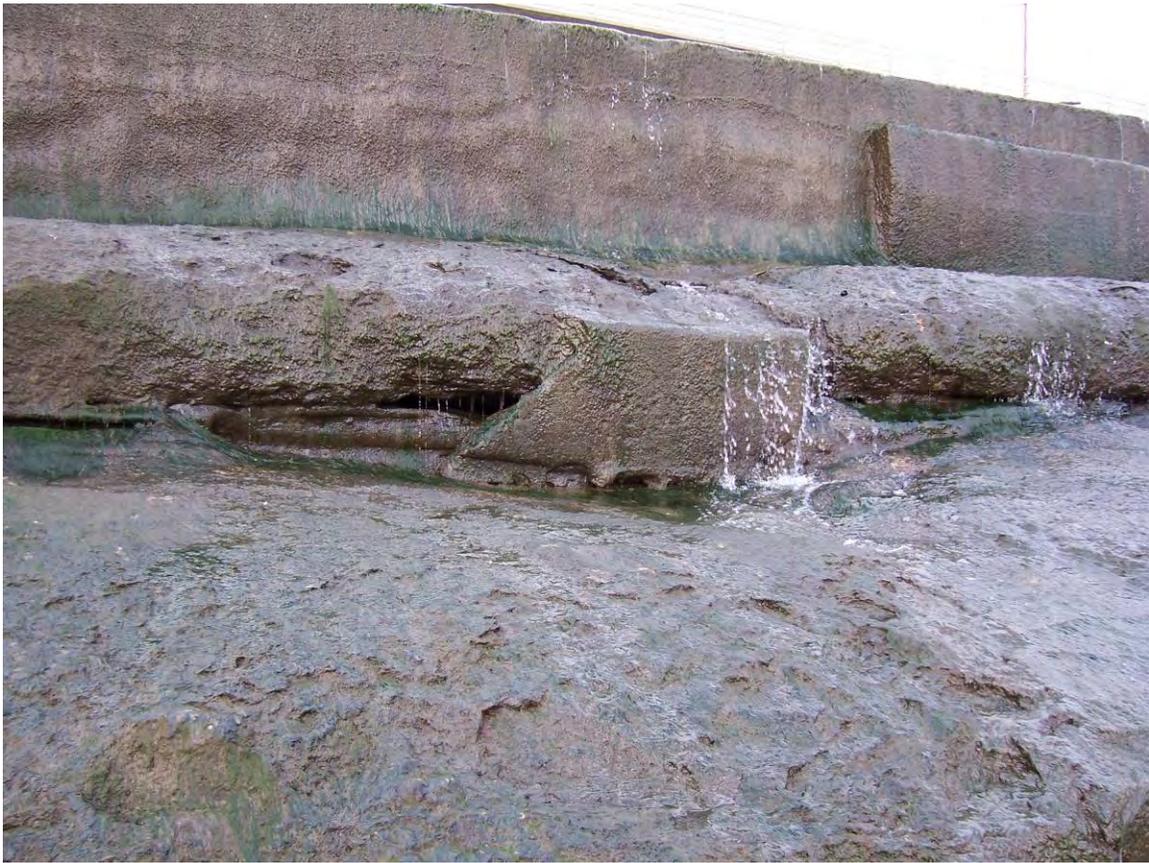
32. Sta 2+45. Deteriorated steps exposed joints.

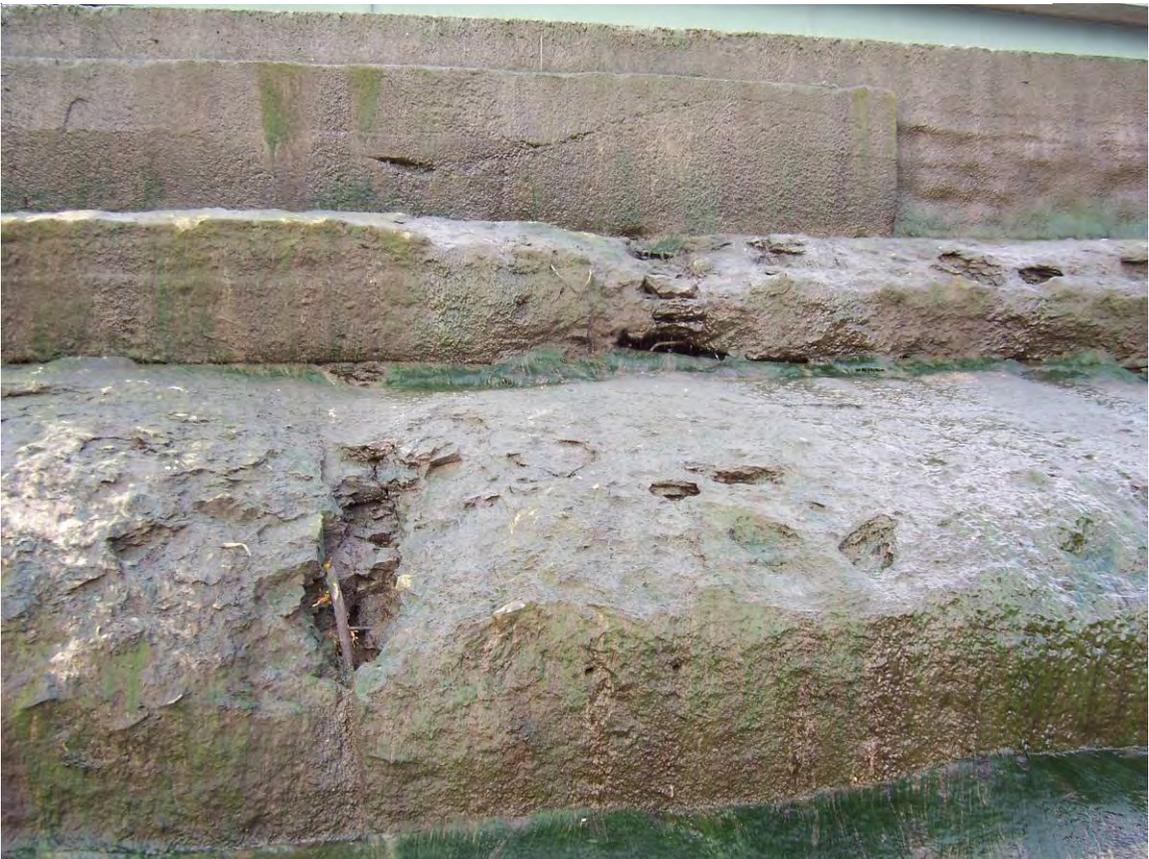
33. Sta 2+65±. Exposed timber holes and rebar. Eroded concrete. Exposed joint between steps.

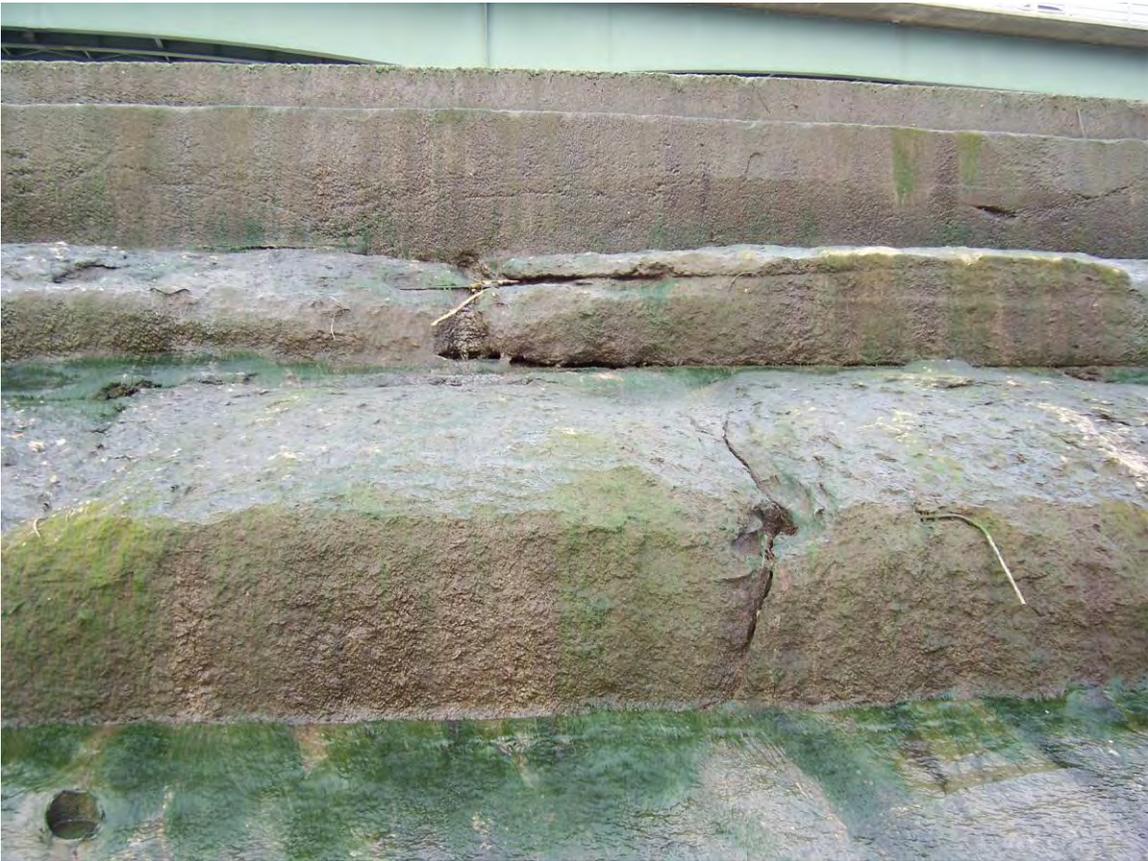
36. Sta 2+75±. Exposed joint and cracked middle step. Crack in bottom step. Weep hole.

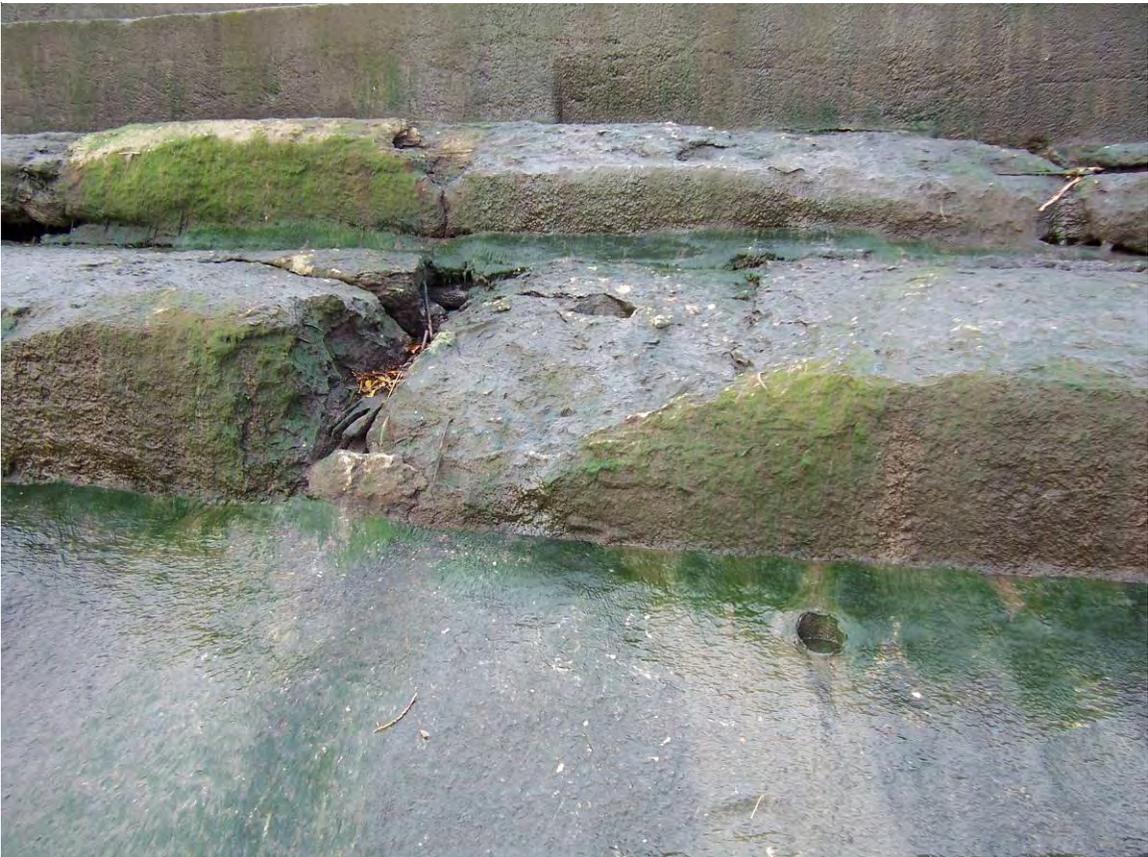
37. Sta 2+80±. Exposed timber and eroded concrete. Crack in bottom step.

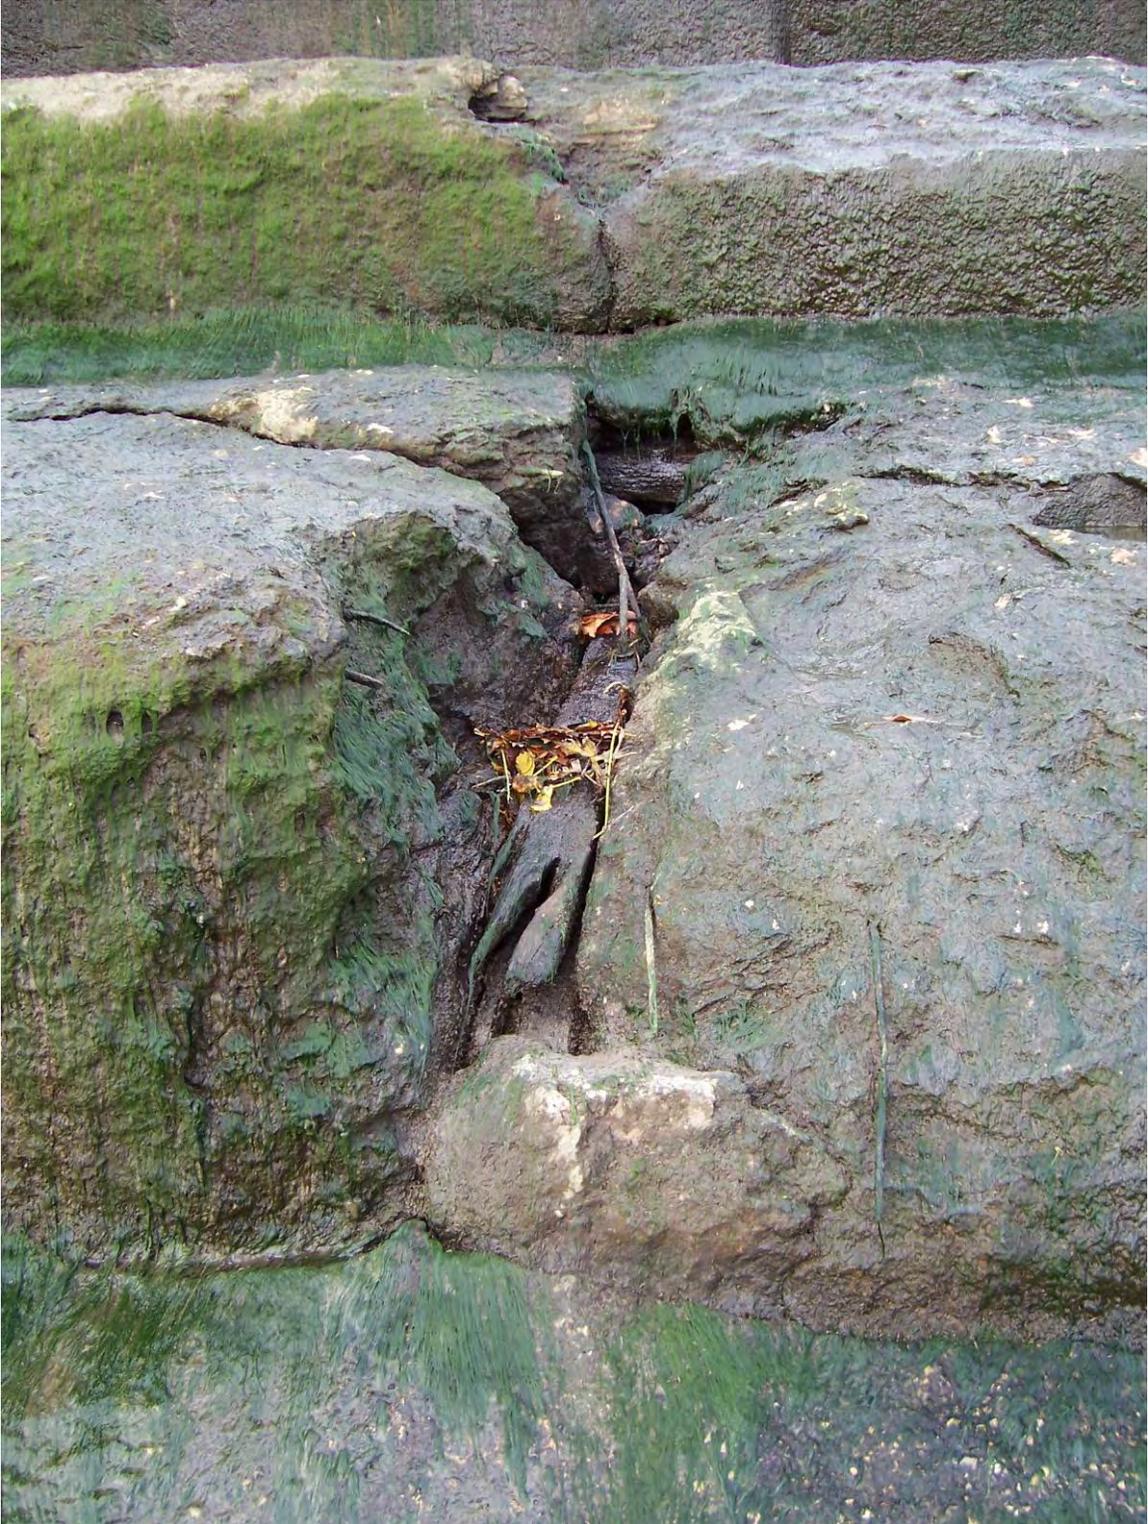
38. Sta 2+80±. Exposed timber and eroded concrete. Crack in bottom step.

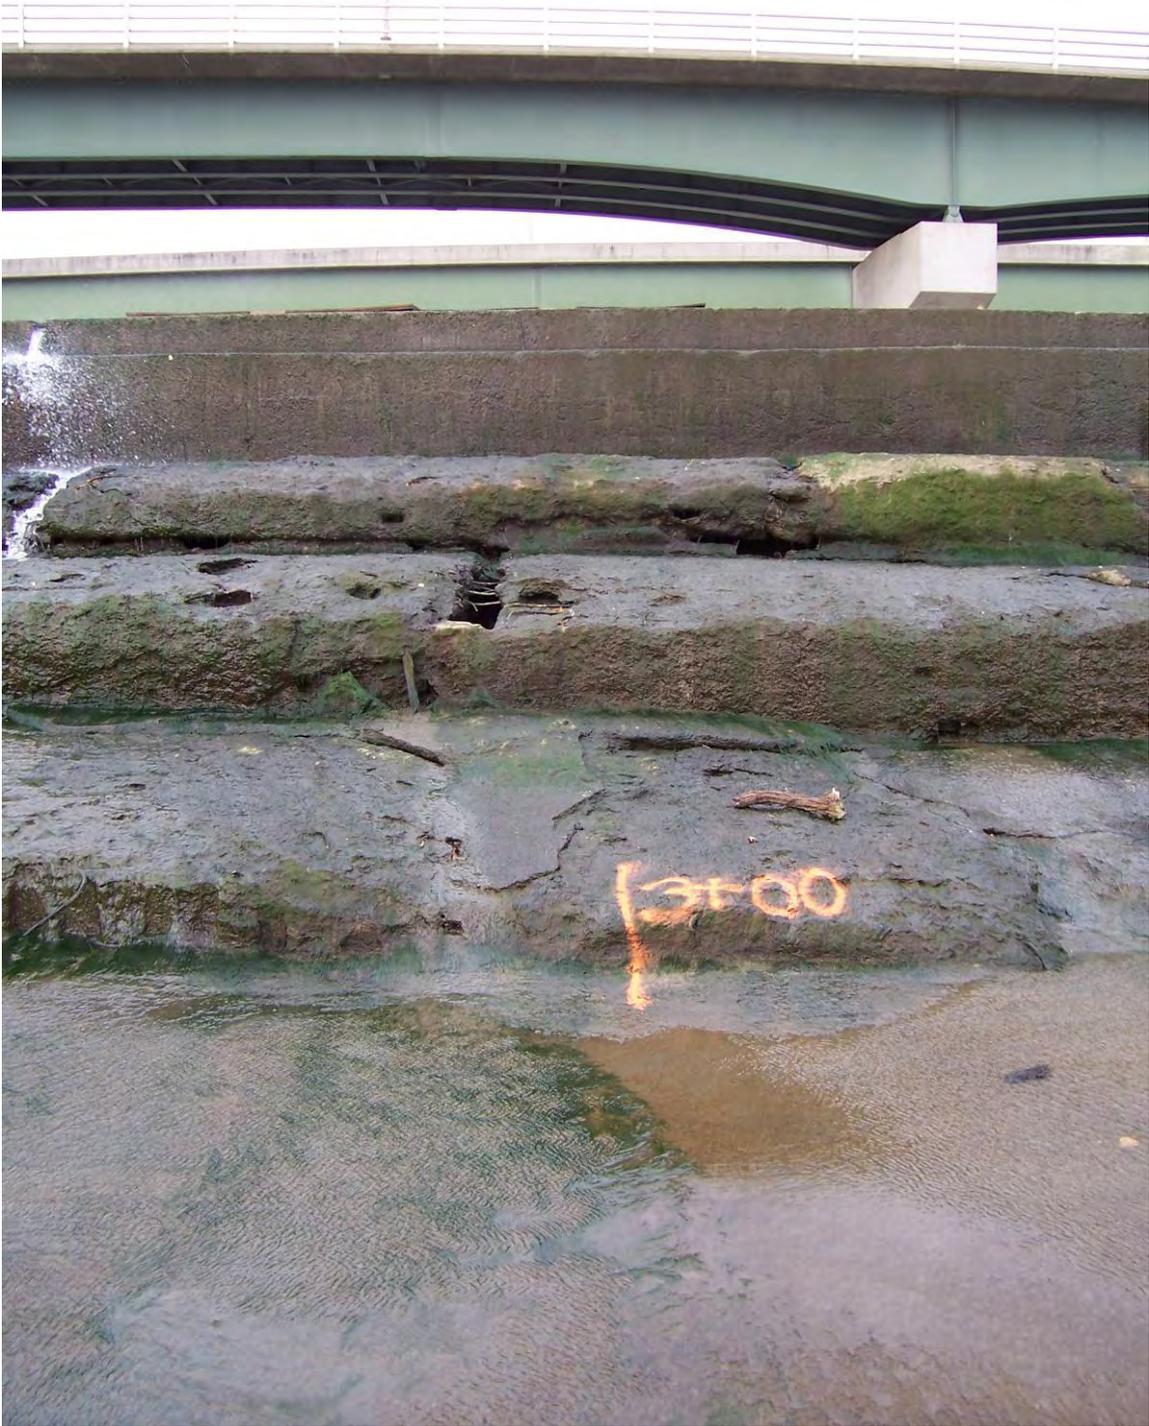
39. Sta 3+00. Exposed and eroded timbers exposed rebar. Severely deteriorated bottom steps.

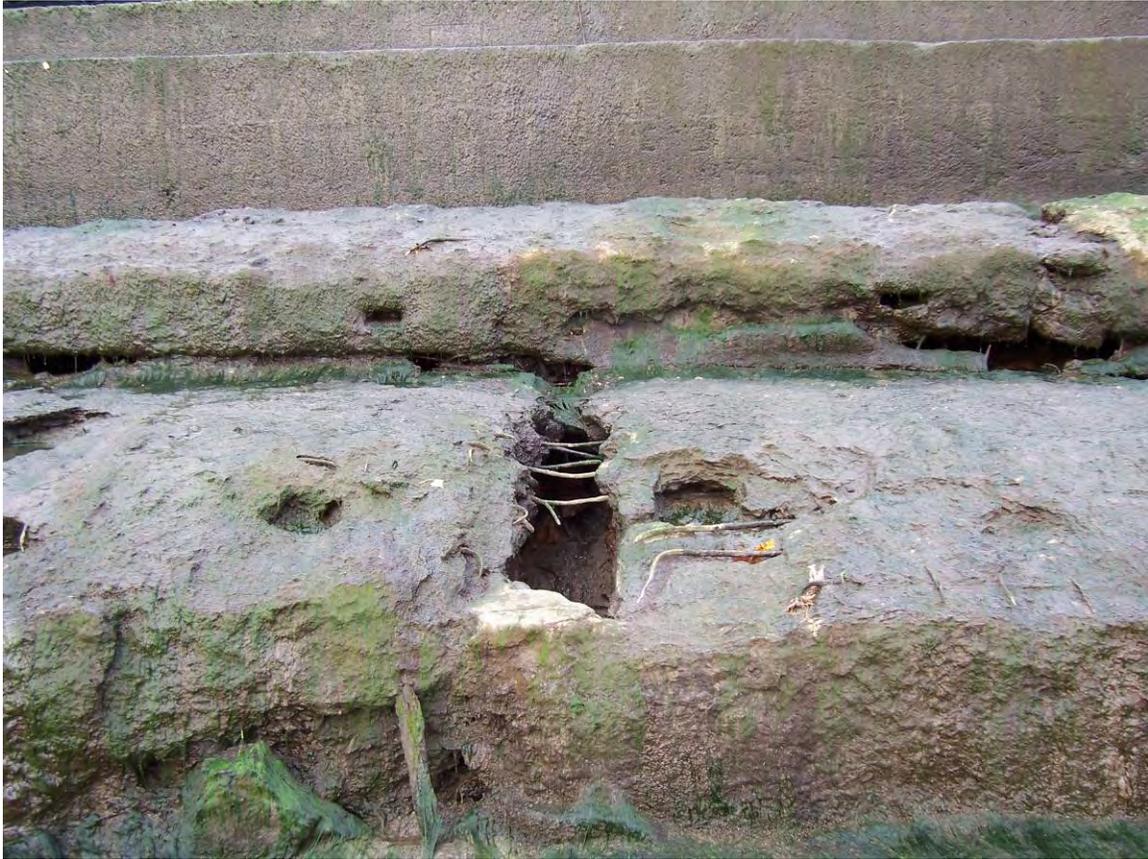
40. Sta 3+05. Eroded timber hole with exposed rebar. Exposed joint between steps.

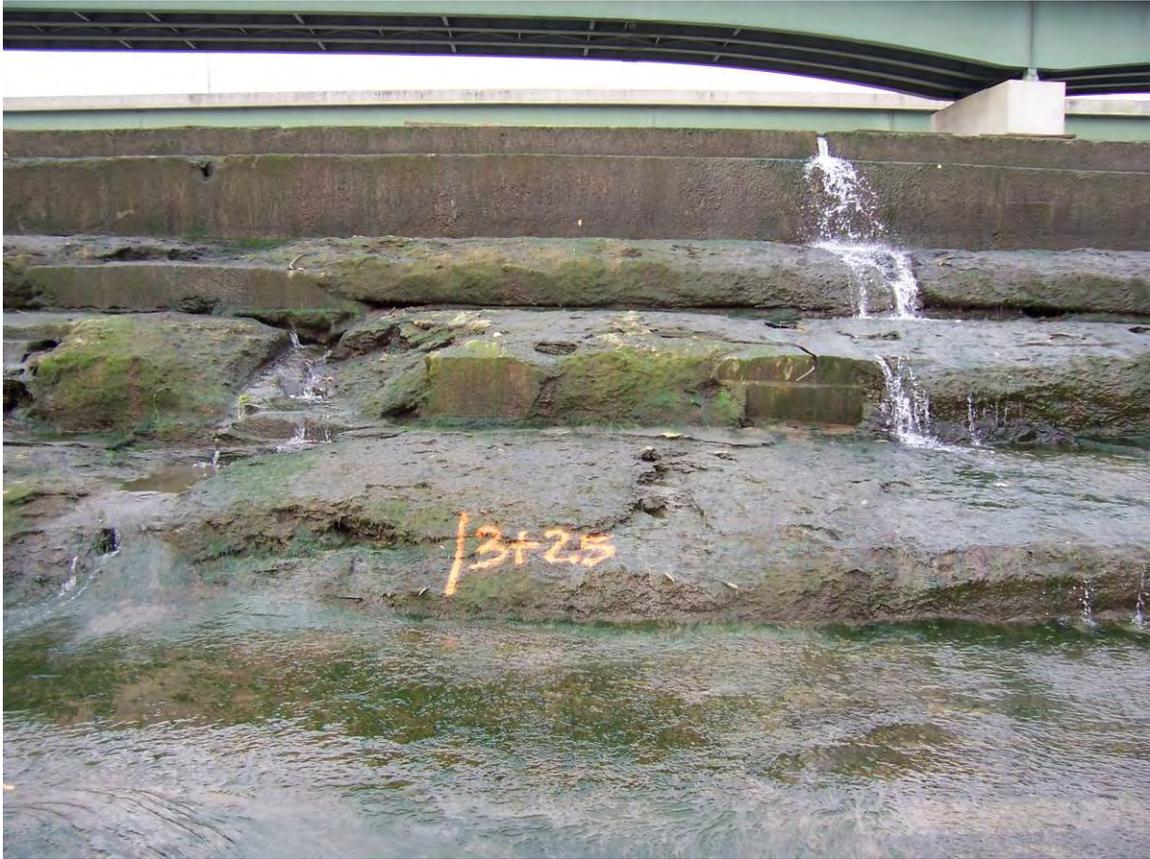
42. Sta 3+25. Severely deteriorated steps. Flow from channel at top of dam.
