Lawrence, Kansas
Bowersock Dam Inspection 2006

B&V Project 146136
B&V File B-1.1
February 14, 2007

On October 30, 2006 an inspection of the Bowersock Dam in Lawrence, Kansas was performed to assess the condition of the dam. This report summarizes the visual observations made of the dam's condition and provides a phased recommendation for corrective actions for the City of Lawrence's consideration.

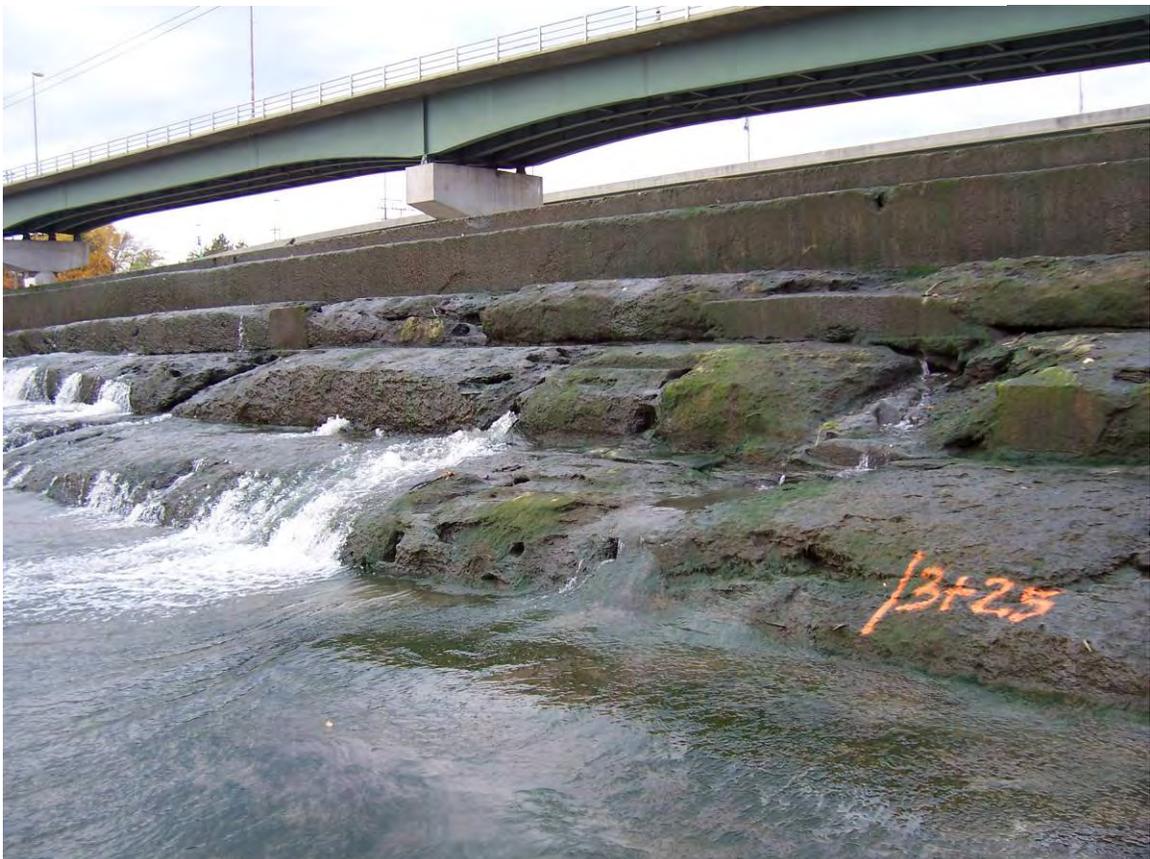
43. Sta 3+25 to Sta 3+50. Severely deteriorated steps. Flow through step joints and exposed, eroded timber holes.

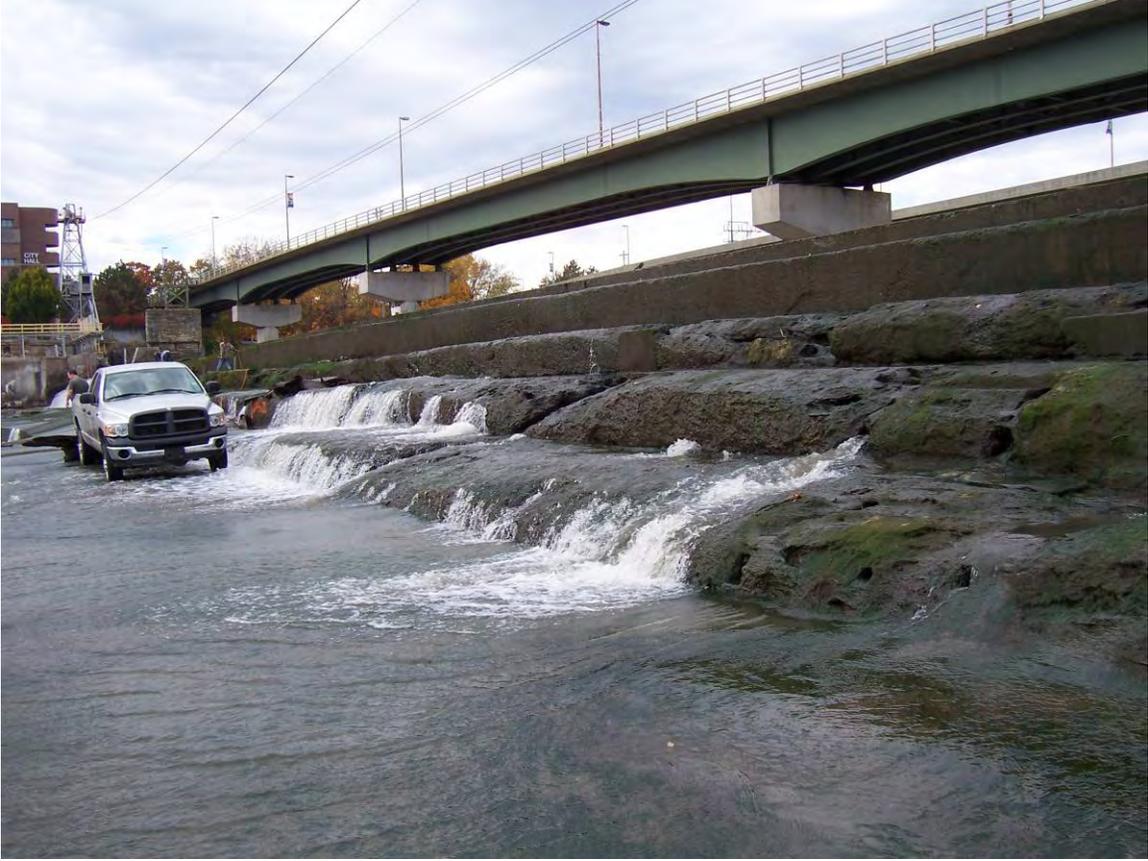
44. Sta 3+50 to Sta 3+90. Severely deteriorated steps. Flow through step joints and exposed, eroded timber holes. Large flow near Sta 3+90.

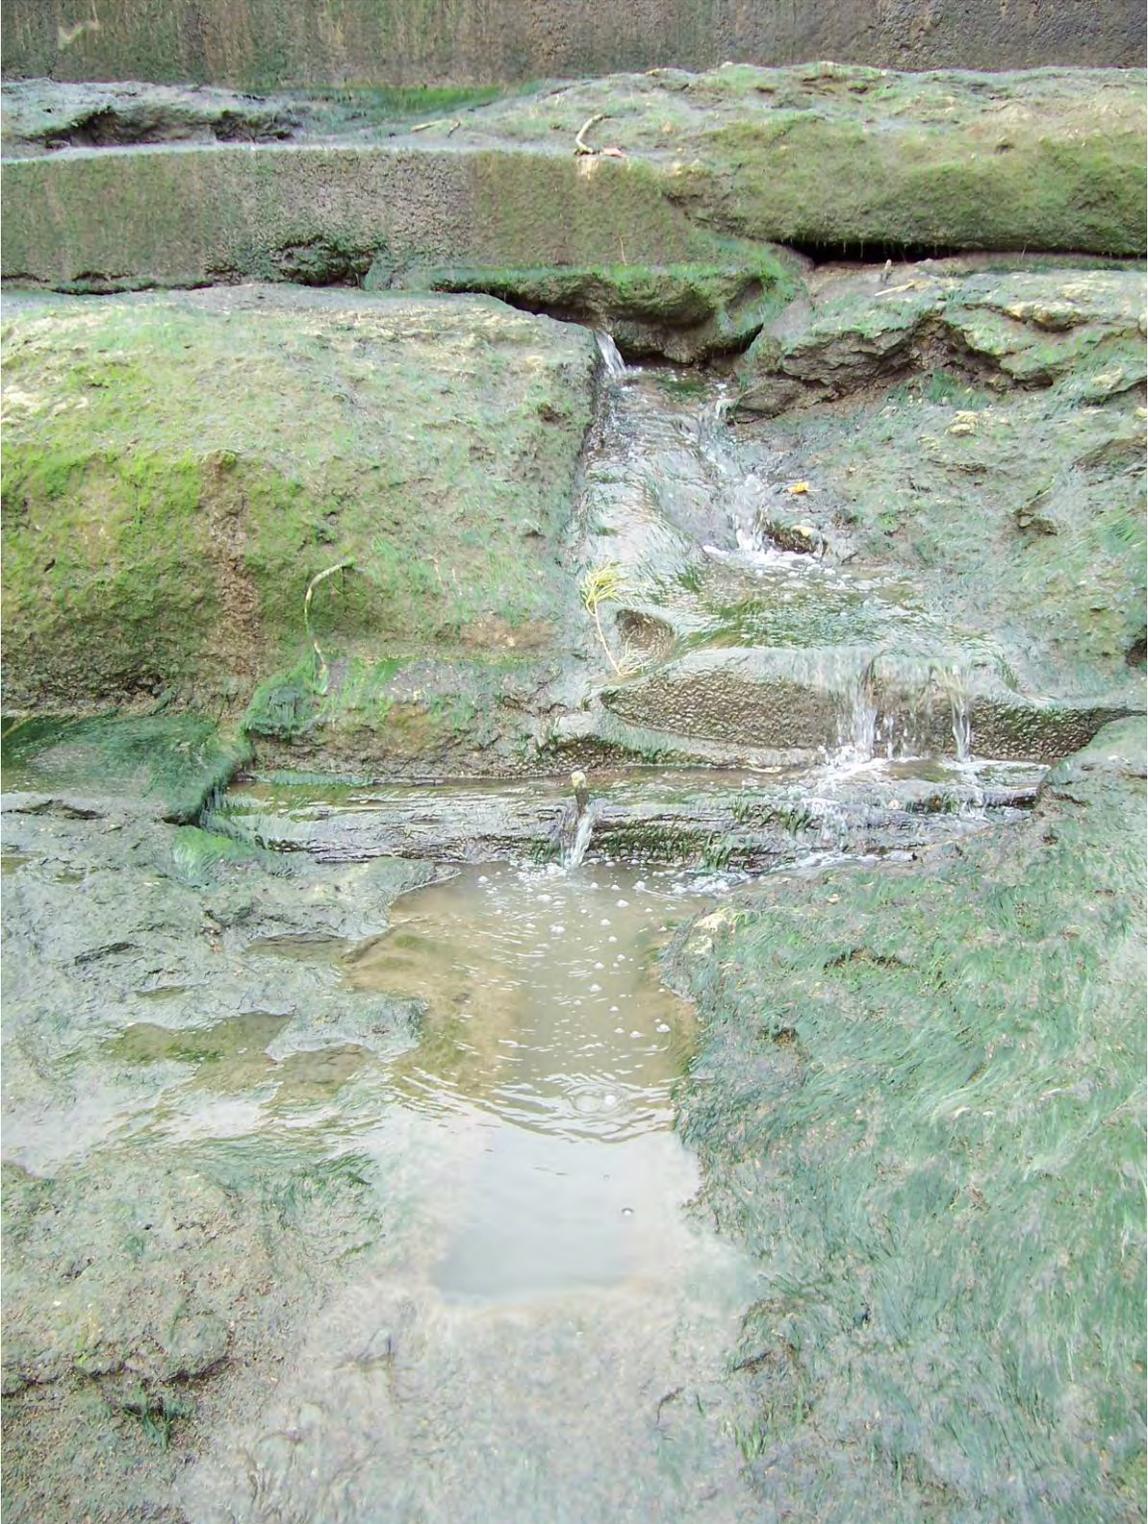
45. Sta 3+30. Exposed timbers between first and second steps. Severe deterioration of steps.

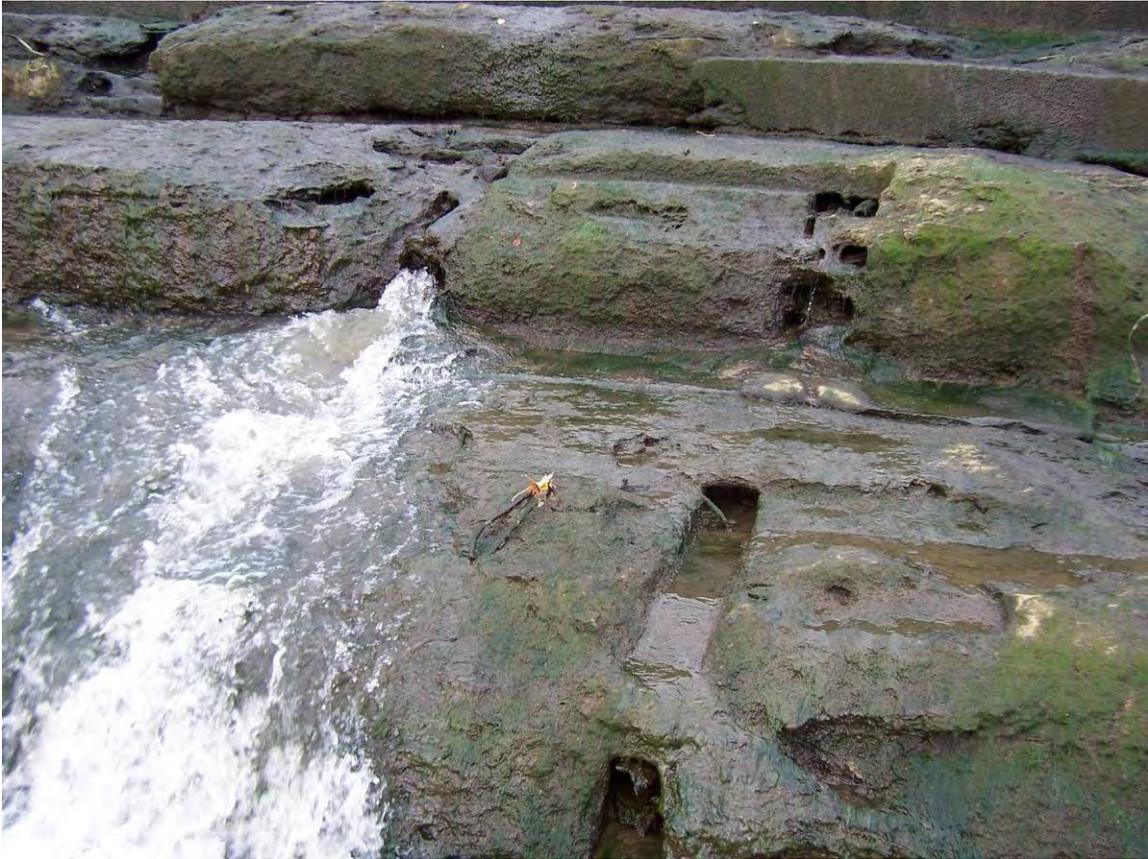
46. Sta 3+40. Eroded timber holes. Flow through timber hole. Severely deteriorated concrete.

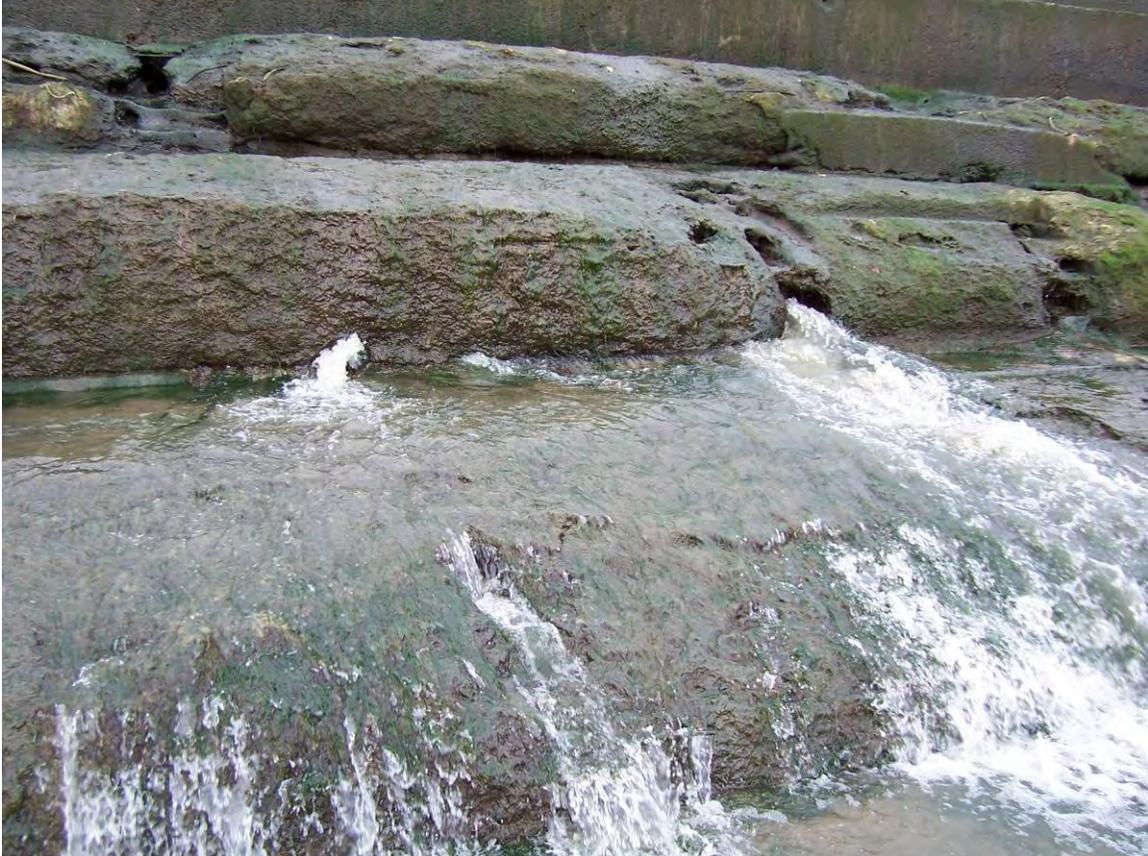
47. Sta 3+45±. Eroded timber holes. Flow through timber hole. Severely deteriorated concrete.

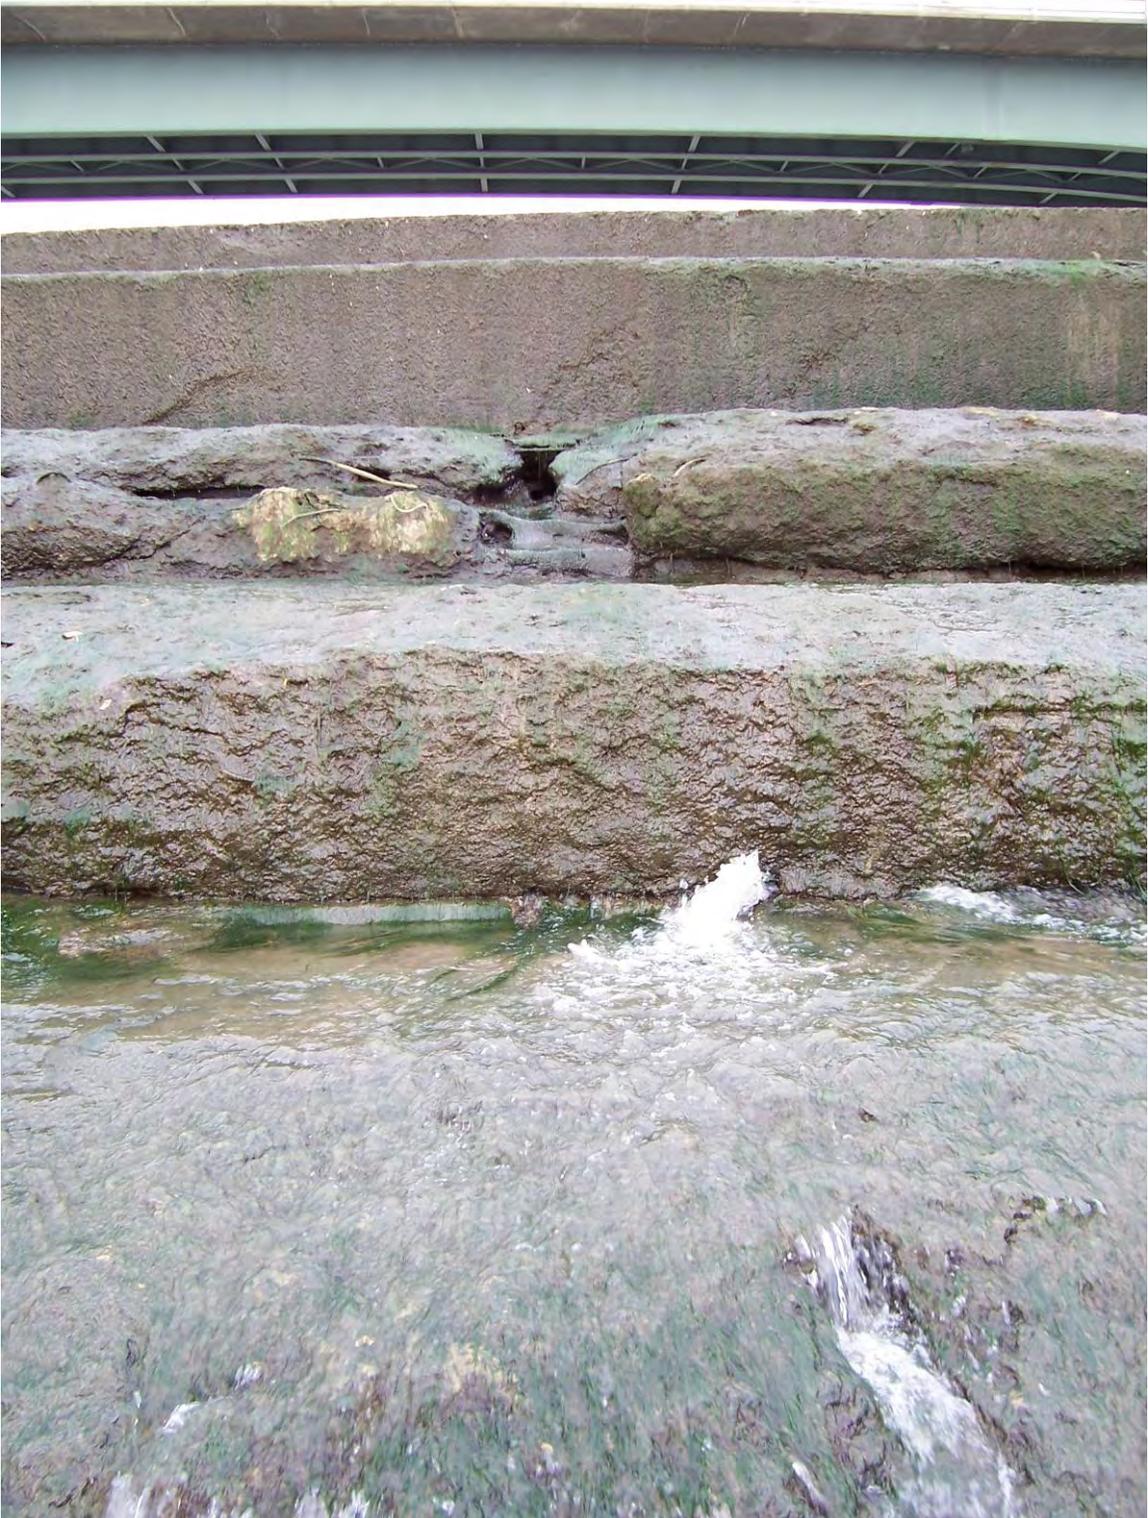
48. Sta 3+45±. Eroded timber hole and crack in top step. Flow through joint between 1st and 2nd step.

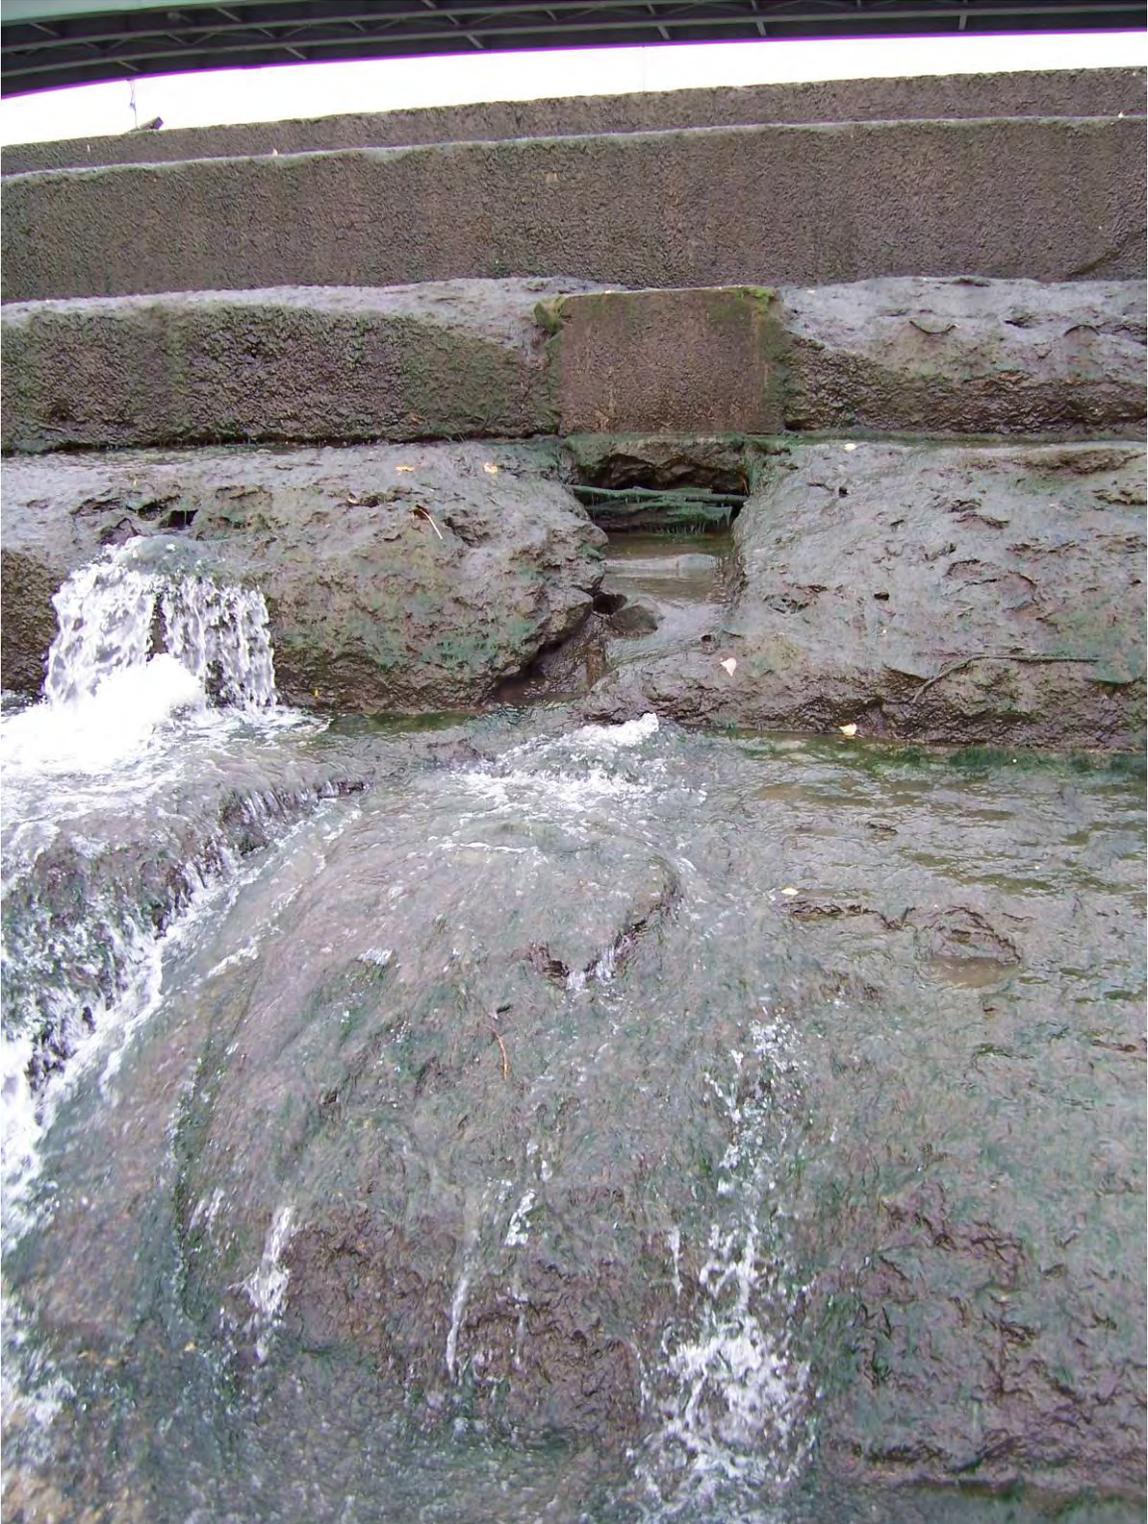
49. Sta 3+50. Eroded timber holes with flow through dam. Severely deteriorated steps.

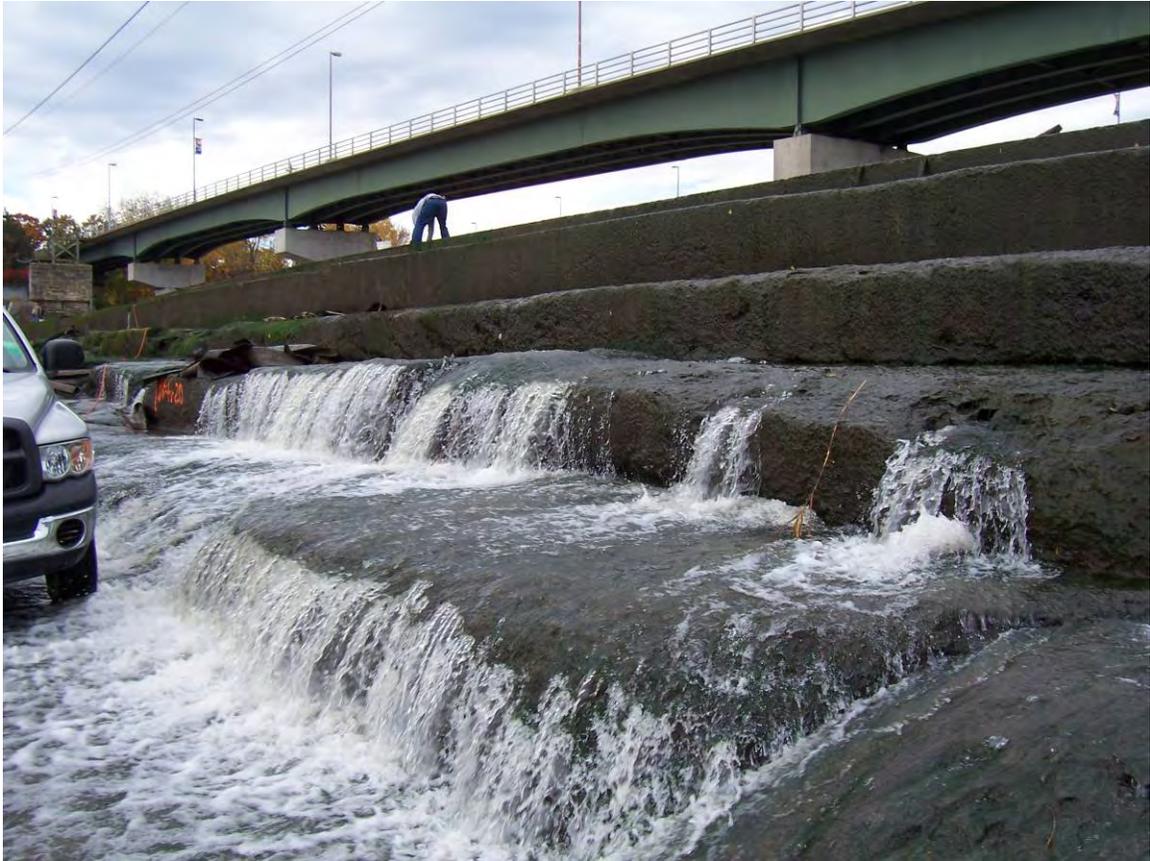
50. Sta 3+65 to Sta 4+20. Significant flow through dam in numerous locations.

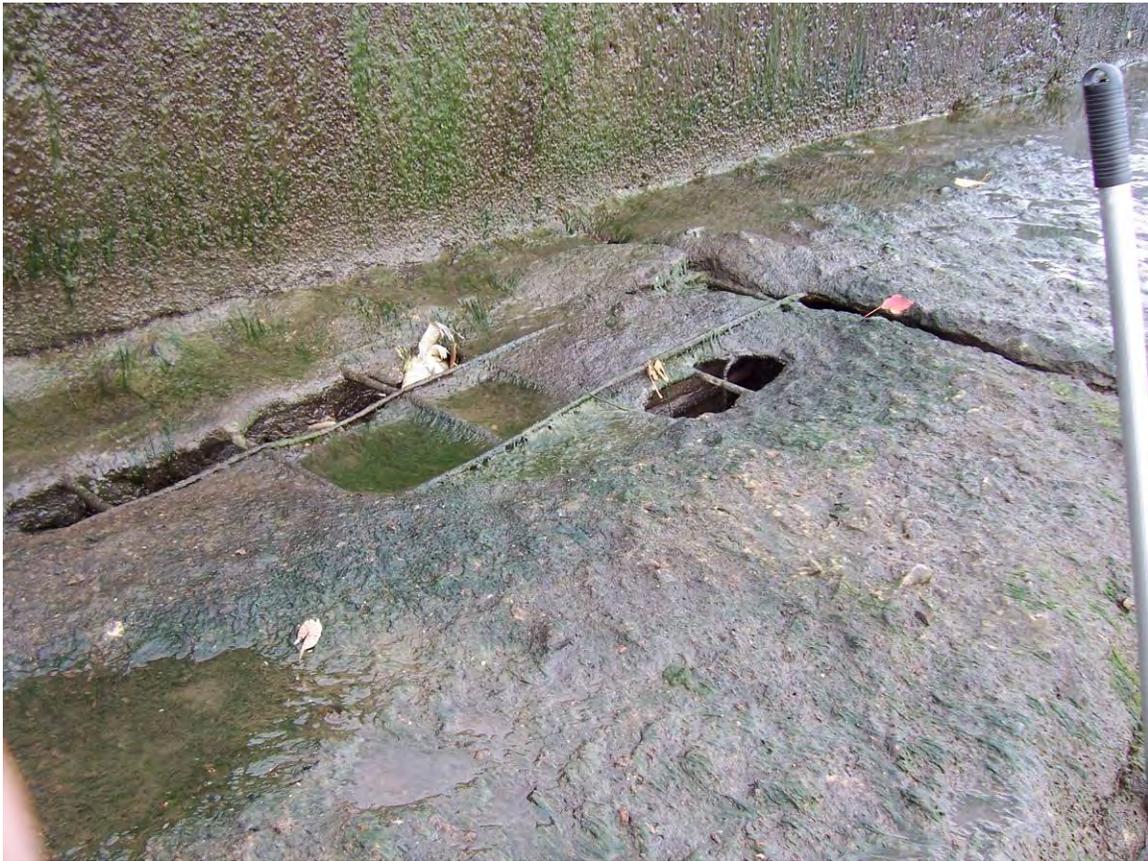
- Between Stations 3+90 and 4+50, there are exposed reinforcing bars and timbers on the second step down. Refer to photographs 55, 98 and 99.
- Near Station 4+40, there is a significant void in the second step, and deterioration of the lower step. See photographs 59 and 60.

55. Sta 3+90±. Severely deteriorated concrete with exposed rebar in top step.

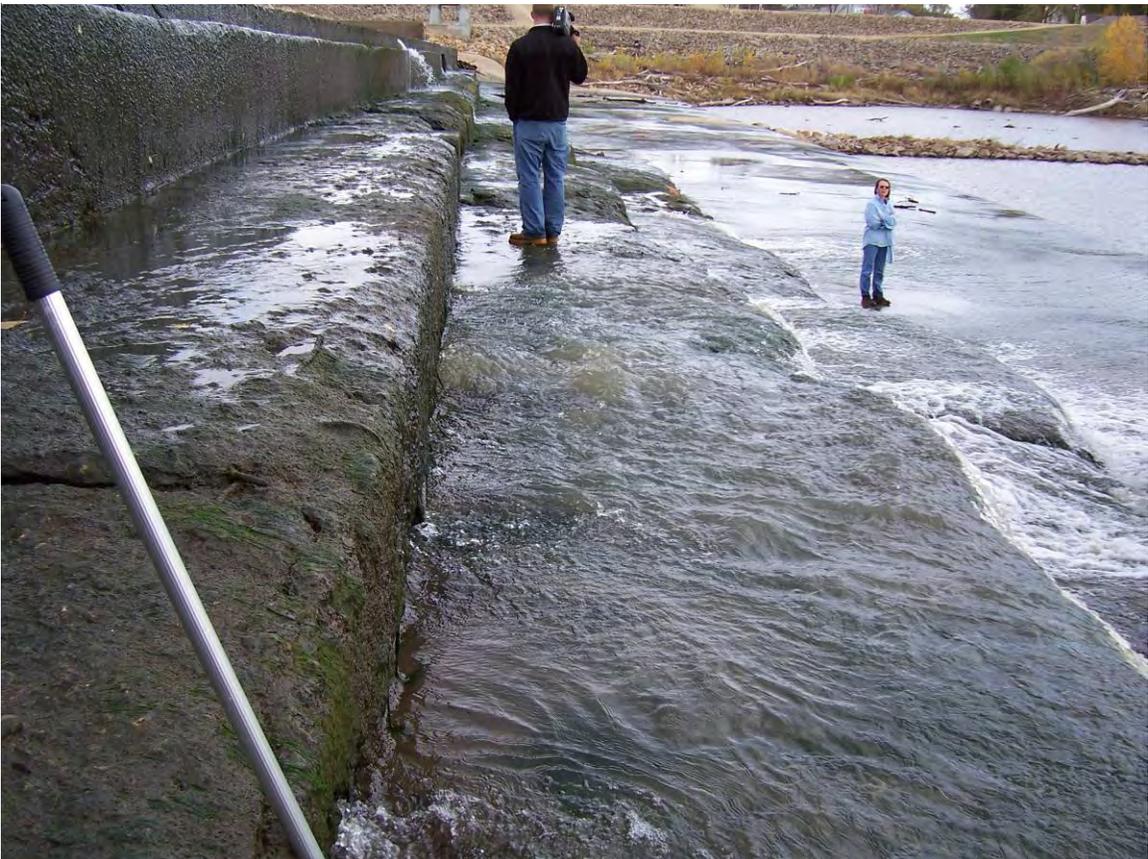
56. Sta 3+90±. Looking north. Main flow point through dam. 4 ft deep hole at flow point.

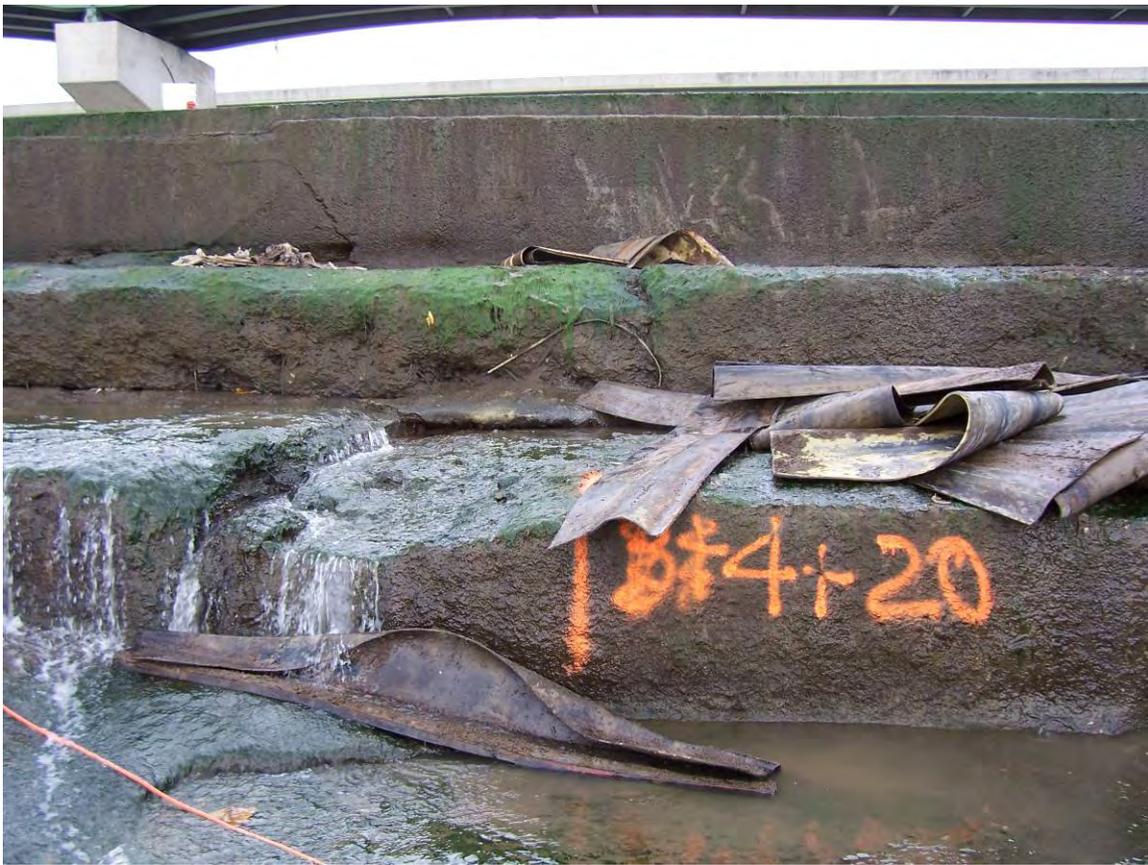
57. Sta 4+20. Severely deteriorated joint at top of bottom step. Seals from flashboards.

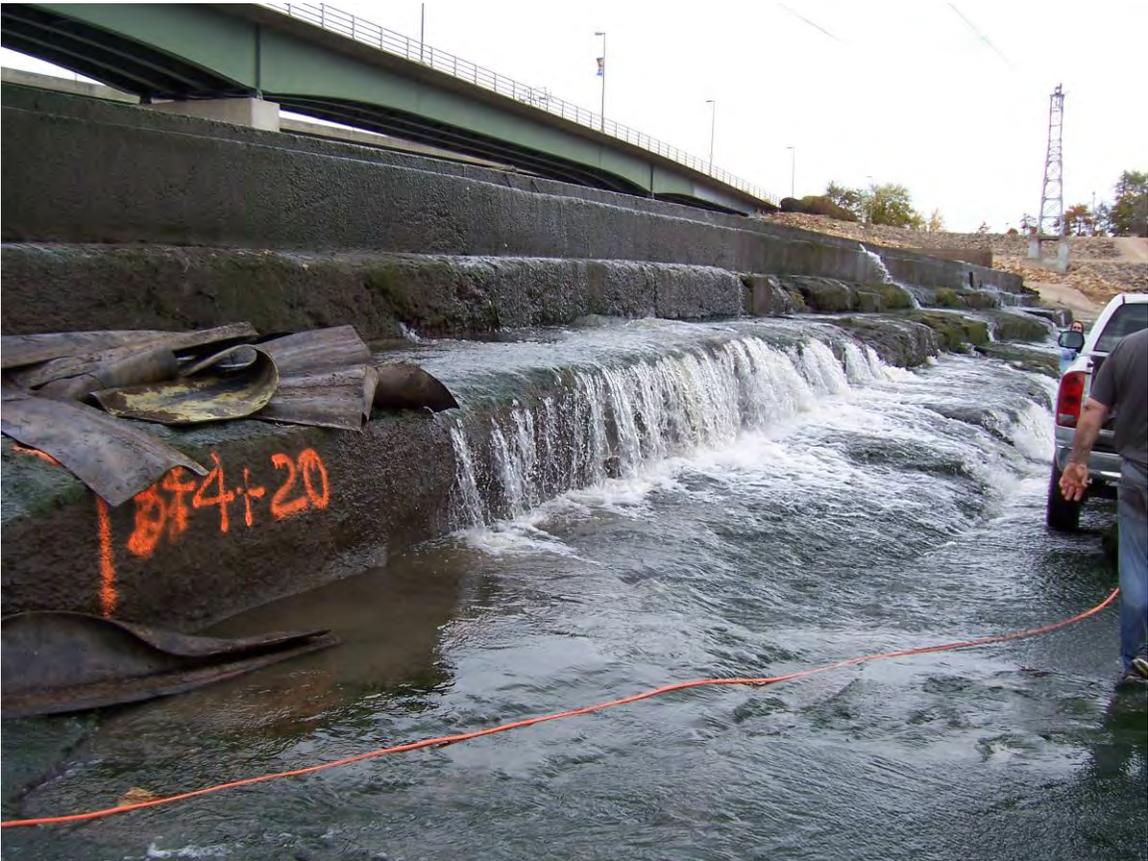
58. Sta 4+20 to North. Significant flow through dam.

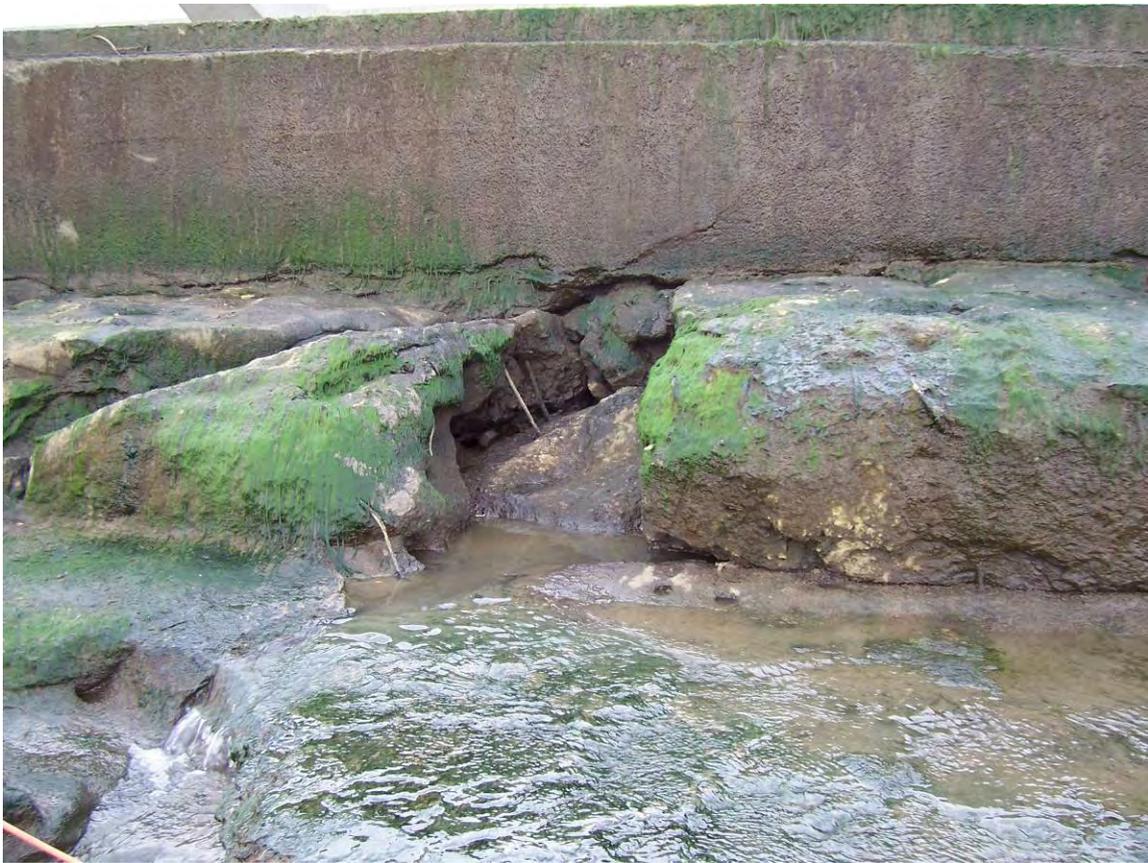
59. Sta 4+40±. Severely deteriorated steps. Exposed joints between steps.

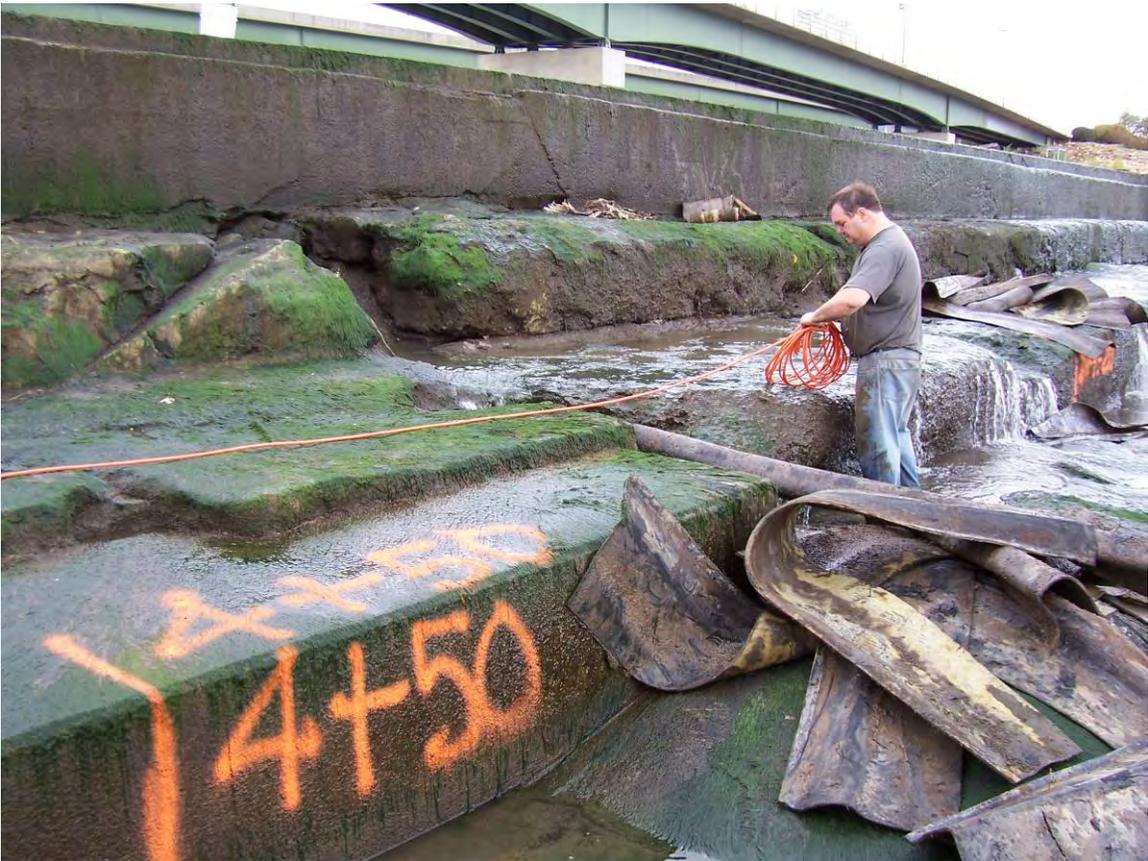
60. Sta 4+50 to Sta 4+40. Severely deteriorated steps. Exposed joints between steps.

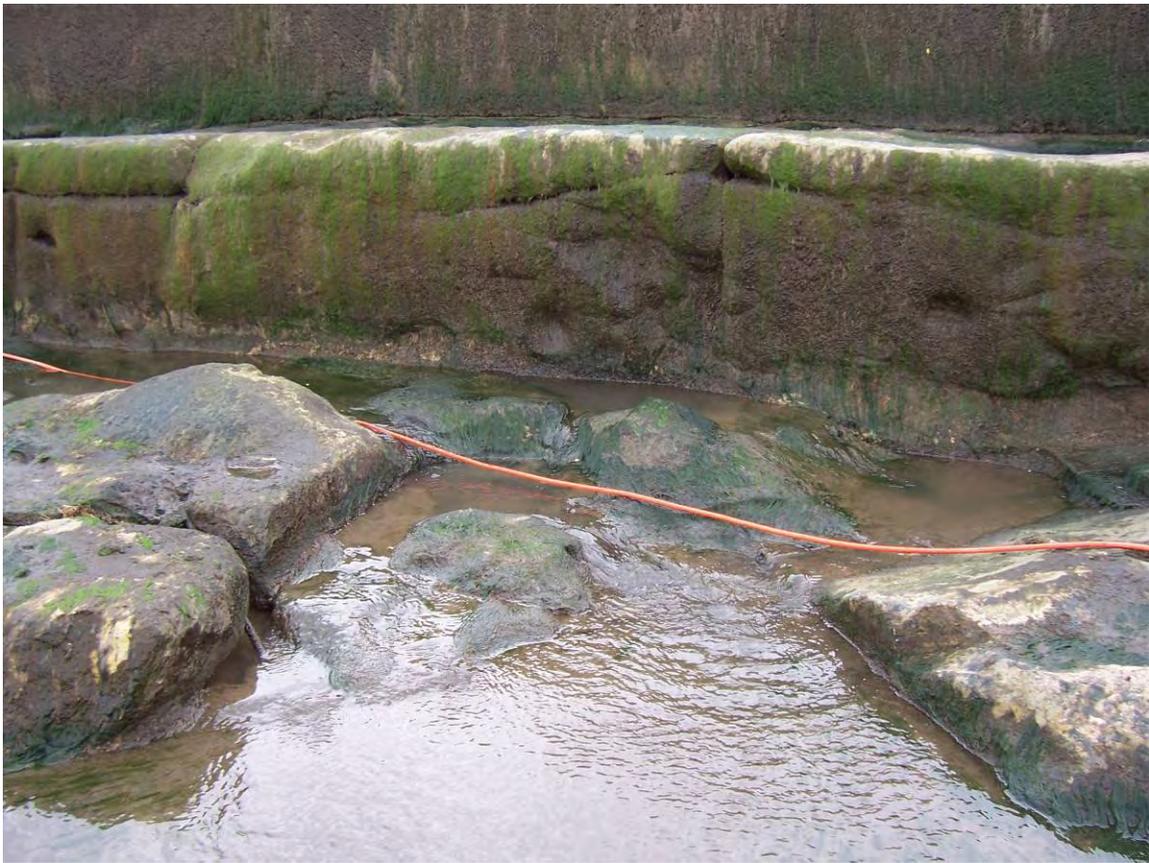
61. Sta 4+50±. Severely eroded concrete and exposed boulders.

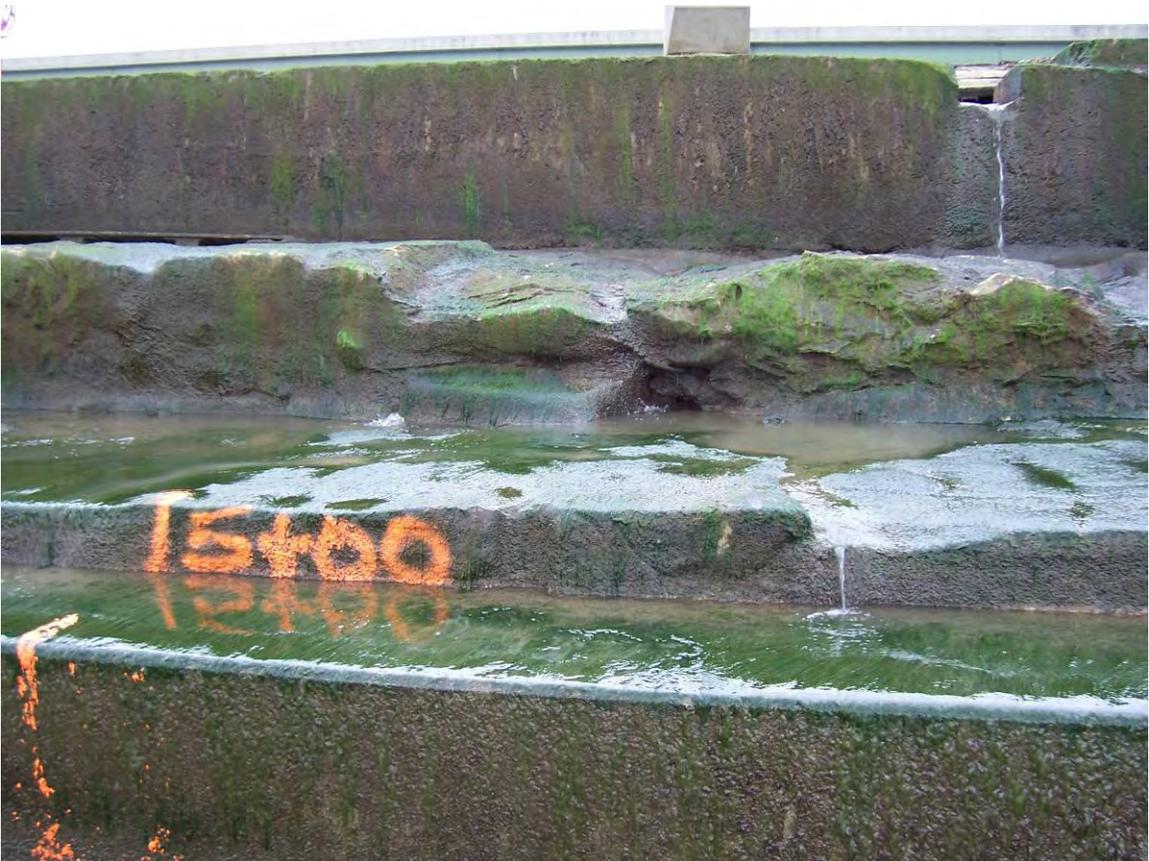
64. Sta 5+00. Deteriorated concrete at top step.

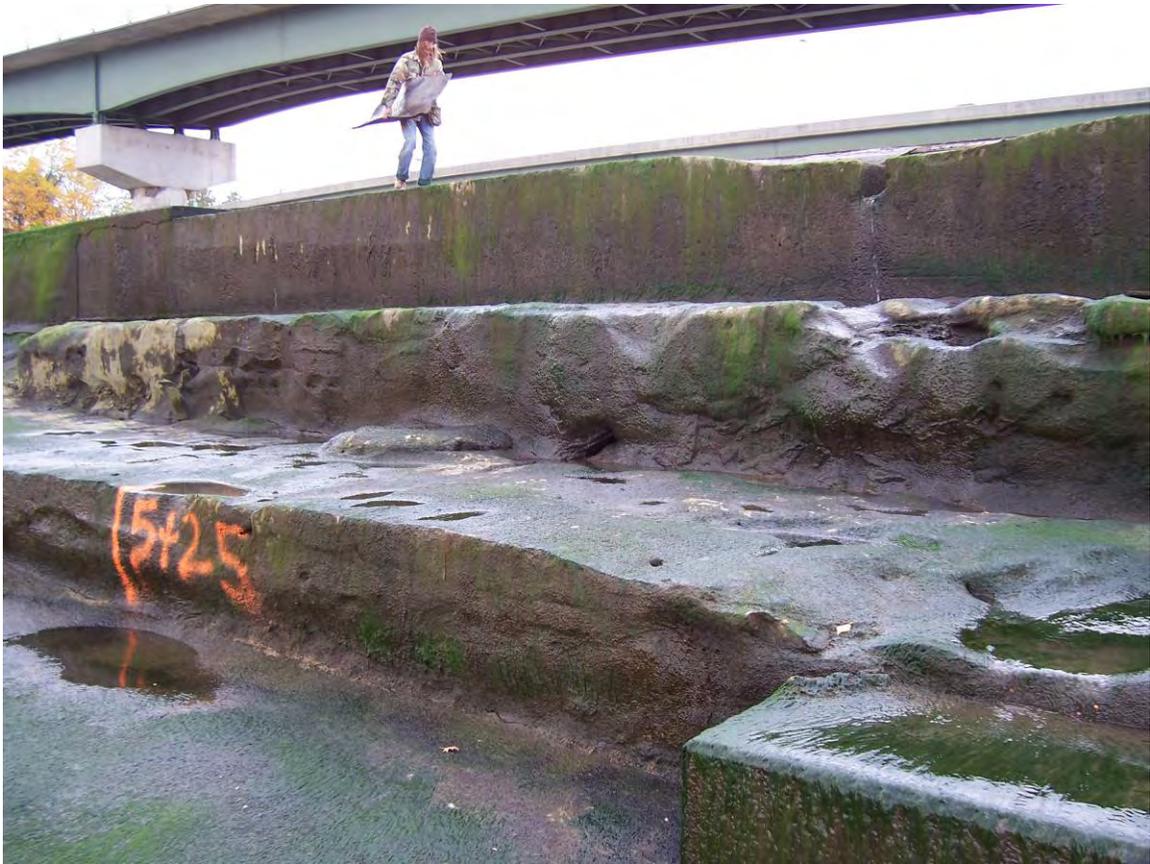
65. Sta 5+10 to Sta 5+25. Deteriorated concrete on top step. Exposed timber.

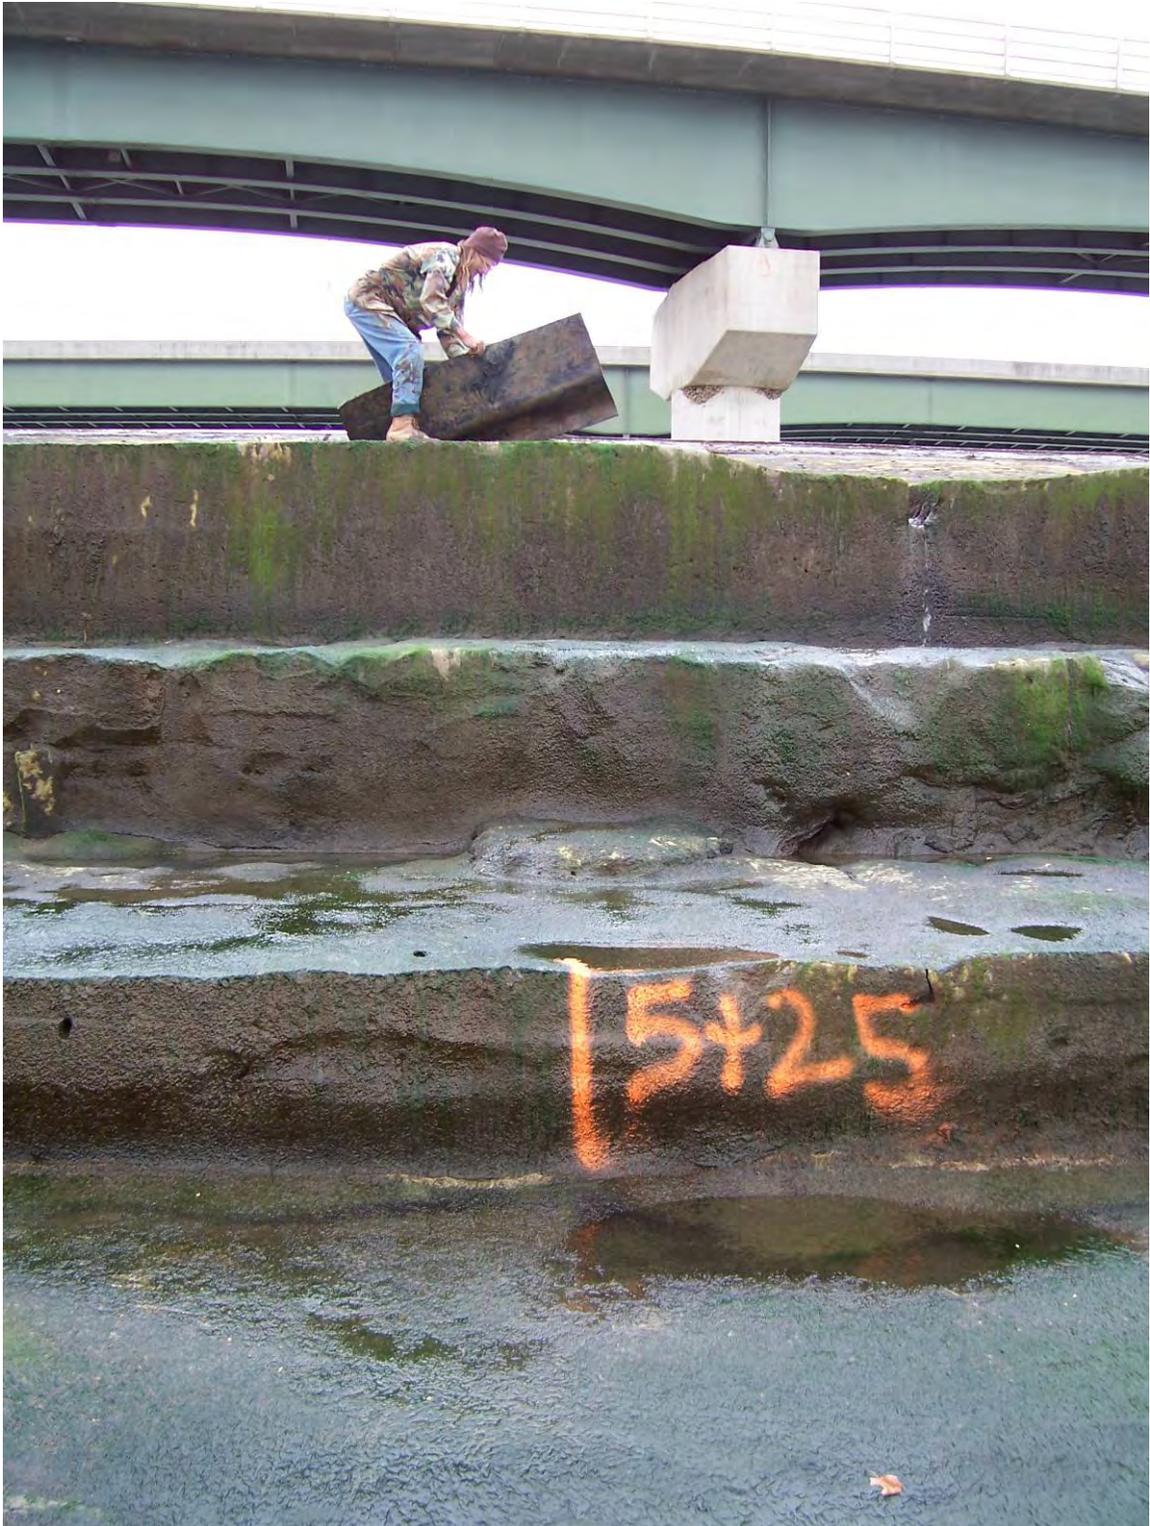
66. Sta 5+25. Exposed joints between first and second steps.

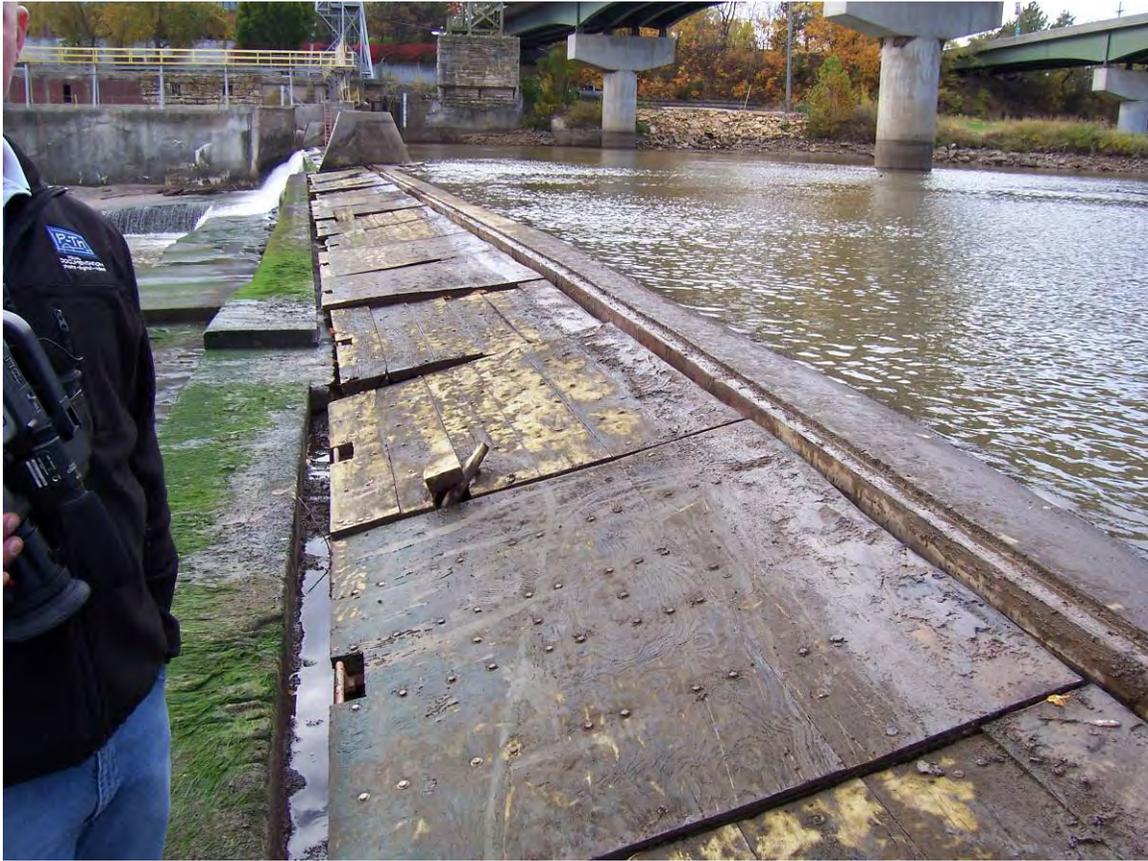
91. Sta 5+50. Top of dam to south. Flashboards being repaired.
