Lawrence, Kansas
Bowersock Dam Inspection 2006

B&V Project 146136
B&V File B-1.1
February 14, 2007

On October 30, 2006 an inspection of the Bowersock Dam in Lawrence, Kansas was performed to assess the condition of the dam. This report summarizes the visual observations made of the dam's condition and provides a phased recommendation for corrective actions for the City of Lawrence's consideration.

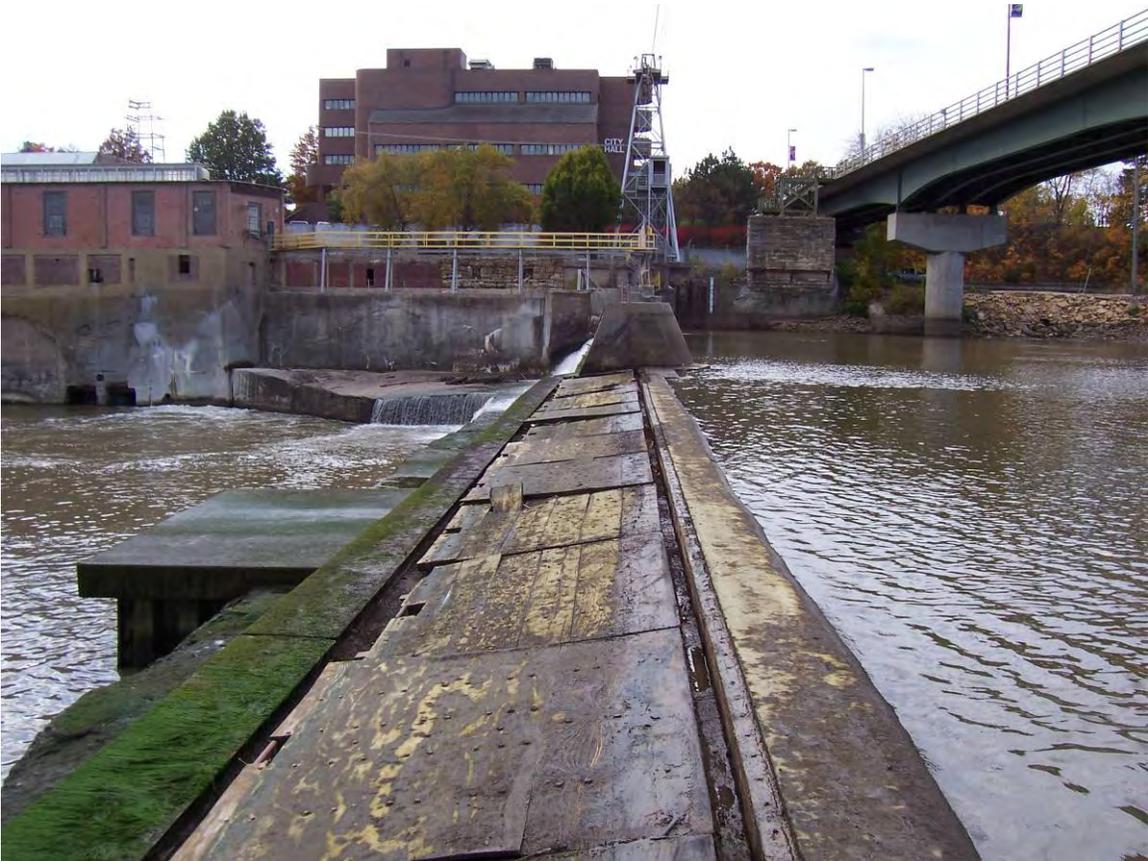
92. Sta 5+75. Top of dam to south. Flashboards being repaired.

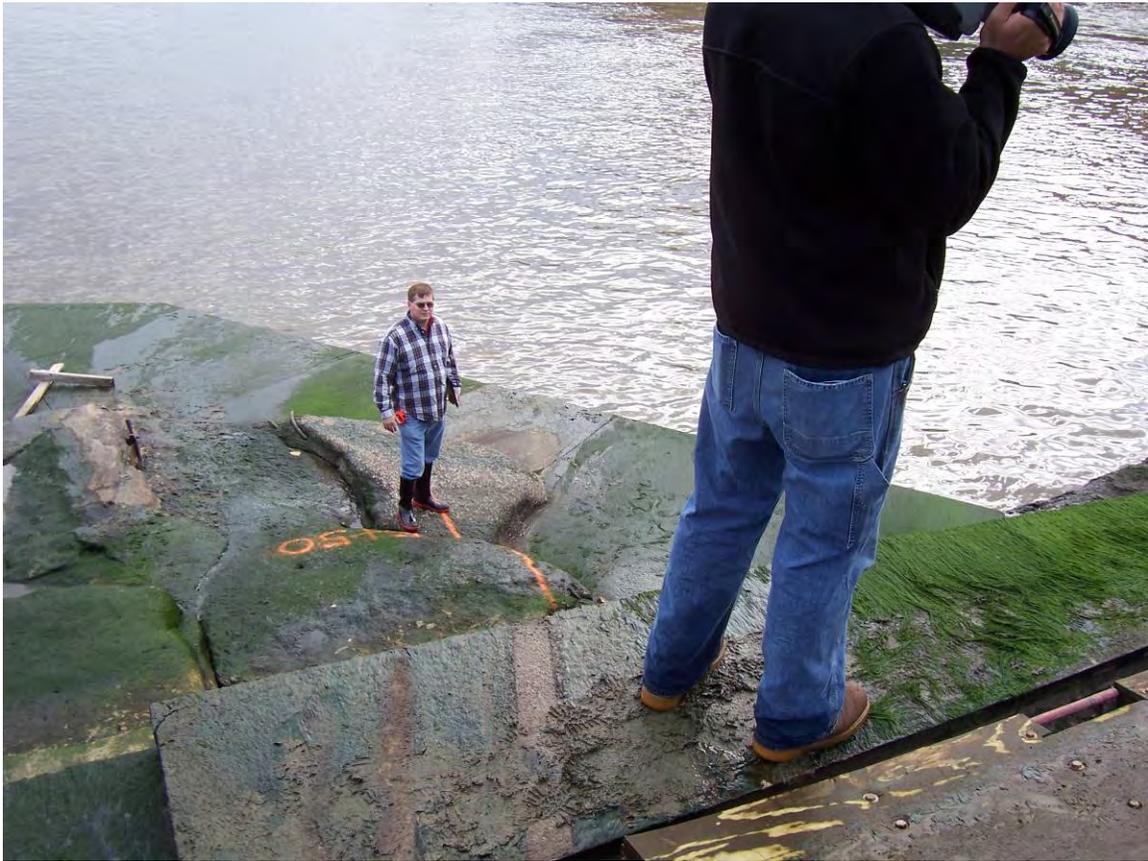
93. Sta 5+50. South end of steps. Eroded concrete with exposed joints.

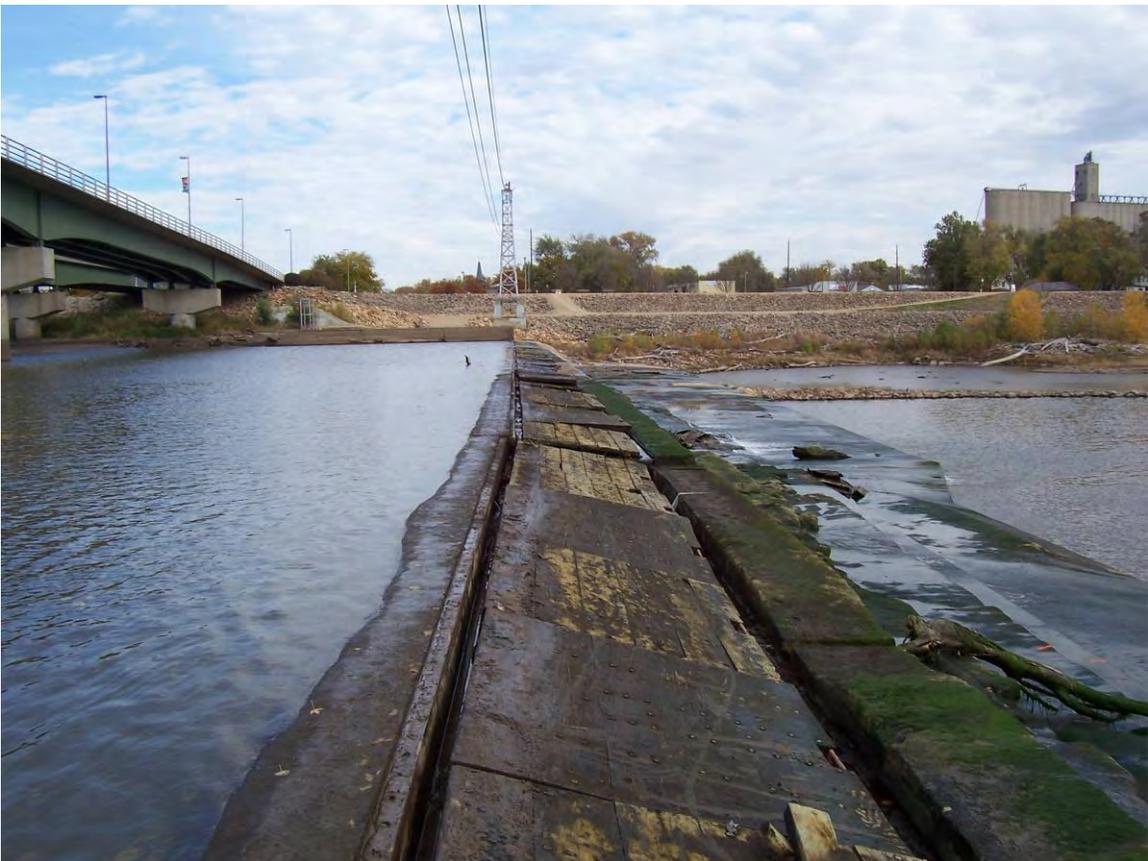
94. Sta 5+50 to north. Top of dam to south. Flashboards being repaired.

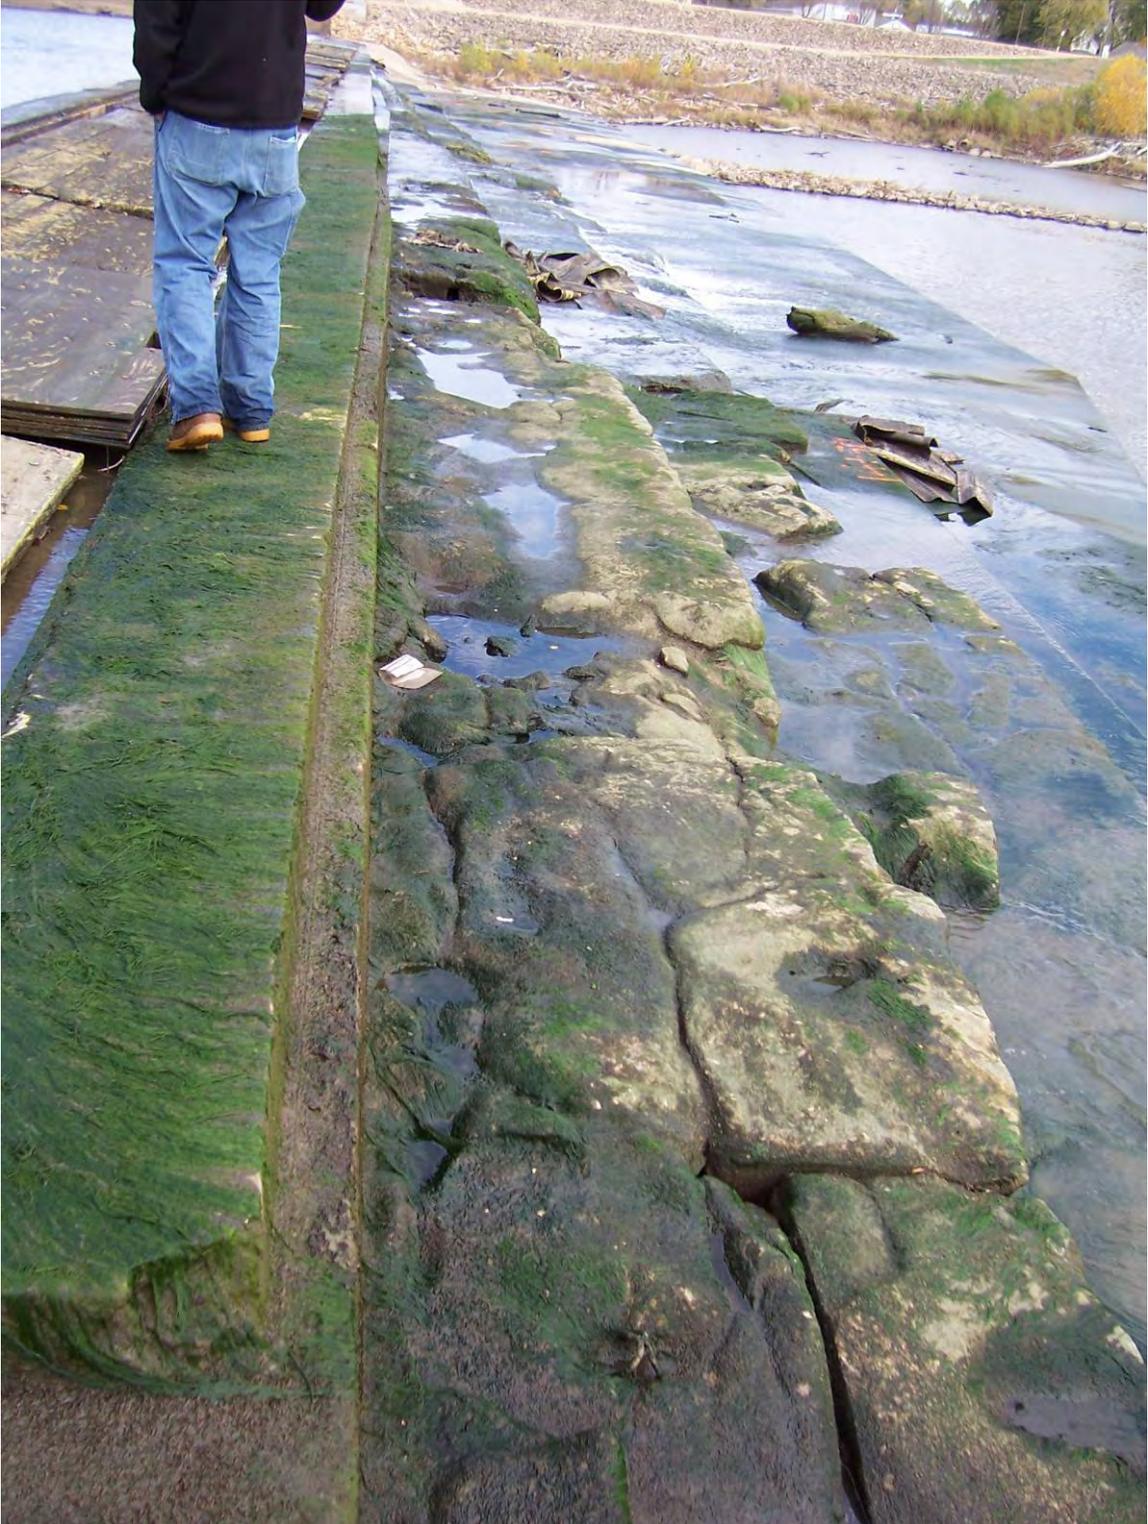
- Between Stations 4+50 and 5+50, the steps have eroded into irregular shapes. See photographs 61 through 71 and 95 through 97.
- Near Station 5+35, two I-beam pilings have been exposed at the base of the second step. Refer to photographs 67 and 68.

95. Sta 5+50 to 4+50 north. Eroded and uneven steps.

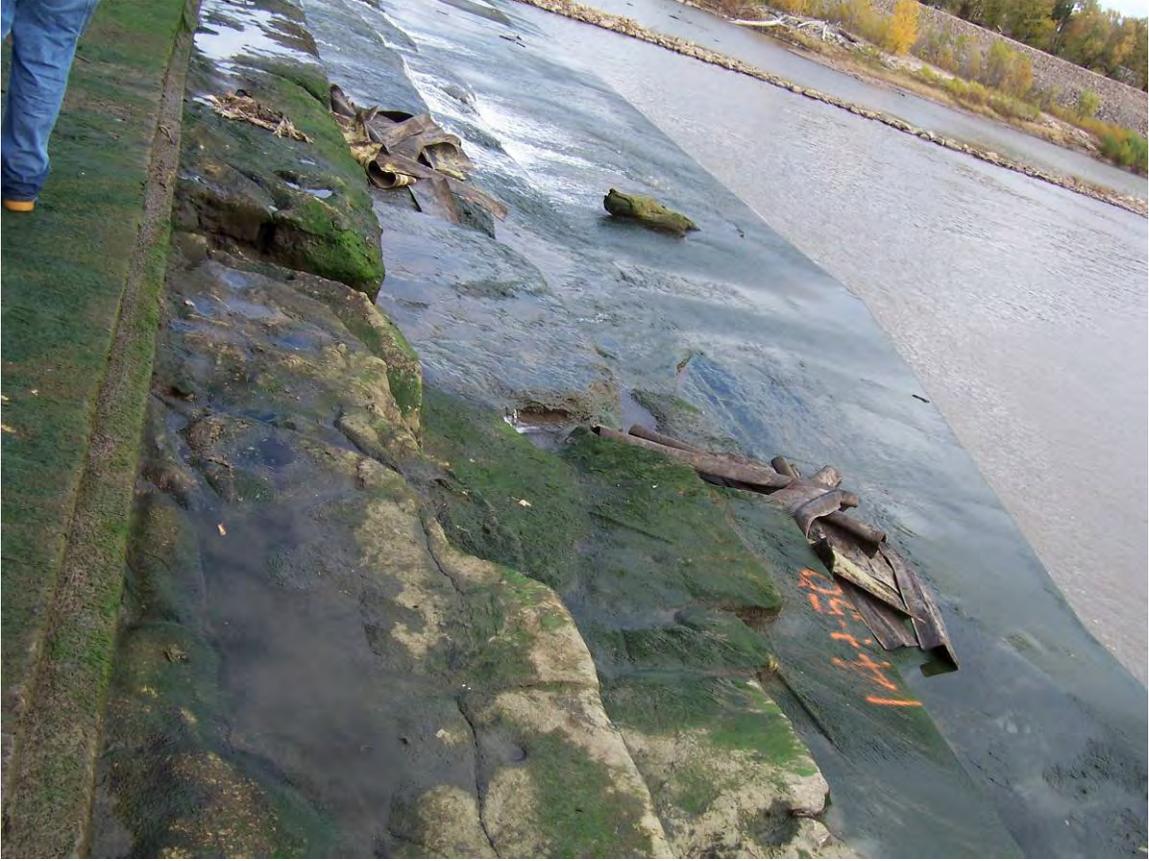
96. Sta 4+50. Eroded and cracked steps.

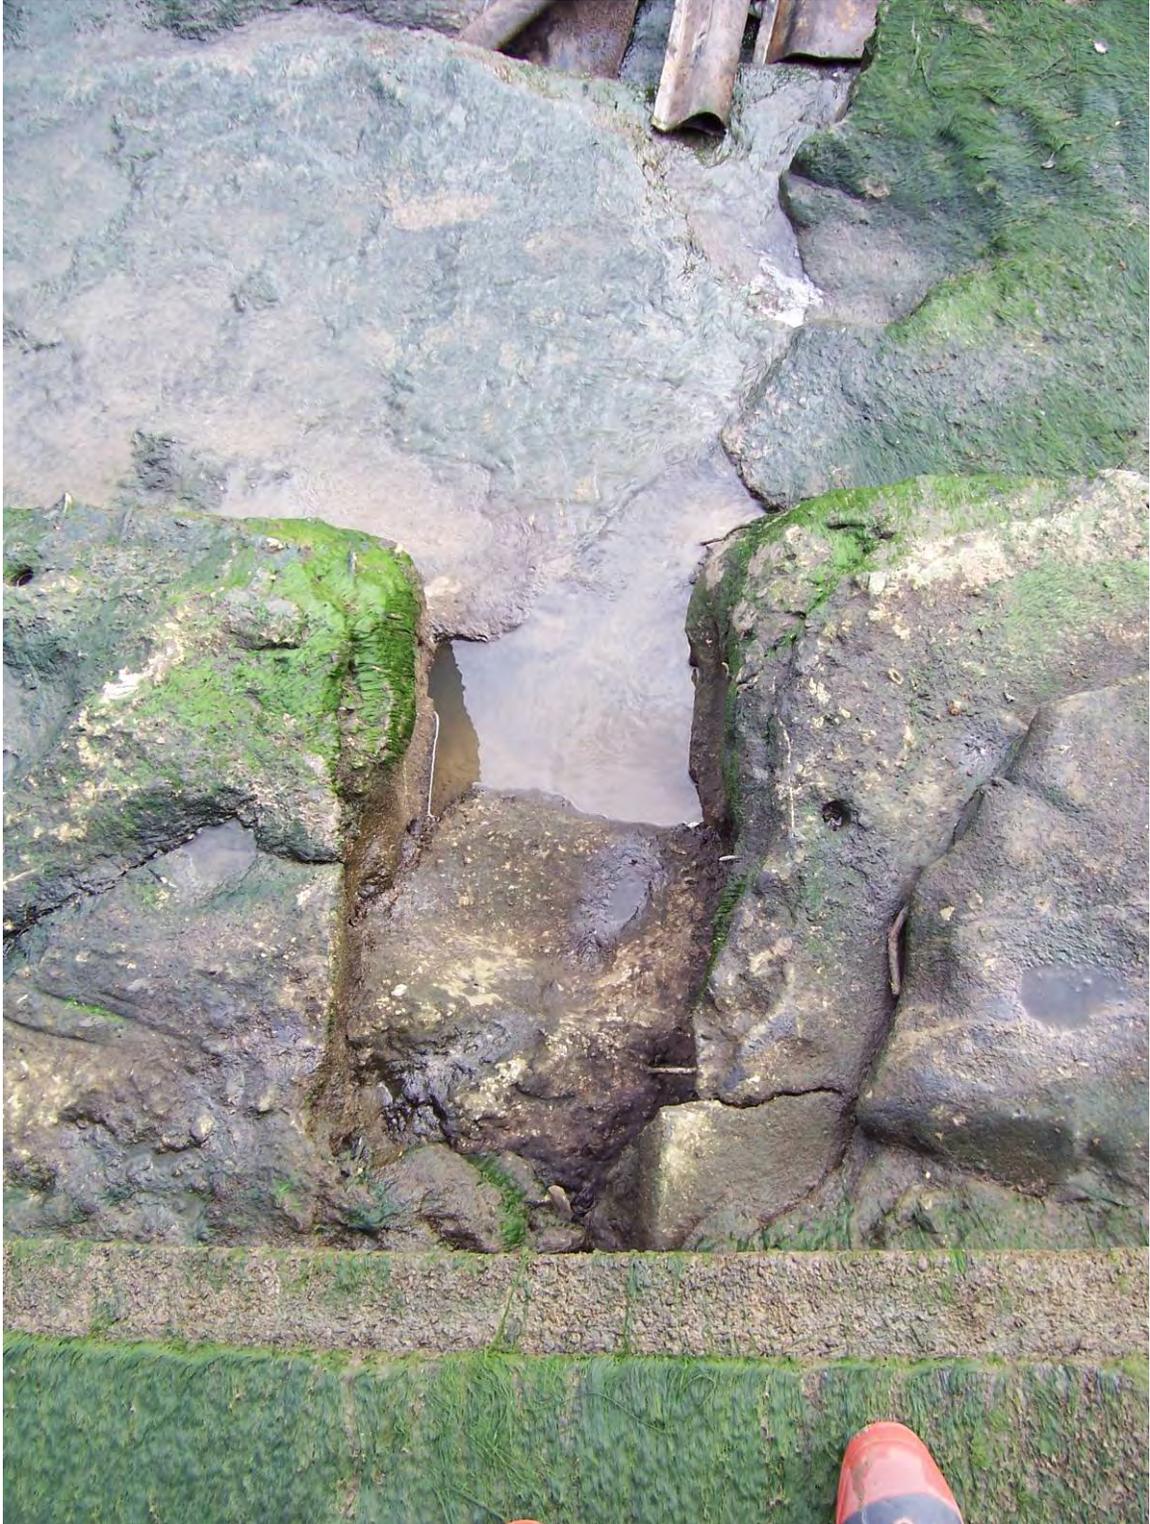
- Between Stations 3+90 and 4+50, there are exposed reinforcing bars and timbers on the second step down. Refer to photographs 55, 98 and 99.
- Near Station 4+40, there is a significant void in the second step, and deterioration of the lower step. See photographs 59 and 60.

97. Sta 4+50 from above. Severe deterioration at old timber location. Multiple joints.

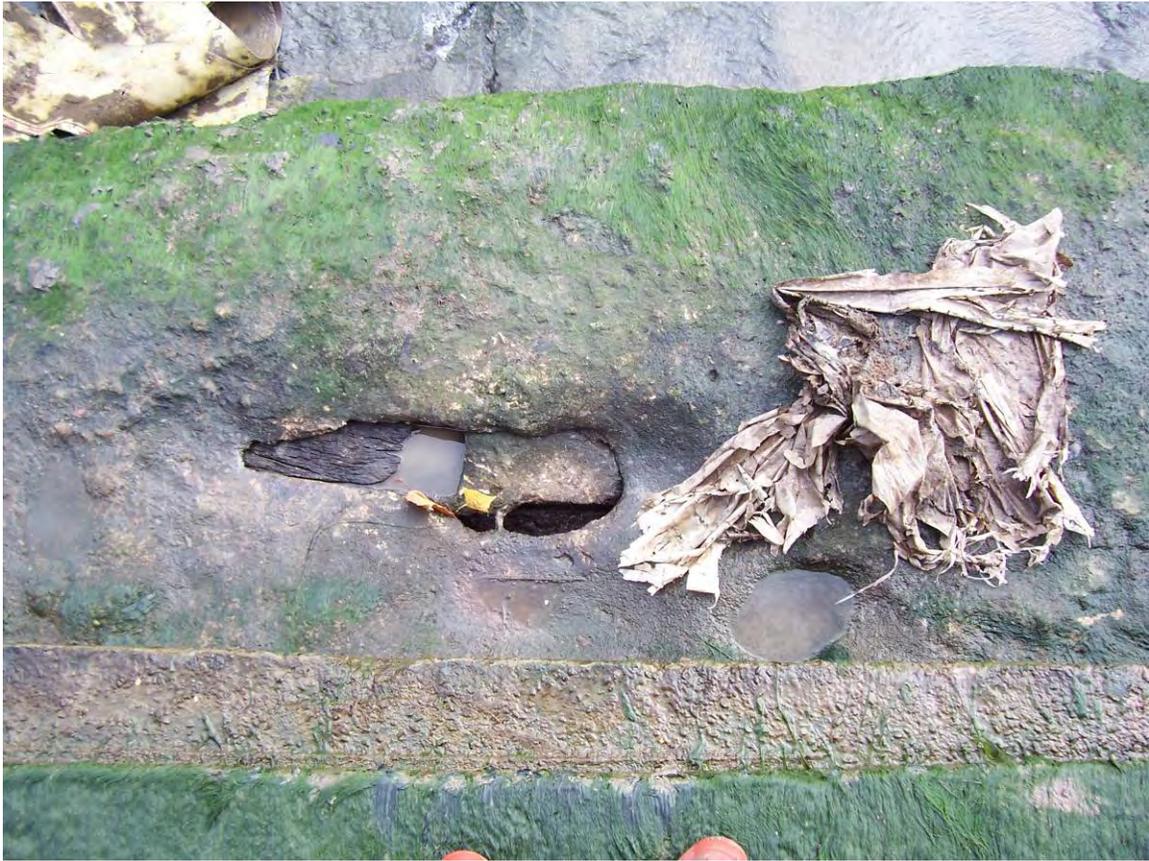
98. Sta 4+40±. Eroded concrete with exposed timber in top step.

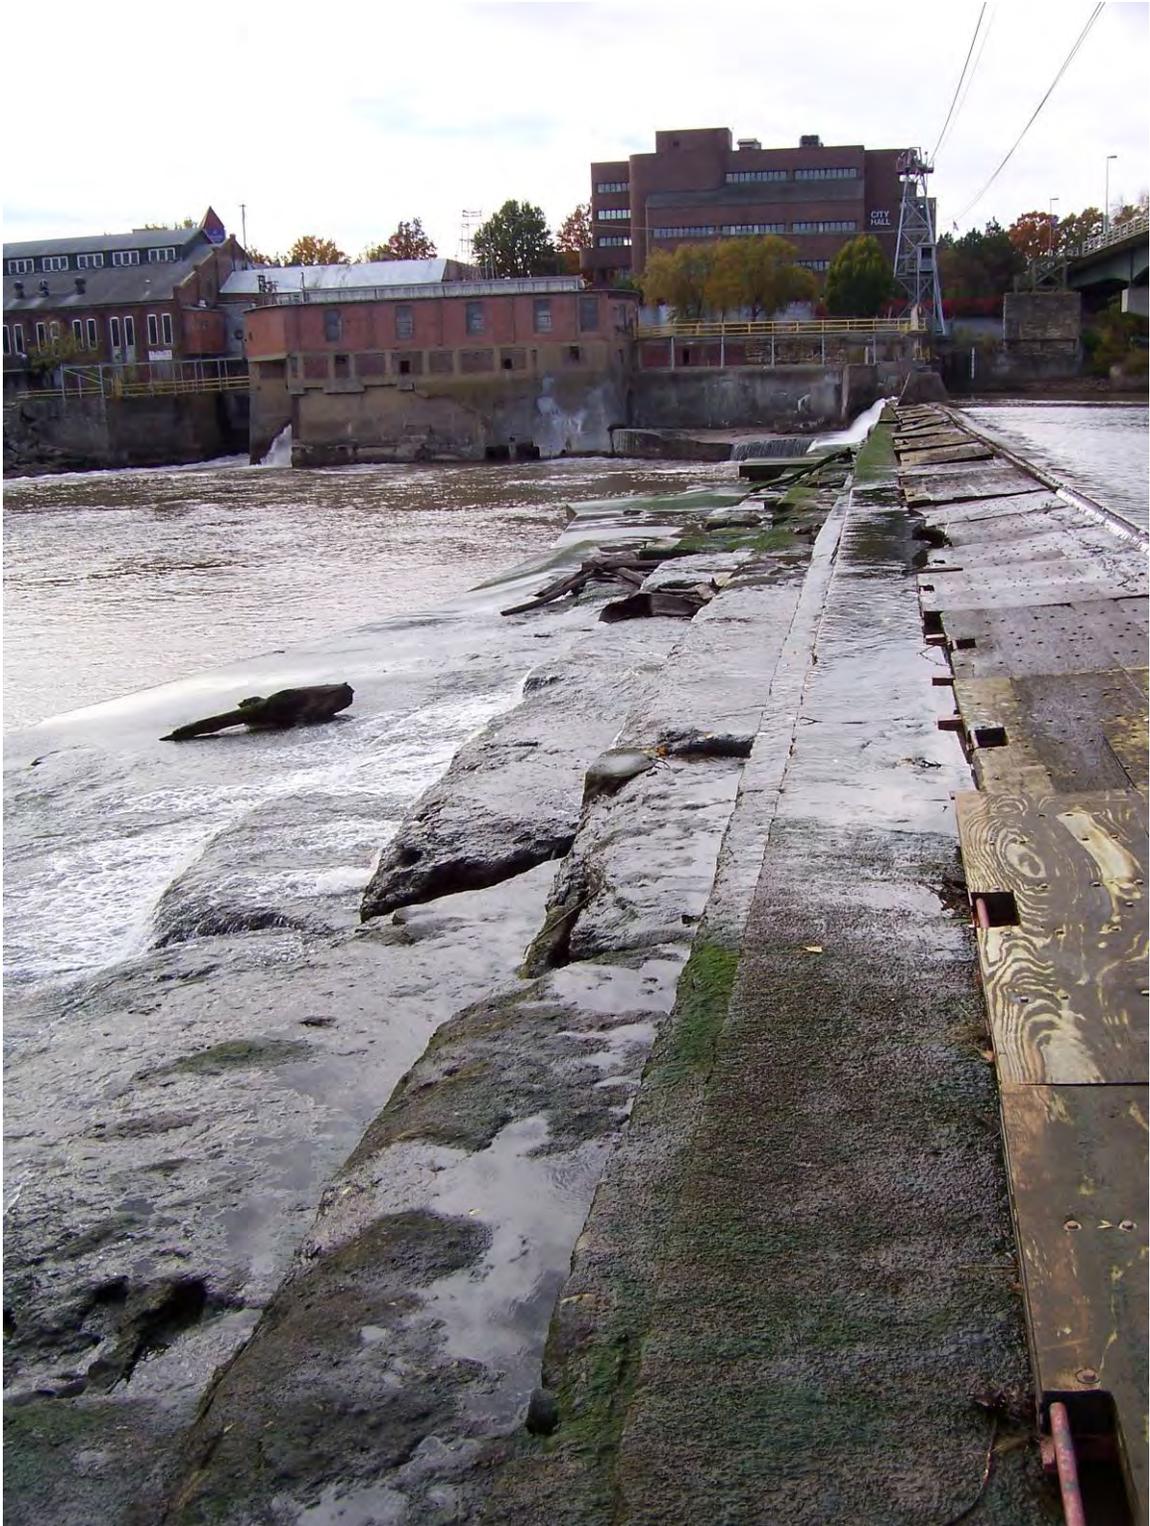
102. Sta 3+40 to south. Severe flow through dam. Cracked and deteriorated steps.

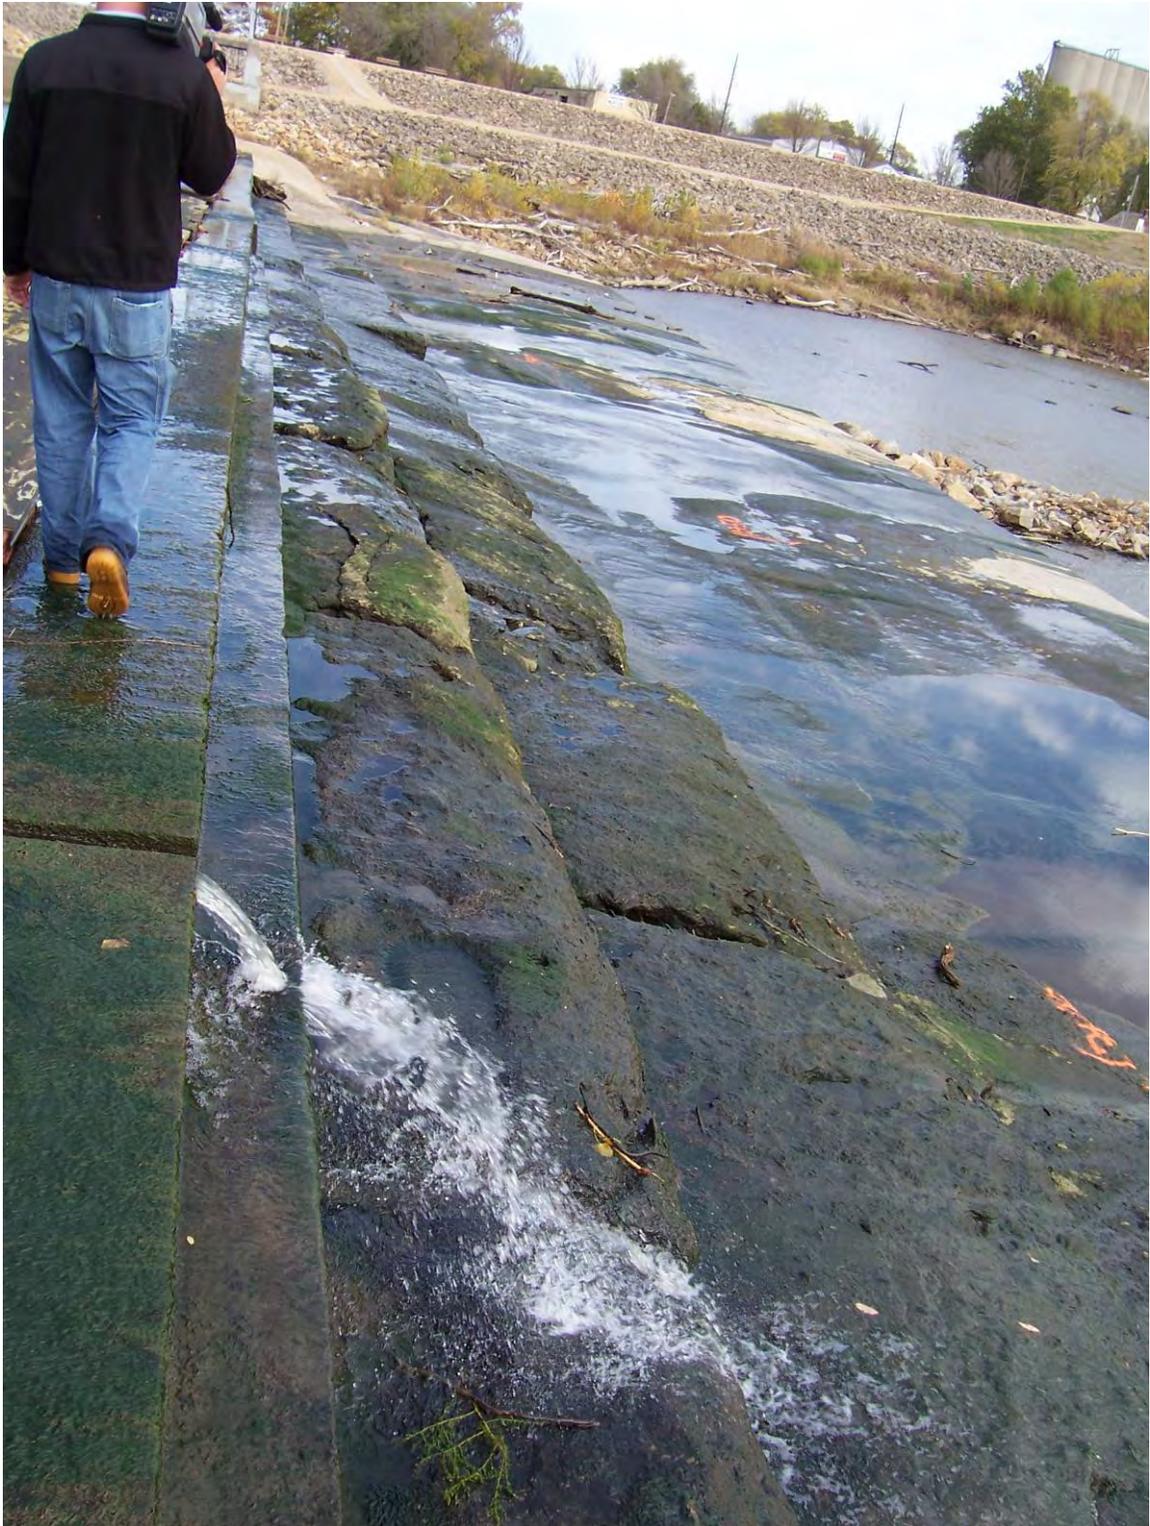
- Between Stations 2+50 and 3+50, the concrete has eroded to expose the timbers. Refer to photographs 30, 31, 33, 35 through 49, 104 and 105.
- Between Stations 2+75 and 3+50, all three steps in the dam are in poor condition. Refer to photographs No 37 through 49, 52, and 102 through 105.

103. Sta 3+00 from top. Flow over dam top. Severe step deterioration.

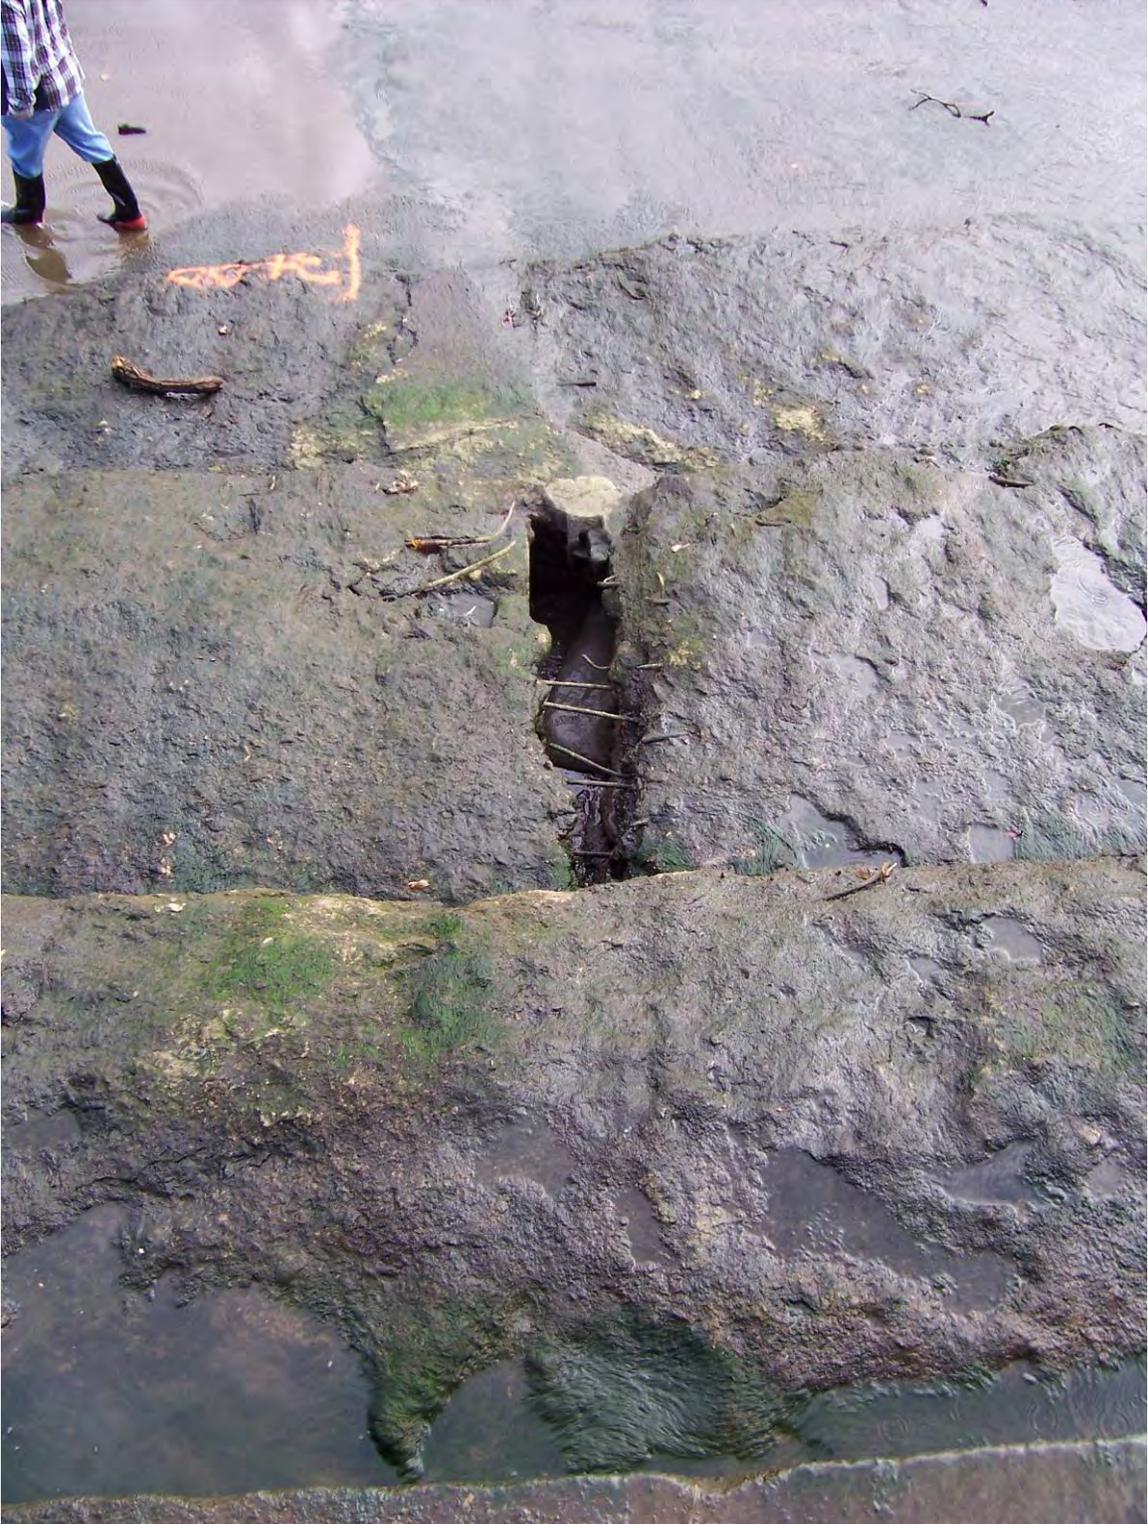
104. Sta 3+00 from top. Eroded timber hole with exposed rebar.

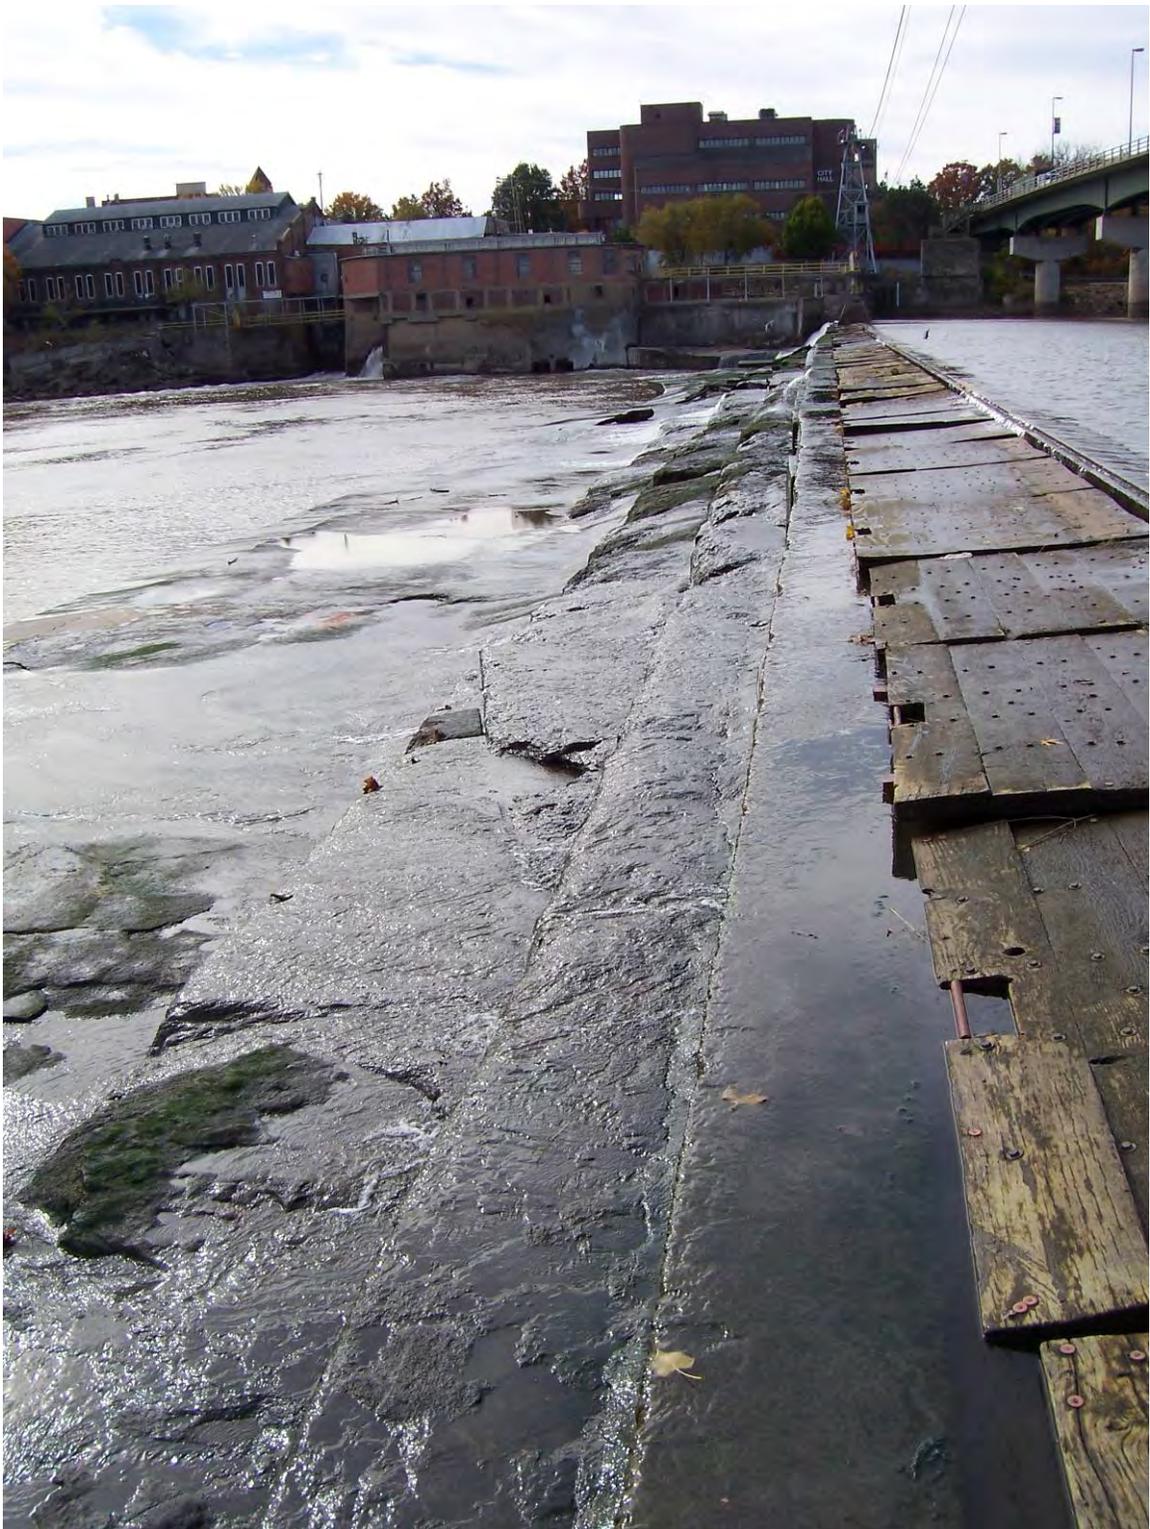
- Between Stations 2+00 and 2+50, there is a significant triangular piece of concrete approximately 25' by 8' that is separated from the lowest step of the dam. Refer to photographs 26 through 28 and 106 through 108.

108. Sta 1+75 to south. Separated triangular section in bottom step. Eroded concrete steps.

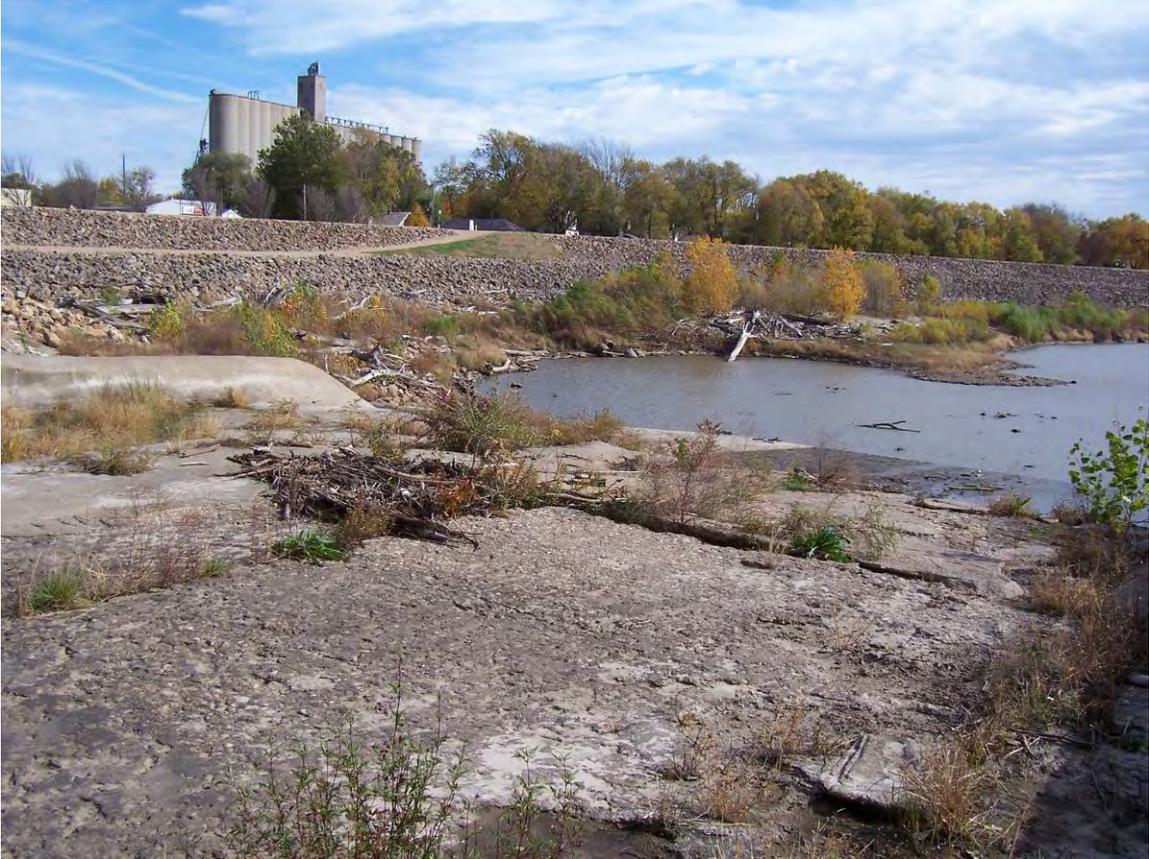
122. Spillway to northeast. Eroded and cracked concrete.

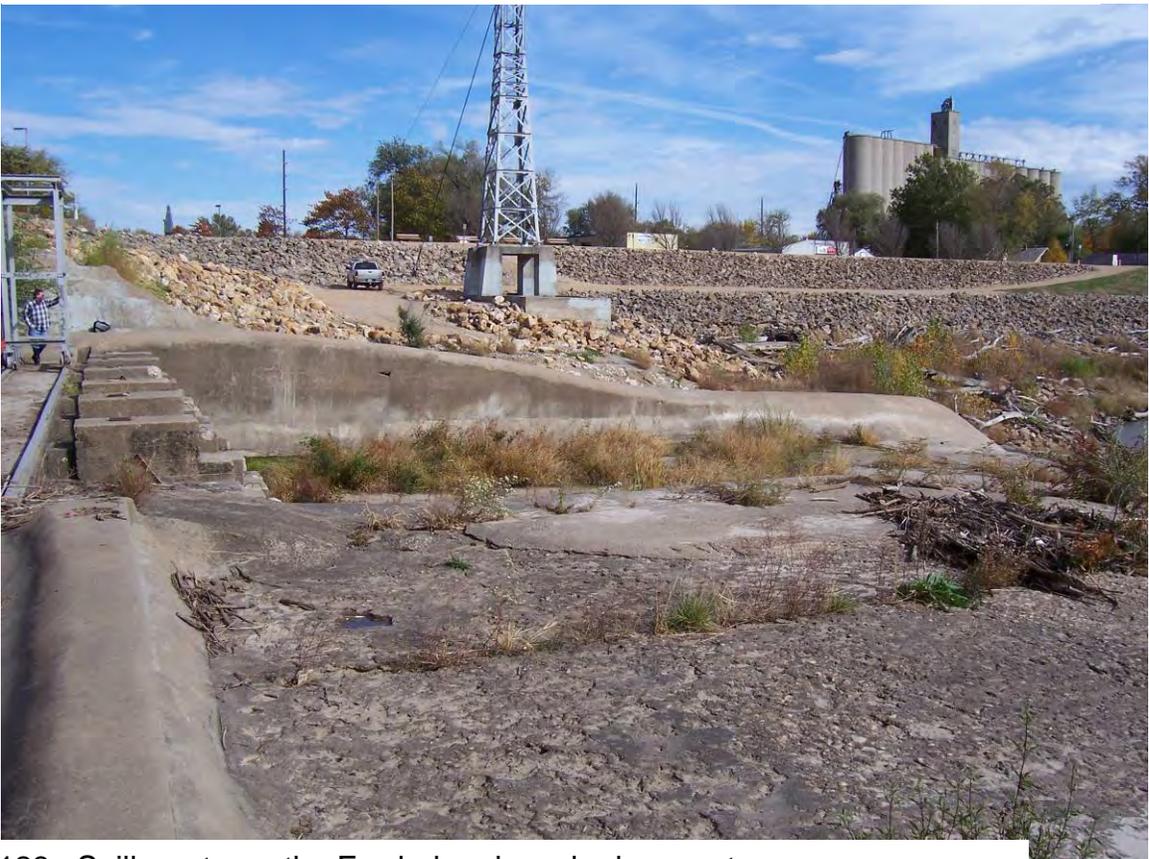
123. Spillway to north. Eroded and cracked concrete.

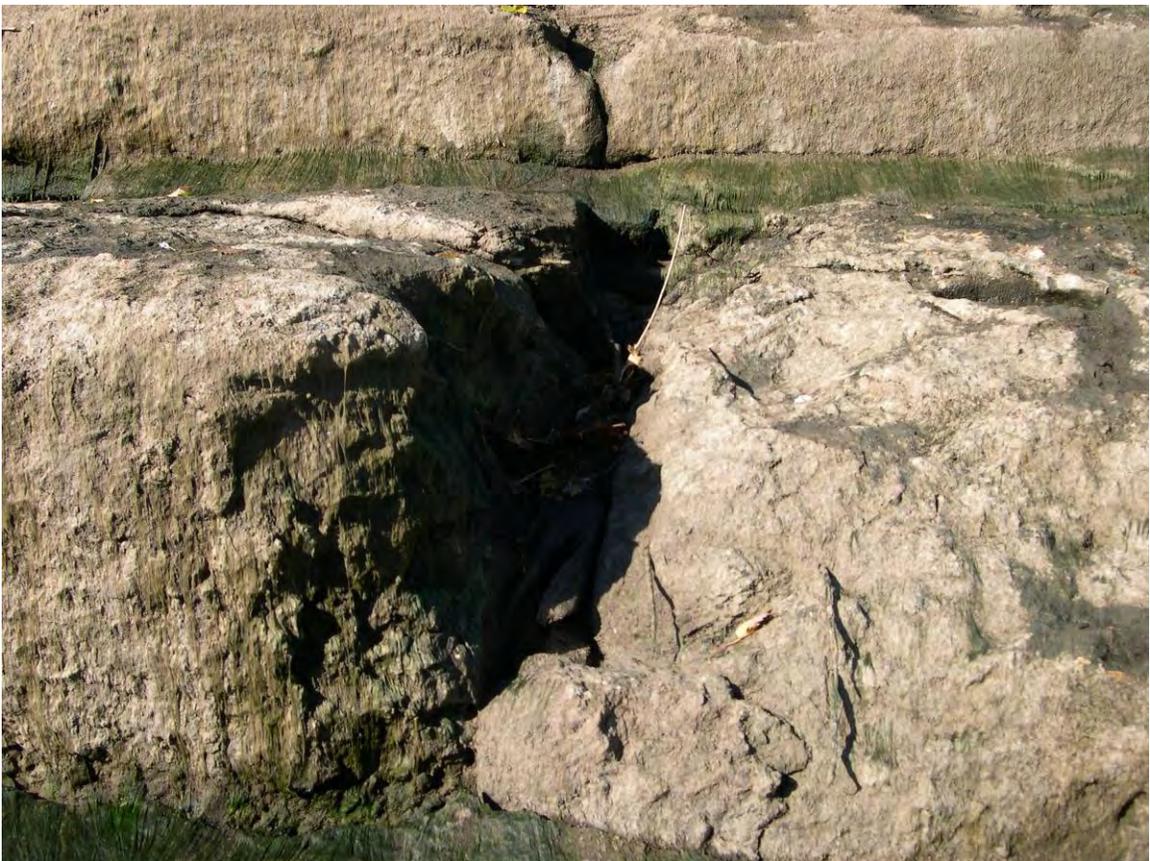
131. Sta 2+80. Exposed timber and eroded concrete. Crack in bottom step.

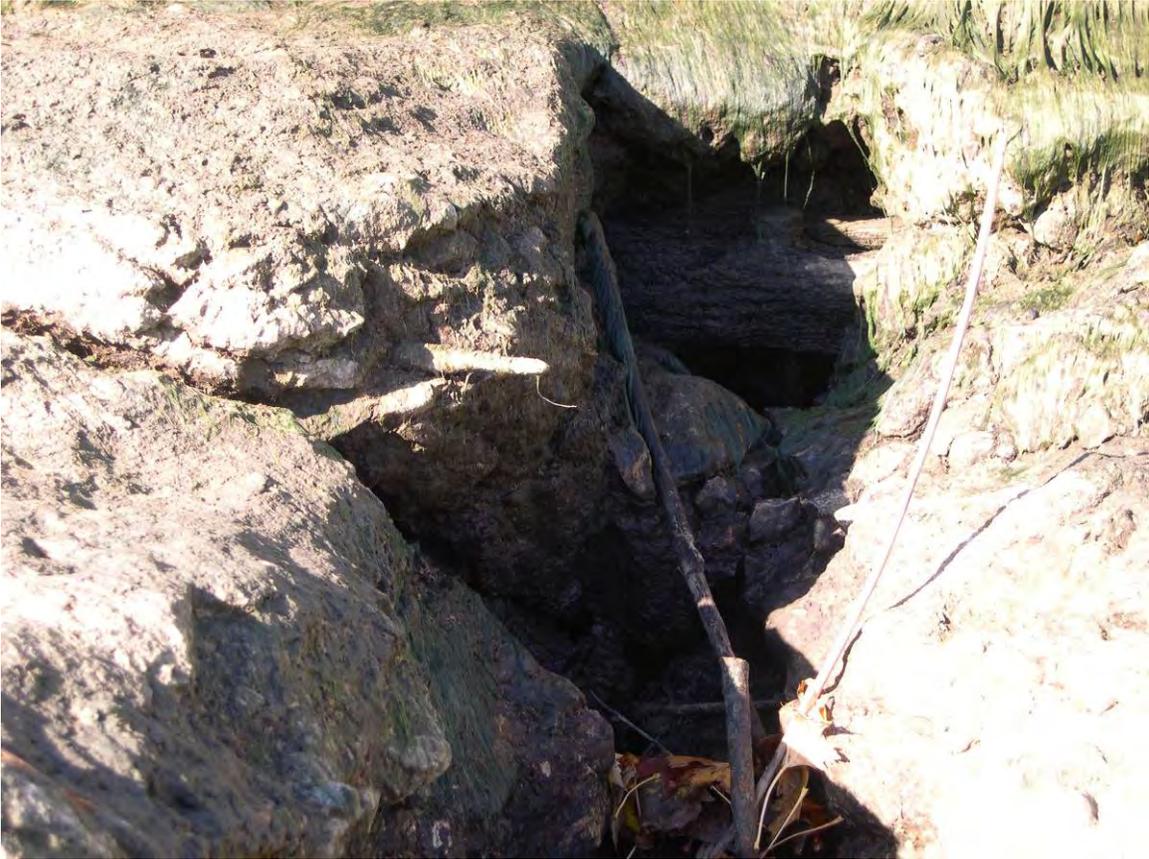
132. Sta 2+80. Exposed timber and eroded concrete. Crack in bottom step.

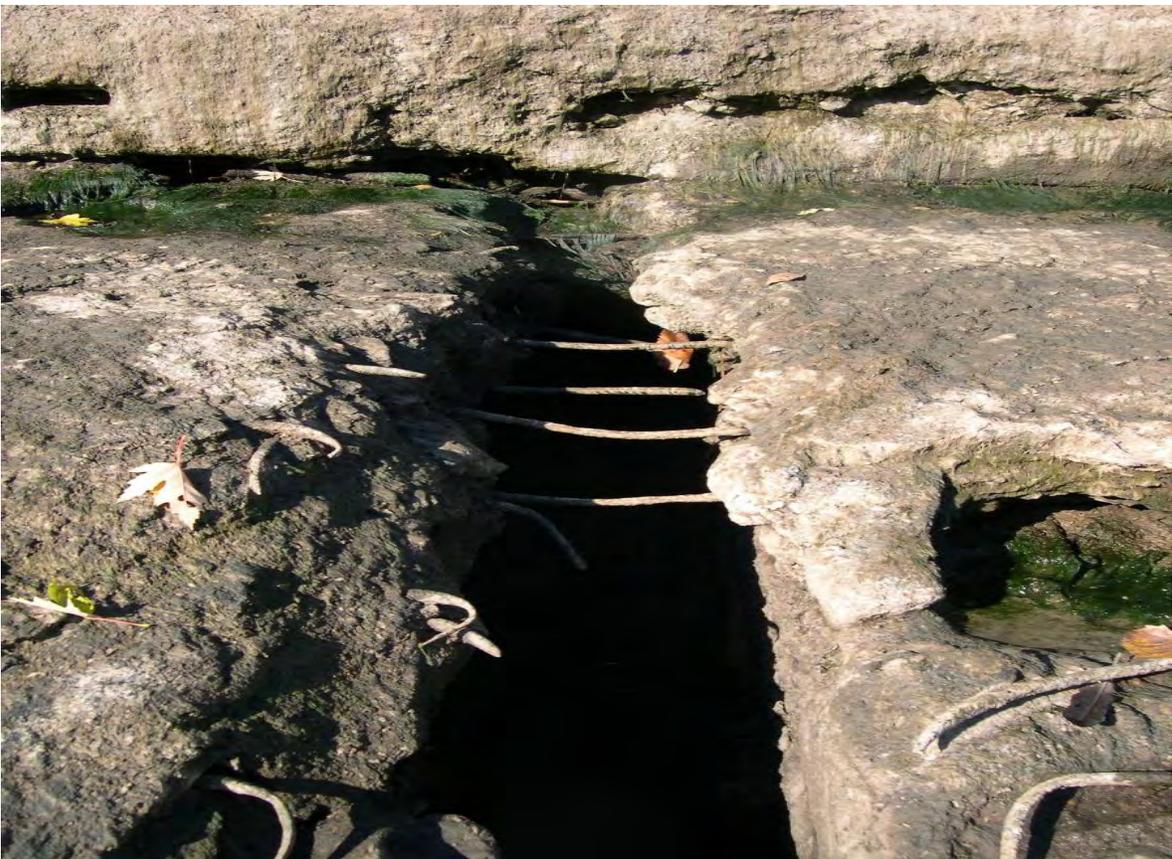
133. Sta 3+05. Eroded timber hole with exposed rebar. Exposed joint between steps.

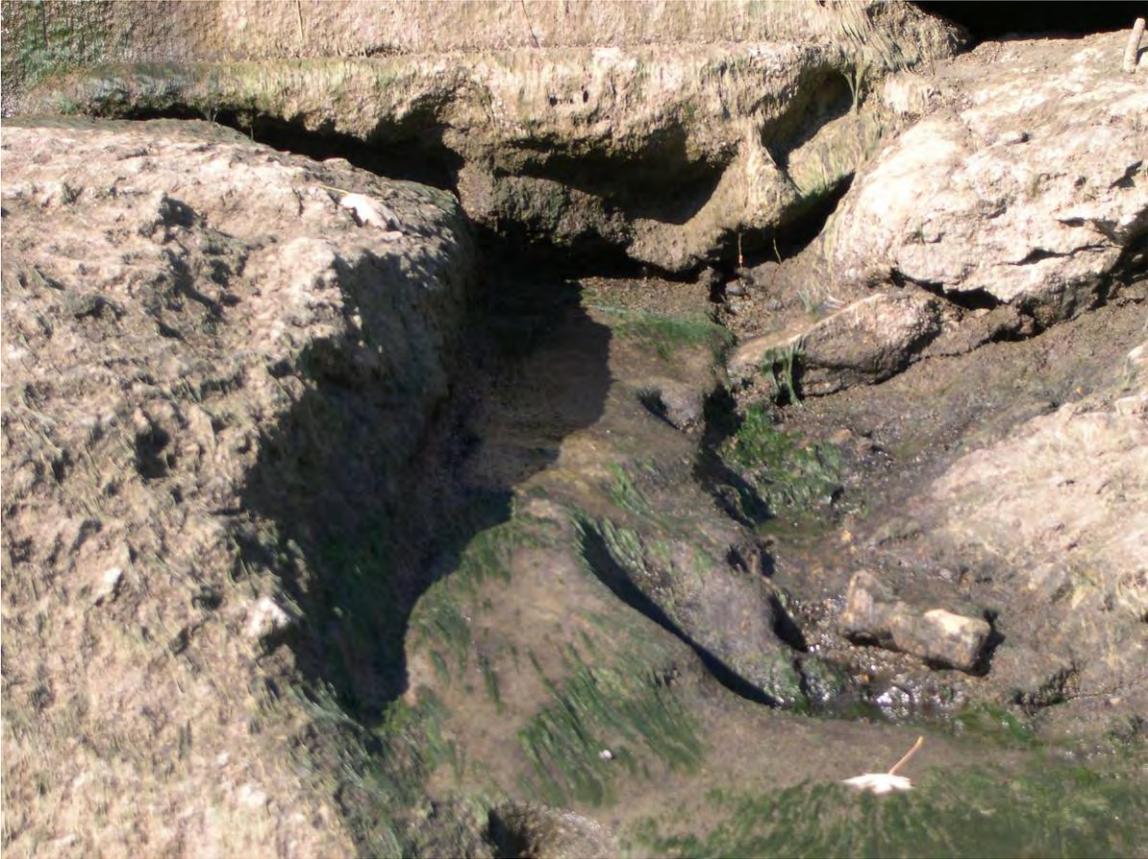
134. Sta 3+30. Exposed timbers between first and second steps. Severe deterioration of steps.

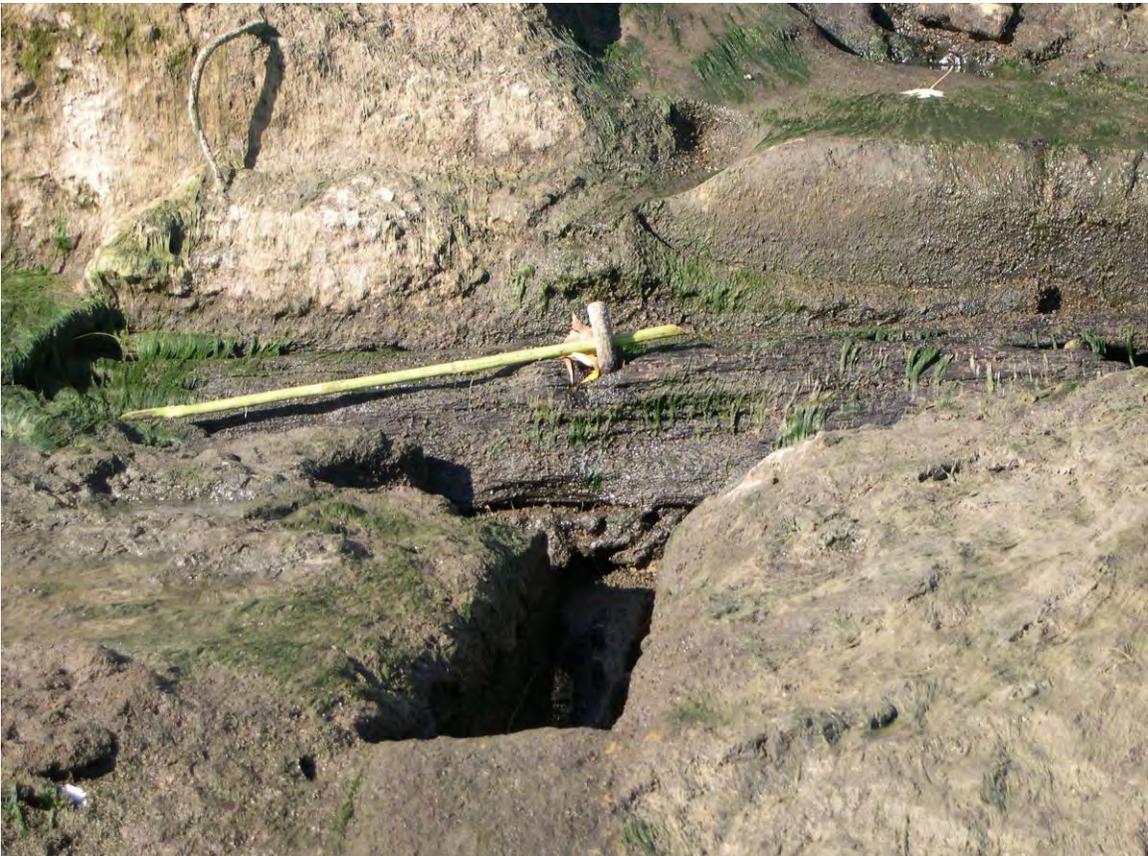
135. Sta 3+30. Exposed timbers between first and second steps. Severe deterioration of steps.
