Lawrence, Kansas
Bowersock Dam Inspection 2006

B&V Project 146136
B&V File B-1.1
February 14, 2007

On October 30, 2006 an inspection of the Bowersock Dam in Lawrence, Kansas was performed to assess the condition of the dam. This report summarizes the visual observations made of the dam's condition and provides a phased recommendation for corrective actions for the City of Lawrence's consideration.

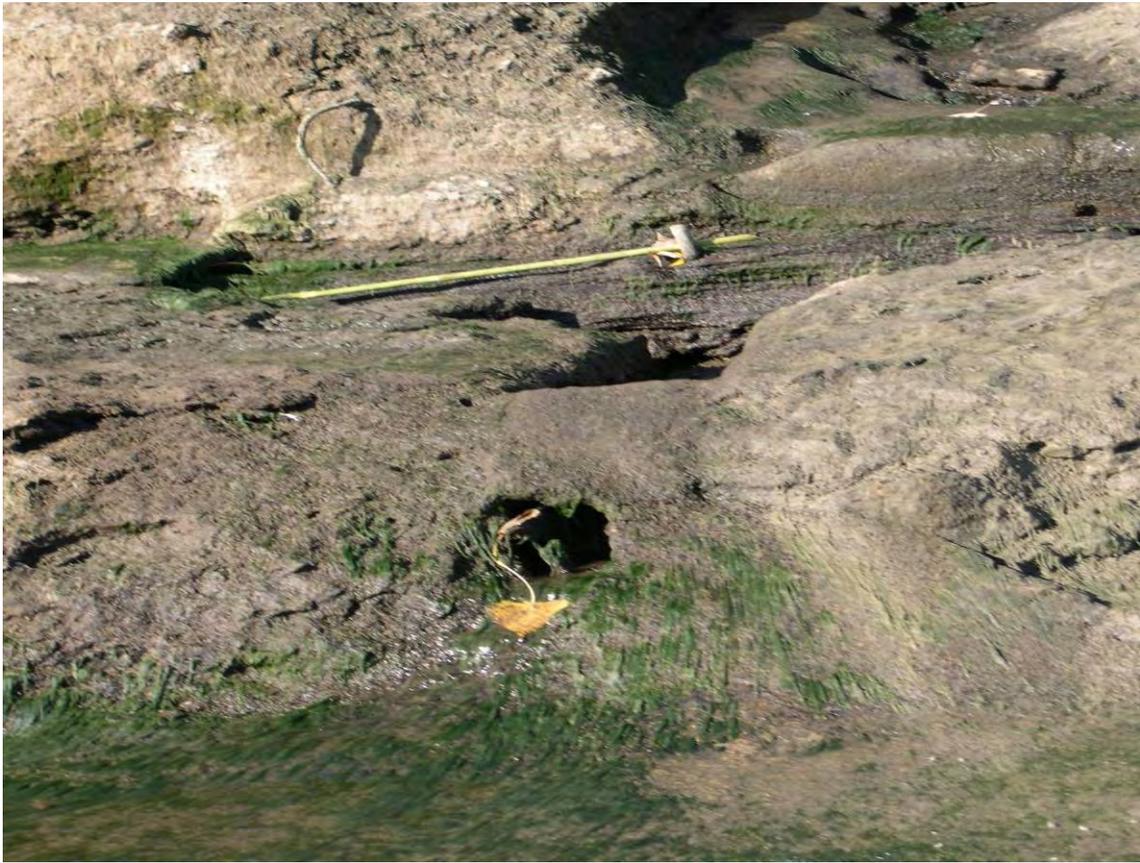
136. Sta 3+30. Exposed timbers between first and second steps. Severe deterioration of steps.

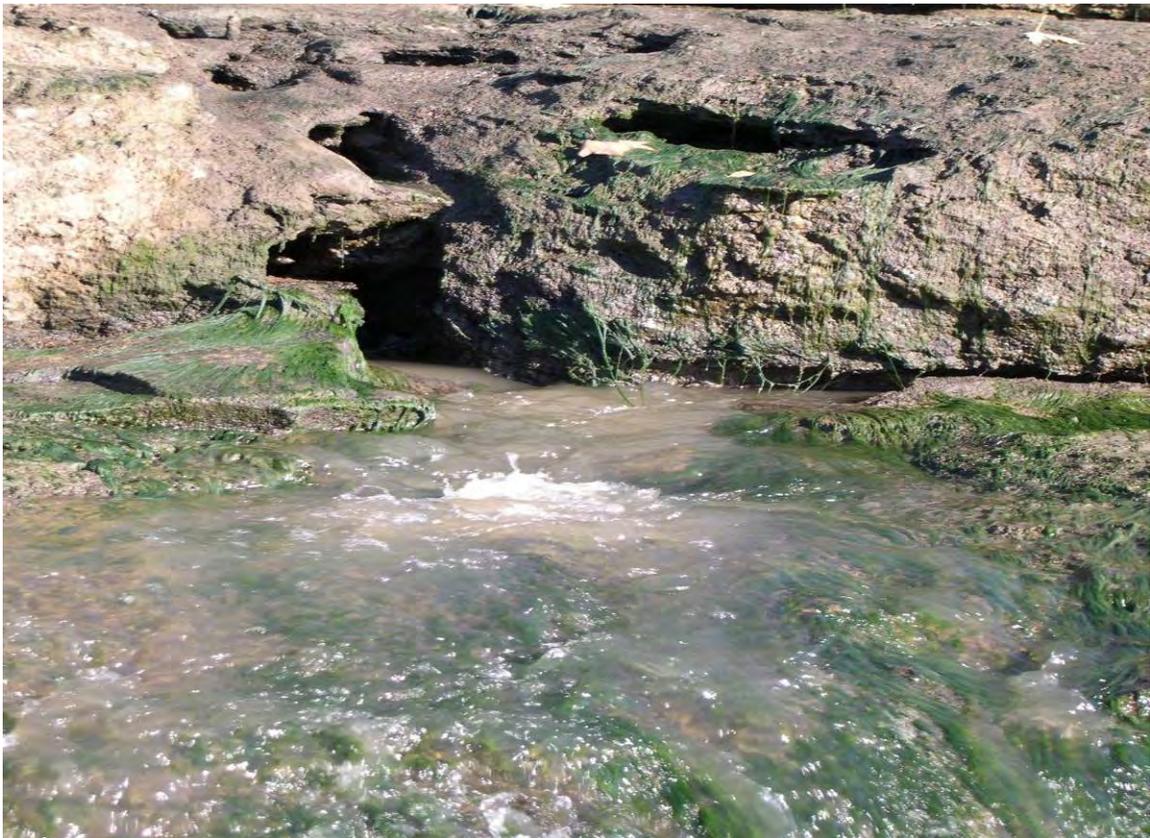
137. Sta 3+40. Flow after dive repairs.

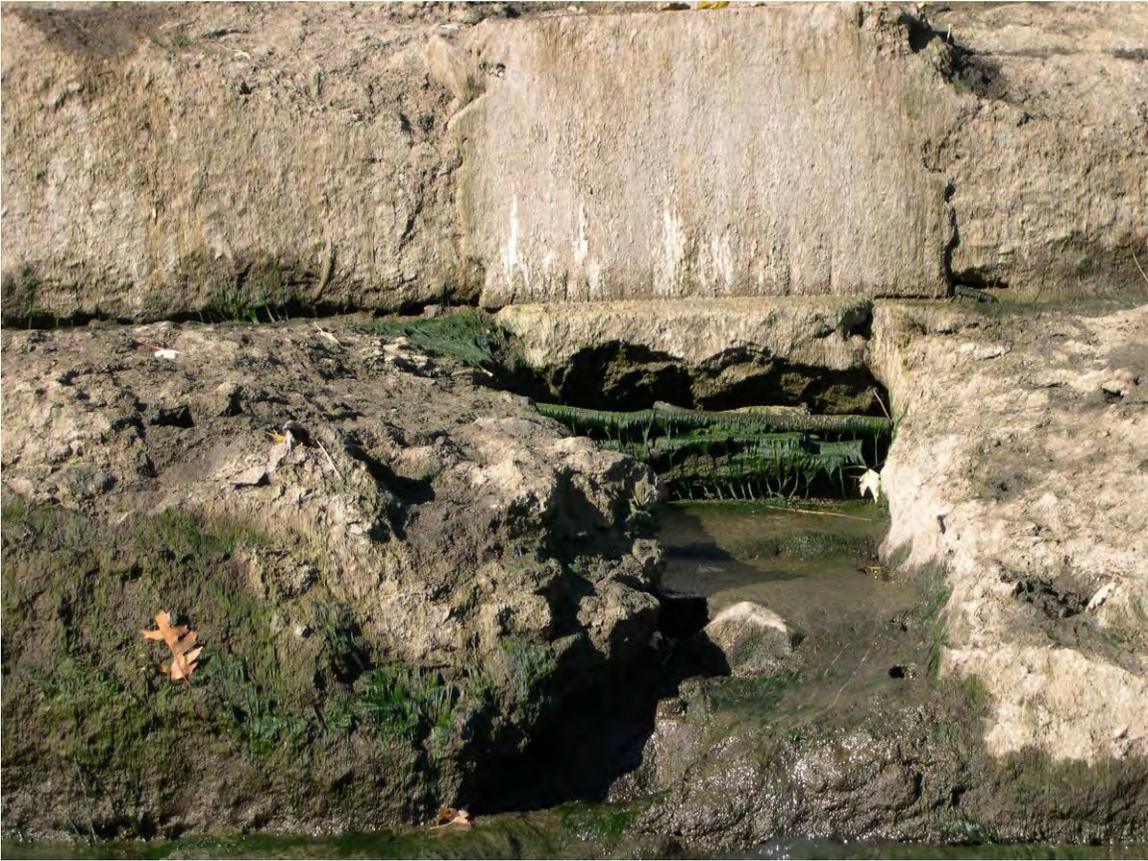
138. Sta 3+50. Eroded timber holes with flow through dam. Severely deteriorated steps.

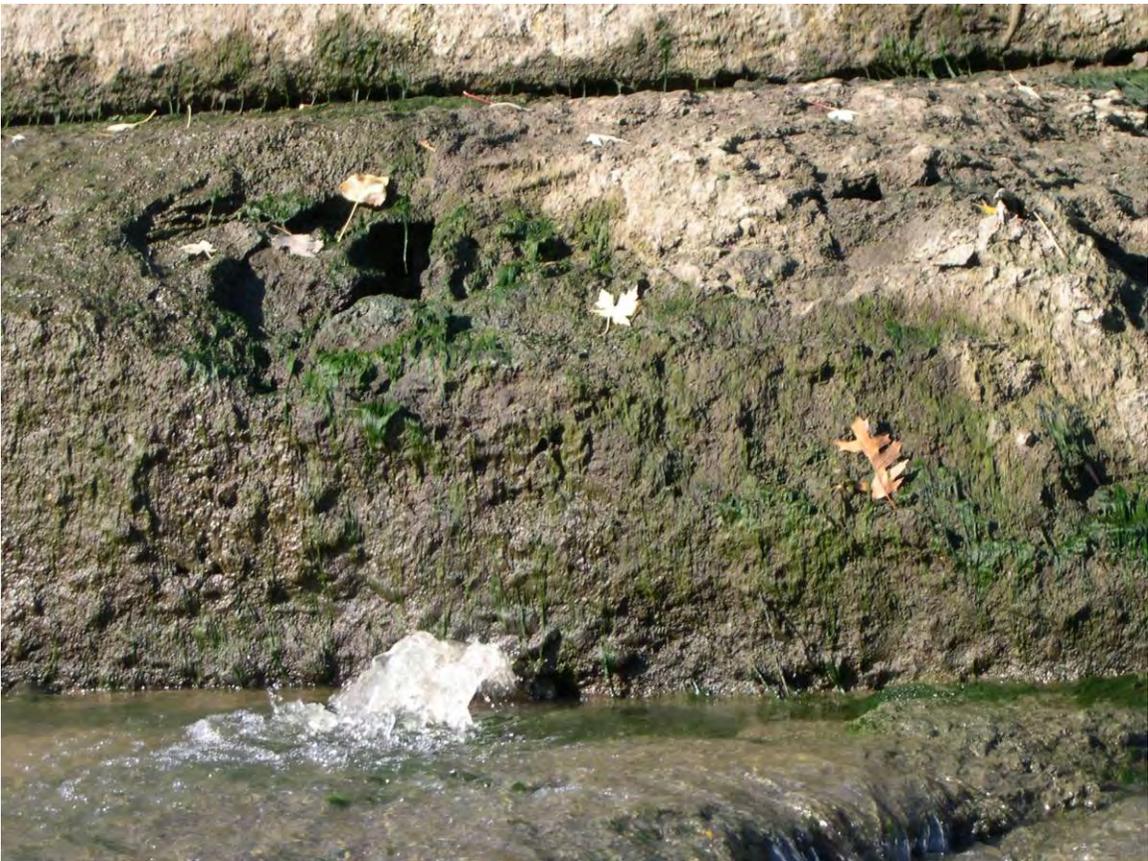
139. Sta 3+55. Flow after grout bag repairs upstream.

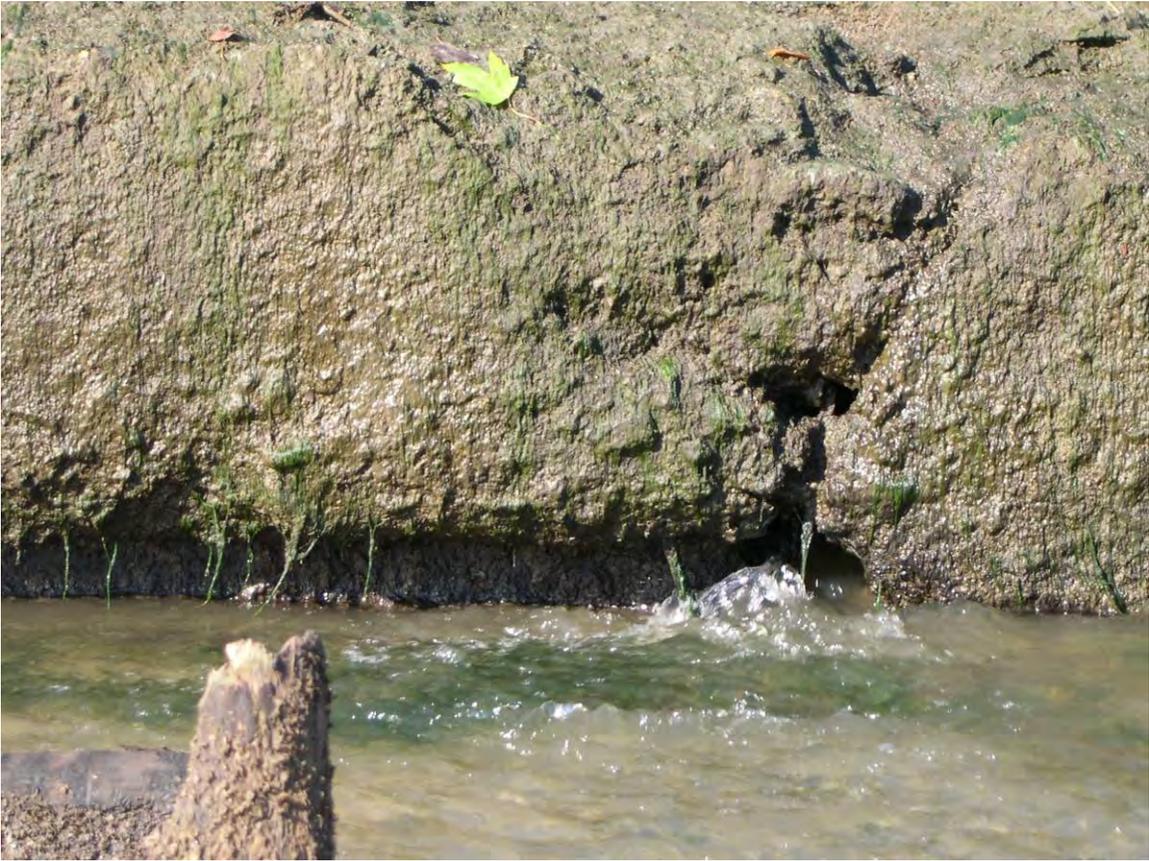
140. Sta 3+80. Flow after grout bag repairs upstream.

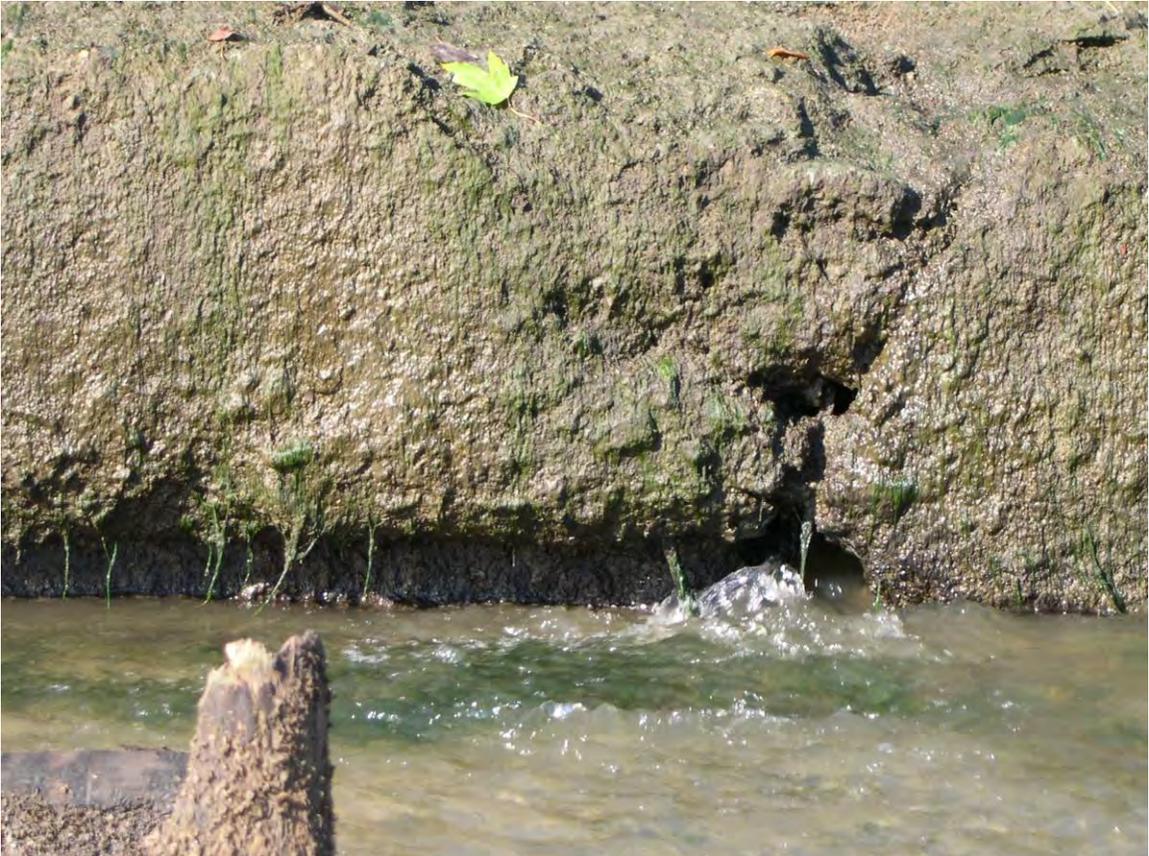
141. Sta 3+90±. Flow after grout bag repairs upstream.

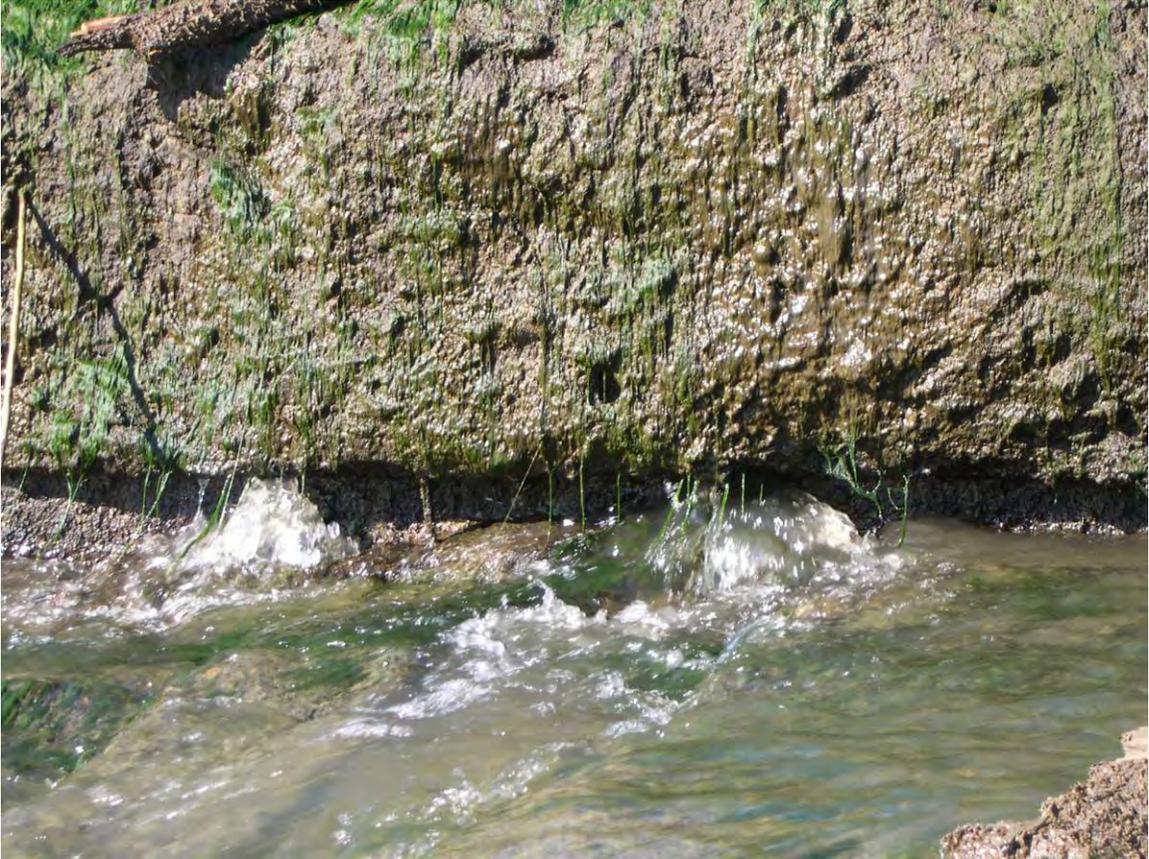
142. Sta 3+90. Flow after grout bag repairs upstream.

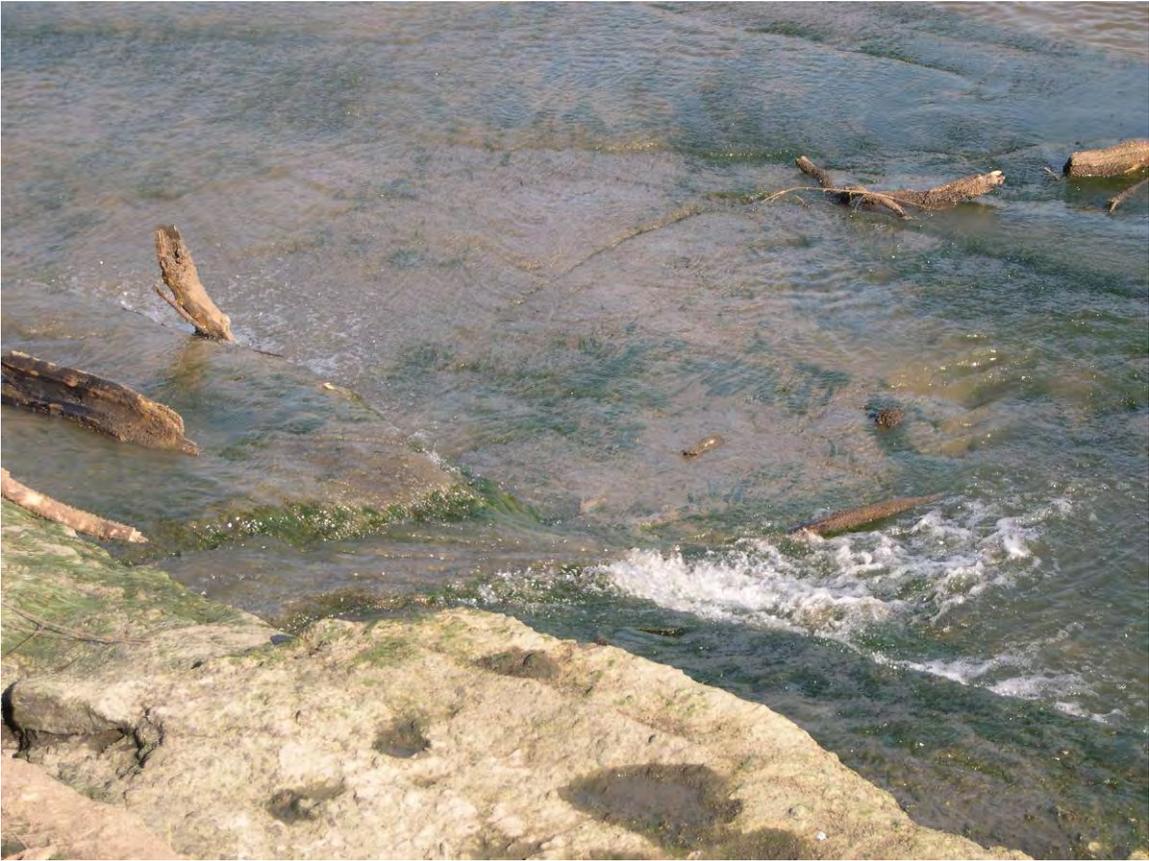
143. Sta 3+90 from top. Flow after grout bag repairs upstream.

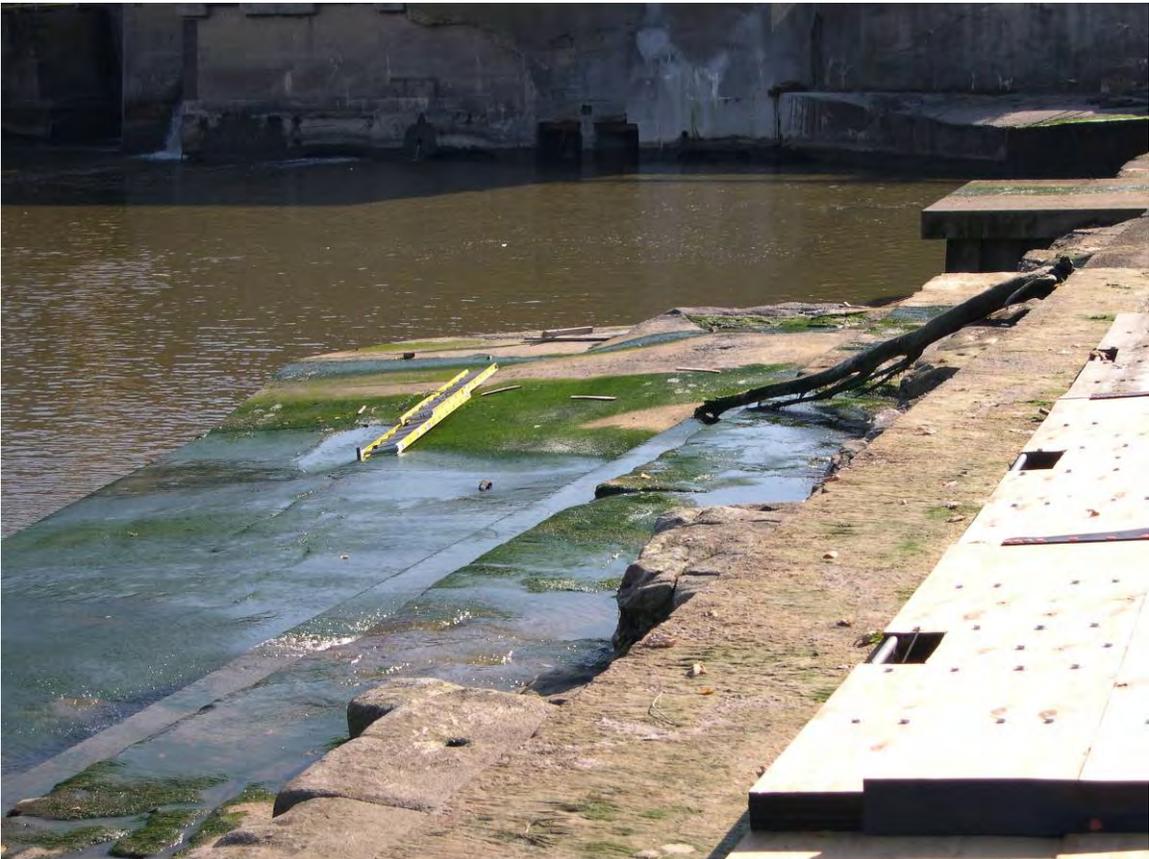
144. Sta 4+50±. Flow after grout bag repairs upstream.

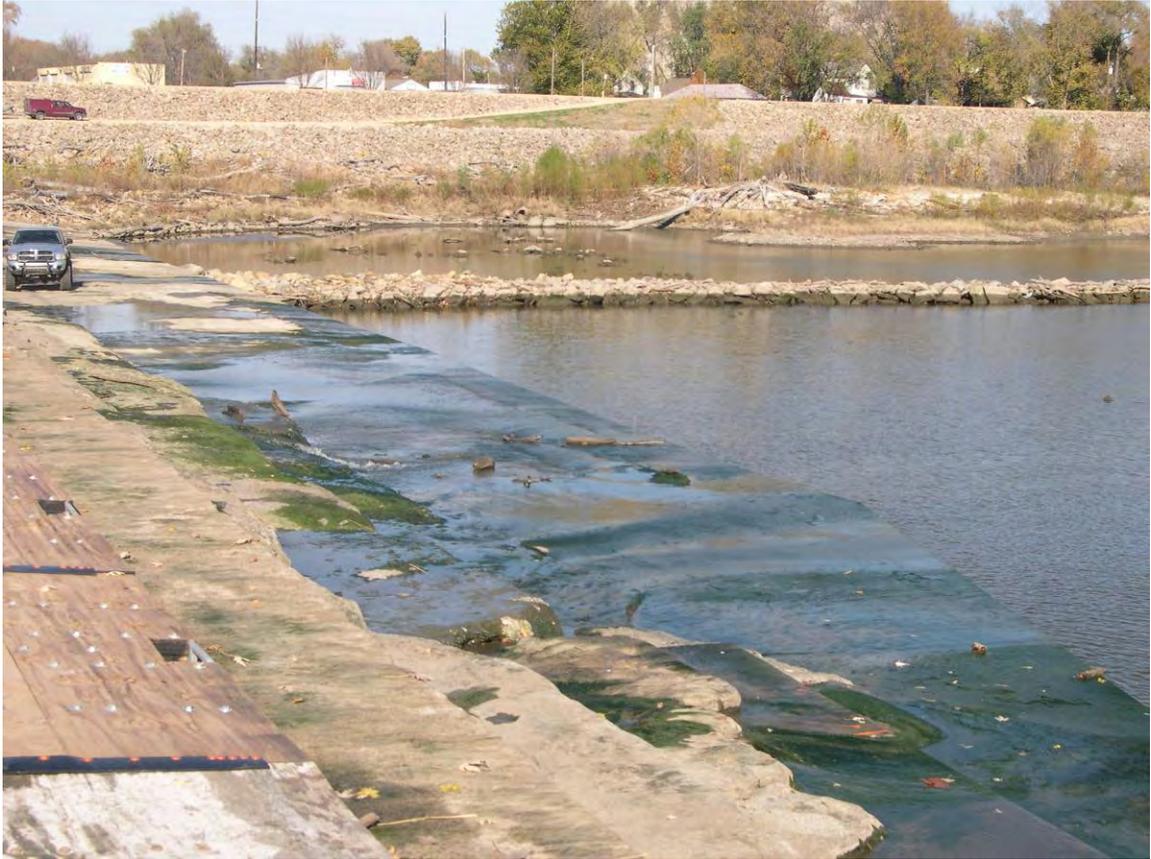
145. Sta 3+90±. Flows after grout bag repairs upstream.

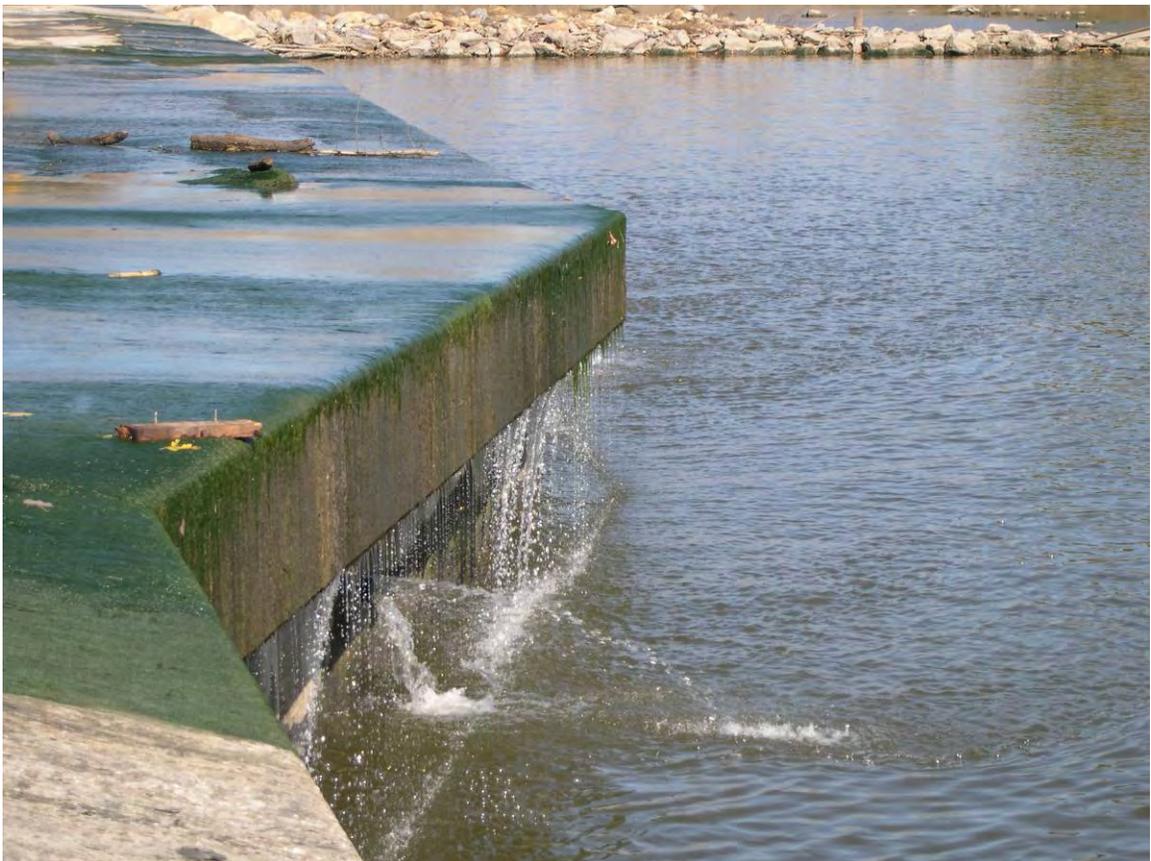
- After the grout bag installation was completed, and the flow through the dam reduced, spouts of water through weepholes in the apron were observed at various locations. Refer to photograph 146.

146. Sta 3+90±. Stream of flow through weep hole in piling below apron.
