Lawrence, Kansas  
Bowersock Dam Maintenance

B&V Project 160988  
B&V File B-1.1  
February 17, 2009

Subject: January 23, 2009 Inspection

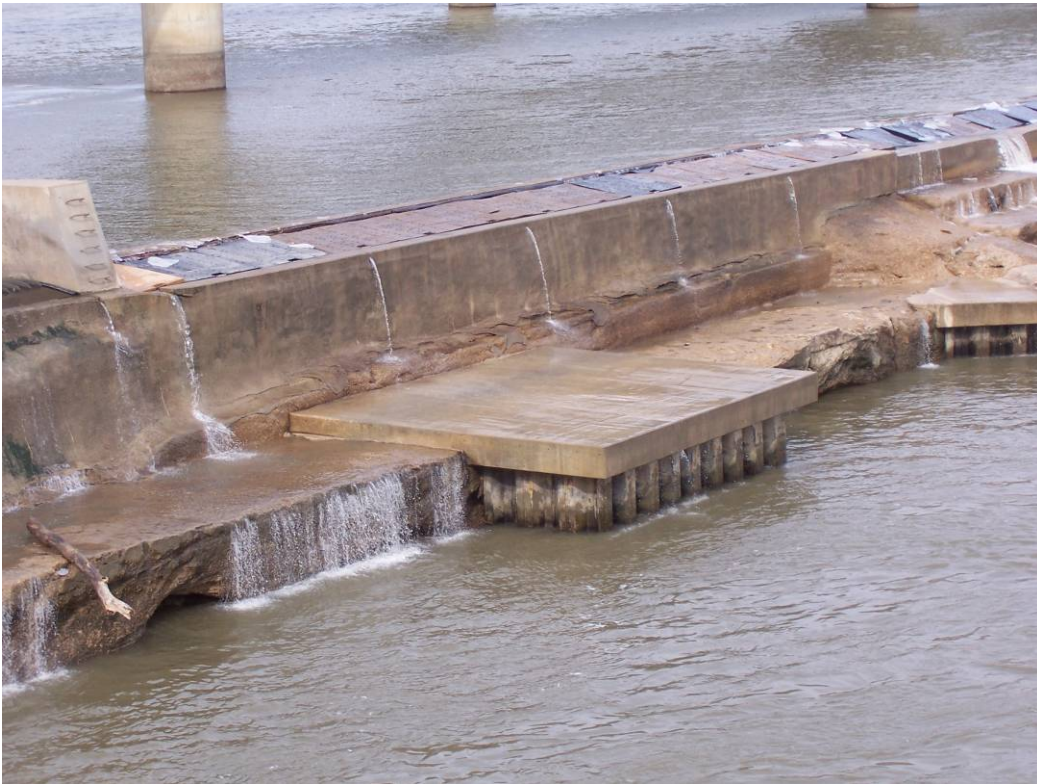
9. Sta 5+50 to Sta 6+50. Location of 2006 scour hole at Sta 5+80± located downstream of 7<sup>th</sup> batterboard (No. 58) north (right) from concrete pylon.

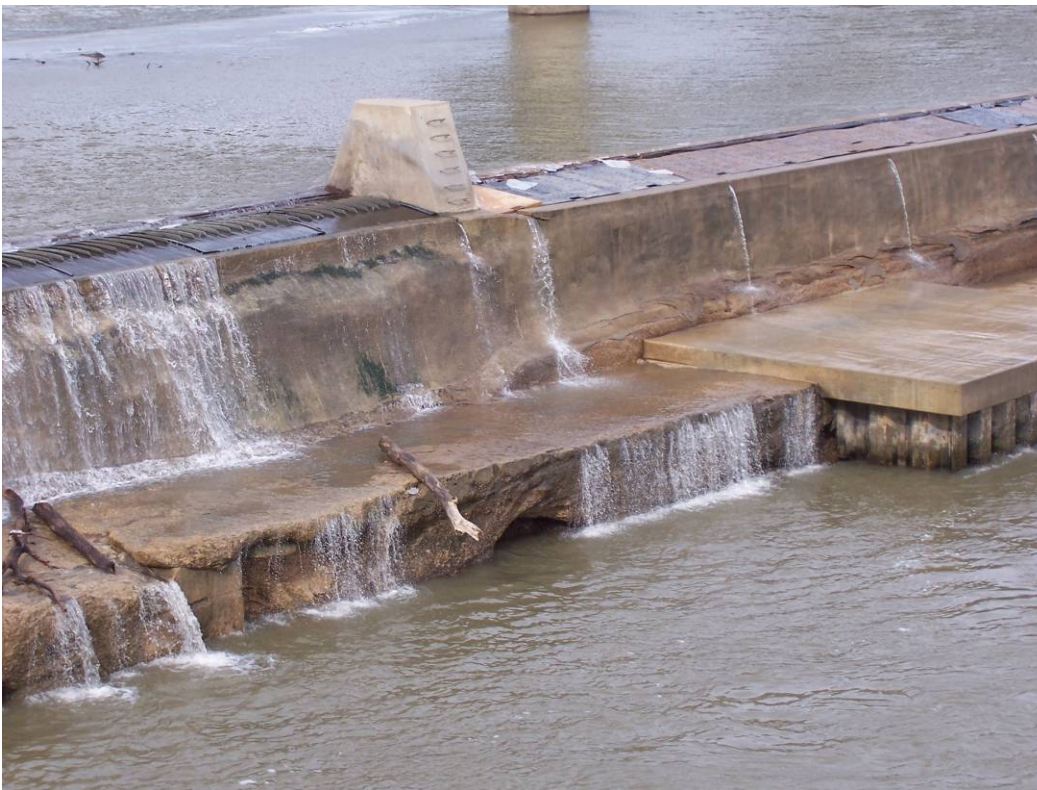
10. Sta 6+35 to Sta 6+75. Scour or eroded concrete under ledge @ Sta 6+60±.

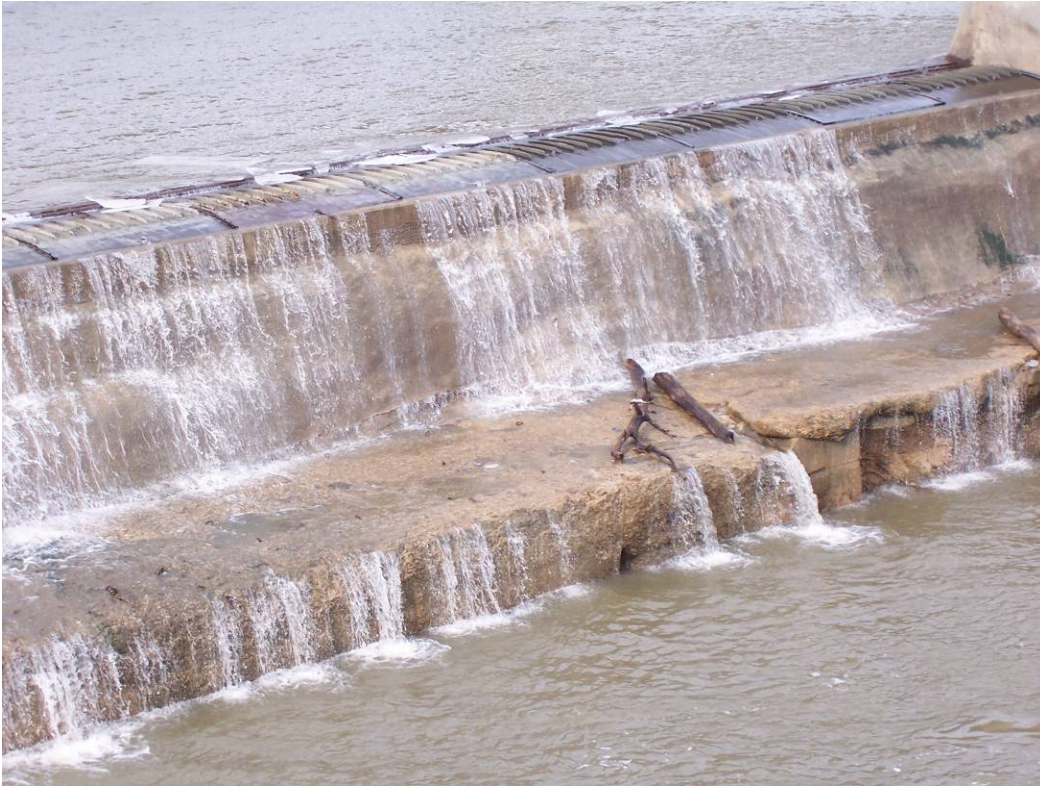
11. Sta 6+50 to Sta 7+00. Non-visible scour hole downstream from Obermeyer gate #7 south (right) from pylon as indicated in 2006 dive inspection.

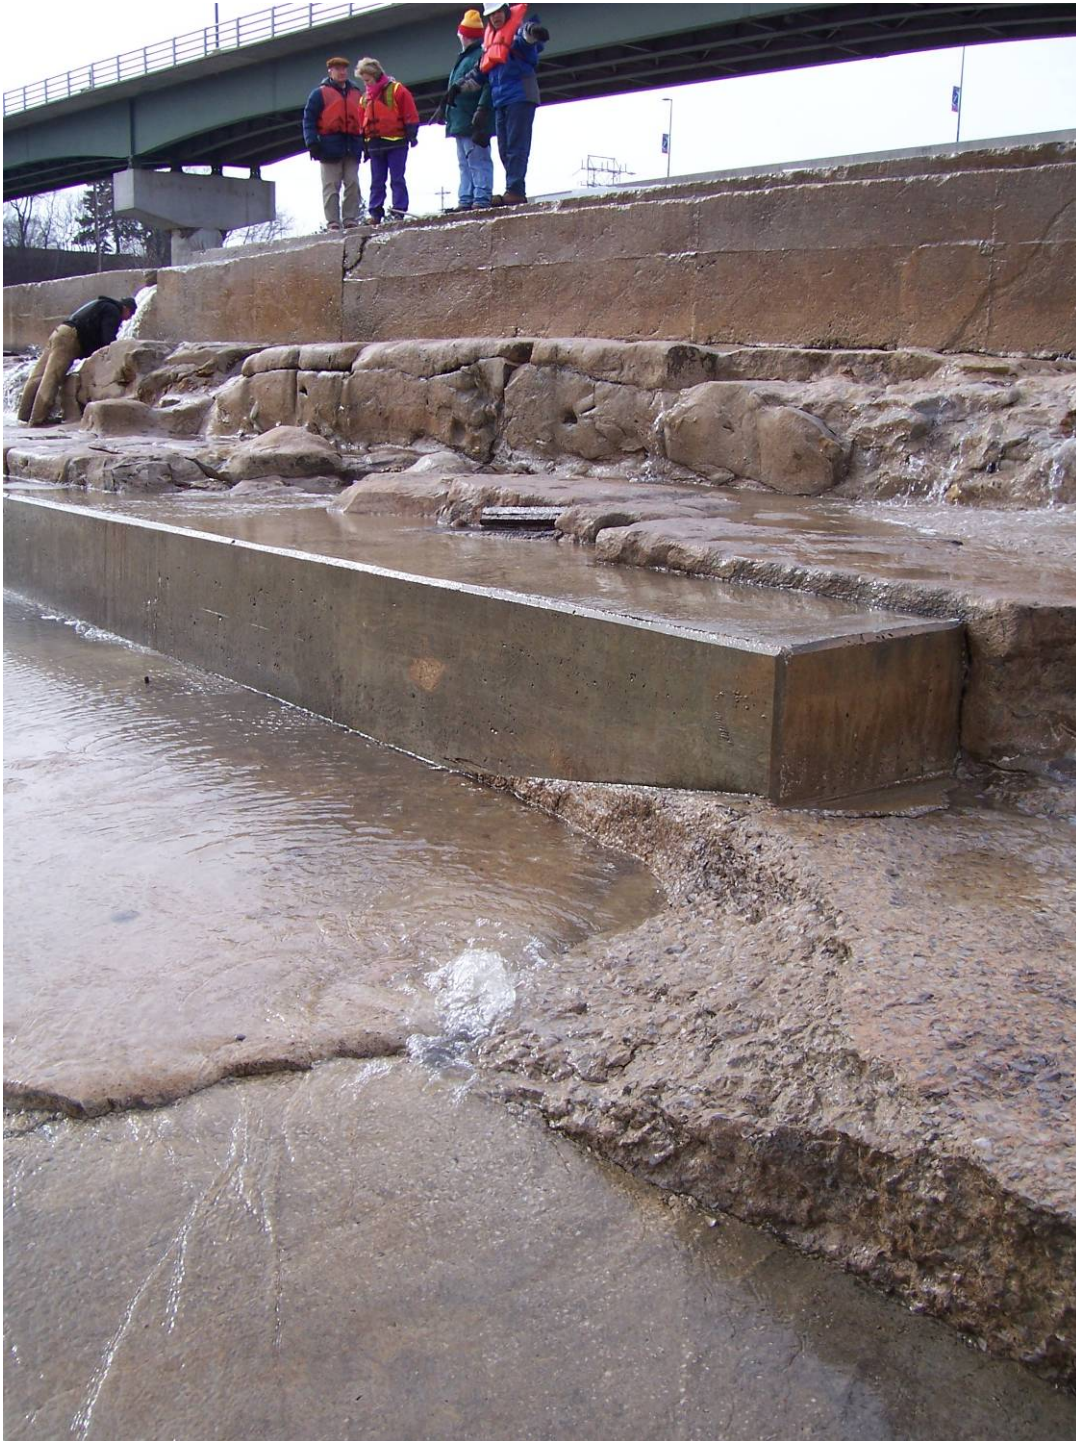
- A new area of leakage through the apron was observed near Sta 4+40. See photograph 13.
- The area between Sta 3+25 and Sta 3+40 was relatively dry during this inspection and a large section of timber cribbing that was previously obscured due to flow over the dam in 2006 was visible. It appears that additional erosion of the prior protective grout repair has occurred in this area. Refer to photographs 22, 23, 24, 25, 26, and 27.

13. Sta 4+40. Leak bubbling up thru start of apron.

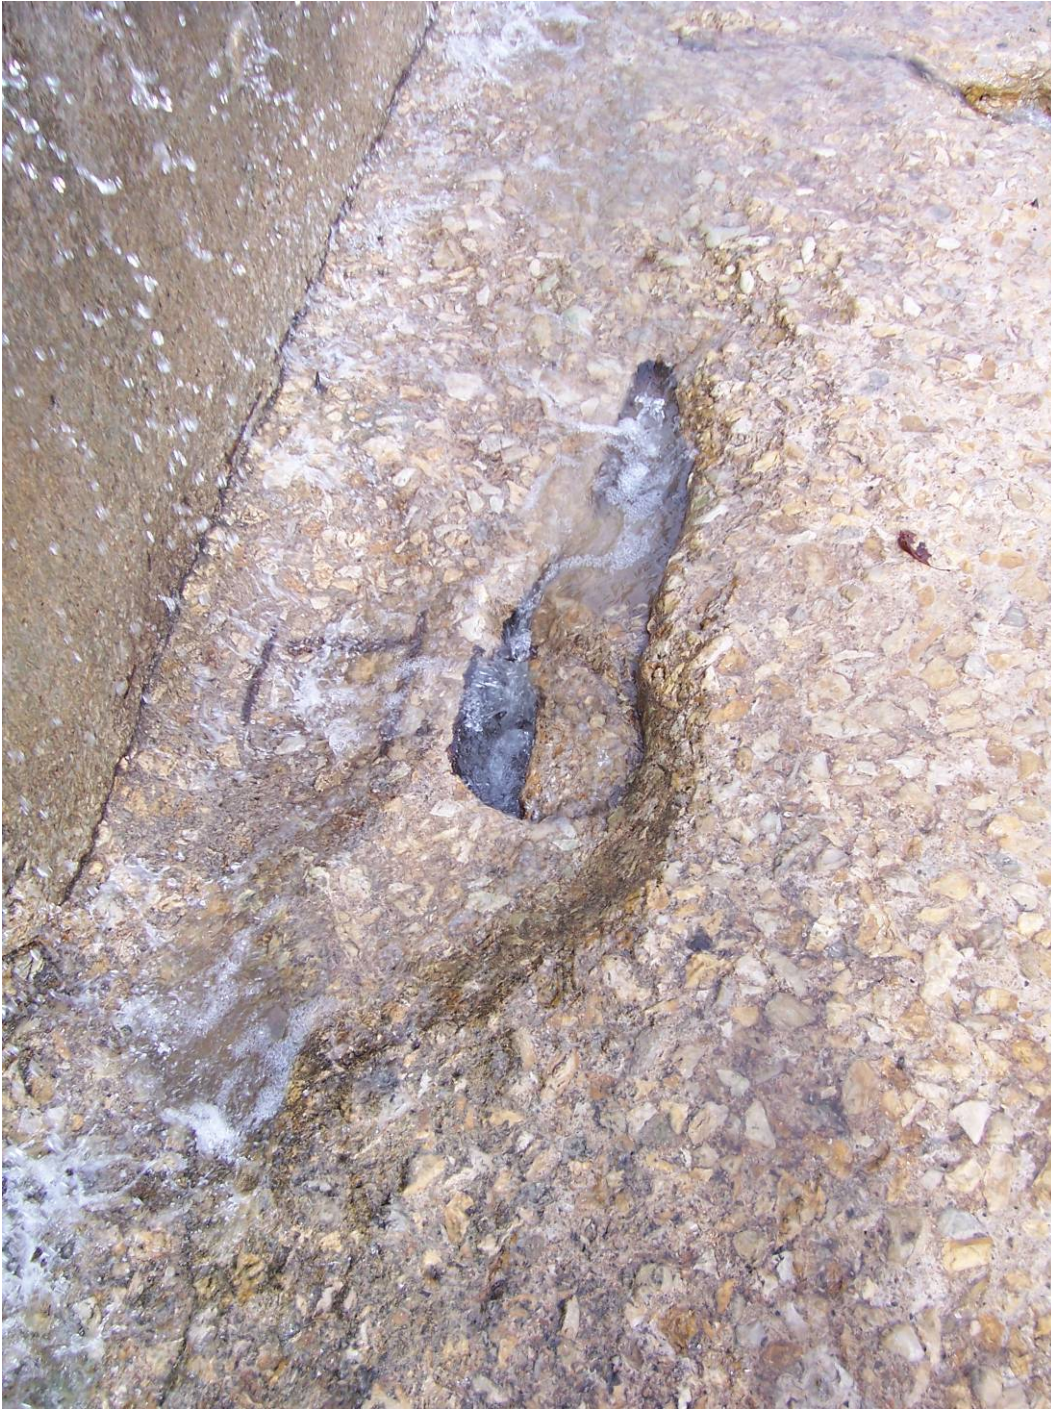
14. Sta 4+40. Water draining into eroded concrete and exposed timber hole.  
(See #98, 2007 Report.)

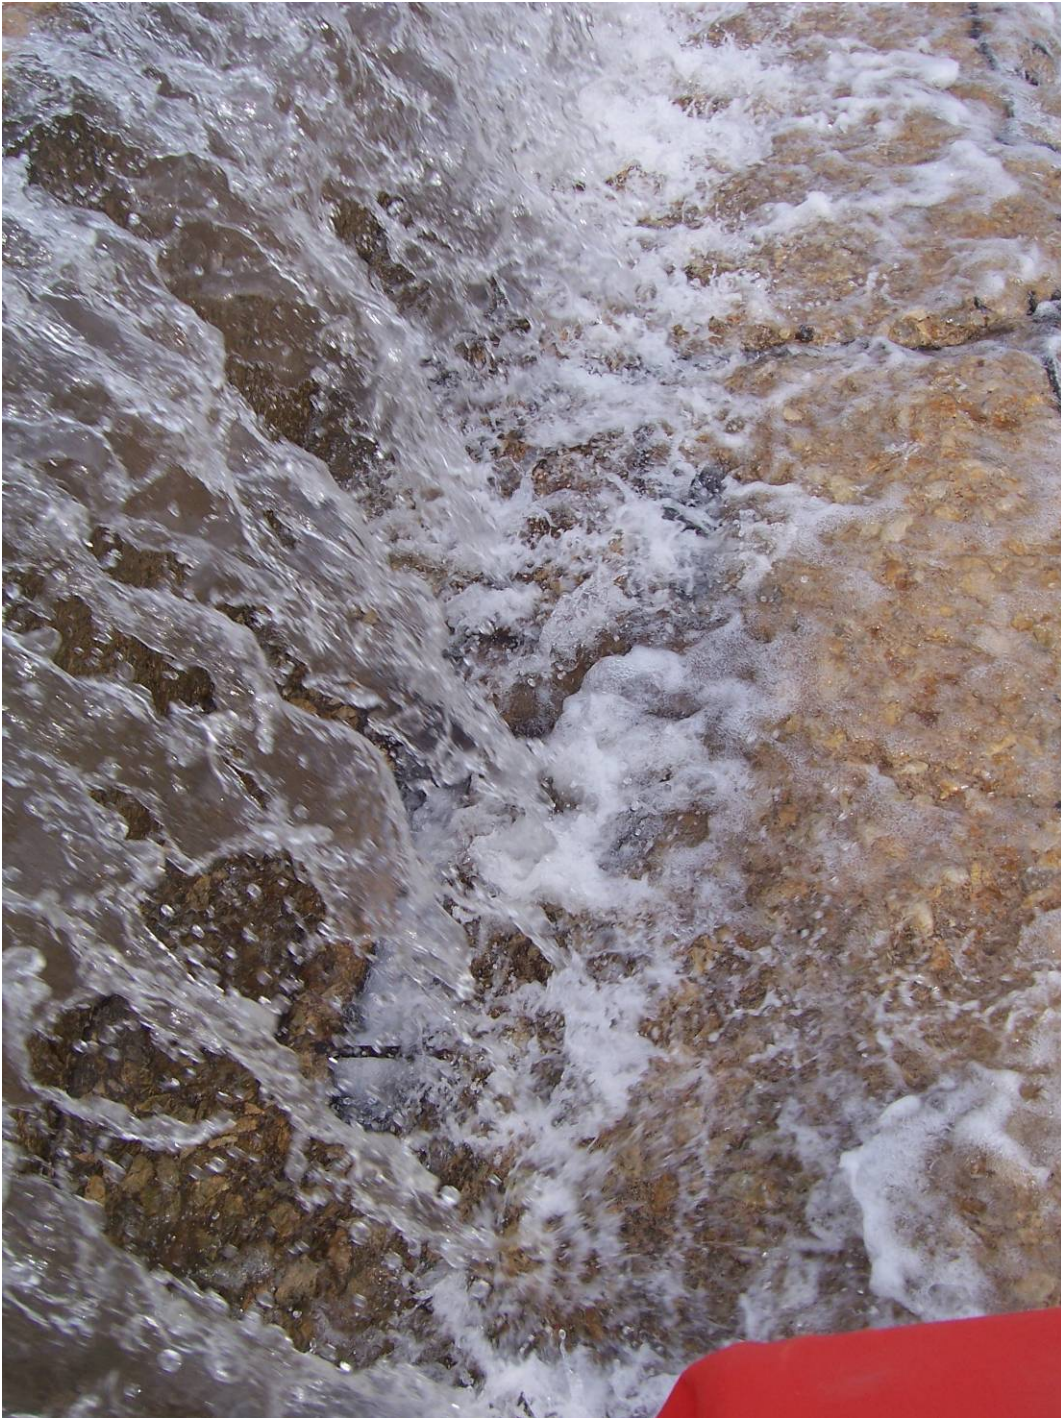
15. Sta 3+90±. Water flowing into eroded concrete with exposed wire mesh in top step. (See #55 & 99, 2007 Report.)

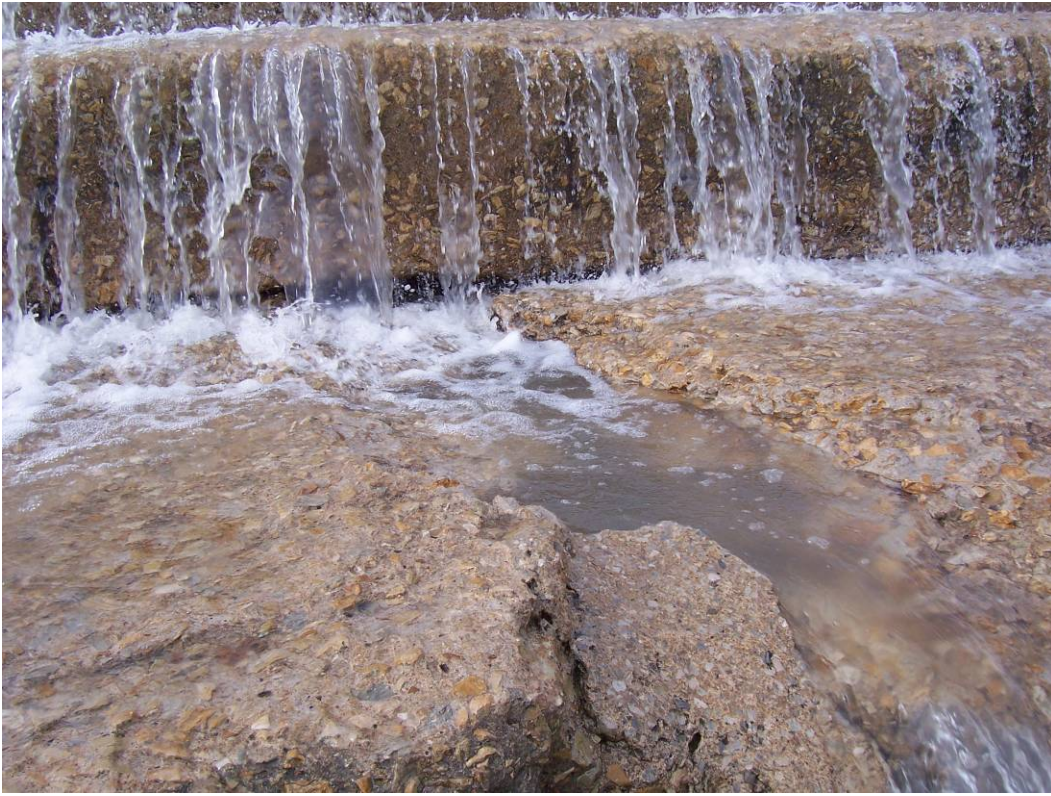
location. Due to the slight flow over the top of the dam at this location, it was difficult to determine if any flow was coming through the dam versus over the dam at this location. Based on this observation, it appears that the grout bag installation is still effective in reducing the flow at this point. Refer to photographs 16 and 17.

16. Sta 3+90±. Location of prior significant leak. 4 ft deep hole in second step. (See #50, 52, 53, 54, 56, 58, 100, 102 in 2007 Report.)

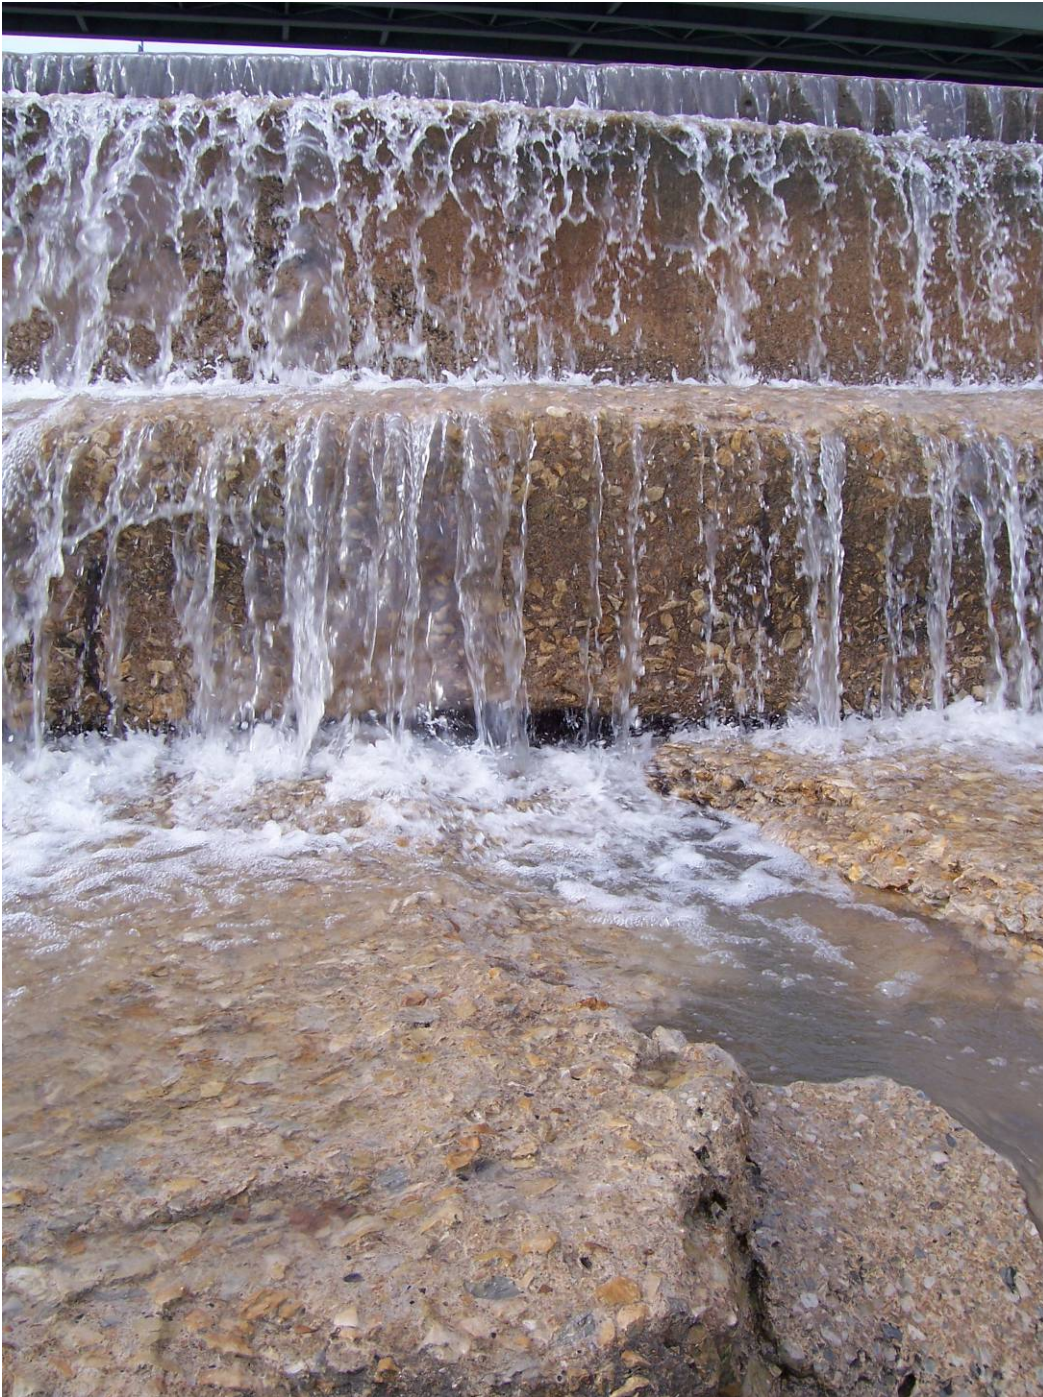
17. Sta 3+90±. Location of prior significant leak. 4 ft deep hole in second step. (See #50, 52, 53, 54, 56, 58, 100, 102 in 2007 Report.)

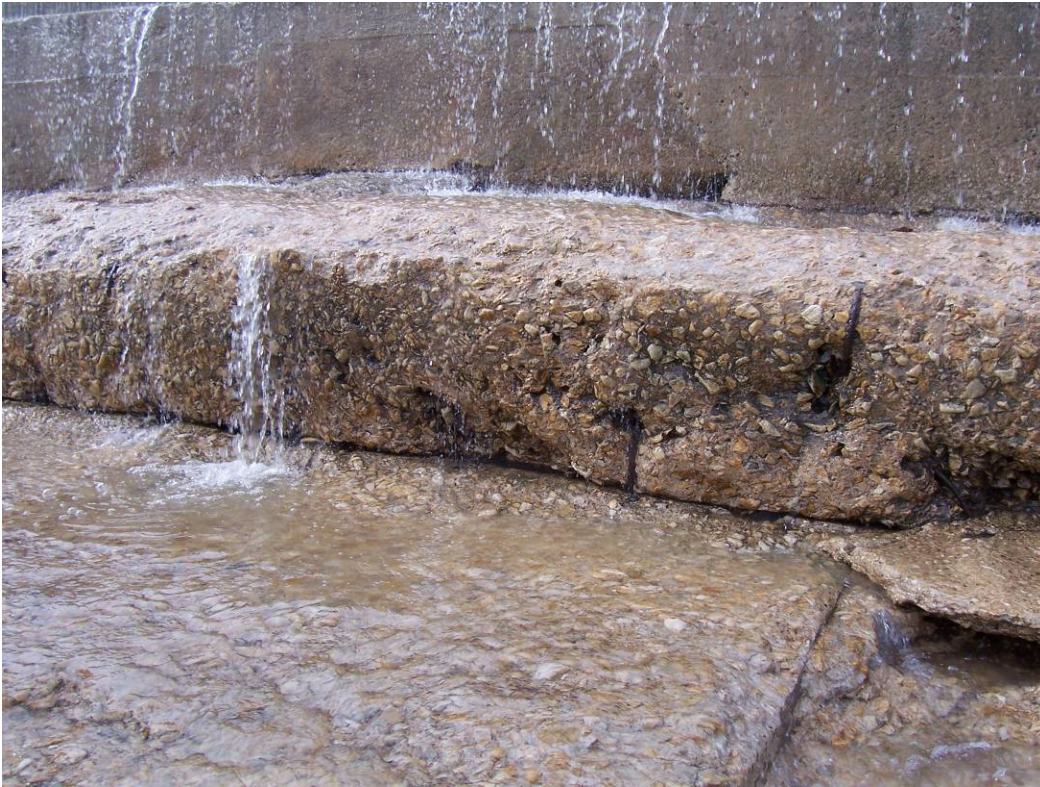
18. Sta 4+25. Deteriorated joint & exposed rebar at top of bottom step.  
(See #57 in 2007 Report.)

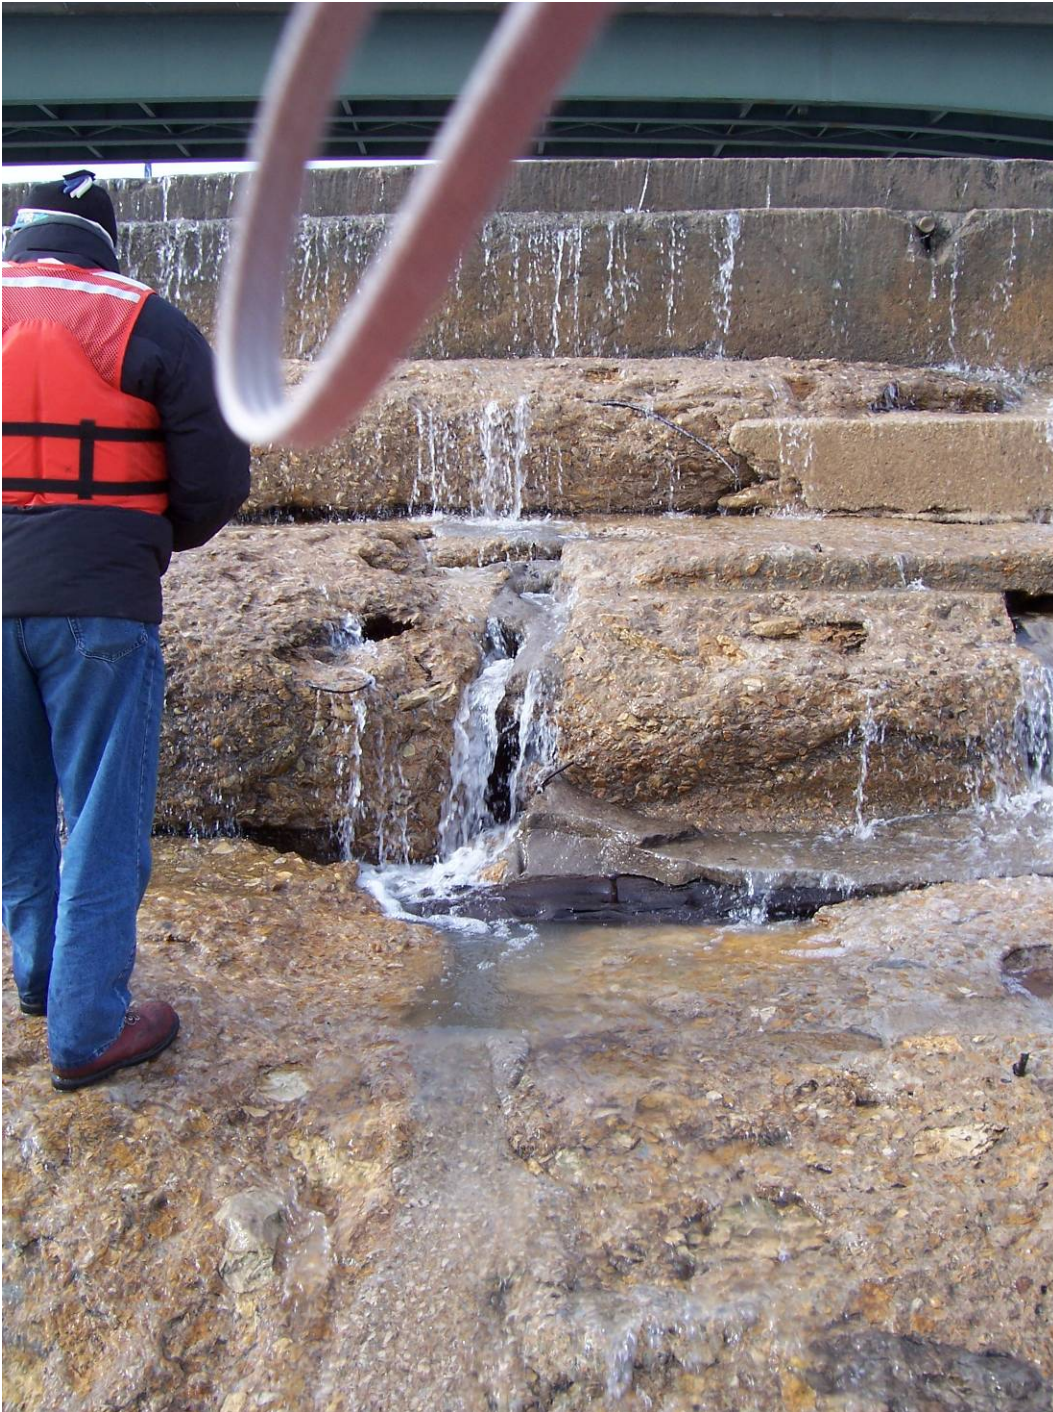
22. Sta 3+40. Eroded timber holes, exposed timber, eroded concrete.  
(See #46, 47, 2007 Report.)

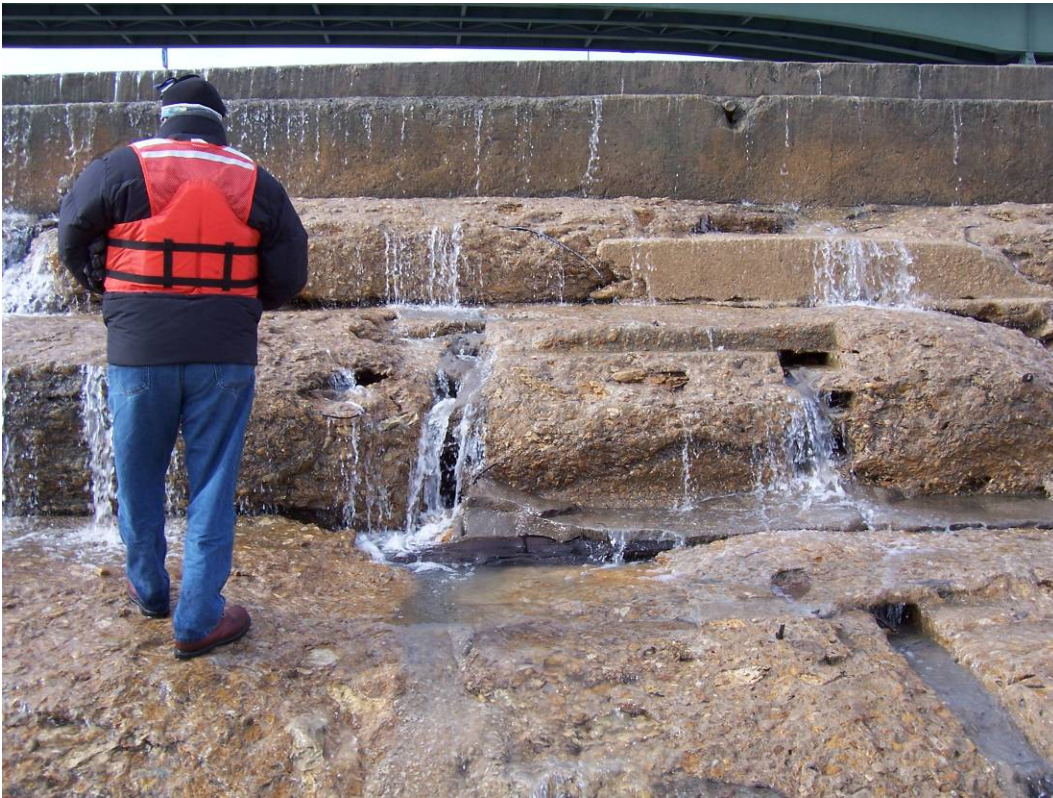
23. Sta 3+40. Eroded timber holes, exposed timber, eroded concrete.  
(See #45, 46, 47, 2007 Report.)

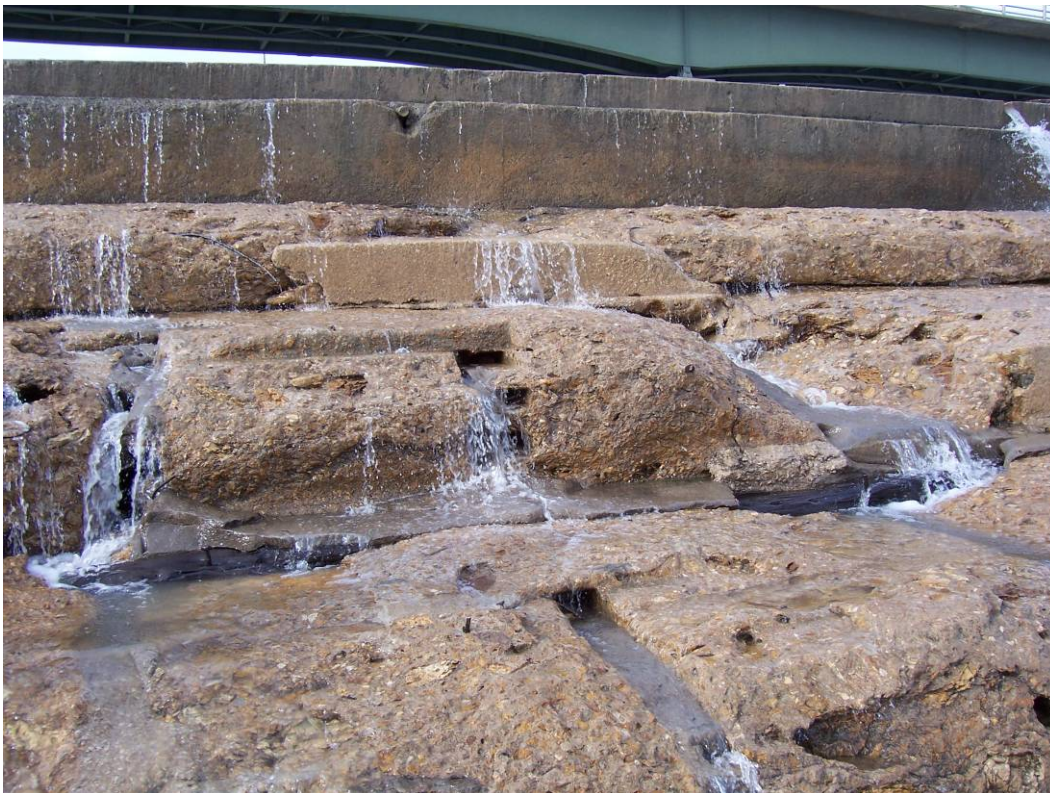
24. Sta 3+40. Eroded timber holes, exposed timber, eroded concrete.  
(See #45, 46, 47, 2007 Report.)

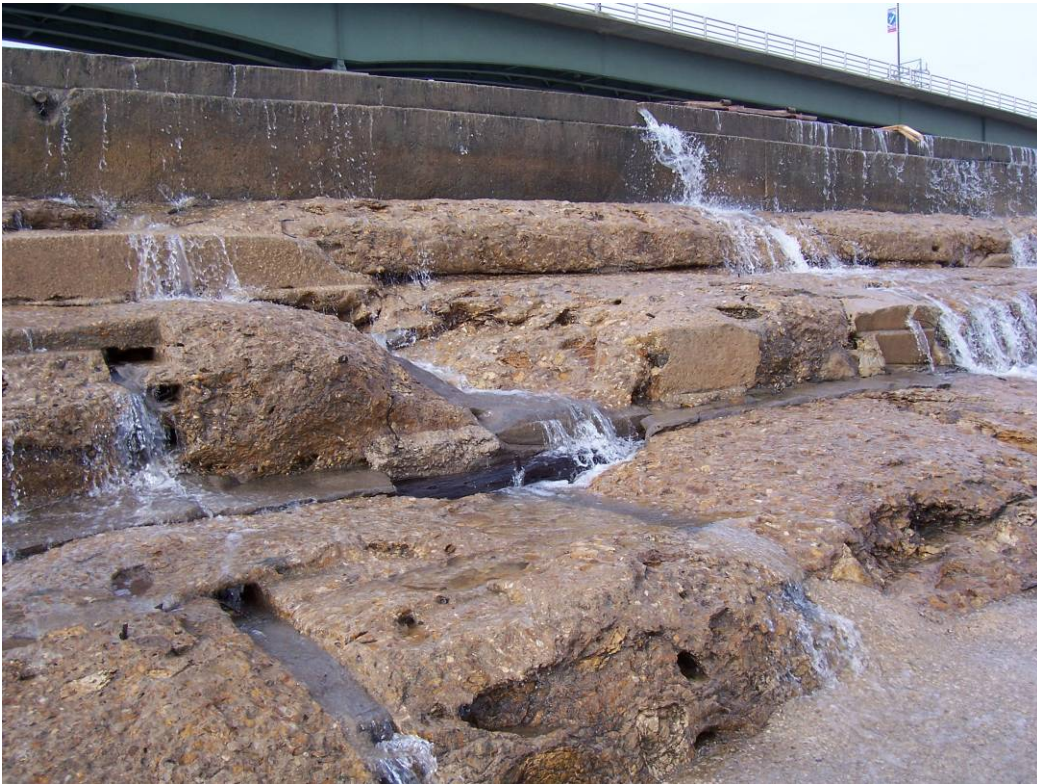
25. Sta 3+25. Eroded timber holes, exposed timber, eroded concrete.  
(See #46, 47, 2007 Report.)

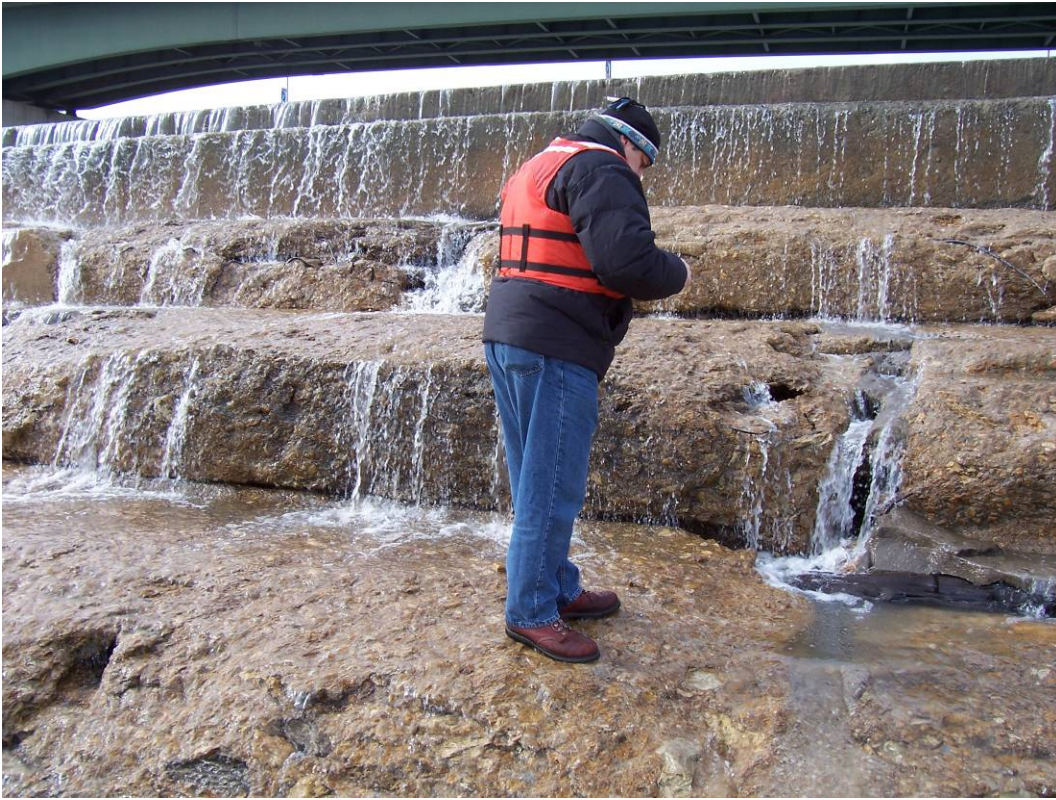
27. Sta 3+40 to 3+50. Exposed timber, eroded timber holes.

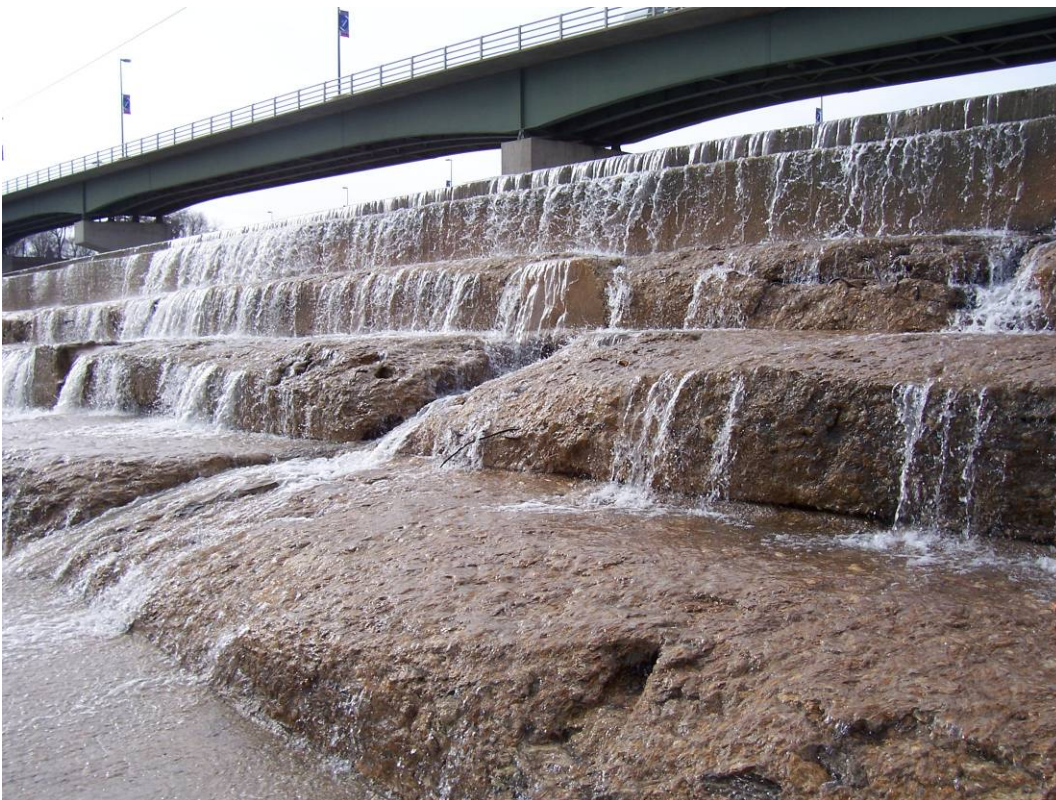
28. Sta 3+50 to Sta 3+70. Severely deteriorated concrete. Eroded timber holes.

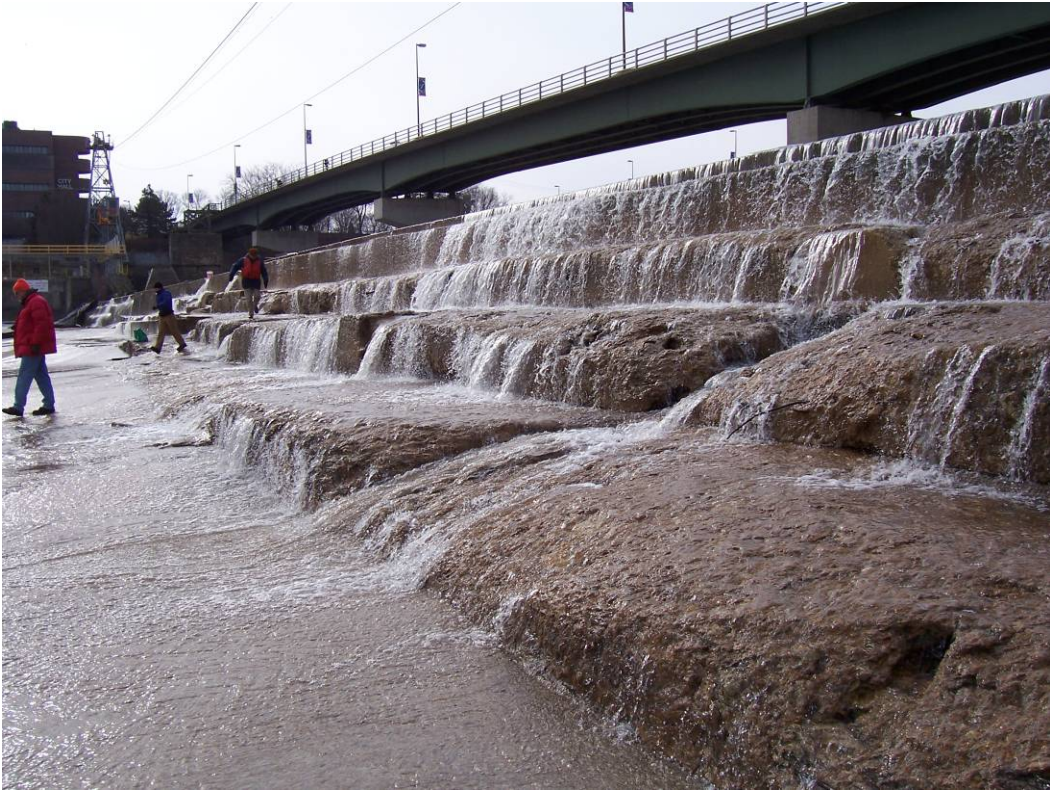
29. Sta 3+60 to Sta 4+00. Severely deteriorated concrete. Eroded timber holes.

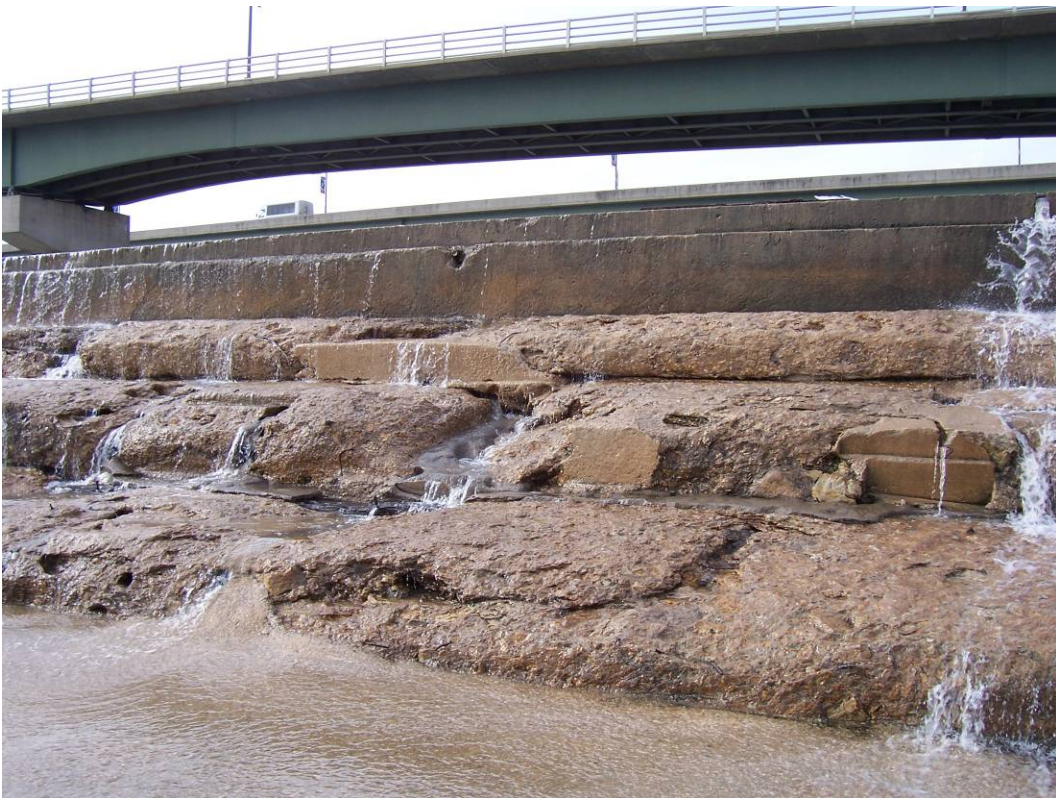
30. Sta 3+30. Severely deteriorated concrete. Eroded timber holes.

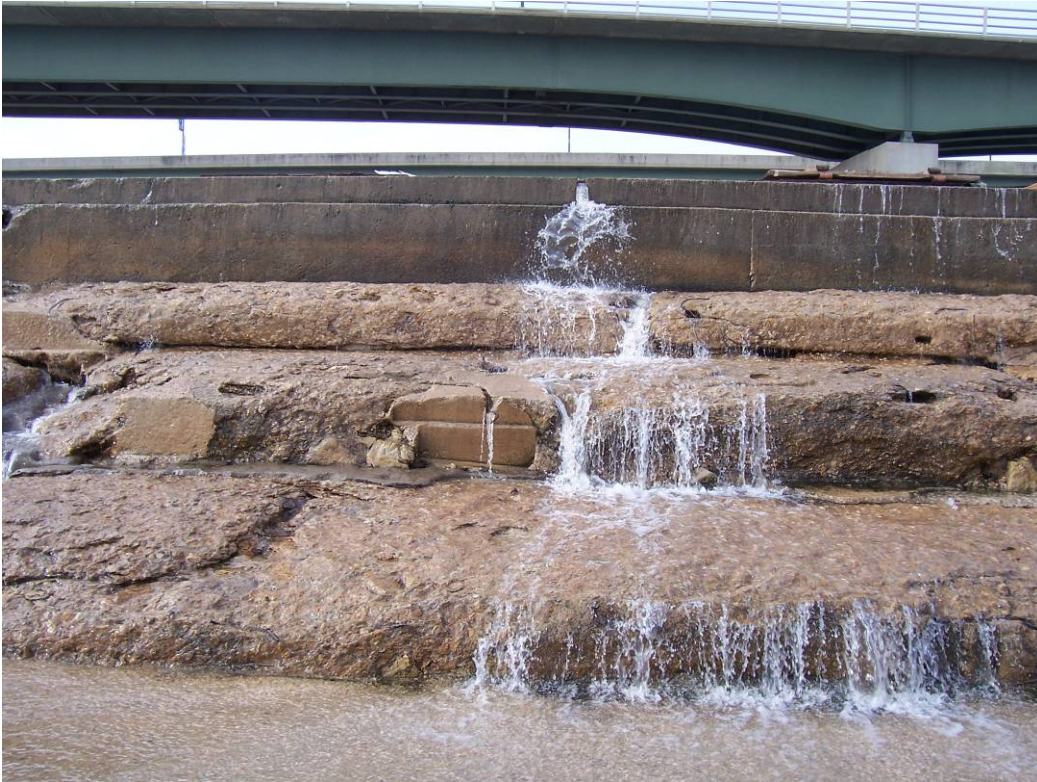
31. Sta 3+25. Severely deteriorated steps. (See #42, 2007 Report.)

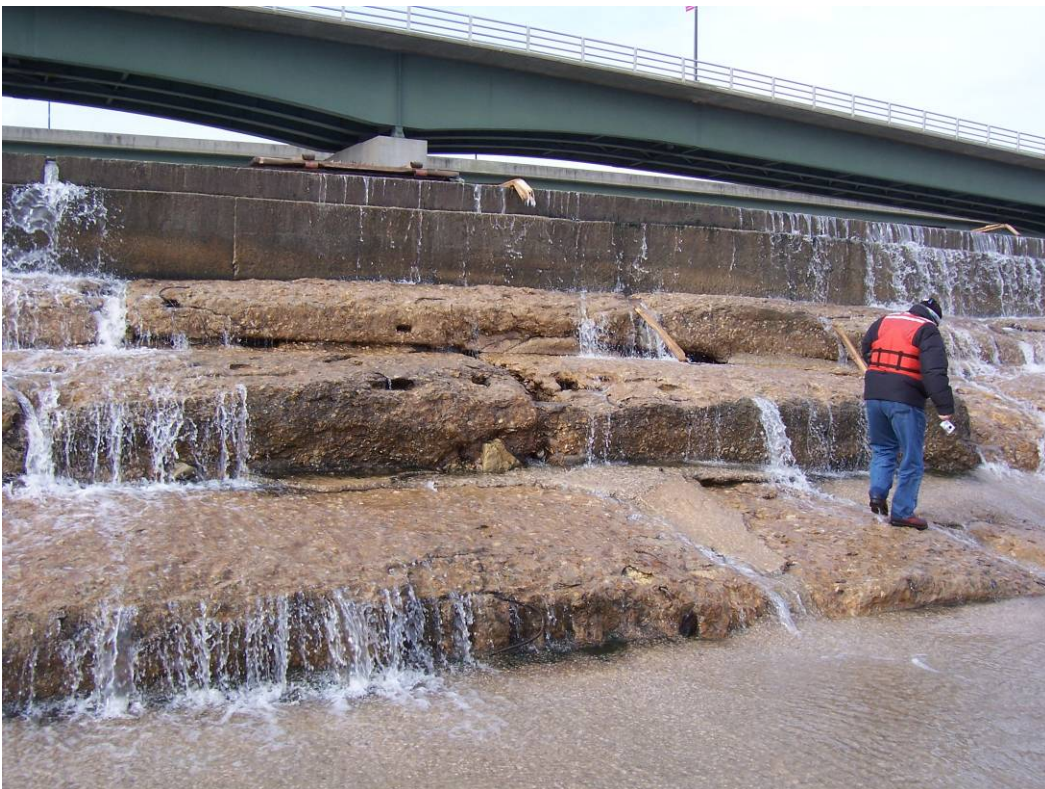
32. Sta 3+00 to Sta 3+20. Exposed and eroded timber holes, exposed rebar, severely deteriorated steps. (See #39-41, 2007 Report.)

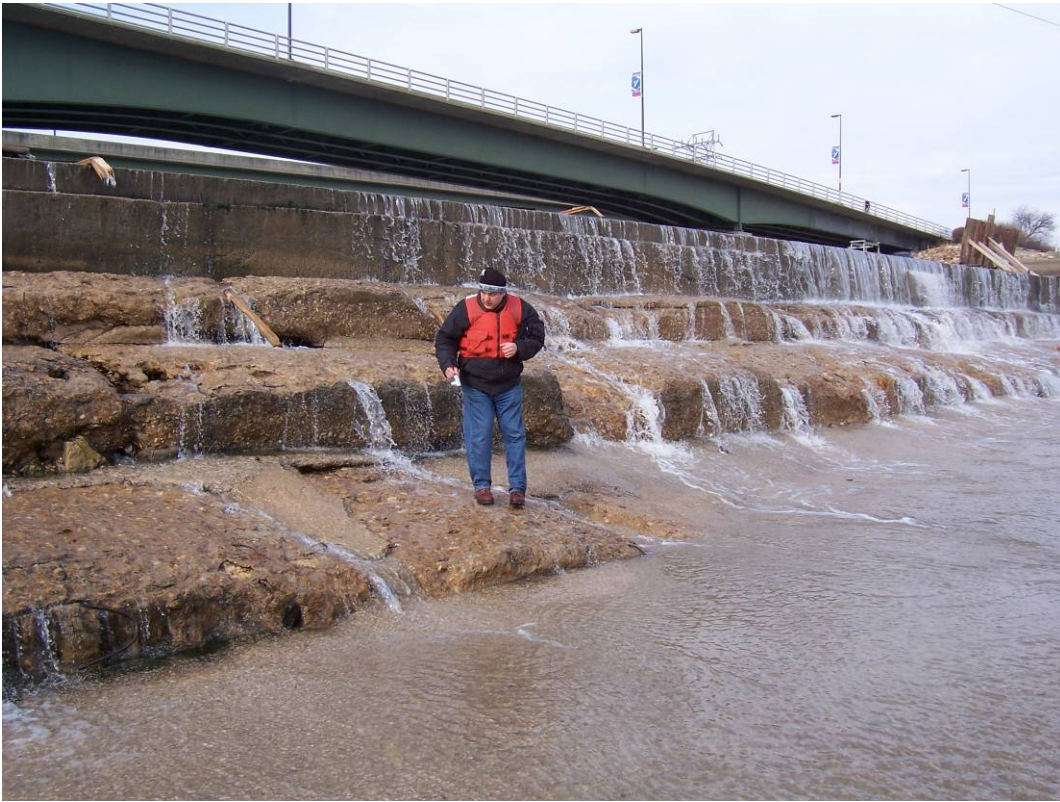
33. Sta 2+50 to Sta 3+60. Exposed and eroded timber holes, exposed rebar, severely deteriorated steps. (See #39-41, 2007 Report.)

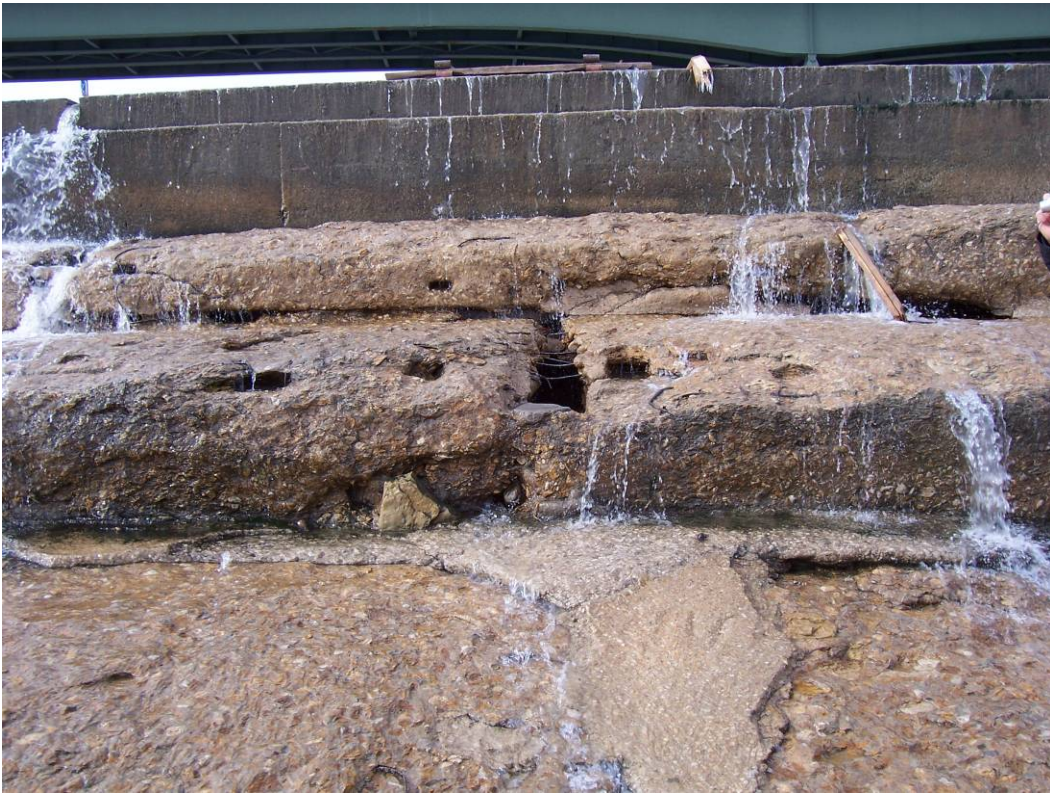
35. Sta 3+00. Exposed and eroded timber holes, exposed rebar, severely deteriorated steps. (See #39-41, 2007 Report.)

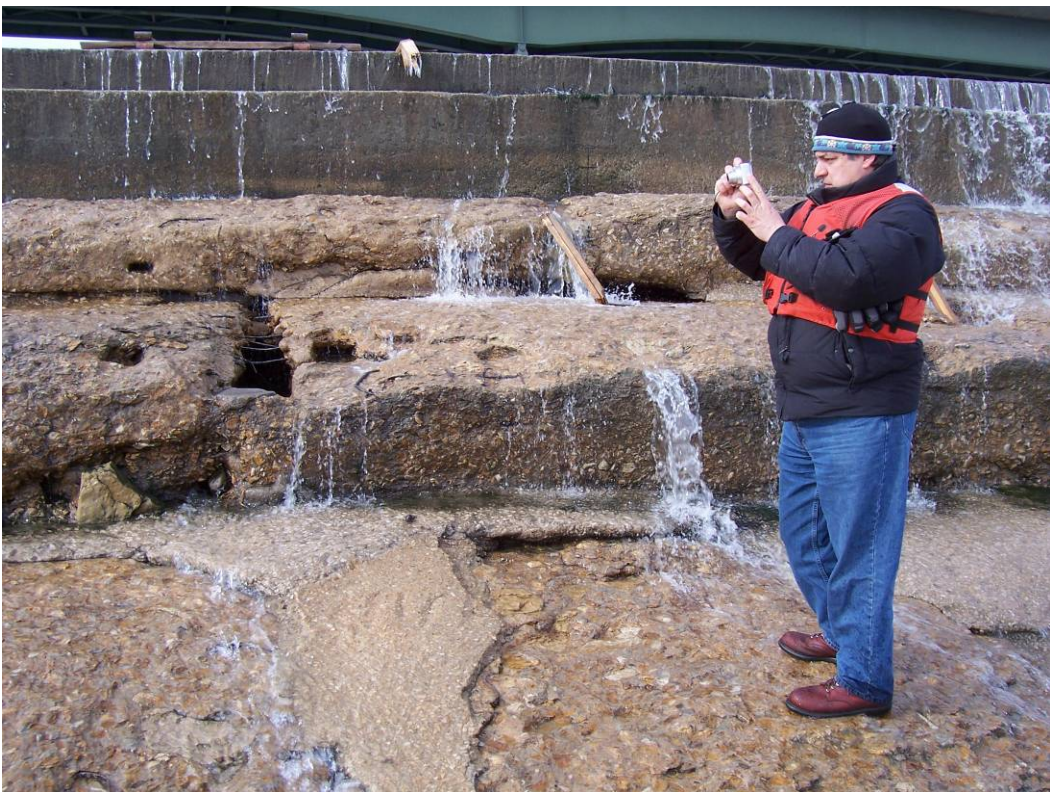
36. Sta 3+00. Exposed and eroded timber holes, exposed rebar, severely deteriorated steps. (See #39-41, 2007 Report.)
