Lawrence, Kansas  
Bowersock Dam Maintenance

B&V Project 160988  
B&V File B-1.1  
February 17, 2009

Subject: January 23, 2009 Inspection

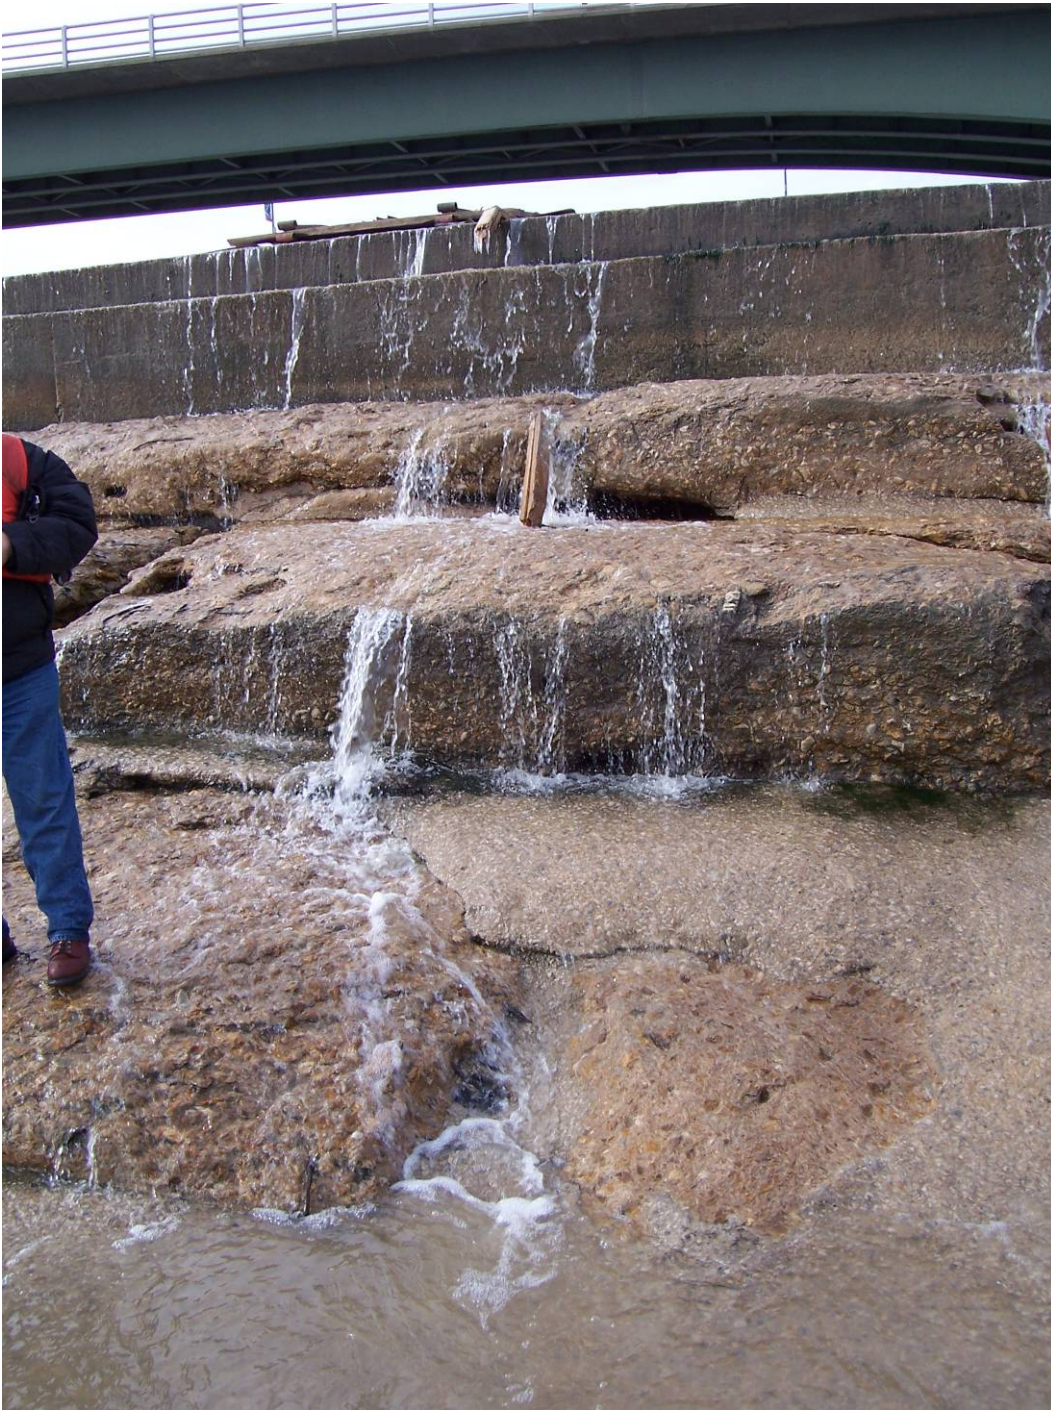
37. Sta 2+95. Exposed joint between 2<sup>nd</sup> & 3<sup>rd</sup> steps, severely deteriorated lower step. (See #41, 2007 Report.)

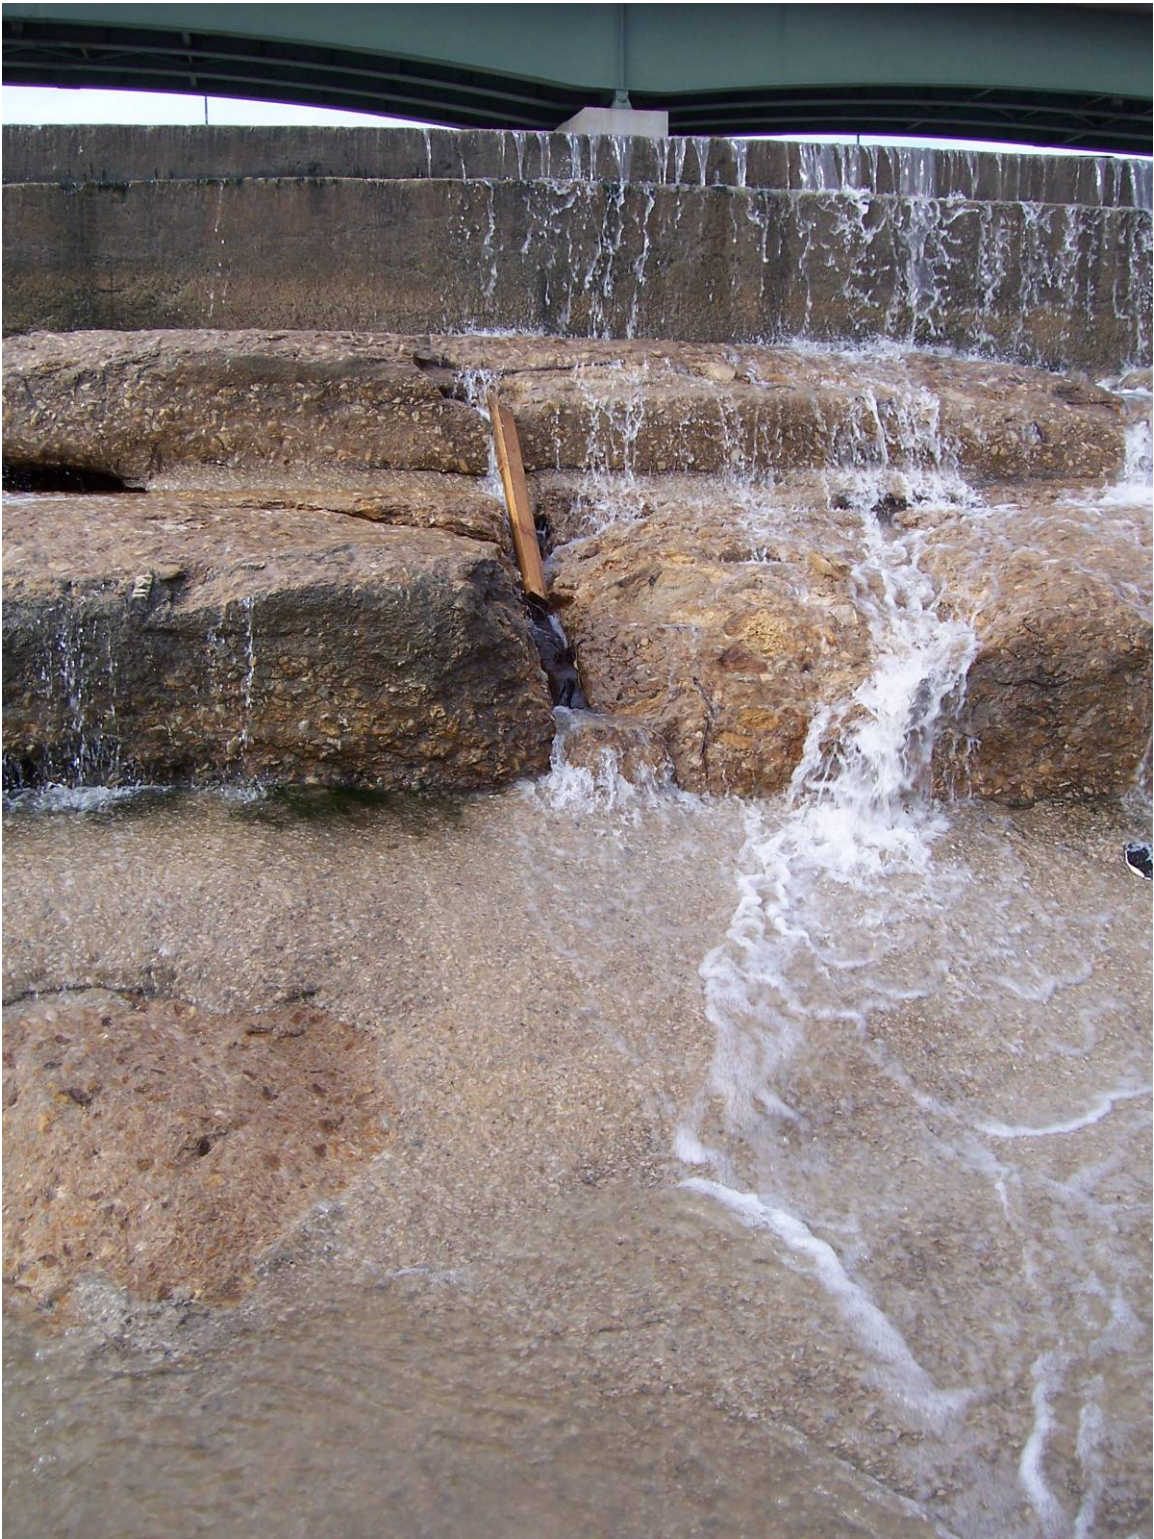
38. Sta 2+80. Exposed timber and eroded concrete. Crack in bottom step.  
(See #37 and 38, 2007 Report.)

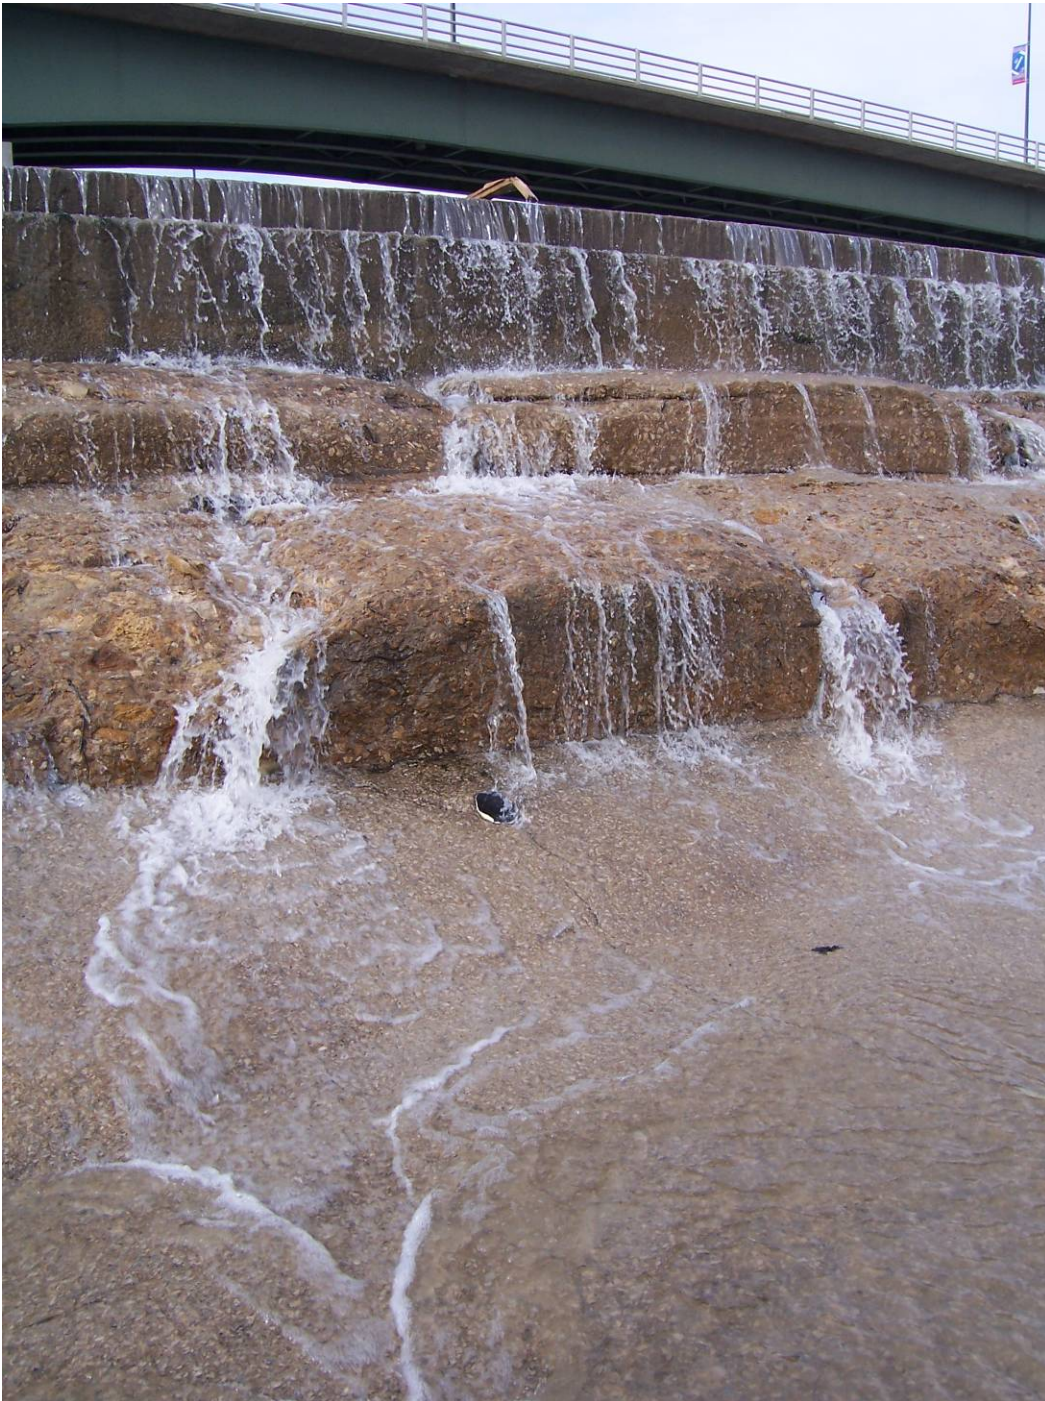
39. Sta 2+75. Exposed joint and cracked middle step crack in bottom step, weep hole. (See #36, 2007 Report.)

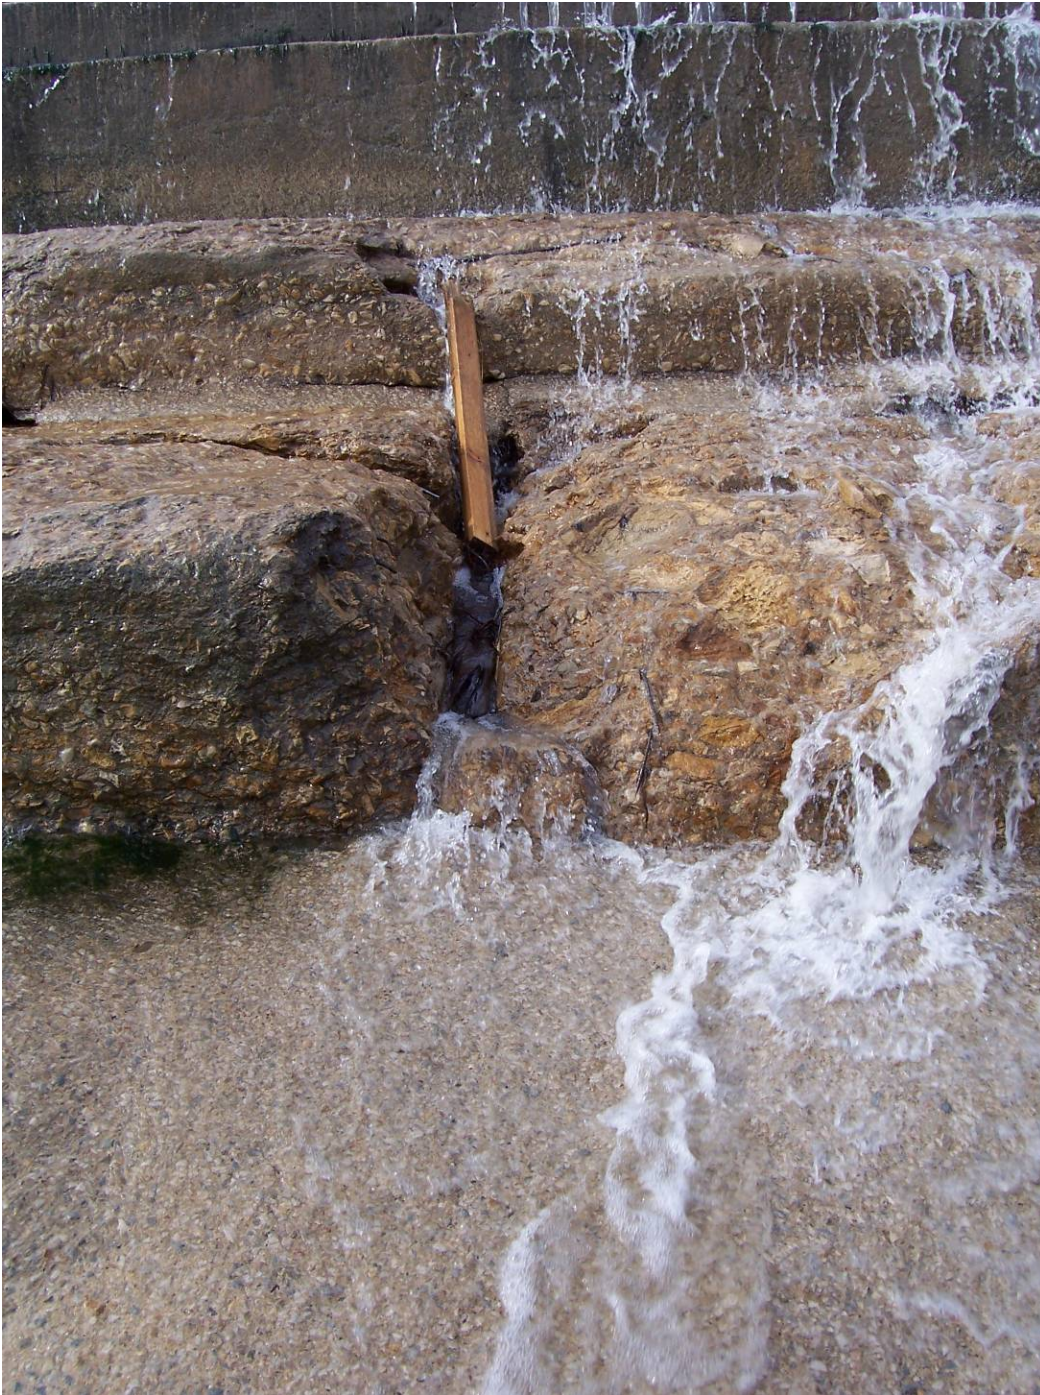
40. Sta 2+80. Exposed timber and eroded concrete. Crack in bottom step.  
(See #37 and 38, 2007 Report.)

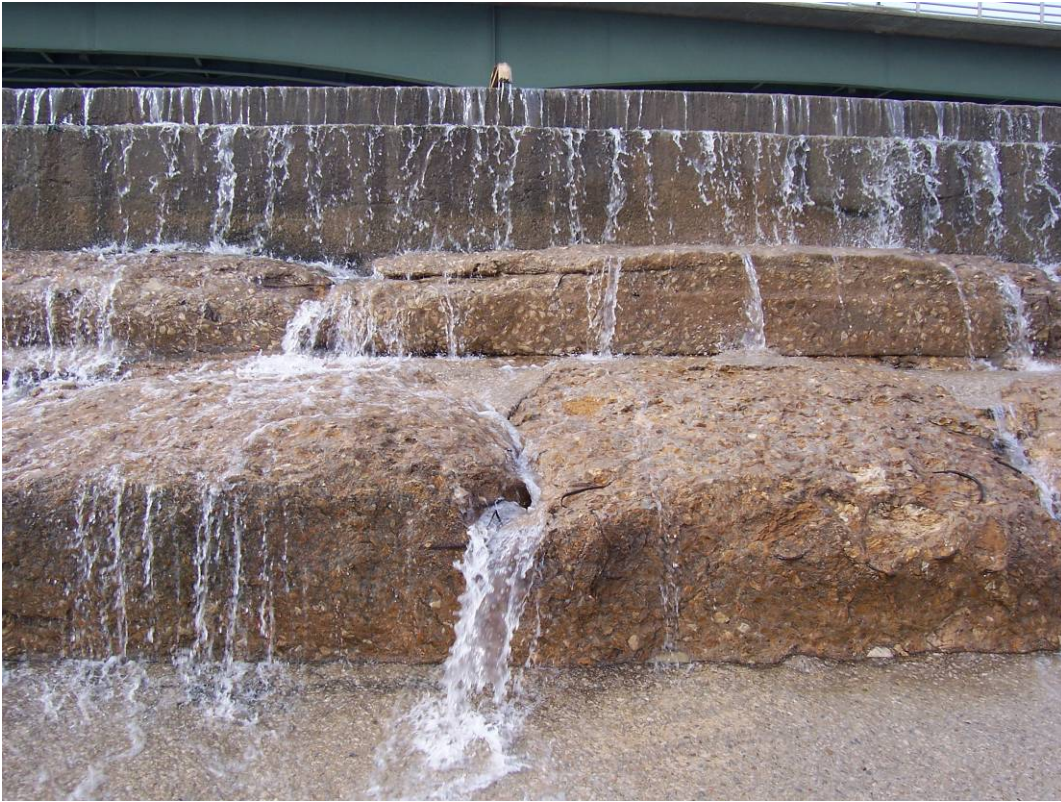
41. Sta 2+75. Exposed joint and cracked middle step crack in bottom step, weep hole. Additional erosion since 2006. (See #36, 2007 Report.)

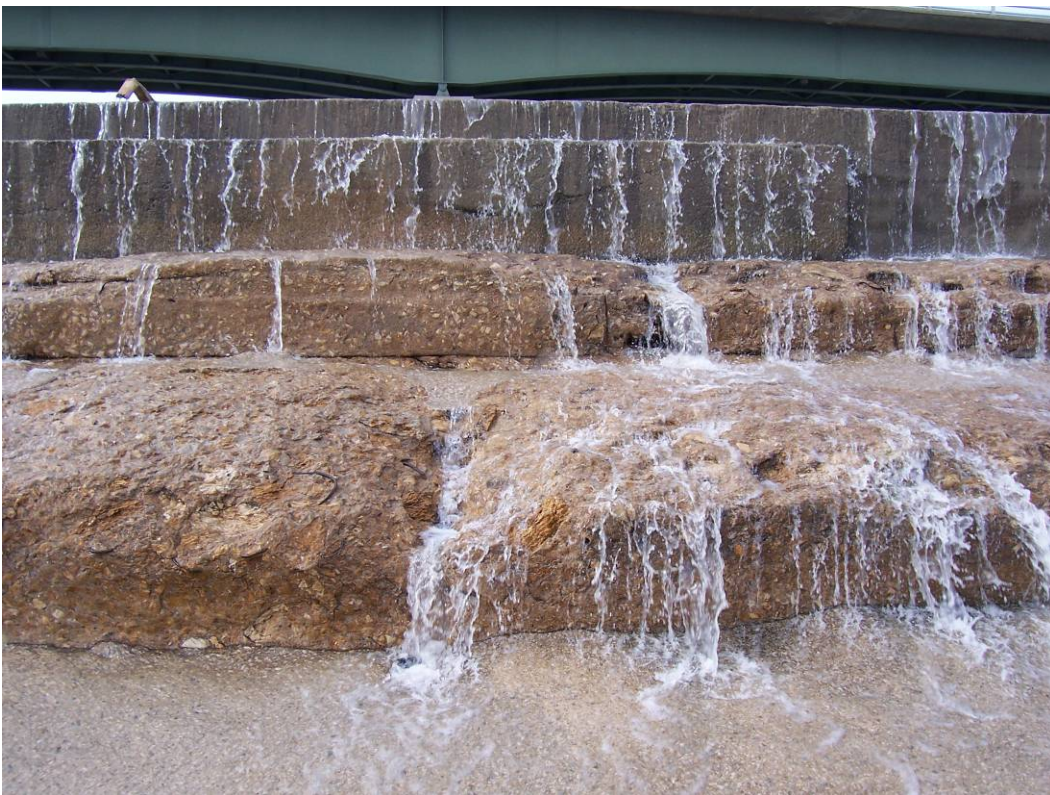
42. Sta 2+65. Eroded concrete and exposed timber hole. Additional erosion since 2006. (See #31, 33, 34 & 35, 2007 Report.)

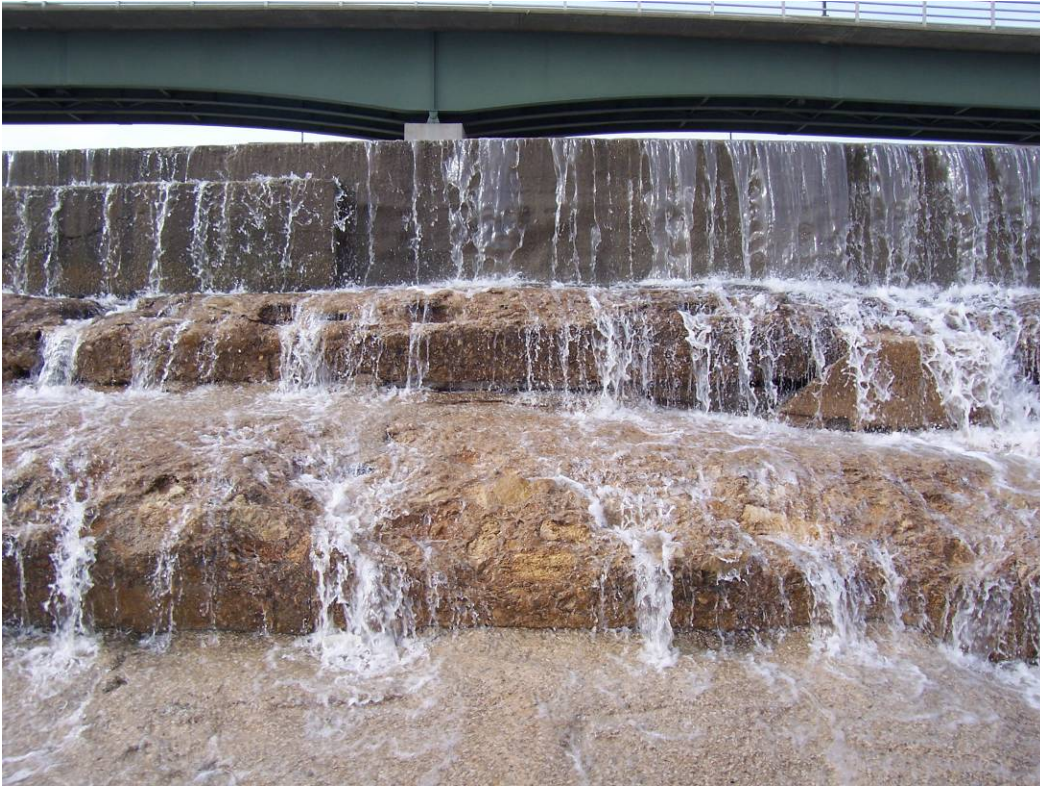
43. Sta 2+50. Exposed joints between steps eroded concrete. (See #30-32, 2007 Report.)

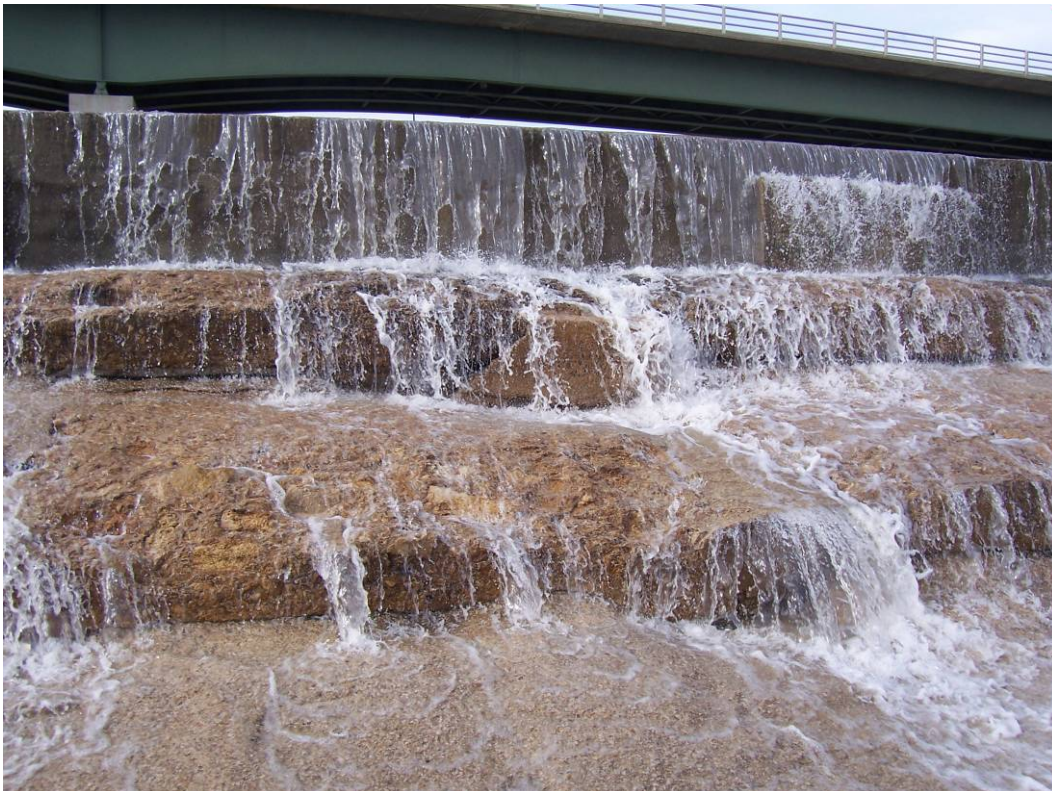
44. Sta 2+45. Exposed joints between steps eroded concrete. (See #30 and 32, 2007 Report.)

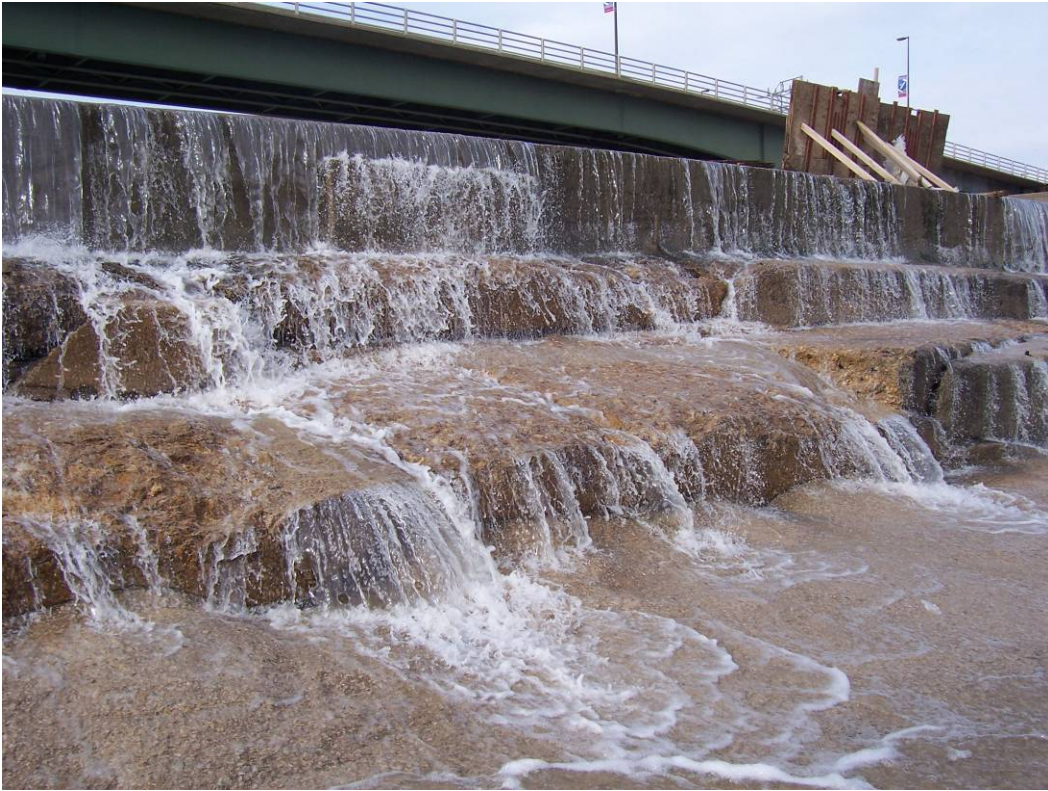
45. Sta 2+40. Deteriorated concrete steps. Exposed joints. (See #29, 2007 Report.)

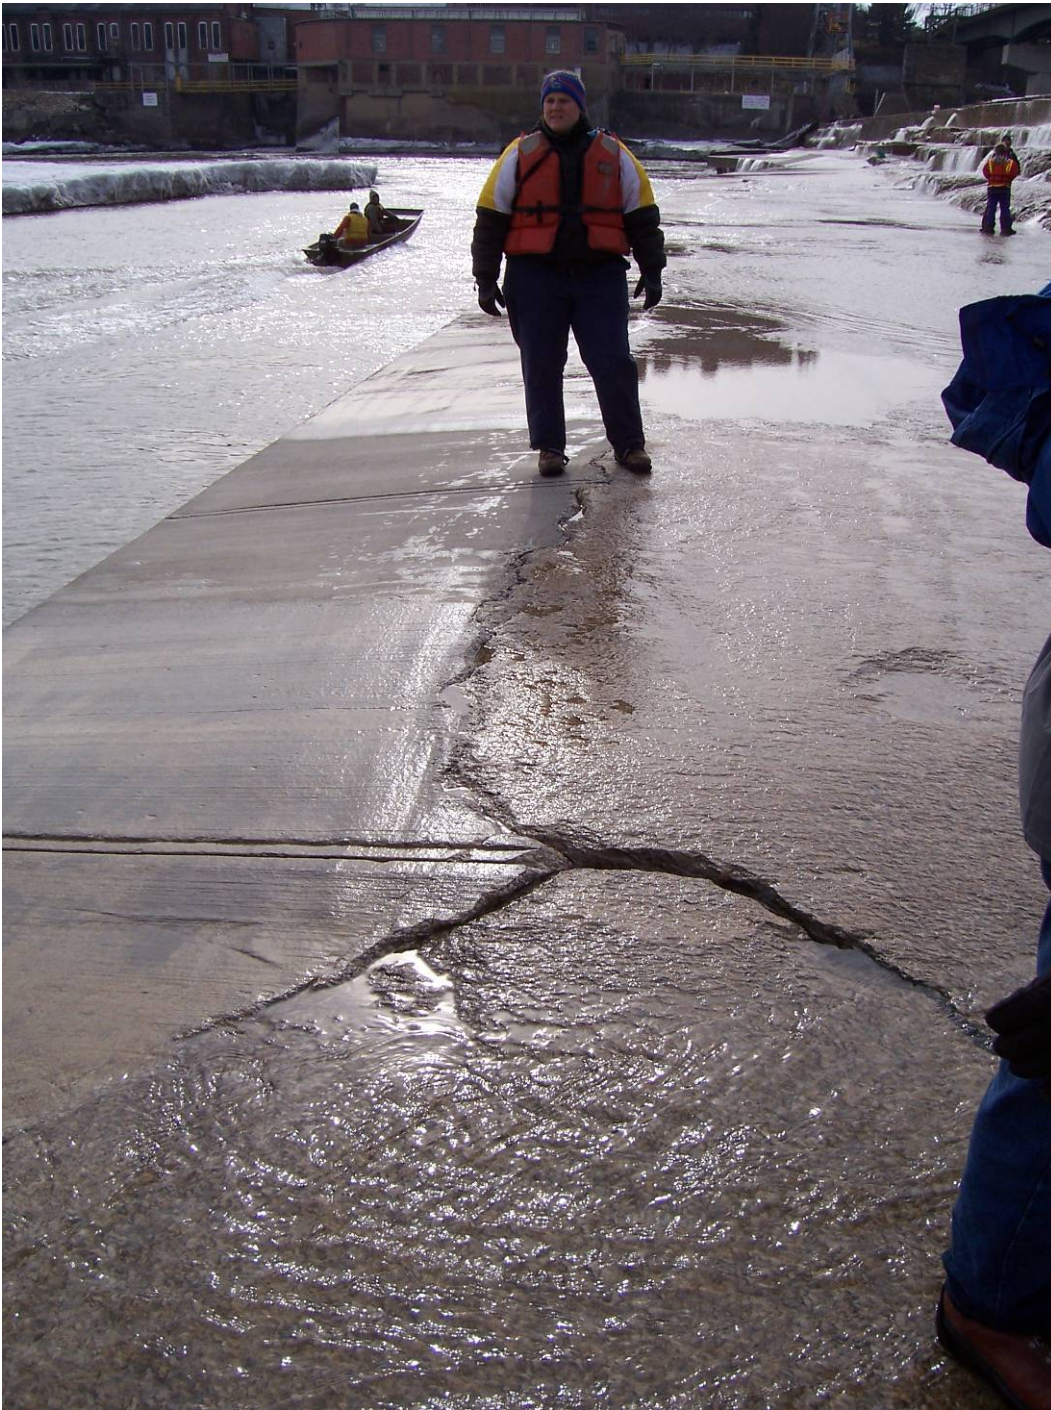
46. Sta 2+70±. Existing crack in apron to new apron interface. No apparent change.

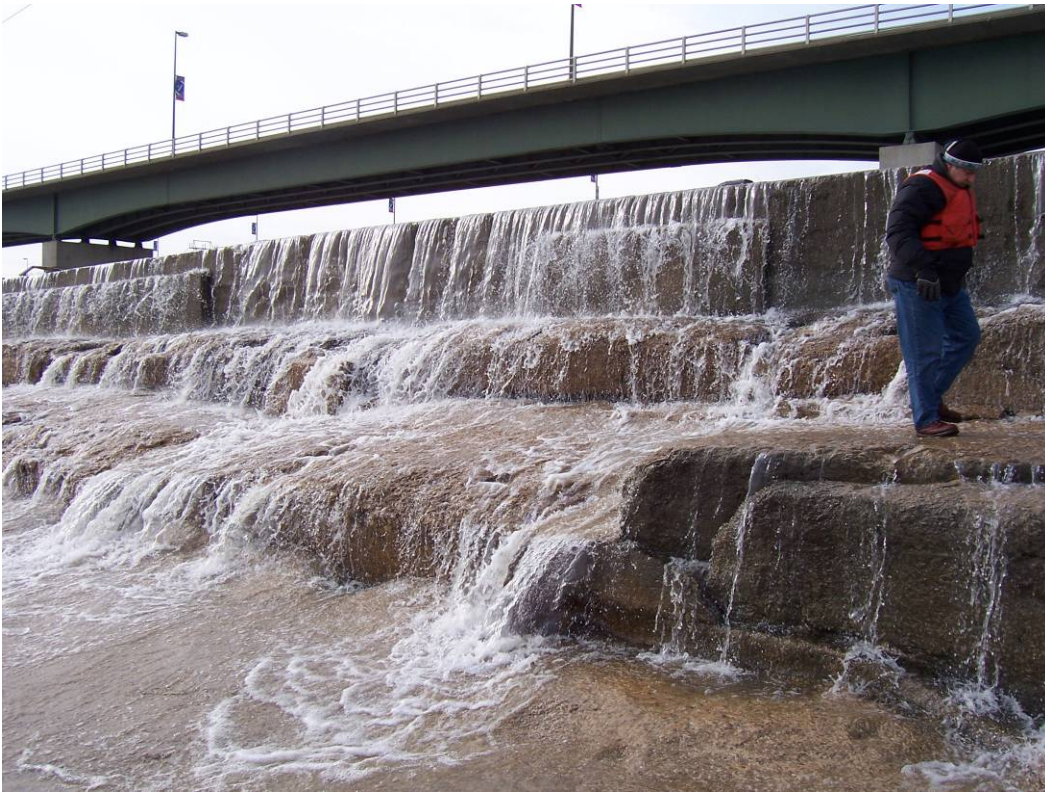
47. Sta 2+40±. Deteriorated steps and exposed joints. (See #27 and 29, 2007 Report.)

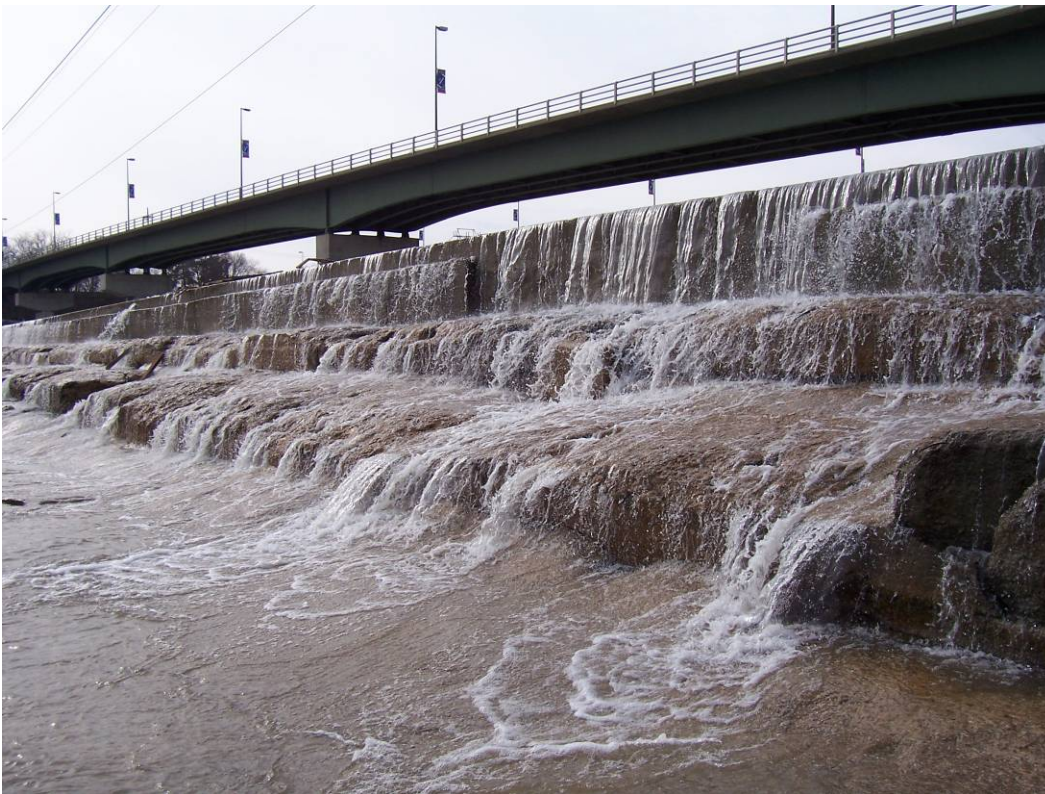
48. Sta 2+40 to 2+80±. Deteriorated steps.

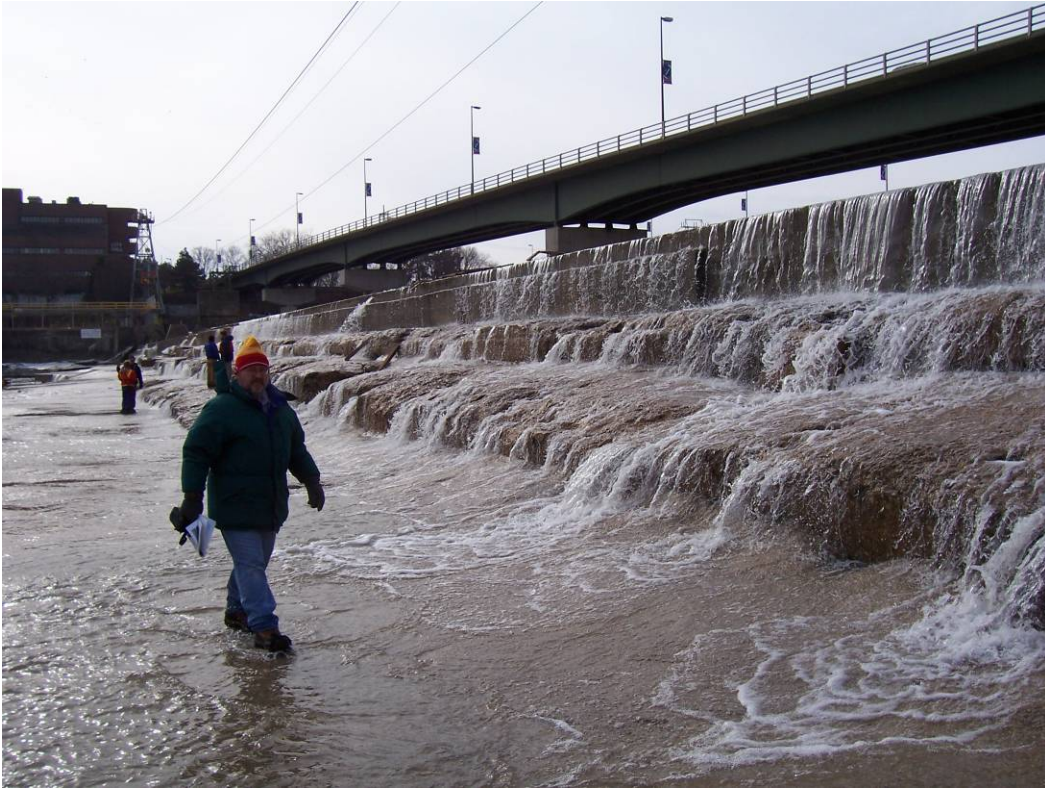
49. Sta 2+50 to Sta 3+00±. Deteriorated steps.

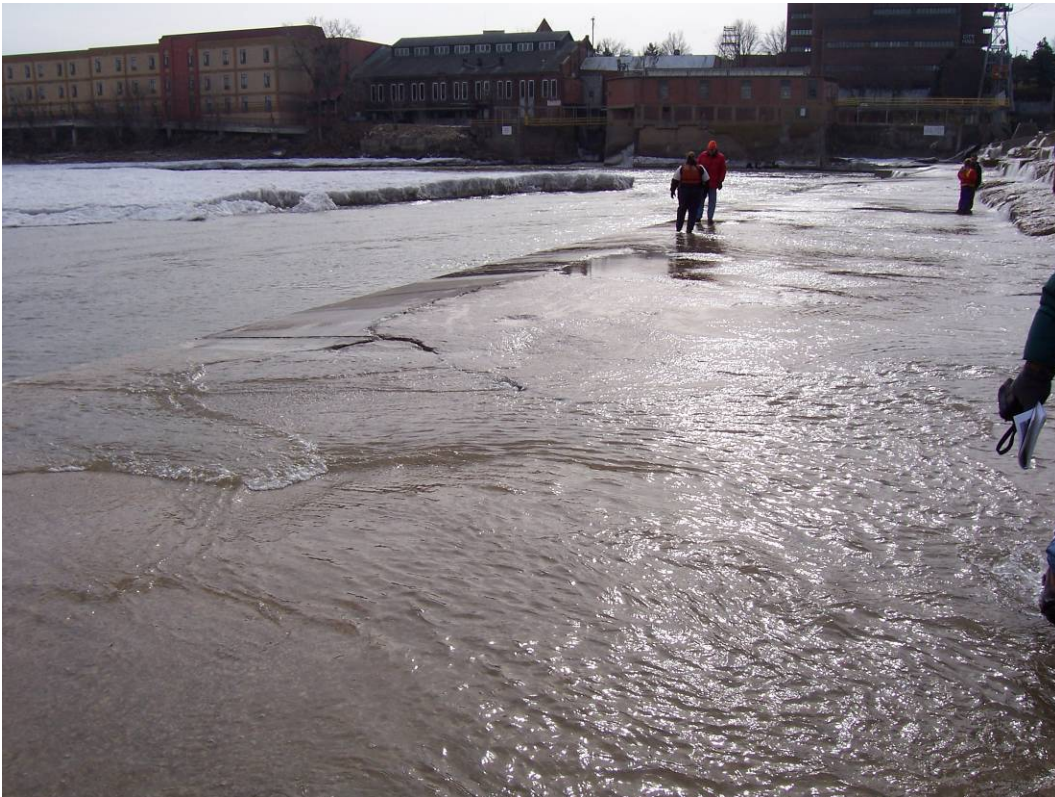
50. Sta 2+40 to Sta 3+00±. Existing crack in apron. No apparent change.

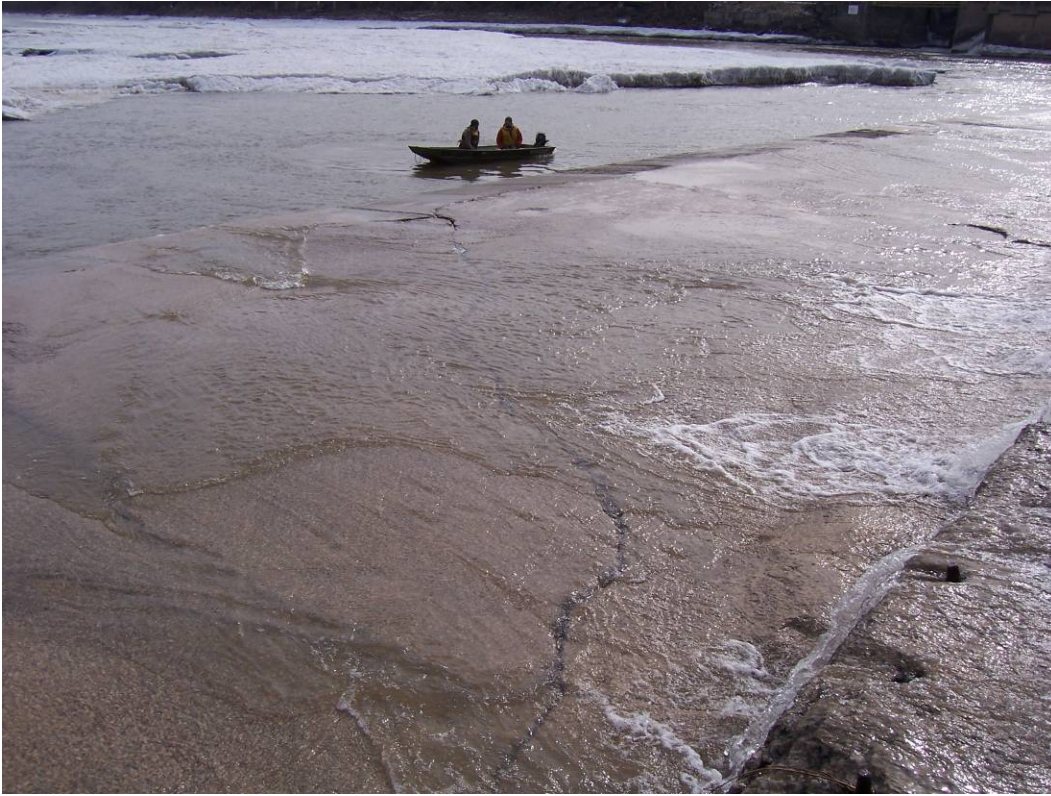
51. Sta 2+40 to Sta 2+80. Existing crack in apron. No apparent change.

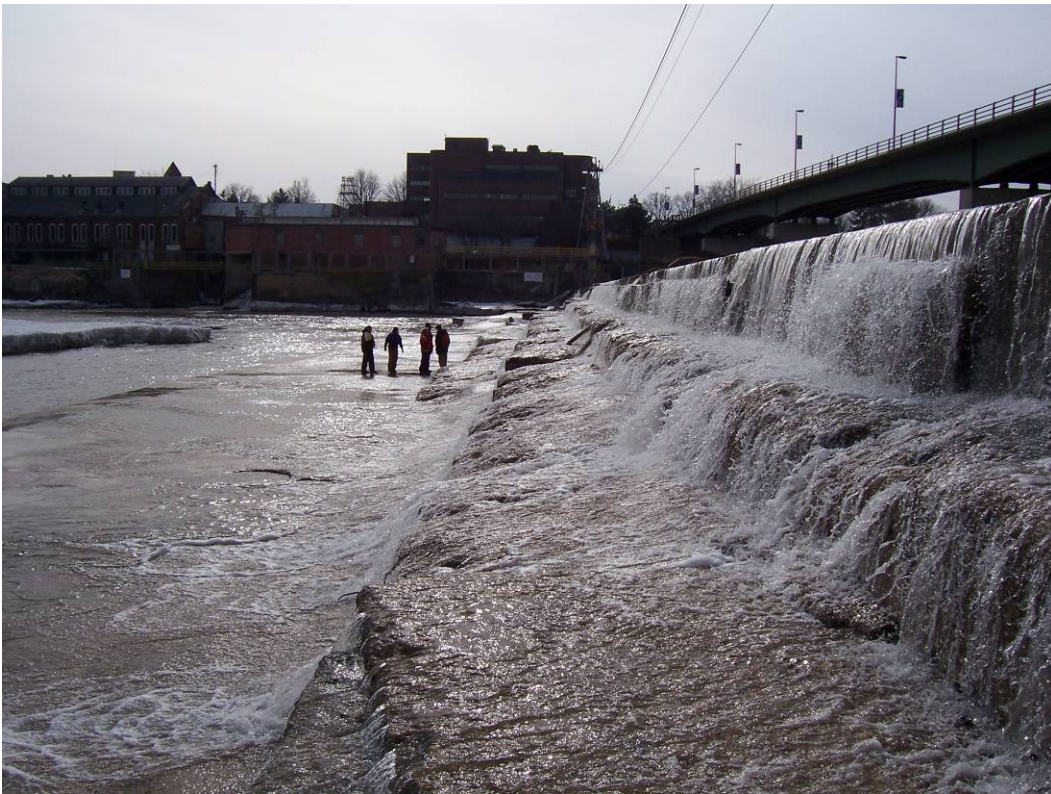
52. Sta 2+40 to south. Deteriorated steps.

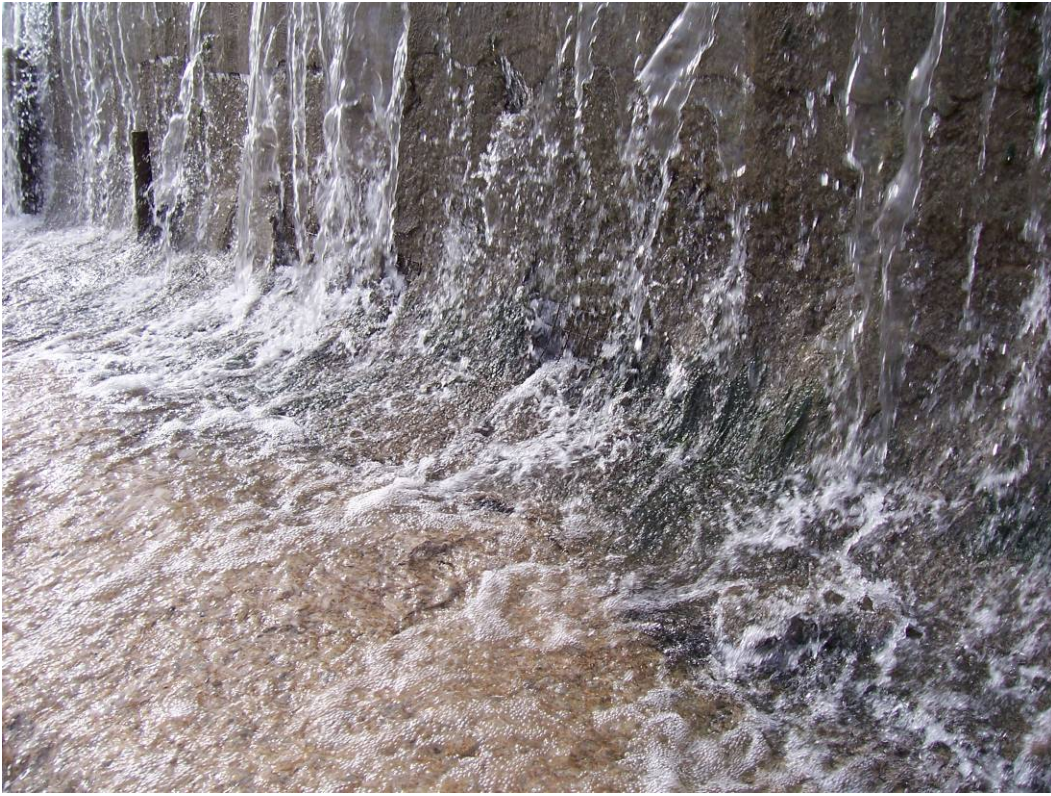
53. Sta 2+40± to south. Exposed wire fabric and eroded shotcrete. (See #29, 2007 Report.)

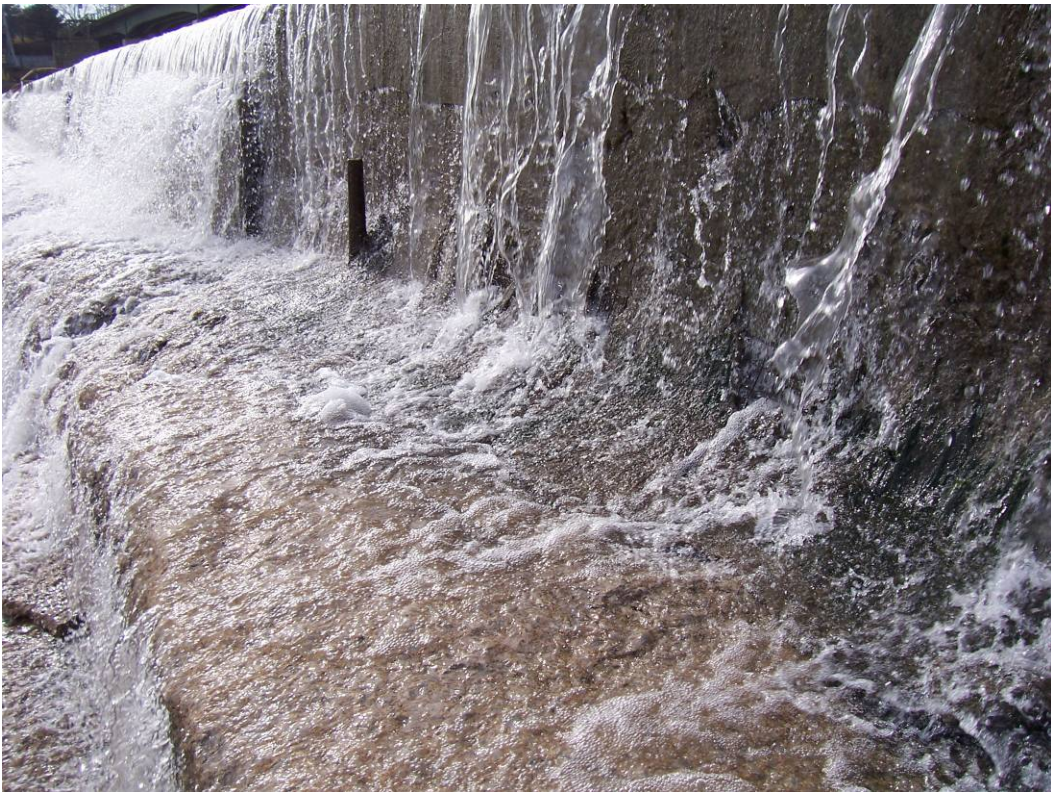
54. Sta 2+40± to south. Exposed wire fabric and eroded shotcrete. (See #29, 2007 Report.)

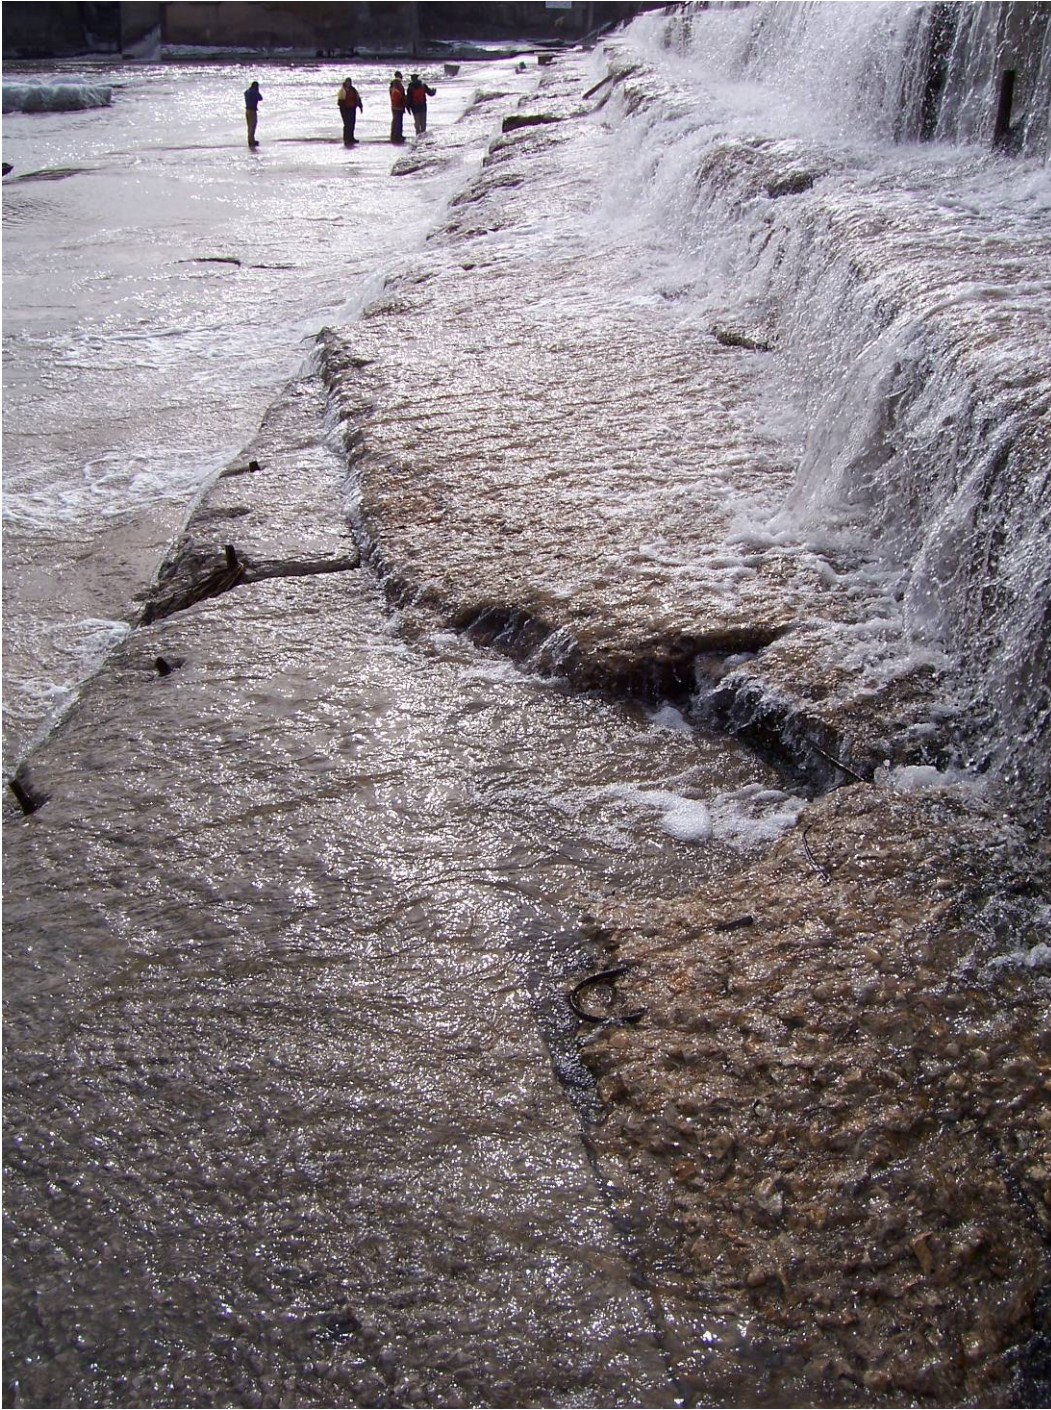
55. Sta 1+90± to south. Separated triangular section in bottom step. Eroded concrete. (See #108, 2007 Report.)

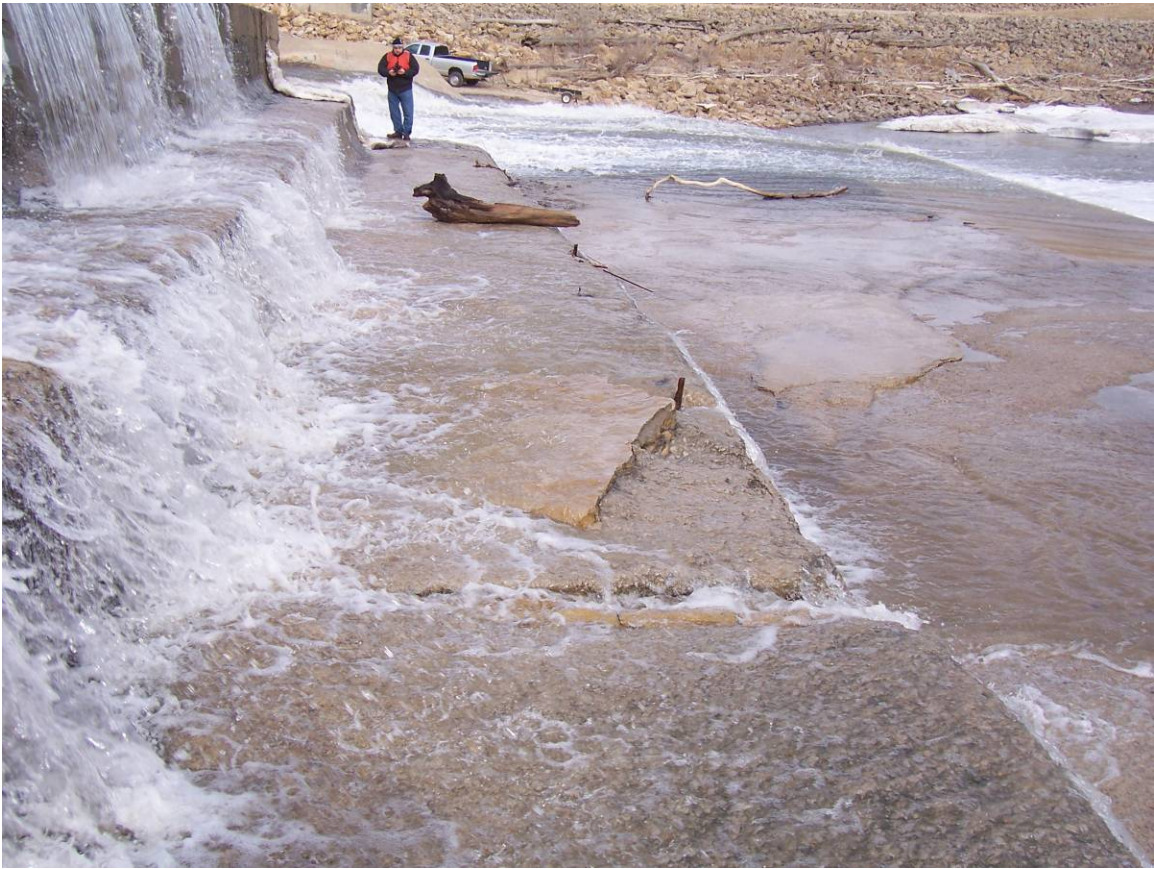
56. Sta 1+80± to north. Eroded concrete step.

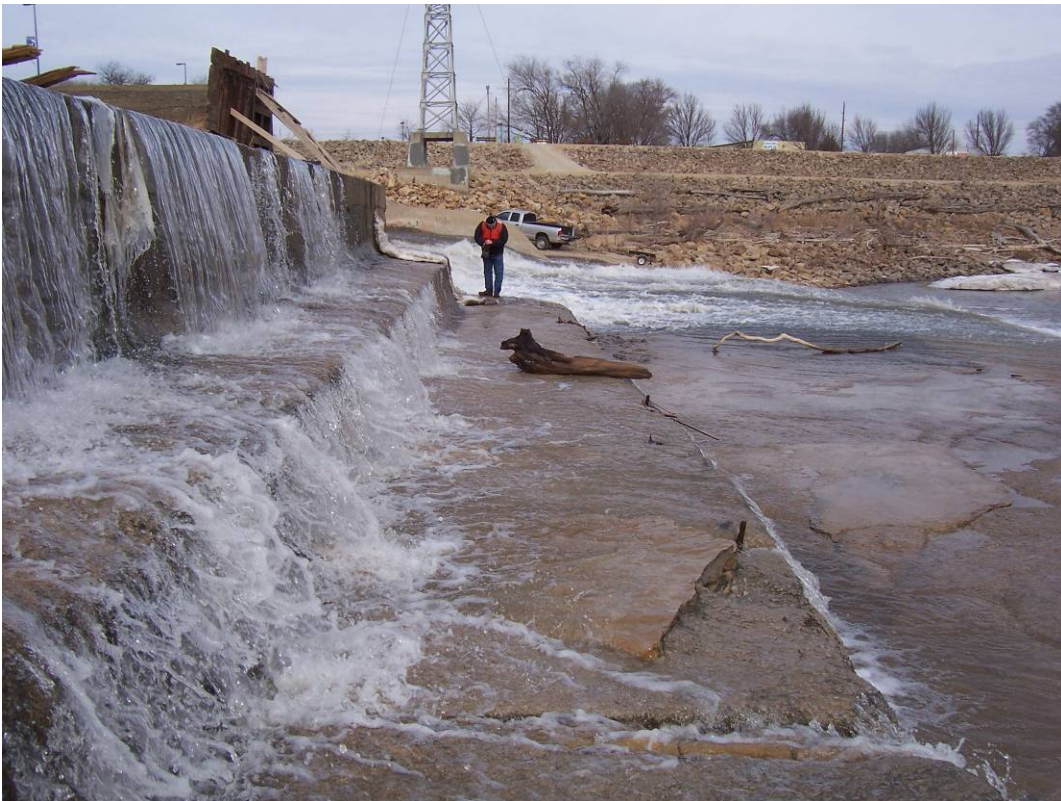
57. Sta 1+80± to north. Eroded concrete step.

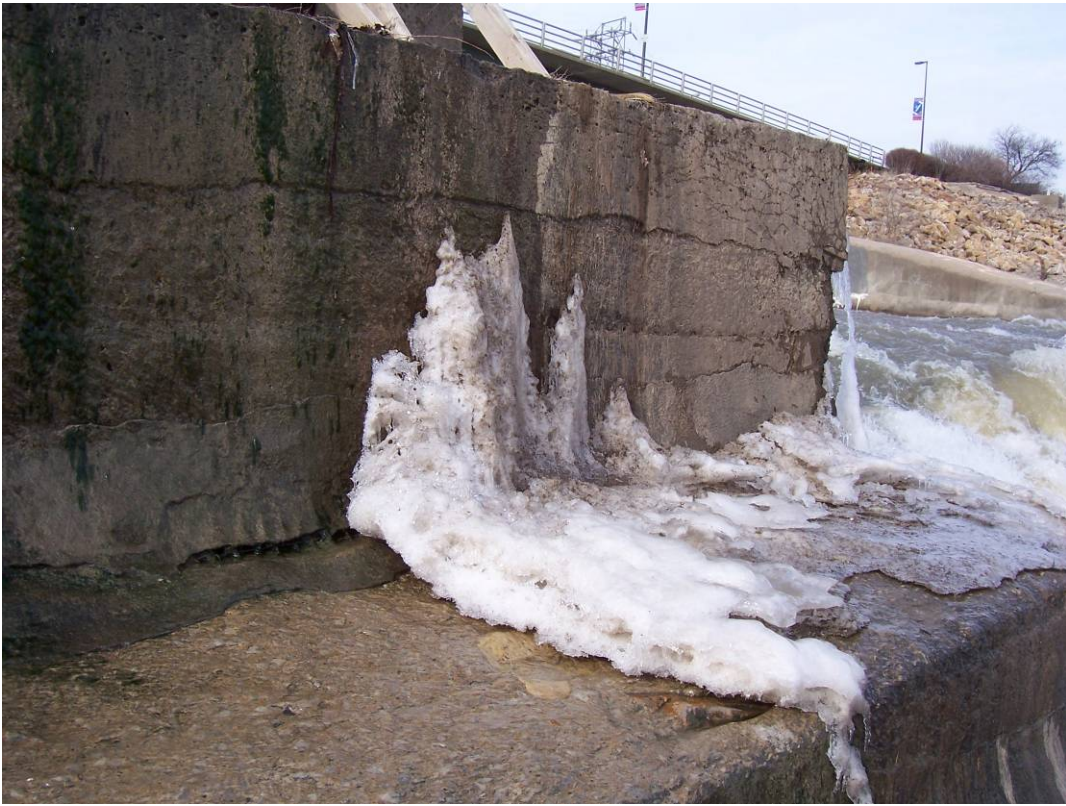
58. Sta 1+25 to northwest. Eroded shotcrete. (See #18, 2007 Report.)
