Lawrence, Kansas  
Bowersock Dam Maintenance

B&V Project 160988  
B&V File B-1.1  
February 17, 2009

Subject: January 23, 2009 Inspection

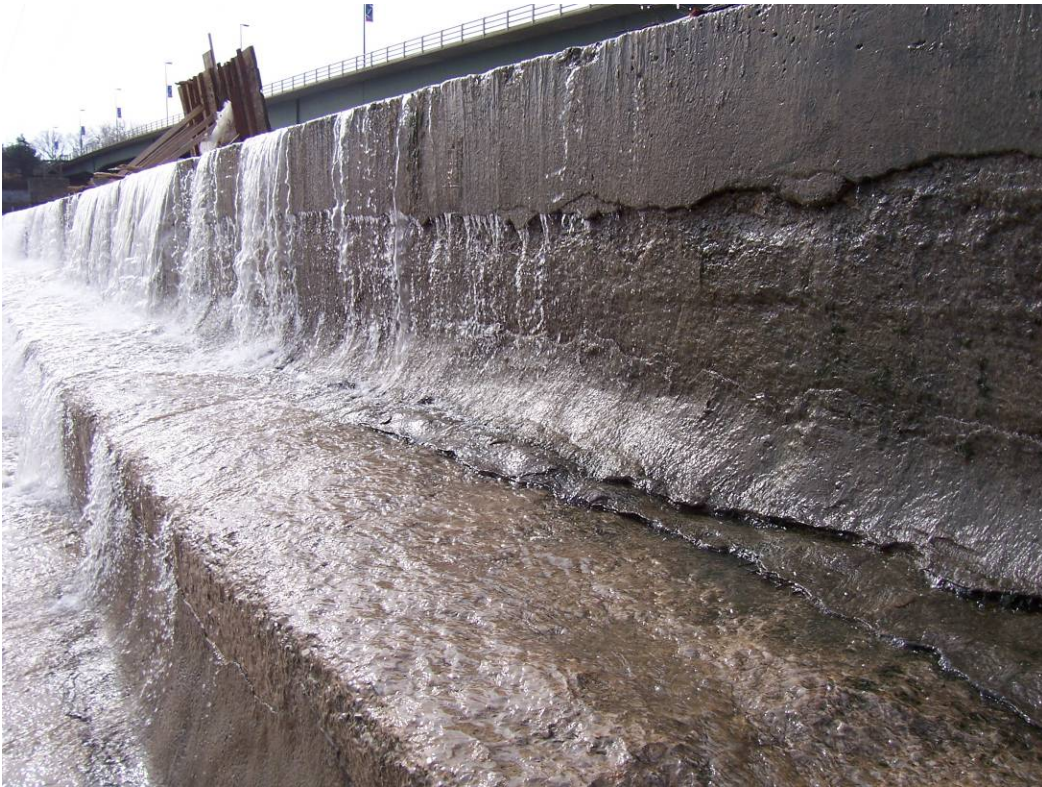
59. Sta 1+25 to south. Eroded shotcrete.

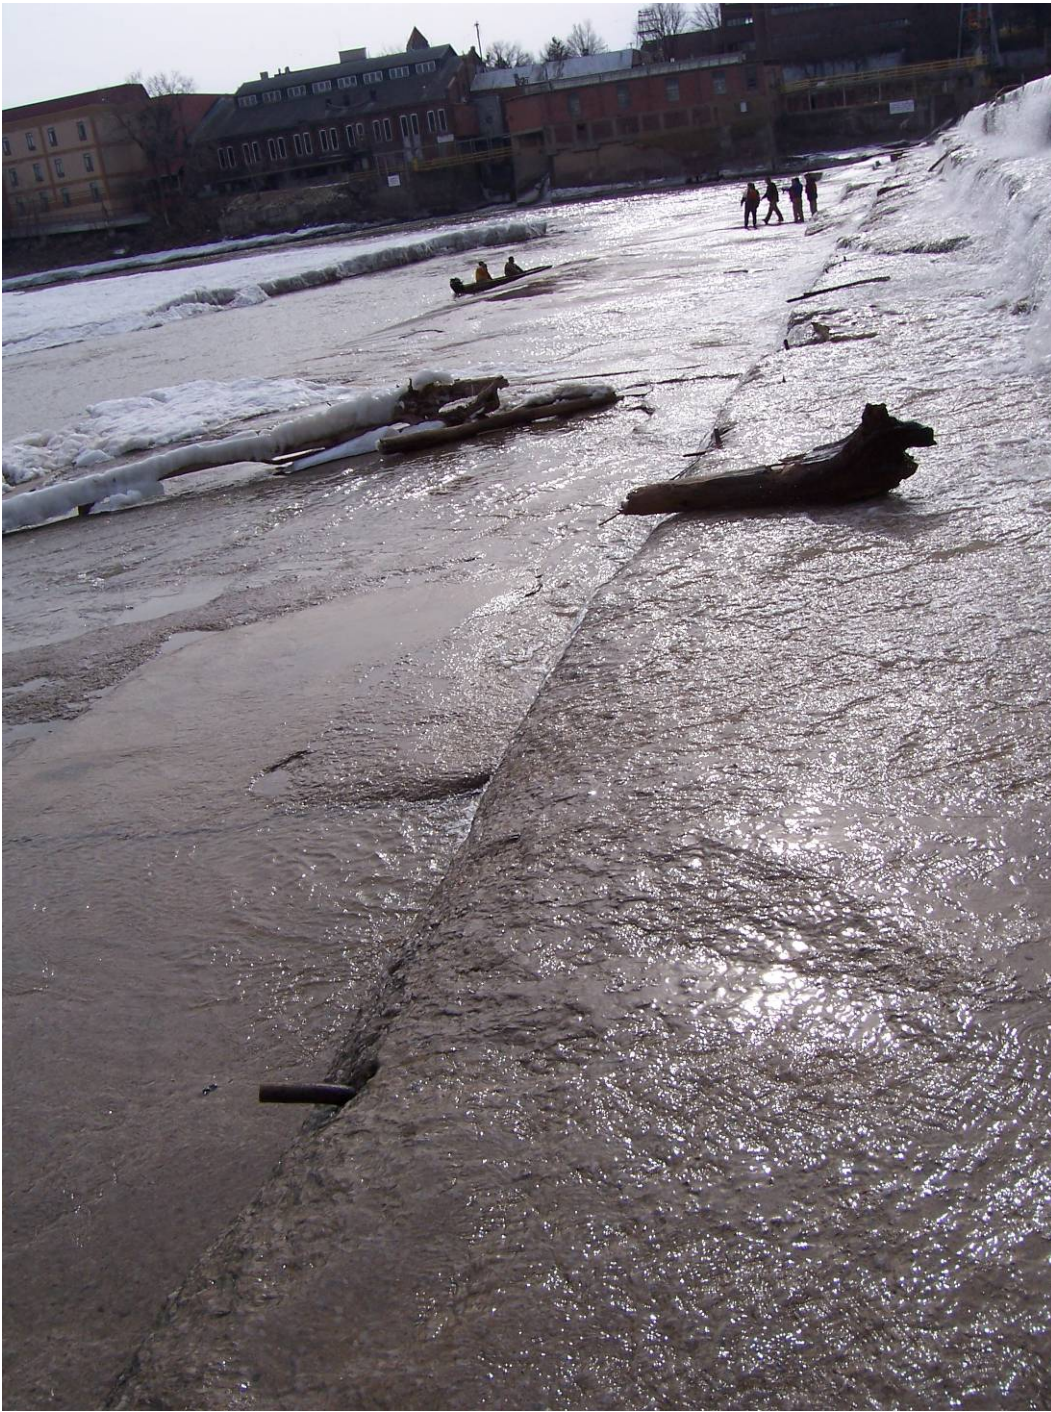
60. Sta 1+25 to south. Eroded concrete. Exposed bar. (See #17 & 19, 2007 Report.)

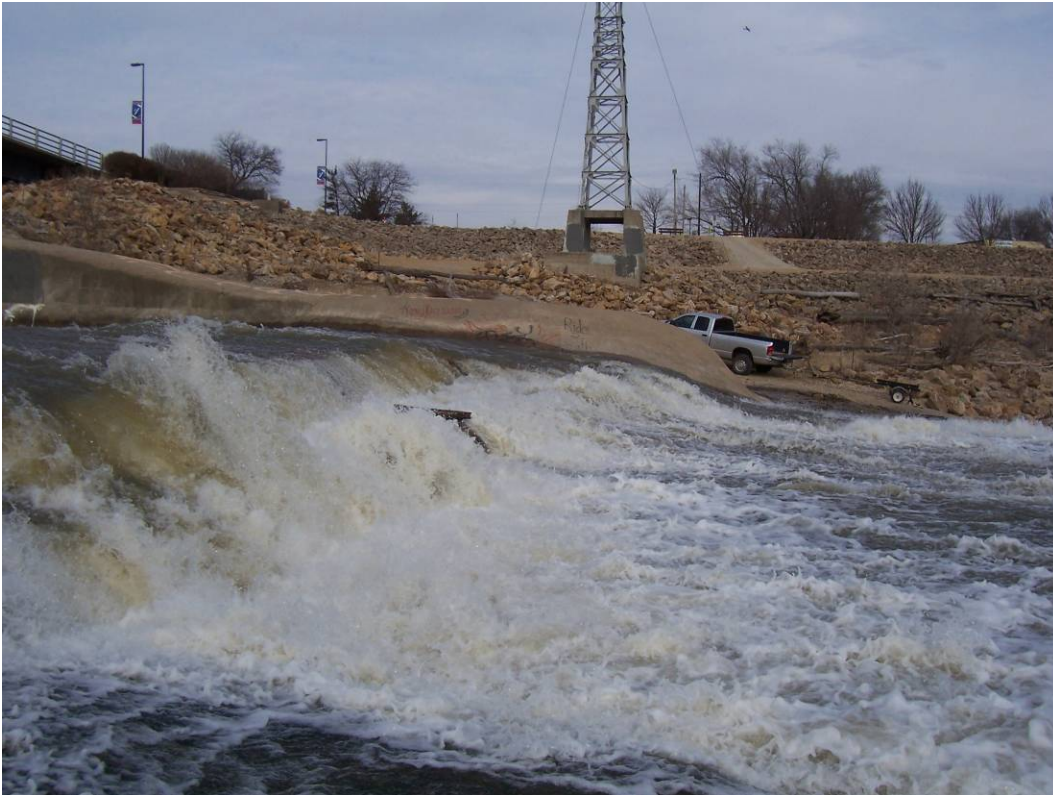
65. Sta 0+80 to north. Flow through spillway.

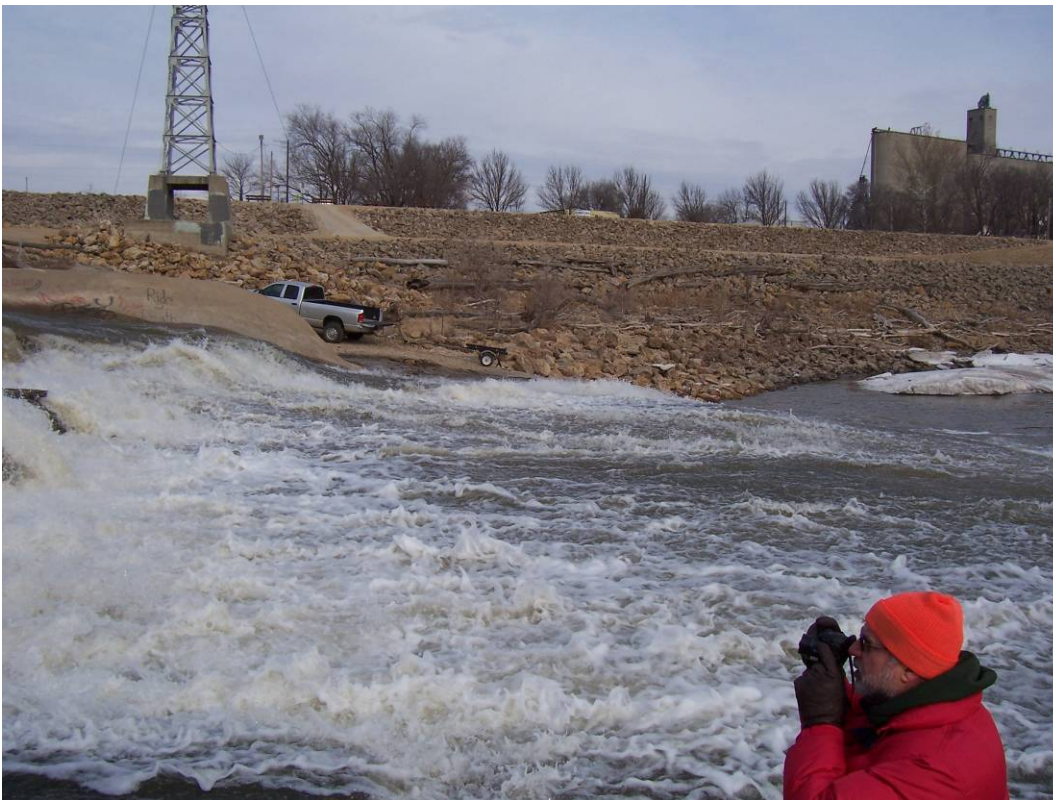
66. Sta 0+80 to north. Flow through spillway.

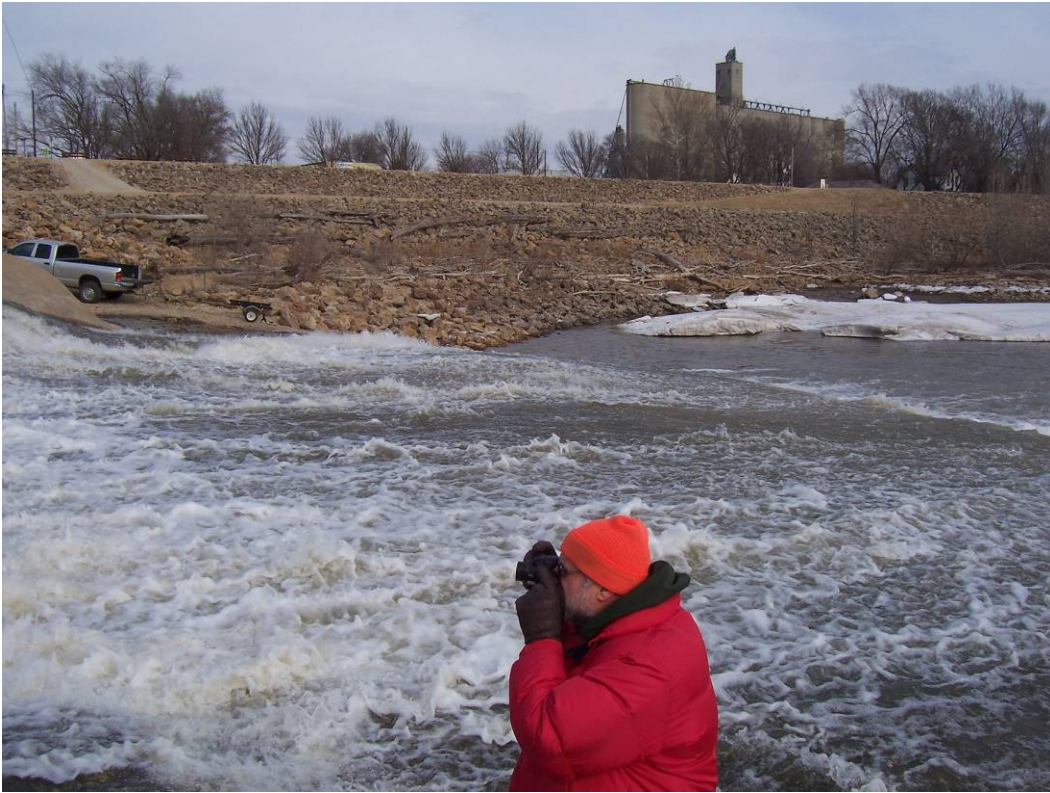
67. Sta 0+80 to northeast. Flow from spillway across apron.

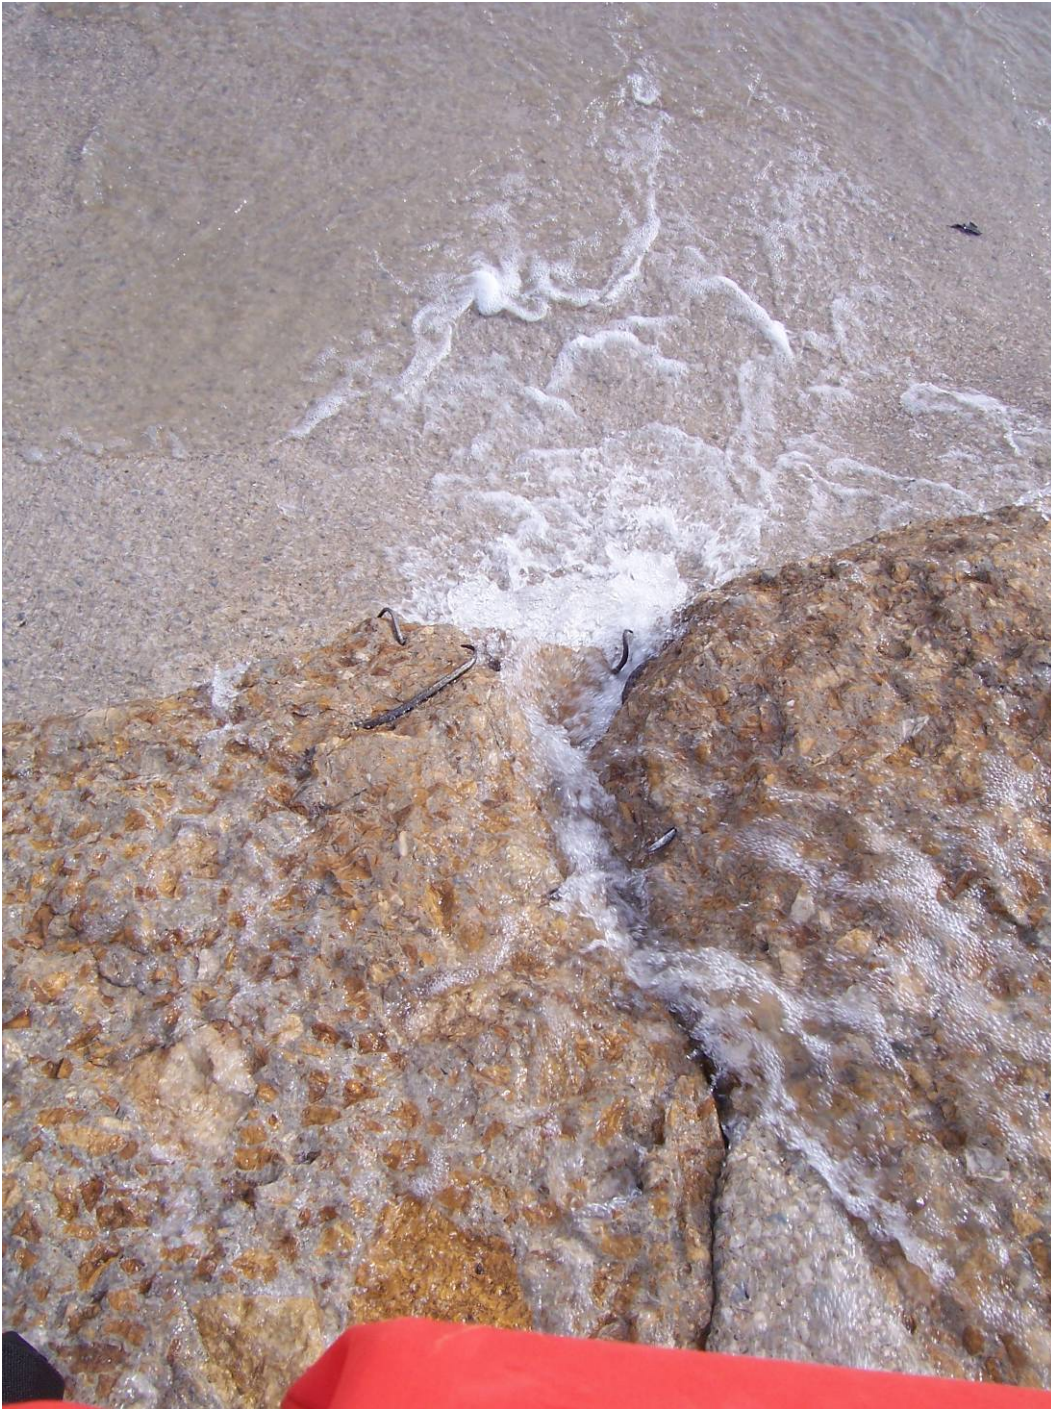
68. Sta 2+75±. Exposed, eroded reinforcing steel on first step. (See #36, 2007 Report.).

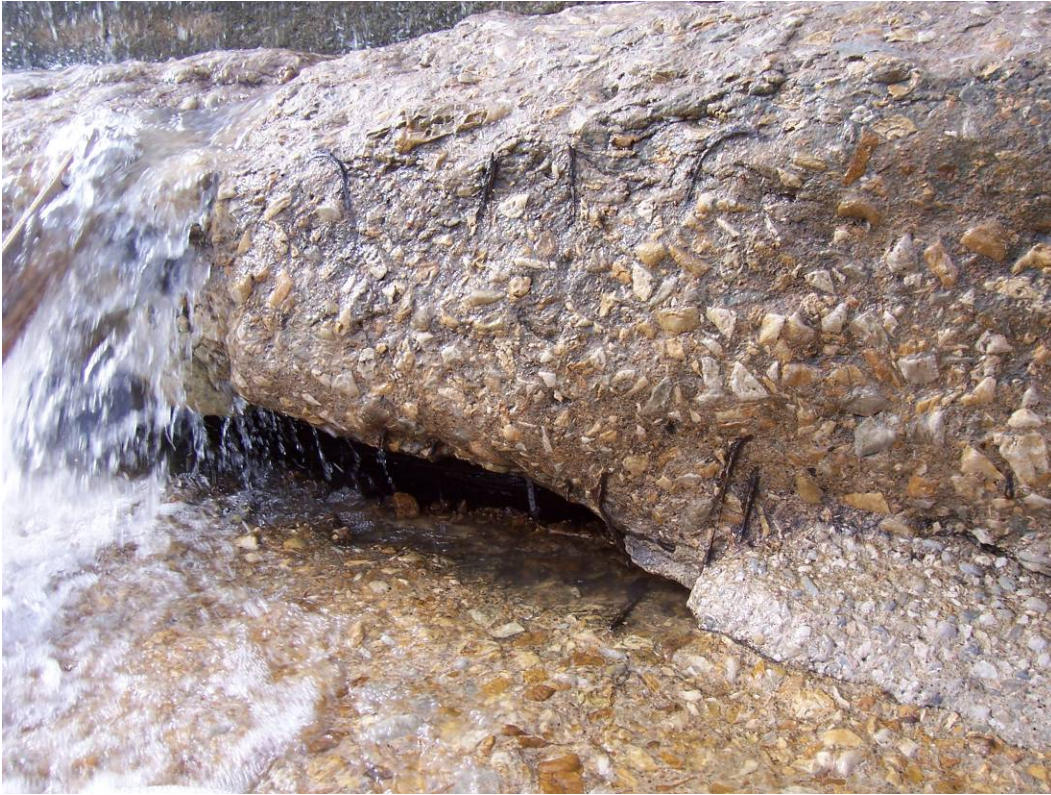
69. Sta 2+95±. Void between lower and middle steps. (See #41, 2007 Report)
