MECHANICAL, ELECTRICAL, & PLUMBING CONDITION

REPORT

**Santa Fe Station
The City of Lawrence
LAWRENCE, KANSAS**

December 1, 2009

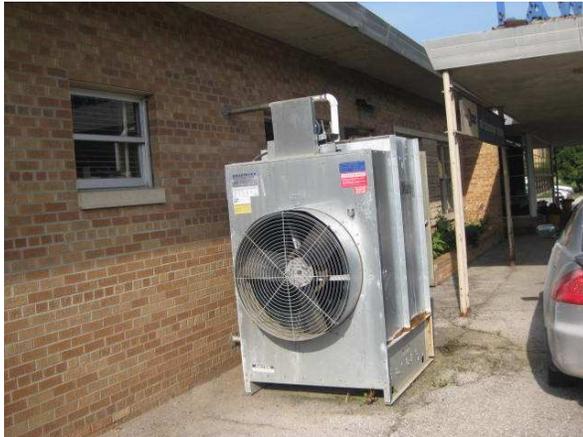
Photo #1 View of six year old Marley cooling tower located on the platform on the north side of the station.

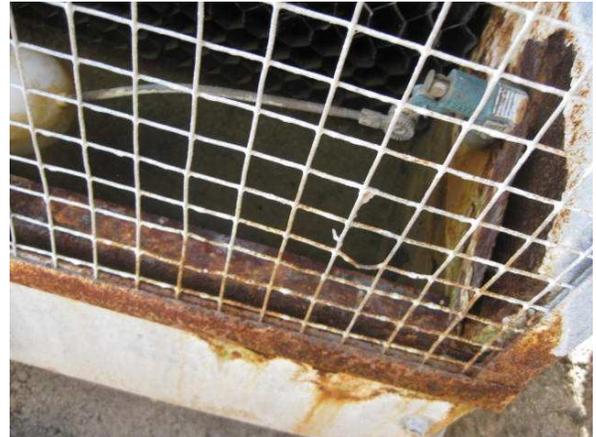
Photo #2 View of some rusting that is occurring on the cooling tower around the basin.

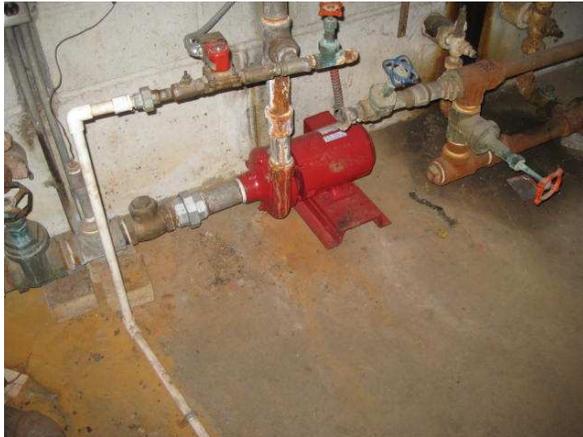
Photo #3 View of condenser water pump that circulates condenser water from the cooling tower to the two floor air handling units in the station.

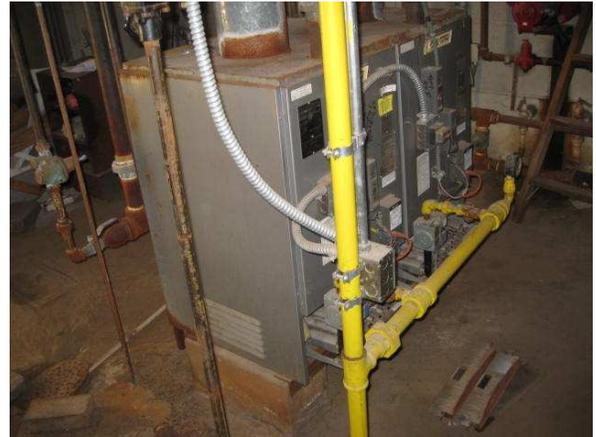
The hot water heating system is old inefficient and the system is close to or beyond its useful life. The current system does not appear to have any controls that work. It is recommended that the heating system be kept as is until it fails. The heating for the depot can be incorporated into the new ground source heat pumps. We may want to keep the under floor radiant system in operation for as along as possible, but have a means in place for heating the station once the under floor radiant system fails. The heating for the depot can be incorporated into the new ground source heat pumps.

Photo #4 View of Hydrotherm 400 MBH water tube hot water boiler in the boiler room.

The current boiler should be replaced with amore efficient unit, along with operational controls. Proposed system would be for a small wall mounted condensing type hot water boiler. This would allow hot water to still be supplied to the under floor radiant heating system and the fan coil units in the air locks.

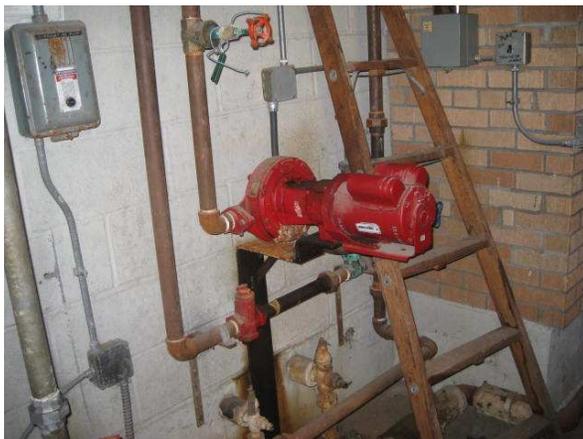
Photo #5 View of one of three hot water circulating pumps that distribute hot water to the under floor heating system and several fan coil units.

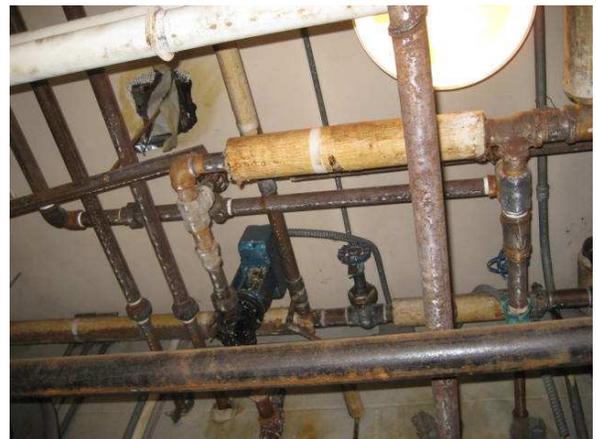
Photo #6 View of one of the three control valves located on the ceiling of the boiler room.

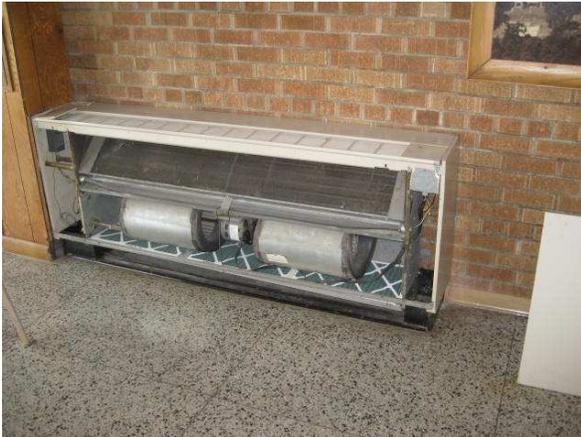
Photo #7 View of heating only fan coil unit with front cover removed located in the main lobby of the station.

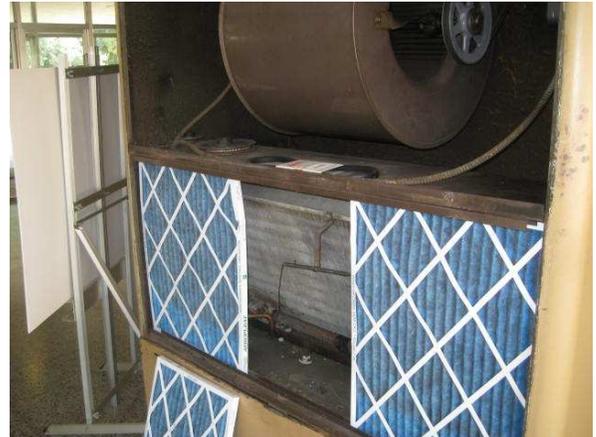
Photo #8 View of the 1 HP fan in floor air handling unit with cover removed located in the main lobby.

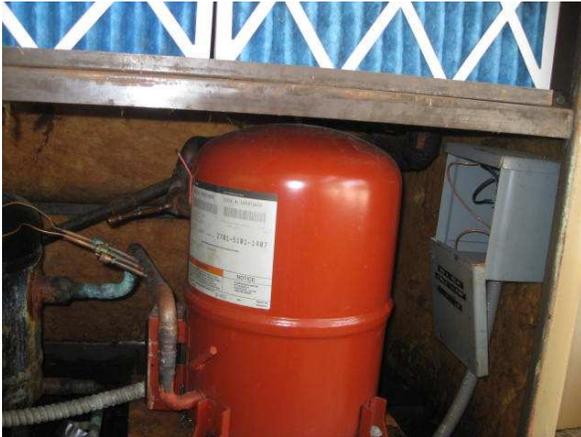
Photo #9 View of compressor in the lobby area floor air handling unit.

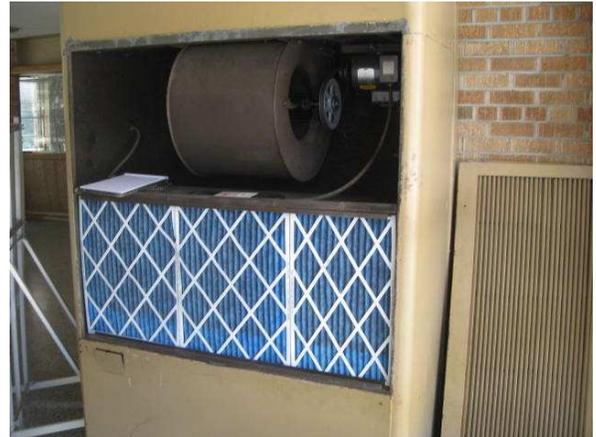
The floor package air handling units located in the main waiting area and in the baggage area have reached the end of their useful life and should be replaced with more efficient and reliable systems. It also appears that the controls for these units are not operating in an efficient manner. The cooling tower that provides condenser water to the floor package air handling unit appears to have some rust and corrosion associated with the basin. It is proposed that the floor package units be replaced with ground source heat pumps. It might be possible to install the ground source heat pump within the shell of the original package floor unit in the station waiting room. Another option would be to replace the floor package units with heat pumps with air cooled condensers mounted outside or the ground or on the roof. Based on the installed cost of the ground source heat pump system and expected 30% higher efficiency than the air cooled condensers heat pumps, the ground source heat pumps are expected to have a quicker pay back than the air cooled condenser heat pumps. Due to the poor operation of the current controls the actual pay back is difficult to determine.

Photo #10 View of 7.5 ton floor air handling unit located in the main lobby area.

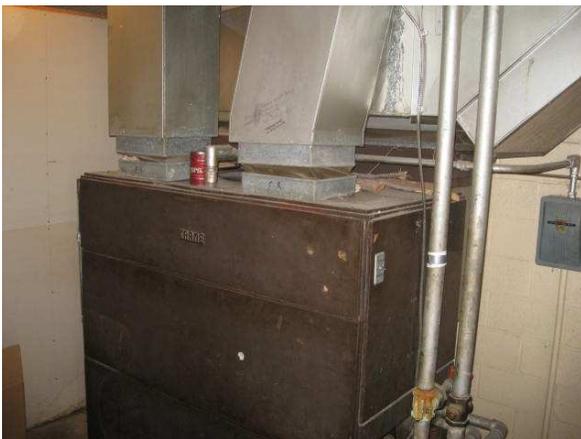
Photo #11 View of 10 ton floor air handling unit located in the baggage area.

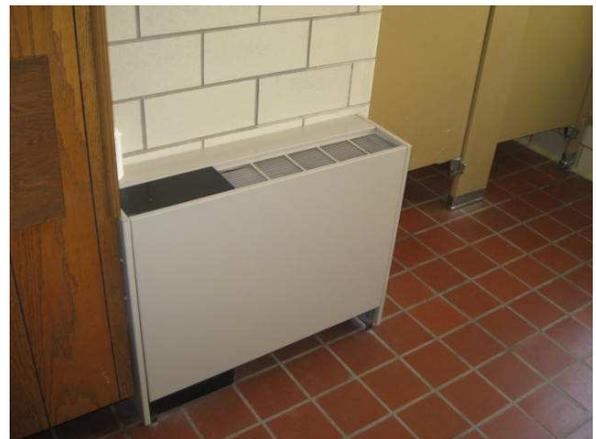
Photo #12 View of small hot water convection unit in one of the restrooms.

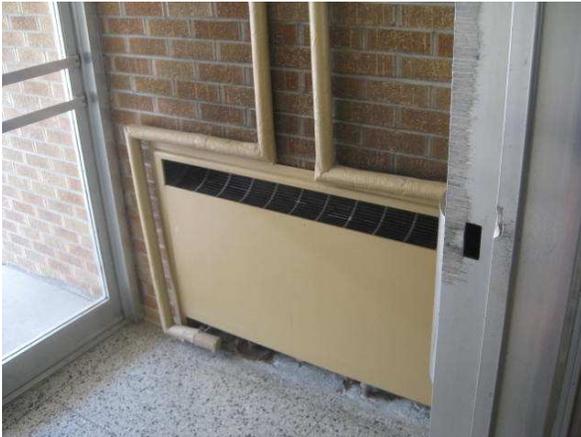
Photo #13 View of hot water convection unit in one of the air locks for the station.

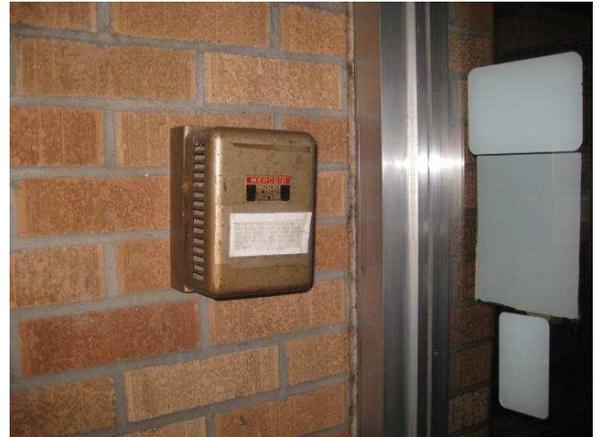
Photo #14 View of older thermostat controlling air lock hot water convection unit.

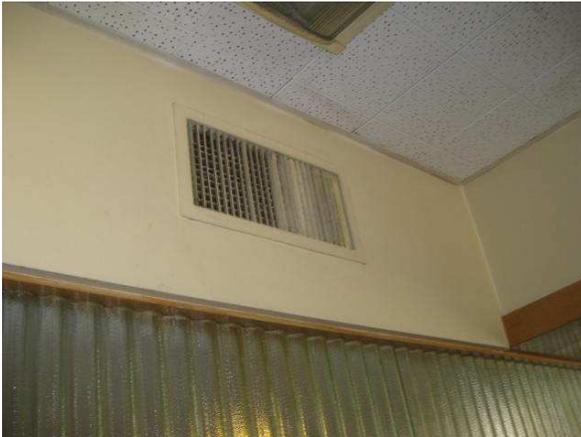
Photo #15 View of supply air diffuser with ductwork in soffit in the main lobby of the station.

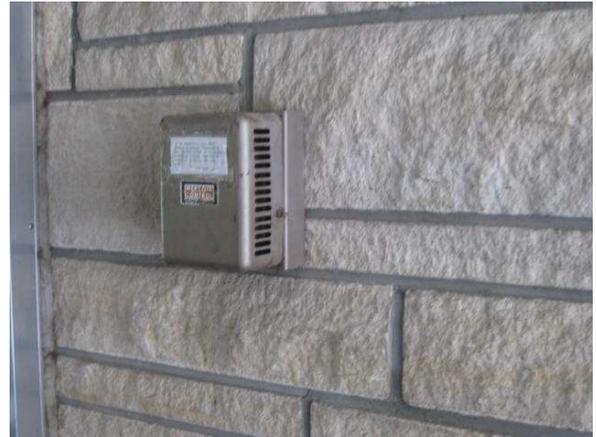
Photo #16 View of older thermostat for one of the floor air handling units.

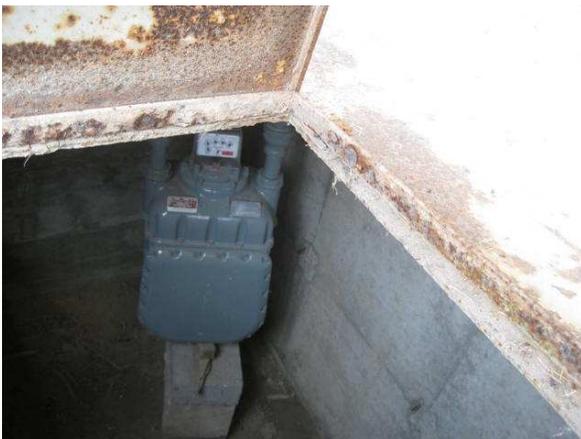
Photo #17 View of 1000 CFH natural gas meter serving the building located in a pit on the south side of the station.

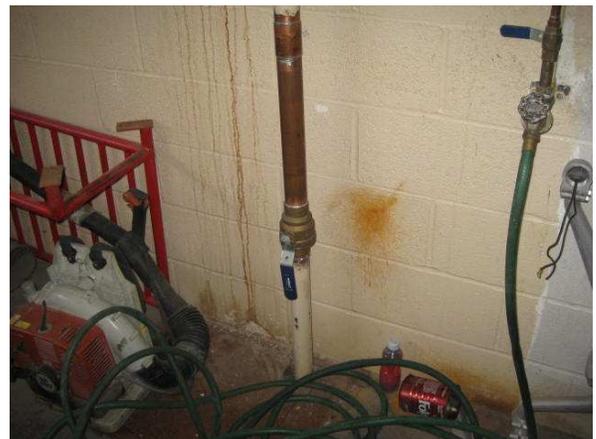
Photo #18 View of the main water service shut off on the east side of the station.

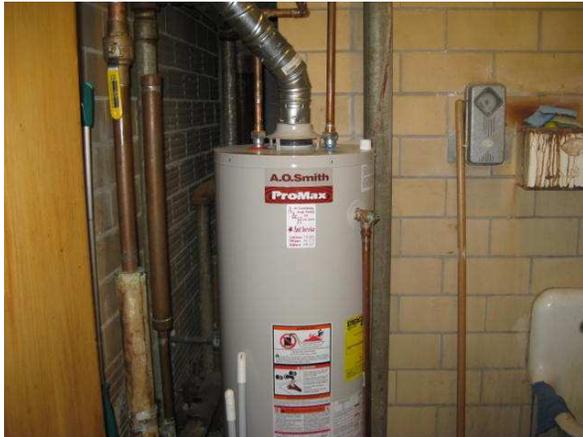
Domestic hot water is supplied to the restrooms, janitor's service sink and several office located lavatories by an *A.O. Smith* Promax 40 MBH 40 gallon natural gas fired water heater located in the janitor's closet. See Photo #19 The water heater was replaced in January 2009.

Observations/Comments: The water heater at the station is approximately 10 months old and should have an estimated useful life of 10 to 15 years. It is expected that the water heater will not need to be replaced in the near future.

Photo #19 View of six month old 40 gallon 40 MBH natural gas fired water heater serving the restrooms and the lavatories located in the offices.

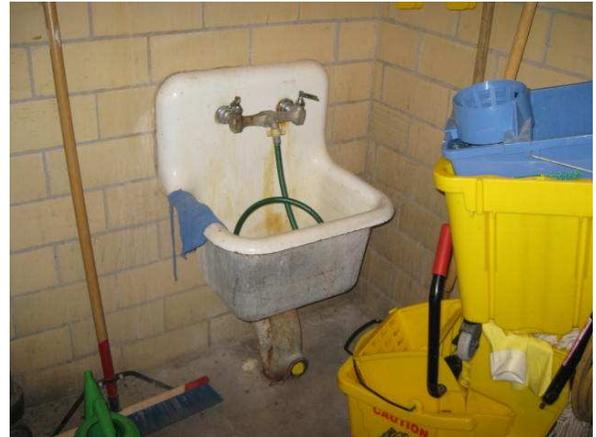
Observations/Comments: The piping, where observed, appears to be in satisfactory condition. No lack of capacity, drainage or plumbing problems were observed. The plumbing fixtures appear to have reached the end of their useful life and need to be replaced with new low water usage fixtures.

Photo #20 View of service sink located in the janitor's closet.

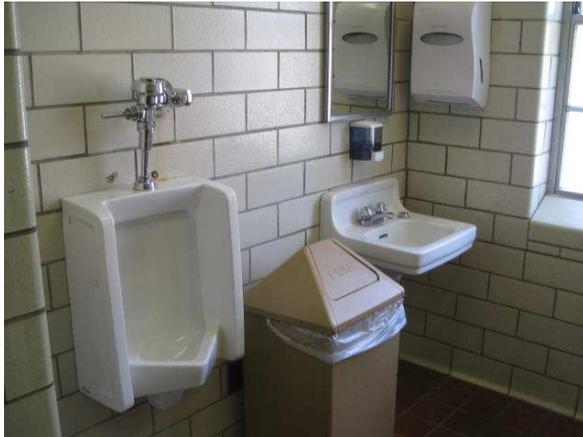
Photo #21 View of urinal and wall hung lavatory in the men's restroom.

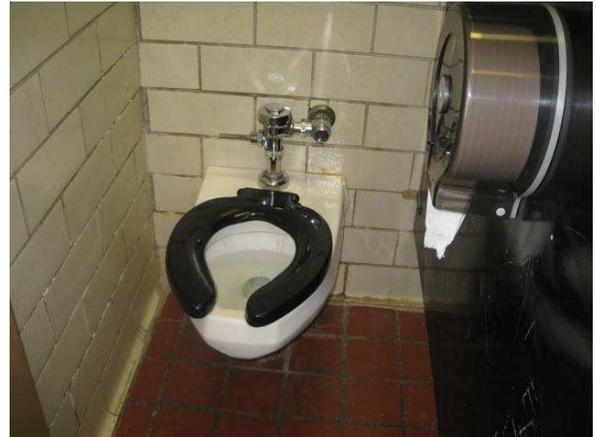
Photo #22 View of typical wall hung water closet with flush valve in the restrooms.

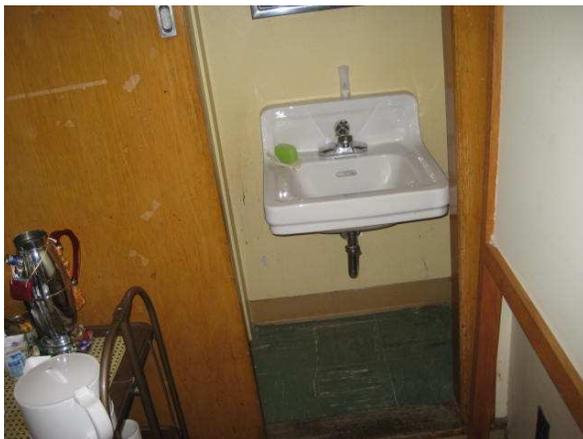
Photo #23 View of typical lavatory in office and ticket office.

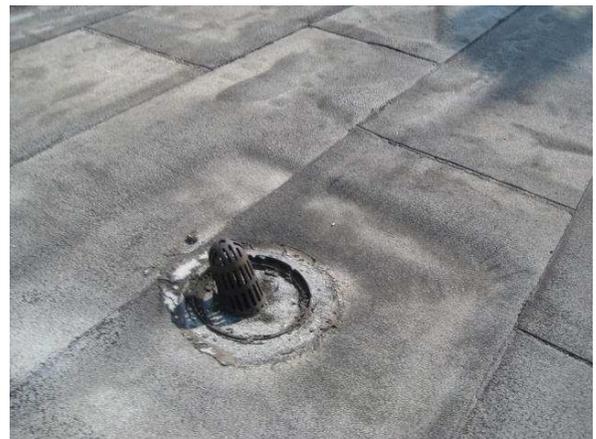
Photo #24 View of internal roof drain.

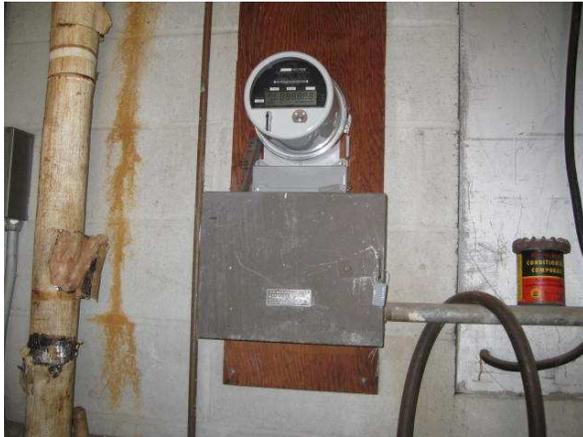
Photo #25 View of utility meter for the 120/240 volt 3 phase high leg electrical service located in the boiler room.

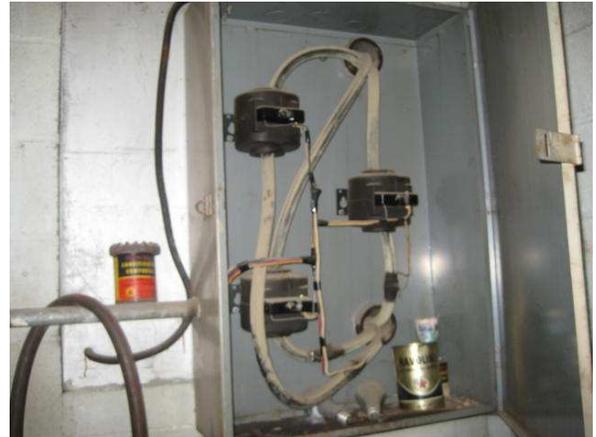
Photo #26 View of CTs in cabinet next to meter in the boiler room.

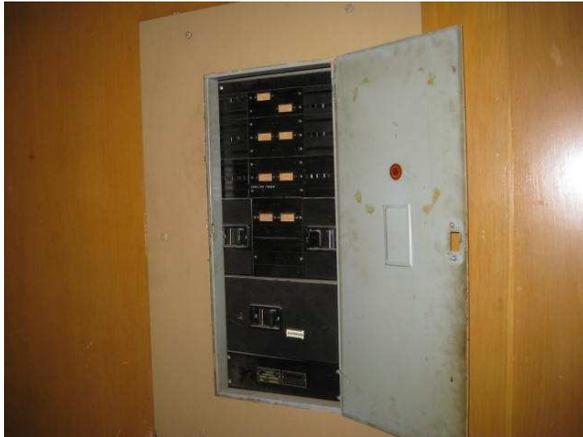
Observations/Comments: The power distribution system for the building is original. Based on the age of the breaker panels and the potential difficulties in getting replacement parts for this equipment and the possibility that the system might not work when needed, it is recommended that the power distribution panels be replaced with new equipment. The main distribution panel should be moved to a location that is not accessible to the public. The existing panel could be retained in its current location as a historical artifact with labels indicating that. The main distribution panel can be moved to the boiler room with new distribution wiring run to the new replacement sub panels and the floor package units.

Photo #27 View of 400 amp 120/240 volt 3 phase Westinghouse main electrical distribution panel for the station.

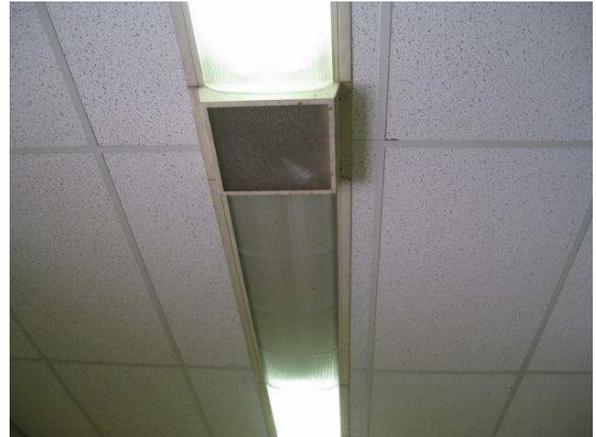
The lighting system appears to be adequate but should be up dated to a more energy efficient system with the replacement of the older T12 40 watt fluorescent fixtures with newer T8 32 watt fluorescent fixtures. It was noted that many of the older incandescent light fixture have compact fluorescent lamps in them. Some of these do not appear to provide adequate lighting from the fixtures and the fixtures should be replaced with fluorescent fixtures with the proper sized lamps for better lighting. It appears that the existing fixtures can be retrofitted with new energy saving ballasts and holders for the more efficient T-8 lamps. We may want to look at installing ballast that allow for dimming of the lamps in the waiting area due to the large number windows in the waiting area.

Photo #28 View of typical lighting fixtures in the public and office areas of the station. Includes both fluorescent and incandescent fixtures.

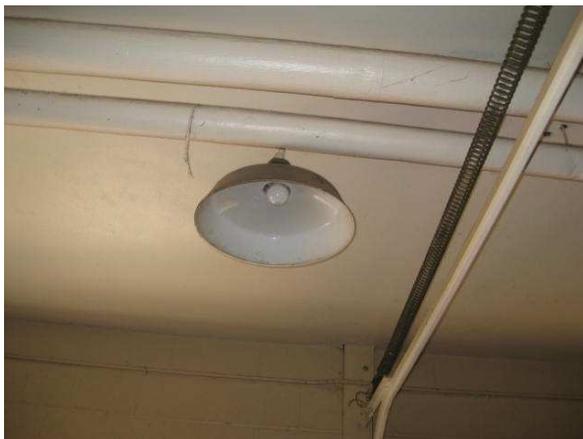
Photo #29 View of incandescent fixtures in the baggage area of the station.

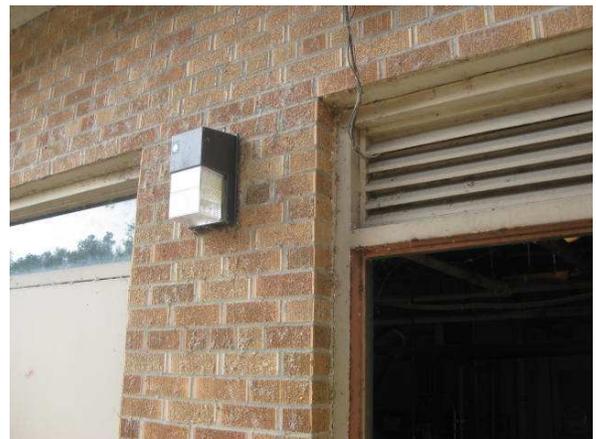
Observations/Comments: The exterior light fixtures appear to be in fair to poor condition and should be replaced. Funds have been allocated to retrofit or replace the exiting fixtures with more efficient lamps.

Photo #30 View of some of the building mounted light fixture along the platform next to the boiler room entrance.

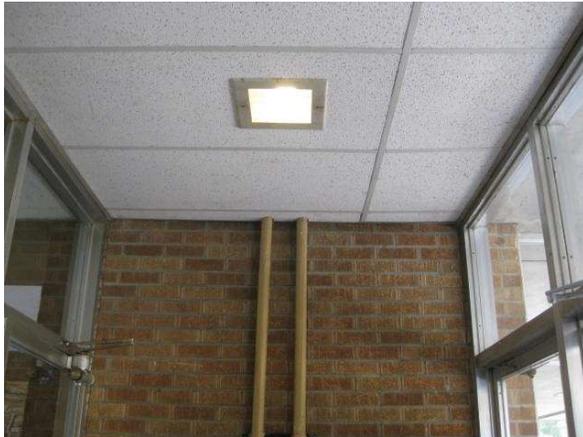
Photo #31 View of recessed lighting in the air lock.

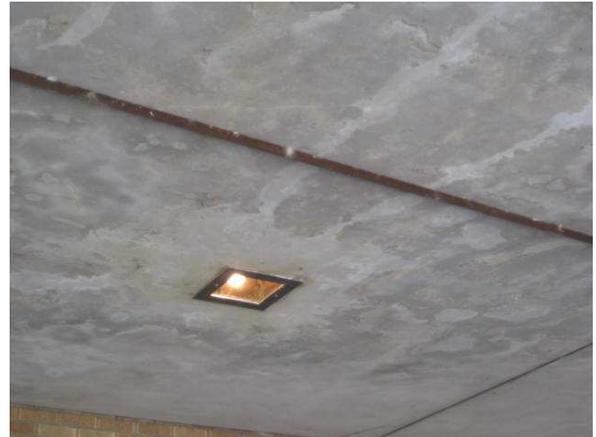
Photo #32 View of recessed lighting in the canopy over the platform.

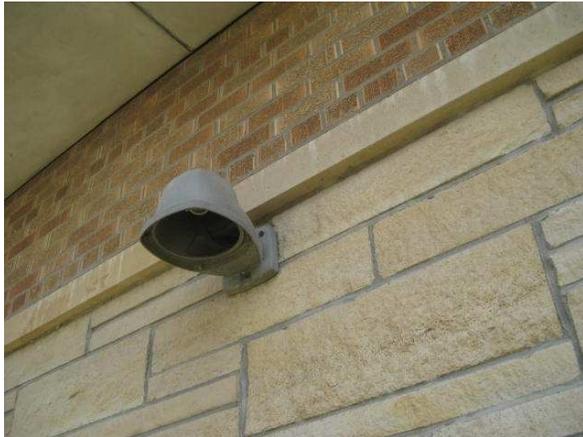
Photo #33 View of building mounted lighting on the south side of the building.

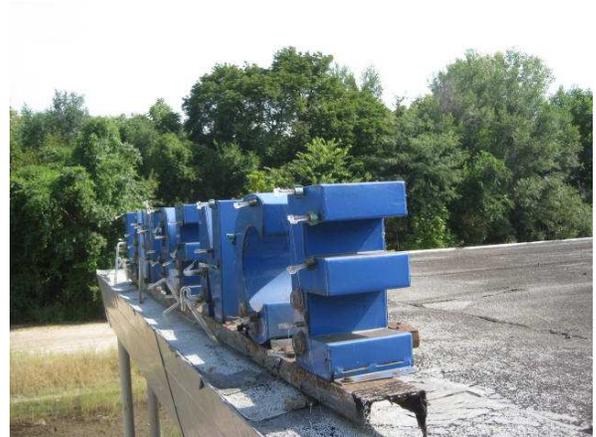
Photo #34 View of sign on the station with damaged neon lighting.

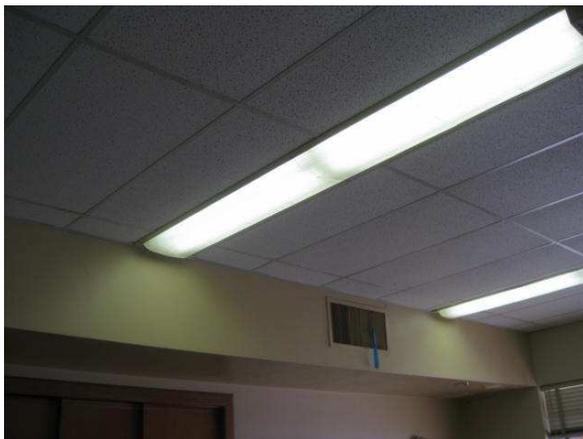
Photo #35 View of light fixtures in office area, note soffit with supply air diffuser.

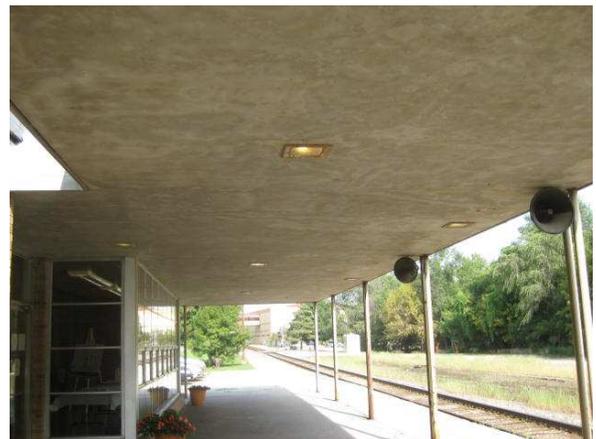
Photo #36 View of platform with recessed lighting.
