DGM Consultants, P.A.

November 24, 2009

Re: Historic Structures Report - Structural and Masonry
Sante Fe Station
413 East 7th Street
Lawrence, Kansas
DGM PN 2009014

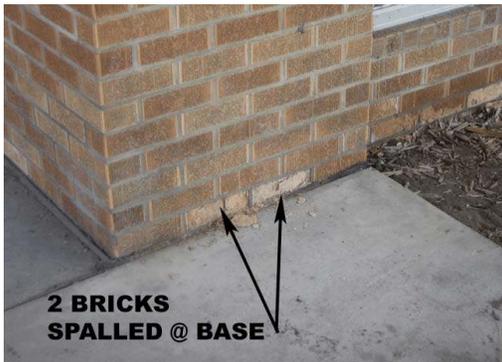
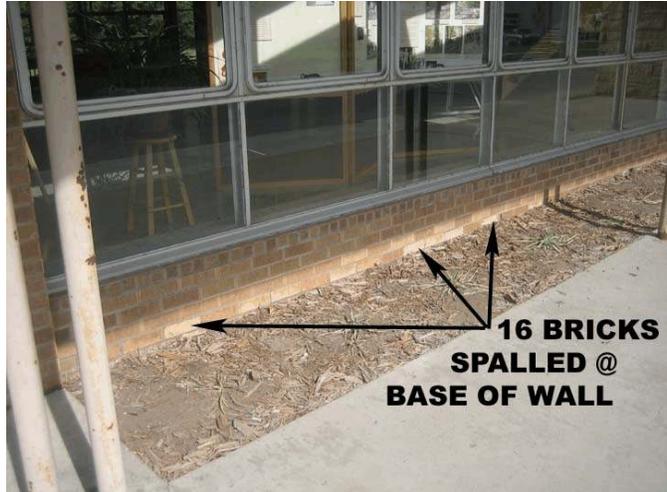
2. Along the front wall we noted 18 bricks that were spalled at the base of wall.

- B. **Masonry**
 1. Spalled bricks were noted along most elevations of the building at the base of wall and on the chimney. At these base conditions the bricks were typically located partially below grade or the pavement surface. The spalled brick at the chimney is likely due to units that are exposed to a more severe exposer above the roof than they can resist. The ability of this type of brick to resist freeze/thaw cycles has not been tested. These units likely become more absorbent once the face is spalled off and should be replaced to restore the strength of the wall at the base and the chimney.

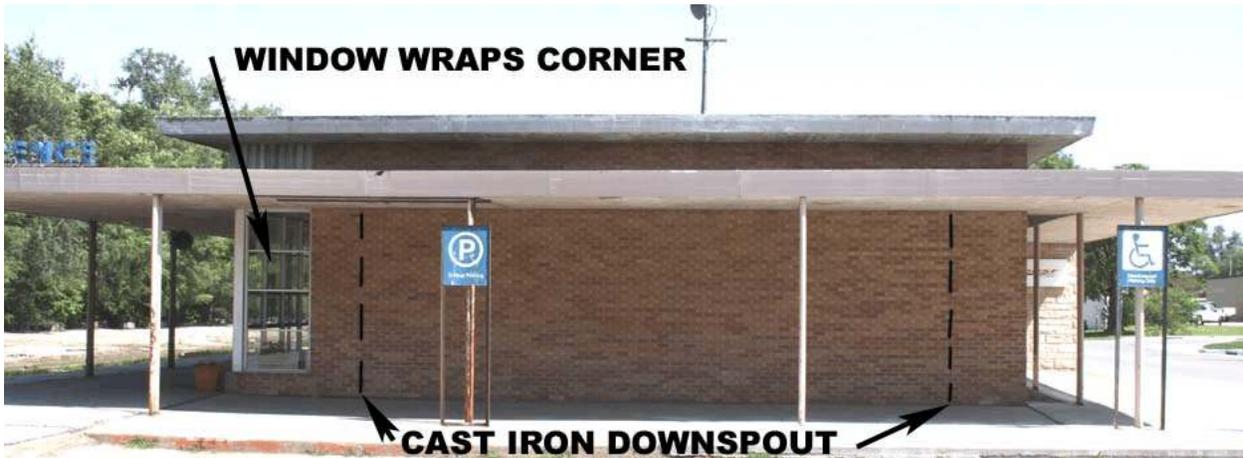
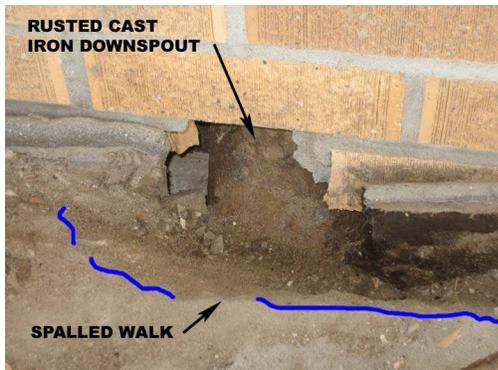
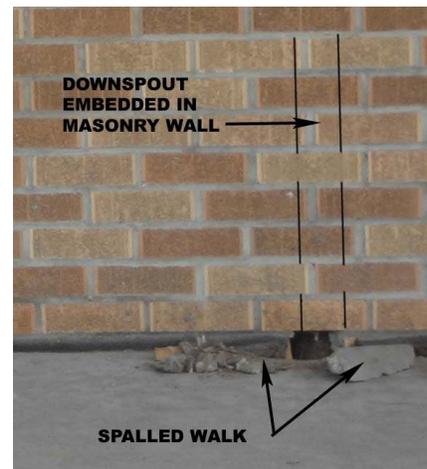
3. Northwest wall is a solid brick wall for most of the wall, except for the window at the north corner. We noted two spalled areas in the side walk and found them to be located at the two cast iron downspouts embedded in the wall. The cast

iron elbow had been turned out near the sidewalk surface and as the pipe corroded it spalled the concrete walk.

1. Cast iron downspouts encased in the northwest wall need to be modified while the walk is replaced so that the missing brick at the base of wall can be replaced and the walk protected from future spalling.
2. Replace site paving around the building.
3. Repair cracked plaster in interior of exterior walls.

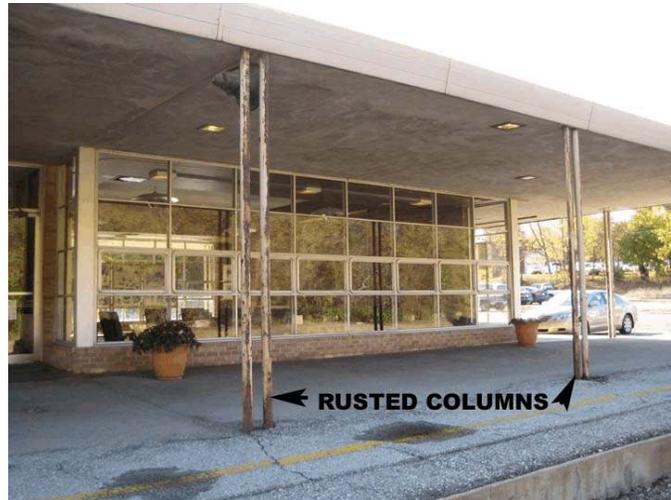
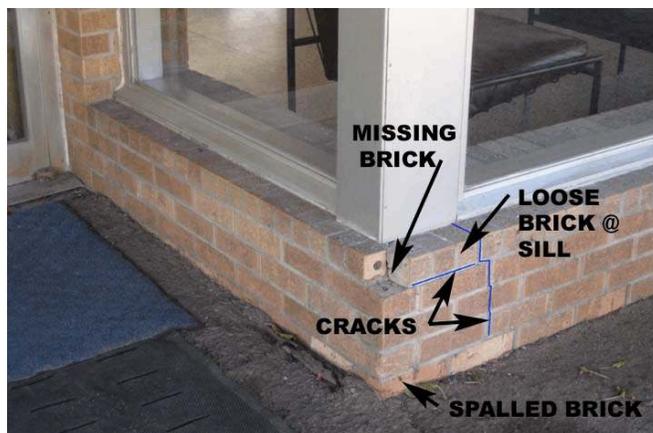
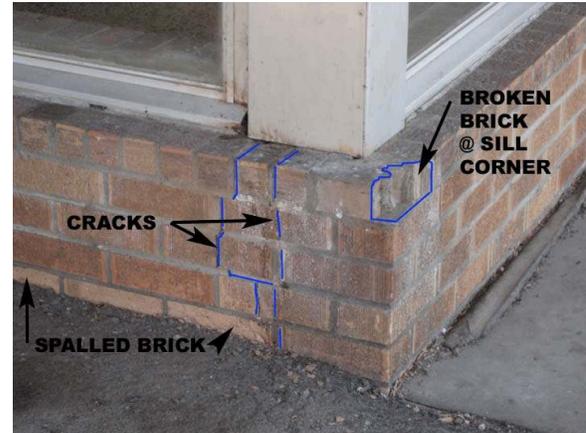
4. The northeast wall parallels the track and is all glass wall, except for the base of wall. We noted about 40 bricks that were missing, cracked, or spalled at the base. The cracking occurs near each corner where there is a steel column embedded in the window wall trim.

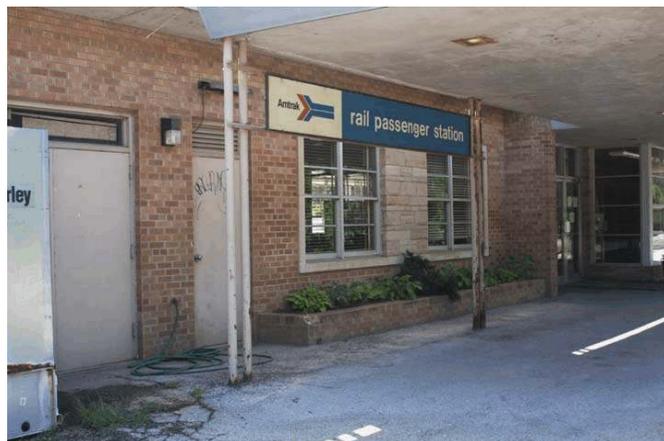
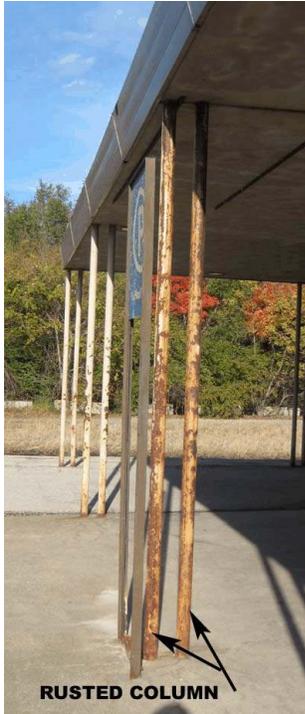
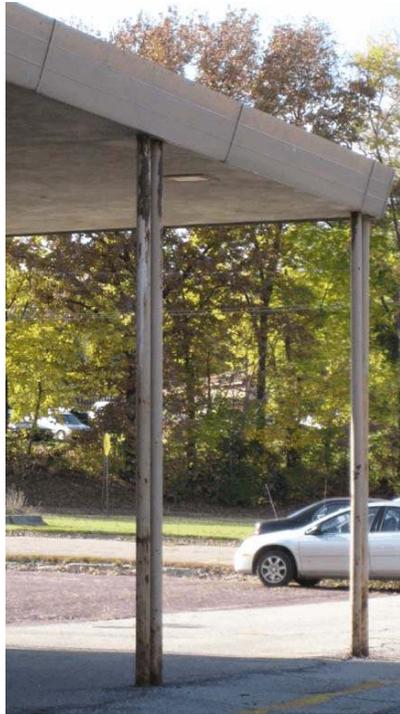
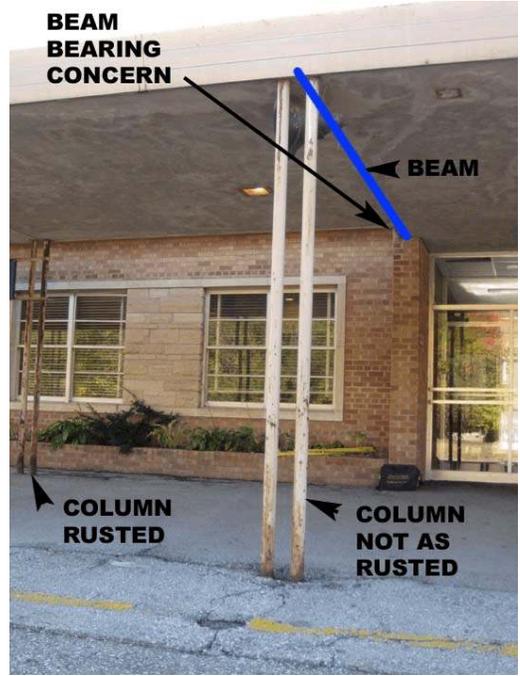
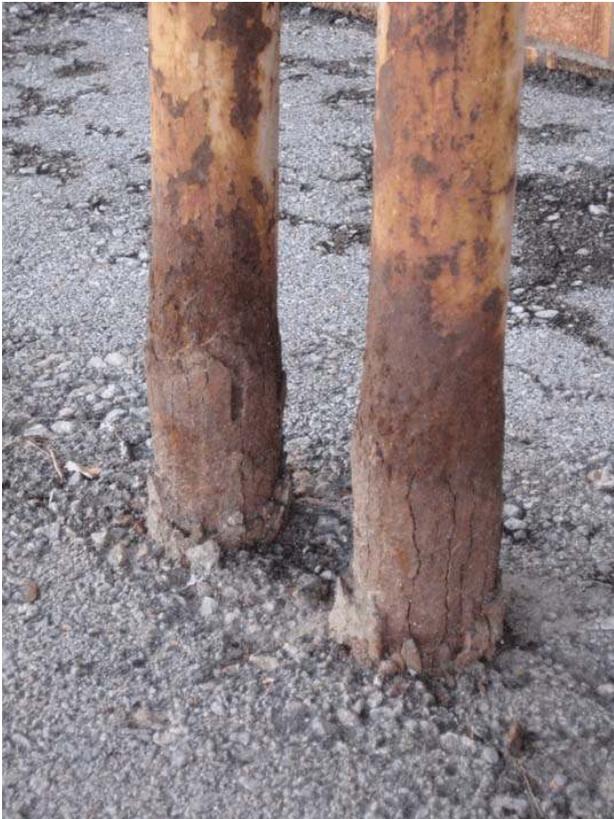
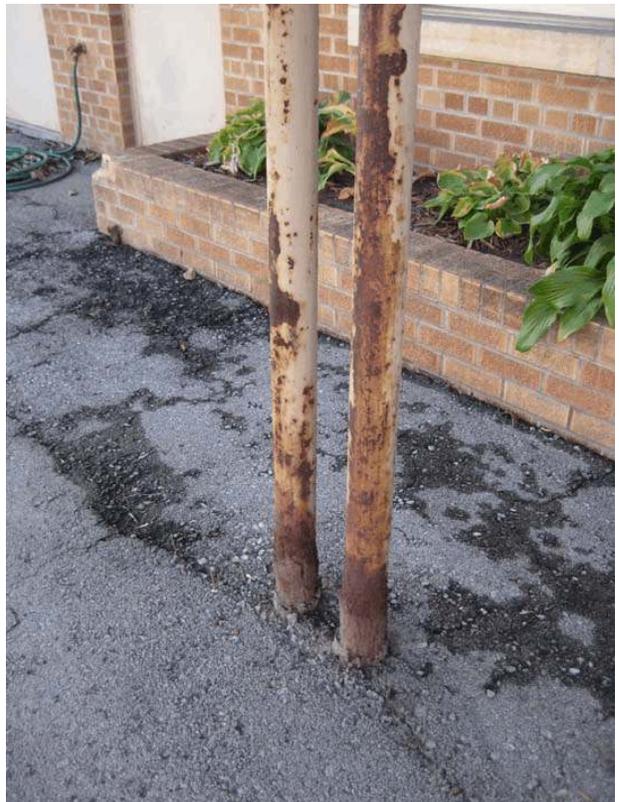
5. Canopy that wraps around the waiting room also extends another 42 feet northeast of the waiting room, parallel to the track.
- The columns for the canopy are constructed from two 2.5-inch diameter steel pipe.
 - The bases of these columns are embedded in the cementitious or asphaltic concrete walks.
 - The bases of some columns are severely corroded. Other columns are corroded the full length of the column or barely corroded at all.
 - Refer to the pictures on the following pages for the various conditions noted.

1. General: The primary concern is the corrosion of steel members. The double pipe columns obviously have a corrosion problem where it is visible. The embedded portions of the pipe columns and other steel members encased in masonry need to be exposed more to fully understand the extent of the repair.

2. Pipe Columns: For now we have assumed that all the pipe columns need to have the bases replaced (19 locations) to be certain that all concerns are addressed while the pavement is replaced. There are two repair options being considered for repair of the 19 double pipe columns (38 pipe columns).
 - a. Repair: Replace the base of the column and clean the top portion, then refinish the column with a high performance coating system. This repair will require field welding and inspection to restore the columns to their intended capacity. Then prepare the top portion for a new finish coating which will include preparation of rusted surface, lead paint removal concerns, priming with a zinc rich coating and two top coats. Since the

- b. Second is to replace the entire column with new galvanized pipe columns, repair the canopy soffit, and finish the steel with a three coat system. This will be the longer lasting option (at least twice as long).
- c. These two options will cost somewhere in the same range due to the labor intensive repair option as compared to the replacement option.

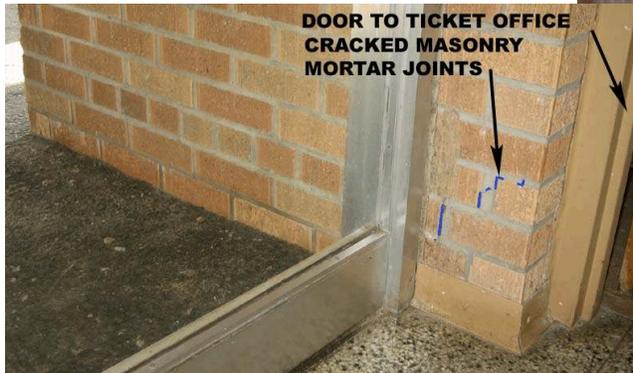
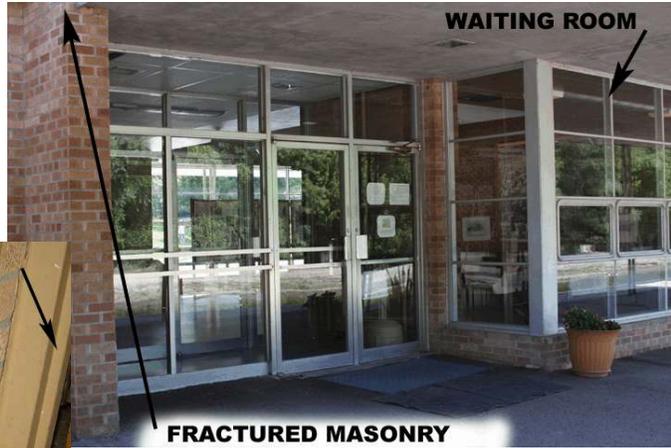
building wings). Inside this entrance we noted the brick wall was cracked at the door jamb.

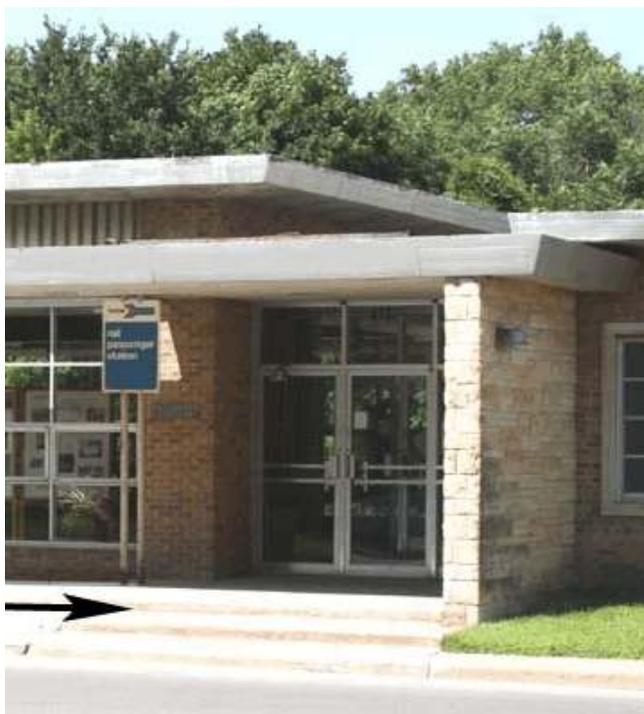
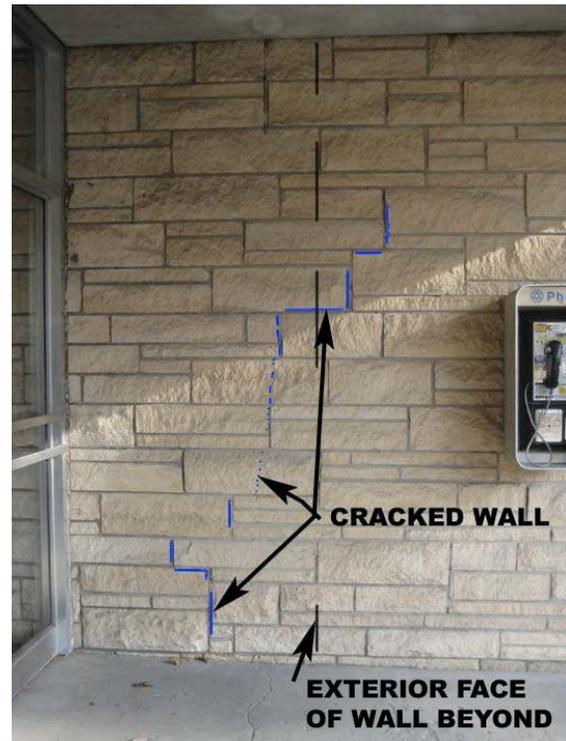
2. The vestibule/entrance on the street side (southwest) is protected by a canopy and the brick wall at the waiting room as well. There is a stone wall on the southeast side. A crack in the vestibule side of this wall was noted and is referenced on the photo below.

- b. Cracked stone wall needs to be repaired to keep moisture from entering the wall.
 - c. The interior walls that are pulling away from the exterior wall need to be monitored to determine if they are still moving. If no movement, then repair could be more rigid, but if there is still movement noted the repair will need to accommodate it.

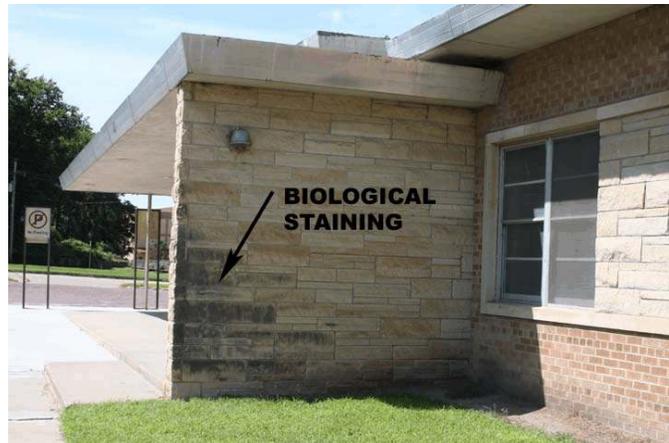
- a. The southeast face of this stone wall was noted to be stained by biological growth.

4. Miscellaneous repairs.
 - a. Tops of partition walls need to be laterally supported if they are spanning vertically.
 - b. Caulk head joints in stone sills.
 - c. Reconstruct brick planter box on southwest side to replace this missing feature.
 - d. Waterproof the interior of the planter boxes to keep moisture out of the masonry wall.
 - e. Clean graffiti of the face of brick with an acceptable paint remover.
 - f. Clean biological staining from face of stone.

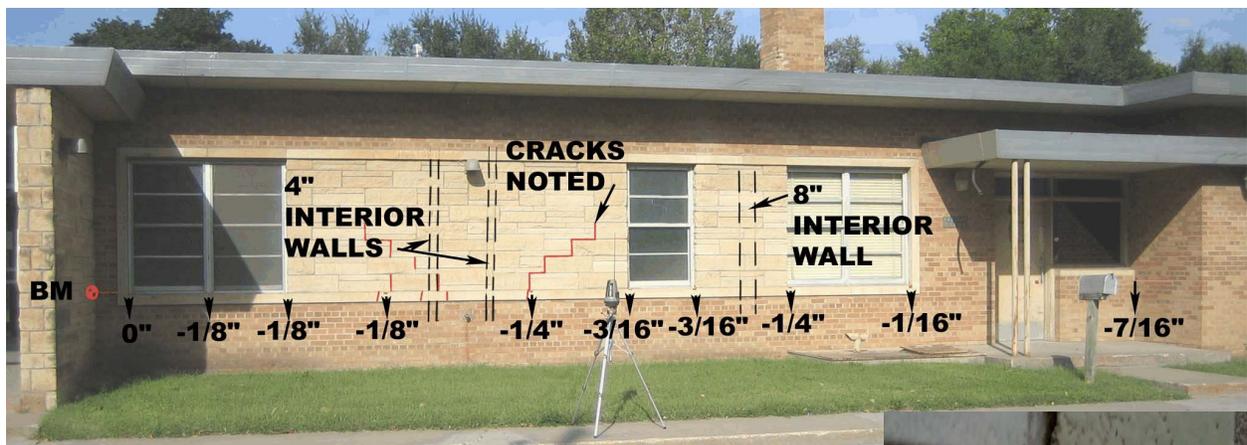
- a. Interior cracking had been noted in the restrooms as well as cracking in the stone panel of this wall.
 - b. We surveyed the elevation of the stone sill at several spots along this wall segment. The relative fractional changes in elevation were calculated and are noted on this photo. There appeared to be the most notable settlement at the men's restroom and over to the agent's office window.

- c. The difference in elevation between the starting point (BM) and the Agent's Office entrance porch was the greatest difference.
 - d. The approximate location of walls on the interior was annotated on photo.

- e. The location of cracks in the stone wythe was highlighted in red on photo.

3. Restroom walls:
 - a. The "settlement" noted from level during our survey can be caused by several factors including, settlement of plumbing trenches, volume changes in a swell potential clay (changes in moisture content), settlement caused by partition loads on interior slab, plumbing leaks, and original construction not being constructed level. Elevations recorded need to be rechecked quarterly to verify if they are consistent or still moving.

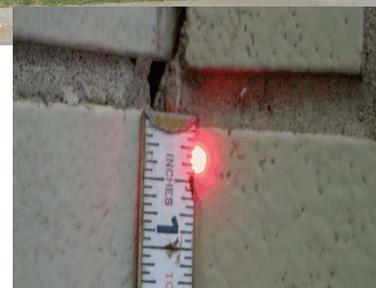
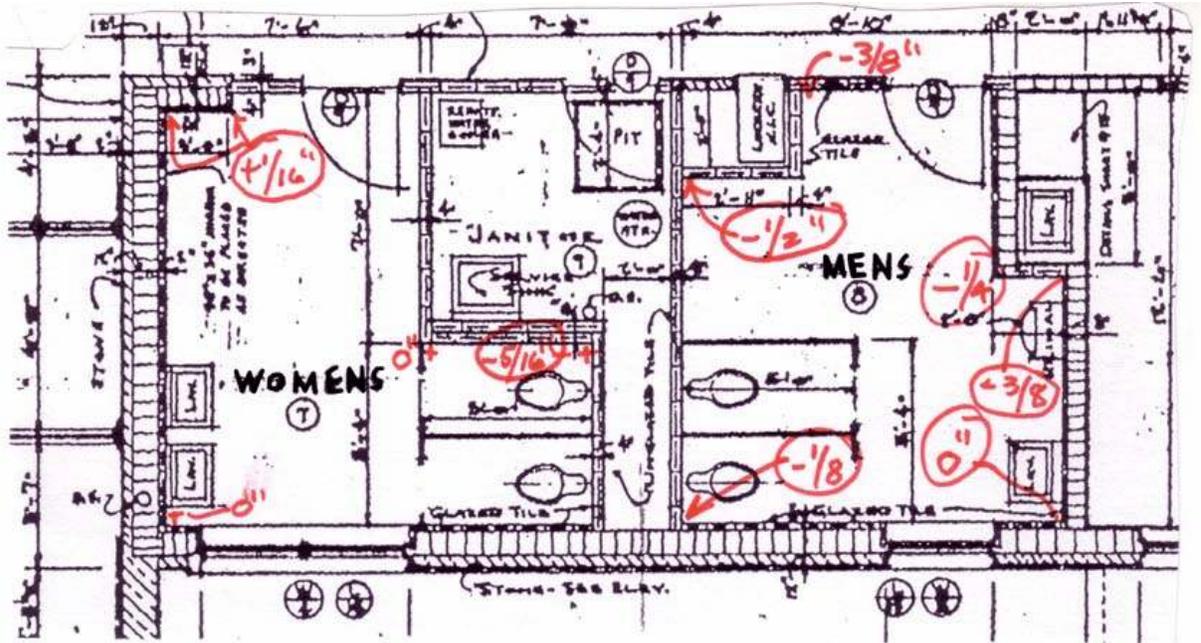
- f. We surveyed the interior glazed concrete masonry unit wall mortar joints and noted cracks and settlement at some locations. A summary of the survey is on the next page. The red numbers are relative to elevations noted as "0".

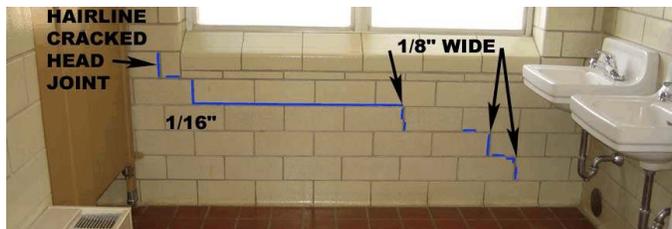
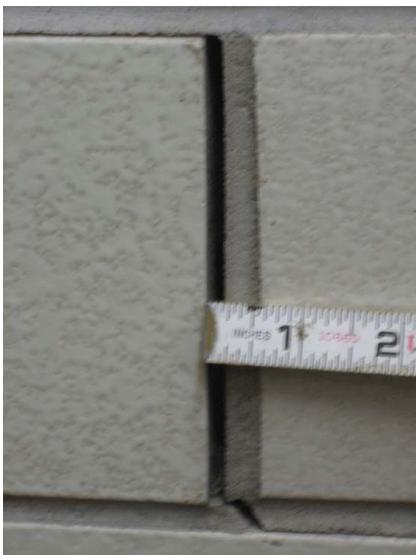
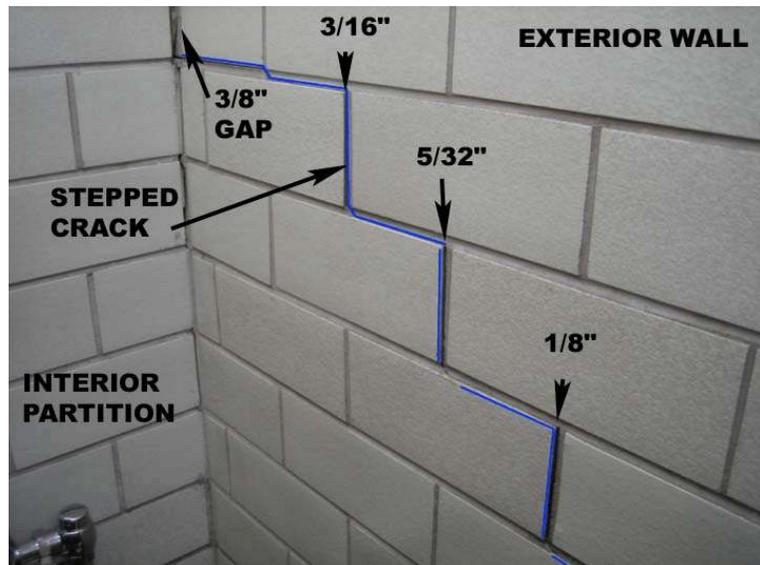
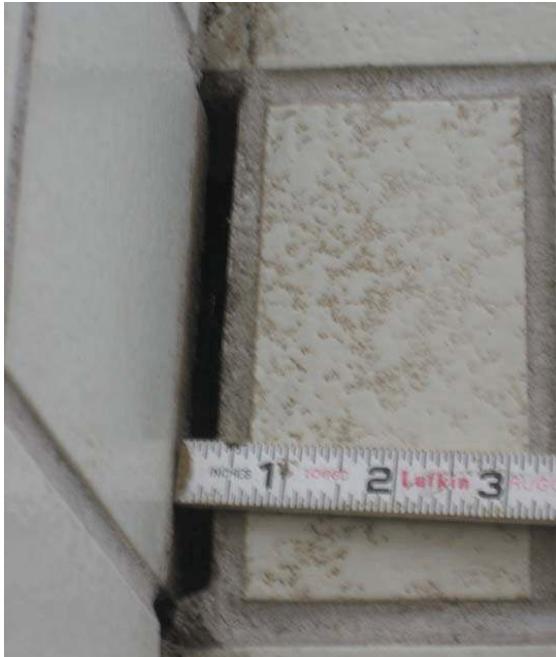
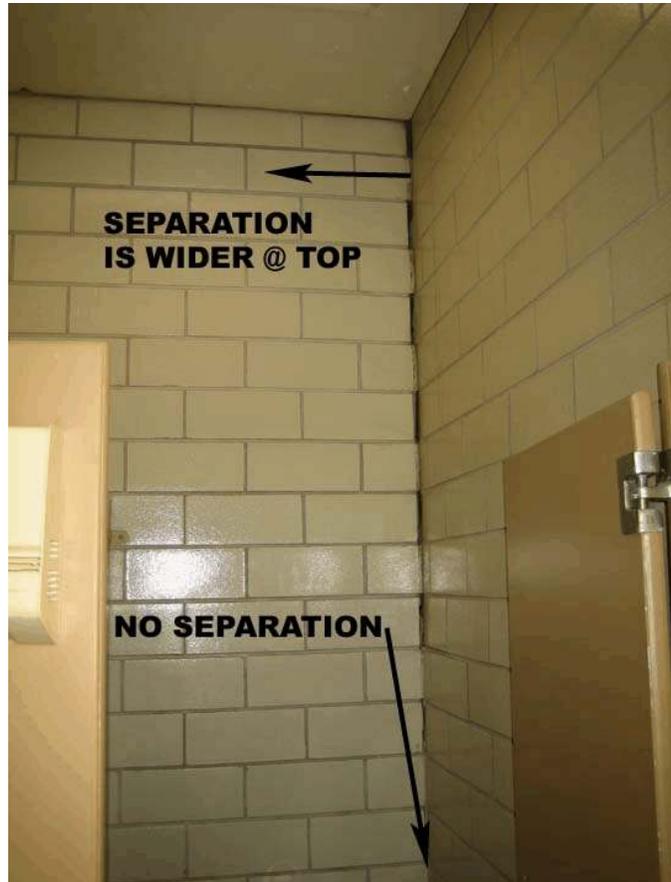
- g. Women's restroom:
 (1) The mortar joints in glazed concrete masonry walls are cracked along the exterior wall. The crack continues into the stall next to the corner.

(2) At the corner, a wide crack near the ceiling was noted. This crack diminished to nothing at the floor level.

- d. Some of the interior walls could be reconstructed to address accessibility issues and also correct the open joints.
 - e. Cracks in mortar joints in glazed concrete masonry walls need to be pointed if movement has stopped.

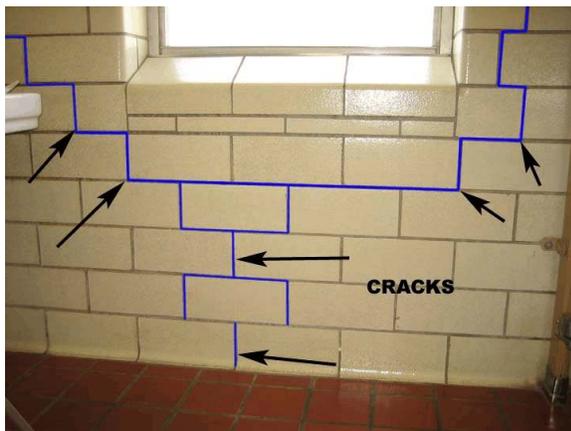
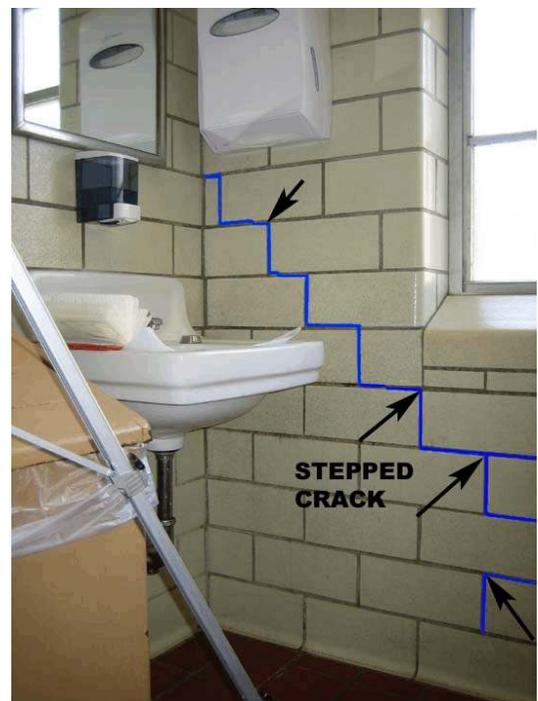
(1) The mortar joints in glazed concrete masonry walls are cracked along the exterior wall. The crack continues from the corner by the sink to the right side of the window.

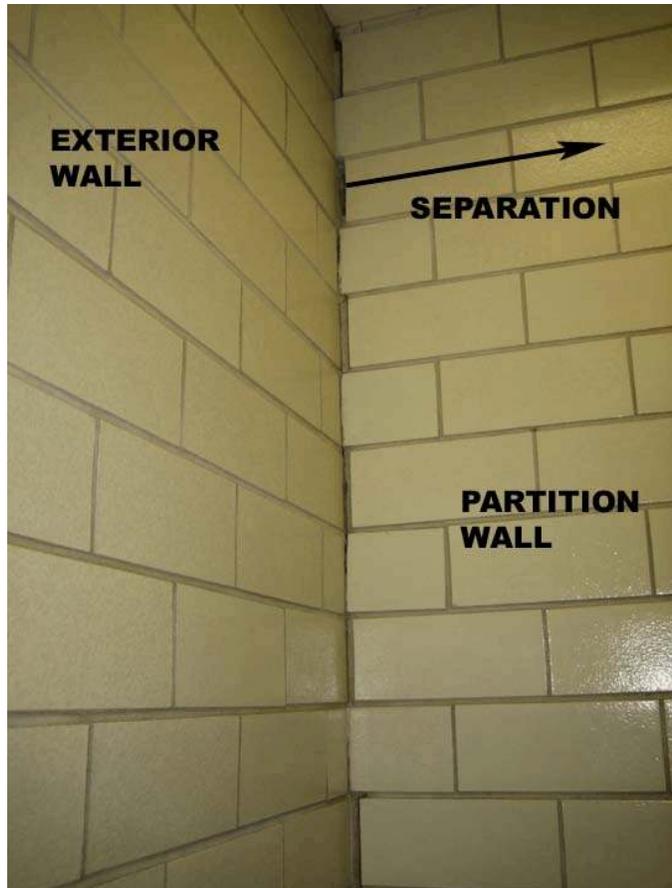
- (2) In the left stall, we noted a similar condition to the women's restroom, the interior 4" partition wall. was pulling away from the exterior wall.

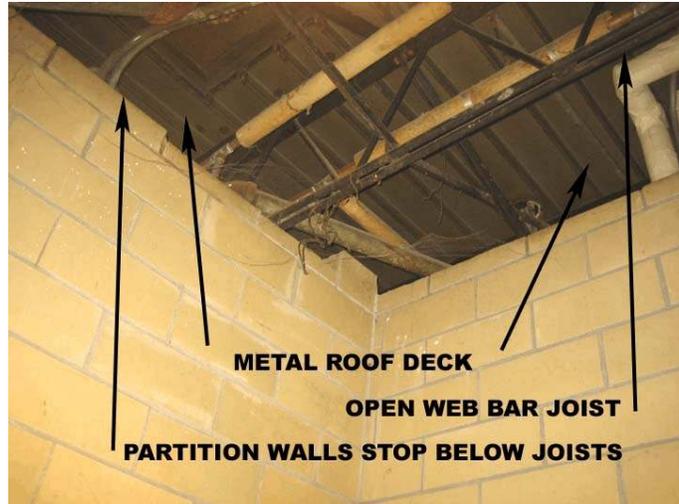
(4) From the janitor room, we were able to review a portion of the roof structure and how the tops of these partition walls were supported (or not in this case). Our observations correlated with the drawings from what was observed.

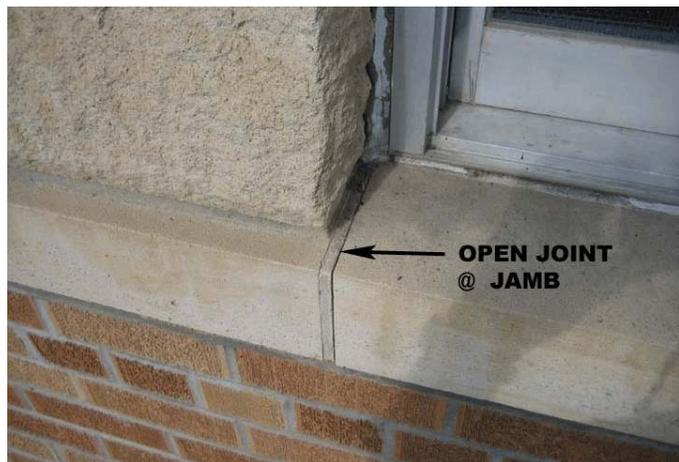
j. The stone window sill mortar joints on the exterior were reviewed and several were noted to be cracked.

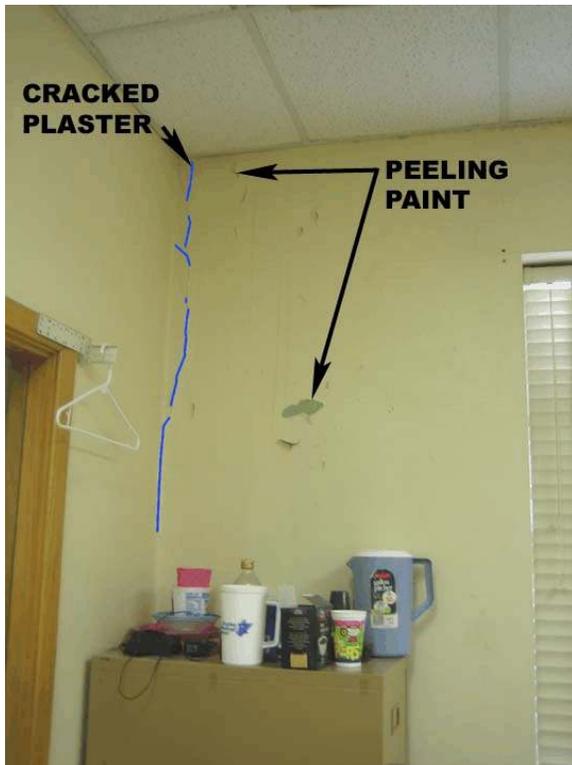
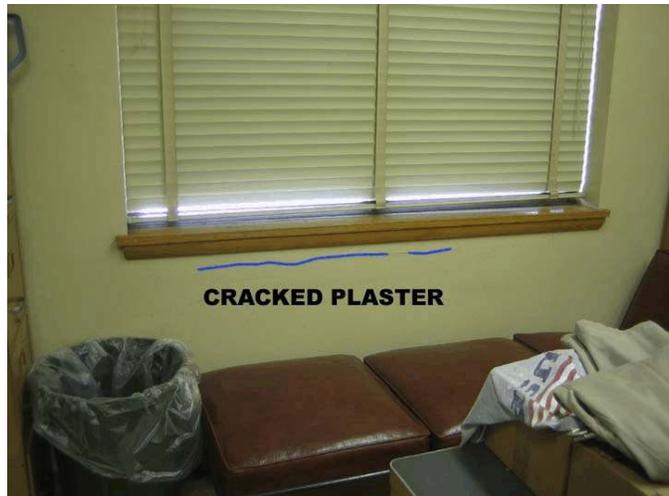
- k. Agents Office: This office was reviewed so the interior side of the exterior wall could be viewed. There was some

cracking of the plaster finish below and to the left of the window. The peeling paint noted suggests that moisture has been moving through the wall.

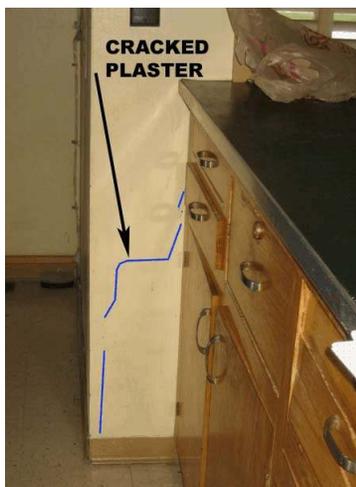
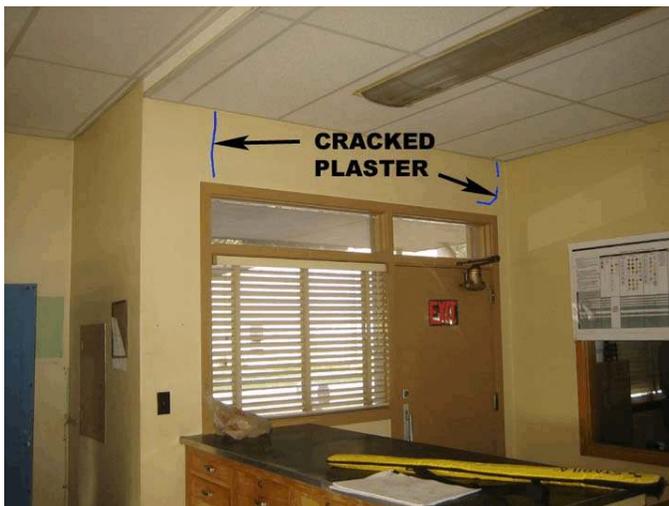
- l. Freight Office Vestibule: This vestibule area was reviewed so the interior side of the exterior wall could be viewed. There was some cracking of the plaster finish above the entrance and along the left jamb at the corner.

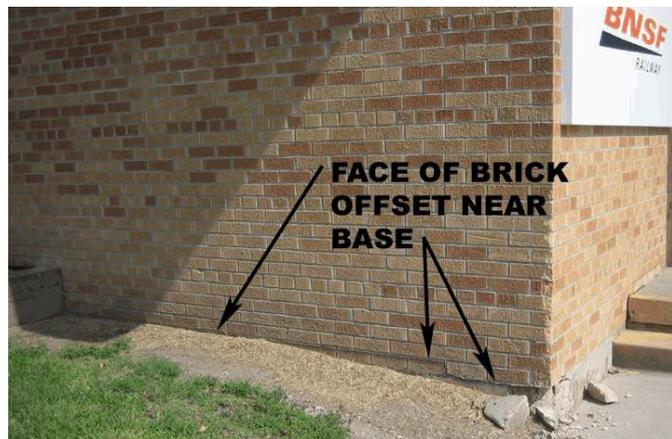
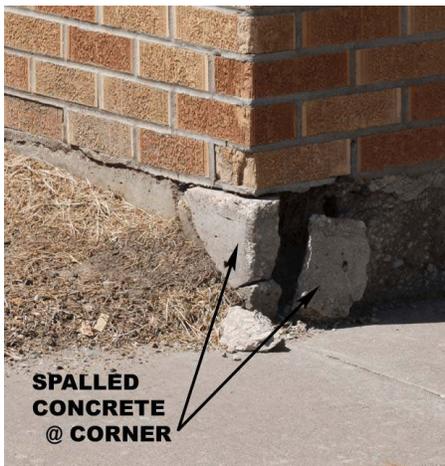
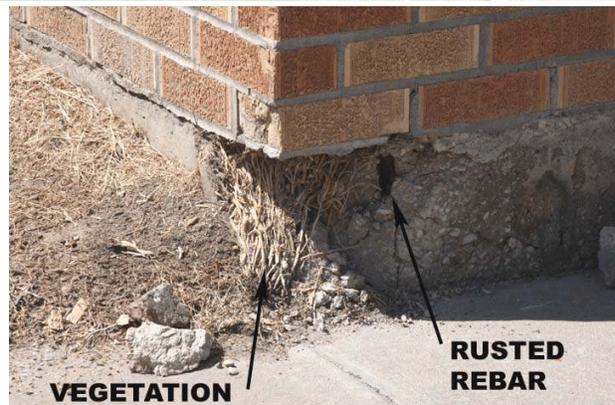
- (3) At the south corner we noted that the brick wythe was offset at the base of wall and the foundation wall was spalled at the corner.

Rusted rebar and vegetation was noted behind the spalled areas.

- b. Cracked brick at the south corner of the freight office is a shorter wall than the long one discussed at the northeast side, but brick expansion has pushed the brick off the corner some contributing to the initial cracking of the foundation at this location. This is a typical failure condition (as documented by BIA) where a brick wall set on concrete foundation wall and insufficient provision are included to control the amount of movement that occurs at the corner. With the concrete cracked, the exposed reinforcing bar is unprotected and rusts, which can cause more fracturing of the concrete. This reinforcing will need to be cleaned and coated prior to patching the concrete. Since this wall is only about 30 feet long and the moisture growth is essentially complete, It most likely that an acceptable solution is to just repair this area. To be more certain of the repairs needed here, a crack monitor should be installed and readings recorded every two weeks for a year or until such time as the movement is better understood. If the movement is excessive then a movement joint will need to be cut through the entire wall prior to repairing the base.

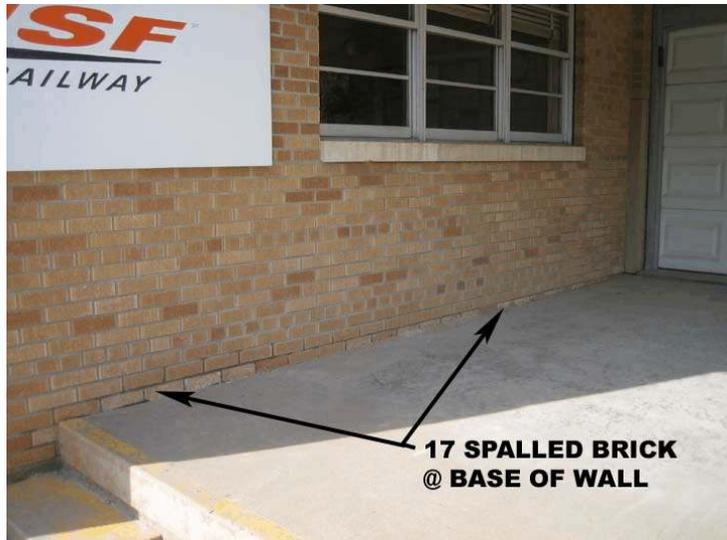
- (4) Southeast wall: This wall forms the end the building at the freight office as well as the side wall at the dock. We noted 17 spalled brick along the base of this wall.

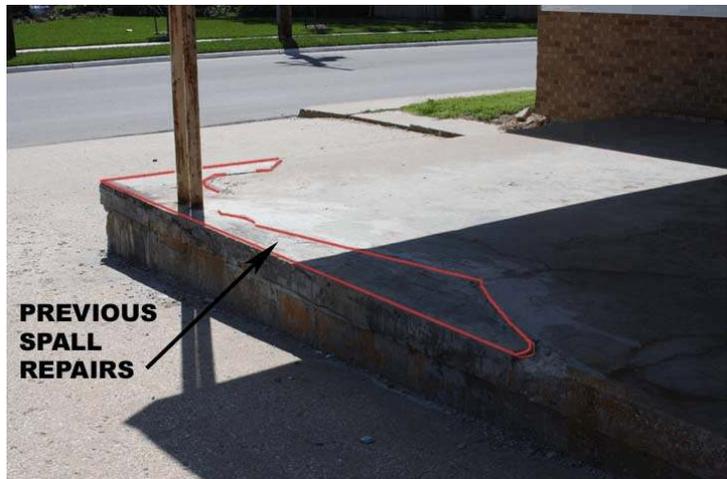
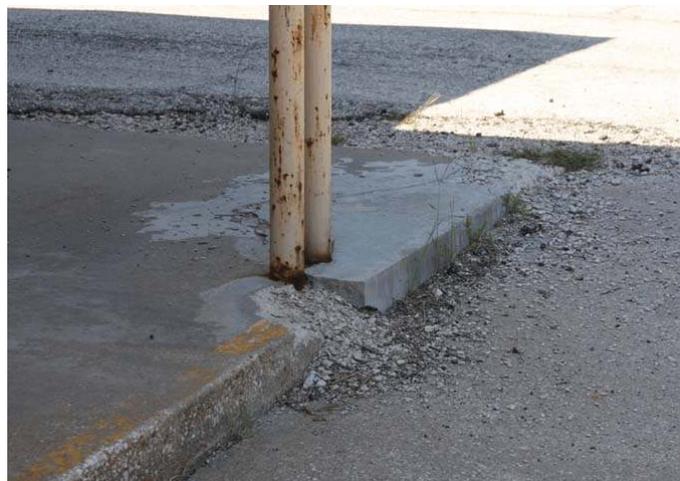
- (5) Canopy: There is a canopy at the southeast end of this portion of the building. The canopy columns are the same type as previously discussed though not quite as rusted. The cementitious concrete walks that embed the column bases have been repaired before and have started to failed again in some spots.

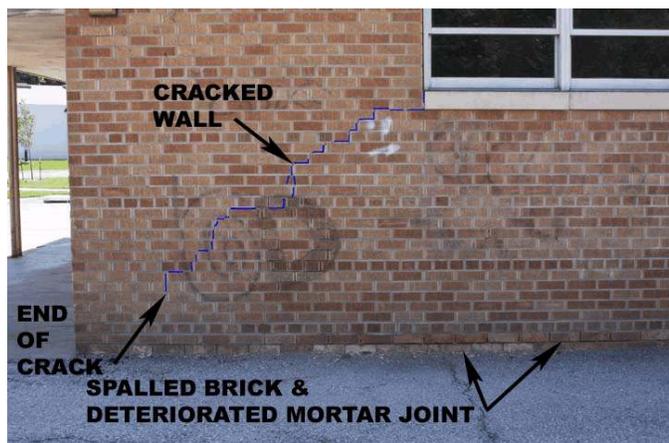
- (2) Near the east corner (baggage room) we noted some cracking of the wall. The crack steps down from the left jamb of the window. The crack is largest at the window sill and stops before the base of wall. There is also spalled brick and deteriorated mortar joints along the base of wall at this location.

2. Cracked brick:
 - a. Cracked brick at the east corner and the jamb next to the overhead door appears to be directly related to the brick expansion along the continuous length of wall. Brick expands for up to 40 years after begin fired in a kiln as the unit absorbs moisture. The Brick Industry Association (BIA)

suggests a formula for this moisture expansion that when used predicts the panel would expand 0.4" or about 3/16" each way from the center of the panel. Brick also expands thermally similar to all materials. BIA's formula for this expansion, based on 100 degree temperature change, predicts a 0.3" total expansion of about 5/32" each way from the center of the panel. At this section, the top of wall expands (moves horizontally) more than the portion below the opening lintels. This movement cracks the masonry producing a rotational type of crack that is wide on one side as the masonry is rotated. To control this masonry movement, an expansion movement joint needs to be installed to reduce the size of the panel and thus the magnitude of the expansion. Since most of the moisture expansion is now complete only one joint is recommended. This joint should be installed between the man door to the baggage room and the file room window. The movement joint will need to be cut through the entire wall thickness and caulked. The cracks will then need to be repaired by replacing cracked brick and pointing the cracked joints. After pointing the joints the joints should also be grouted to further bond the wall together.

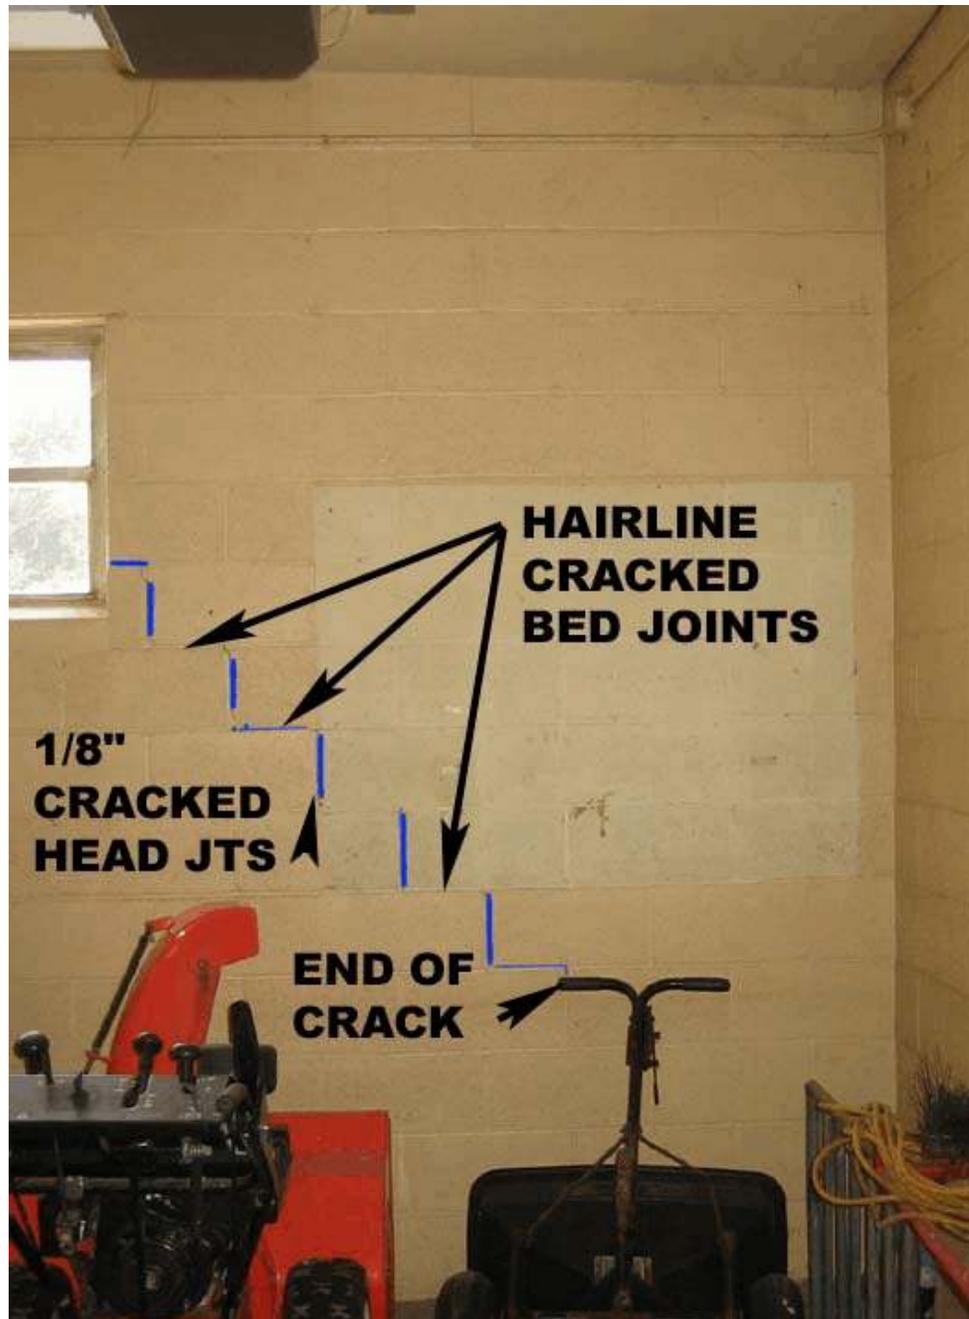
- (3) Inside of this portion of the building there is a similar crack pattern in the concrete masonry wall. There are hairline cracks in the bed joints and about 1/8" wide cracks in the head joints. The crack also stops before the base of wall.

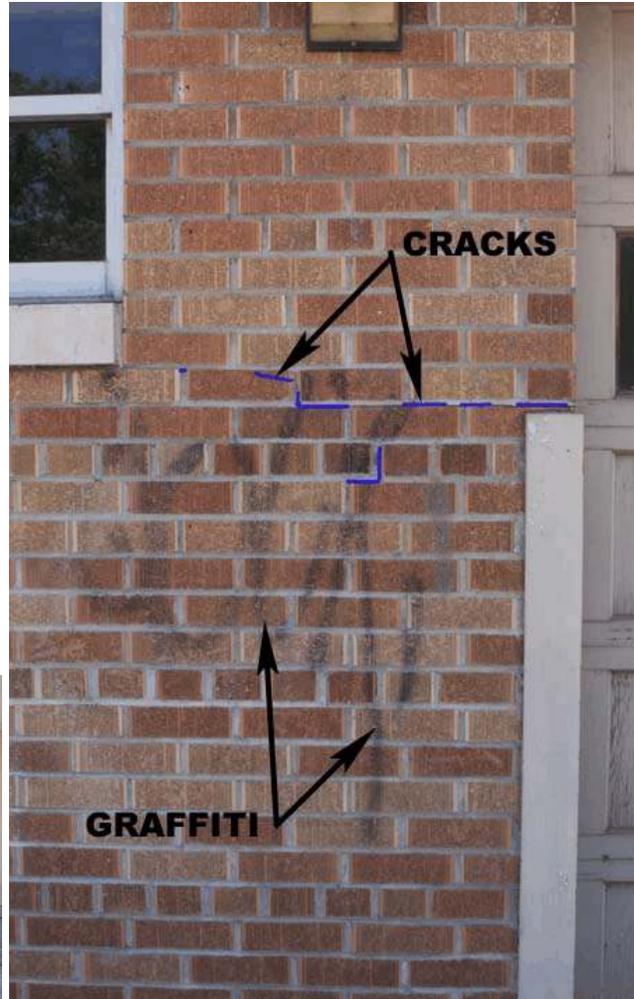
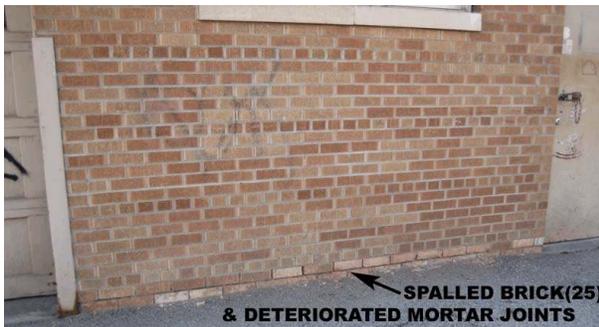
- (4) At the other side of the baggage window (at the overhead door) the brick pier is cracked horizontally (widest at the door jamb).
- (5) Graffiti was noted on the brick at several locations.
- (6) Right of the overhead door is a brick panel that has spalled brick and deteriorated mortar joint at the base of wall.

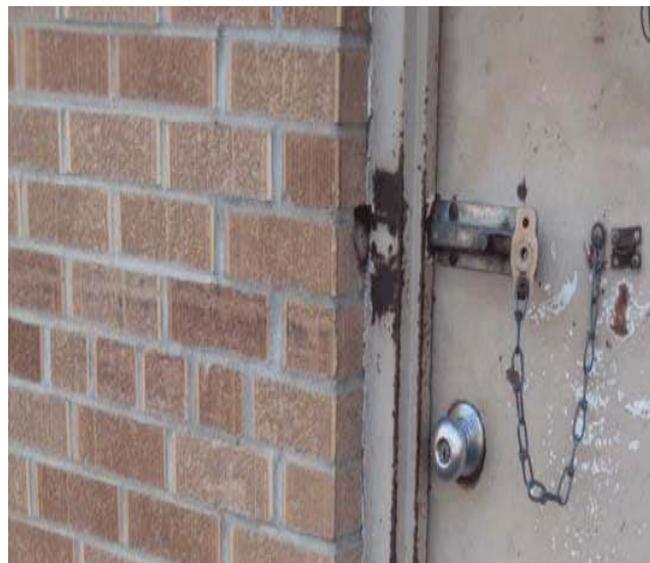
- (7) At the left jamb of the man door a brick has been chipped to make room for a hasp lock.

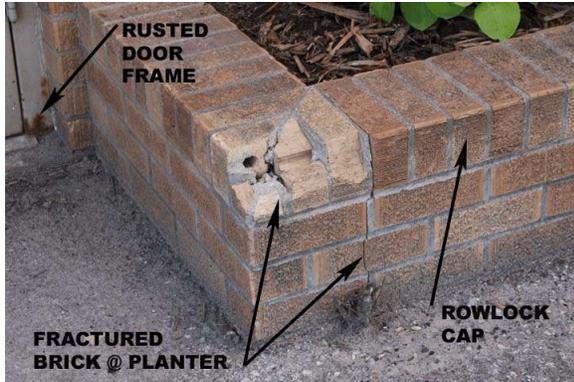
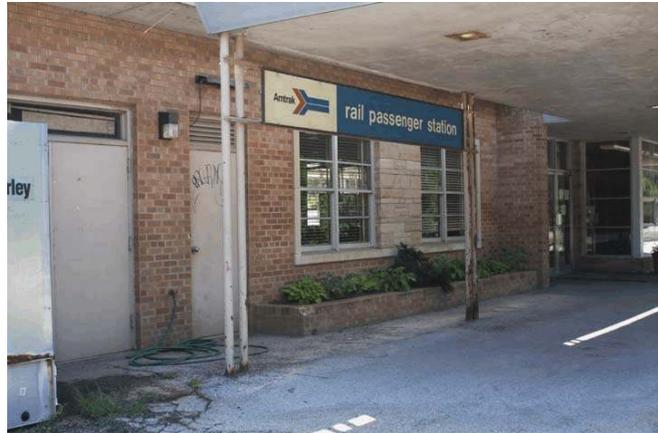
- (8) At the ticket office there is a brick planting bed wall as shown on the

drawings. The corner of the planting bed wall is cracked and there are several fractured bricks in the rowlock cap.

- c. Cracked and fractured brick at the various areas appear to be a result of impact and possible due to rust expansion at embedded steel. The impact areas (sills and planter wall corners) should be repaired by replacing the damaged units with new or salvaged brick. The damaged areas due to rust expansion need to be opened up, the steel cleaned and painted, and brick relaid around the steel with a 1/2" gap to allow for further expansion.

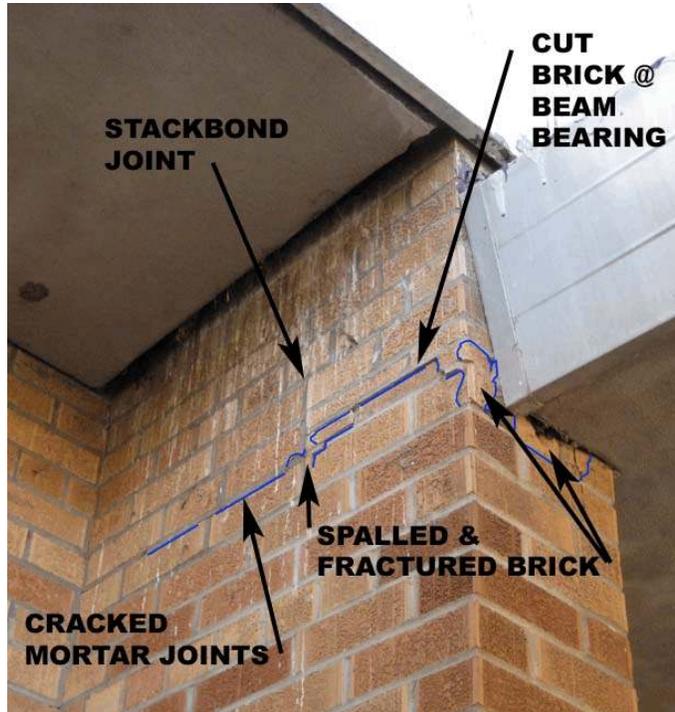
- (10) At the right end of this long wall there is a wing wall at the vestibule entrance (reference page 7). The brick wall is fractured at the beam bearing elevation. Closer examination reveals cut brick to form the beam pocket.

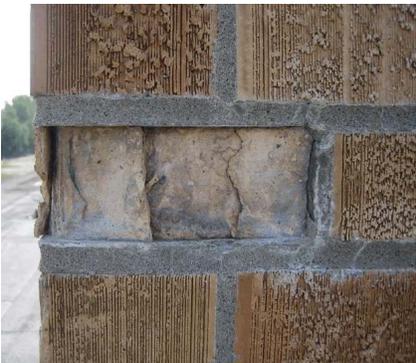
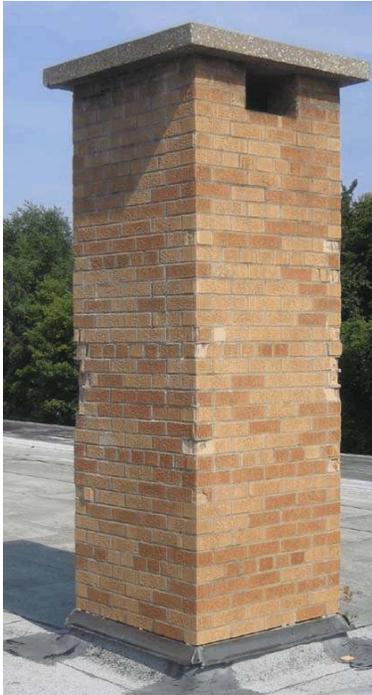
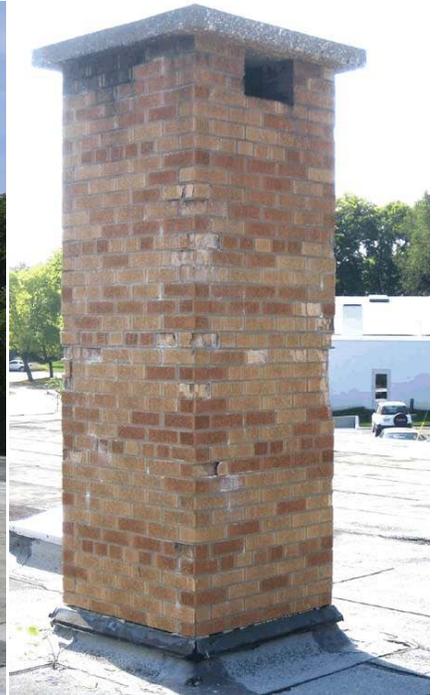
3. Masonry above roof:
a. The chimney extends 37 courses above the roof base flashing at the south corner of the boiler room. There are 16 bricks per course around the perimeter of this chimney. About 10 percent of the units are deteriorated and faces are spalled.

- d. Replacement units: Finding replacement brick has not been investigated. If it is determined that acceptable units are not available, one solution might be to salvage units from the chimney and use a new close-match unit to reconstruct the chimney. Its remote location makes finding a good match less of a concern.
