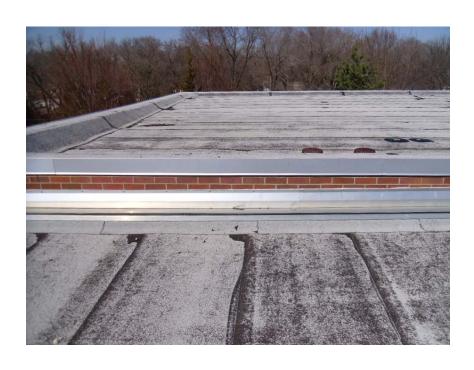
- Current roofing system for the Rec Center is Modified Bitumen Mineral cap. The mineral has worn off leaving the membrane exposed to harmful UV rays.
- Unprotected membrane will eventually start to crack and separate from the scrim.

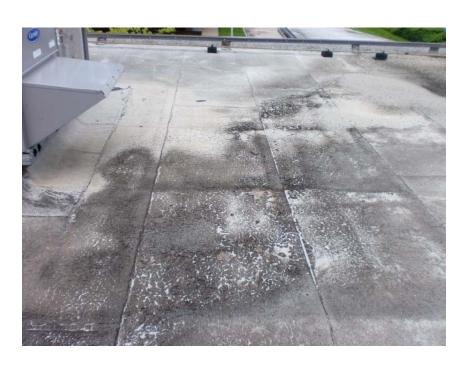
- This photo shows the later stages of damage from UV rays (this is at a different facility). The asphalt is starting to flake off the membrane leaving only the Scrim left to protect the building
- At this point water will penetrate the insulation causing R value to be lost.

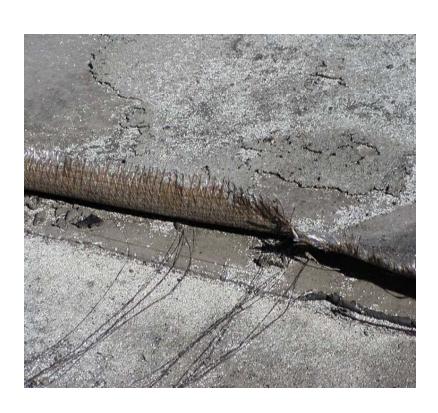
- UV rays has destroyed this roofing system
- The asphalt has completely failed on this roof. The scrim is separating from the first roofing ply. (not this facility)

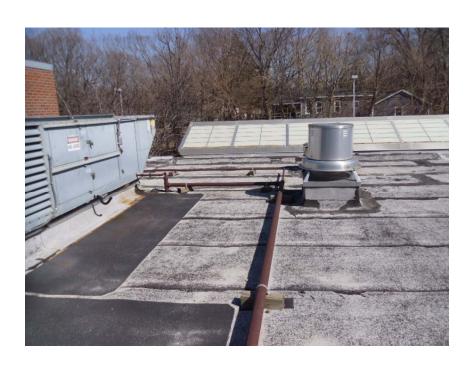
- Gas lines move during normal operation and weather causing current wood pipe supports to rub into the membrane causing damage.
- Miro Pipe Supports will be added under the gas line. These supports will all the pipe to move side to side while the base will remain stable and not hurt the membrane.
- This gas line will be coated with a rust prohibitive coating to protect it from further damage.

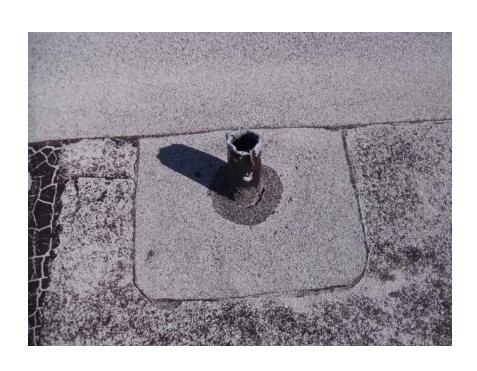
Flashing detail is failing around all pipe vents. Neoprene Pipe boots will be installed then stripped in under the membrane which will then be coated with White Knight Urethane reflective coating.

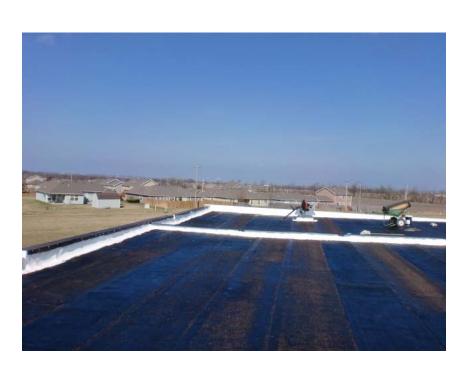
- This photo is from a facility that American Roofing did last summer for The Garland Company.
- The roof was swept with a power sweeper removing the remainder of the mineral and other loose impediments and then primed with an asphaltic primer to add oils back into the membrane before the flood and gravel coating was installed. Base flashings were also coated with a white coating to also give added protection to the membrane flashings.
