Architectural Condition Survey

Santa Fe Railroad / AMTRAK Depot, Lawrence. Kansas

for the City of Lawrence, 2002

Survey: Lindsay Marion (student)

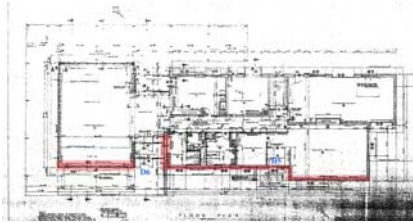
<p>Notes:</p> <ul style="list-style-type: none"> - Left click on a picture or plan to view a larger version.
<p>Southwest Walls</p>	<ul style="list-style-type: none"> - Brick on Southwest side of Freight Office shows no visible spalling, some deterioration and discoloration where the wood planter intersects the wall (3ft. from left corner of office and 10ft. from the right corner). (P46) - Northwest wall of Freight Office shows spalling (<5%). (P47) - Wall from Door 5 to Door 6 shows spalling (<5%). - Stone wall to right of Door 6 has two spots of tar leakage (3ft. from left and 1.5ft. from right, both at top) and one spot of discoloration (possibly from water) 6ft. from left at top. (P48) Crack in the wall beginning from 2ft. up and 2ft. to the right of the bottom left corner of the wall extends upward and to the right at 45° (6.5ft. length). (P49) - Southwest wall of waiting room shows 30% spalling. (P50) - Metal above the bank of windows in waiting room shows corrosion (<5%). (P51) 	<div data-bbox="1213 537 1522 769">

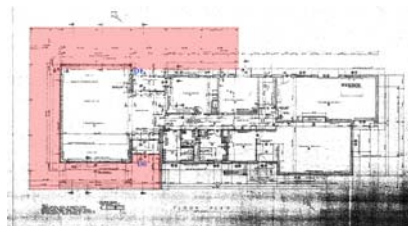
- Evidence of water damage on underside of canopy over platform. (P52)
- Some cracking on underside of canopy near Door 1. (P52)
- Glass missing from the lighting fixtures (90%).

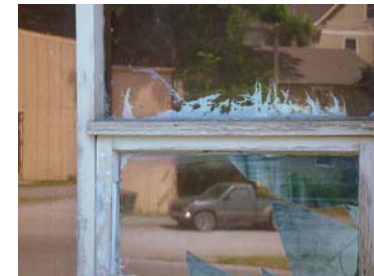
P84

- Window 1 – minor gaps between mortar and stone above and below window. Cracked glass in two panes.
- Window 2 – Wooden frame around window has peeling paint, most notably on the lower half of the window. (P84) Glass is intact, but the tinting application is peeling off in several places (5% of total glass area).
- Window 3 – frame good, cracked glass in one pane.
- Window 4 – cracked glass in one pane
- Window 5 –cracked glass in two panes.
- Window 6 (main windows on Southwest side of waiting room) - Frame in good condition, with no deterioration of brick sill. Cracked glass in one pane.
