785 Maple, 5/01/12

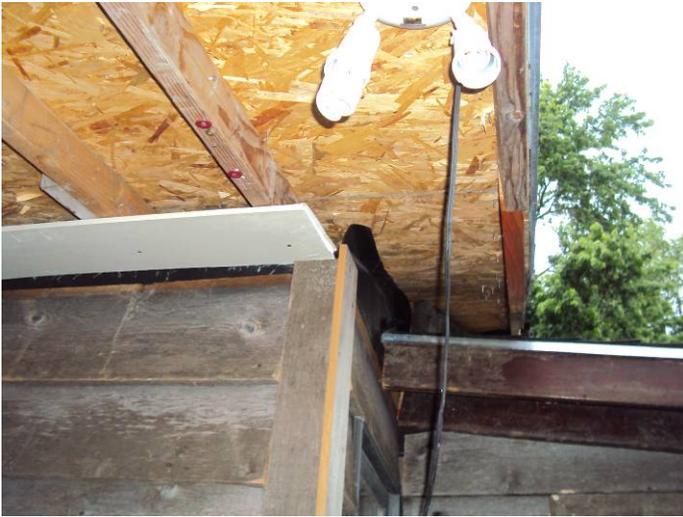
Front porch - lighting

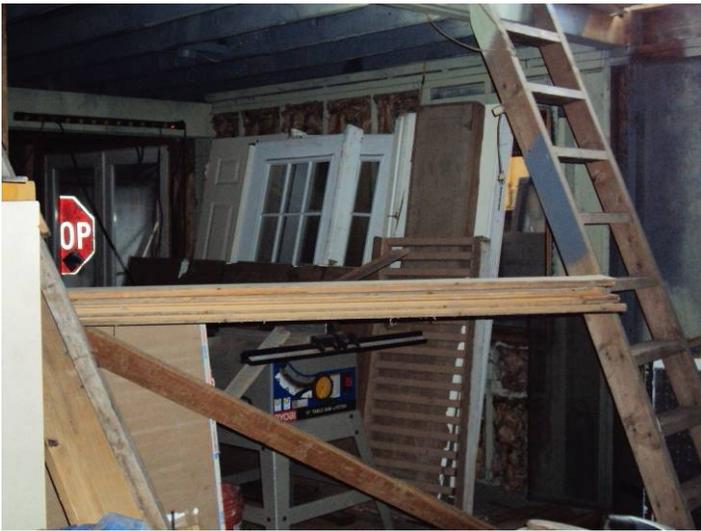
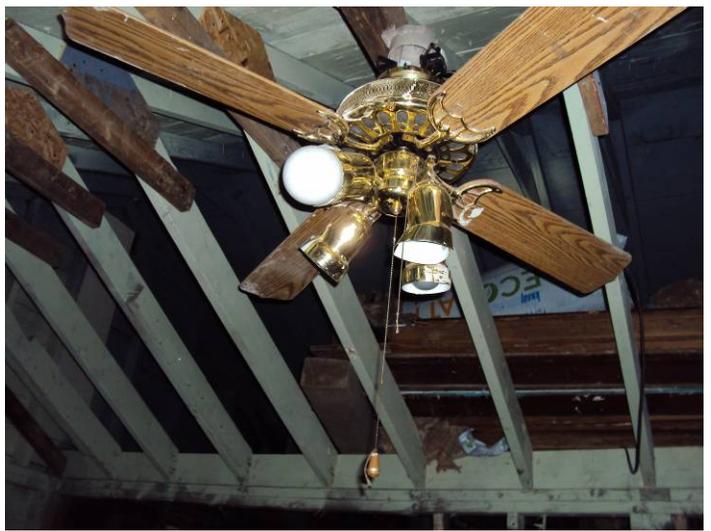
(power strip – with power – mounted above doorway)

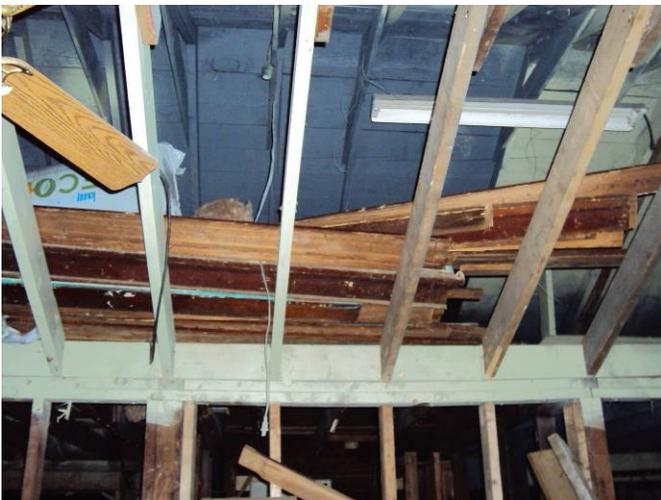
Open stairwell to basement (front room)

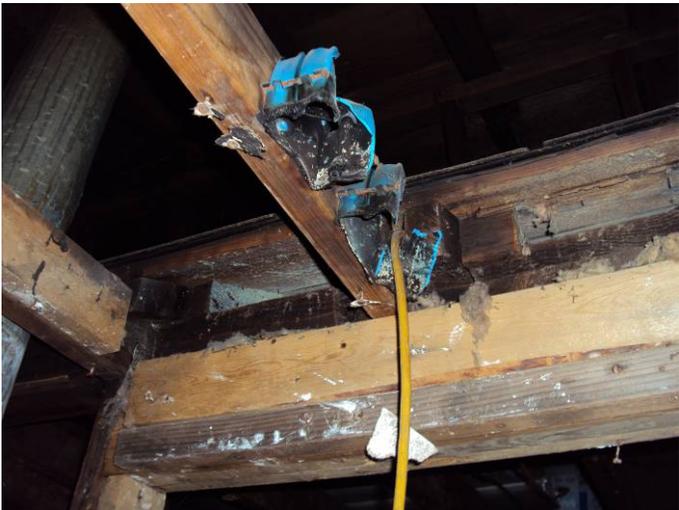
Fire damaged electrical boxes in ceiling (1st floor)

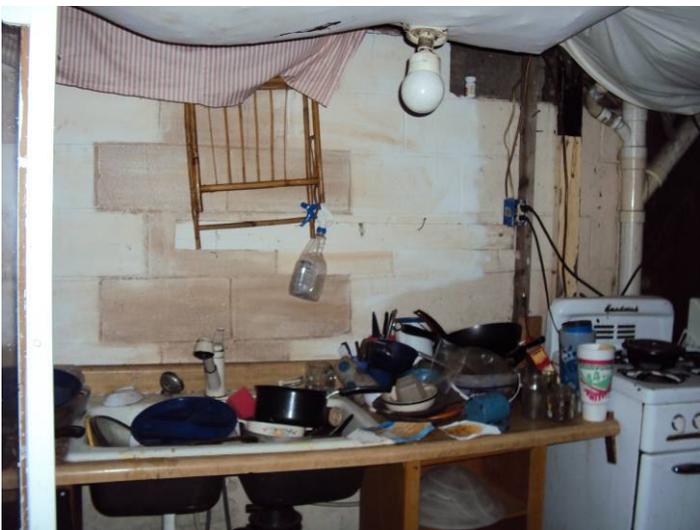
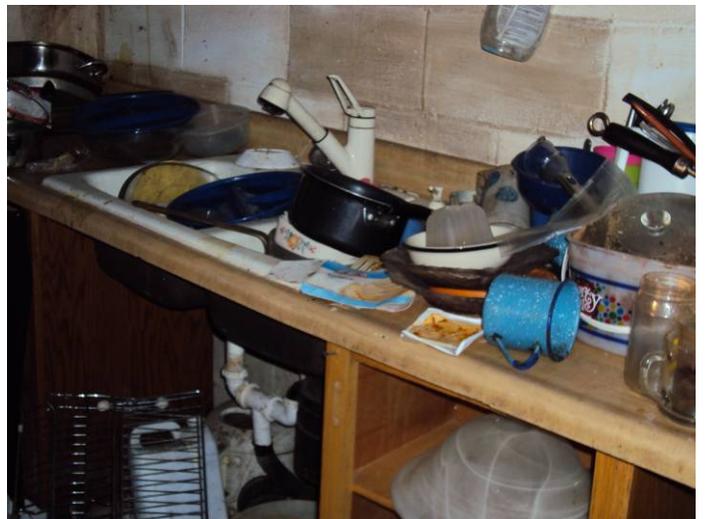
Make-shift kitchen area in basement

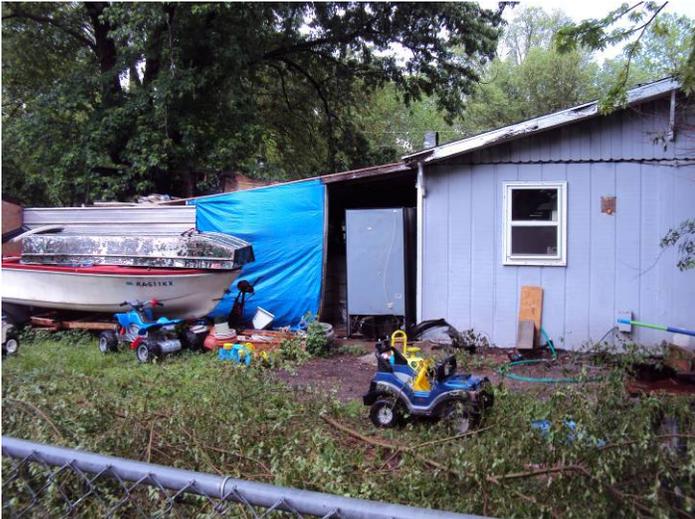
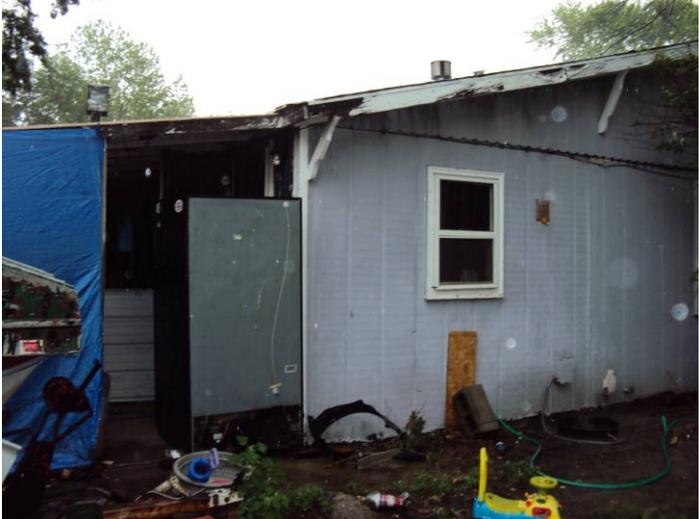
Refrigerator – plugged in and exposed to weather
