929 Holiday Drive, 8/18/11

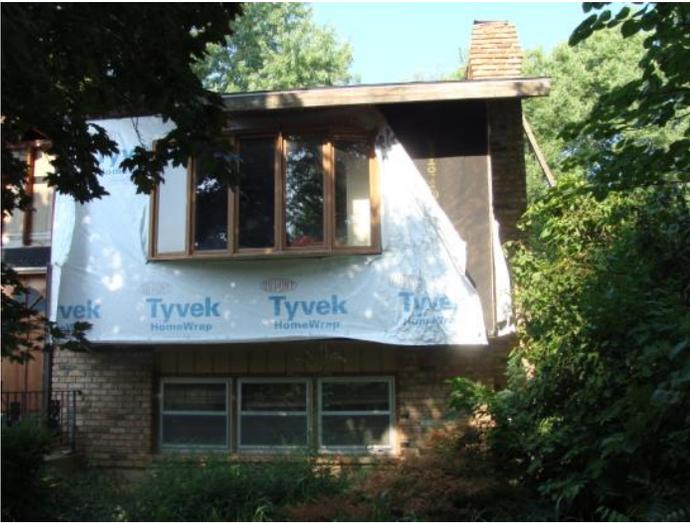
Front of house, window frame rotted

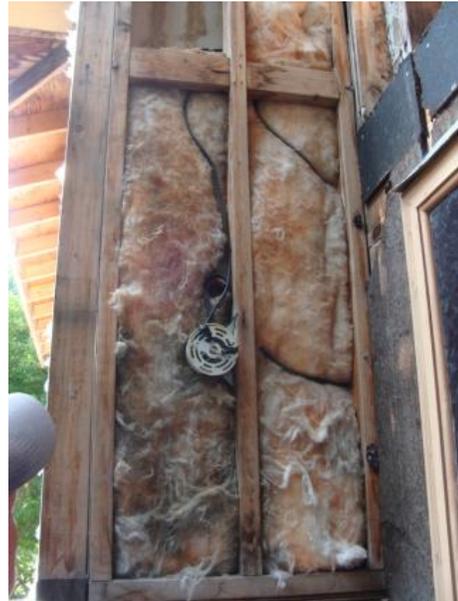
Front entry – exposed wiring and insulation:

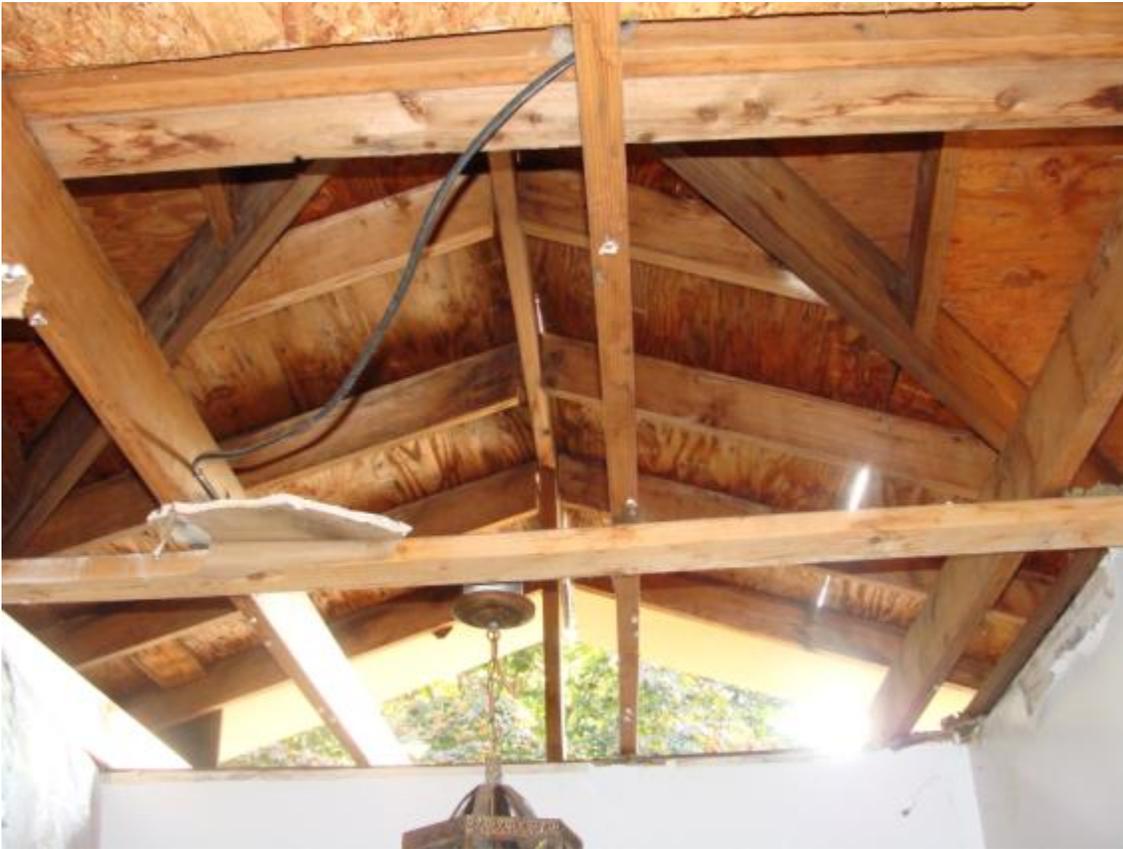
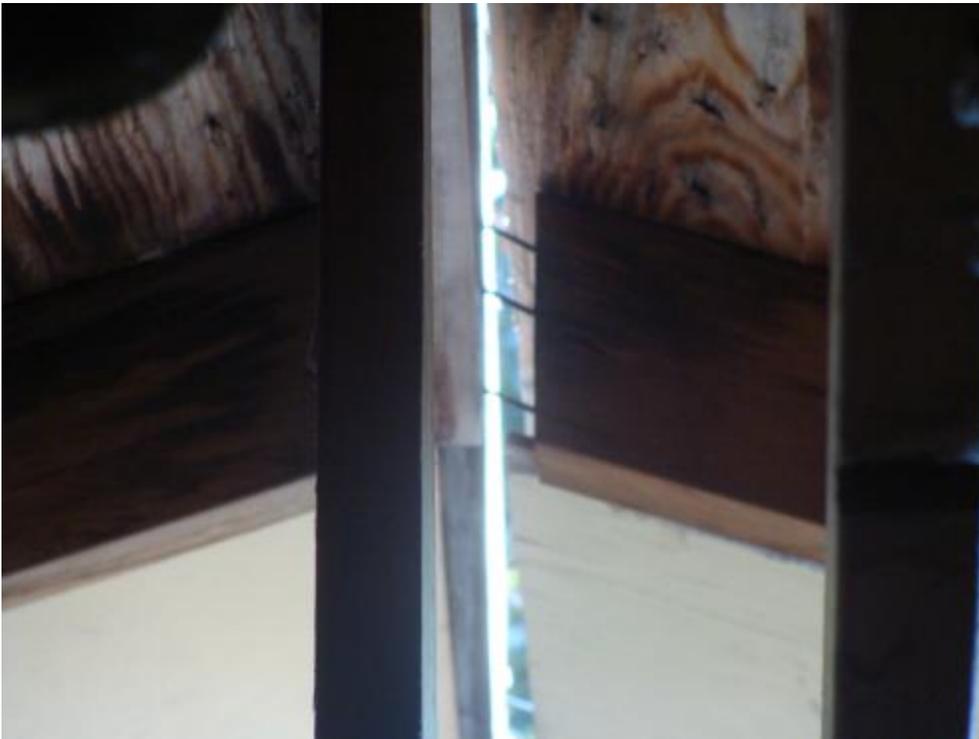
Front porch roof – open and rafters are pulling away from ridge board:

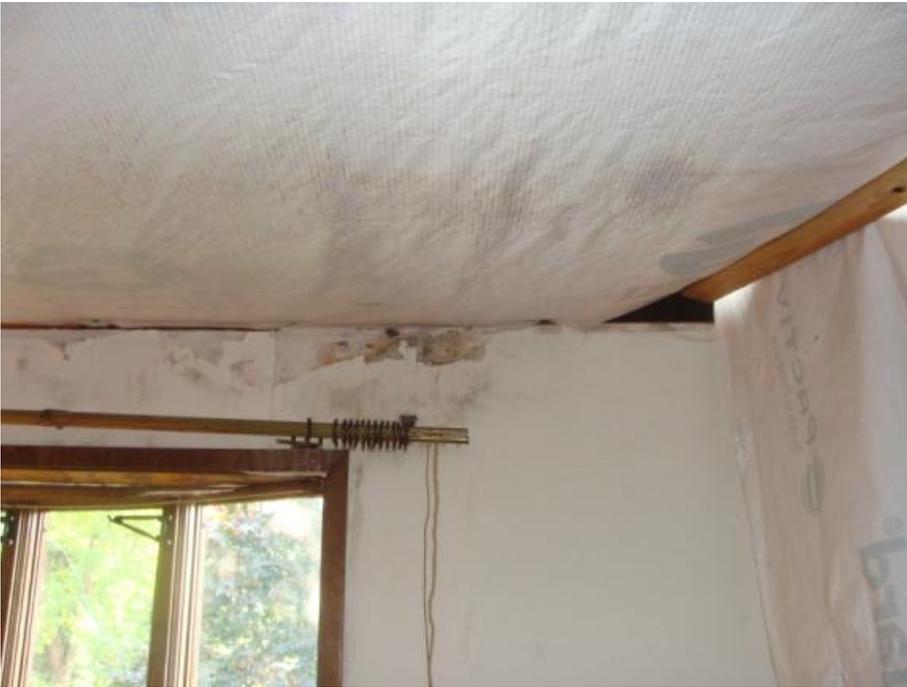
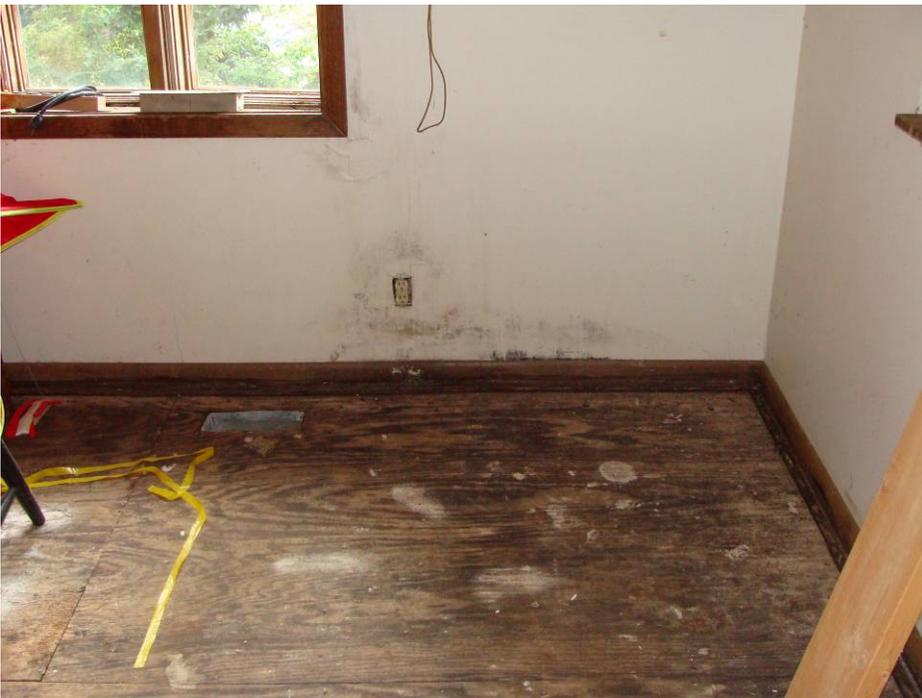
Living room – plastic wrap for ceiling, mold, window frame rotted:

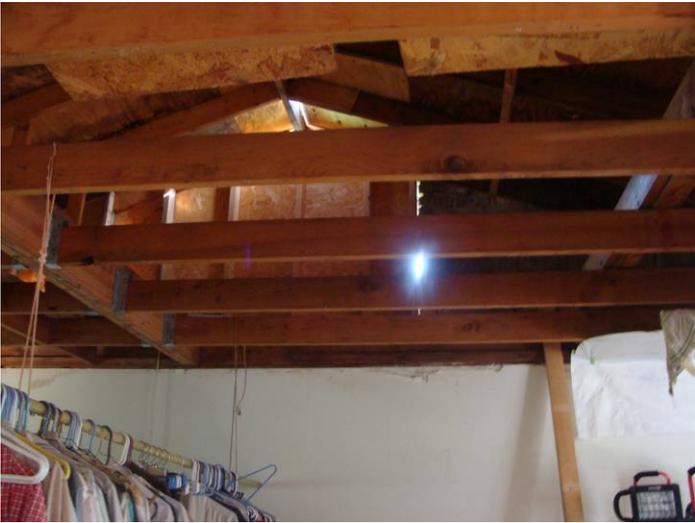
Living room – looking north – exterior wall open

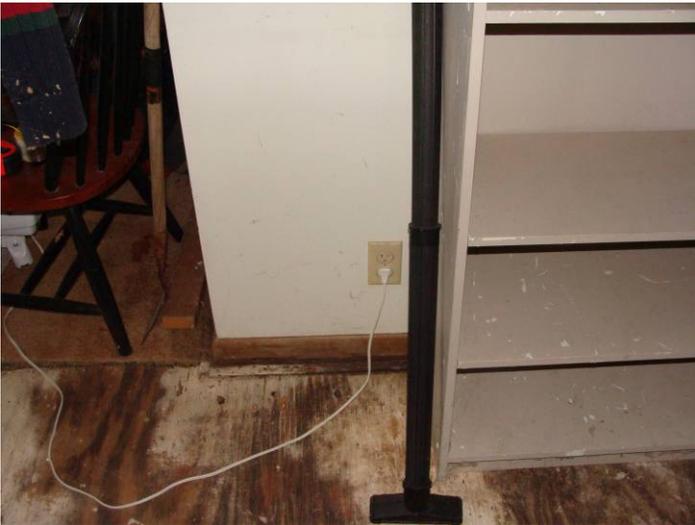
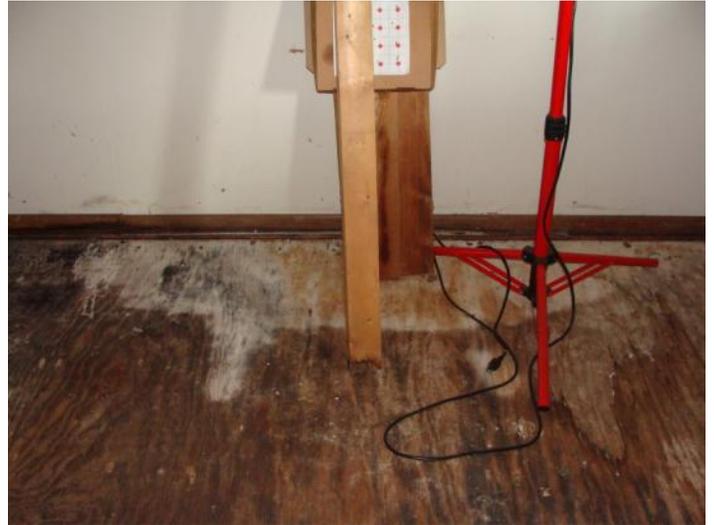
Living room – floor is saturated/damp:

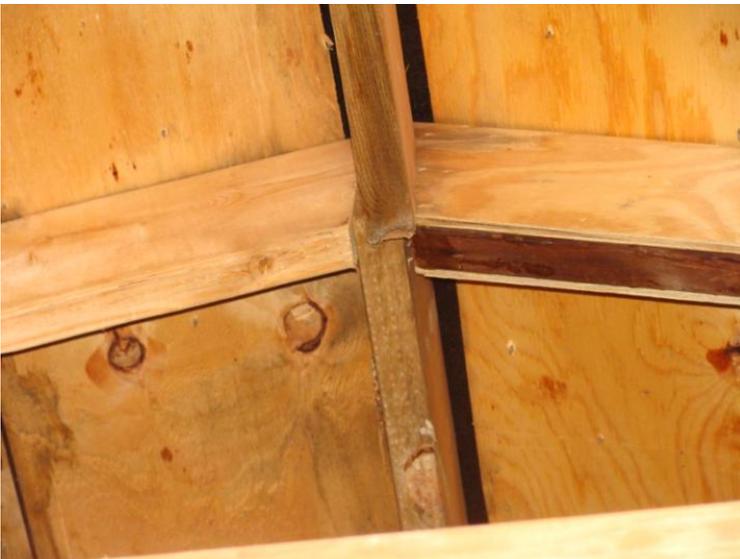
Roof structure – above living room, ridge board shifted:

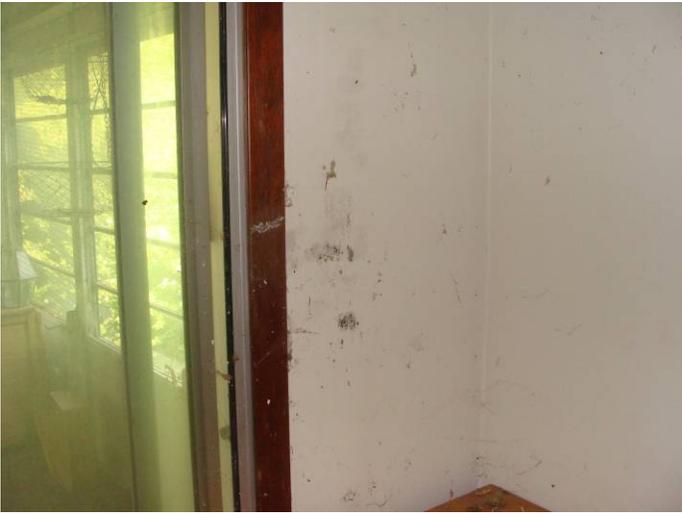
Dining room wall – mold

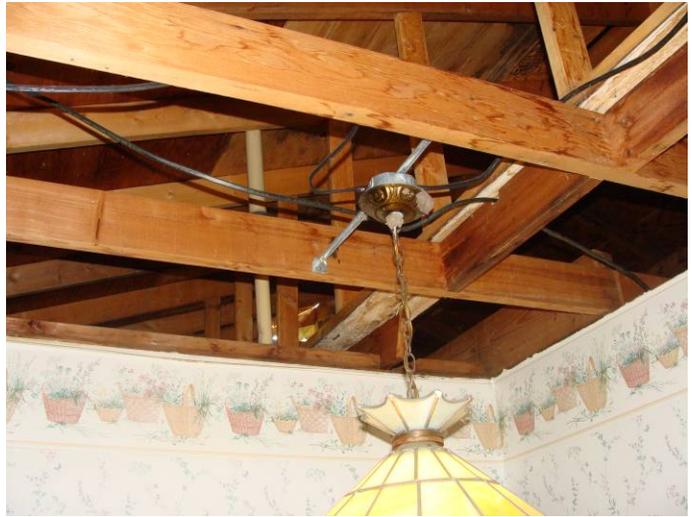
Dining room – light fixture, water stains on joists

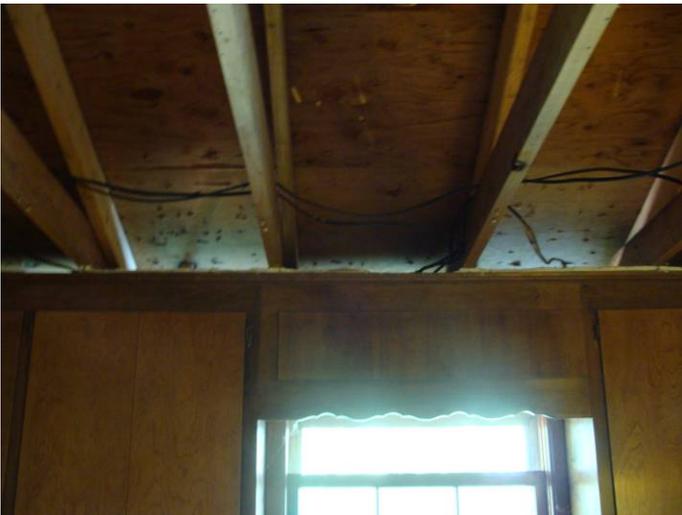
Kitchen ceiling, damaged electrical wiring

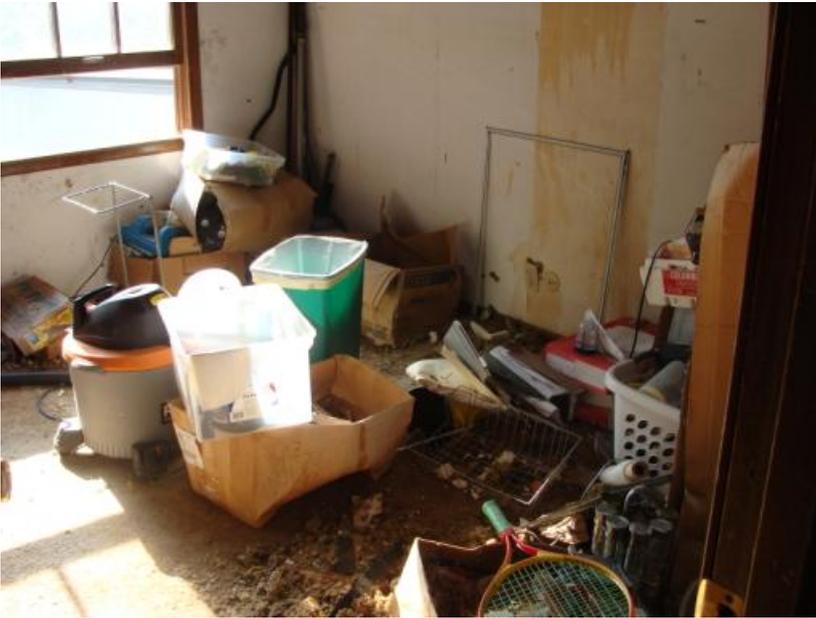
Bedroom (middle/east side), water damage

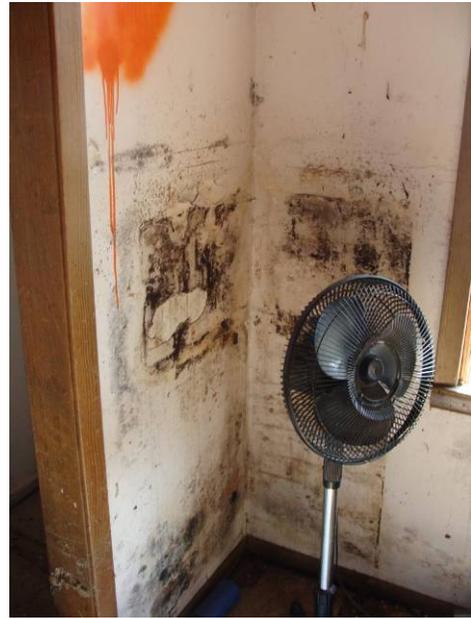
mold

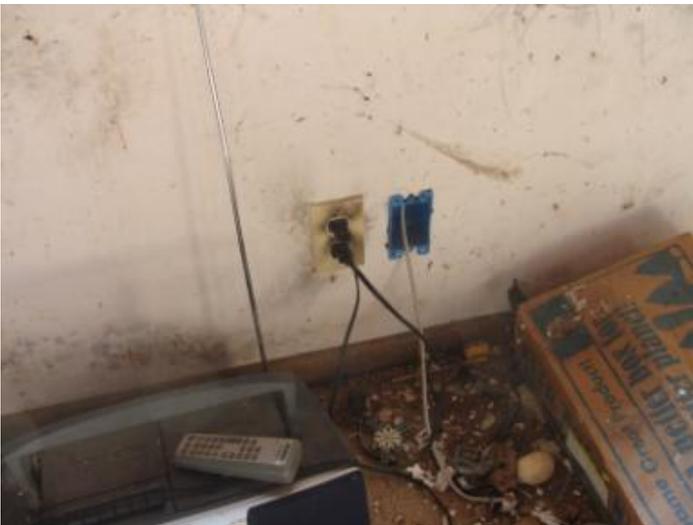
Electrical outlet – scorched:

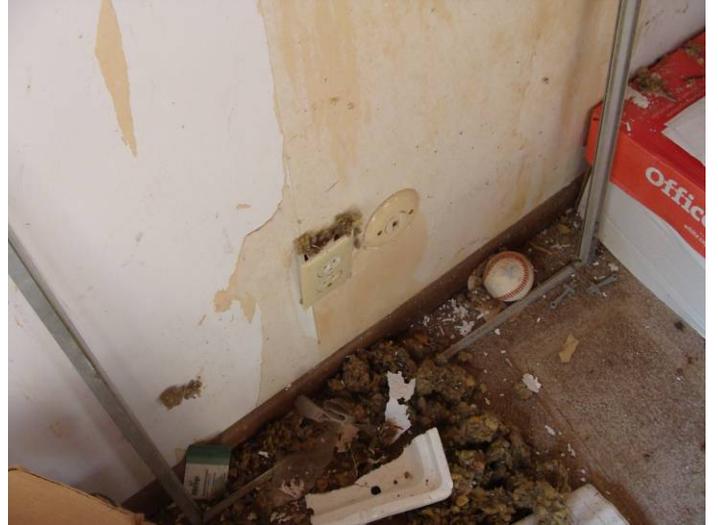
Electrical outlet – unsecured, insulation

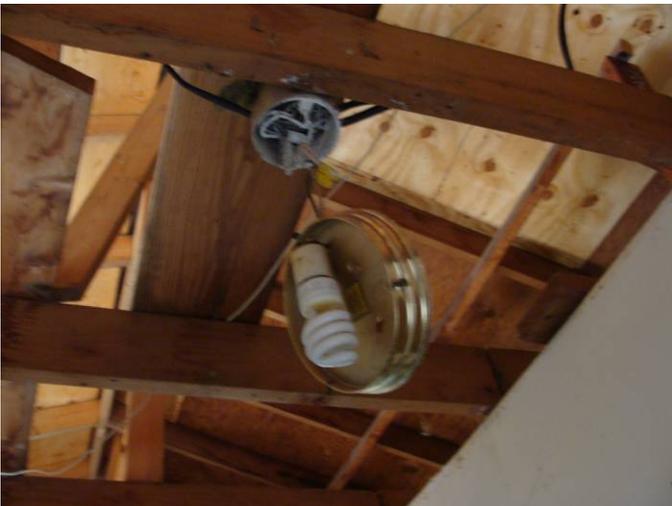
Unsecured light fixture - hallway

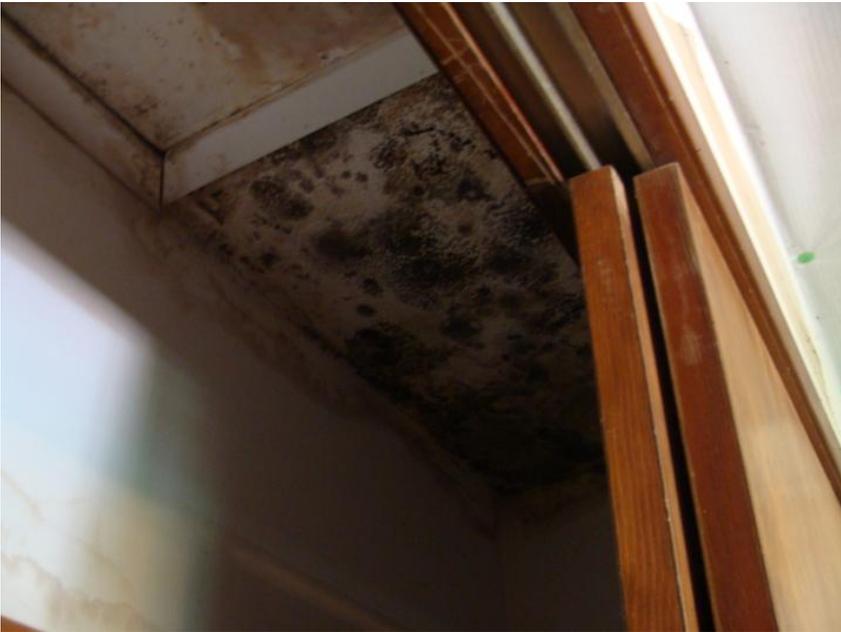
Master bedroom closet - Ceiling — mold:

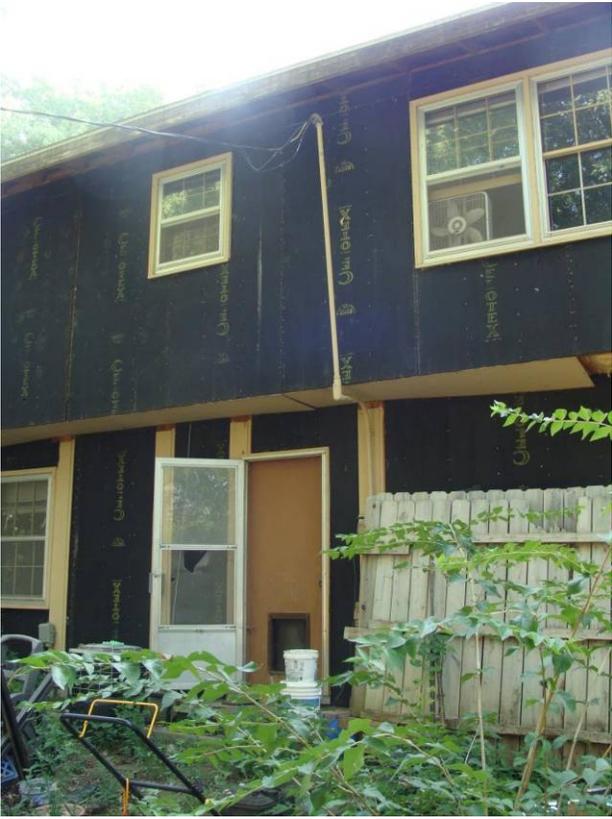
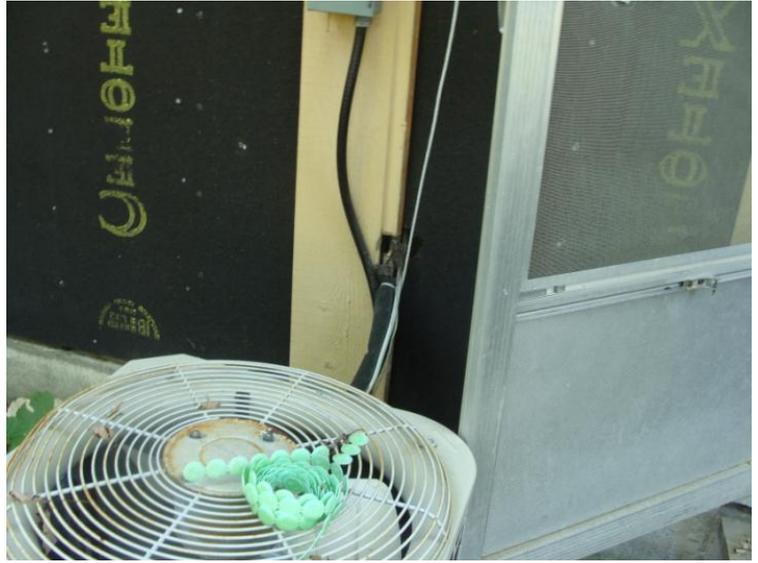
Rear of house, electrical service unsecured:

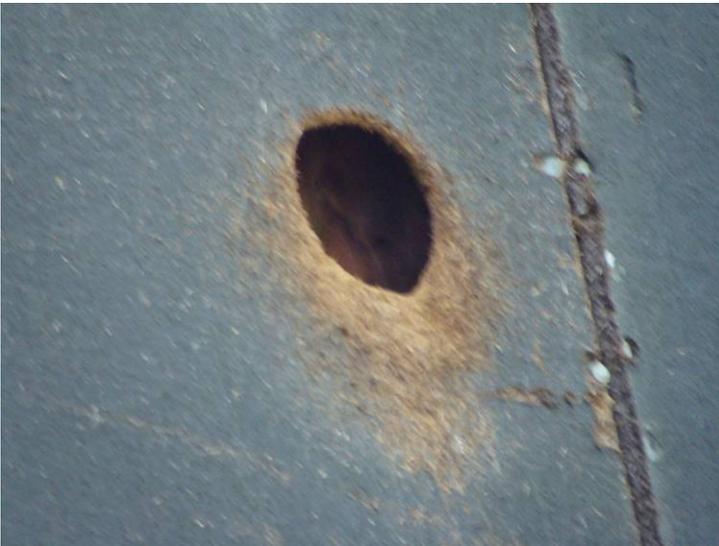
Hole – back exterior wall:
