# Memorandum

## City of Lawrence

**RE:** Oread water tank inspection results

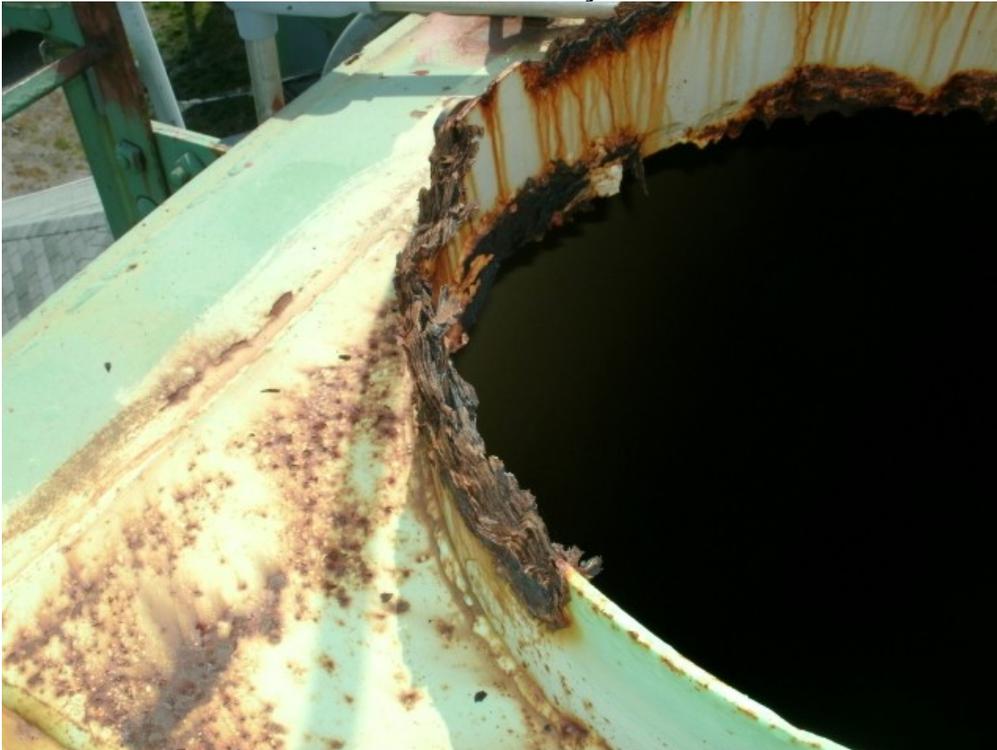
The roof hatch on the north tank shows heavy corrosion.

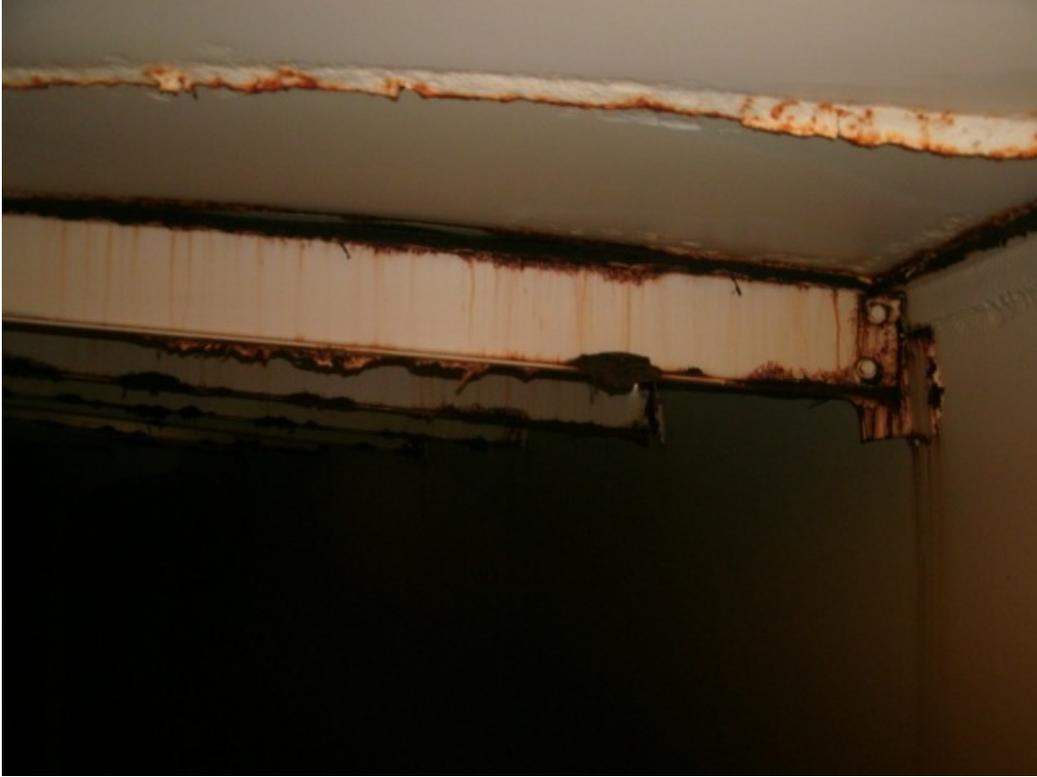
Roof beams show significant deterioration of the metal and coating, as well as corrosion.

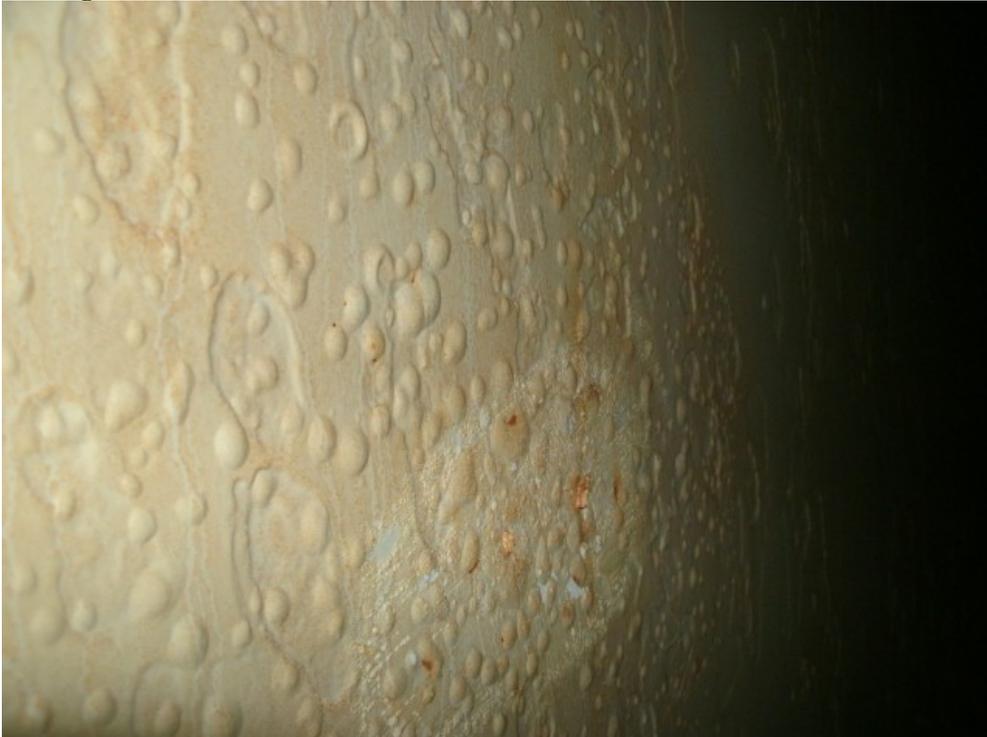
Coatings on the interior walls show severe blistering caused by moisture under the coating.

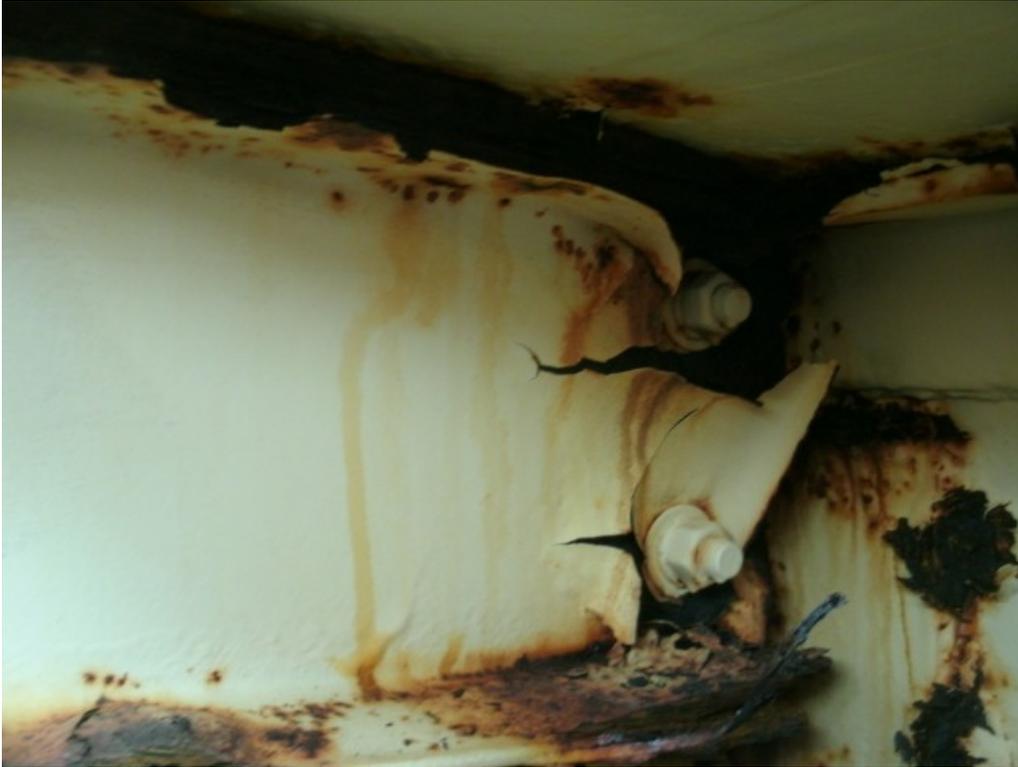
Severe corrosion and coating failure as seen on the below beam as it attaches to the roof and sidewall.

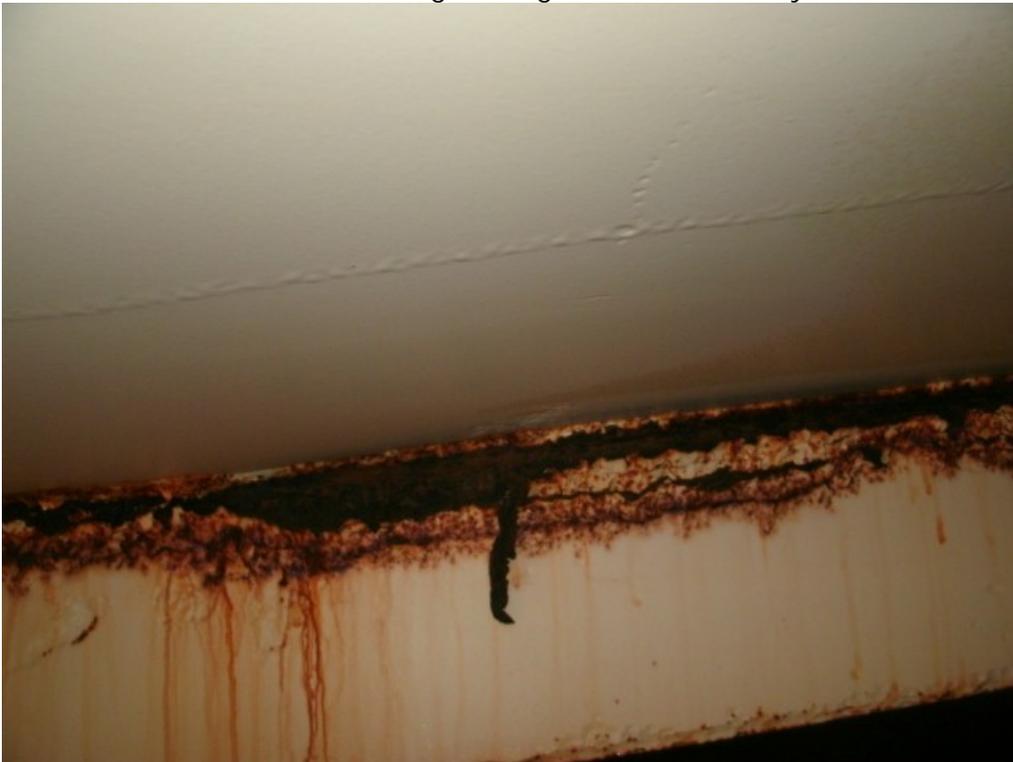
Corrosion has deteriorated coating causing metal loss of many of the roof beams.

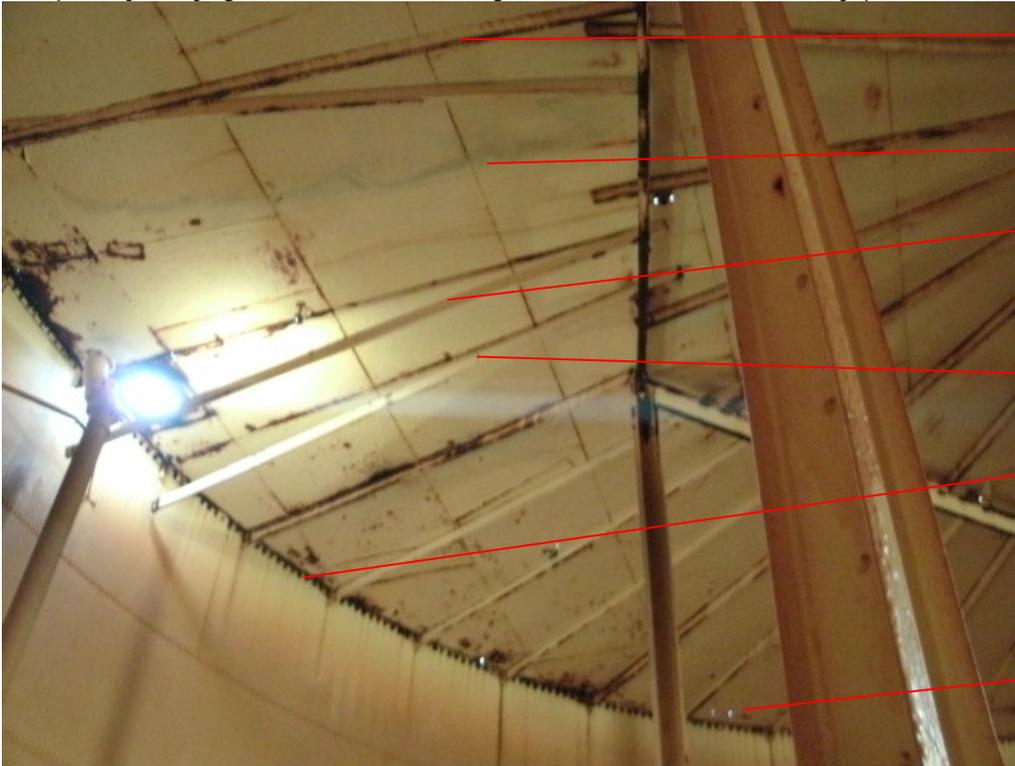
Several roof beams have come loose and hang from the roof, as well as one missing completely. Daylight also shows through holes in the roof in many places.

Beam loose and hanging.

Beam missing.

Beam loose and laying on brace.

Severe corrosion and missing rivets at sidewall/roof seam.

Two of the many holes in the roof.

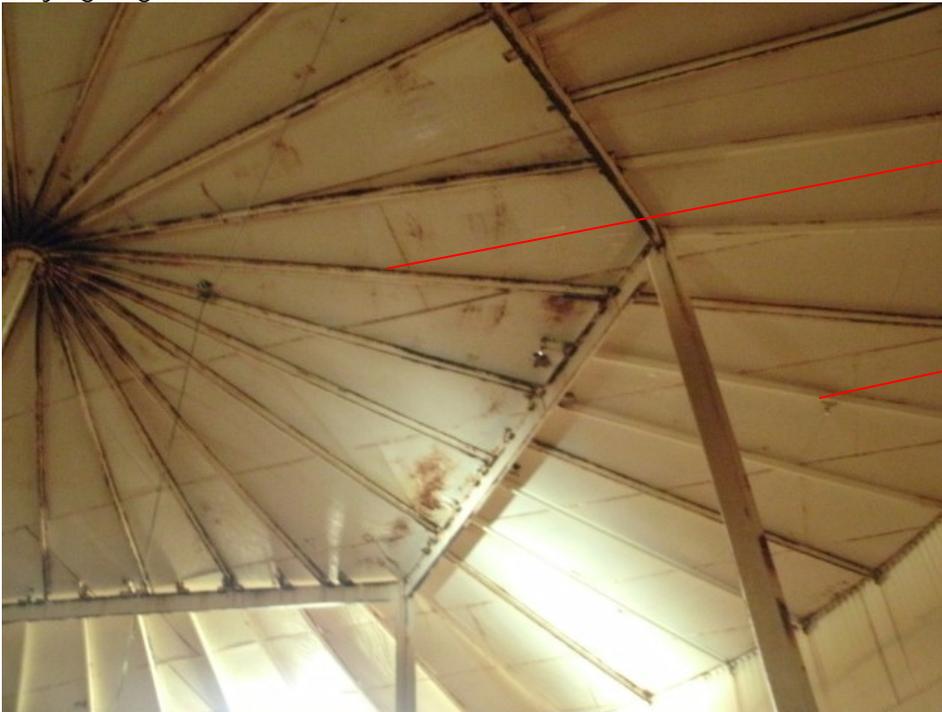
72 beams support the roof, 24 on the interior ring and 48 on the exterior ring. All have varying degrees of corrosion.

24 Interior Ring Beams.

48 Exterior Ring Beams.

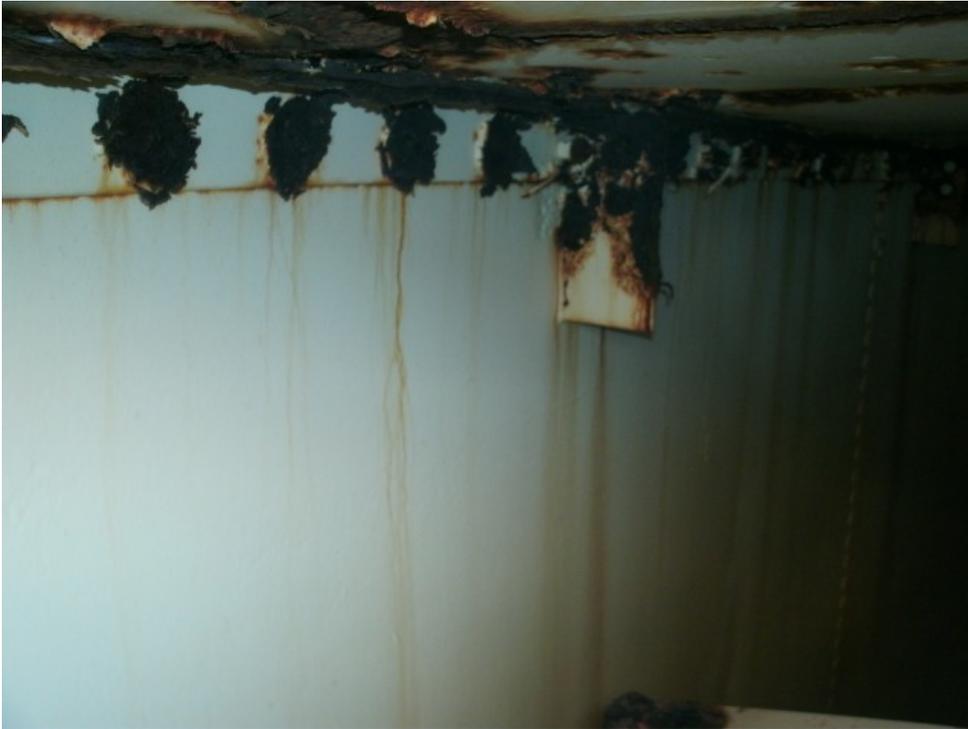
Corrosion of the rivets at the sidewall and roof seam has corroded into the metal.

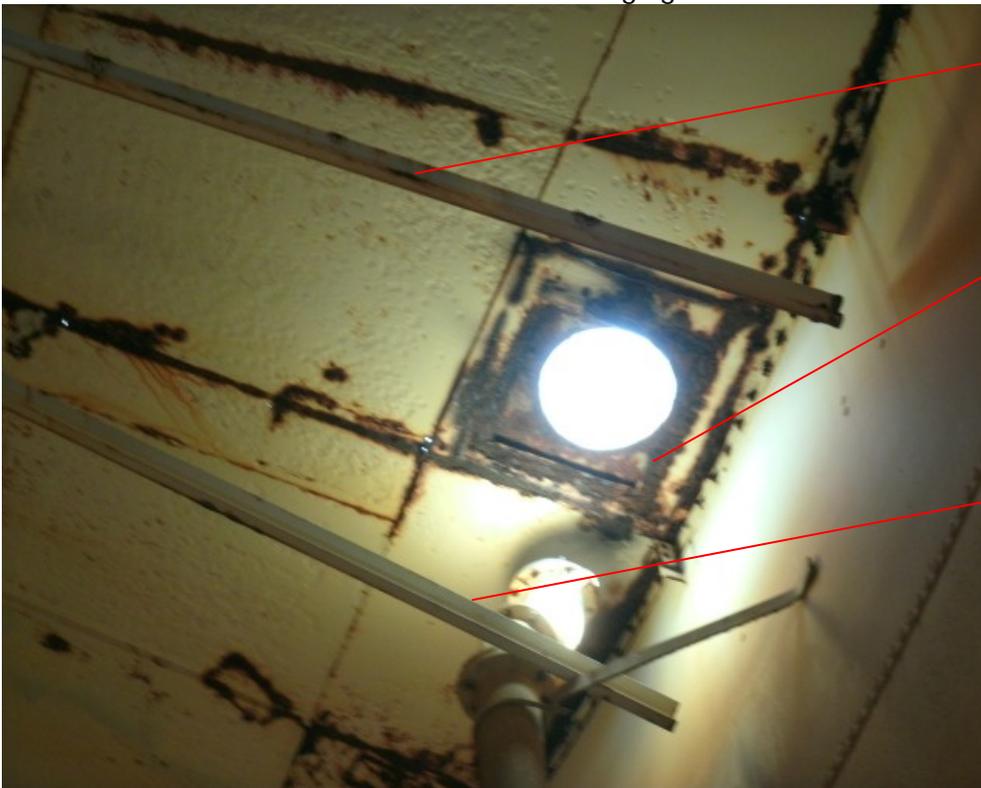
Severe corrosion around the roof hatch and hanging roof beams.

Beam loose and hanging.

Severe corrosion of roof hatch.

Beam loose and laying on brace.

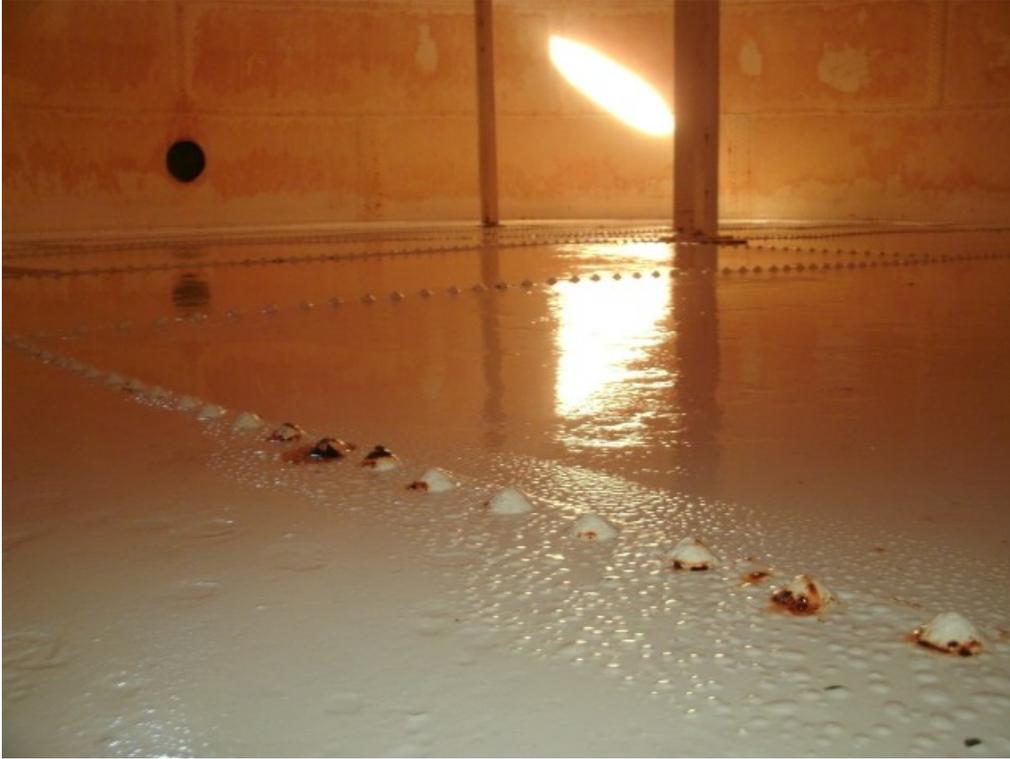
Blisters in the coating of the tank bottom, indicating moisture under the coating.

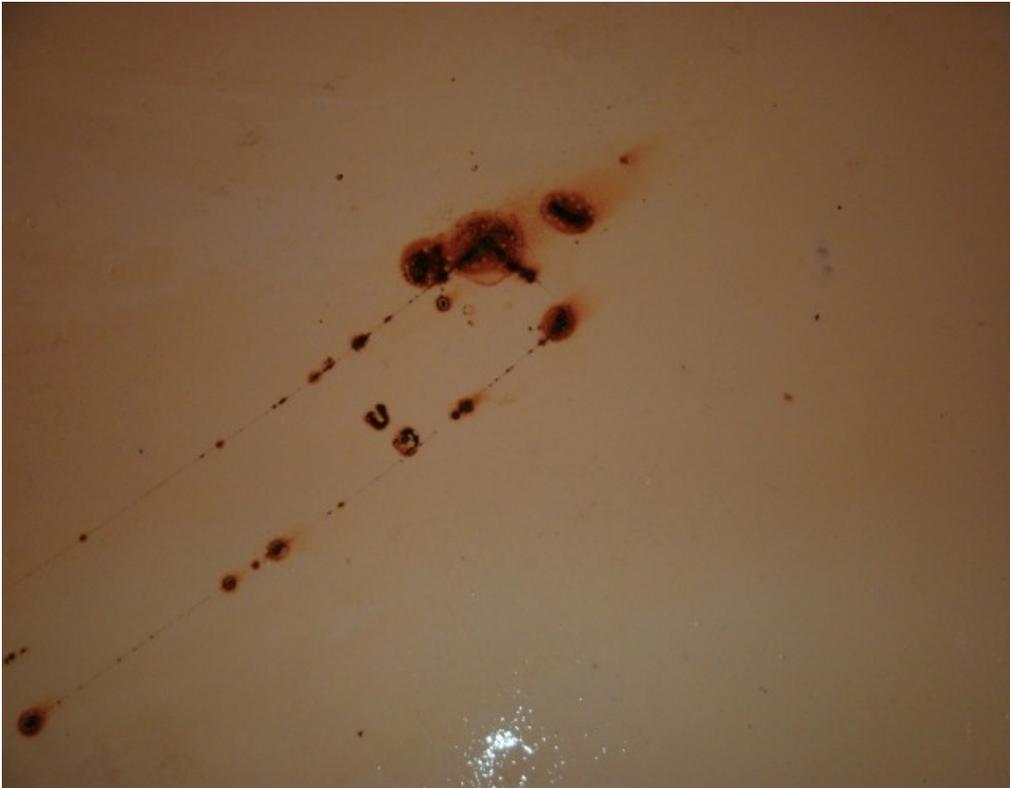
Corrosion caused by the missing roof beam that possibly fell and lay on the floor of the tank.

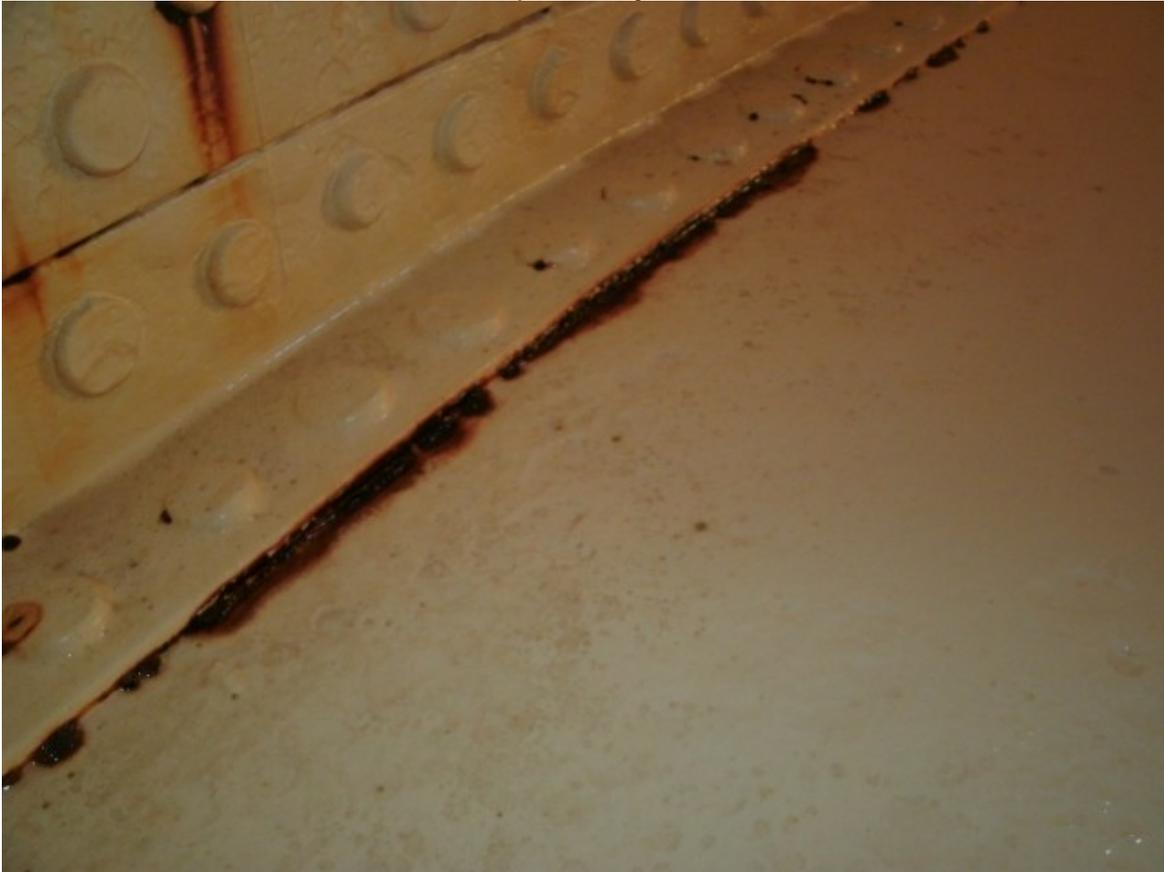
Corrosion near the sidewall/floor seam, potentially the cause of a leak in the tank.
