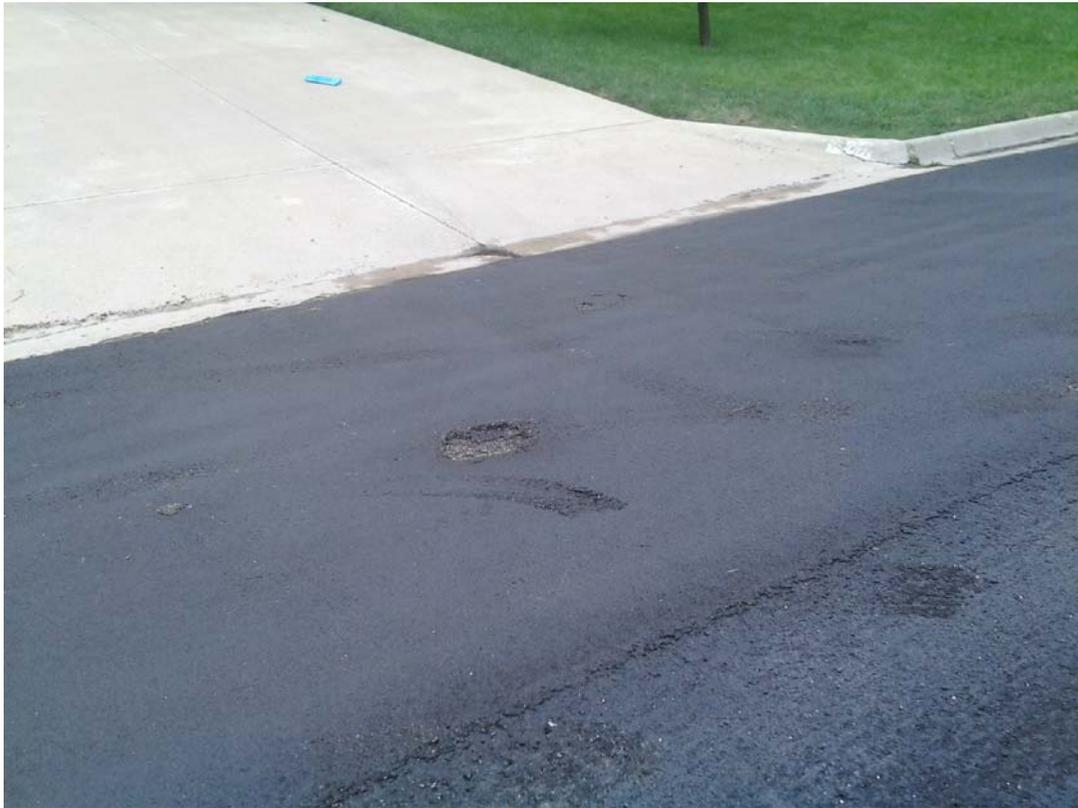
Vantuyl Dr – example of power steering marks, some leading to complete loss of seal requiring minor patch

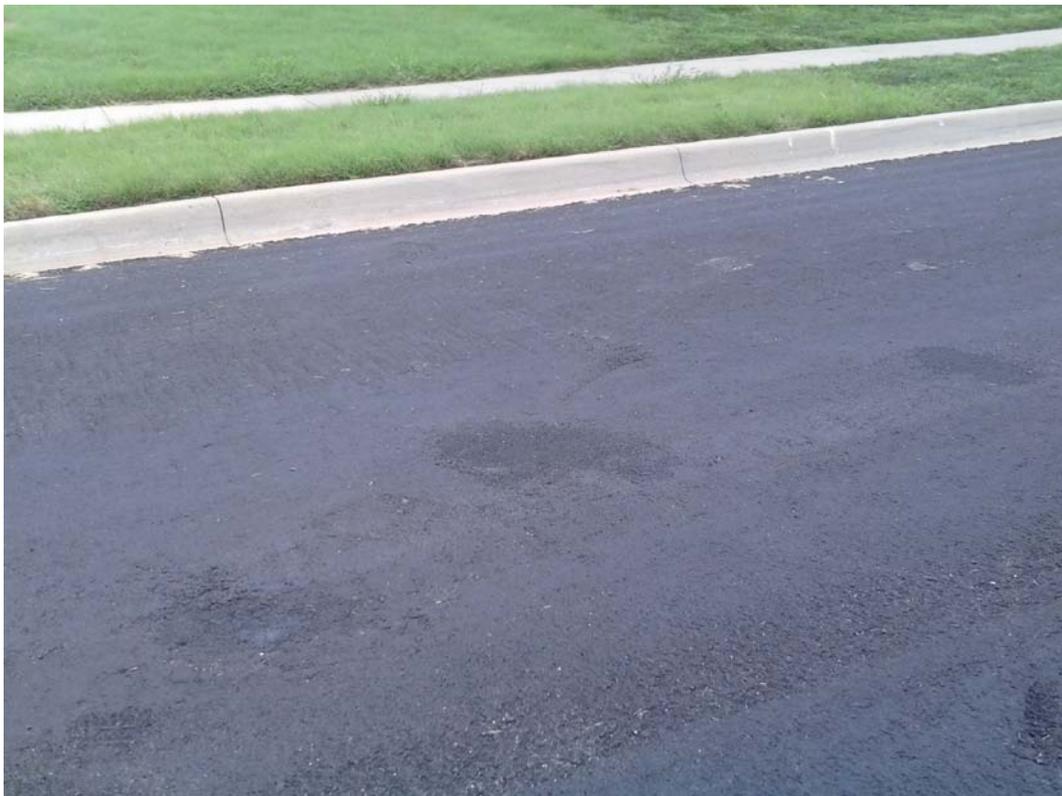
Lili Dr - example of power steering marks with loss of seal, completed with minor patching

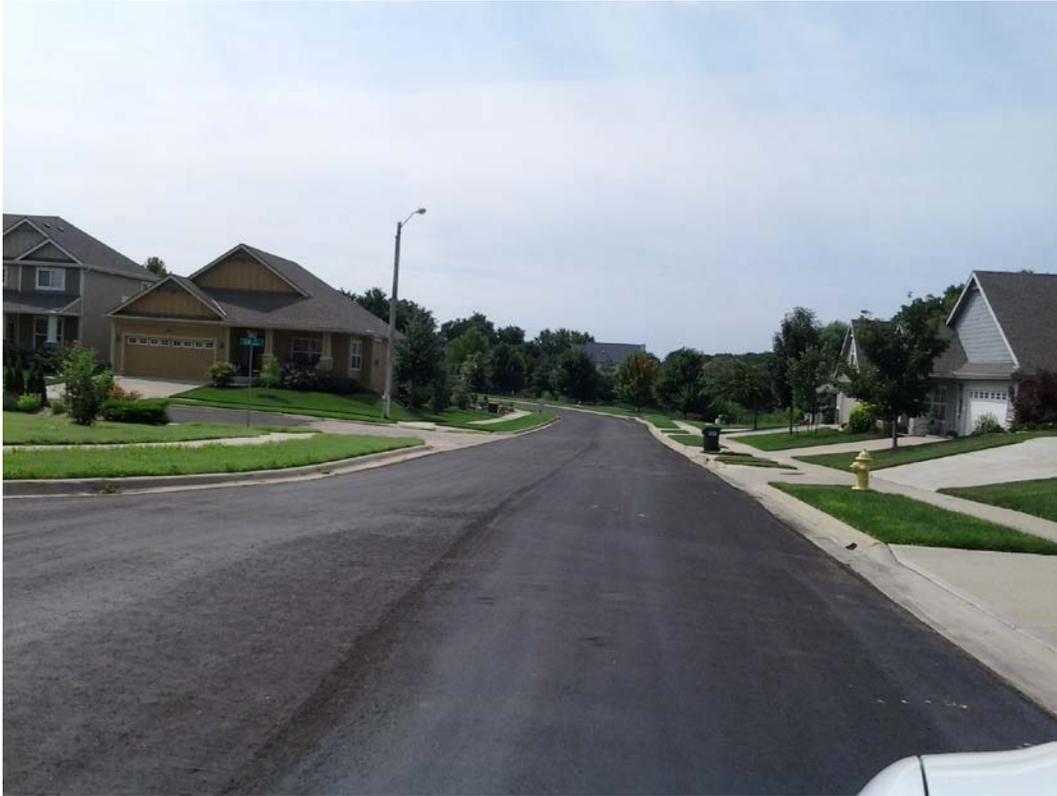
Larissa Dr near cul-de-sac – rougher texture apparent but typical in bulb areas where there is overlap of the application passes of the surface seal machine

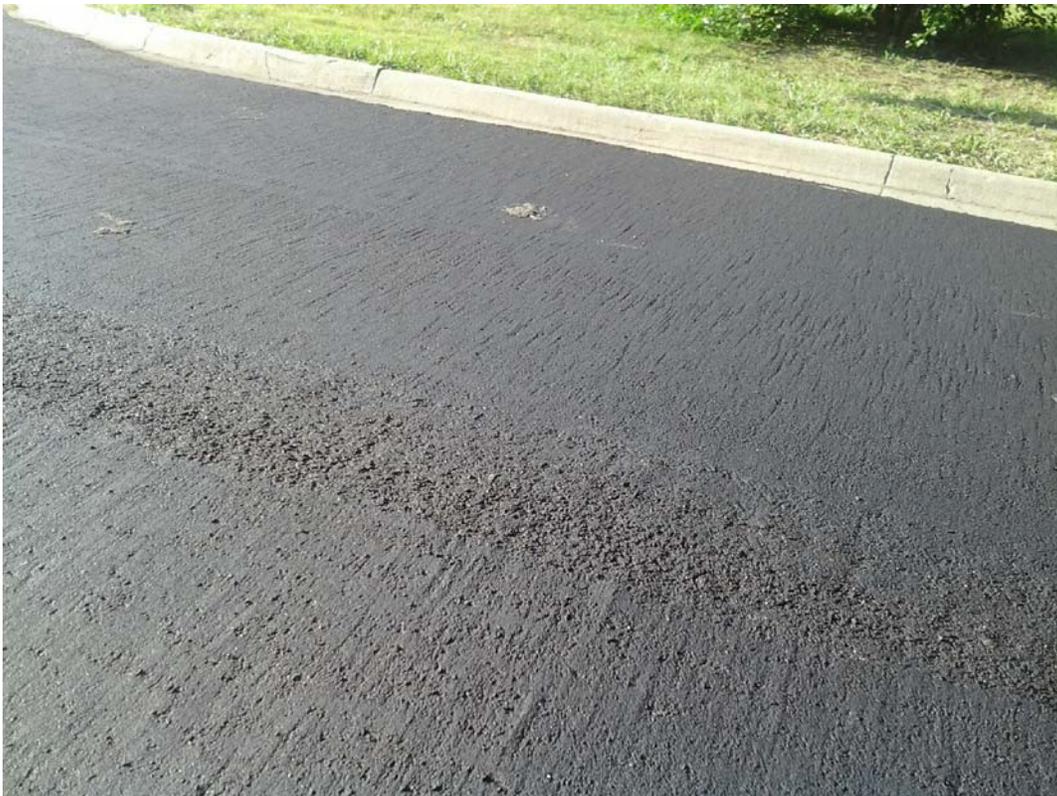
Example of microsurface seal with rougher texture than a roller compacted 2" mill and overlay;
Over time and with traffic, the material will tend to smooth out more

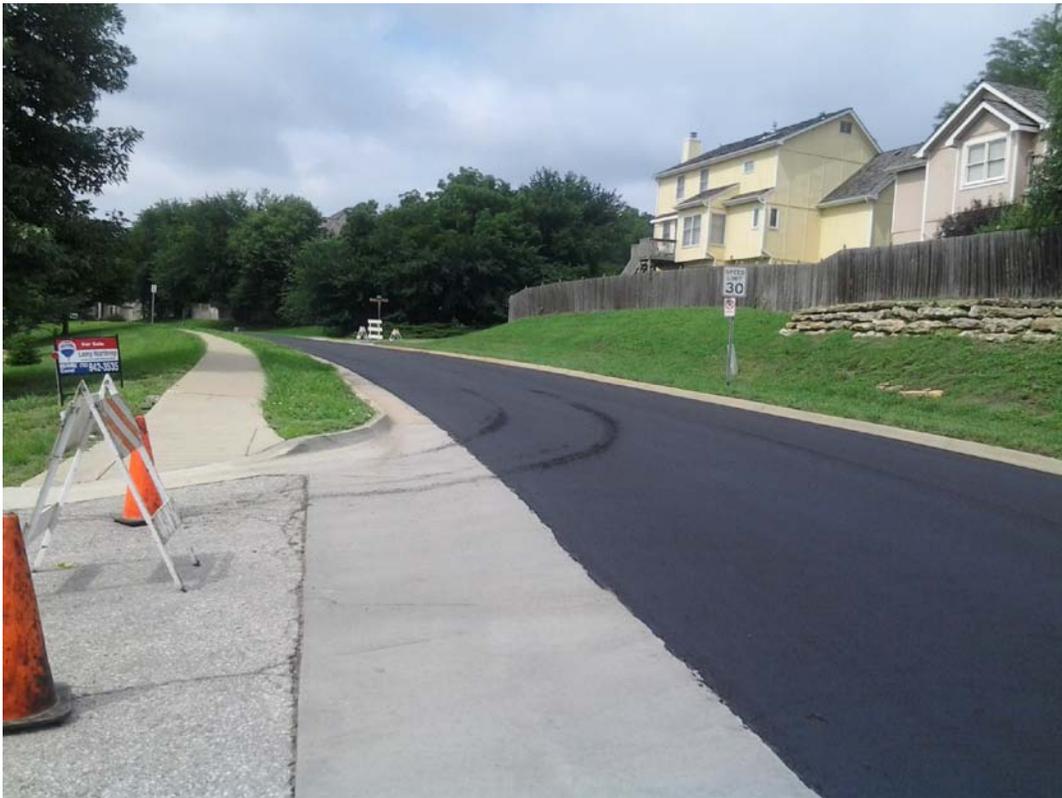
Inverness Dr – example of seal damage from aggressive vehicle turn near a temporary road closure

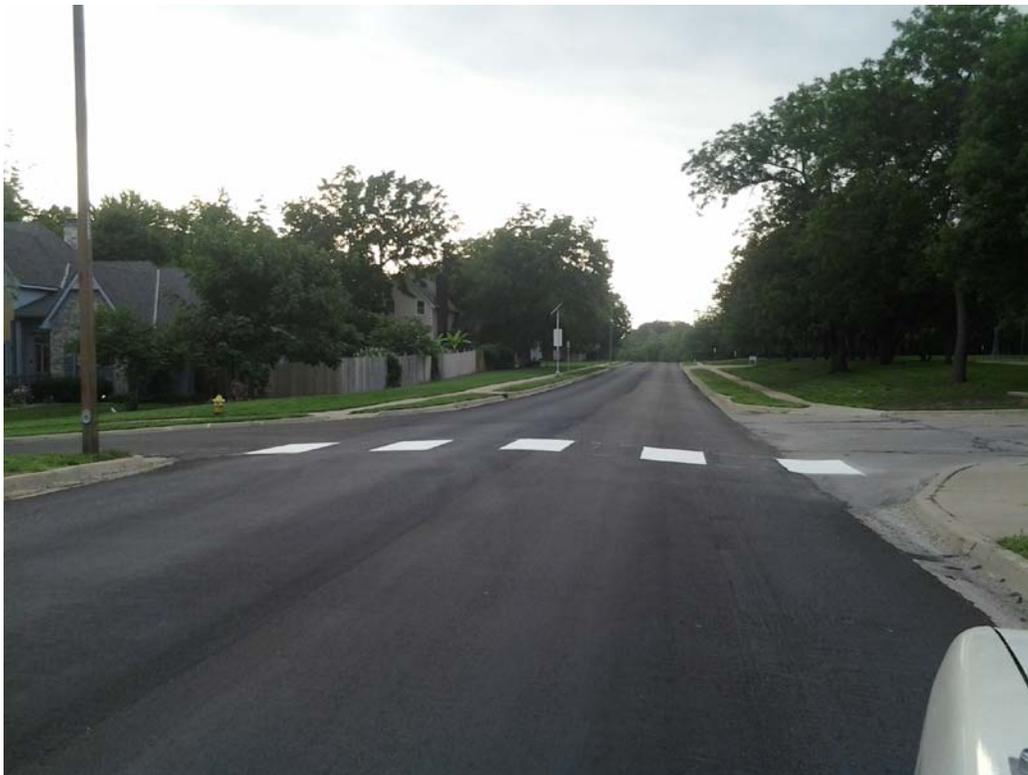
Inverness Dr – completed with pavement markings/ crosswalk near Quail Run Elementary

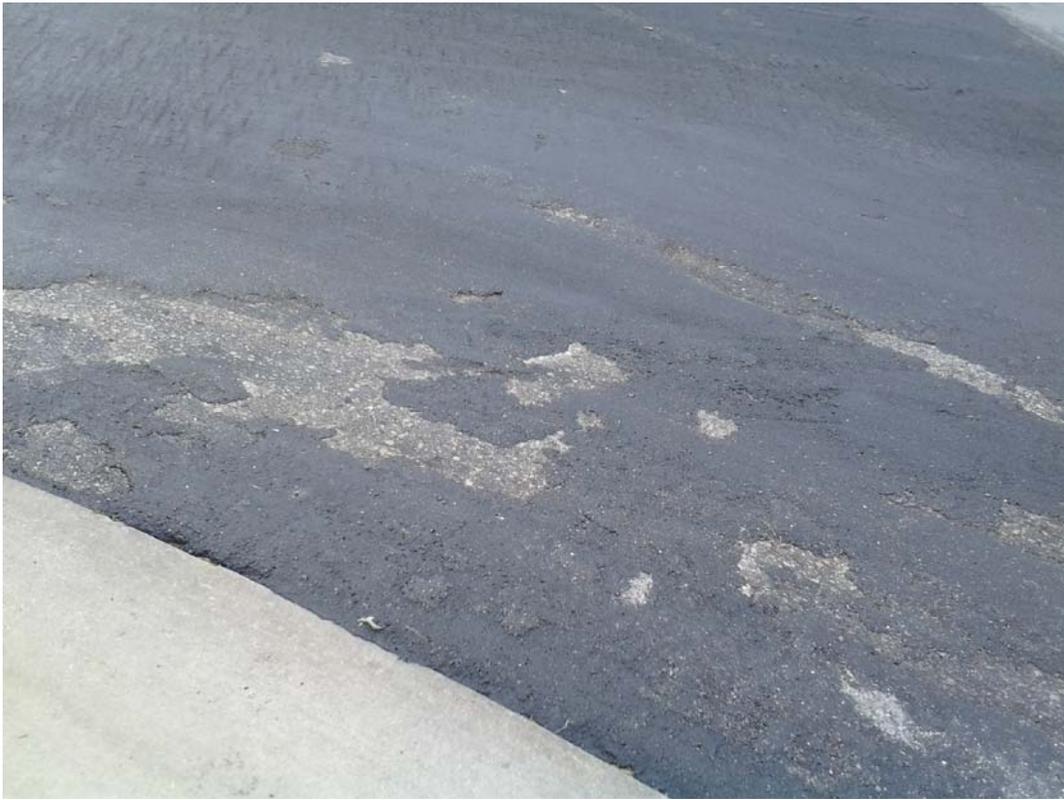
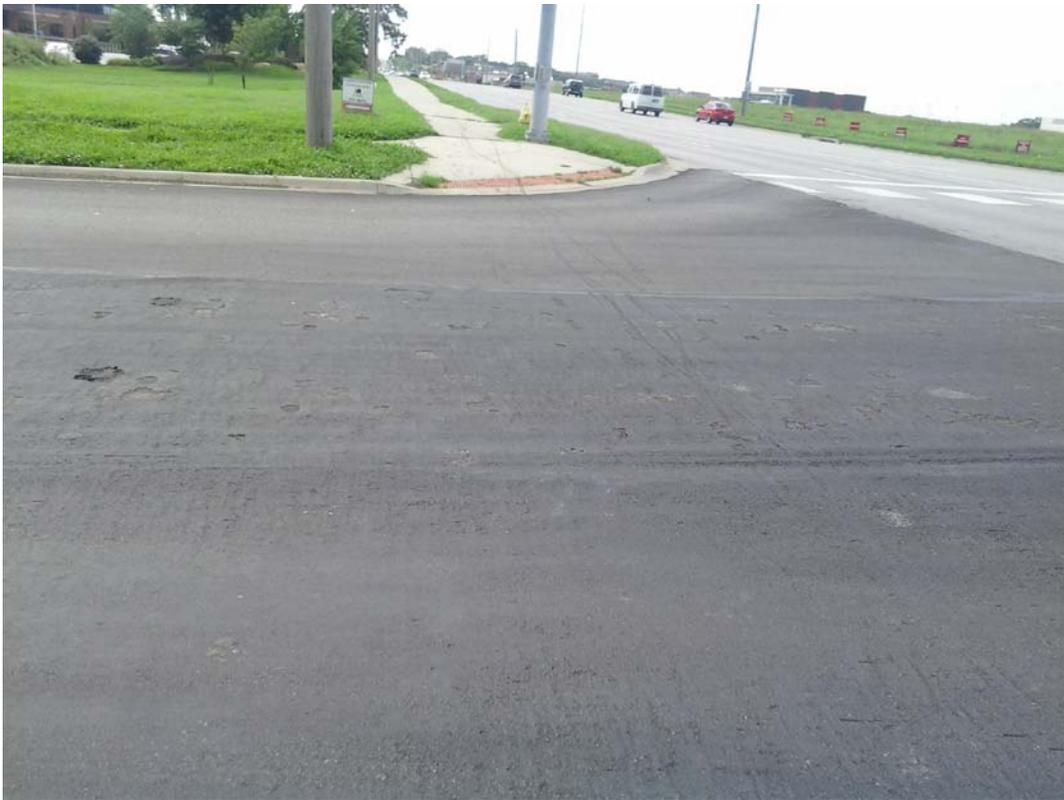
Folks Rd (south of 6th St) – example of heavy loss of material from vehicles

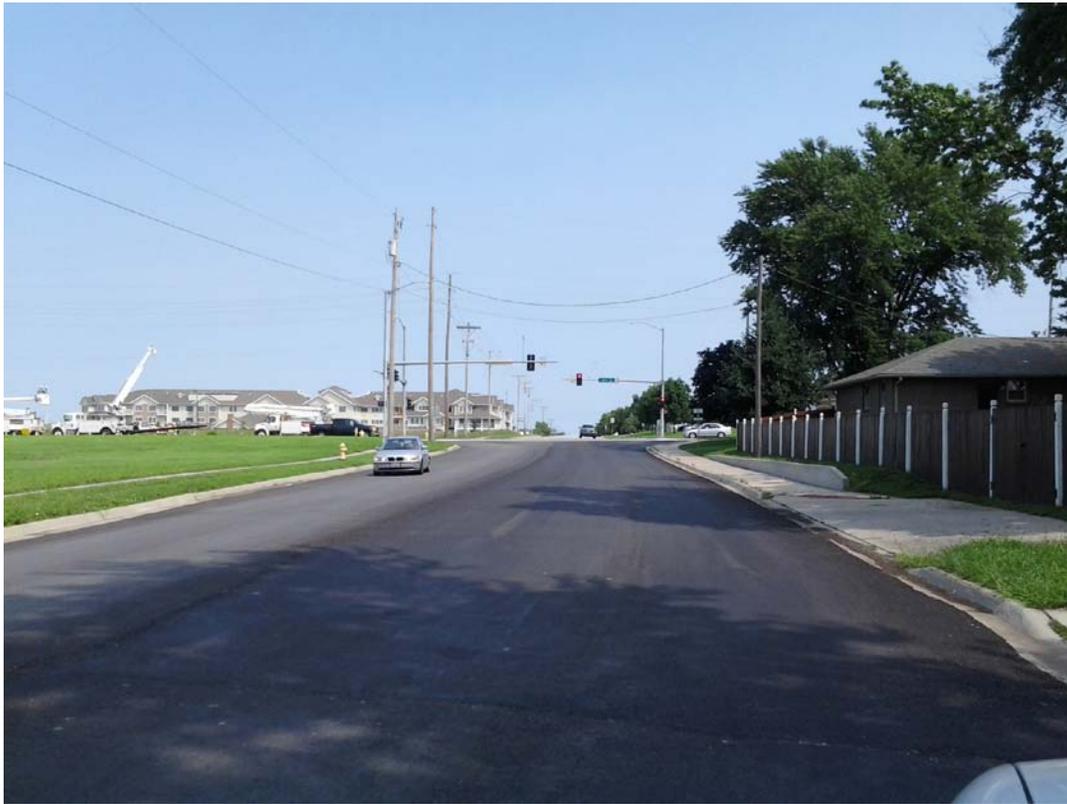
Folks Rd (south of 6th St) – after patching/ reapplication of surface seal by machine

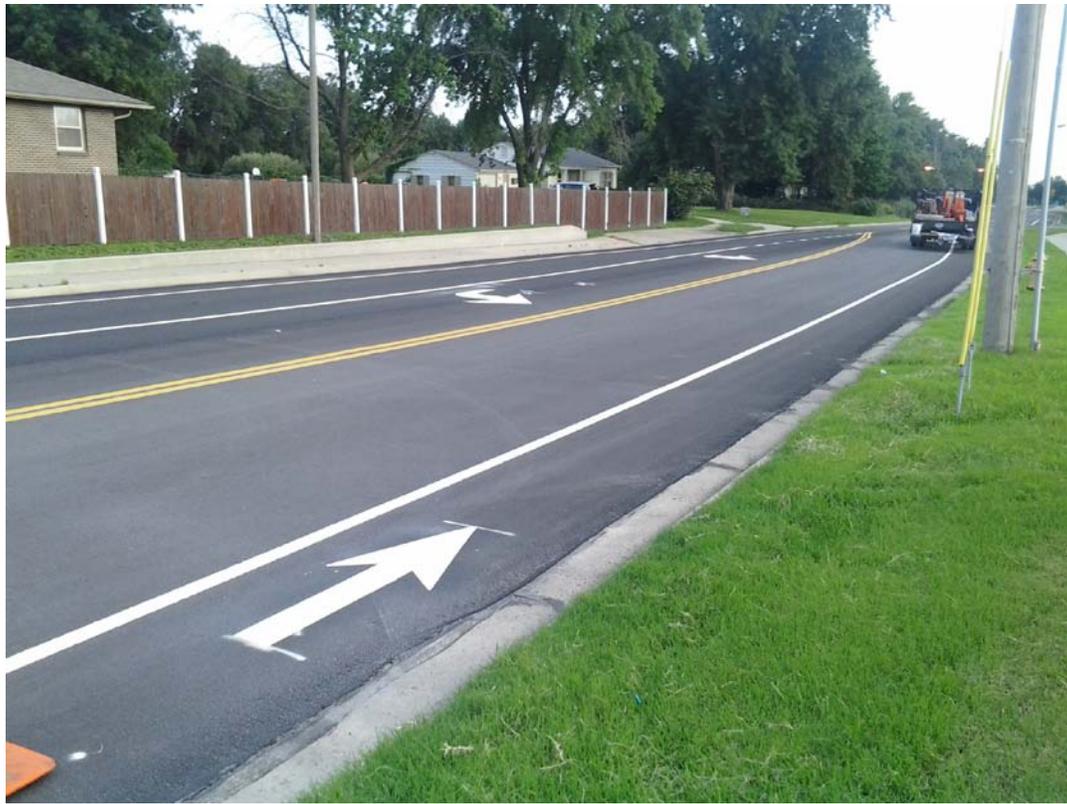
Folks Rd (south of 6th St) – completed with pavement markings

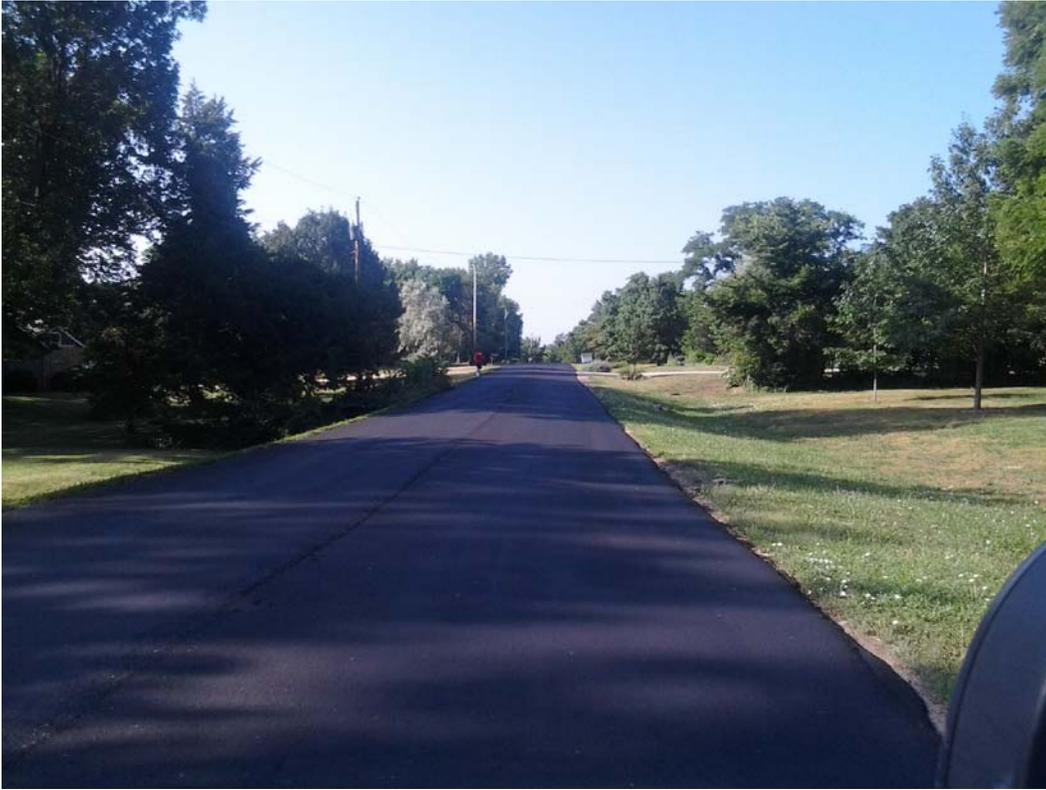
Wagon Wheel - completed

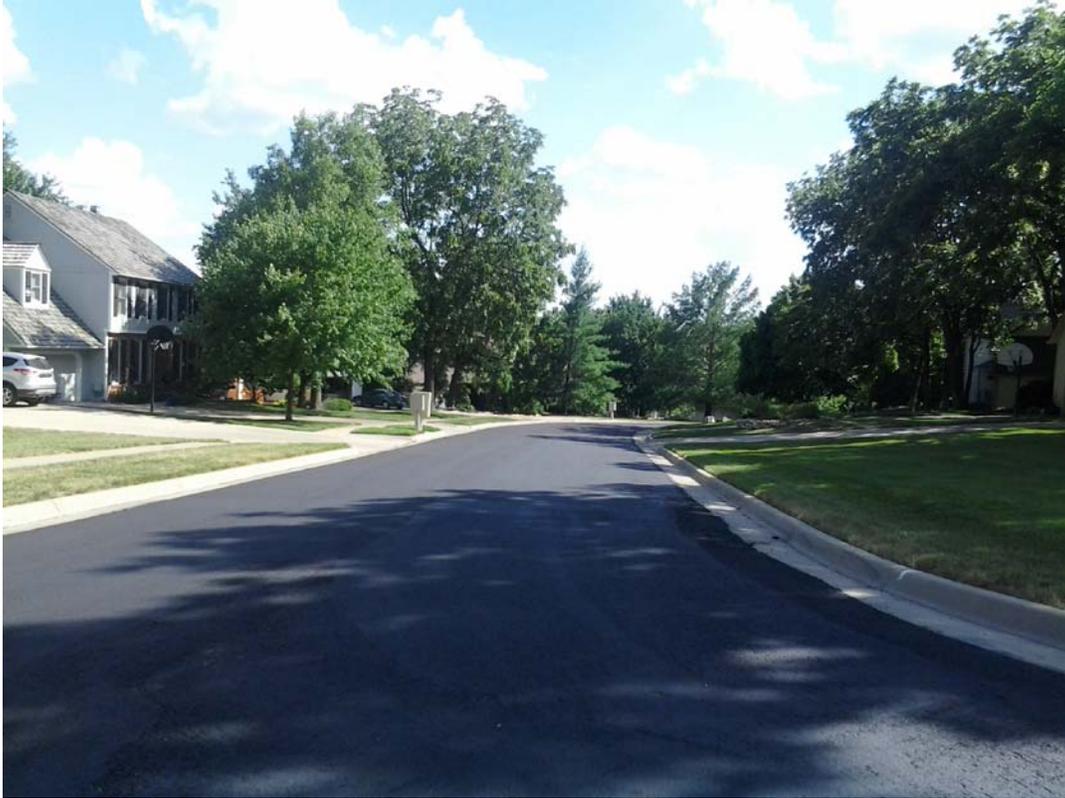
Royal Birkdale Ct - completed

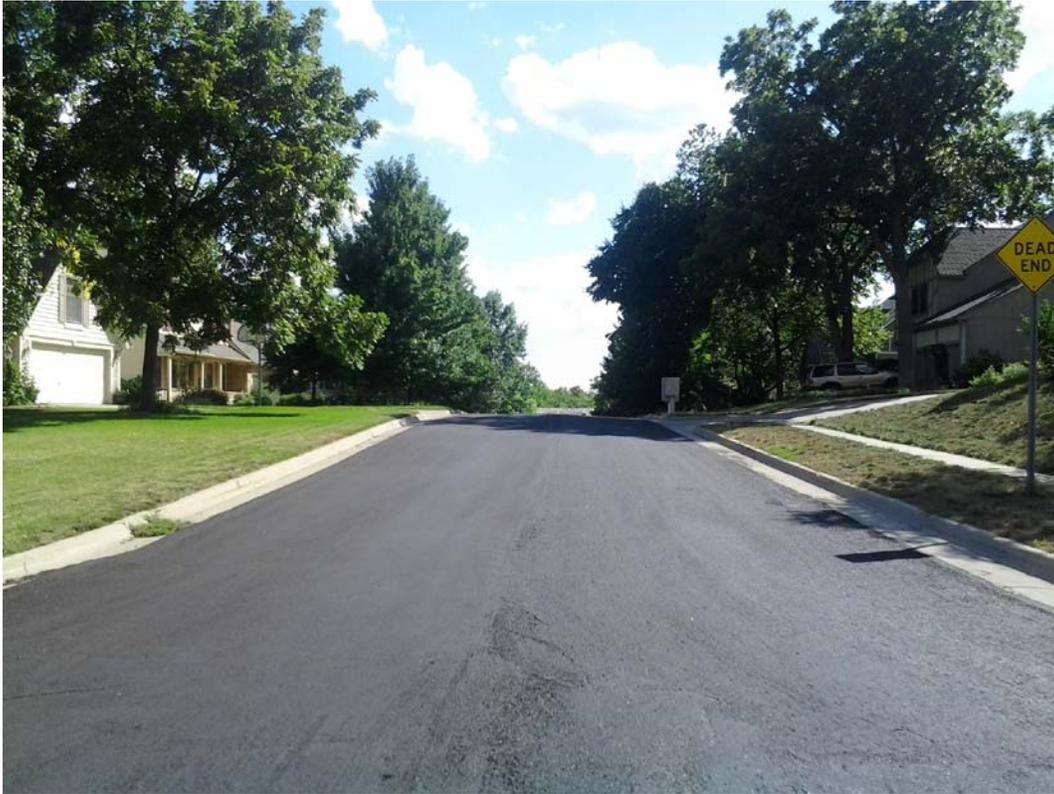
Cedar Ridge Ct - completed

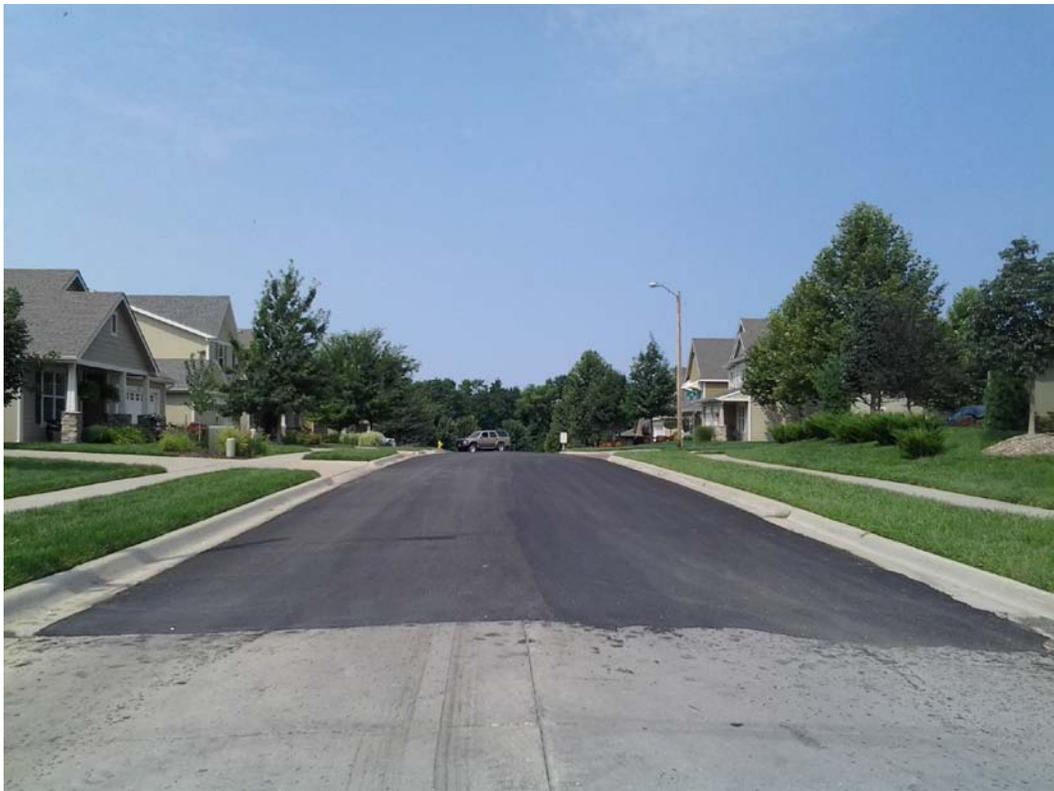
Larissa Dr - completed
