1231 Pennsylvania Street, 1/30/2015, Pictures of interior

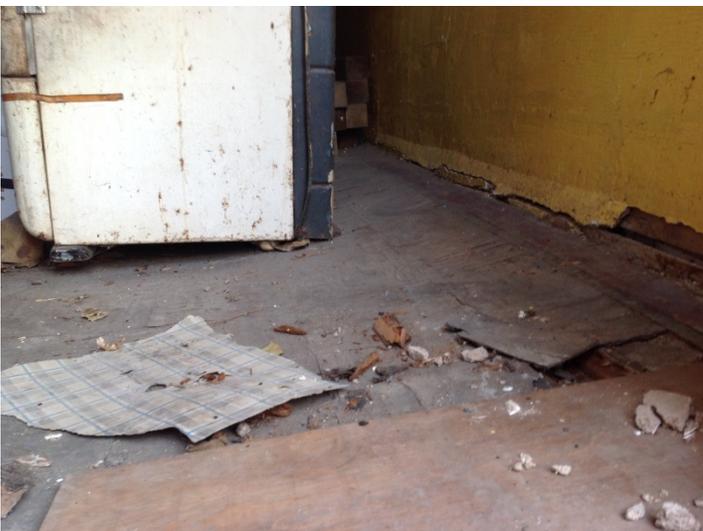
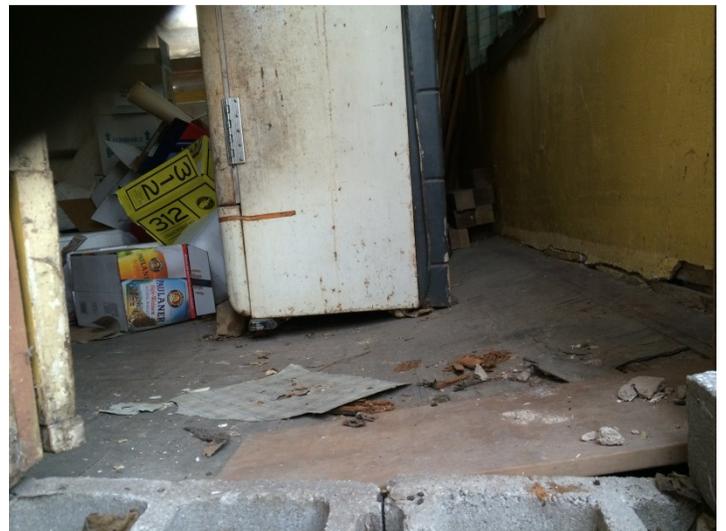
Failing floor structure (kitchen)
