Airport Community Hanger Executive Summary 2014 1925 Airport Road

Executive Summary 2014

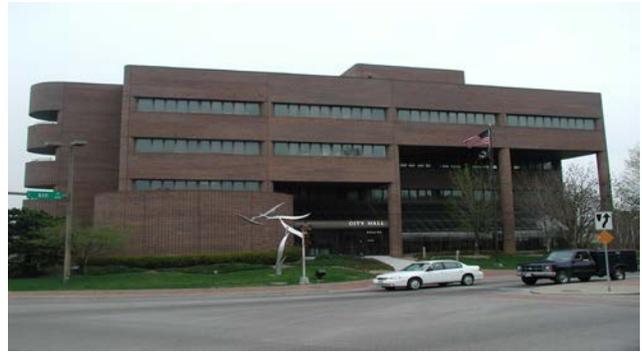
City Hall is in good overall condition. The slate roof on the north slope needs attention to prevent deterioration of the structure. Windows need updated.

- Replacement of all windows
- Replace atrium windows
- Roller blinds in atrium

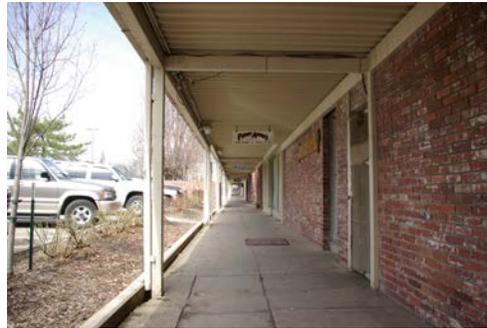
Fair condition, Metal needs painted, guttering and lighting need repaired and replaced,

This is vandalized on a regular basis. Graffiti is a big problem. Lighting and electrical have been repaired over the years. Downspouts have been replaced regularly due to vandalism and theft. Gutters, downspouts, and drains are cleaned yearly. Debris is cleared from the roof twice a year or as needed.

- Lighting improvements, vandalism is a problem 4,000.00
- Paint, guttering, and flashing 70,000.00

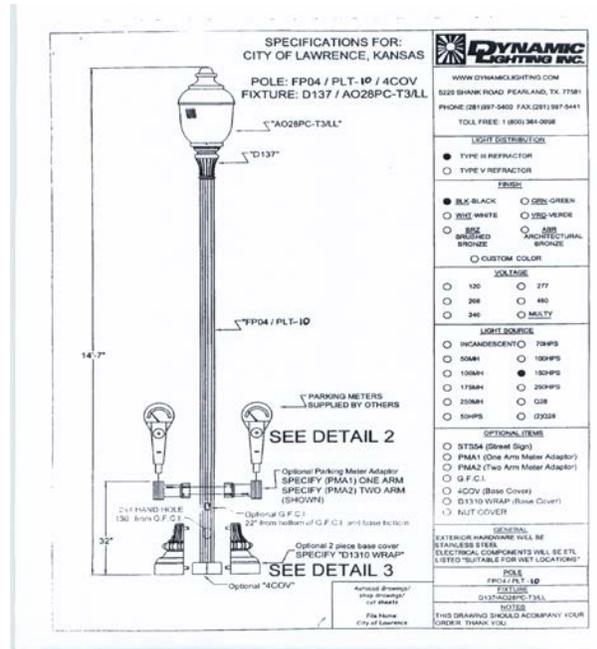
Many poles are rusted and failing

- 2014 Replaced 60 10 foot poles
- 2014 Replace 2-30 foot poles
-

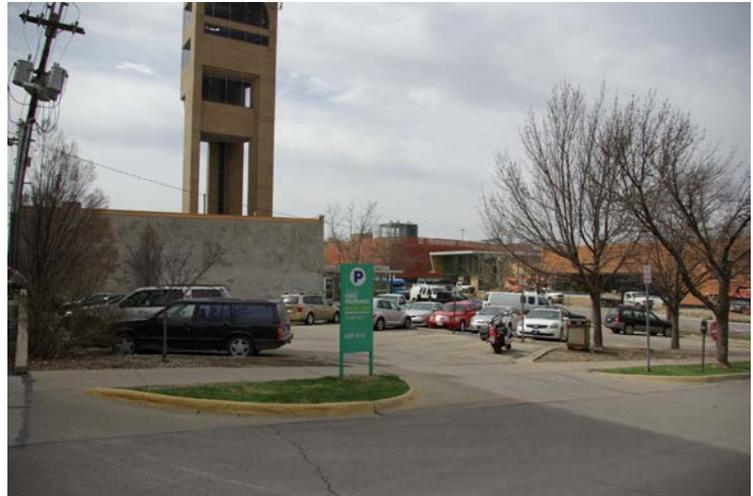
Parking Lot 12

Needs Paint

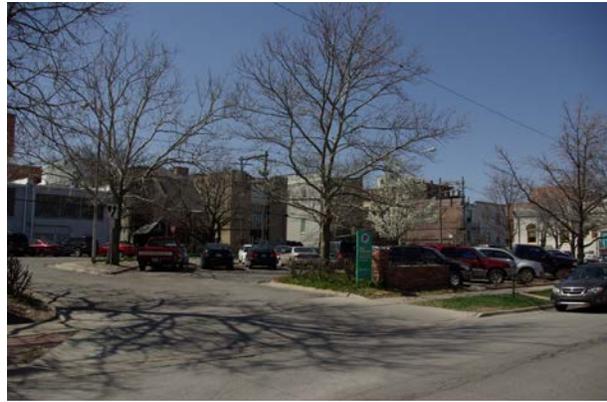
Parking Lot 2

Needs painted
