Property Condition Inspection

826 Oak St., Lawrence, Ks

18:34 October 13, 2015 Shannon Oury/Lawrence Douglas Co Housing Authority
Page 1 of 12 826 Oak St.

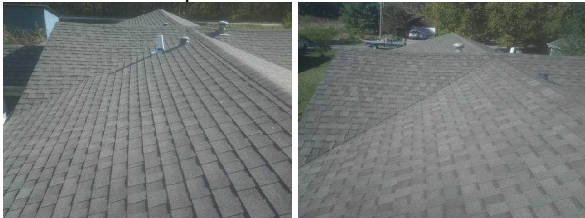
1. Method of Inspection: On roof

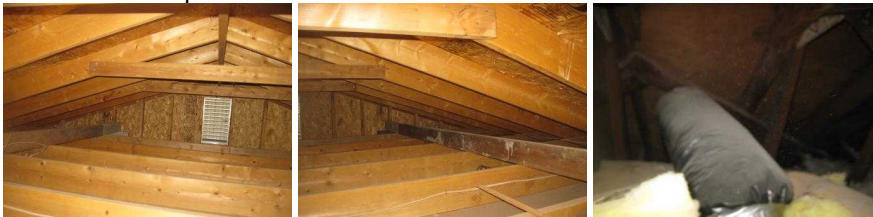
1. Method of Inspection: From the attic access
