**Subject Notice of Lead-Based Paint Inspection (NOTICE)**  
**413 E. 7th Street, Lawrence, KS 66044**

# LEAD -BASED PAINT INSPECTION REPORT

Santa Fe Station  
413 E. 7th Street  
Lawrence, KS 66044

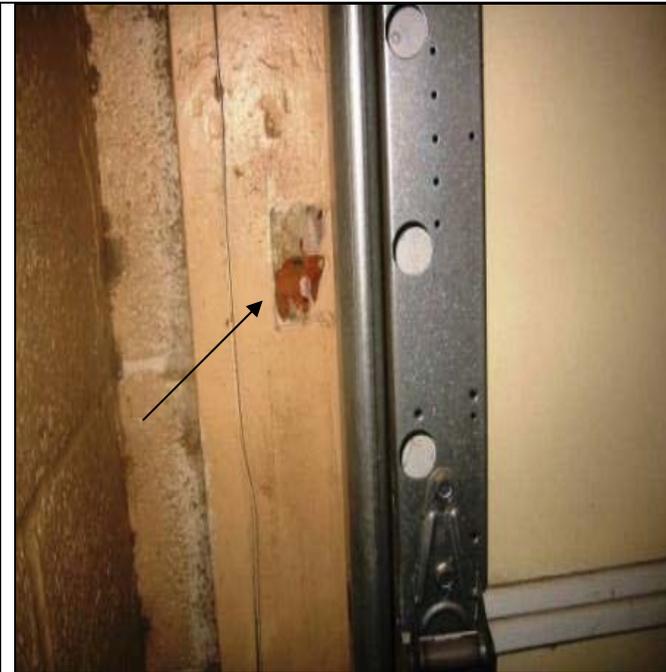
026	A	Garage door	Lft	Casing	F	Wood	Cream	1.7	QM
025	C	Garage door	Ctr	Face	F	Wood	Cream	2.5	QM

Deteriorated LBP on the baggage room A wall garage door casing.

ROOM	COMPONENT	ACTION	LOCATION / APPROXIMATE QUANTITY
Baggage Room	Overhead garage door frame	Prep/Paint using EPA RRP Lead Safe Work Practices as shown below	"A" wall overhead door-25 LF
Baggage Room	Overhead garage door face	Prep/Paint using EPA RRP Lead Safe Work Practices as shown below	"C" wall overhead door- 65 SF
Waiting Lounge	Air handling unit	Prep/Paint using EPA RRP Lead Safe Work Practices as shown below	"D" wall - Right - 100 SF
Exterior	Metal panel siding	Prep/Paint using EPA RRP Lead Safe Work Practices as shown below	All sides of structure above windows & platform cover "A" wall (South) - 85 SF "B" wall (West) - 16 SF "C" wall (North) - 102 SF "D" wall (East) - 16 SF
Exterior	Metal columns	Removal/replacement of columns using EPA RRP Lead Safe Work Practices as shown below	A, B & C sides of structure at exterior platform area - 20 columns
Exterior	Garage Door Face	Prep/Paint using EPA RRP Lead Safe Work Practices as shown below	C side of structure - 65 SF

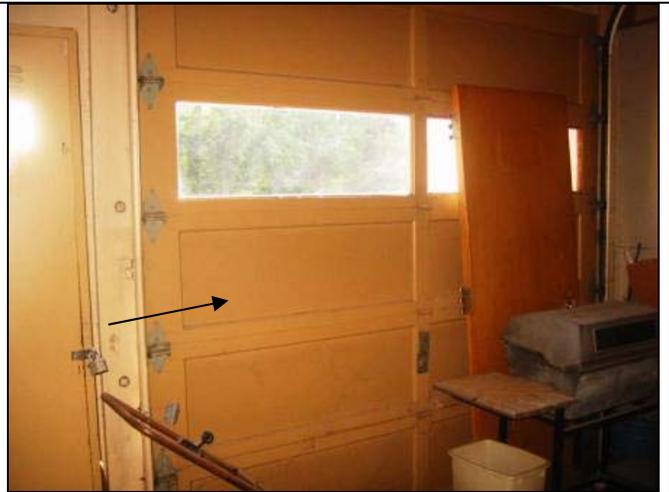
Deteriorated LBP on the baggage room C wall garage door face

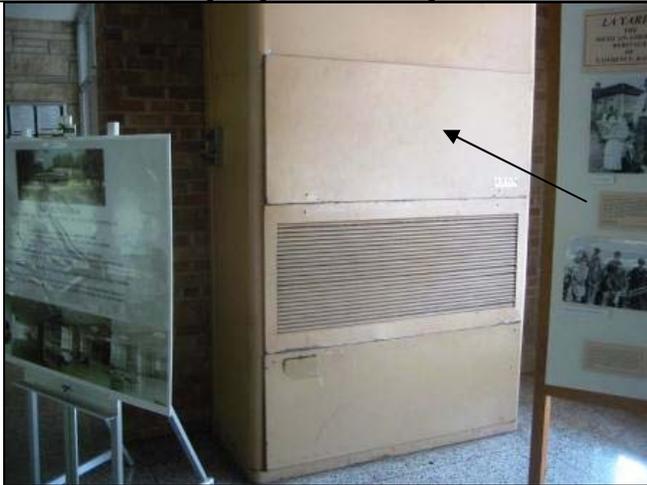
170	D	Air Handling Unit	Rgt		F	Metal	Tan	2.0	QM
-----	---	-------------------	-----	--	---	-------	-----	-----	----

Deteriorated LBP on waiting lounge air handling unit

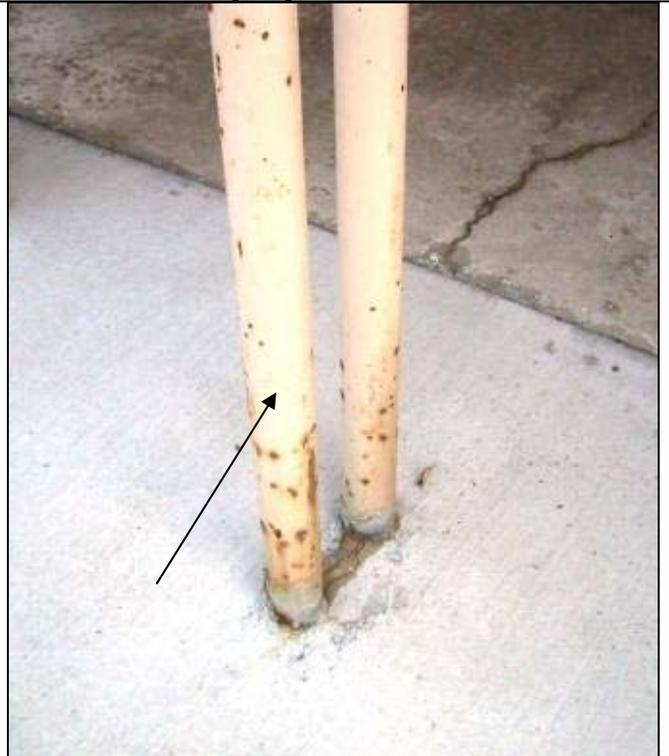
Deteriorated LBP on the exterior columns

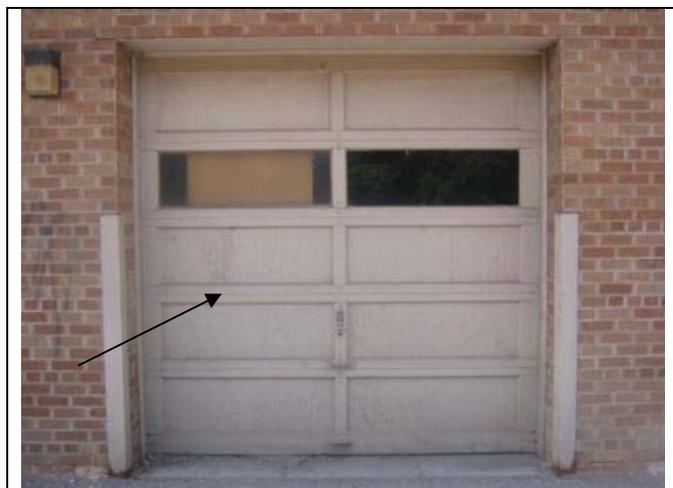
Deteriorated LBP on the exterior C wall garage door face.

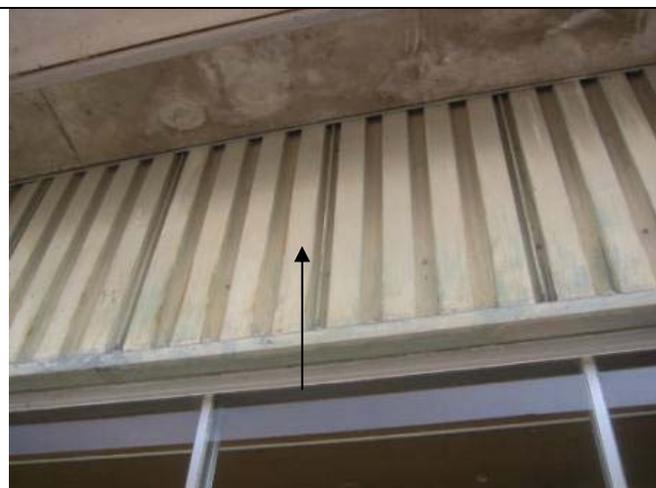
Deteriorated LBP on the exterior A wall siding
