From: Justin E. Burgoon, P.E., S.E. - BSE
To: Ernie Shaw – City of Lawrence Park & Rec.
RE: Lawrence Sports Pavilion Concrete Crack Assessment

Date: 7/3/2017
Project No: 17-236

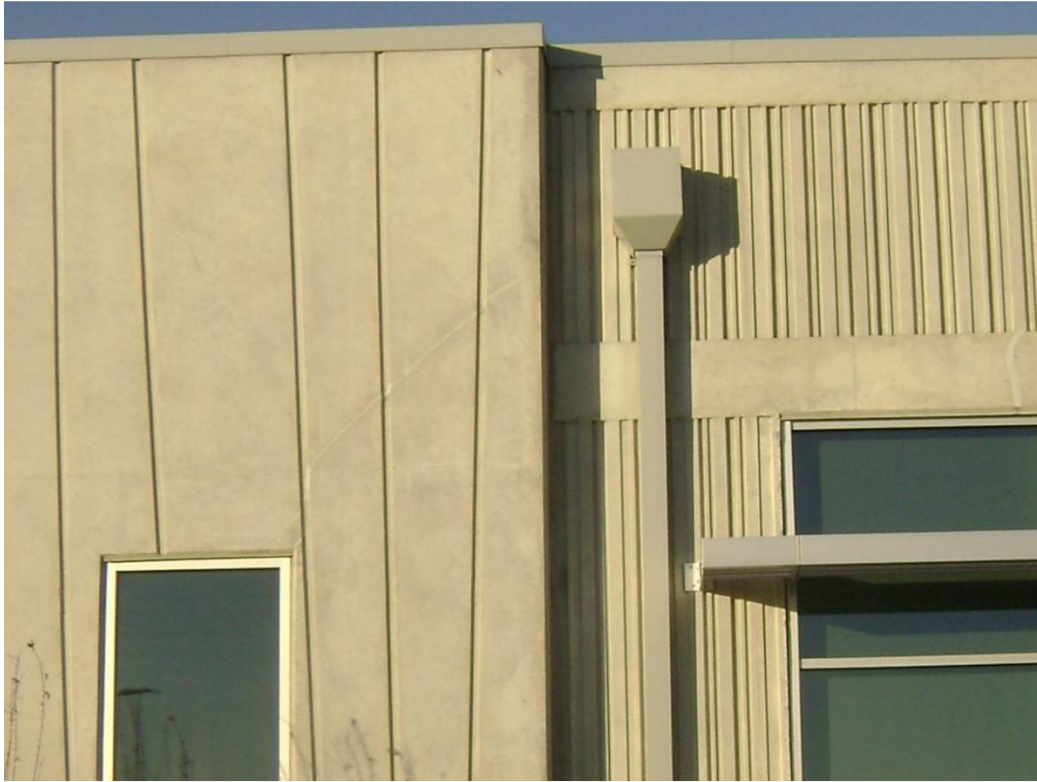
Photo 1 – 2015

Focusing on the tilt wall cracks and comparing photos 1 through 4 (attached to this letter) it appears that these specific cracks in the concrete tilt walls have not changed in size or length over the last 30 months. BSE's conclusions and recommendations from the January 22, 2015 letter are still accurate.

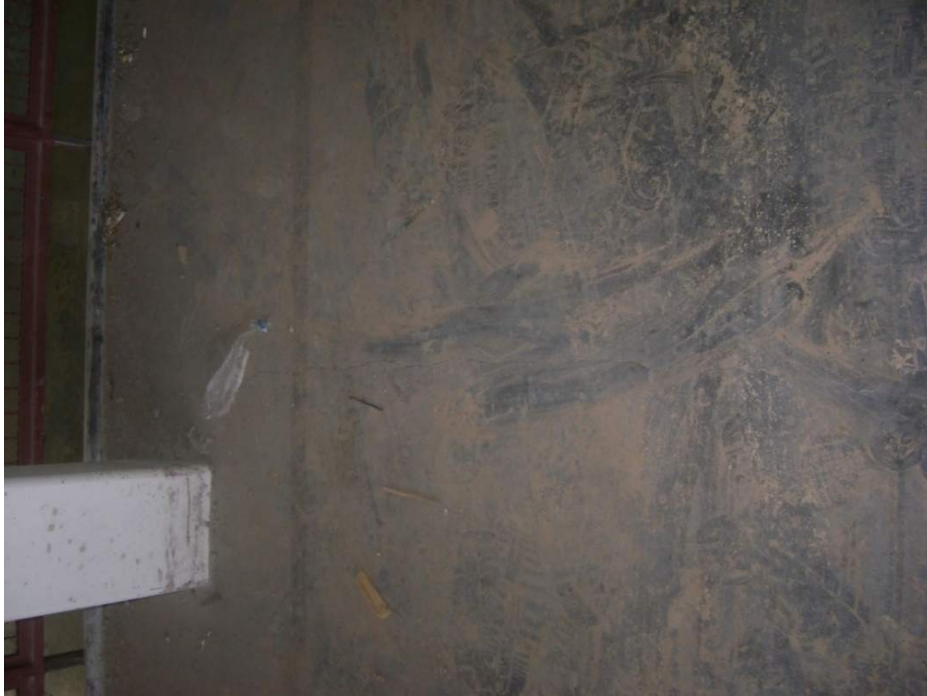
Photo 5 - 2014

Focusing on the mezzanine slab cracks and comparing photos 5 through 7 (from 2014) with photos 8 and 9 (from 2017) it appears that the cracks have occurred in areas in which random shrinkage cracks are common. These areas include corners of floor openings (duct penetrations and stairwells) and points of floor support (column locations and girder lines). The photos from 2014 show that cracks immediately showed in these areas. In addition to the cracks mentioned above, several transverse cracks have occurred in an 8 foot to 16 foot spacing with a longitudinal crack running in the perpendicular direction along the length of the mezzanine. See attached photo 10. These cracks have occurred in a pattern that is similar to the control joint pattern sawn into the concrete slab on grade. See attached photo 11. The difference between the cracks in photo 10 and photo 11 is that the cracks were controlled in the slab on grade with sawn control joints. The cracks in the mezzanine slab were not controlled because sawn control joints were not sawn into the mezzanine slab. The pattern and spacings of these cracks are consistent with temperature and shrinkage cracking. BSE's conclusions and recommendations from the November 17, 2014 letter are still accurate.
