# Roof Inspection Report

City of Lawrence  
Mr. Jason Stowe  
PO Box 708  
Lawrence, KS 66044

Roofing Solutions, Inc.  
6728 W. 153<sup>rd</sup> Street  
Overland Park, KS 66223

Arts Center  
940 New Hampshire Street  
Lawrence, KS 66044

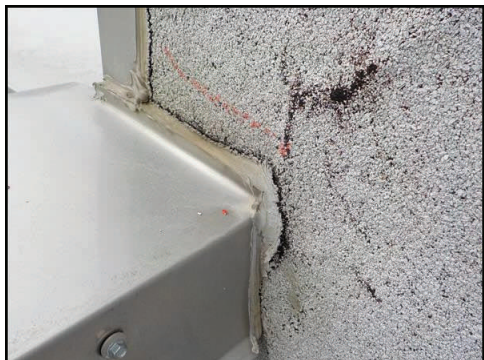
| Defect Code: | 1 | Quantity: | Under 10 LF | Priority: | First Year |
| Description: Deteriorated or missing sealant at counterflashing, termination bar, sealant lip, metal flashing, expansion joint, etc. | | | | | |

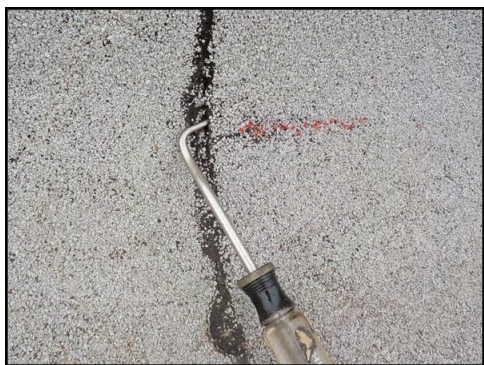
| Defect Code: | 45 | Quantity: | 2 | Priority: | First Year |
| Description: Open flashing lap | | | | | |

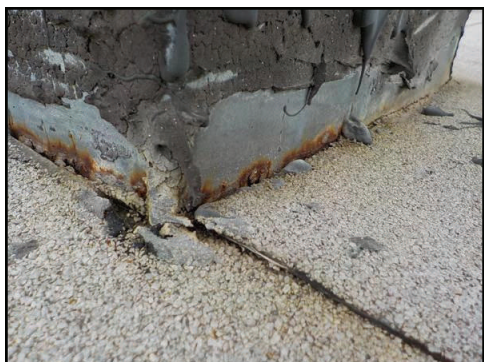
| Defect Code: | 86 | Quantity: | 2 | Priority: | First Year |
| Description: Corrosion or rust | | | | | |

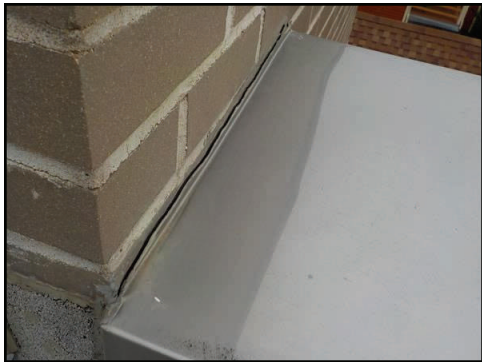
| <b>Defect Code:</b> | <b>1</b> | <b>Quantity:</b> | <b>Under 10 LF</b> | <b>Priority:</b> | <b>First Year</b> |
| Description: Deteriorated or missing sealant at counterflashing, termination bar, sealant lip, metal flashing, expansion joint, etc. | | | | | |

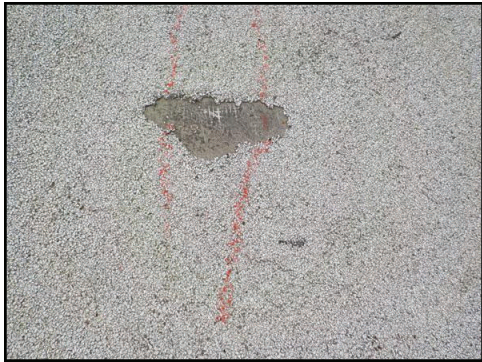
| <b>Defect Code:</b> | <b>8</b> | <b>Quantity:</b> | <b>Under 10 SF</b> | <b>Priority:</b> | <b>First Year</b> |
| Description: Surface erosion. | | | | | |

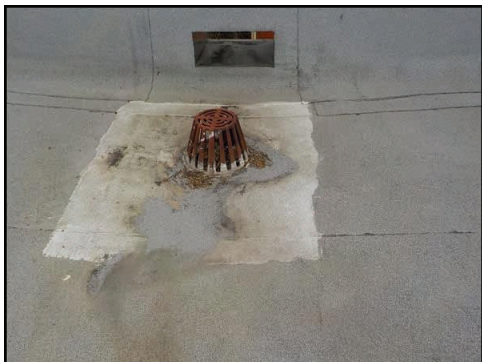
| <b>Defect Code:</b> | <b>24</b> | <b>Quantity:</b> | <b>1</b> | <b>Priority:</b> | <b>Monitor</b> |
| Description: Evidence of past problem and previous repair. | | | | | |

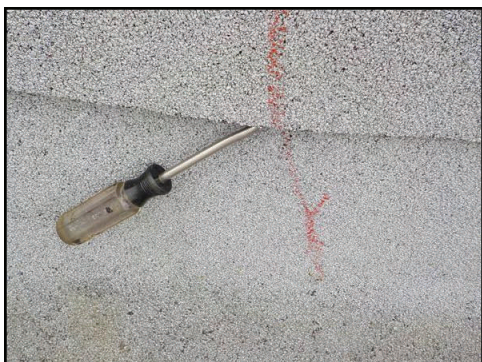
| <b>Defect Code:</b> | <b>45</b> | <b>Quantity:</b> | <b>1</b> | <b>Priority:</b> | <b>First Year</b> |
| Description: Open flashing lap | | | | | |

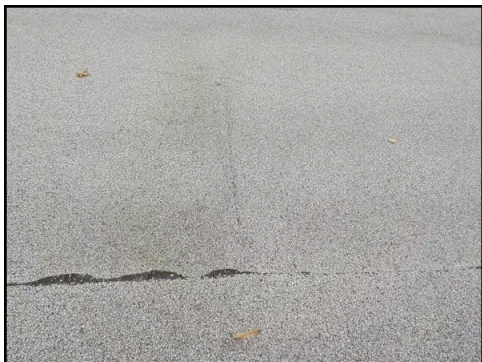
| Defect Code: | 5 | Quantity: | Random | Priority: | Monitor |
| Description: Buckling or ridging of membrane. | | | | | |

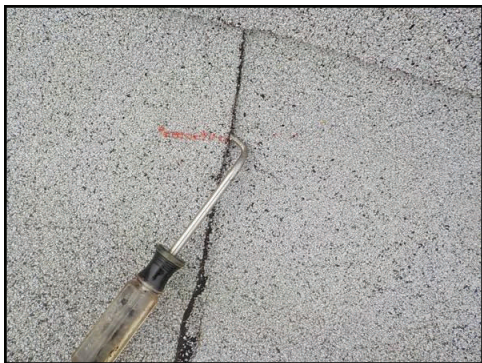
| Defect Code: | 45 | Quantity: | 2 | Priority: | First Year |
| Description: Open flashing lap | | | | | |

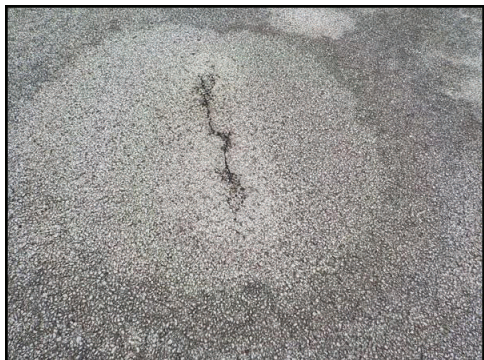
| Defect Code: | 23 | Quantity: | 12 | Priority: | First Year |
| Description: Physical damage to membrane including cuts, holes, tears, scrapes, scuffs, or abrasions. | | | | | |

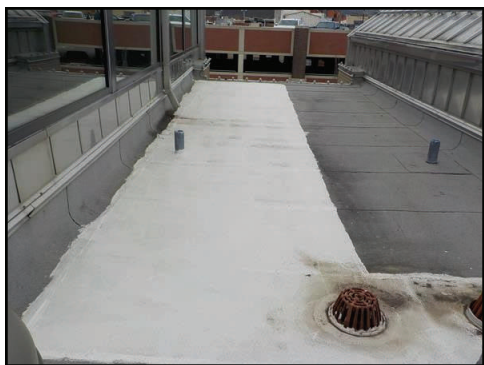
| Defect Code: | 24 | Quantity: | Random | Priority: | Monitor |
| Description: Evidence of past problem and previous repair. | | | | | |

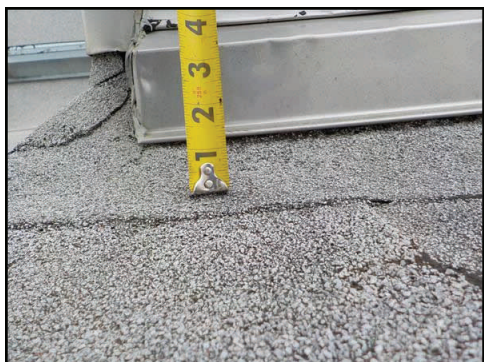
| Defect Code: | 40 | Quantity: | 1 | Priority: | Monitor |
| Description: Low flashing height. | | | | | |

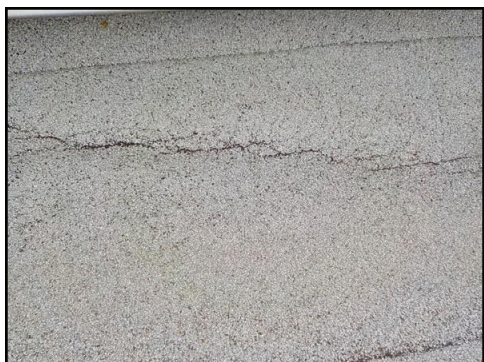
| Defect Code: | 43 | Quantity: | Random | Priority: | Monitor |
| Description: Weathered and deteriorated flashing | | | | | |

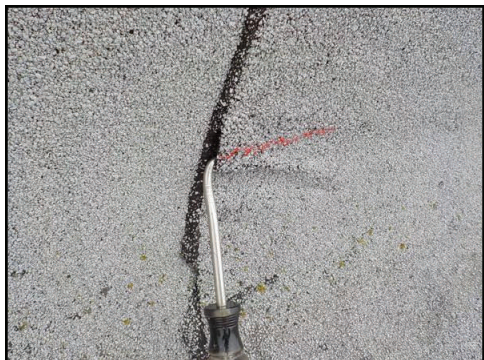
| Defect Code: | 45 | Quantity: | 2 | Priority: | First Year |
| Description: Open flashing lap | | | | | |

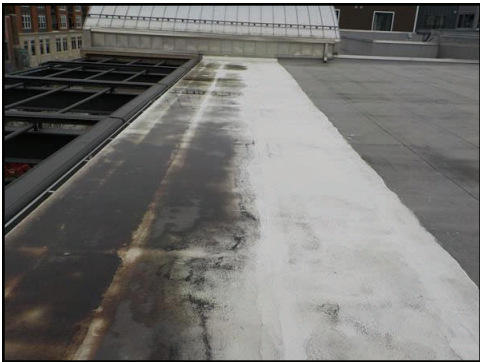
| Defect Code: | 24 | Quantity: | Random | Priority: | Monitor |
| Description: Evidence of past problem and previous repair. | | | | | |

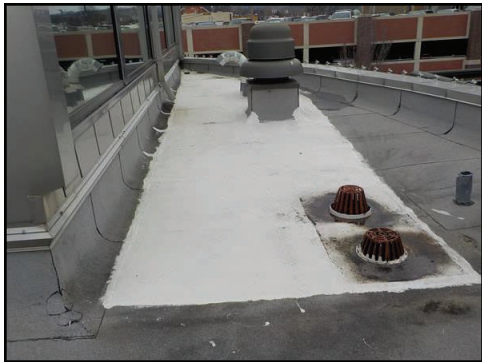
| Defect Code: | 24 | Quantity: | Random | Priority: | Monitor |
| Description: Evidence of past problem and previous repair. | | | | | |

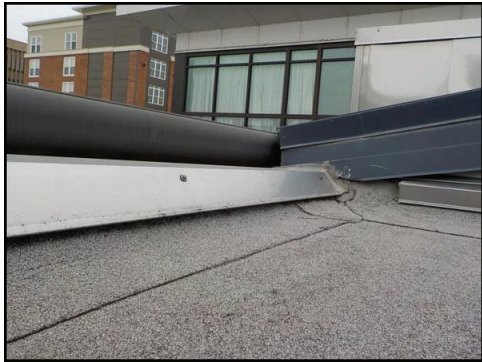
| Defect Code: | 40 | Quantity: | 1 | Priority: | Monitor |
| Description: Low flashing height. | | | | | |

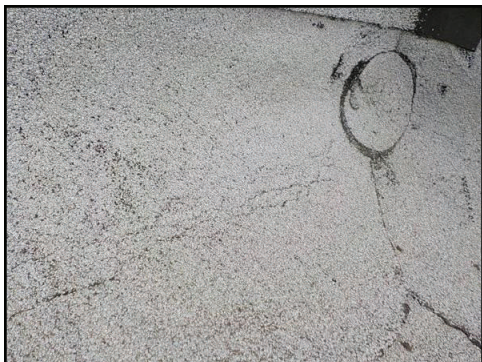
| Defect Code: | 43 | Quantity: | Random | Priority: | Monitor |
| Description: Weathered and deteriorated flashing | | | | | |

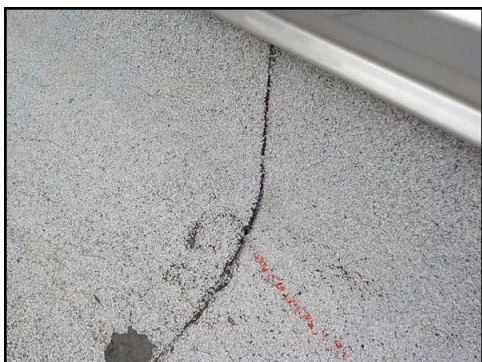
| Defect Code: | 45 | Quantity: | 1 | Priority: | First Year |
| Description: Open flashing lap | | | | | |

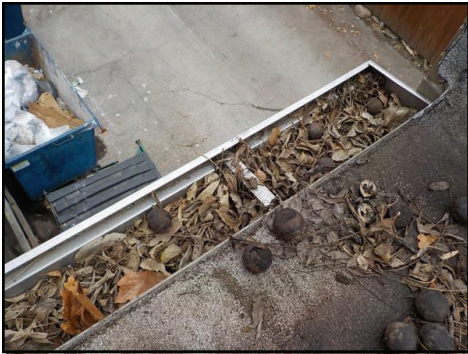
| Defect Code: | 16 | Quantity: | 1 | Priority: | First Year |
| Description: Blocked drain, scupper, or downspout. | | | | | |

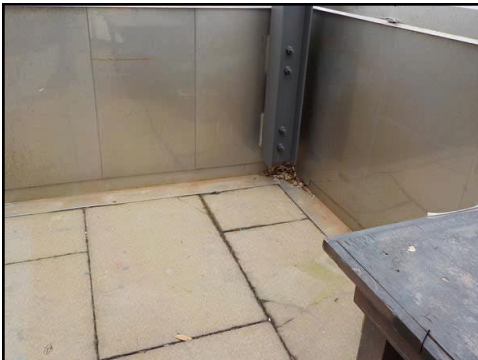
| Defect Code: | 59 | Quantity: | Random | Priority: | Monitor |
| Minor cracks in pavers | | | | | |
