# TURNHALLE

## Historic Structure Report

*Lawrence, Kansas*

*JULY 25, 2013*

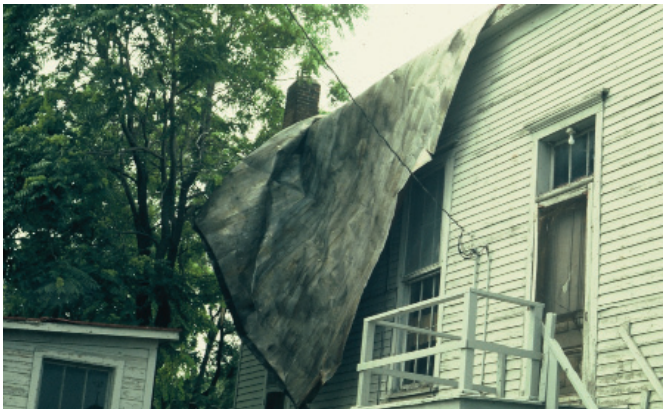
The 1973 storm damage photos show that a metal roof covering has been peeled off the stage addition like the lid off a can. This could have been the original roof covering, as that type of material could have lasted that long. The 1889, 1897, 1905, 1912 and 1927 Sanborn maps indicate a "slate or tin" roof on the addition. Another photo in Larry Miller's collection, likely from the late 1960's, clearly shows the original hall with a metal roof as well. The roof sheathing is solid, not skip-sheathing which is used for cedar shingle roofs. The 1889, 1897 and 1927 Sandborn maps indicate a "slate or tin" roof on the main hall; whereas the 1905 and 1912 indicate a "shingle" roof.

*Storm Damage of Metal Roof, 1973 (Courtesy of Larry Miller). The storm damage photographs indicate a metal roofs at both the flat and gabled roofs prior to 1973.*

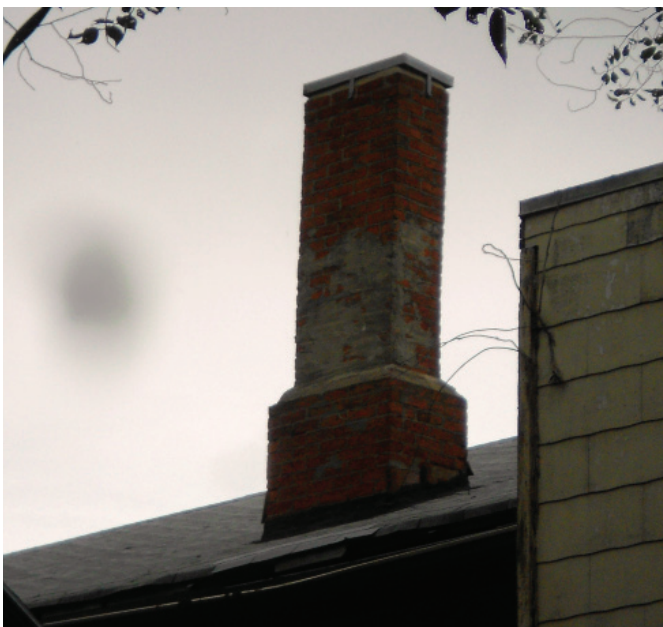
*Chimney on South Slope of Roof*

The front-gabled roof is currently covered by composition shingles with metal edge flashing. The roofing is in poor condition with displaced shingles. Four original brick chimneys penetrate the roofline along the north and south sides of the building. The chimneys have had their decorative brickwork dismantled and are capped with galvanized pipe ventilators for non-functional heaters found in the basement. The chimney flashings are too low. A gutter extends along the south side of the roof and has a downspout daylighting to the southwest corner of the building. No gutter exists along the north side of the roof. An unconnected downspout resides mid-span along the north elevation.

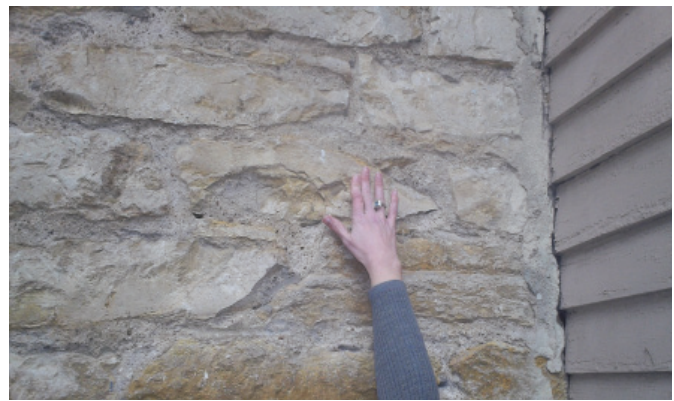
Mortar joint condition varies from fair to poor. The joints have been subject to a number of pointing campaigns over the years. Some of these repairs were well executed and others not. Four distinct colors of pointing mortar can be identified that are not the original mortar. None of these pointing activities have been entirely comprehensive. Local mason, Karl Ramberg, performed some repairs on the west and south face in the mid 1990s. He recalls that the north, west and south elevations were pointed in the mid 1980s, but does not know who performed the work. Another local mason, Keith Middlemas, re-set the keystone above the entry c.2000 because it had slipped down. Some repointing in this area appears to have been accomplished as part of this work. The original mortar appears to be a lime sand mix, as it is very soft and crumbles under firm pressure applied with the fingers. Repointing mortars all appear to have some Portland cement content, based on color and relative hardness.

*Original Pointing Mortar on South Elevation*

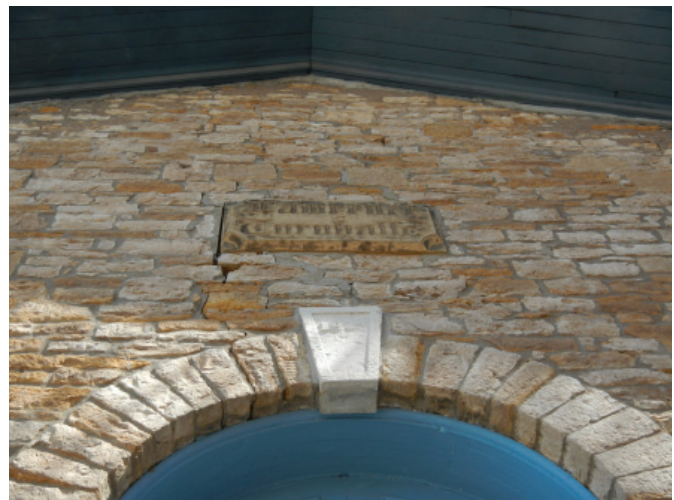
The west wall has bowed outward. This is evidenced on the outside by a crack that begins at the keystone of the central arch running vertically along the north side of the cartouche and up to the gable. There are also vertical cracks above the south window on the west elevation and along the west face of the southwest corner.

*Vertical Crack Along Keystone and Cartouche on West Elevation*

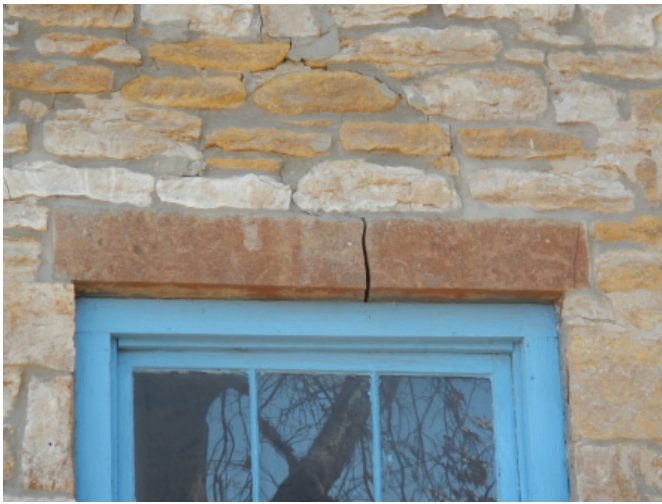
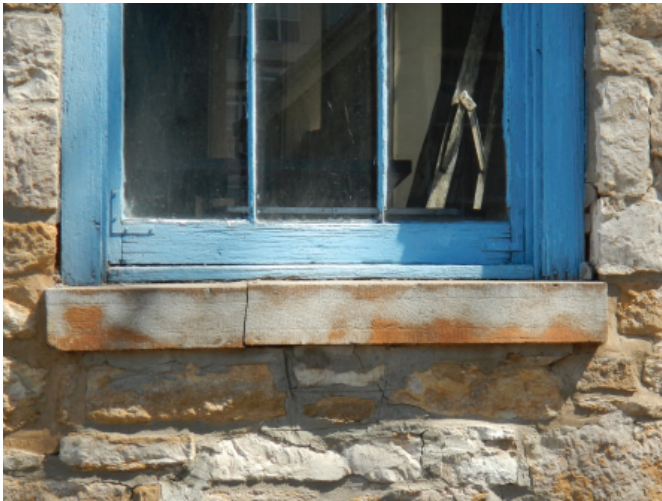
*Cracked Window Lintel and Windowsill*

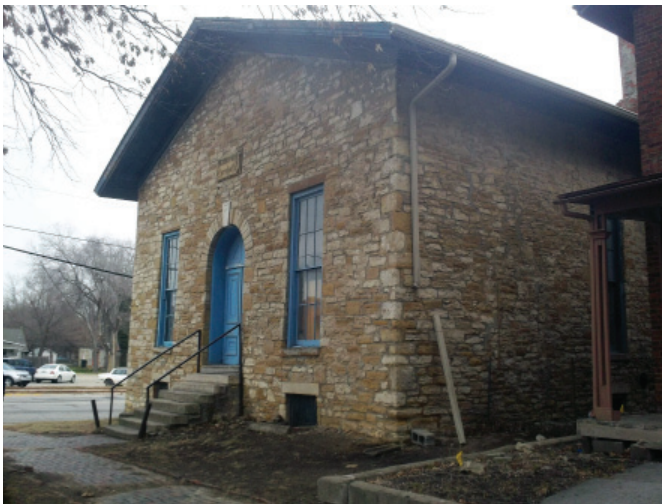
*Disconnected Downspout at Southwest Corner (since reconnected)*

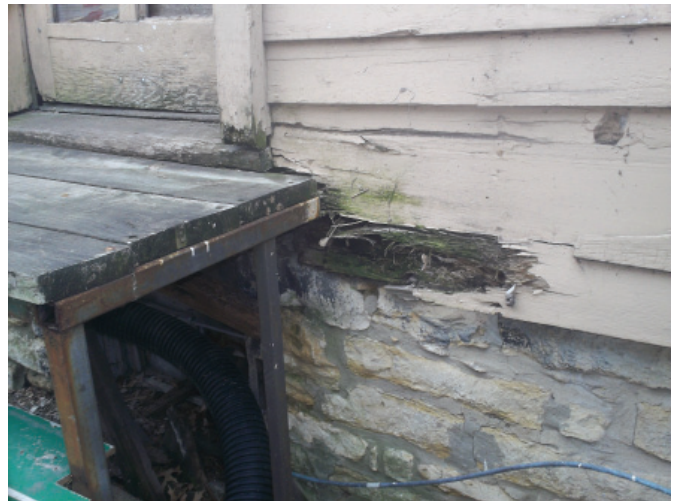
*Deteriorated Wood Siding on East Elevation*

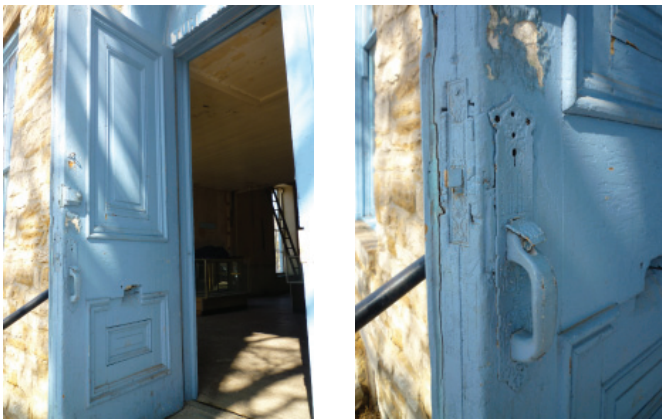
*Original Pair of Wood Entrance Doors and Hardware*

The most significant door opening is the pair of main entrance doors on the west elevation. This ornate pair of paneled wood doors retains much of its original fabric and is in fair condition. The historic photograph indicates that the doors are original to the construction of the building; however, a previous alteration replaced the glazed fanlight transom with a wood paneled transom. Also non-extant are the pair of interior swinging doors, possibly screen doors, of which only the hinges are intact.

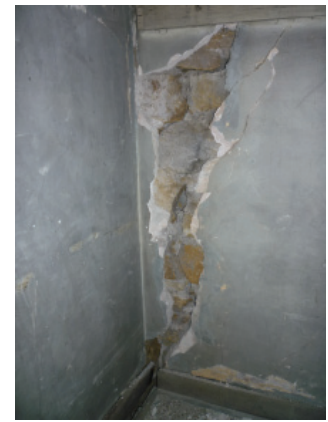
*Plaster Deterioration as a Result of Structural Settlement*

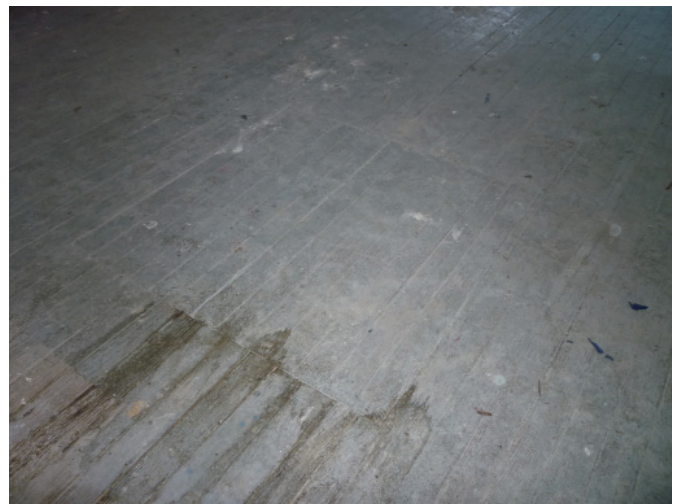
*Stage Wood Floor. Scars in the stage floor and basement tin ceiling below indicate a change in configuration at the stage floor.*

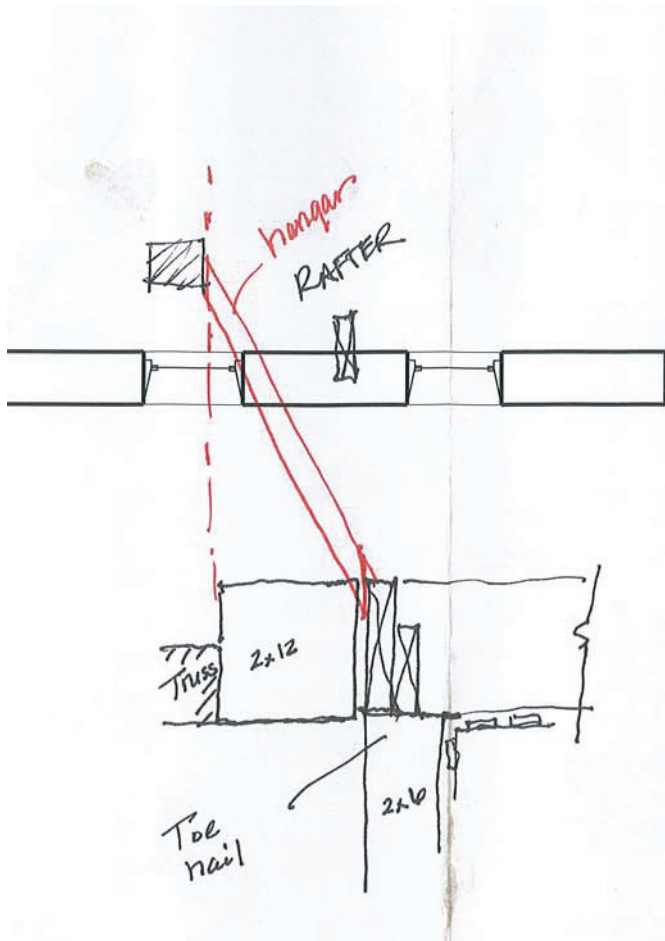
*Sketch of Existing Roof Conditions*

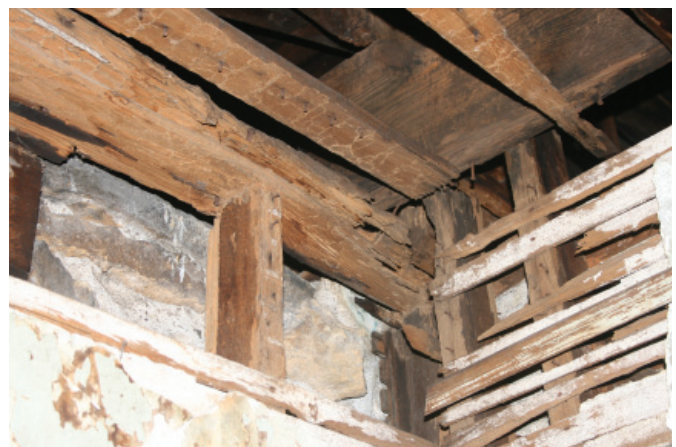
*Badly Deteriorating Wood Bearing Wall at South End of Stage*

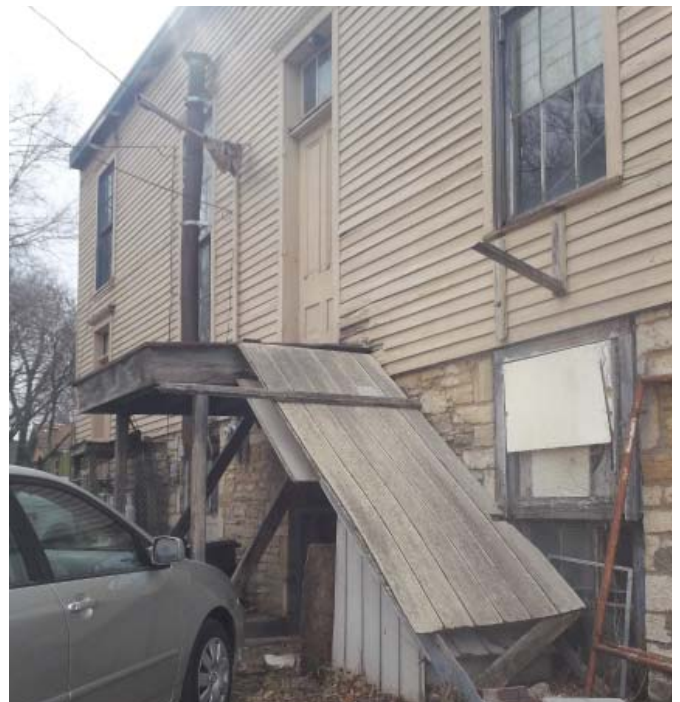
*There are several features on the east elevation that exhibit low integrity. The rear wood stoops and steps are deteriorated and it is unclear how the exits have been modified over time. The windows on this elevation have also been modified by the insertion of exhaust ductwork. Enough material remains, however, to restore or replicate these features.*

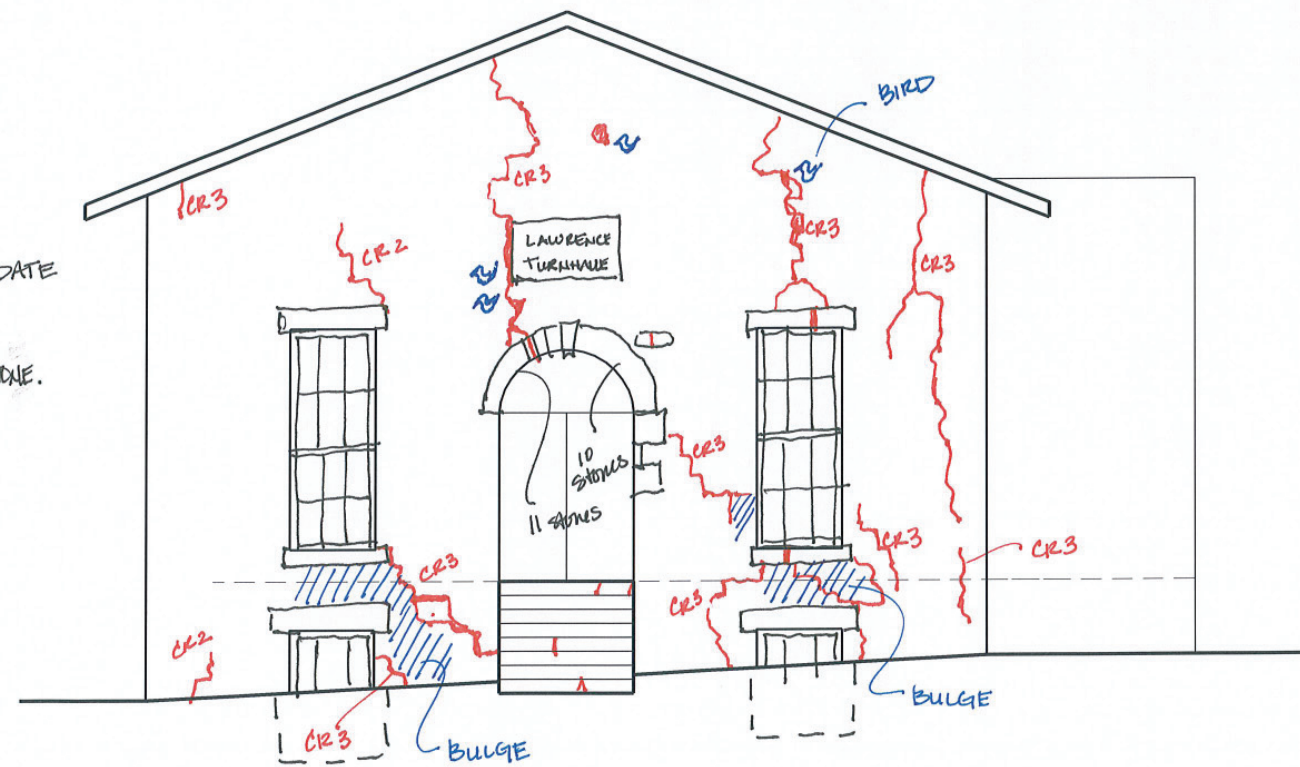
West Elevation **A2**  
1/8" = 1'-0"

- BASEMENT LINTELS: LIMESTONE  
NOT THE SAME AS 1<sup>ST</sup> FLOOR
- 3 REPOINT REPAIRS (AT LEAST) SAND IS MUCH FINER THAN ORIG
  - UMBER - MOST PREVALENT
  - OCHRE
  - GRAY
- LINTELS & SILLS HAVE DRESSED MARGINS & BUSHED FIELD
- KEystone IS DRESSED & DATED - DATE IS FADING/ERODED
- TURNHALLE SIGN IS VERY FINELY DONE SCRIPT - MIGHT BE SANDSTONE.
- FEW CRACKED STONES BUT UNITS ARE IN GOOD CONDITION
- CRACKS ARE PRIMARILY AT JTS.
- OPEN & DET. JTS.
- ORIG. MORTAR BEHIND REPOINT IS SOFT, CRUMBLES TO TOUCH, SLIGHTLY HARDER THAN FOUND INSIDE  
LARGE SAND GRAINS.
- SOILING IS LIGHT - EXCEPT FOR SIGN  
BLACK BIO OR GYP CRUSTS -
- FRONTS OF STEPS LOOK LIKE THEY WERE DRESSED LIKE LINTELS TOPS SMOOTH

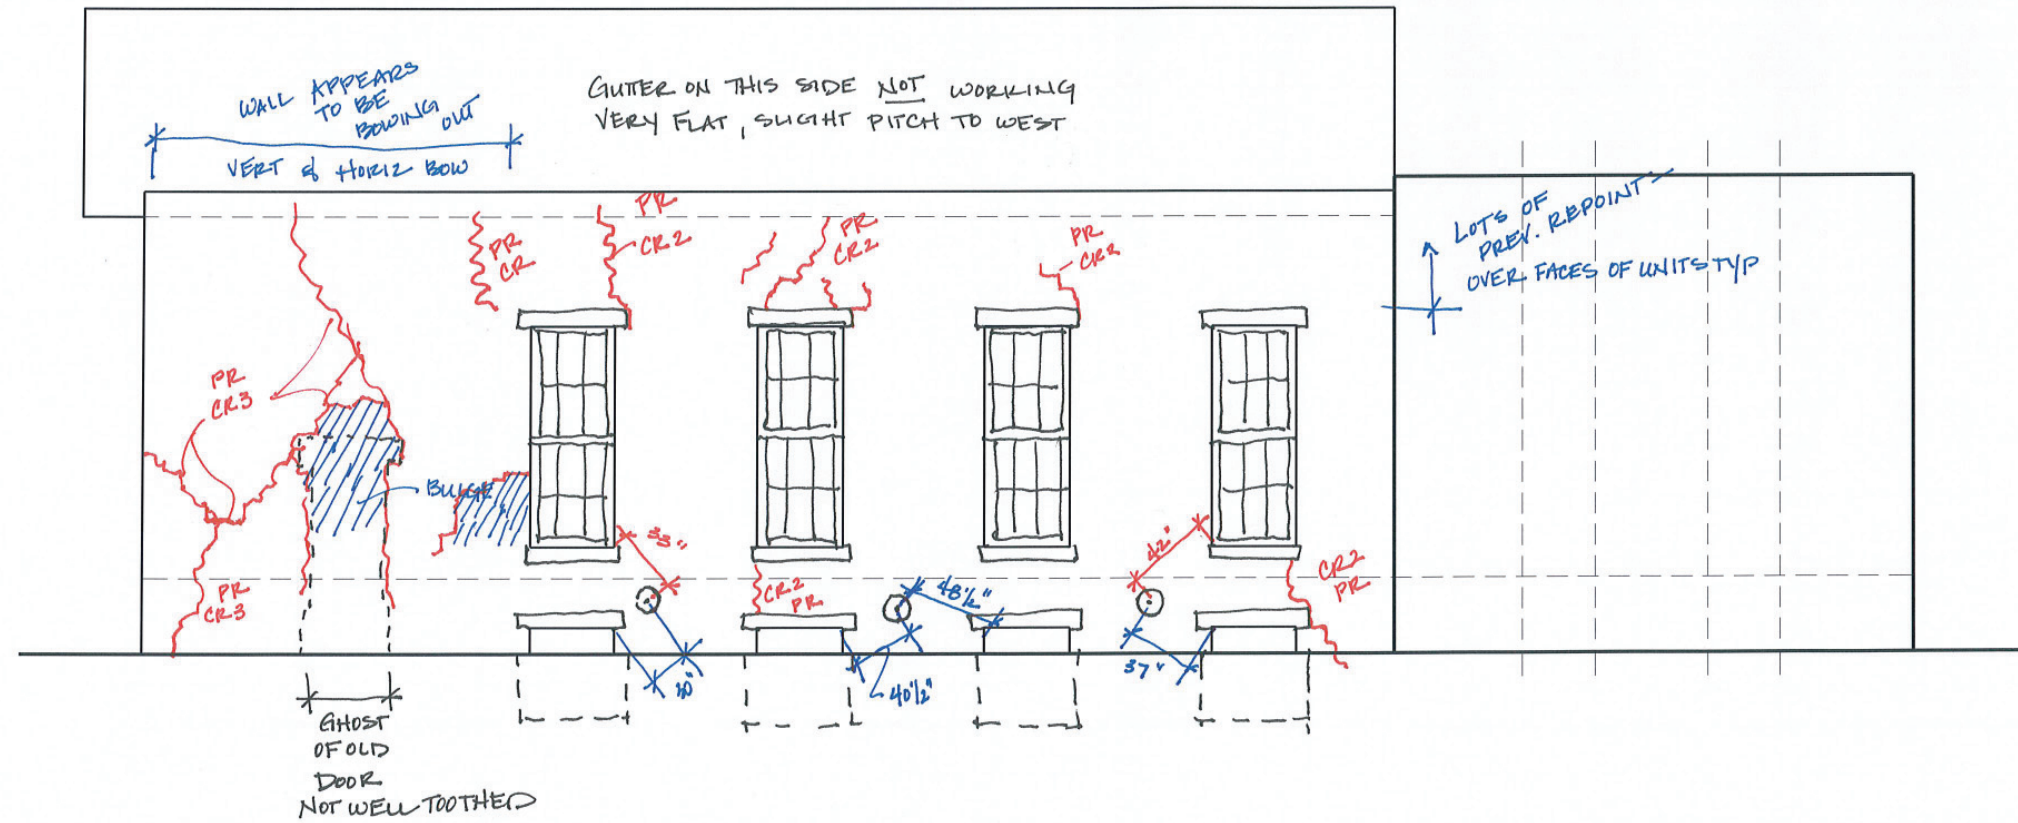
South Elevation **A3**  
1/8" = 1'-0"

- REPOINTING GENERALLY NOT GOOD - DOESN'T APPEAR TO BE RAKED PRIOR, LOTS OF MORTAR OVER FACES OF UNITS
- SOME PARGING w/ MORTAR AT WINDOW JAMBS.

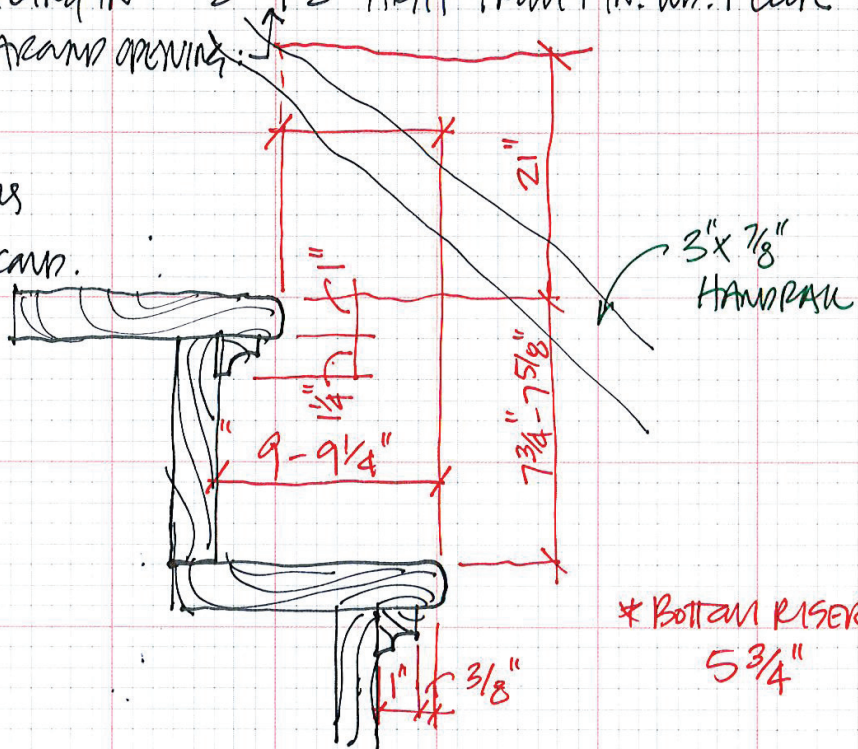
TREADS/RISERS  
 WOOD, FAIR COND.

TOP 5 TREAD NOSINGS WORN; MAY NEED REPLACEMENT

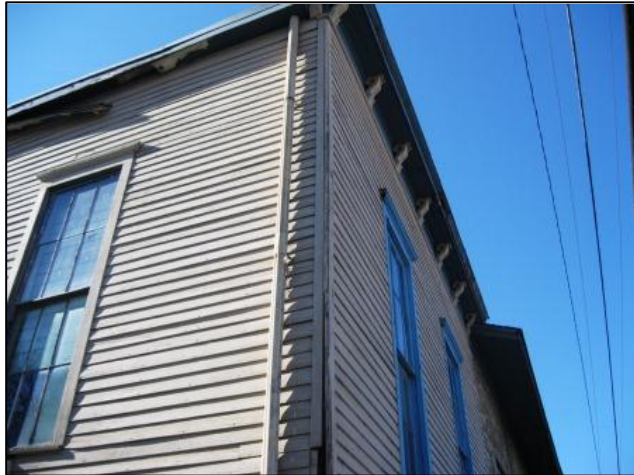
Deteriorated LBP on the exterior siding, trim, window, gutter/downspout components

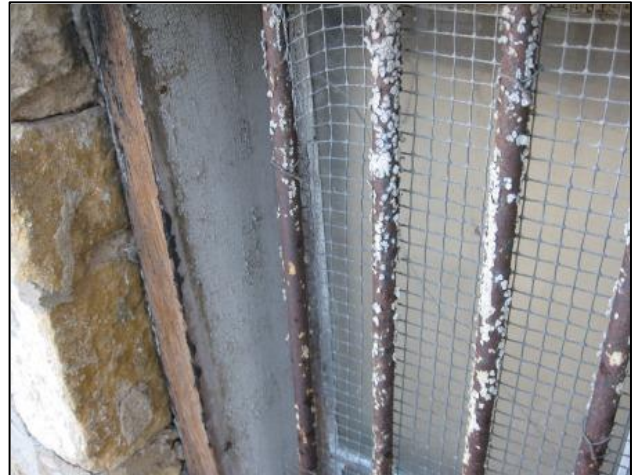
Deteriorated LBP on the exterior window components & window bars

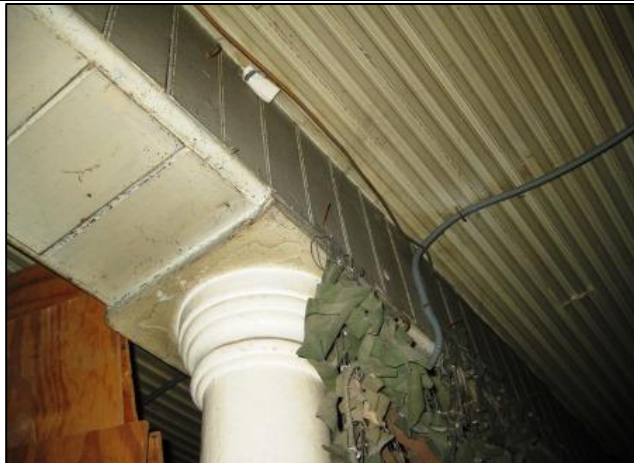
Deteriorated LBP on the interior basement ceiling, beam and column

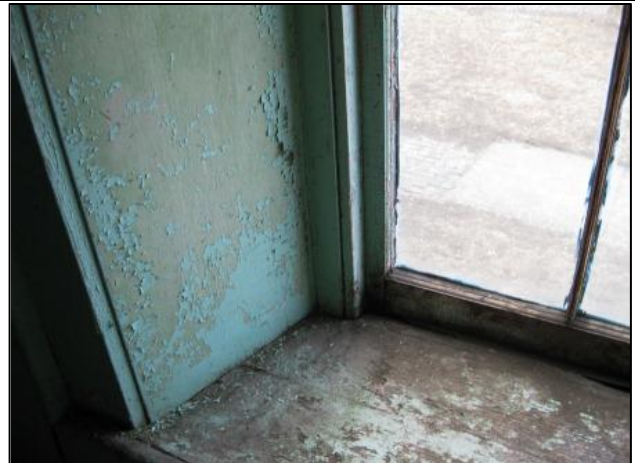
Deteriorated LBP on interior 1<sup>st</sup> floor window components

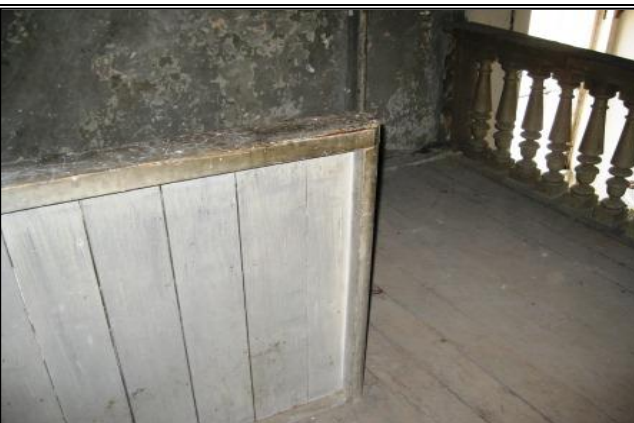
Deteriorated LBP on the interior balcony half wall, railing components, baseboards and floor

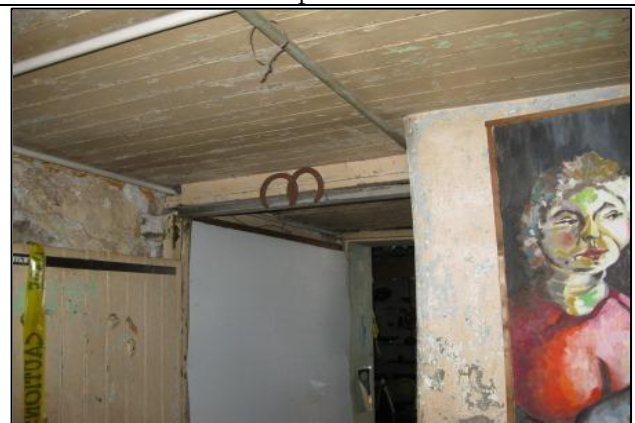
Deteriorated LBP on the interior basement bathroom walls and trim
