Carnegie Building Roof Rehabilitation Phasing Plan

**THE CARNEGIE BUILDING
PARAPET WALL REHABILITATION**

200 West 9th Street
Lawrence, KS 66044

DGM Consultants, P.A.

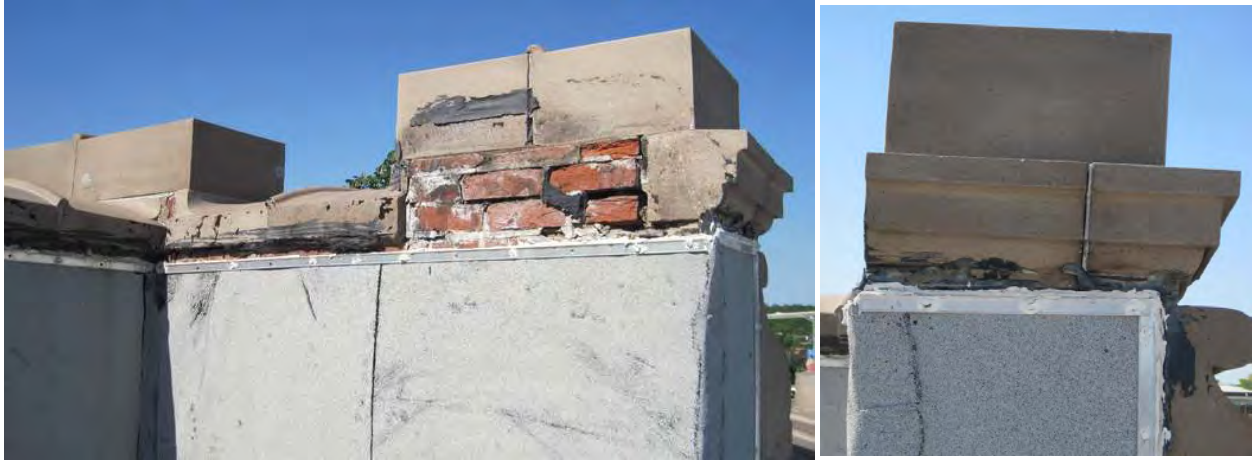
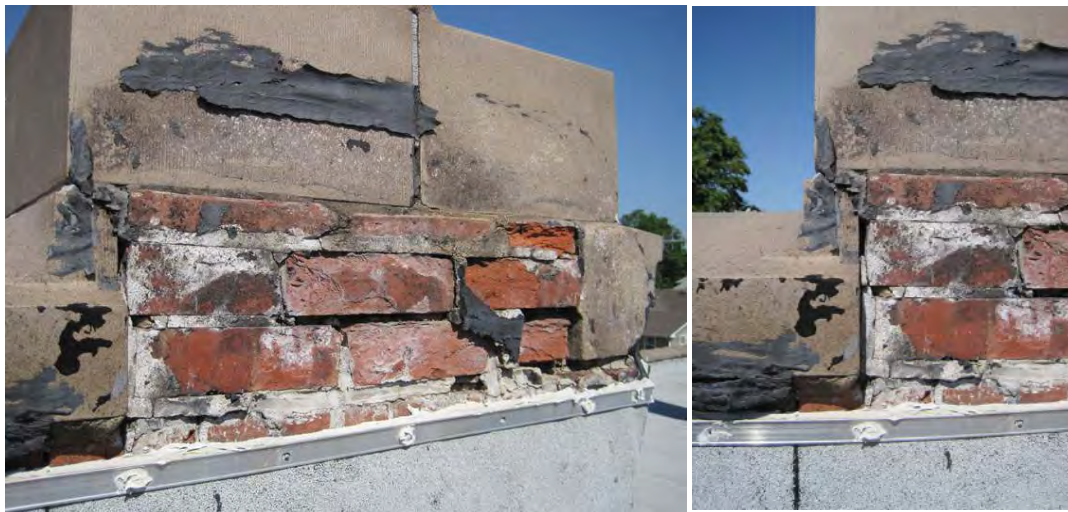
- i) The west wall was surveyed first. Most vertical joints between stones are open and the previously covered brick is deteriorated.

The original mortar joints are severely deteriorated or open and the previous pointing is failing.

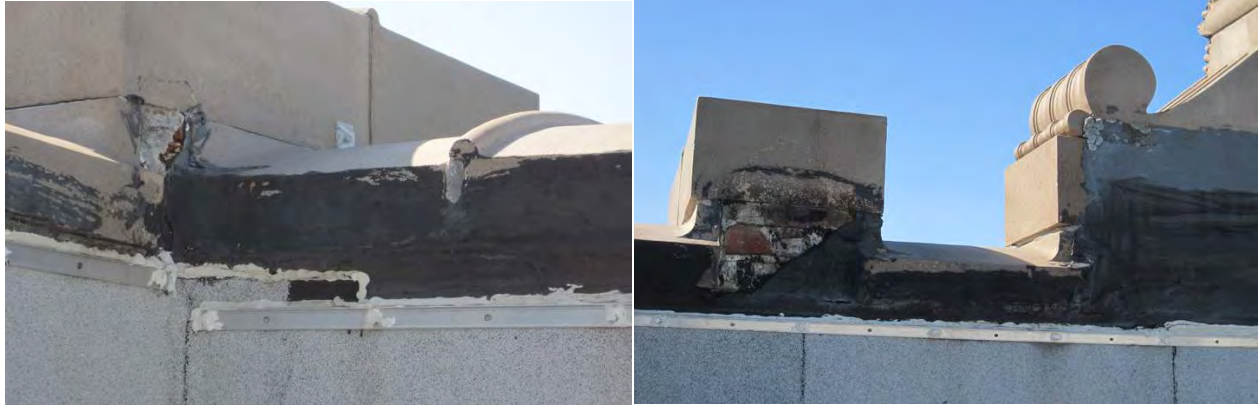
East of the center section, similar conditions were noted.

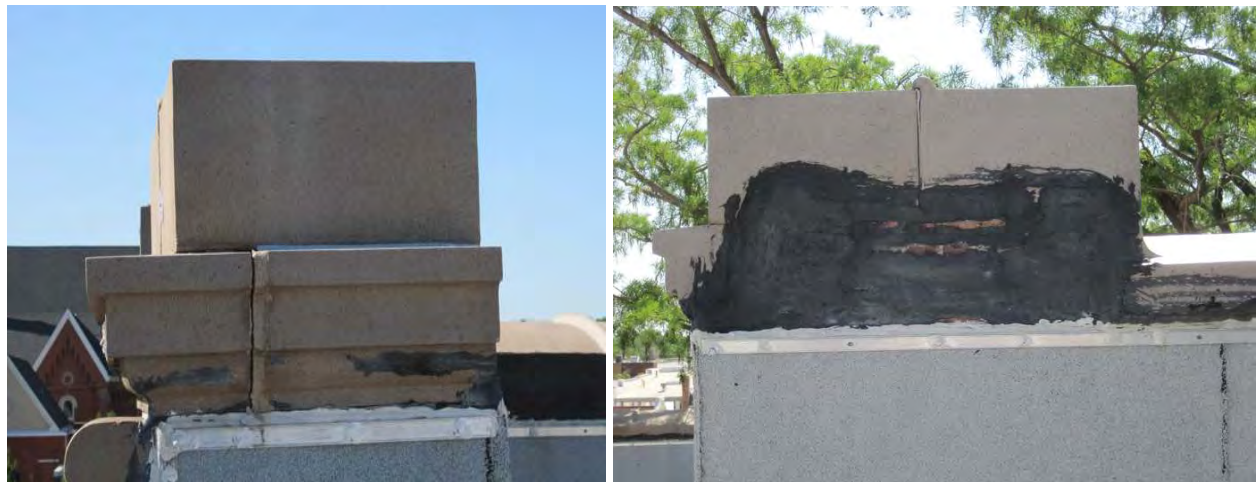
- iii) East wall, at the inside corner, did not appear to be as deteriorated as the opposite condition at the west wall, but joints were noted as being partially open.

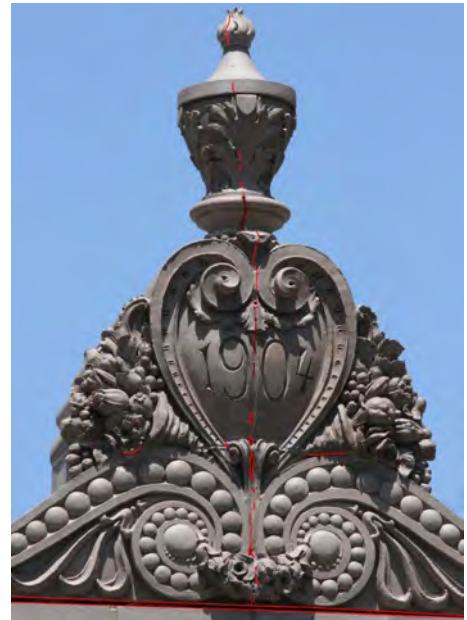
- iv) From the south face, the terra cotta finial on top of the wall looks to be in good condition, except for numerous open joint lines and a few cracks (highlighted in red).

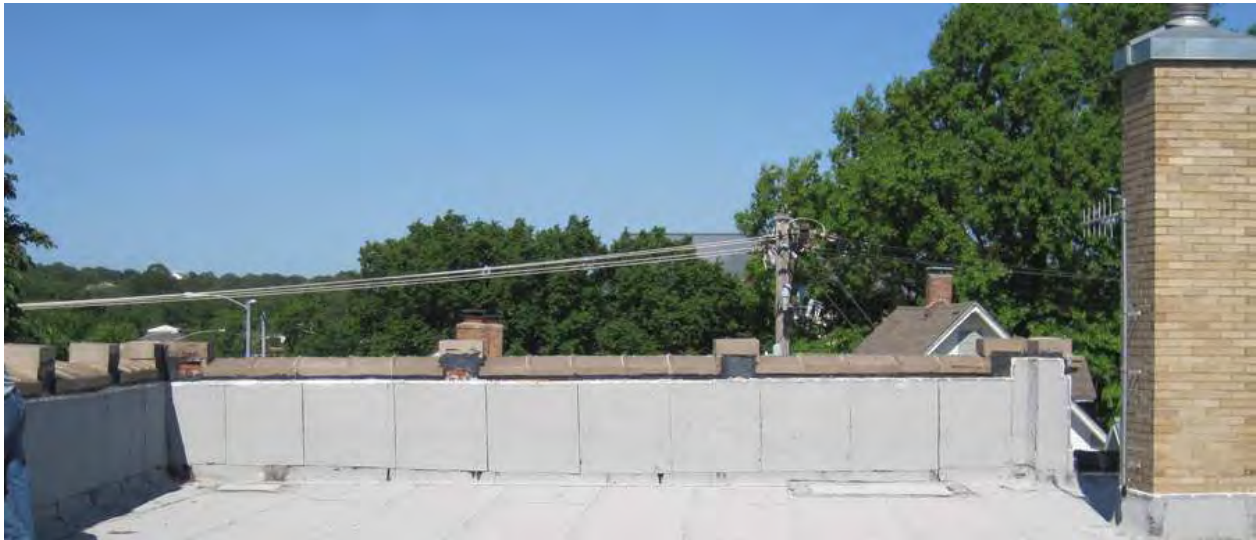
- (3) West parapet wall (31'-4"): The deteriorated conditions along this wall are

similar to the other walls.

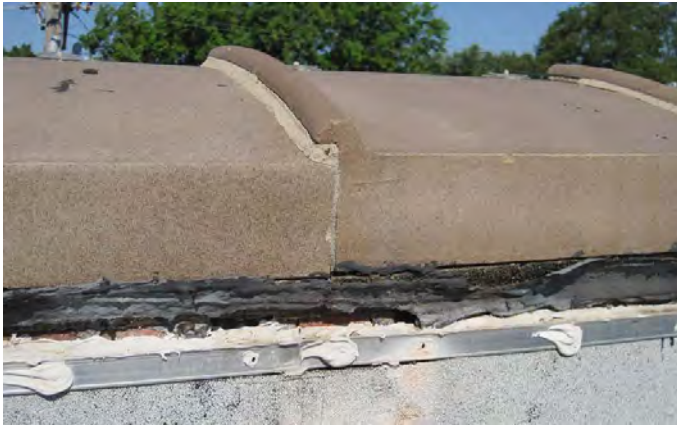
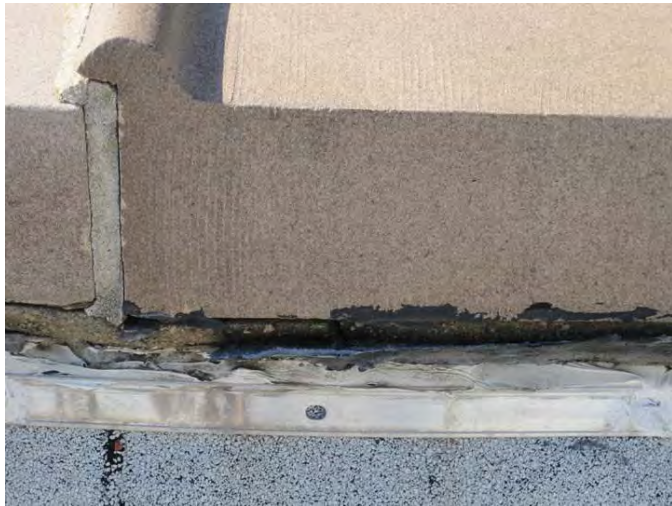
- (4) Terra cotta coping: Copings appear to be a very durable material, based on the noted condition in most locations. We noted several chips, open joints, and gaps under the coping. Several of the open joints noted were a direct result of the leaning walls. Refer to pictures on next page.

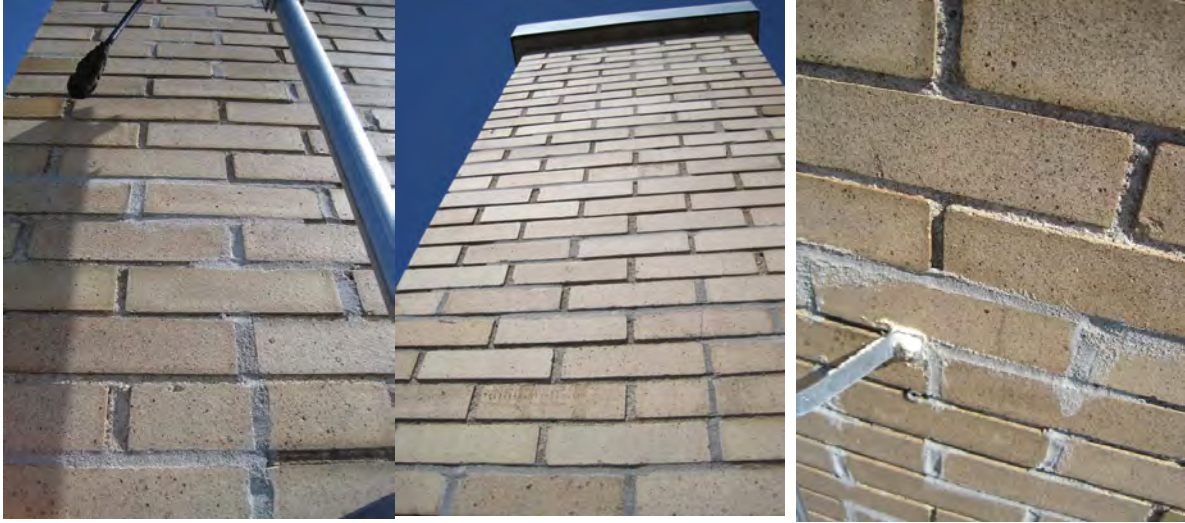
- d. Chimney: The original chimney extends above the roof quite a ways. The mortar joints are weathered and some joints appear to have been pointed, but others not at all. Pointing appeared to be improper at several locations.

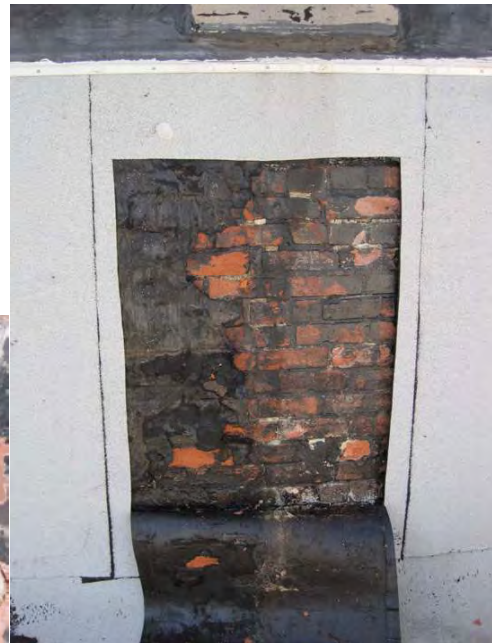
- (1) The first was at the center section. After folding the roofing down we noted the wall to be visibly wet from the glistening surface moisture. The brick backup wall had been coated with an asphalt coating subsequent to some pointing and the bricks were spalling.

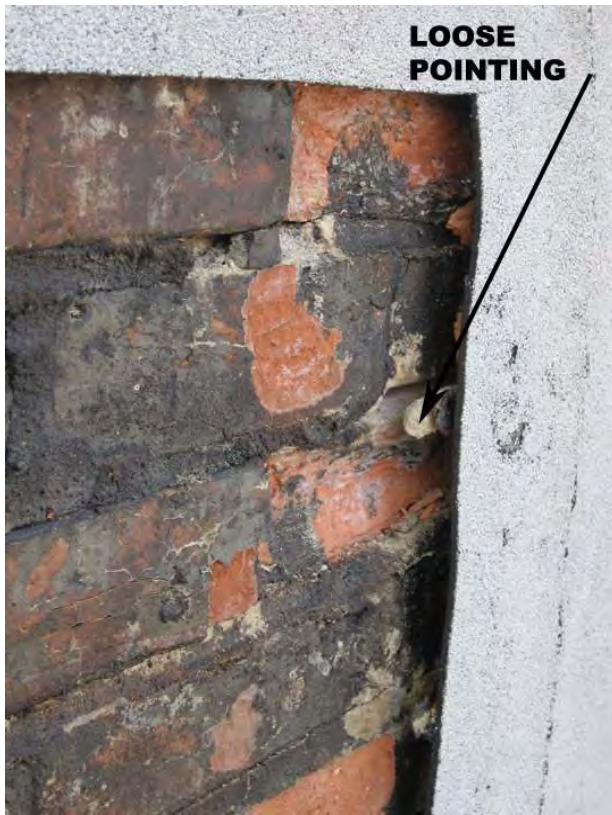
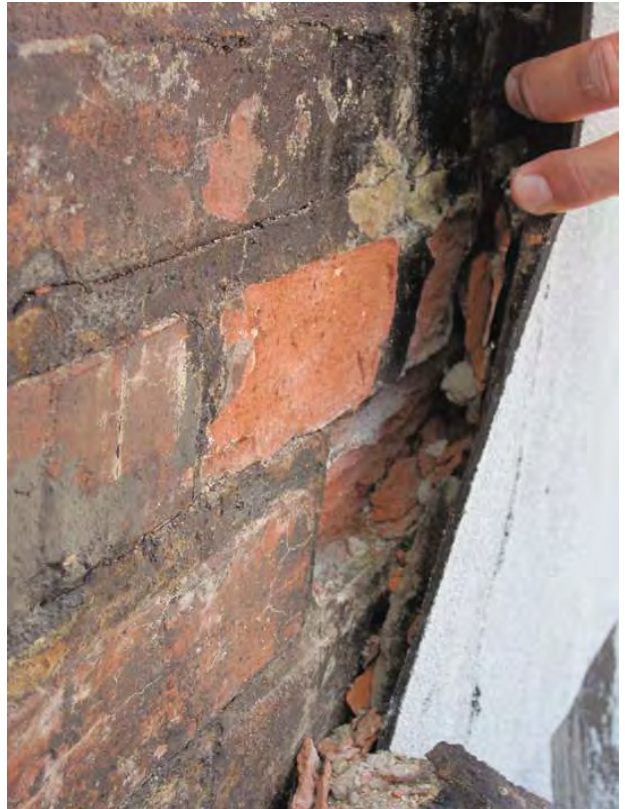
- (2) The second was the east parapet section.
- (3) The mortar original mortar joints were wider than the exterior joints and they were severely deteriorated. Previous pointing attempts appeared to be just shallow joint fills that were not

bonded to the brick well or deep enough.

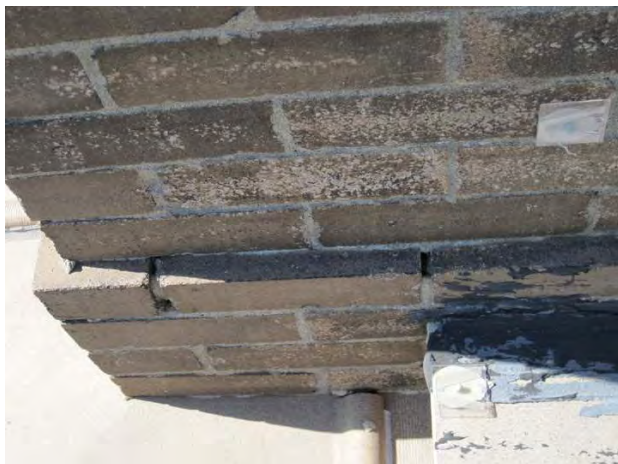
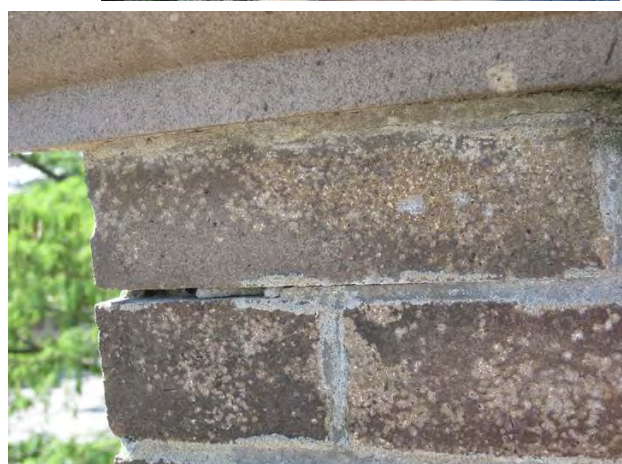
- (1) At the end of the original return wall we noted some open mortar joints in the brick.

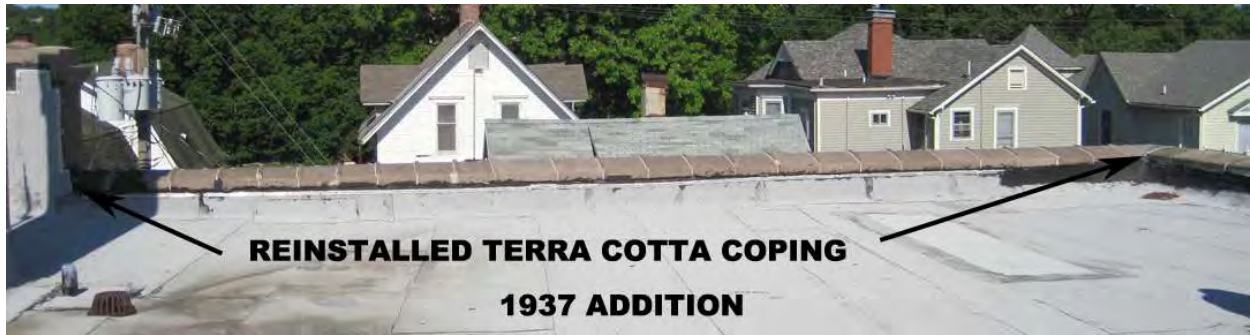
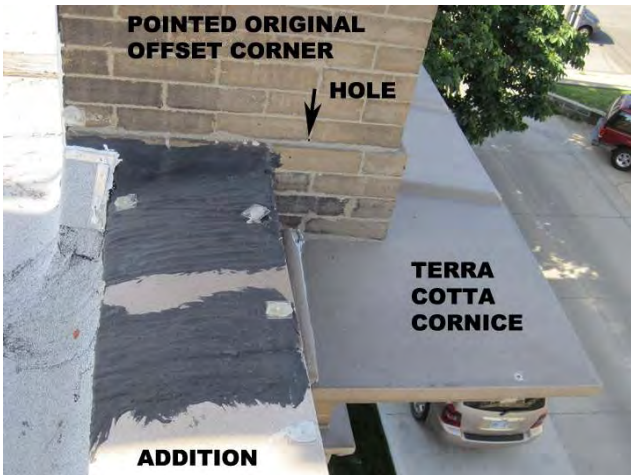
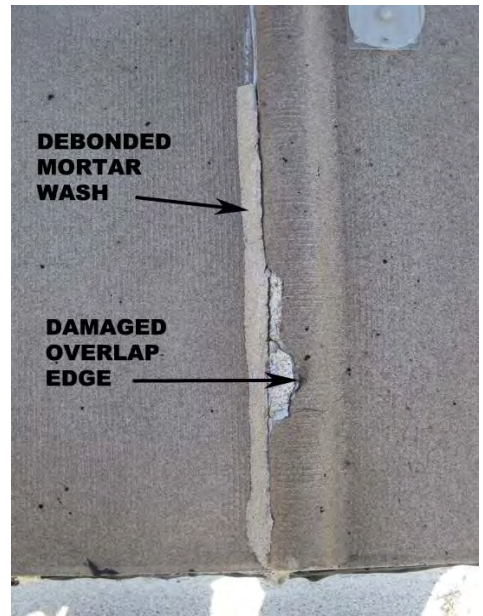
- c. West wall (36'-5"): Wall is capped with 25 terra cotta coping units, plus three pieces at the corner, from the original building that was replaced by this addition. These terra cotta coping units are in good condition, except for several chipped units and open joints.

The coping at the northwest corner has been made by mitering three original pieces.

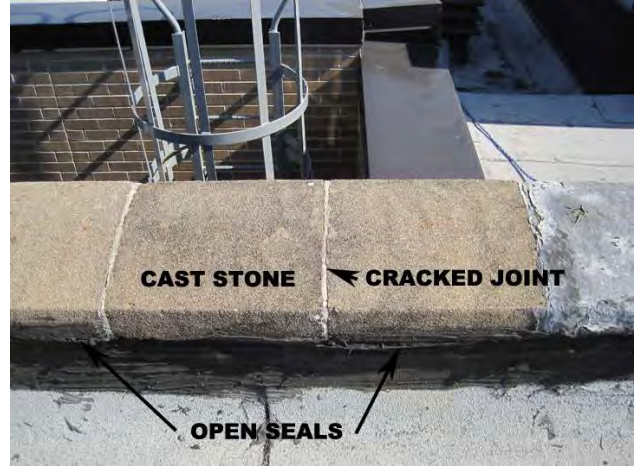
(1) The copings on the north wall are cast stone units that are of a similar cross section as the original, but 24 of the 47 units are severely deteriorated and joints are cracked.

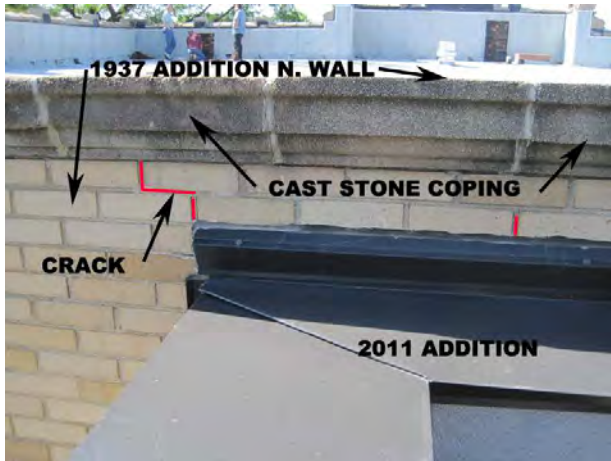
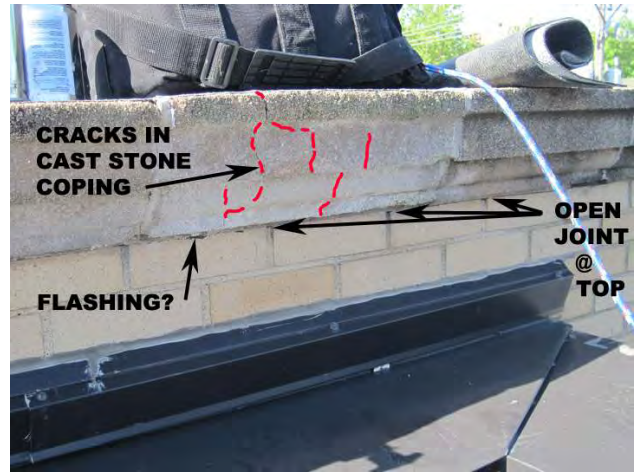
(2) The north face of this coping wall was reviewed from the 2011 Addition roof. Cracked units and gaps in brick wall below were noted.

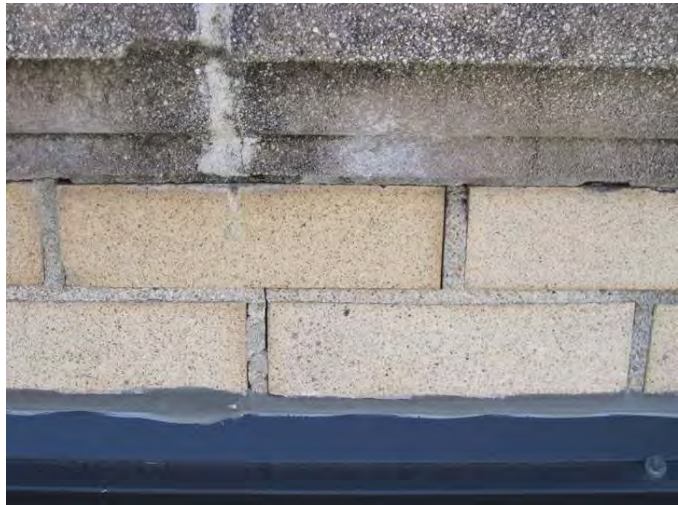
Flashing appears to be projecting from under the coping. The 1937 drawings show a “fabric waterproofing” sheet under the coping. The cracked mortar joints allow moisture to enter the wall.

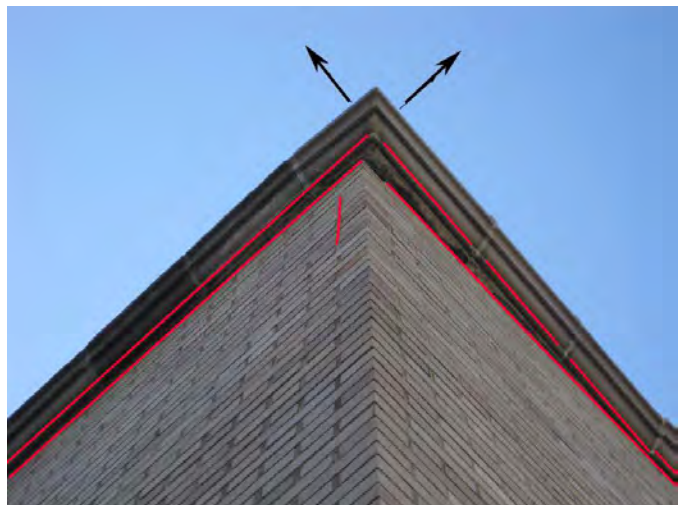
- (3) At the northwest corner (from the ground), we noted that the coping was being pushed off the wall in both direction but more toward the west since the north wall is twice as long. The expansion toward the west has also cracked the brick wall below.

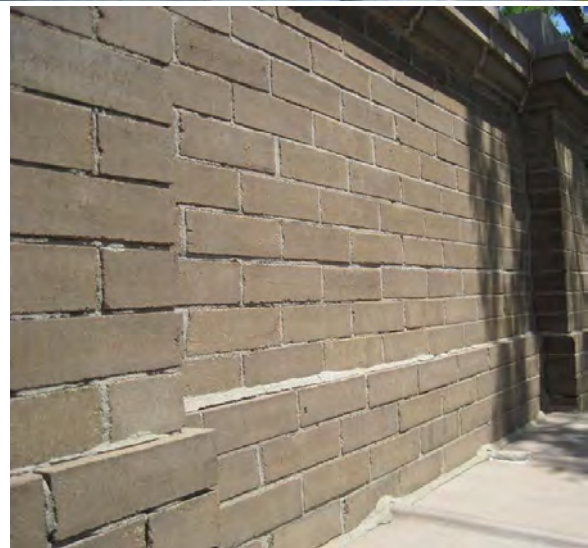
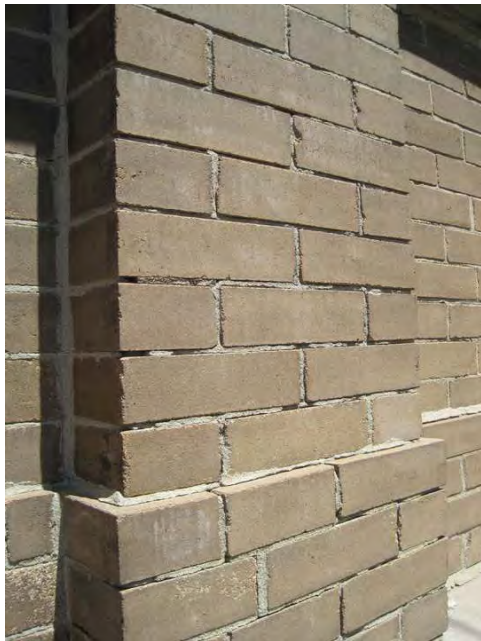
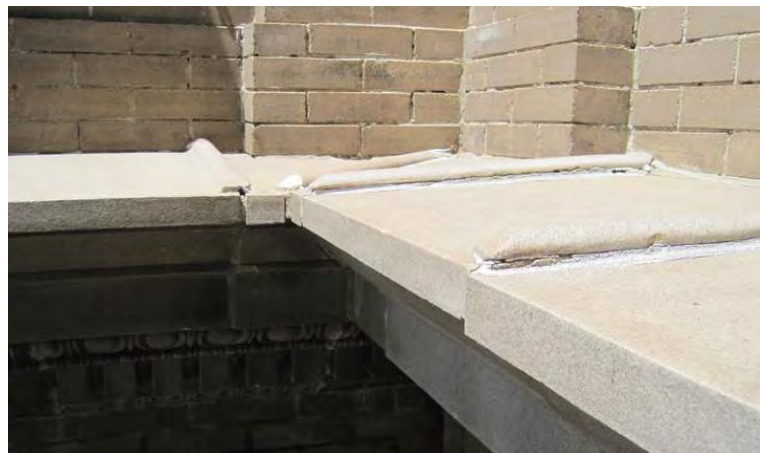
- (a) Some parapets were accessed with a ladder
- (b) Eastern
 - i) Accessed with a ladder.
 - ii) Narrow mortar joints are weathered. Some pointing has failed. Watertable is in good condition, but some open joints were noted.

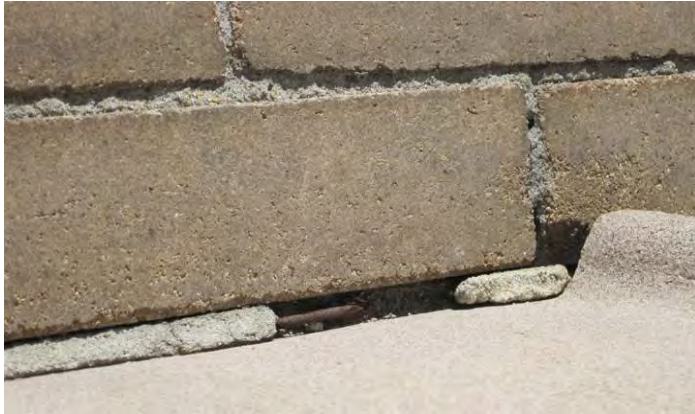
- iii) Pointing at base of parapet wall (at watertable) appears to be installed

improperly and holes were noted in mortar joints.

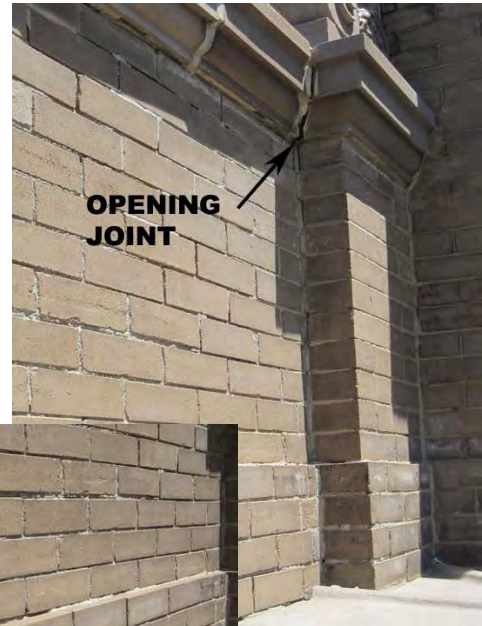
- iii) Displaced units were noted near the top of wall (photo right).

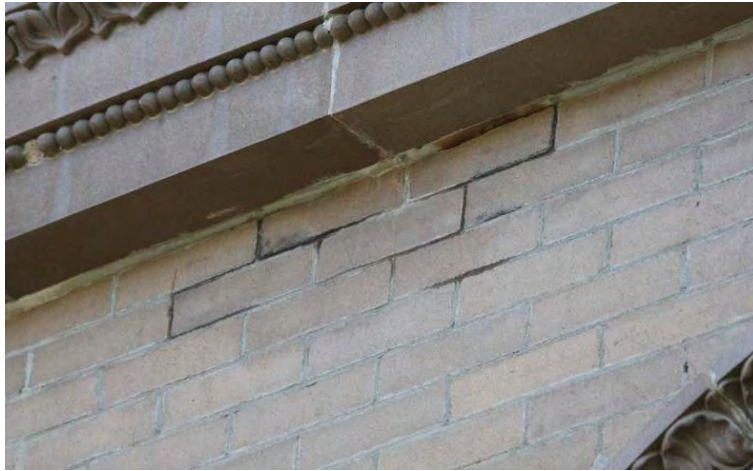
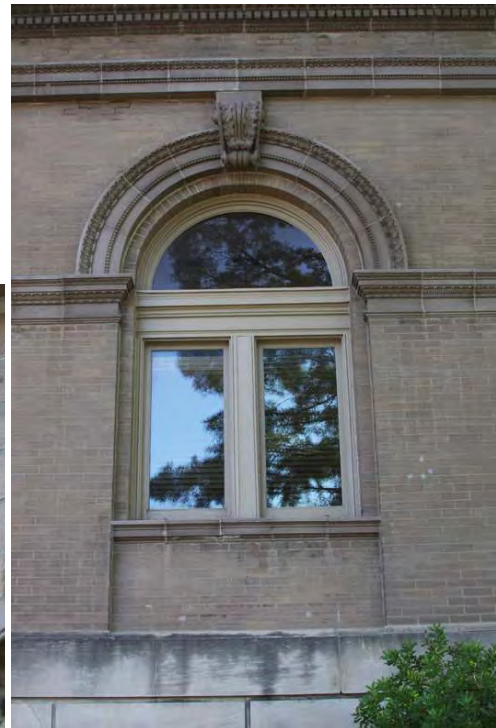
- (3) Eastern wall
 - (a) Looks relatively good, except for some biological staining below the window and along the top of the foundation wall. Some joint discoloration was

noted at upper left of window, suggesting a leak.

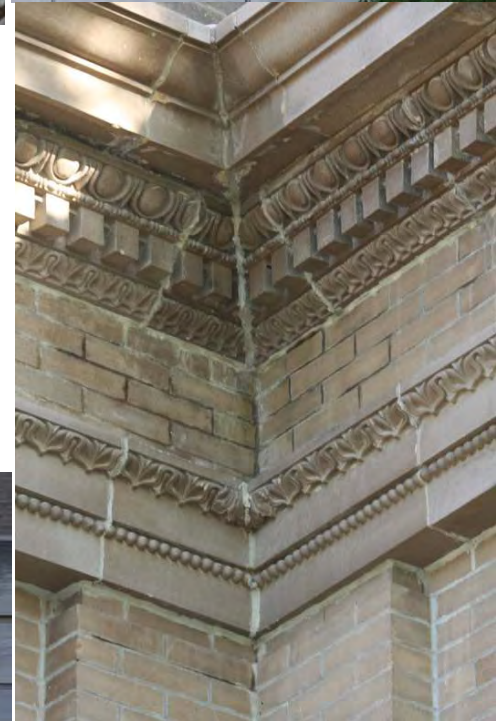
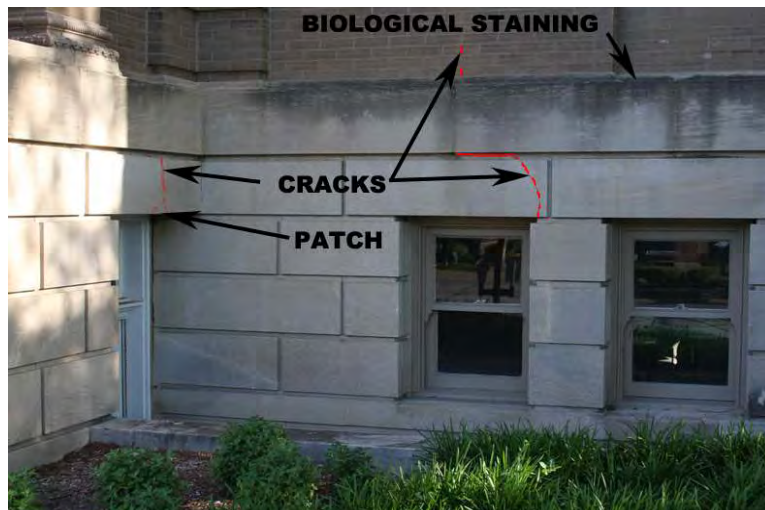
- (b) Signs of moisture coming through terra cotta joints were noted at the inside corner below the watertable.
- (c) Cracked lintels were noted at two basement openings. One crack extends up into the brick wall. Previous pointing and crack repairs,

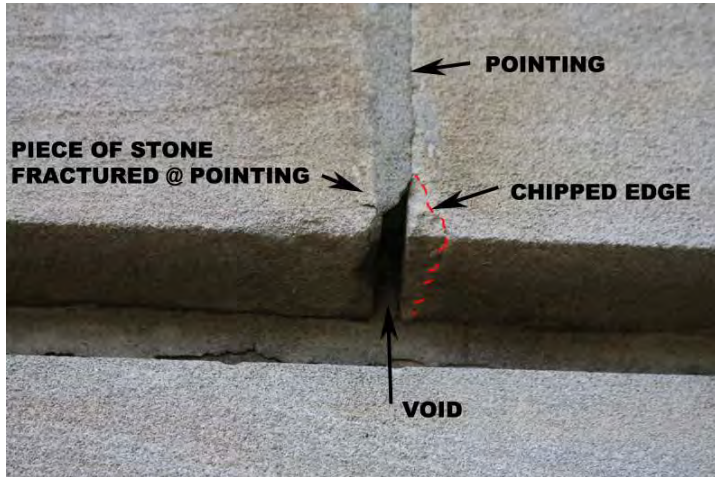
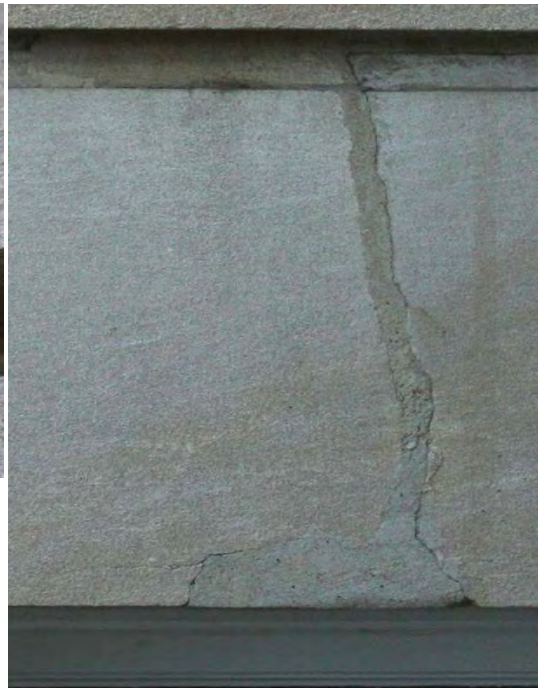
near this location, are a concern. The pointing repair seems to be too shallow and as a result the edges of the stone foundation wall are cracked and chipped. Reference photos at the top of the next page. No guardrail at lower level stairwell.

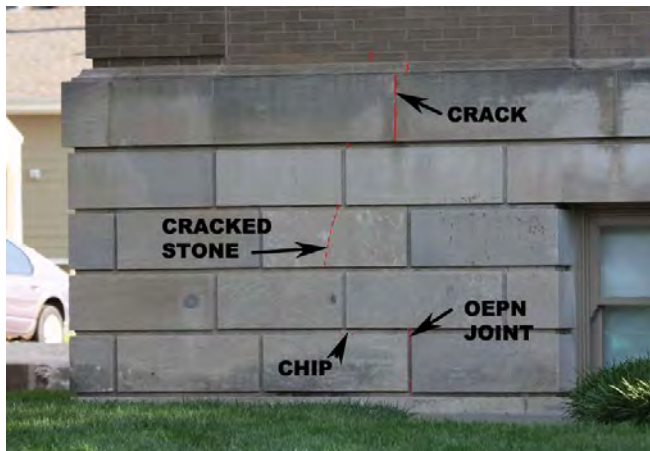
(5) Western wall
(a) Noted a few cracked joints and

cracked stones in the foundation wall. Biological staining was also noted along the top of the foundation wall.

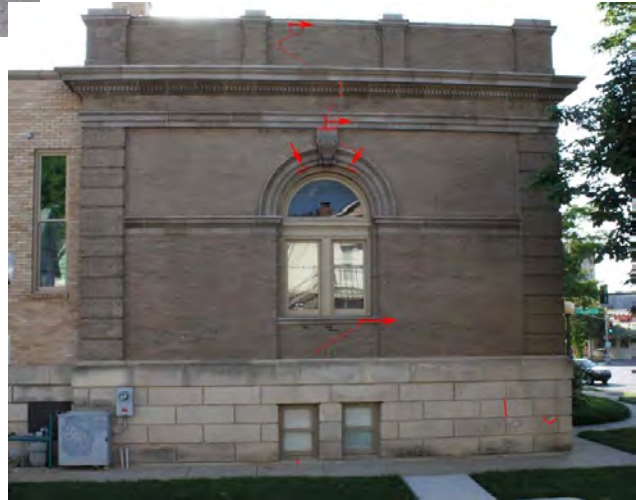
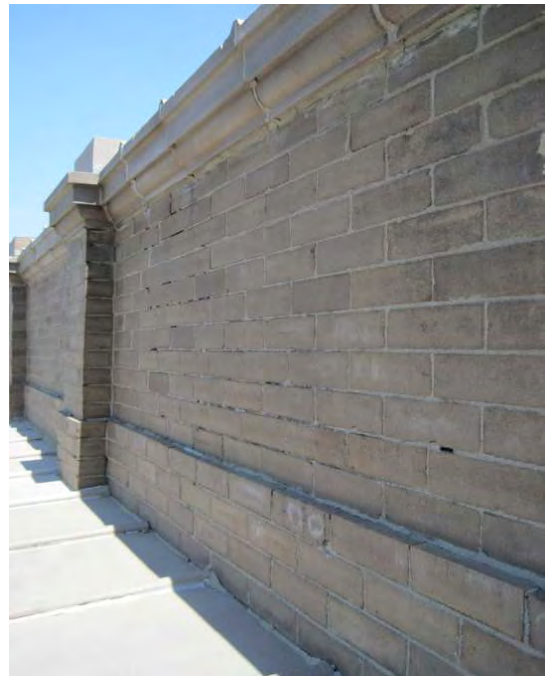
(a) The parapet was accessed with a ladder
(b) Mortar joints appears to be deteriorated in several locations.

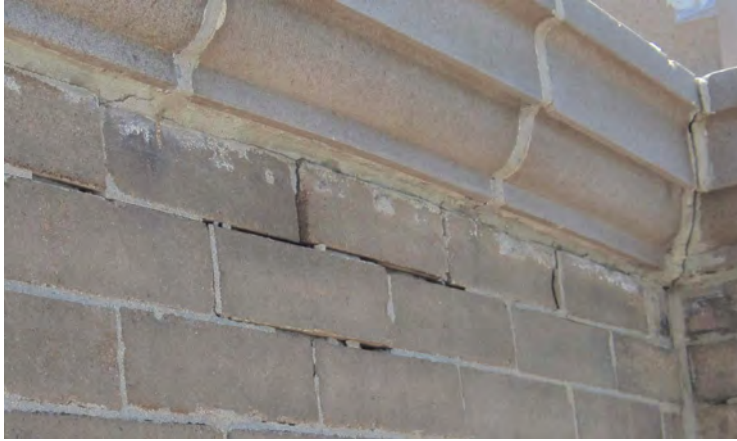
(c) Displaced bricks were

noted at another location.

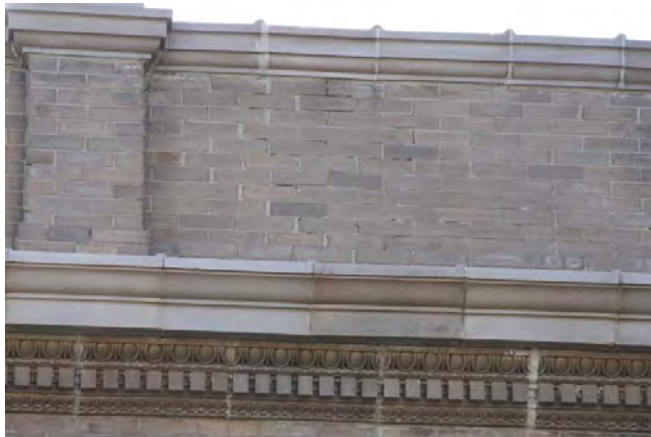
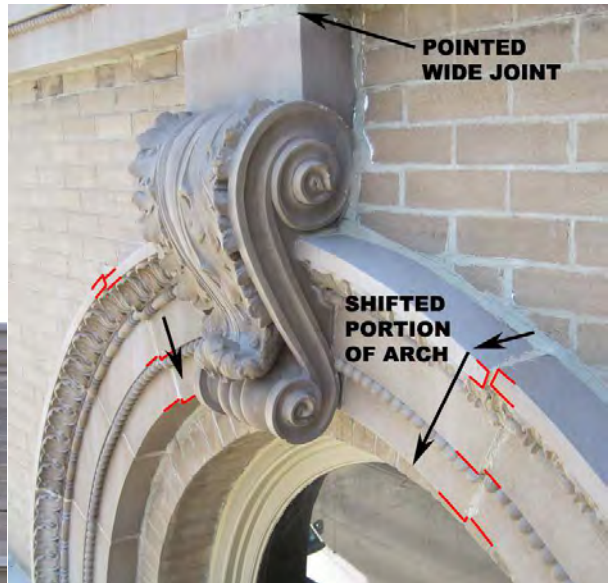
- (3) Original building foundation settlement:
(a) Displacement of arch stones at window head.
(b) Repaired crack at top of wall.

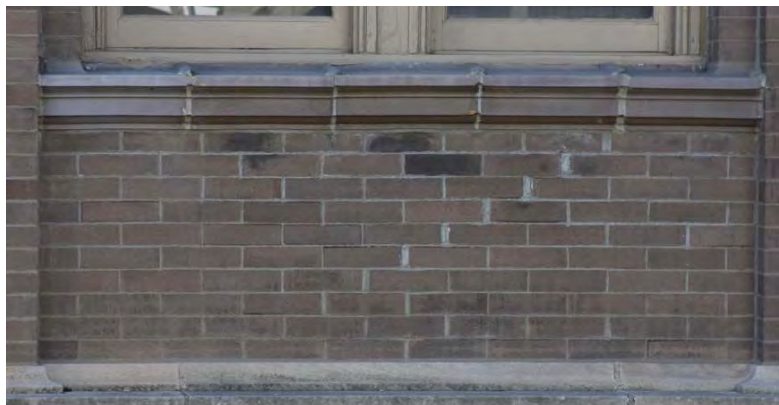
(c) Repaired crack in brick wall below window.

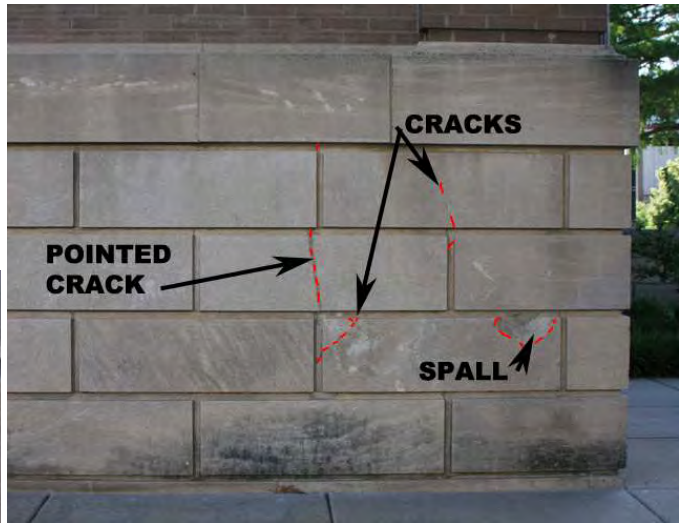
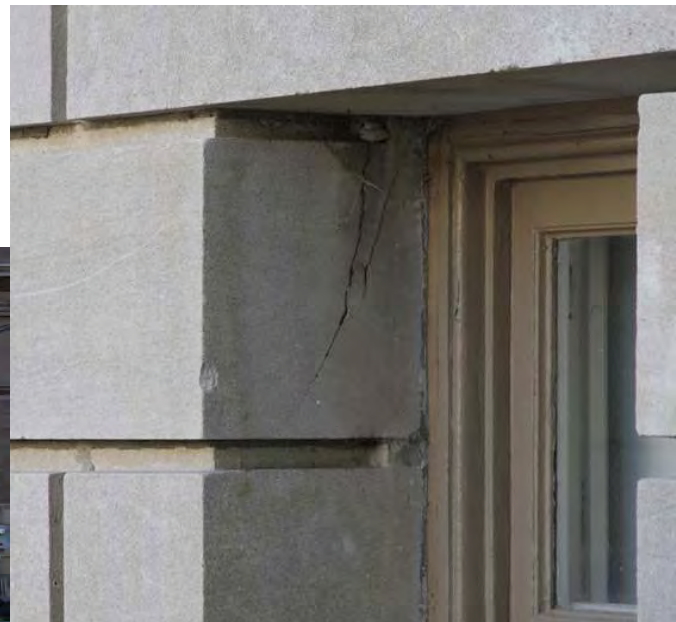
- (d) Cracks in foundation wall near corner and at basement window.

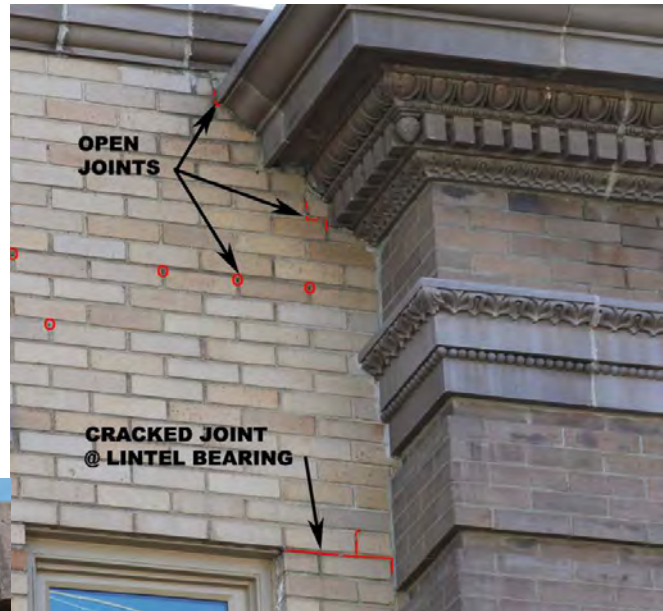
- (c) Open mortar joints were noted in brick wall near original building's northwest corner. The mortar joint, at the lintel bearing, is cracked.
- (d) Deteriorated

rowlock window sill and cracked joint at jamb were noted.

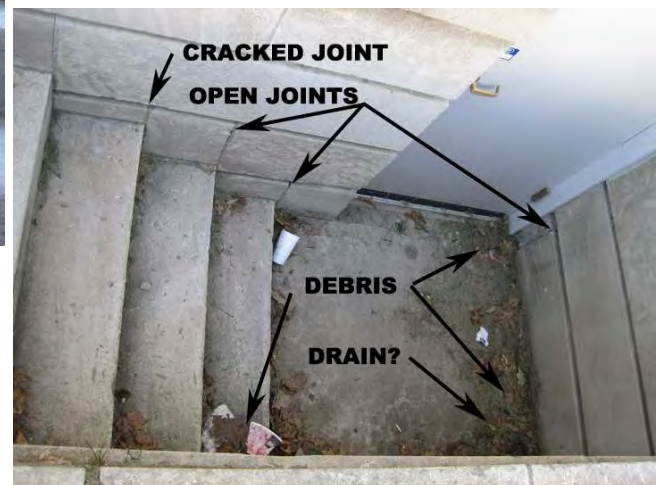
- (g) Deterioration at base of stairwell was noted.

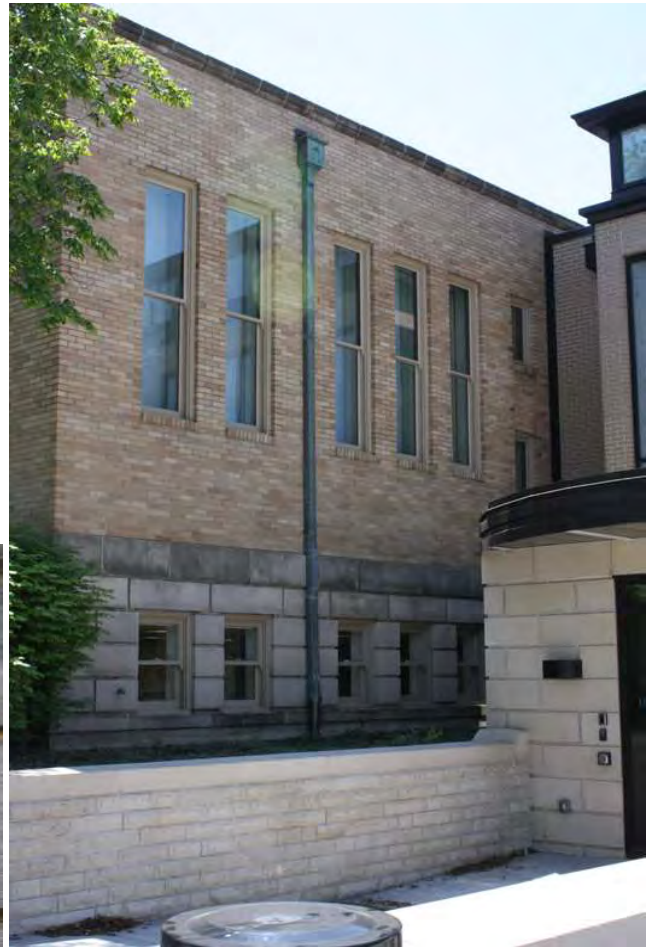
- d. North elevation
 - (1) 1937 Addition
 - (a) Western portion of elevation is partially visible from the northwest. Noted concerns were previously discussed.
 - (b) Eastern portion of north elevation is more visible from the northeast. Lintels were noted to be rusted along this elevation.

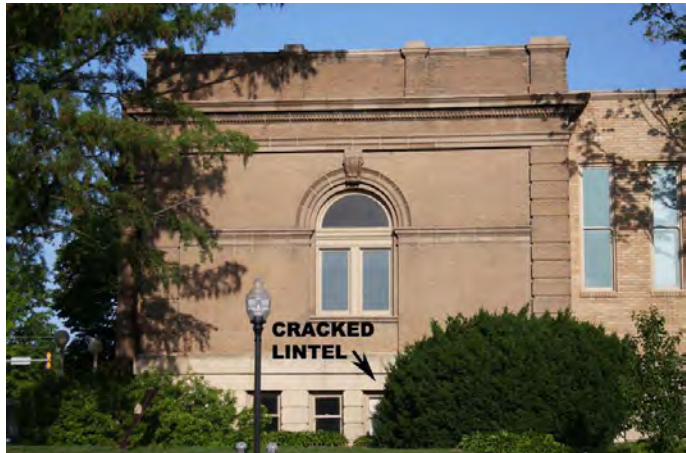
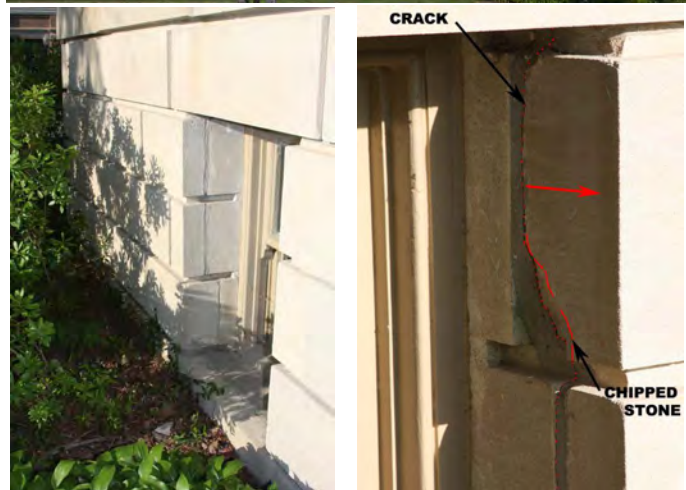
- (2) Original building
 - (a) Cracked lintel was noted in the stone foundation wall.

- (b) Repaired jamb conditions were reviewed and previous repairs are cracked.
 - (c) Parapet wall is like the others, except only open mortar joints were noted.
