Dennis Brown
Painting Estimate and Evaluation
July 3, 2010

Watkins Museum
Lawrence, KS

Exterior Windows

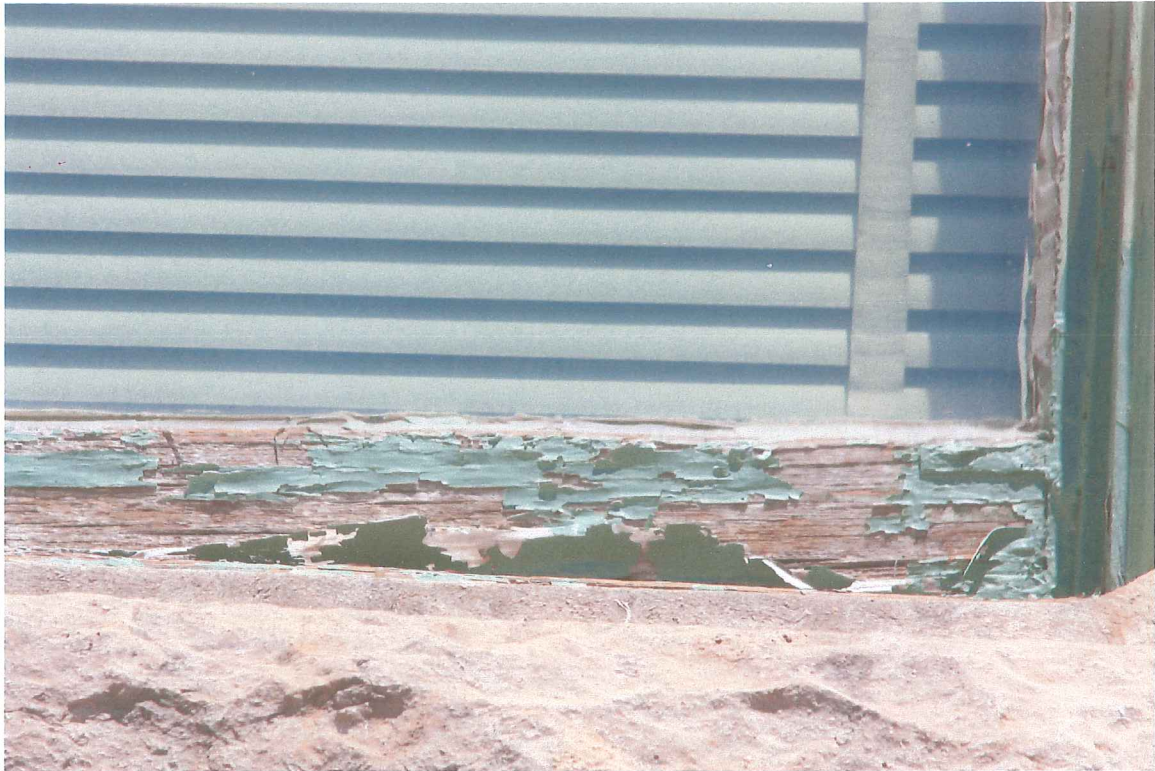
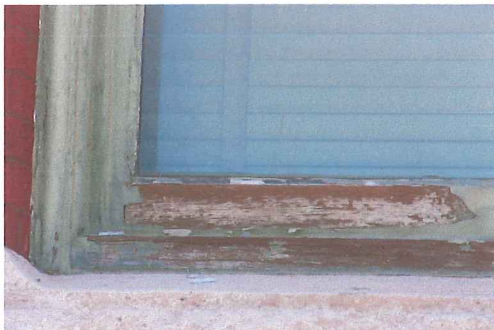
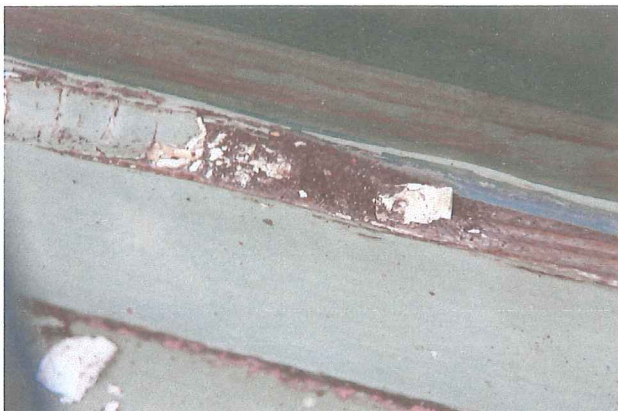
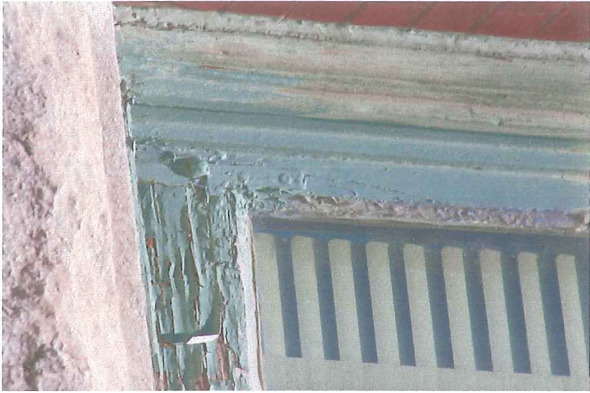
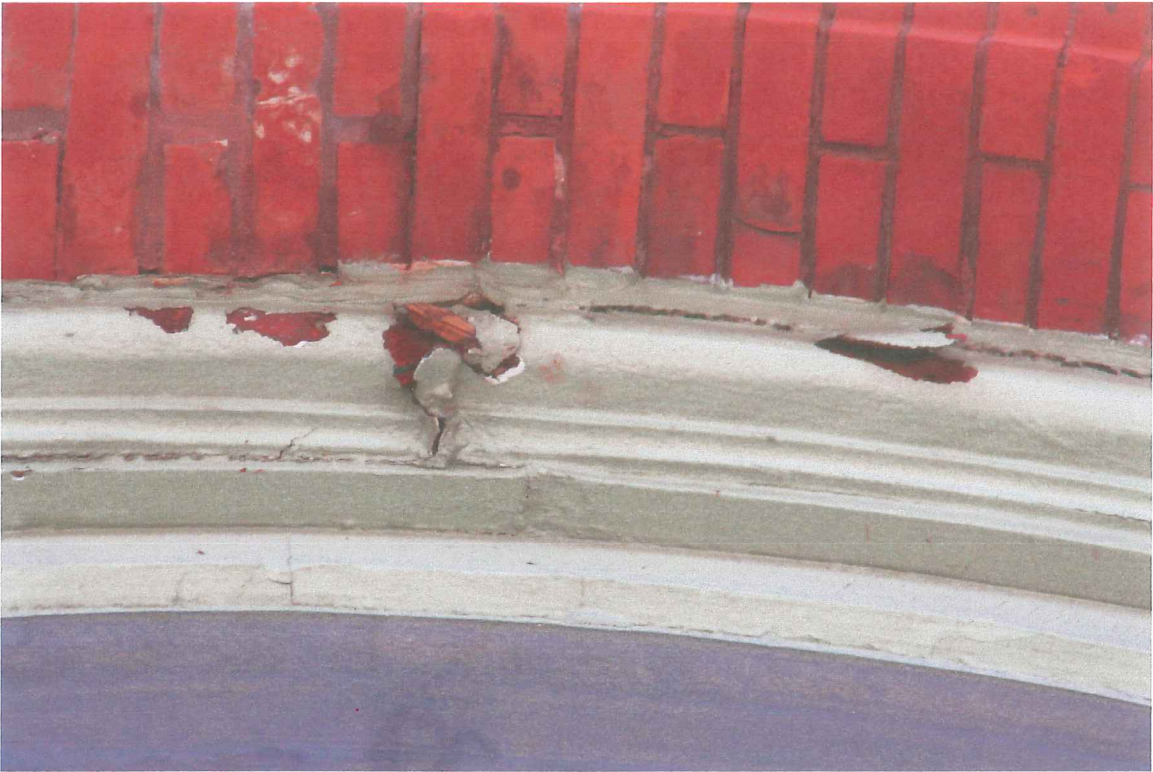
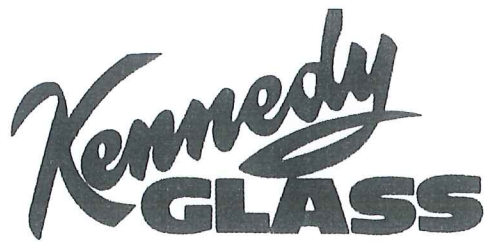
The windows I observed are in dangerously poor condition. The paint on the sills and the bottom rail of the lower sash is completely failed. Foot long sections of thick paint film are loose and can be pulled from the substrate by hand. Actually, the wood is better served by being completely bare than by having the failed paint film in place, which allows water from rain and snow to get behind the failed paint and deteriorate the wood underneath, instead of flashing off in the sun and wind.

There are no storm windows on the building and I can see definite signs of hail damage which probably started the deterioration.

The sills and bottom rails of the lower sash are soft enough on their surface that in my opinion priming and painting is a waste of time without first taking additional repair steps. The main product available is a 2-part epoxy wood hardener that needs to be liberally applied to the sill and bottom rail surfaces where paint has failed to the point that it is totally removed. I have been working with these products for over a decade. I suspect that this material could soak into the substrate as much as an eighth of an inch to even a quarter inch on the sills. Cracks and furrows can be seen on some sills that almost resemble driftwood. The wood-hardener will help fill these. Those areas can be further repaired with a 2-part epoxy paste to fill those defects to the surrounding surface. This

product sands easily and is accepted by the National Parks Service for work on historic registered properties. It is likely that some window trim pieces on this building need to be replaced. In that case I would strongly recommend replacement with salvaged old-growth timber rather than modern lumber. Matt Jones of Struct-Restruct has the knowledge and materials to do this.
