LAWRENCE  
DOUGLAS  
COUNTY

## MULTIMODAL STUDY FIELD OBSERVATION

Eudora & Baldwin City, Kansas Primary and Middle Schools

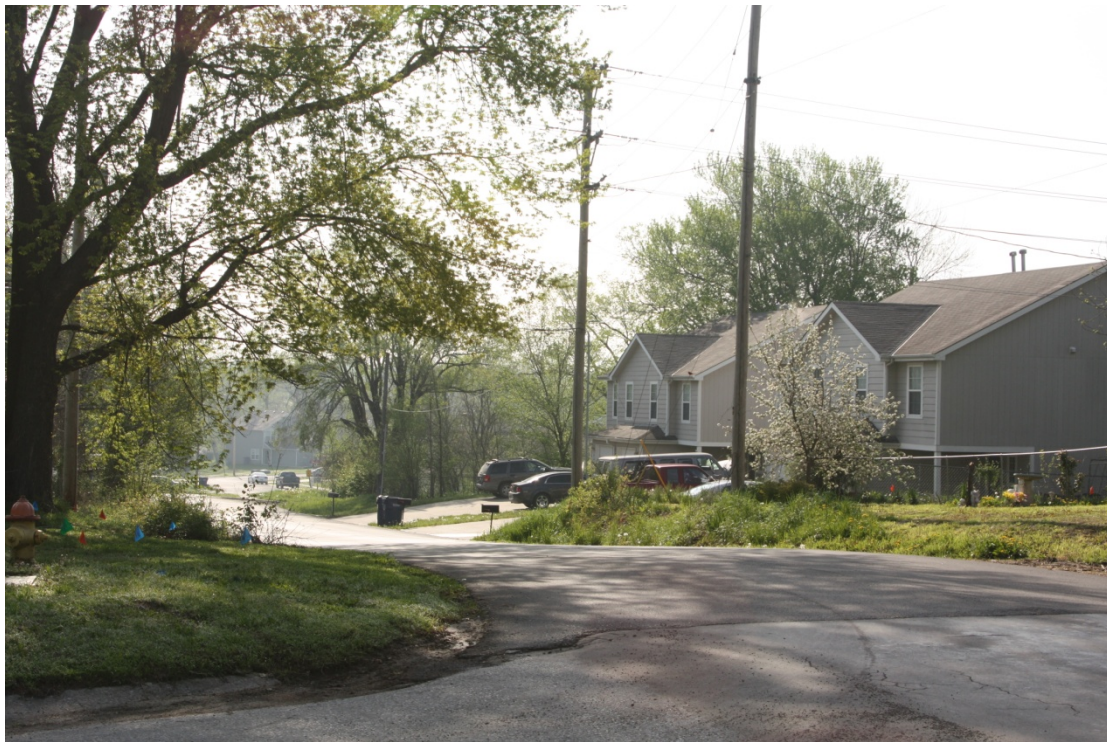
Figure 2. Neighborhoods to the west of Eudora Elementary School are primarily characterized as roads with no curbs, gutters or sidewalks. There are roads with sidewalks present to the west, but sidewalk connectivity toward the Elementary School is quite limited.

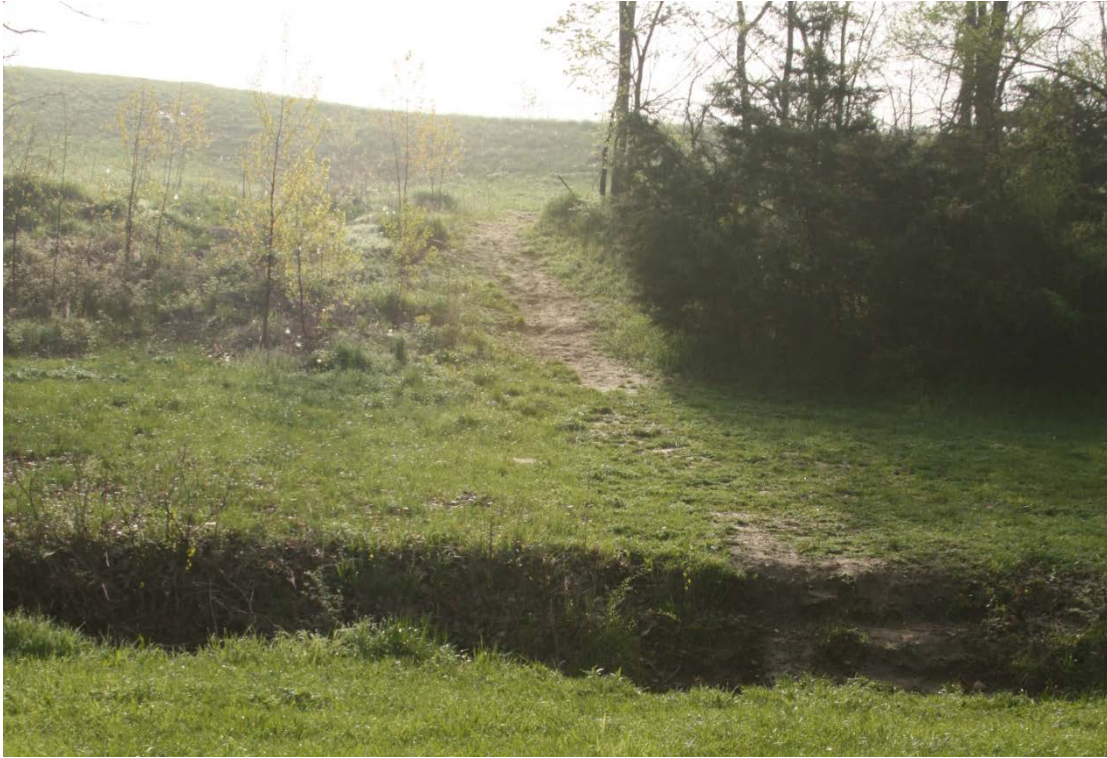
There is currently no pedestrian connection to the west, but pedestrian traffic does pass north of the ballfields, drops down the slope and jumps the creek, as is evidenced by the worn grass path across from Lane C.

Figure 5. Travel path from the neighborhood just west of the school showing the path across the creek and up slope to the school property.

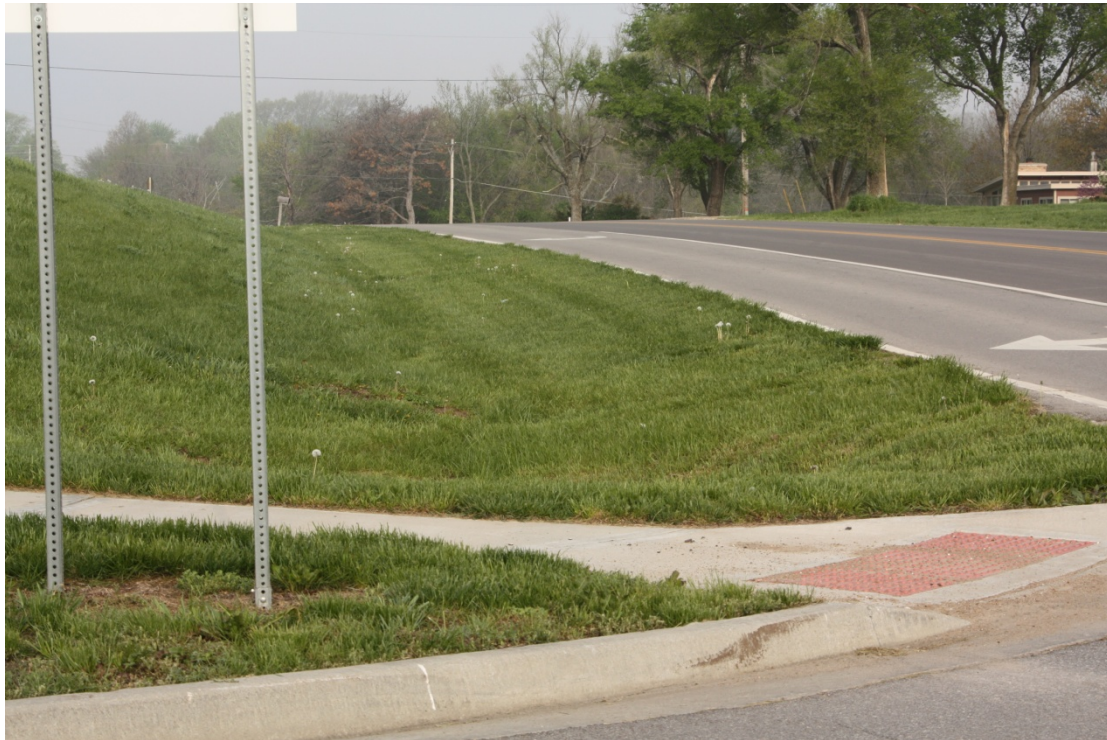
Concrete sidewalks form the south and east connections and tie into neighborhood sidewalks with well-signed crosswalks. The sidewalk from the front entry of the school to N 1400 Road connects only to the roadway, as no other sidewalks are present on the north.

Figure 7. Sidewalk to the front door of the school dead-ends at N 1400 Road where there are no other sidewalks to tie into.

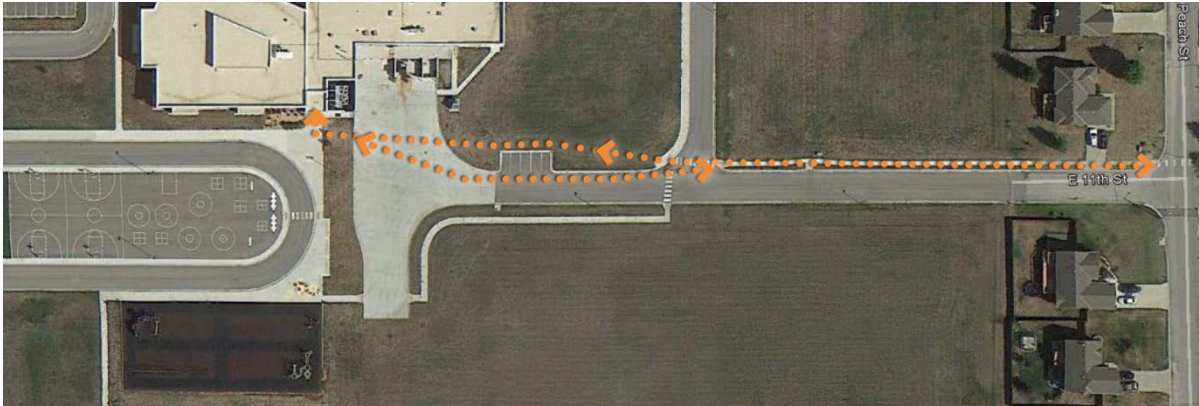
**East:** The east access point follows alongside a gated school access driveway that begins as 11th Street at the intersection of Peach Street. The east access walk at Peach Street begins on the north side of 11th, continues onto school property along the driveway, then makes a crossing to the south side of the drive and follows the south side until reaching a portion of drive that forces the walkers south again then east and then connects with the walk that runs south to north from the playground to the south building entry (Figure 9). Since most people prefer to take the most direct path, most students deviated from the sidewalk once it took the

first jog to the south side of the street. At this point, they either continued in the grass or walked in the driveway, then crossed a patch of grass up a slope near the building entrance.

Figure 9. East access to Eudora Elementary's south entrance.

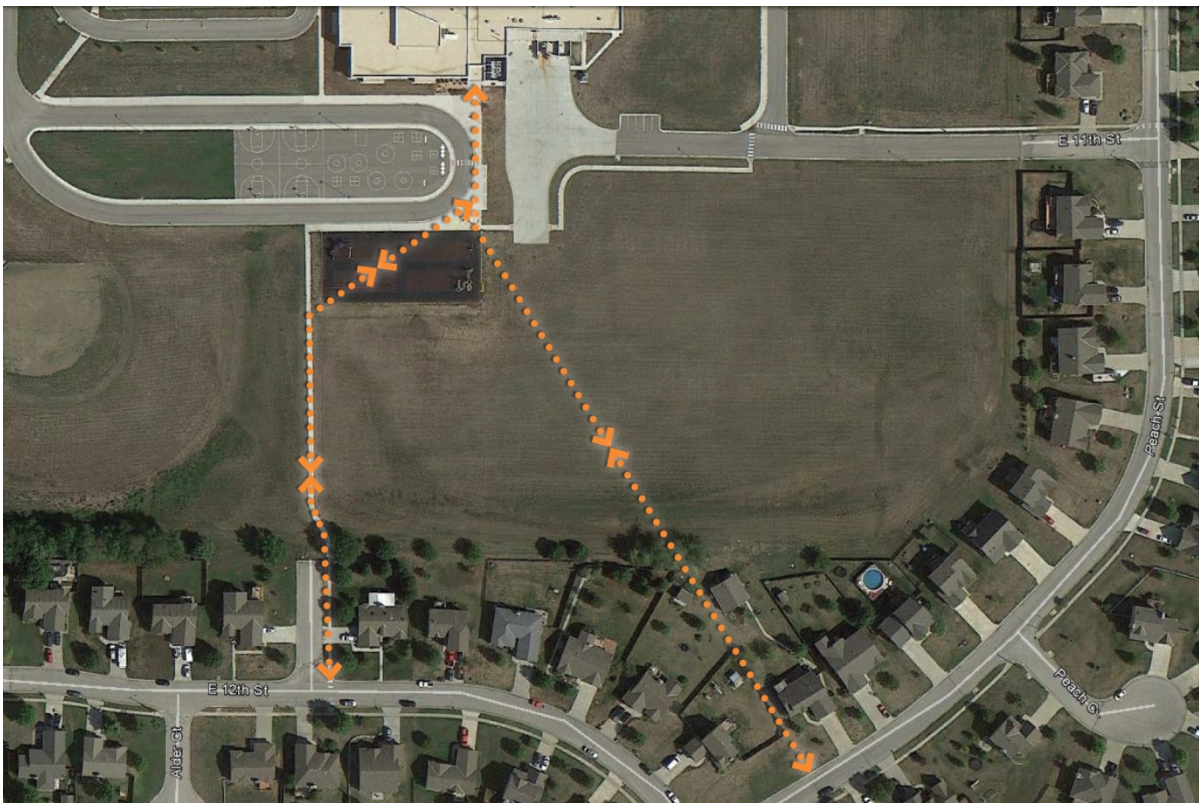
**South:** Most students walking to and from the neighborhoods on the south were observed using the provided walk for most of the distance, then shortcutting through the playground. A few students opted to ignore the provided walk and cut across the southeast field and one of the home's side yards (Figure 10).

Figure 10. South path and sidewalk to Eudora Elementary's south entrance.

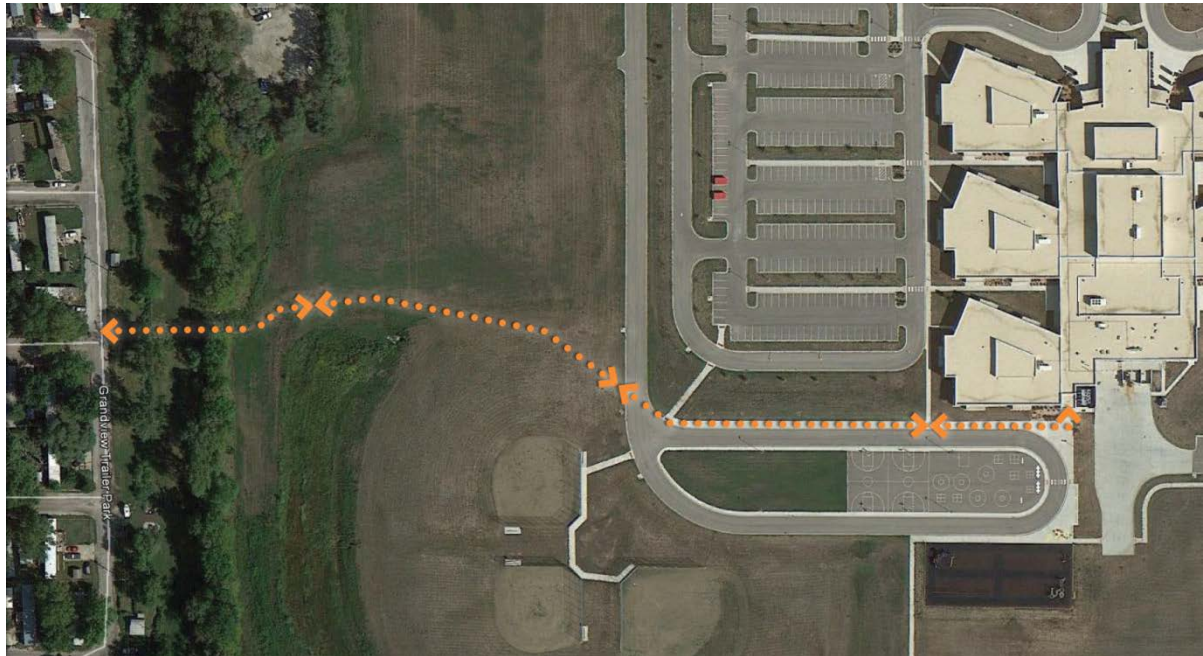
**West:** Students observed travelling by foot from the south entrance to the west travelled along the school walk and then across the driveway, across the northernmost ball field then down the steep slope and across the creek. (Figure 11)

Figure 11. West travel pattern to Eudora Elementary's south entrance.

It is recommended that a trail within the East 10th Street/North 1400 Road right-of-way be added to tie the elementary school safely to the neighborhoods to the west and north, and to facilitate walking/bicycling from neighborhoods into the commercial districts.

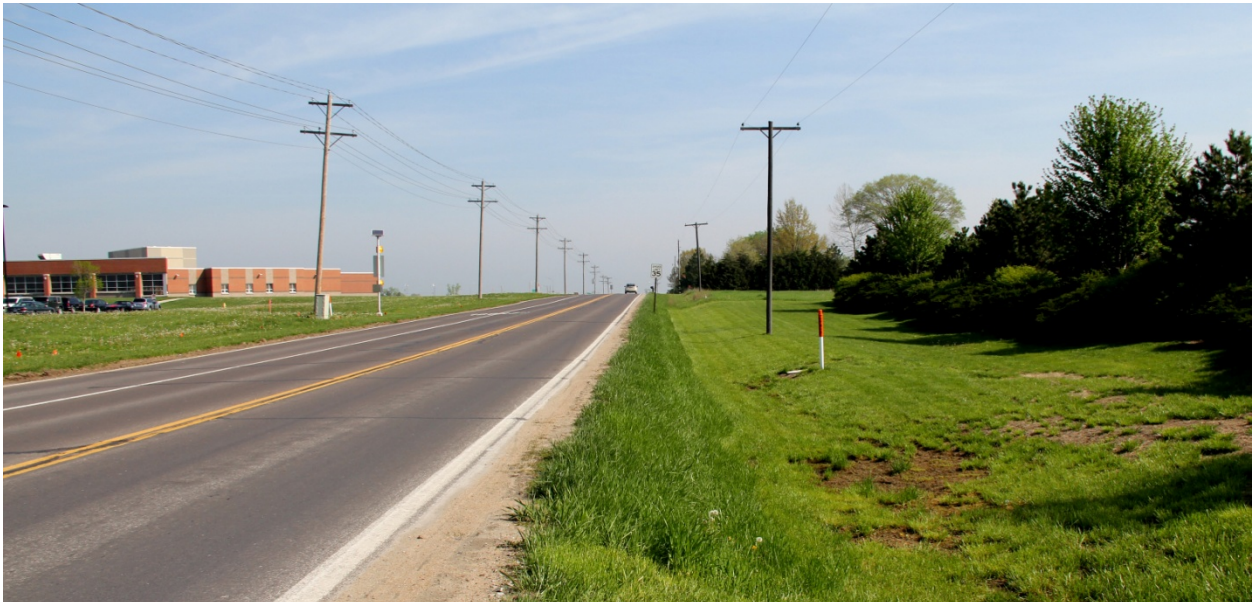
Figure 16. East 2200 Rd is a two lane road with no sidewalks and ditches on each side and is the only road connecting the Middle School to surrounding development.

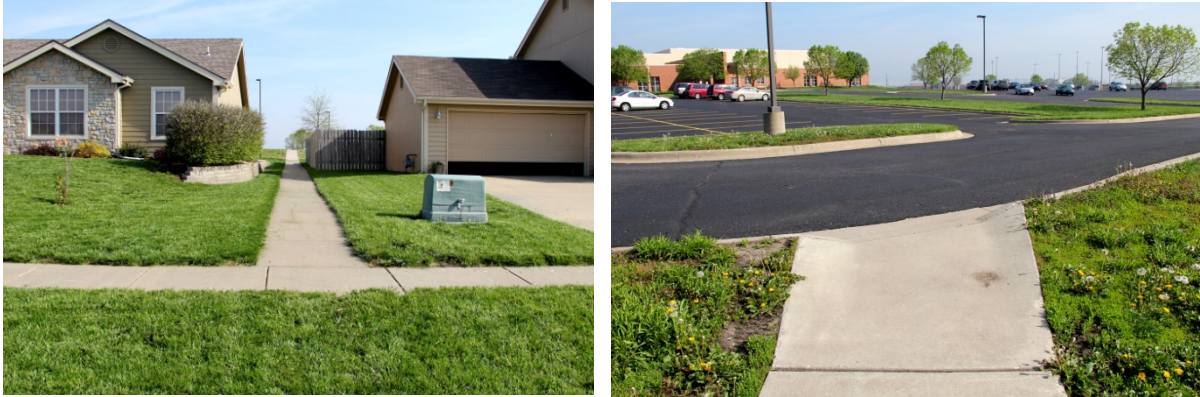
Figure 17. The southern pedestrian connection from Shadow Ridge Drive to Eudora Middle School ends at the staff parking lot. Students walk through the parking lot to reach the front doors.

**South:** Students walking to and from the neighborhood to the south were observed using the provided concrete walk connecting Shadow Ridge Drive to the staff parking lot. Because this is not a continuous sidewalk to the building entrance, students must walk through the staff parking lot. Fortunately, most of the staff is parked before walkers arrive.

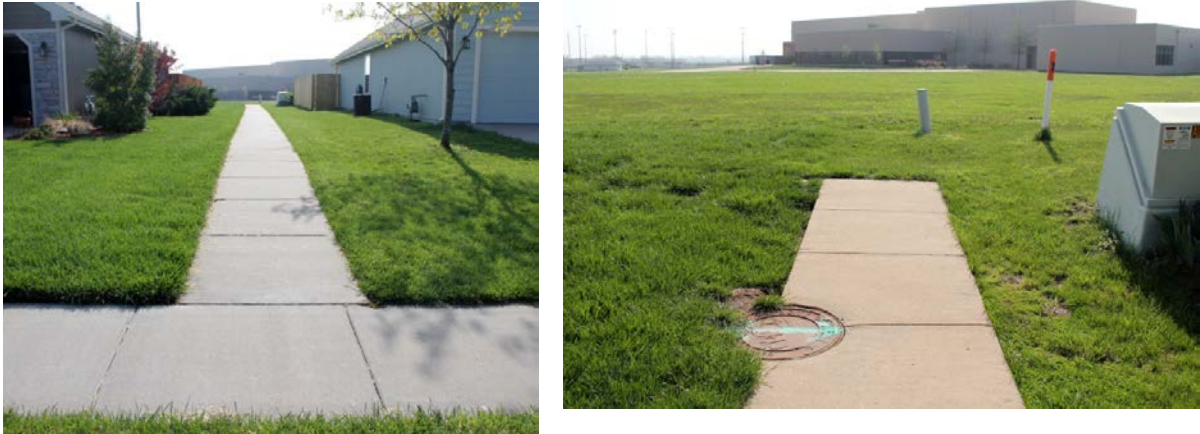
Figure 18. The western pedestrian connection from Elm Street to Eudora Middle School ends at the school property line. Students walk through a grassy field to reach the building entrance.

**West:** A concrete sidewalk from Elm Street ends at the school property boundary, forcing students to travel through a grassy field. Since no clear walk to and from the neighborhood is delineated, students were observed crossing to the west and southwest through grassy open space and private backyards.

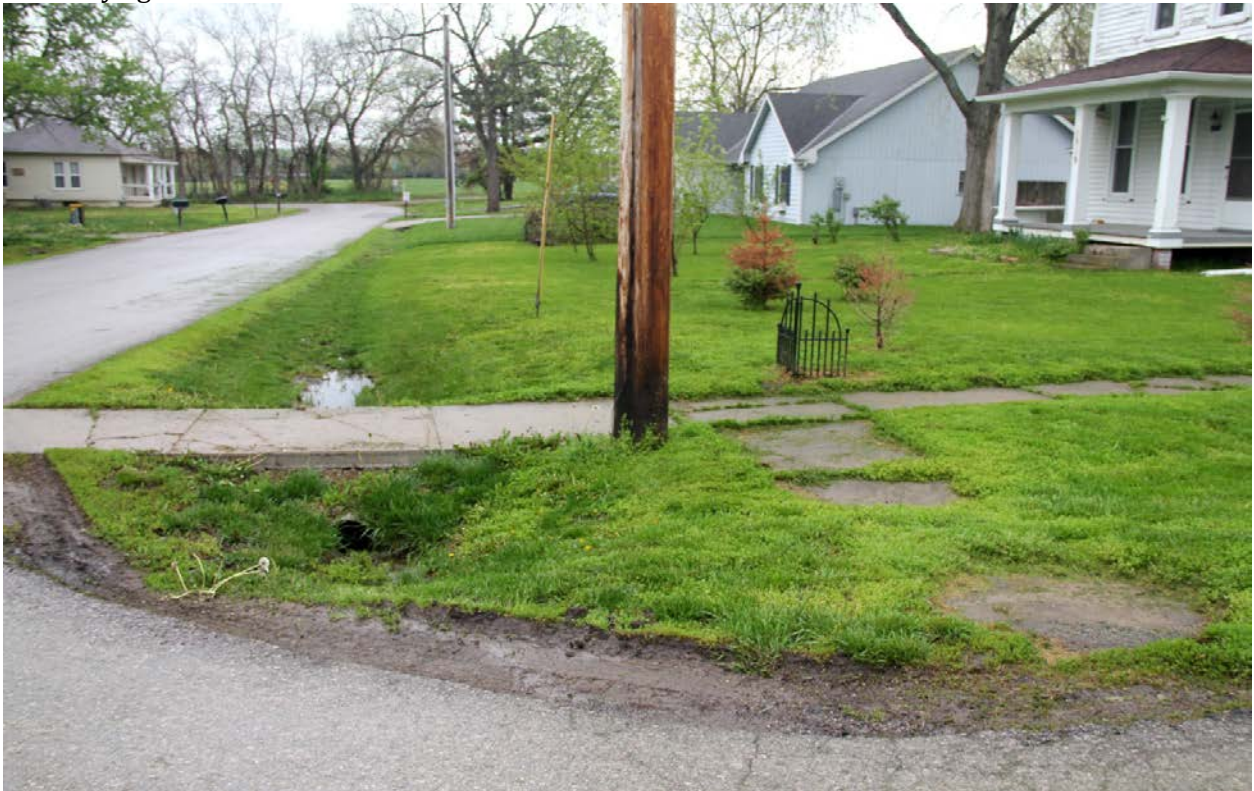
Figure 30. Typical sidewalk condition in the neighborhood south of Baldwin City Primary Center.

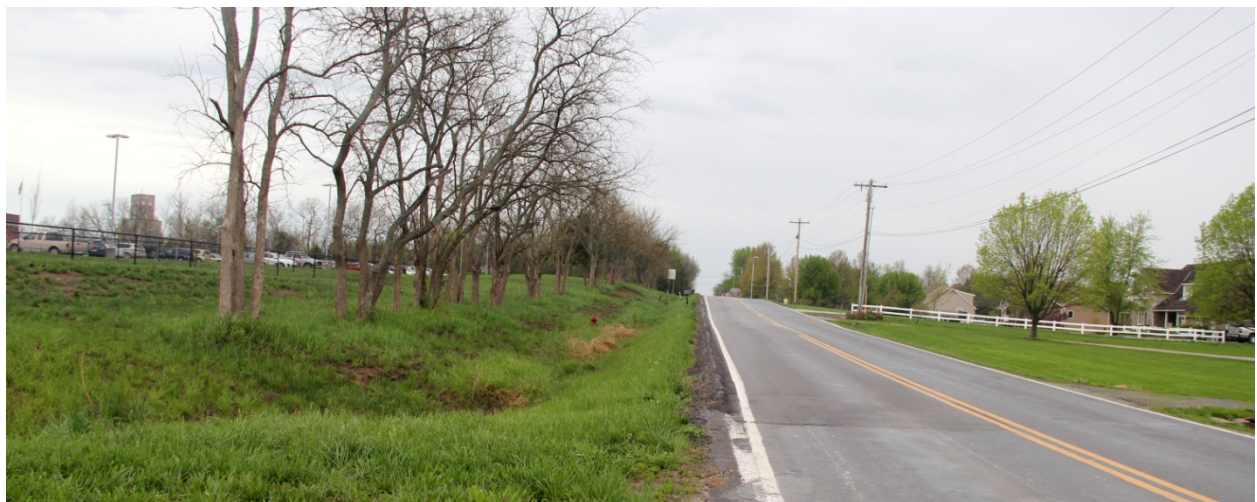
Lawrence Road, a two-lane road with no sidewalks and ditches on each side, is the only road connecting the school to development to the south.

Figure 32. Lawrence Road.

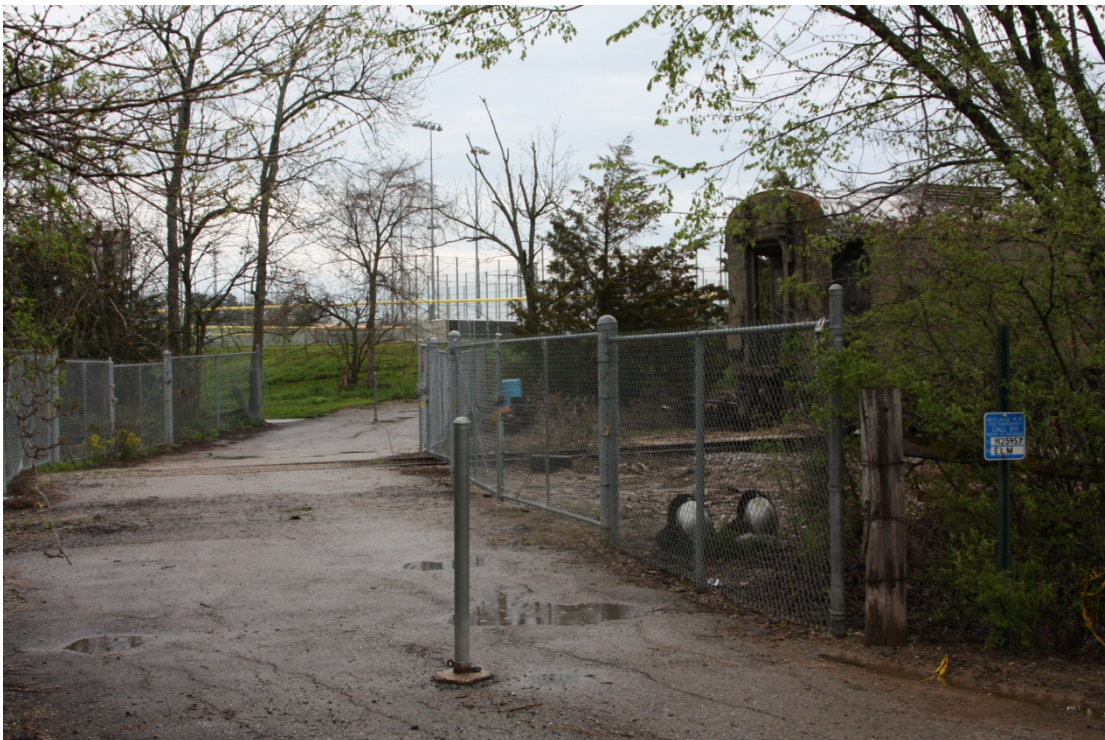
Figure 37. Most residential development in Baldwin City is separated from the Intermediate School by the Midland Railroad tracks. This crossing at Elm is the only access across the tracks between US 56 Highway and High Street.

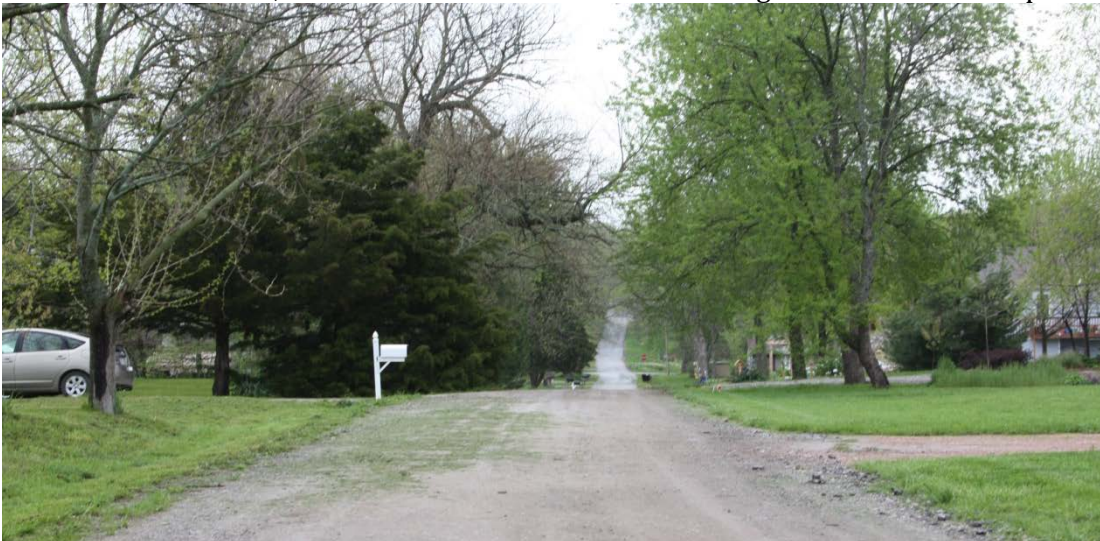
Though Elm Street does provide the best connection to the Intermediate Center, the road does not include sidewalks; the children must walk in the road to get to the connection point.

Figure 39. Children must walk in the road on Elm Street to access the railroad crossing.

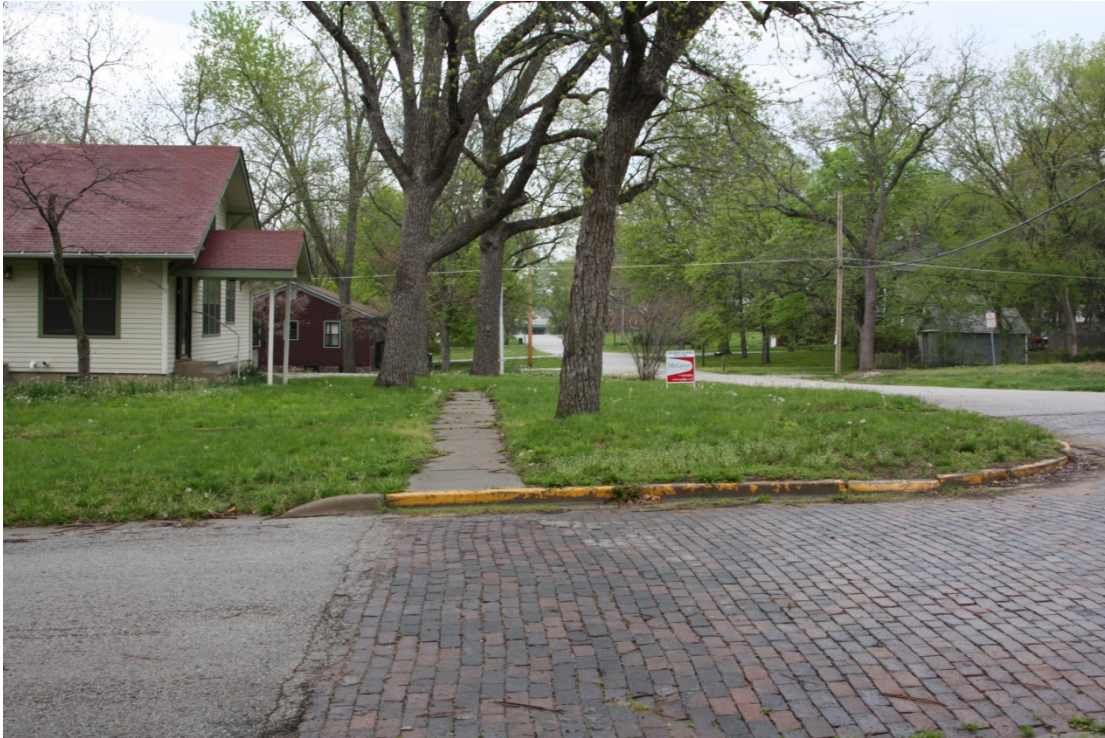
In the neighborhoods to the east, remnant sidewalks are present, but they are predominantly intermittent and lacking curb ramps. These are some of the oldest neighborhoods in Baldwin City, flanking the 1858 Baker University Campus. The original cross-sections include wide setbacks between road edges and homes, with the sidewalks closer to the homes than the roadways.

Figure 40. Original sidewalks are set far away from roadways.
