Historical Resources Commission
Design Review Submittal
for
Redevelopment of 1043 Indiana Street

18 October 2010

FROM : Paul Werner
TO : Lynne Zollner
RE : 1043 Indiana Street
DATE : 18 October, 2010

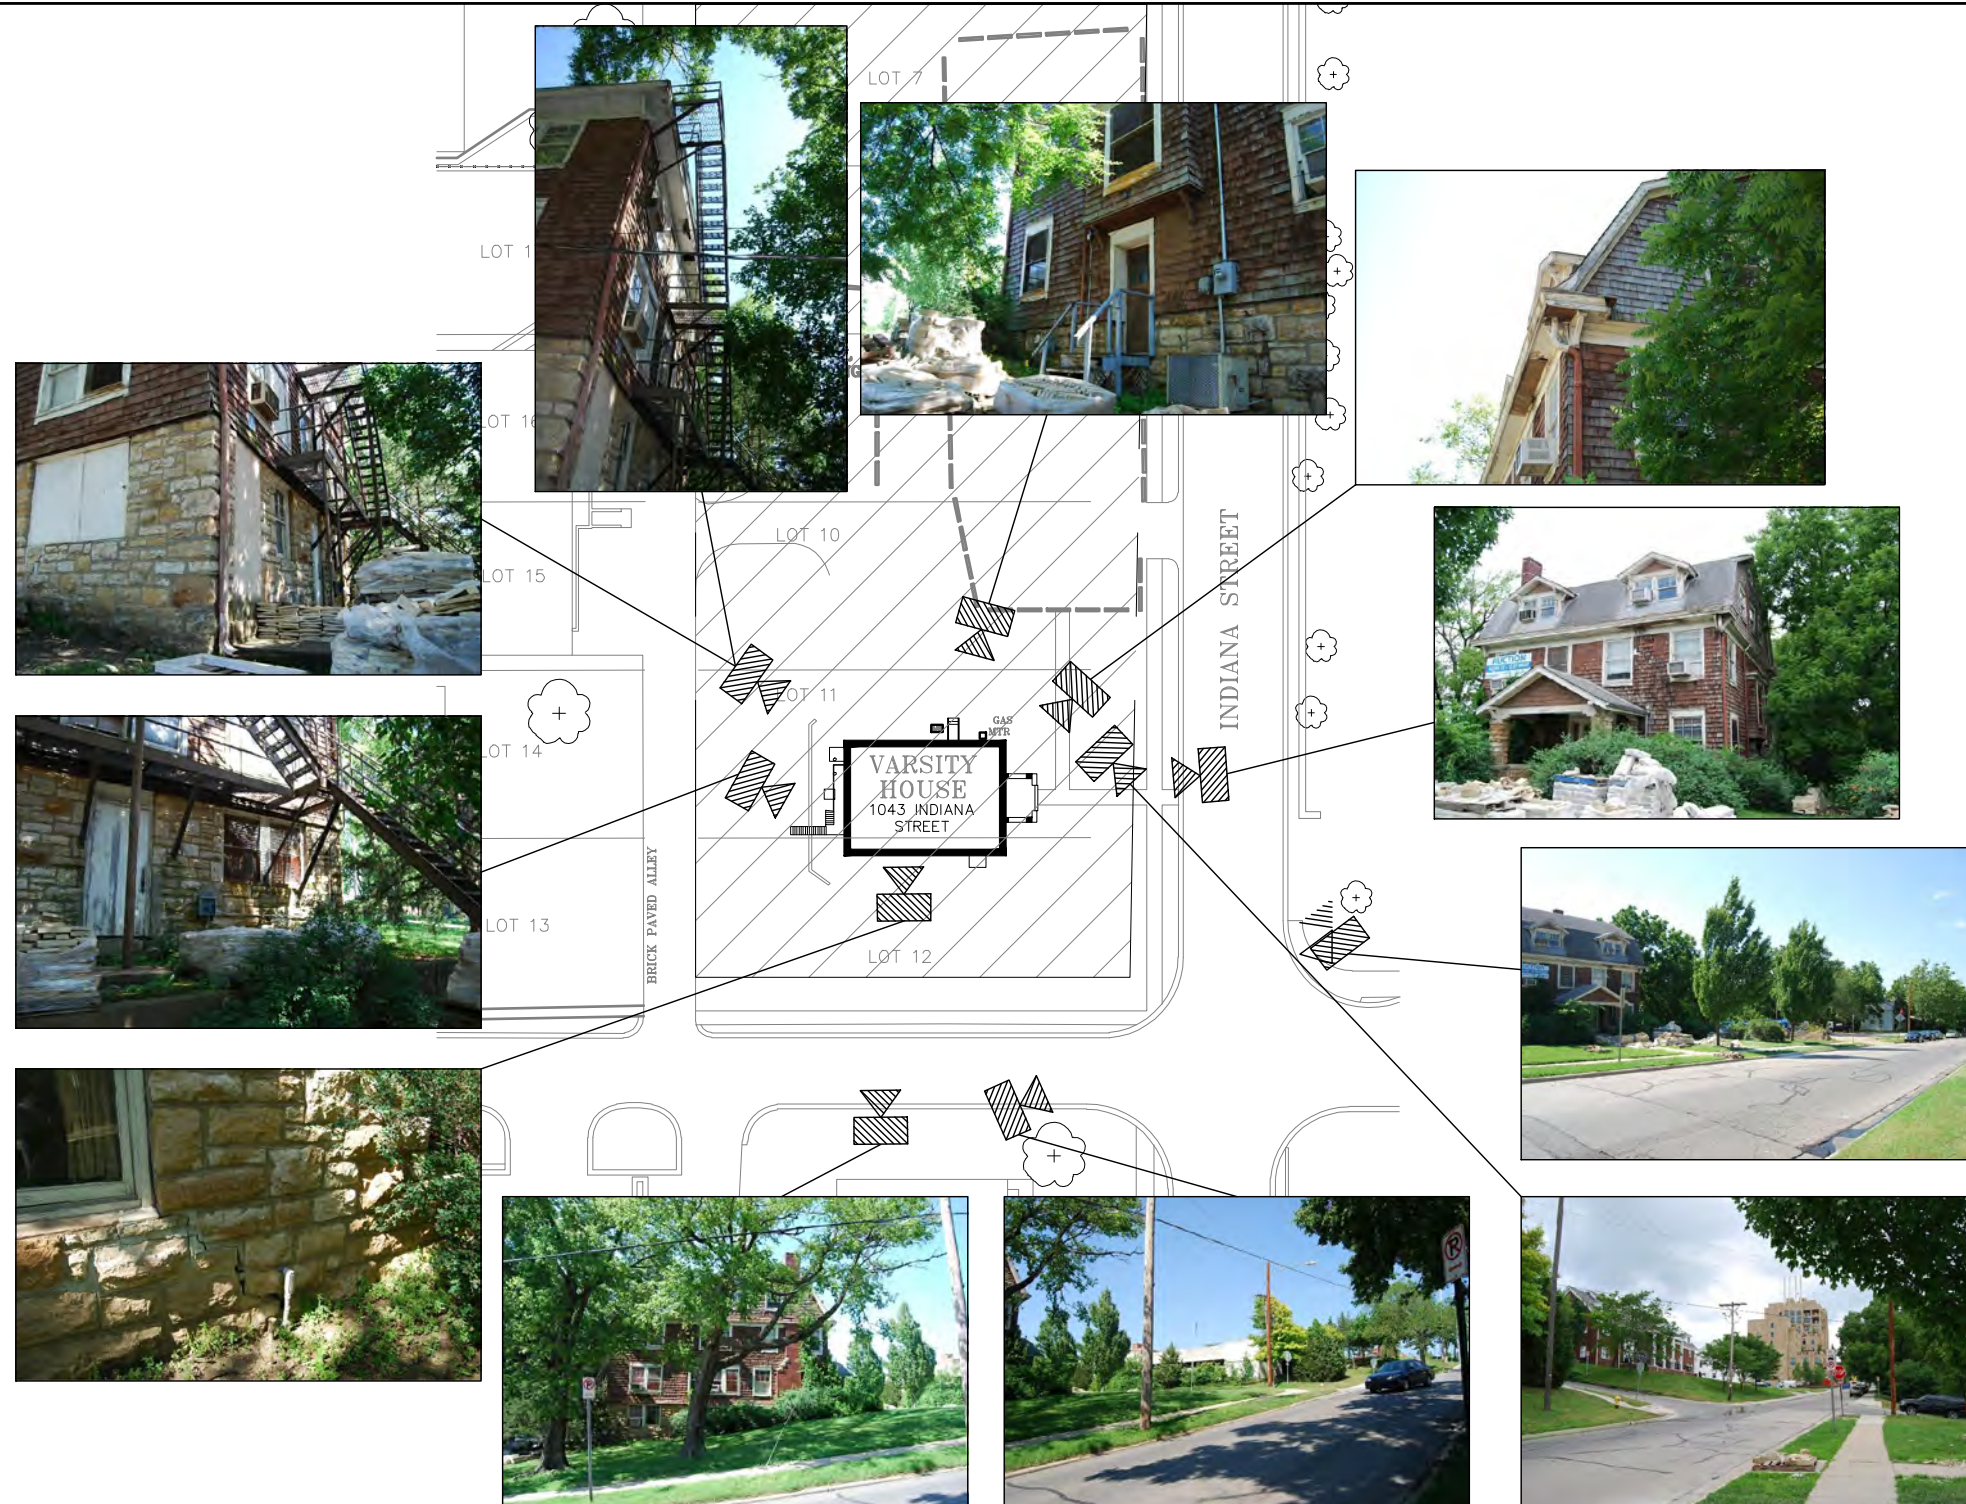
EXHIBIT 6e: Photos: 1043 INDIANA

Ronald Hutchens and Chris Harlow of Paul Werner Architects visited 1043 Indiana on June 22, 2010 to access the status of the structure. We walked around the site and reviewed the existing condition of the Building (Ref exhibit 5a-5c and the accompanying CD). The structure is showing signs of settling and rotting wood. Some of the windows have been boarded up. The Shake shingle siding is rotting in areas, along with areas of the soffit. The existing window air conditioning units looks as though they could fall out. The Screens on the windows are rusting. I saw only one broken window on the south side. The north side entry has wooden steps and they are rotting and falling apart. There is cracking in the stone foundation walls which are signs of the foundation shifting or settling.

The rear of the house has some windows boarded up and there is a section that has been cut out and replaced with concrete block. The steel fire escape that appears to have been tacked on is rusted. The fire escape has pulled away from the structure, and appears to be a safety hazard.

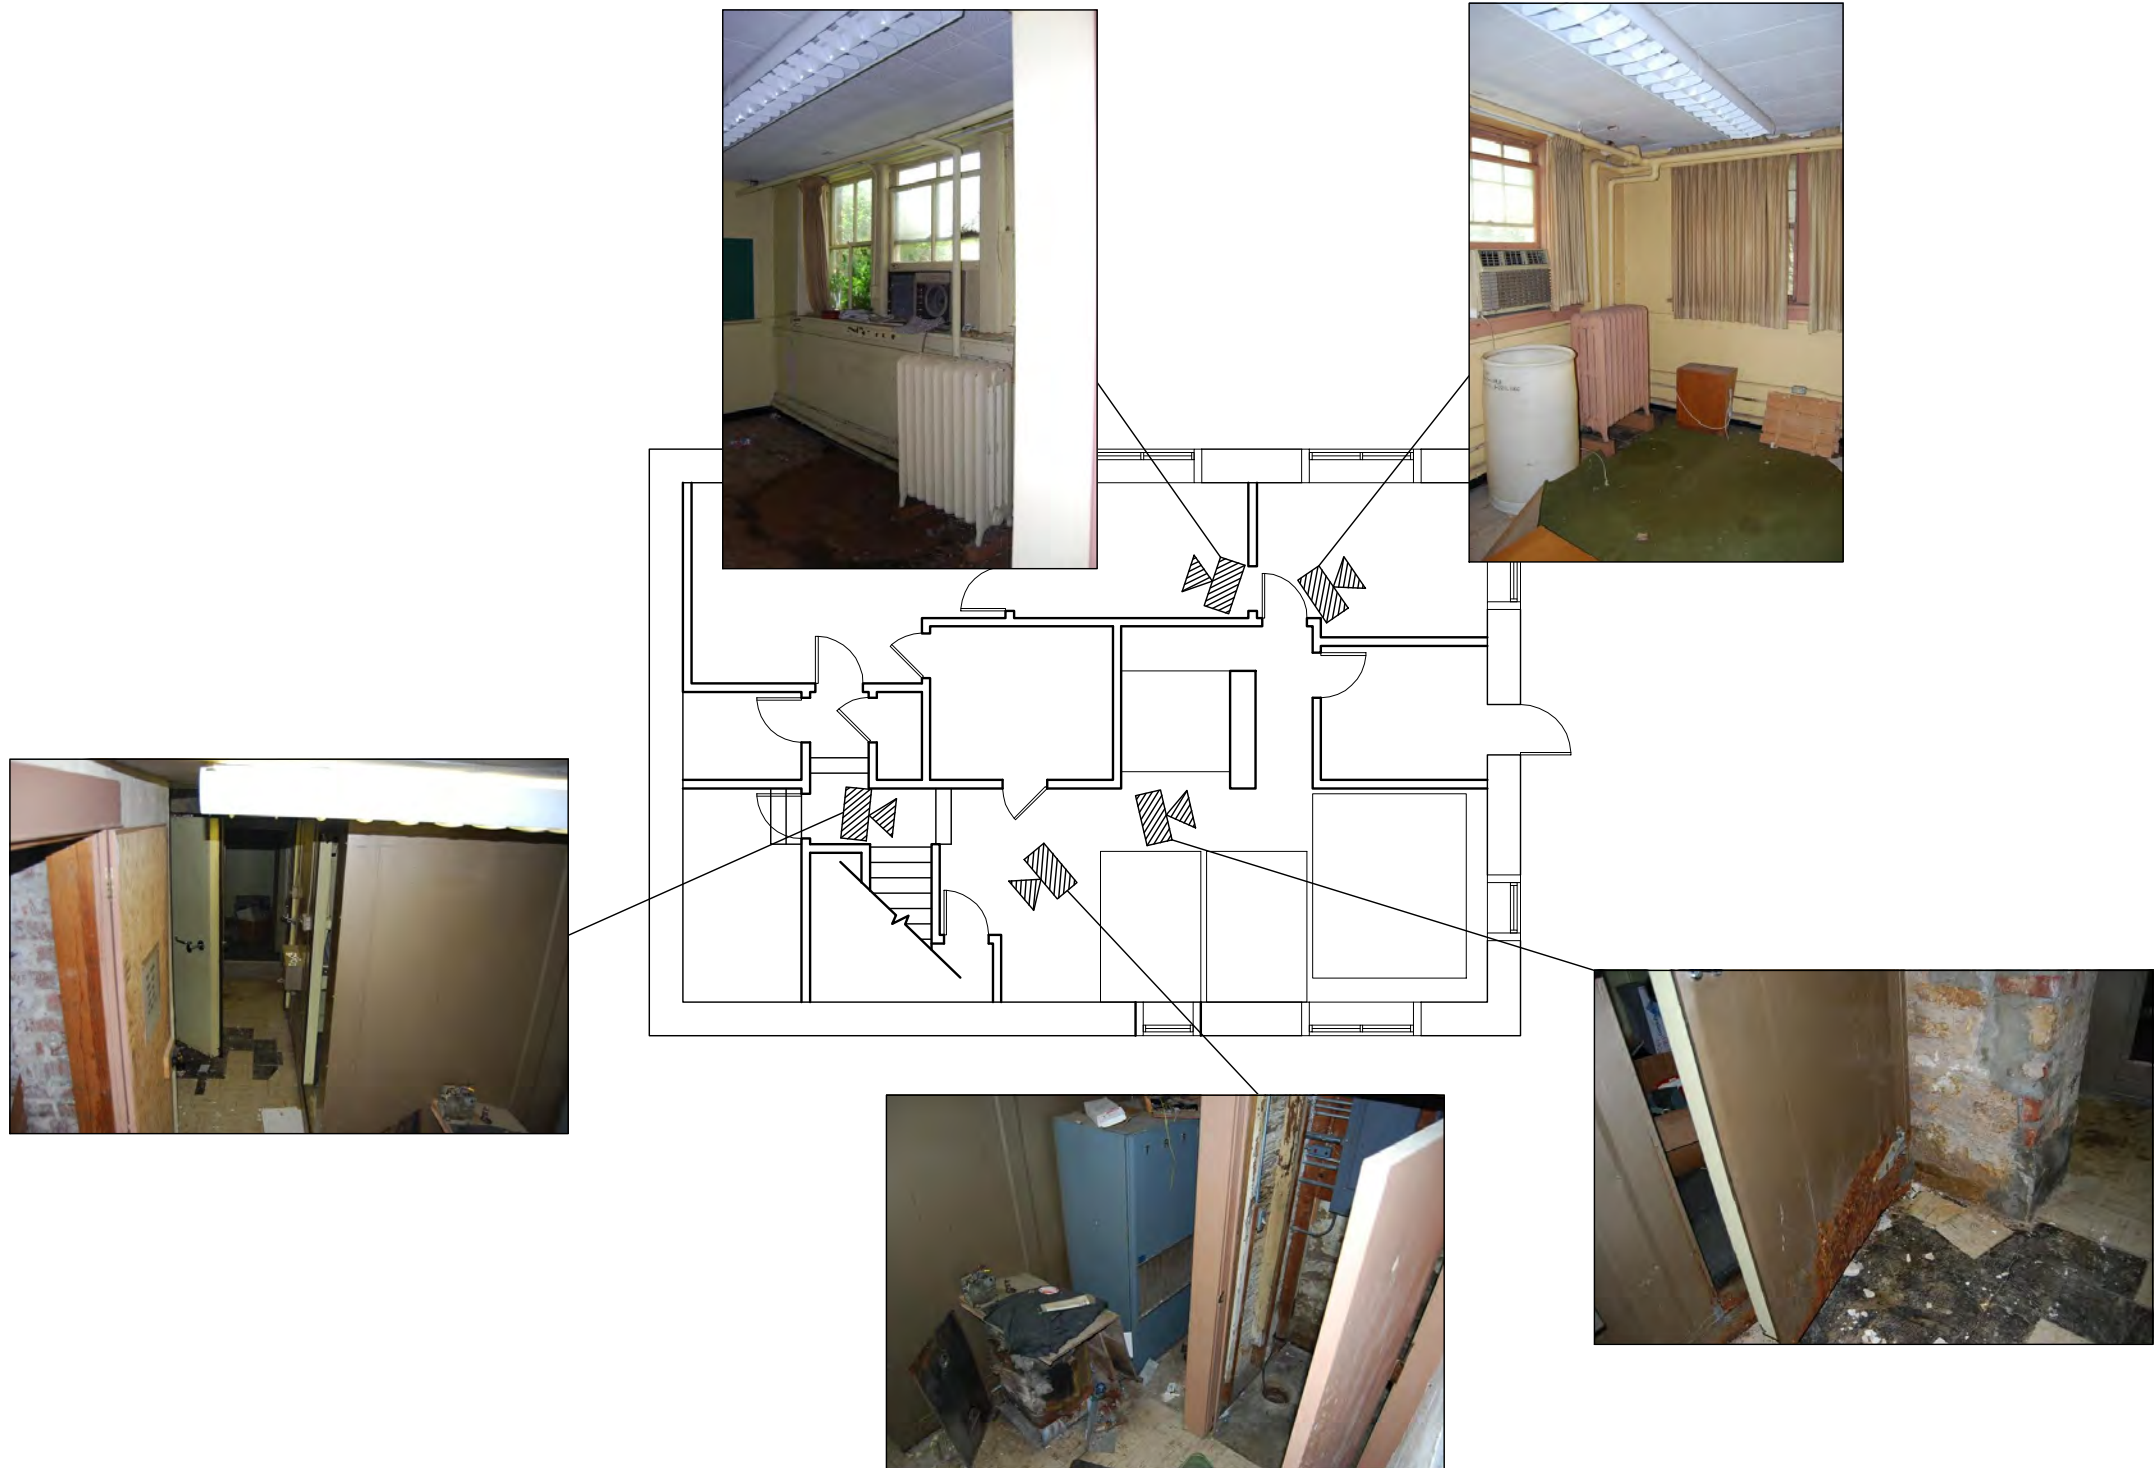
EXHIBIT 6f: Photos: 1043 INDIANA - Basement

We entered through the rear door into the basement, only to be welcomed by a dead rat. It was early afternoon so there was ample light to view the interior. The ceilings had applied acoustic tile to the ceiling with surface mounted fluorescent lighting fixtures. The floor had a mixture of Vinyl composite tile and carpet that had been pulled up in places. The VCT had worn through to the concrete below. The plaster walls have numerous cracks and the trim was pulling away from the wall in areas. A lot of the walls had been covered with a similar acoustic tile as the ceiling. There was chalk boards on the walls so some of the rooms may have been classrooms. There was exposed conduit throughout for electrical service. There appears to be water damage in areas around the air conditioning units. We found a sign that was warning of asbestos near the old central heating unit. The Central Heating was surrounded on two sides with a stone foundation wall. The old sound booths could pass for walk in refrigerators from the way they were constructed. The sound booths look as though the house was built after they were installed which makes me think that there was an addition on the West side. The Exposed stone walls in the center of the basement would support that. They could just foundation walls in the core of the house.

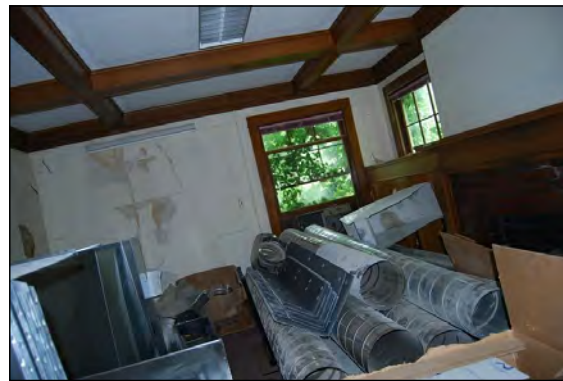
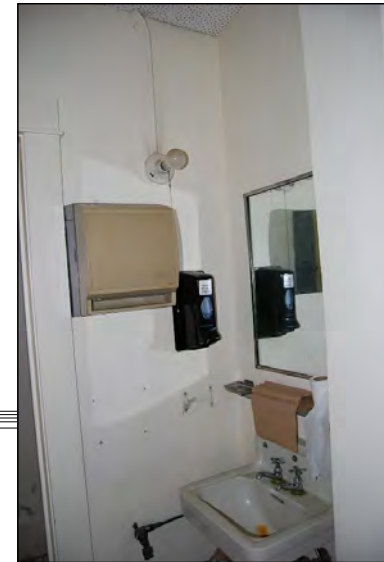
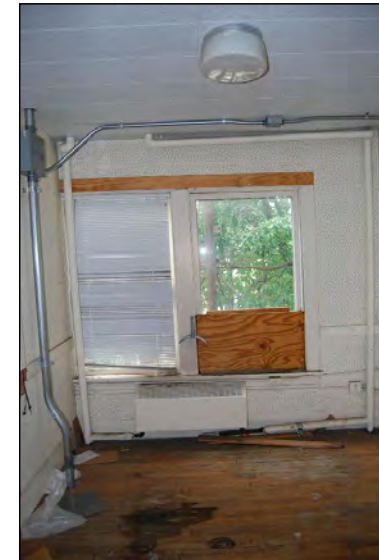
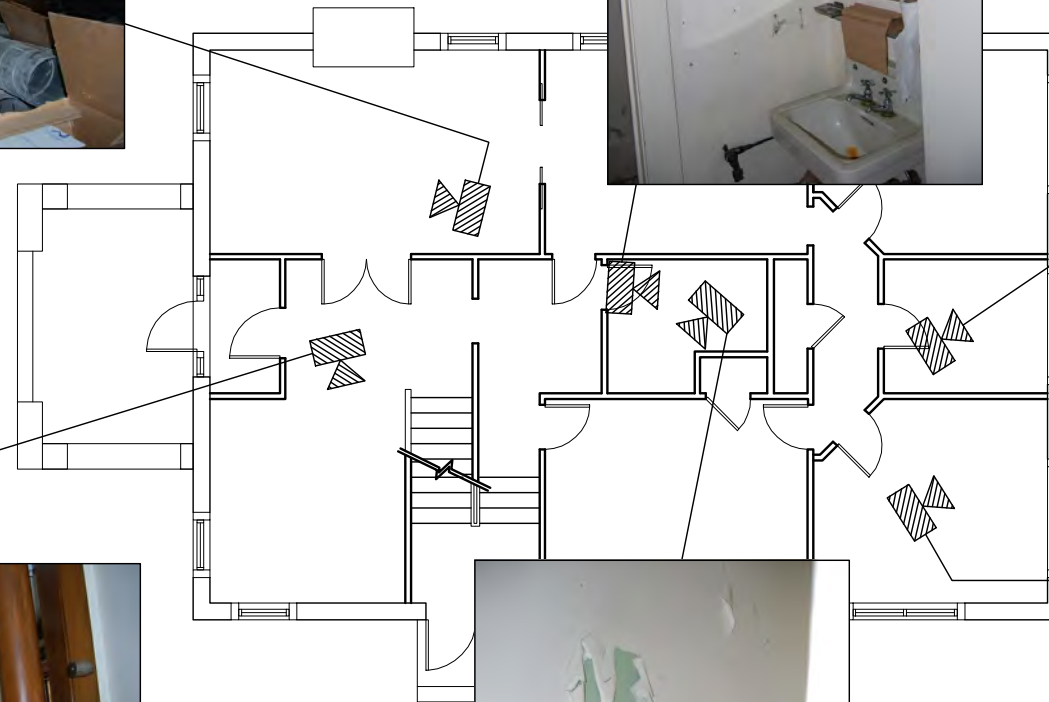
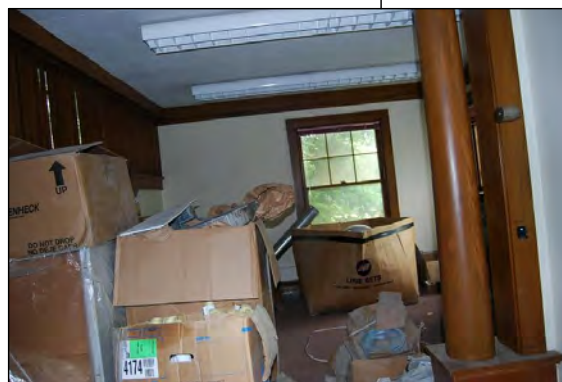
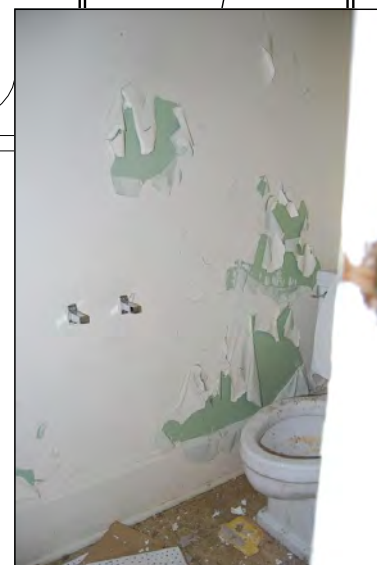
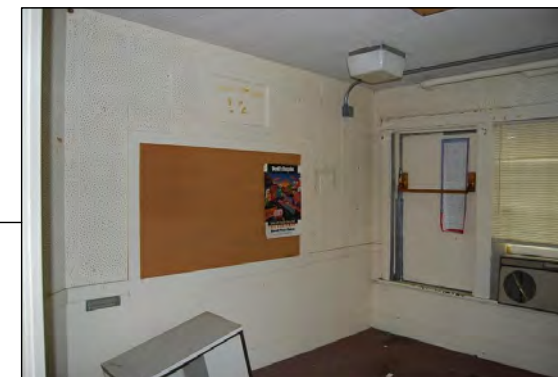
EXHIBIT 6g: Photos: 1043 INDIANA - First Floor

The First Floor. Going up a narrow stairway to a landing at the north side door and continuing up to the first floor, or the ground floor. It is immediately apparent that this was used for office's at one time. More old carpet, acoustic ceiling and

walls, fluorescent light fixtures, exposed conduit, and cracked plaster. There was no sign of a kitchen, although there was a small room that may have been a kitchen at one time. The bathroom was converted to a restroom with a drinking fountain outside in the hallway and a plywood partition screening the toilet. Any bathtub that may have been there has long since been removed.

On a positive note, the front two rooms had been maintained to some degree and the wood trim and cabinetry looked pretty good, although the space was chopped up by a vestibule that was added on the interior. There is a pair of sliding doors that may have opened into a dining room at one time, but was converted to an office like the rest of the house. One of the windows was converted to a half height doorway complete with panic hardware. I don't know the purpose as it would not meet any building code. There is existing hardwood floors on this level but it has all been covered with carpet, one of the rooms had it exposed where they had pulled up the carpet.

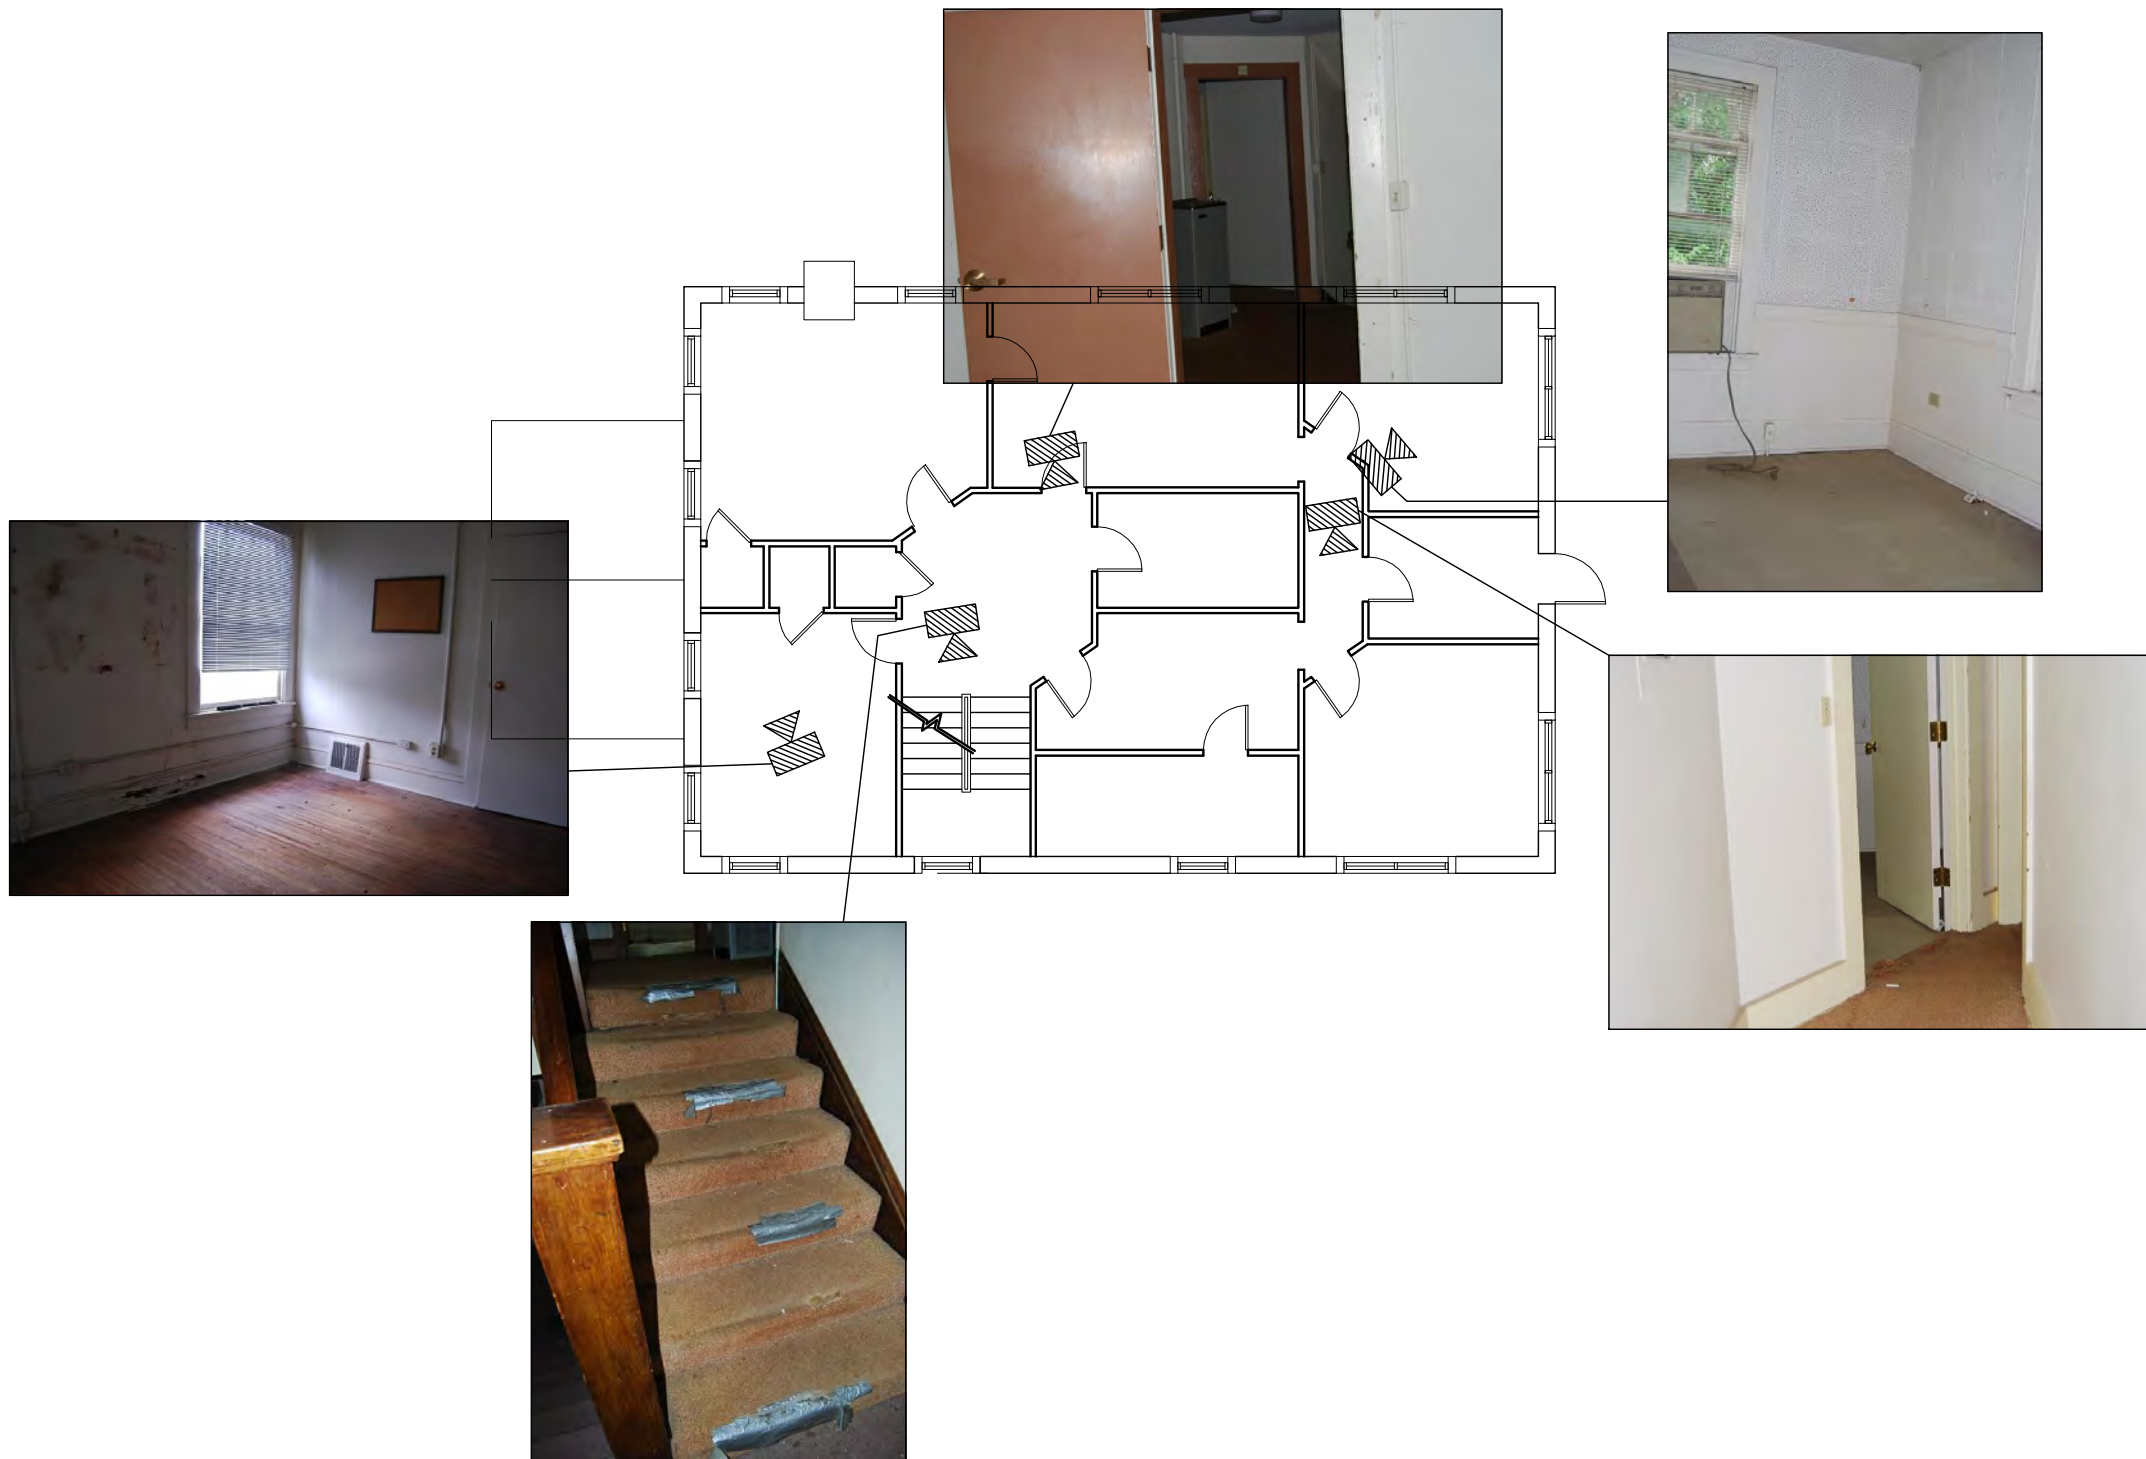
EXHIBIT 6h: Photos: 1043 INDIANA - Second Floor

Upstairs, The wood banister looked fairly good, considering, but the finish was scratched and beat ups and had years of dirt buildup. As soon as you were beyond any visibility from the front rooms you were back to the horrible office renovation that was done. The Hallway was old carpet with a drinking fountain. The restroom converted from a second floor bath. You pass through a room to get to a second hall in the rear of the house with three more rooms, this adds more support to the theory that the rear of the house was an addition. The History of the house is very spotty during that time.

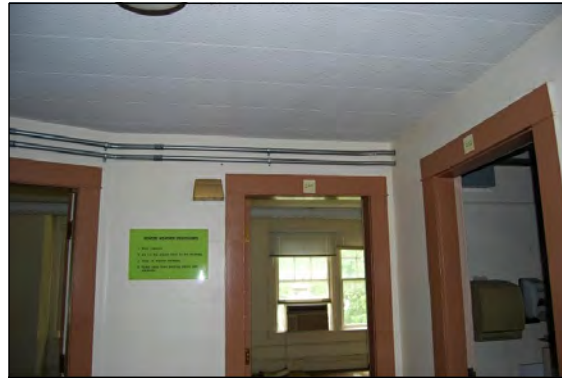
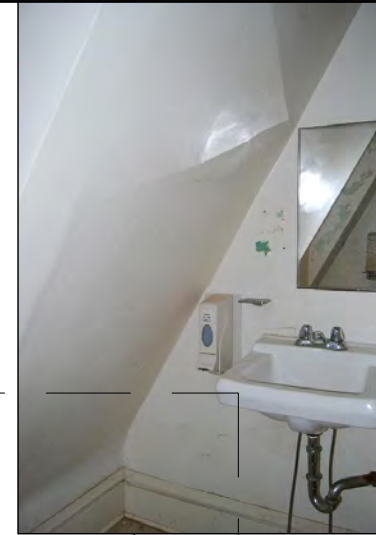
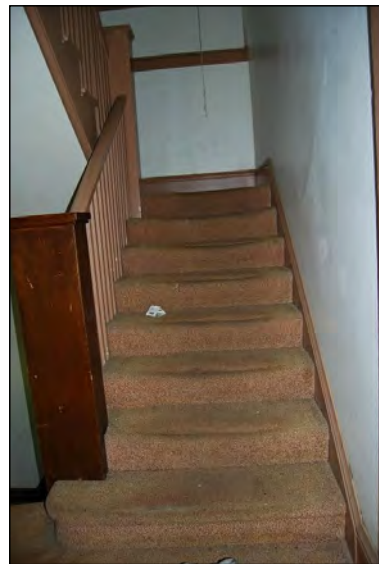
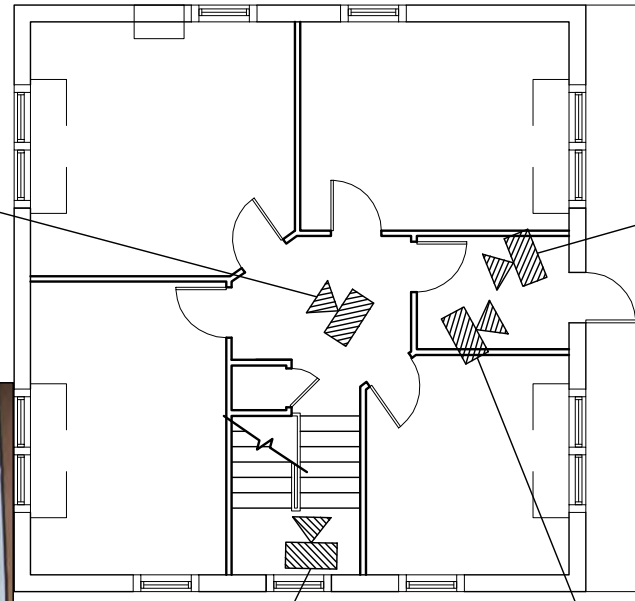
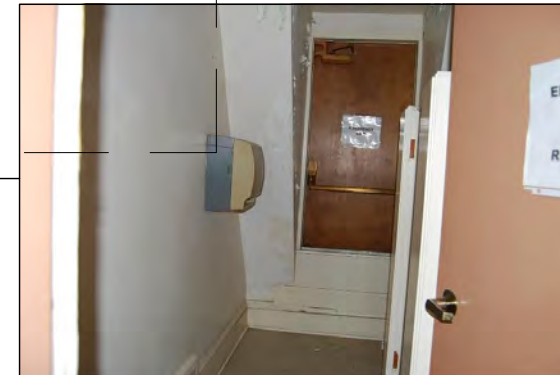
EXHIBIT 6i: Photos: 1043 INDIANA - Third Floor

The third floor appears a little cleaner than the lower levels maybe there was offices up there more recently. The finish on the hardwood floors has worn away, the converted bathroom has been done in the same way. There is a converted window with a half door and panic hardware in the bathroom, and a paper sign on the bathroom door saying emergency exit through restroom.
