North Lawrence Water Main Leak – May 8, 2013

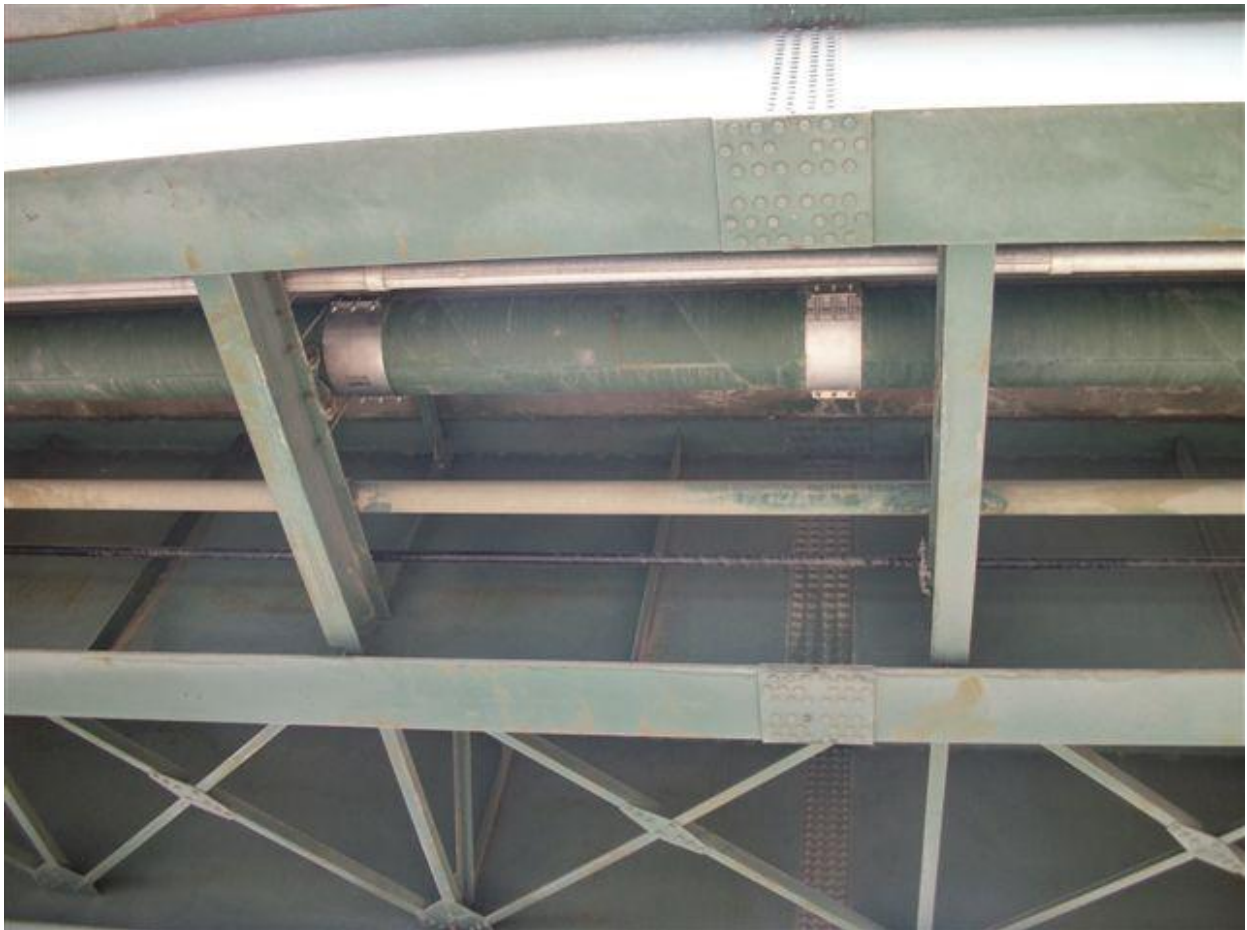
Utilities Department field crews responded to a water main leak on the North Lawrence water line on Wednesday, May 8. The water line is located under the southbound Kansas River Bridge and is an 18 inch steel main, installed in 1977. The leak was spraying from a pinhole that had developed approximately 6 feet from a previous leak. The crew installed a repair clamp to stop the leak. Utilities staff will meet to review the possible replacement of the section of pipe to prevent future leaks in this area. The clamp put in place for this leak is located on the left side in the below photo near the I-beam.
