OAK HILL CEMETERY TEMPORARY RECEIVING VAULT

TEMPORARY/HOLDING VAULT

CONDITION

PROJECT: Oak Hill Cemetery Vault – Exterior Masonry Restoration

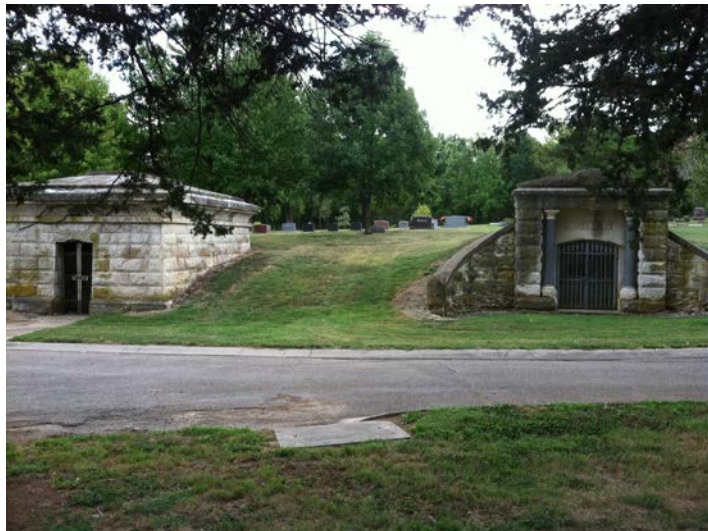
Holding Vault and John P. Usher Vault

The exact construction date has yet to be determined but it is estimated that the vault at Oak Hill was constructed between 1865, when the cemetery was established, and 1884. The exterior is constructed of limestone on all sides and the roof, with stone sizes varying from 46" x 15 ½" to 54" x 16". On the east side there is a small brick inset with a ventilation pipe. The door is made of steel. The overall size of the structure is approximately 500 square feet, or 19 x 26. The design is a simple revival style with little ornamentation. Rusticated stone walls join the stone architrave, which supports a concave frieze and the slightly pyramidal stone roof. The interior of the structure is constructed of brick covered with plaster and is undecorated. The walls come up to form a pointed arch over the open interior space. Both the interior and exterior walls are tuck-pointed with lime putty mortar, which is typical of the period of construction. This is a mixture of water, sand and lime (calcium oxide).

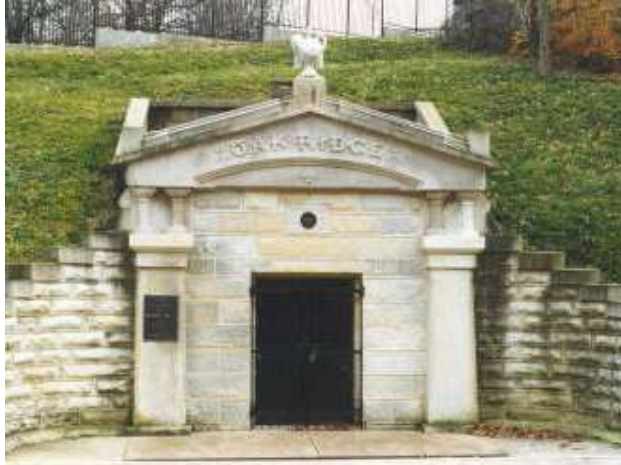
Oak Ridge Vault 1860

This was also the case with the vault at Oak Ridge Cemetery in Springfield, Illinois which held the casket of Abraham Lincoln, and his son, while the President's monument was finished. Another example is the vault at West Lawn Cemetery in Canton, Ohio that held the casket of President McKinley during the construction period of his monument.

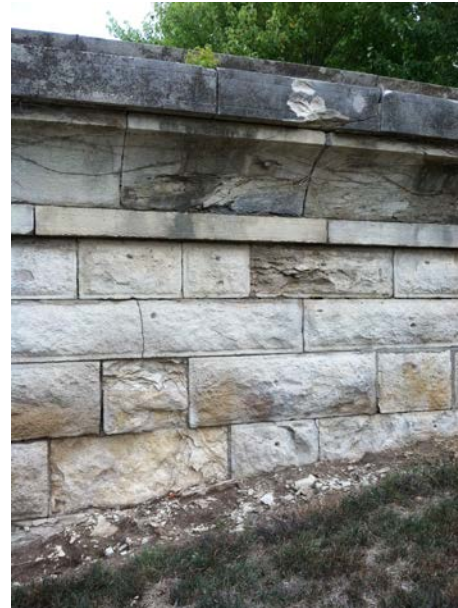
The overall condition of this structure is fair. Evidence suggests that there was at one time vegetation growing on the surface of the stone. This has proven to be detrimental to the condition of the stone and is one of the causes for the spalling (pieces breaking off the façade of the stone), especially near the base. When vegetation grows on the surface of stone, small roots penetrate the stone, creating many ways for water to get behind the surface. The water is then subject to regular freeze/thaw cycles, which compromises the integrity of the stone. Also the minerals in the water try to push out through the face of the stone.

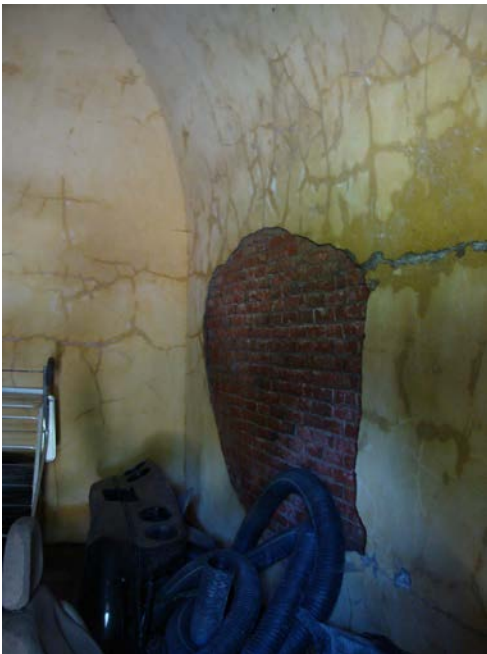
The other probable cause is mortar damage that was either left unchecked or was fixed with an incompatible replacement mortar. When mortar is damaged and the seal between the stone and mortar is compromised, water is able to get into the wall, just as with the vegetation. It is important when repairing historic masonry buildings that the correct materials are used. In this case, a Portland cement mortar was used to re-point joints on the roof. Portland cement is too firm for use on most historic masonry buildings that are constructed out of natural stone or brick. The result is further damage to the joints and the stone. Since the repaired joints are on the roof, the damage can typically be traced from the joint down to the ground level.

The re-pointing issues on the roof have also led to minor problems on the interior. Overall the plaster is in good condition for its age, with no indications that it has been replaced from the original. As water has gotten behind the stones on the roof, it seeps into the walls, compromising the mortar joints of the interior bricks, which then seeps to the plaster, creating the cracks that are visible today.
