Assessment Report

Pedestrian, Bicycle, and Transit

City Of Lawrence, Kansas 19th Street from Iowa to Barker

Practical Road Safety Assessment

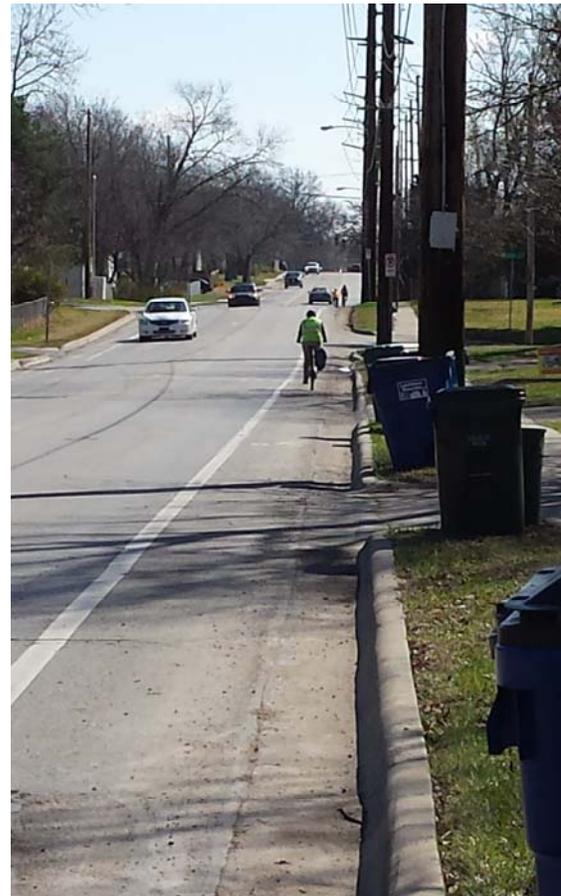
Bicycle: Except where there are bike lanes, bicyclists must share the road with high traffic volumes including commercial vehicles. Vehicles were observed not giving the required 3' passing clearance.

Discussion: This is generally a two lane street with a center turn lane from about Alabama St. to Kentucky St. and at other major intersections in the corridor. Two segments have bicycle lanes, between Naismith and Alabama and east of Massachusetts St. Only experienced riders should use 19th St., particularly from west of Tennessee to east of Kentucky where there is less than desirable pavement condition and an auxiliary lane which may cause confusion.

Bike lane between Naismith and Alabama.

Lower Cost: Consider a parallel alternate route on 21st St. for a bicycle boulevard. This much lower volume residential street would be safer and favorable to less experienced riders.

Initiate an education campaign to bring public attention to the 3' passing law. Suggest it correspond with the start of school in September.

Provide "Shared-Lane Marking" to fill gaps between segments with bike lanes particularly where lanes are too narrow for a bicyclist and a motorist to travel side-by-side and to eliminate any confusion as to where a bicyclist should be when extra lanes are present.

Provide timely street cleaning for bike lanes and along curb where a bicyclist will normal ride to remove sand and other debris.

Higher Cost: Reconstruct to 3-lanes with bike lanes (planned between Iowa and Naismith; but bike lanes are not shown on planning map).

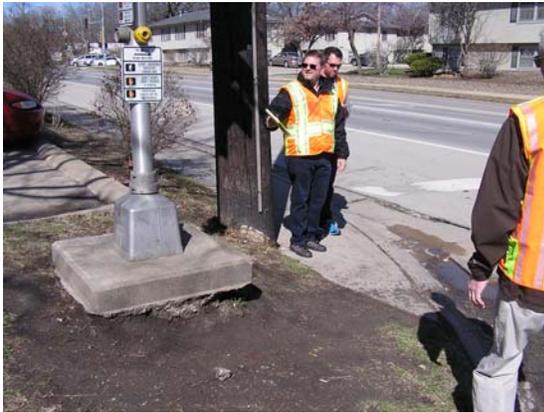
SW Corner of 19th & Kentucky

Pedestrian: Much of the sidewalk in the corridor is less than 4' wide, aging and in poor condition. Pedestrian walk intervals at signalized crossings provided less than 7 seconds to initiate a crossing for both minor and major roadways.

Discussion: Cracking, faulting, and general deterioration of sidewalks are prevalent. Many curb ramps exhibit these conditions in addition to having running slopes and/or cross slopes greater than desirable with no turning space. Many sidewalk sections have no buffer space.

Lower Cost: Update crosswalk markings as necessary to maintain visibility.

Provide recommended pedestrian walk interval of 7 seconds at signalized crossings. Consider longer intervals on minor street crossings.

Moderate Cost: Upgrade to pedestrian countdown signals.

Upgrade to APS.

Higher Cost: Reconstruct with appropriate pedestrian accommodations (planned between Iowa and Naismith, should include pedestrian facilities on both sides of 19th St.

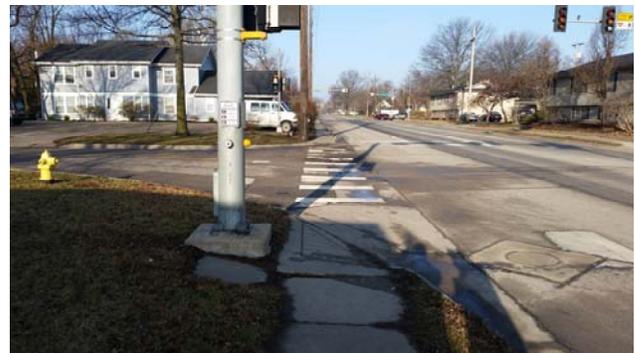
Looking west from the SE corner at Kentucky.

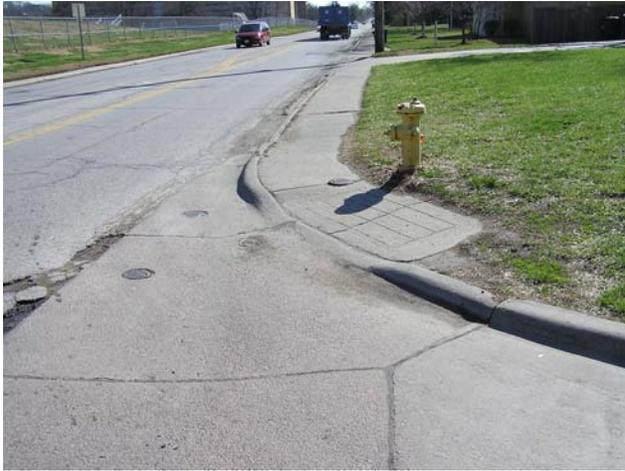
Looking east from the SW corner at Ousdahl.

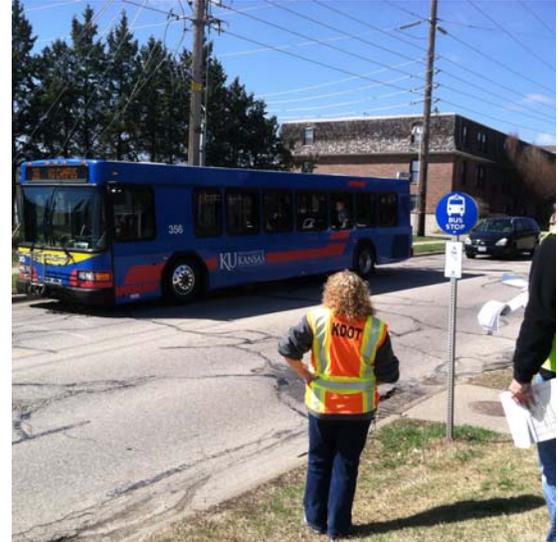
Transit stop at Anna Drive.

Transit: There is a lack of improved bus stop waiting areas along the corridor. Patrons tended to stand on the curb close to traffic.

Discussion: Concrete pads at bus stops provide patrons room to be a safer distance from the street. A sheltered seating area provides a dedicated space for waiting with greater visibility to a motorist. In addition, greater accessibility to transit services can be achieved with a concrete pad.

Suggestions:
Add concrete pads at transit stops. Consider benches, shelters, bike racks, and trash receptacles.

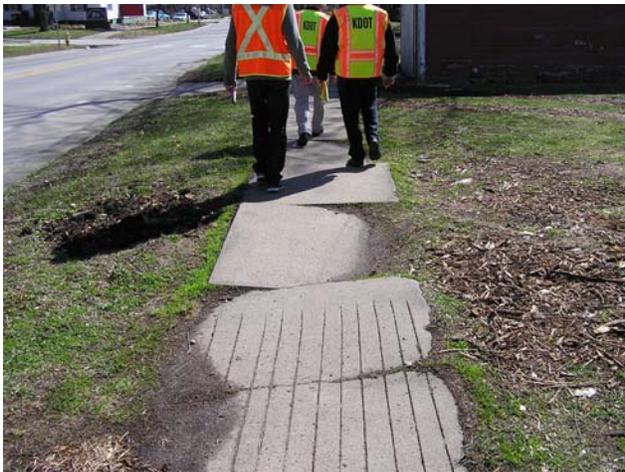
South side of 19th east of high school.

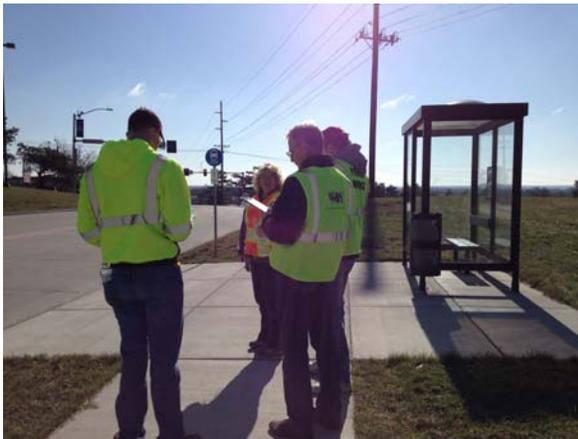
Transit: No bike racks at Constant Avenue transit stop

Discussion: Transit provides bicycle racks on buses but no bike rack accommodation at stop. Space was allocated for racks in bus stop design but not installed at time of construction.

Constant Transit Stop.

Lower Cost: Install bike rack.

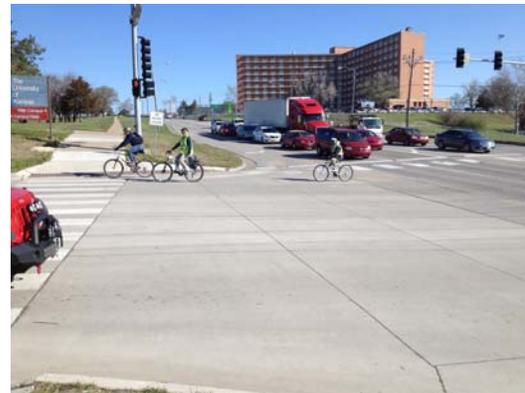
Bicycle: Poor connectivity across Iowa St.

Discussion: There is an existing multi-use path along the west side of Iowa St. KU is proposing a multi-use path (Jayhawk Trail) which will generally run diagonally on campus from the NE across the intersection to the SE. Crossing Iowa St. with its high volume is a concern.

Looking north across 19th at Iowa.

Lower Cost: In conjunction with the planned transit center and bicycle boulevard concept discussed under corridor wide issues, create a signalized crossing at 21st St. that connects the transit center and the bicycle boulevard on the east side of Iowa St. with the multi-use paths on west side of Iowa St.

Coordinate KU improvements (Jayhawk Trail) with planned City of Lawrence improvements on 19th St. to address bicyclists crossing Iowa St.

Enhanced pavement markings and signing to support bicycle movements through the intersection. Consider bicycle detection in conjunction with a bike box concept.

Medium Cost: Consider the optional use of a bicycle signal face to control bicycle movements consistent with the MUTCD Interim Approval.

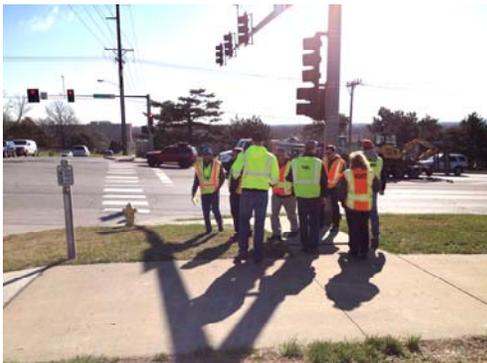
Pedestrian: This is not a pedestrian friendly intersection.

Discussion: Large intersections can be difficult for pedestrians to manage with long exposure times. Large corner radii promote high speed turns. An injury pedestrian crash occurred in a crosswalk at this intersection. An additional challenge of negotiating steep curb ramp grades with lack of level landings in conjunction with the street crossing increases the difficulty.

ramps are provided on all quadrants, these are generally undesirable in terms of accessibility as they direct pedestrians into the intersection potentially exposing them to parallel crossing traffic. This is particularly problematic for wheelchair users who then must turn in the roadway. Necessary landings were lacking on all quadrants. Landings provide a staging area and turning space. The elevation difference between the roadway and sidewalk on the NW, NE and SW corners have led to excessive grade on these curb ramps.

There are no cross walk markings across 19th on the east side of Iowa. An offset pavement marked median area is currently provided on Iowa St. for turning traffic on Iowa St.

Looking east across Iowa at 19th.

Lower Cost: Add crosswalk marking on the east crossing of 19th St.

Provide minimum 7 seconds walk interval and consider more time for 19th St. crossing.

Medium Cost: Consider a pedestrian refuge median for the Iowa St. crossing. See http://safety.fhwa.dot.gov/provencountermeasures/fhwa_sa_12_011.cfm. Provide countdown pedestrian signals.

Re-grade and add landings for curb ramps. Curb ramps should not exceed 15' but a combination ramp should be considered. This is where perpendicular ramp runs are brought to an intermediate landing. Then the ramp is continued in the direction of the sidewalk (parallel). Provide APS.

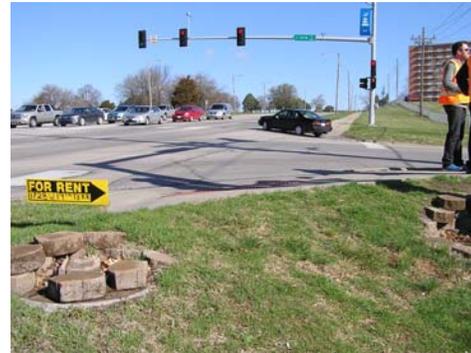
Looking north across 19th at Iowa.

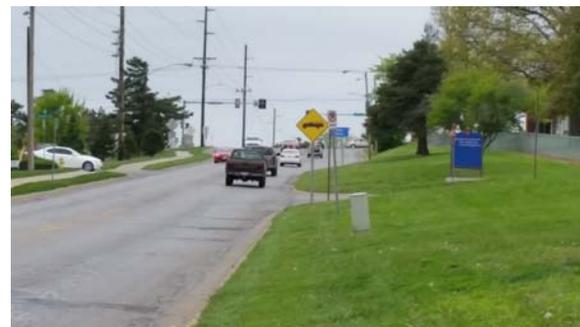
Bicycle: Moderate grade approaching Iowa St. heading west.

Discussion: Grade can slow down even the best bicyclists and can be challenging to less experienced riders to maintain a straight path.

Looking west back to Iowa St.

Lower Cost: Add a west-bound bike climbing lane approaching Iowa St. using striping.

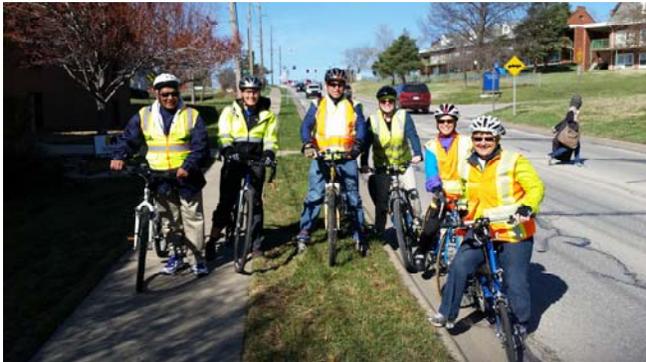
Pedestrian: No sidewalk on the north side of 19th St.

Discussion: This is an area of higher pedestrian volumes. There is no crosswalk to support access to the Anna Drive transit stop. An injury pedestrian crash occurred near the Anna Drive intersection.

Note pedestrian crossing road.

Lower Cost: Add crosswalk markings at Anna Drive transit stop.

Moderate Cost: Add sidewalk.

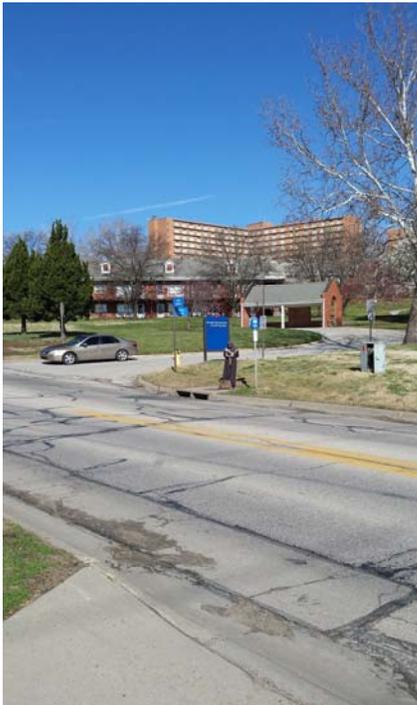
Pedestrian was accessing transit stop.

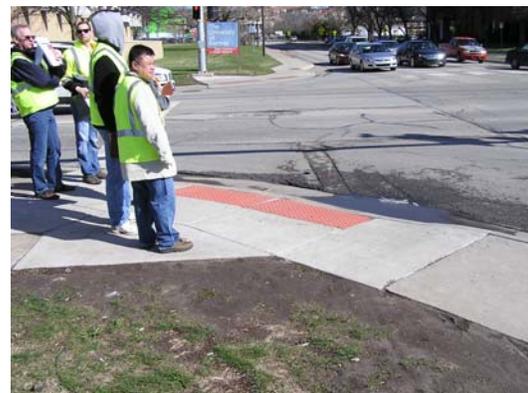
Bicycle: No space allocated for a bicyclist queued or moving through this intersection.

Discussion: Naismith Dr. is a major bike route to KU. There are some older style shared lane markings along the curb on Naismith Dr. but a bicyclist is not allocated any dedicated space at intersection.

At Naismith Dr. looking north

Lower Cost: Reallocate space in the cross-section to better accommodate a bicyclist and keep a motorist aware of the mixed use.

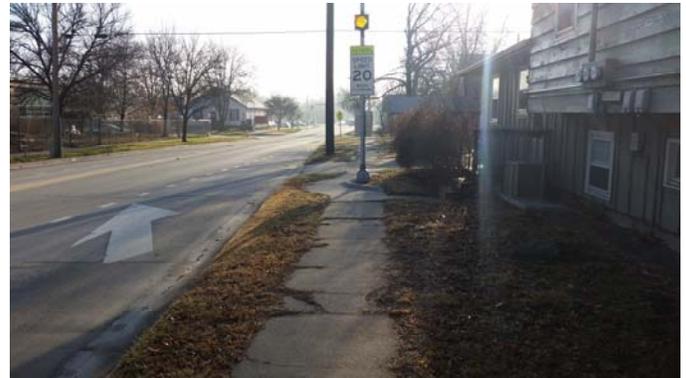
Discussion: There are intermittent added lanes to accommodate high vehicle turning movements. The injury crashes involving bicyclists are indicative of the need to better address a bicyclist needs. Tennessee and Kentucky are paired one-way major collector routes north of 19th but are local two-way streets south of 19th. Overwhelmingly, traffic using Tennessee and Kentucky involves turns to/from 19th St. There is very little desire for east bound right turns from 19th St. yet there is an auxiliary

lane with a starting taper near Ohio St. heading eastbound with an ending taper starting at Kentucky terminating west of Vermont St. This encourages weaving and can lead to unsafe vehicle maneuvers. -

Auxiliary lane termination east of Kentucky

Lower Cost: Consider a roadway reconfiguration which eliminates the eastbound auxiliary right lane and add bike lanes

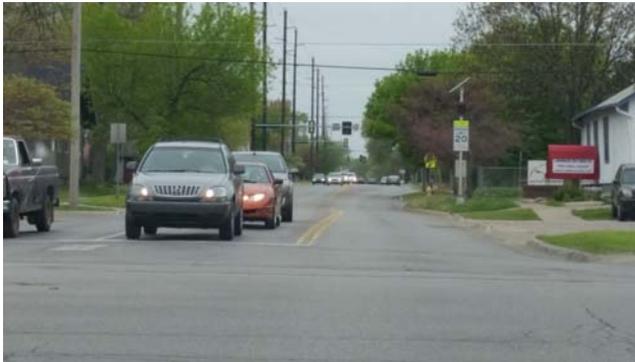
Pedestrian: A majority of the injury pedestrian crashes in the corridor occurred in this segment.

Discussion: The 7 injury crashes involving pedestrians in the two block stretch including Tennessee, Kentucky and Vermont is a concern. As noted, Tennessee and Kentucky are one way routes to/from the downtown area. Additional weaving due to the auxiliary lane and high vehicle turning movements creates a poor pedestrian environment. Cordley Elementary School is located between Kentucky and Vermont. While it does not appear any of the pedestrian crashes involved elementary school children, consideration should be given to children walking to school. Data provided shows 19th St. is a proposed route for SRTS planning.

School x-walk sign looking East from Mass. St.

Lower cost: Implement a SRTS program at Cordley. Consider a walking school element in the SRTS program.

A lane reassignment as discussed above under bicycle considerations for this segment.

Trim trees to keep desirable sight lines to signs.

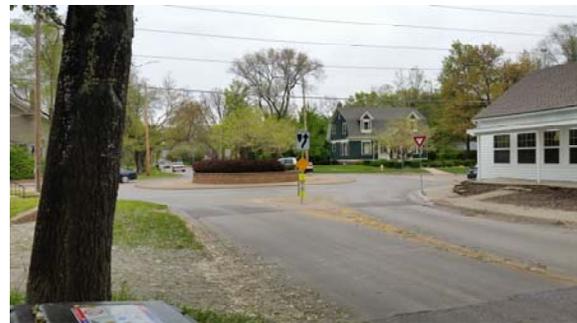
Bicycle: While there are bike lanes approaching this roundabout, a bicyclist must share the lane through the roundabout.

Discussion: Barker Avenue is a relatively low volume residential street. 19th St. is also located in a residential area east of the Massachusetts corridor. However, there are higher traffic volumes than one would expect for the residential area including what appears to be

disproportionate high level of commercial vehicles.

Looking east to Barker Roundabout.

Lower Cost: Provide bike guidance approaching roundabout and “Shared-Lane Marking” in the roundabout. This includes improving the overall pavement markings at this location.

Restrict through commercial traffic east of Massachusetts St.
