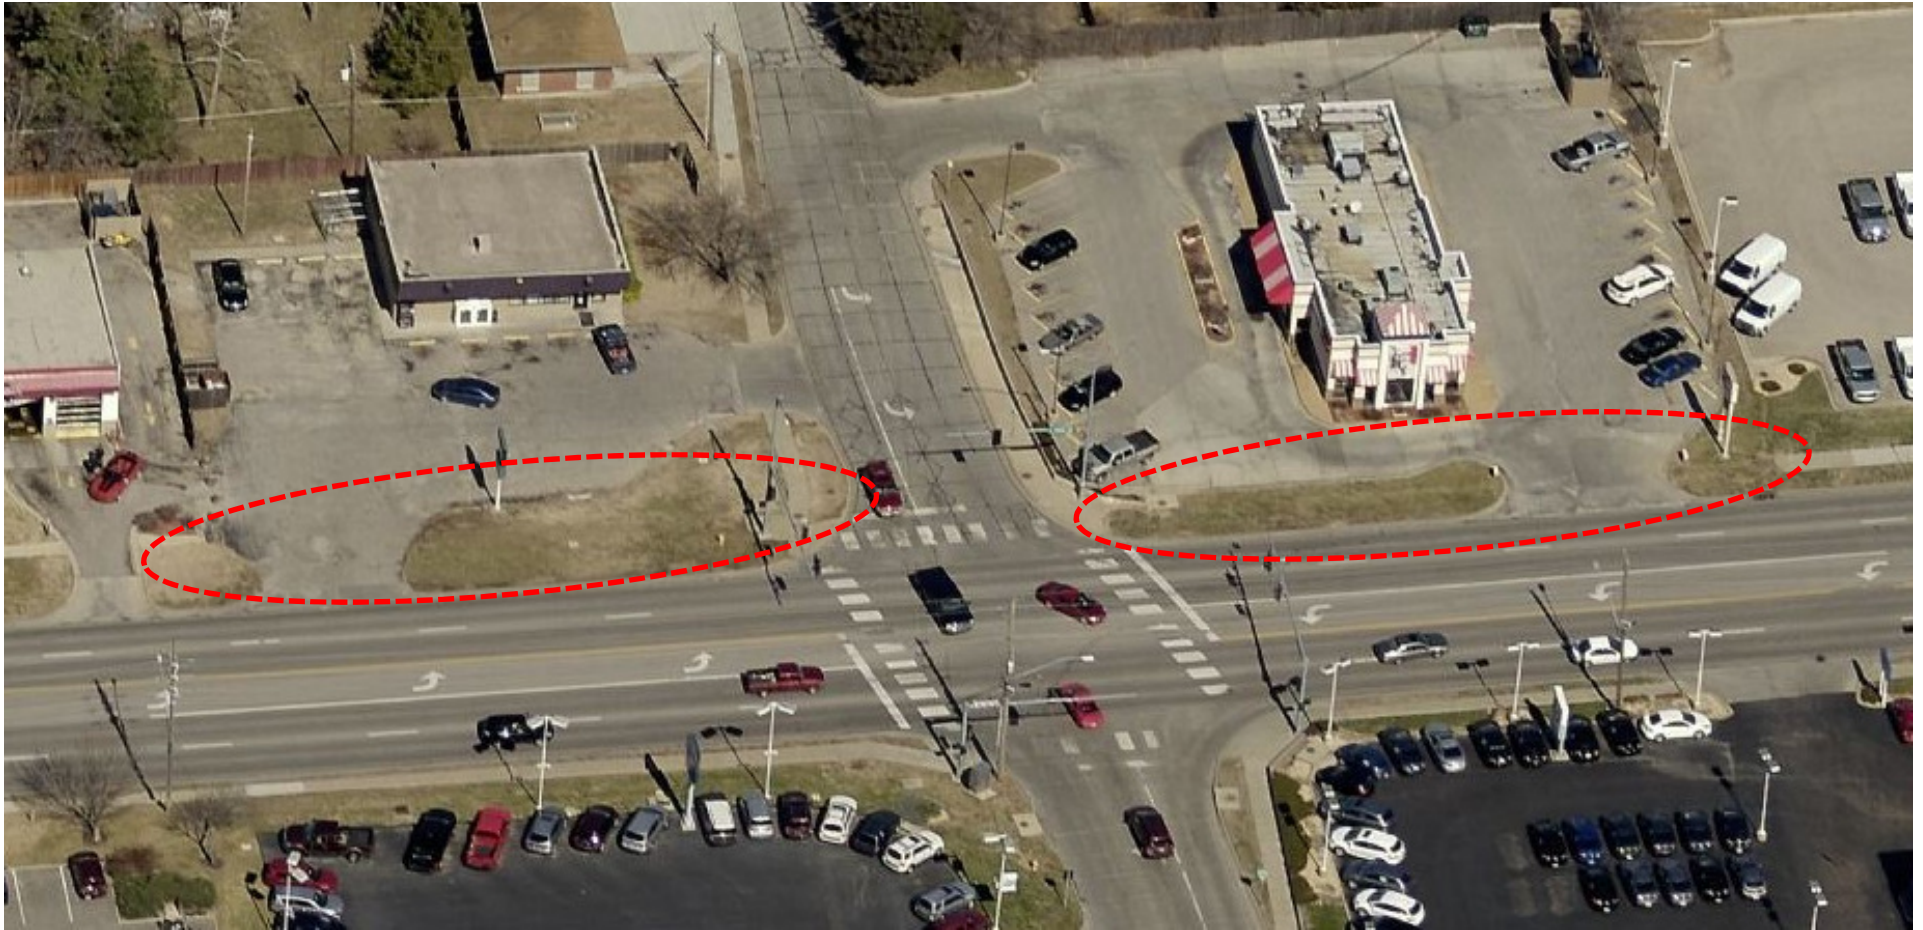
23rd Street at Alabama Street Intersection

- Missing sidewalk on north side of 23rd Street at Alabama Street
 - 70', 85' and 25' segments missing
 - Estimated cost ~ \$5,000
 - Assumes 5' wide sidewalk

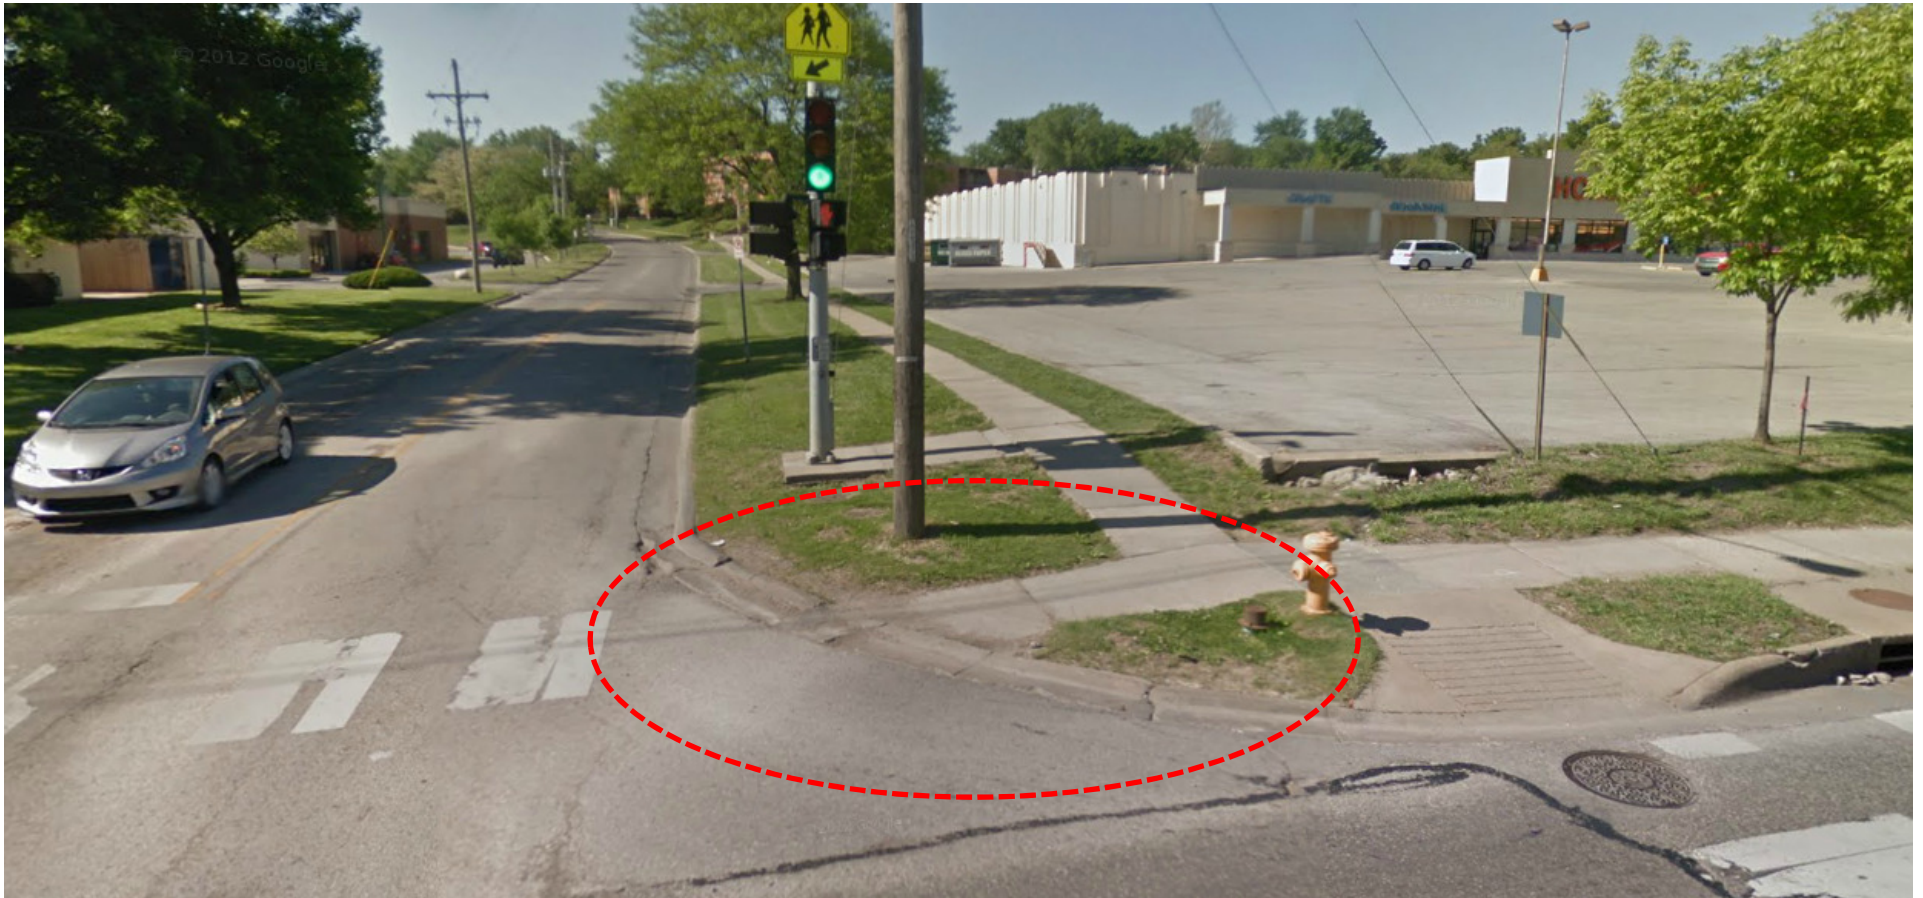
23rd Street at Ousdahl Road Intersection

- Southwest quadrant curbramp and gutter pan in disrepair
 - Remove and reconstruct e/w curb ramp and adjacent sidewalk panels
 - Reconstruct gutter pan to improve drainage
 - Estimated cost ~ \$1,500
 - Entire intersection could be improved concerning ADA access to push buttons and truncated dome tiles (at a greater cost)

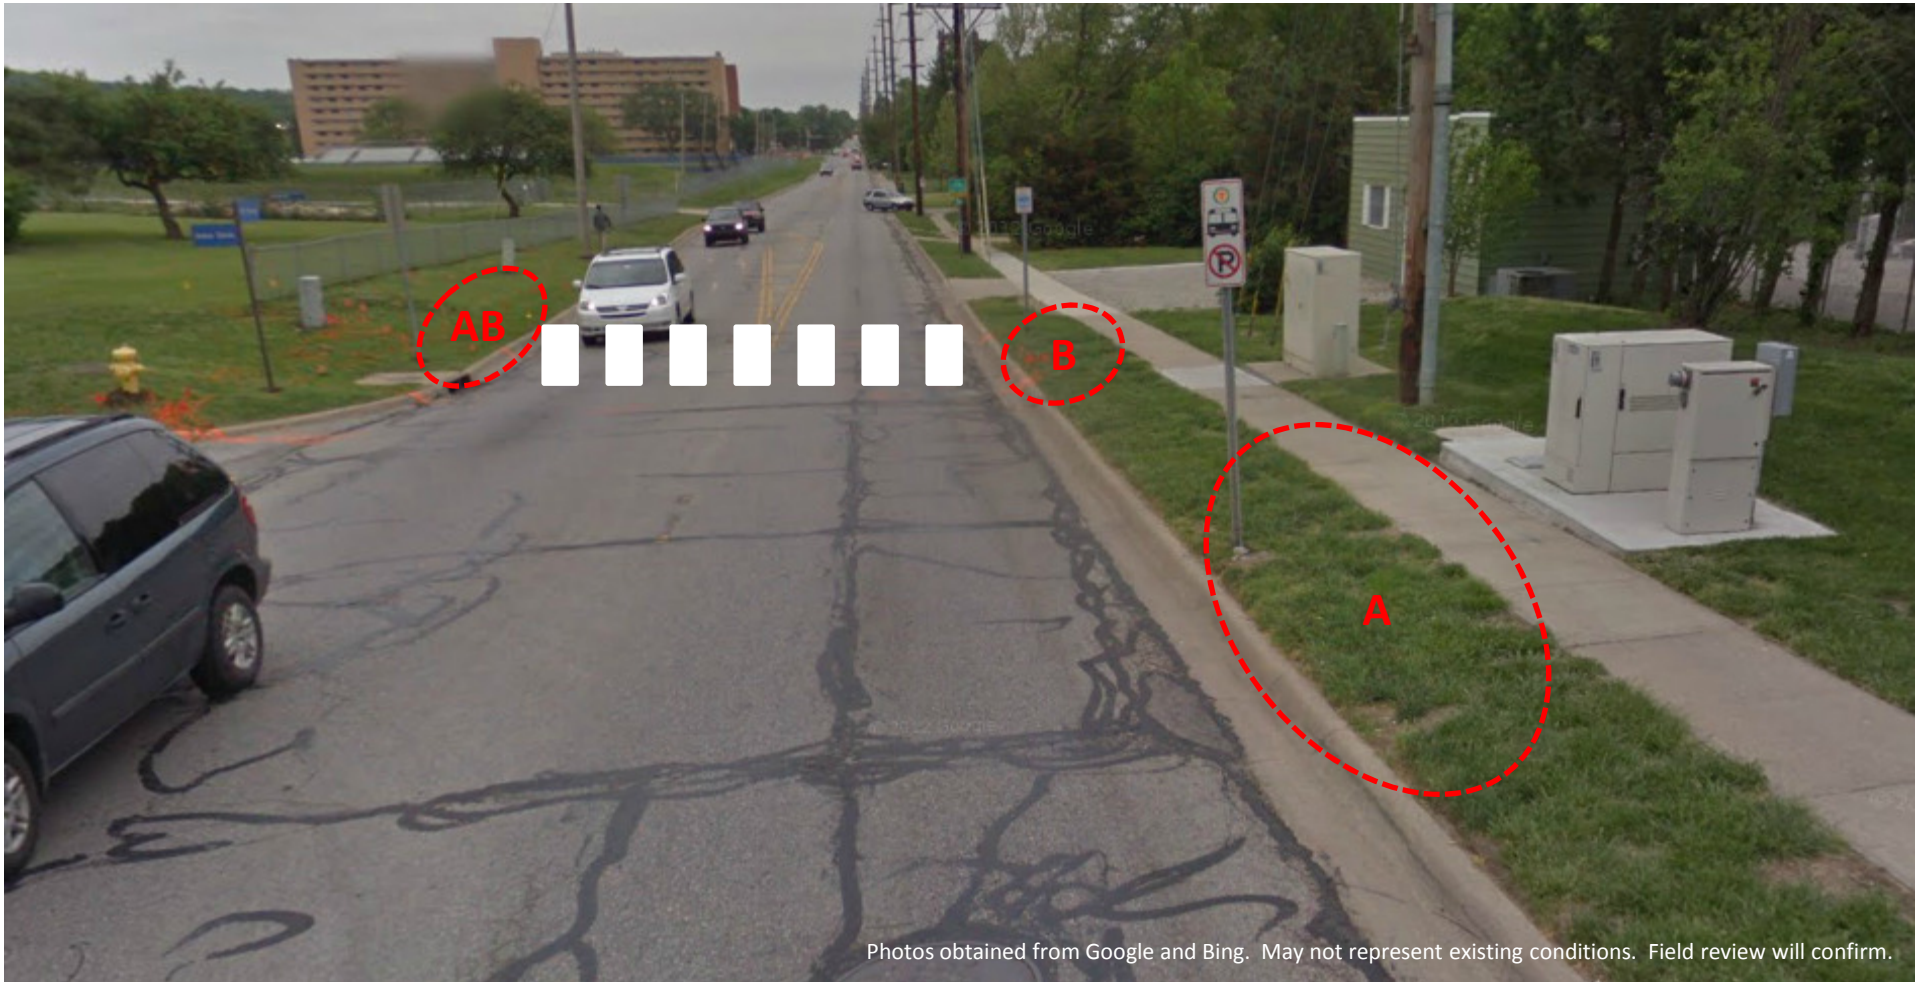
A – 19th Street near Anna Drive

- Bus stops with no rider amenities
 - Concrete pads could be installed
 - Estimated cost to add 6' x 6' concrete pad ~ \$300 each

- No bus stop connection to sidewalk
 - Improvements would include concrete pad (AB), sidewalk extension/ramp (B) and curb cuts and painted crosswalk
 - Estimated cost for all improvements above ~ \$1,800

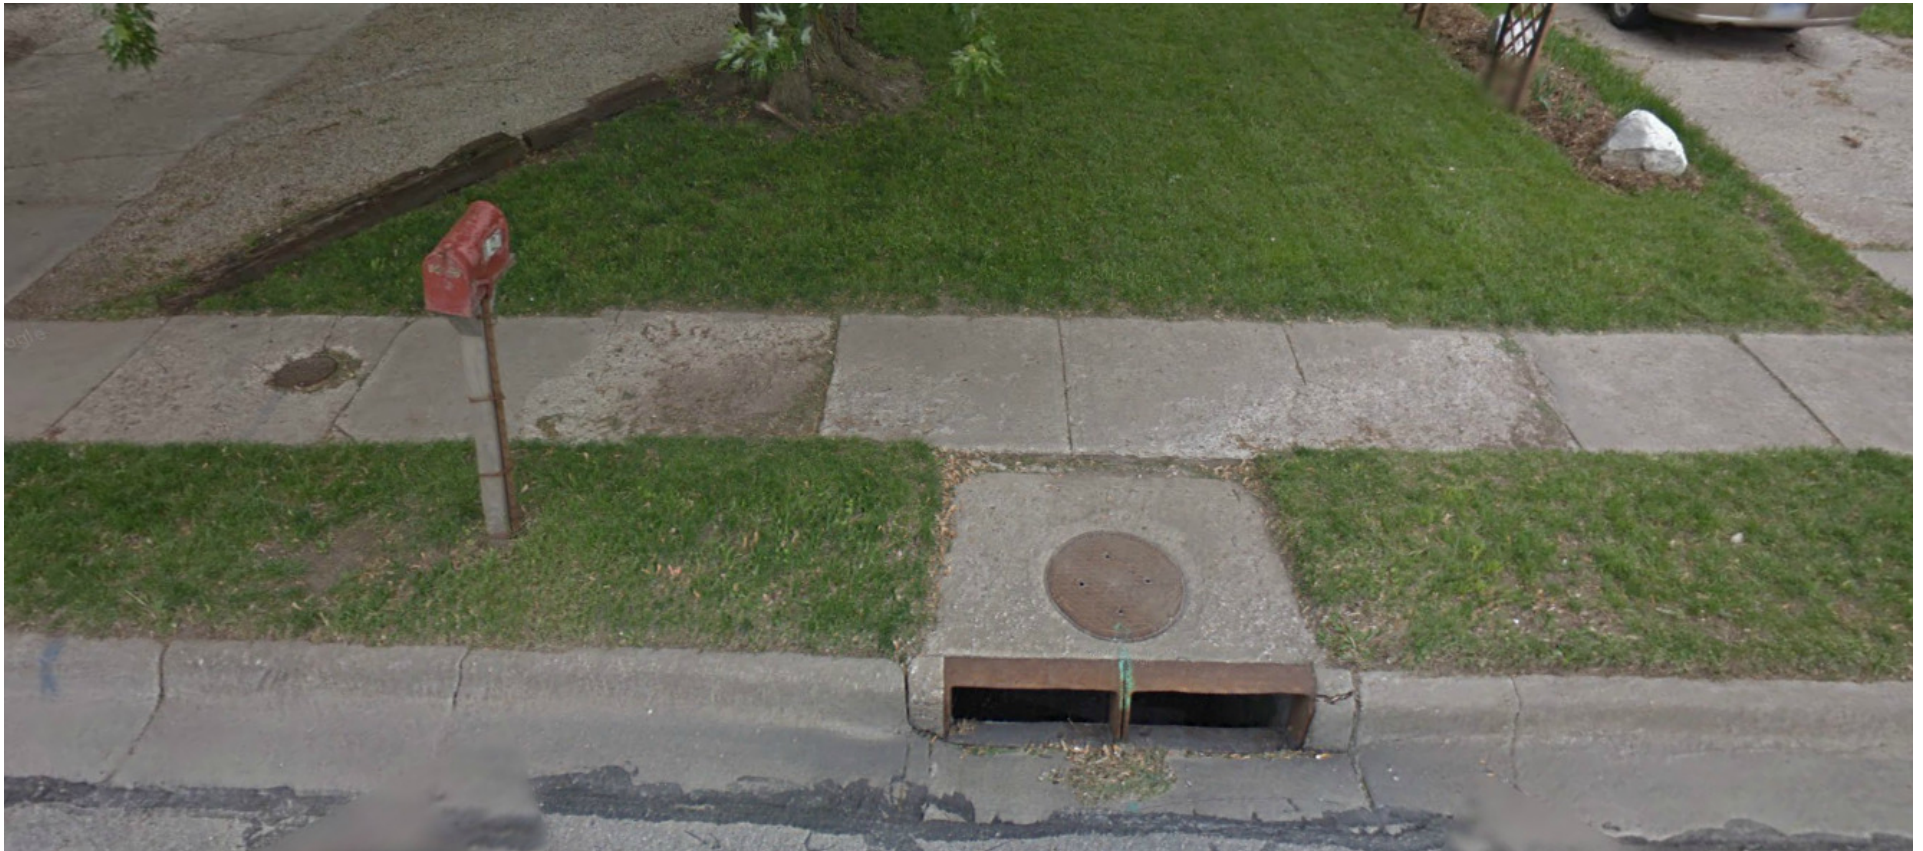
19th Street west of Naismith Drive

- Sidewalk in disrepair (south side of 19th Street)
 - Removal, disposal and reconstruction of about 40'
 - Estimated cost ~ \$1,500
 - Assumes 4' wide sidewalk

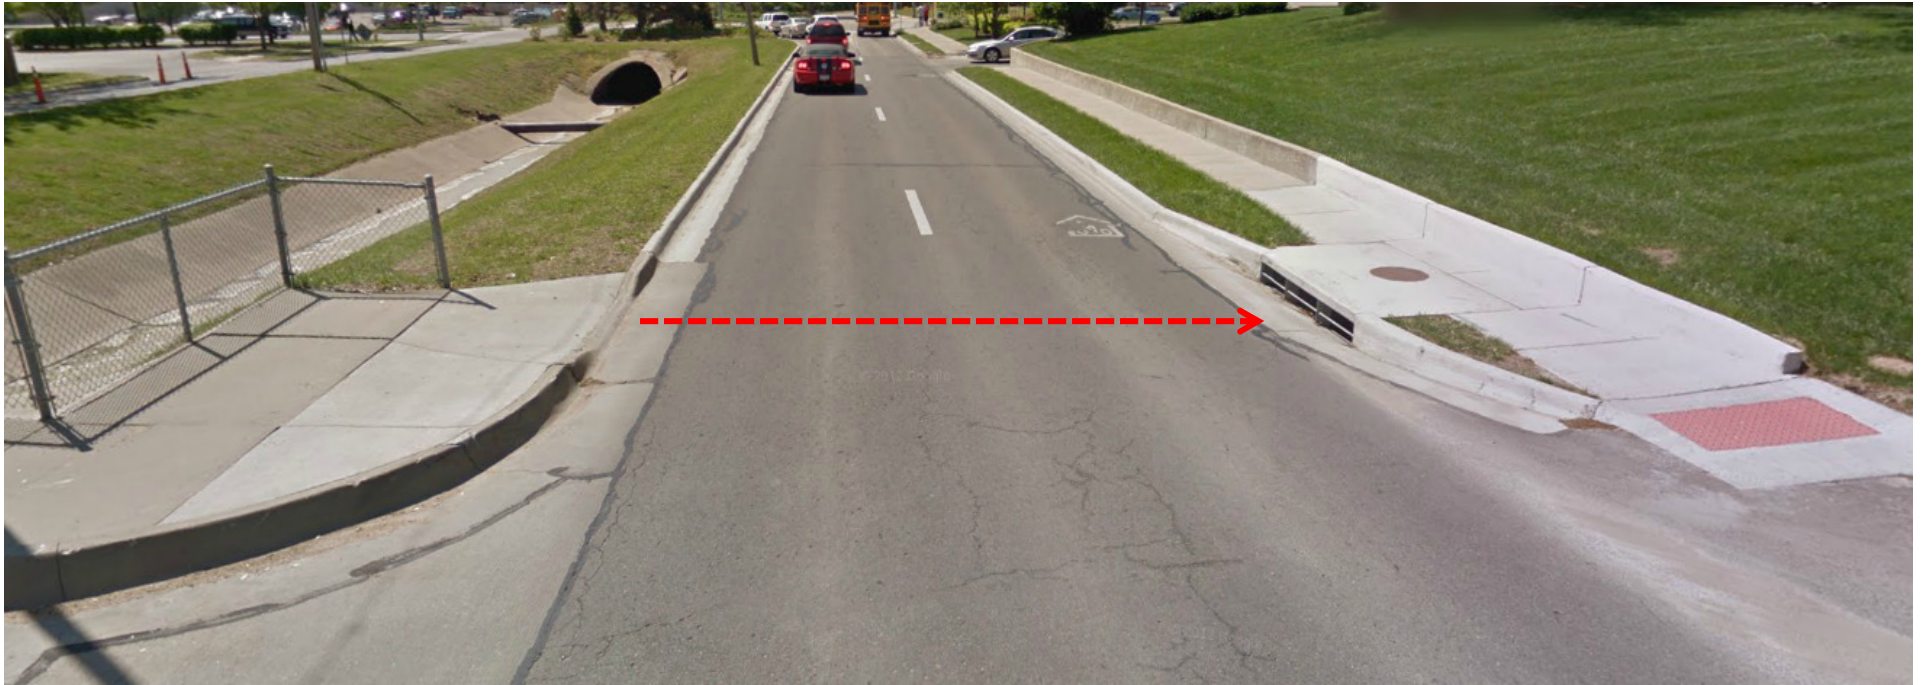
Naismith Drive at 22nd Terrace – (SB looking south)

- Pedestrian ramp from median leads pedestrians into catch basin
 - Reconstruction of curb ramp area to provide pedestrian ramp at radius
 - Estimated cost ~ \$2,000
 - Several locations similar to this along Naismith corridor

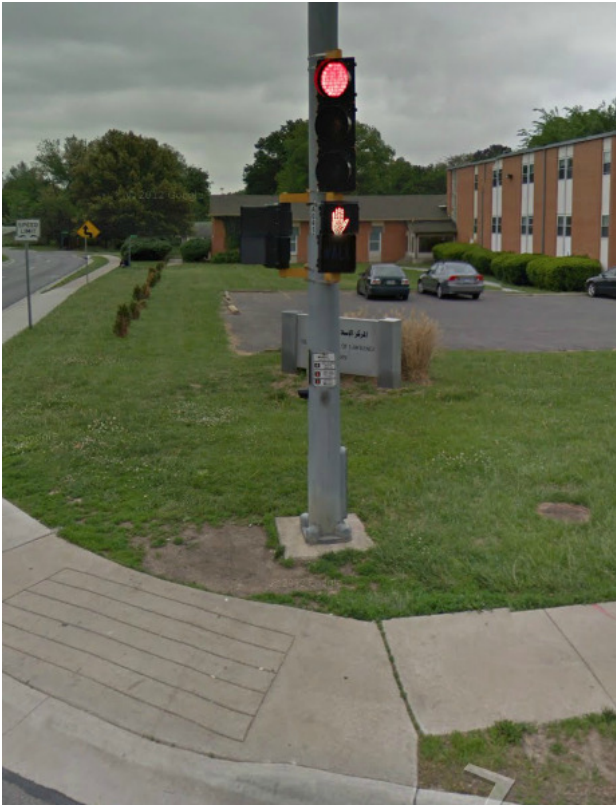
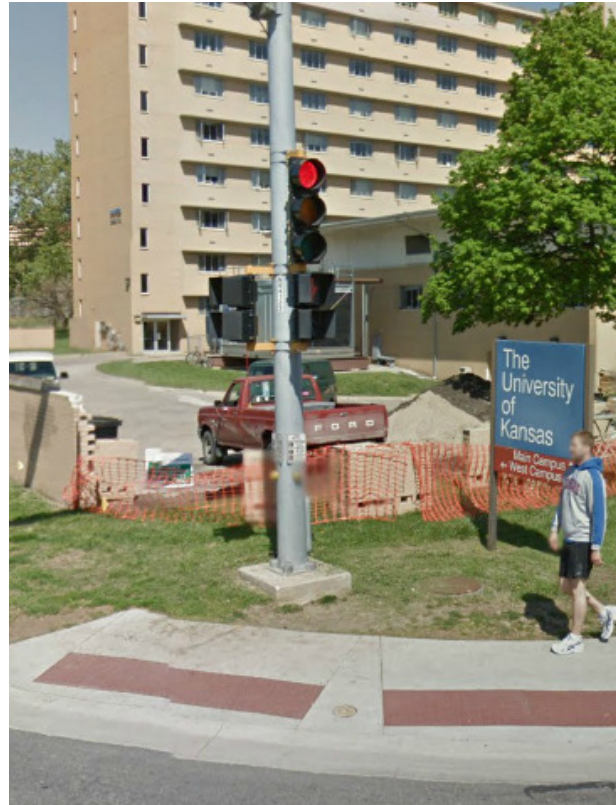
Naismith Drive and 19th Street intersection – All Quadrants

- Difficult to access pedestrian push buttons – especially for disabled users
 - Possible improvements include:
 - Splitting out push buttons – adding pedestals
 - Installing more concrete to provide barrier free access to signal poles
 - Estimated cost varies significantly by type of improvement and quadrant

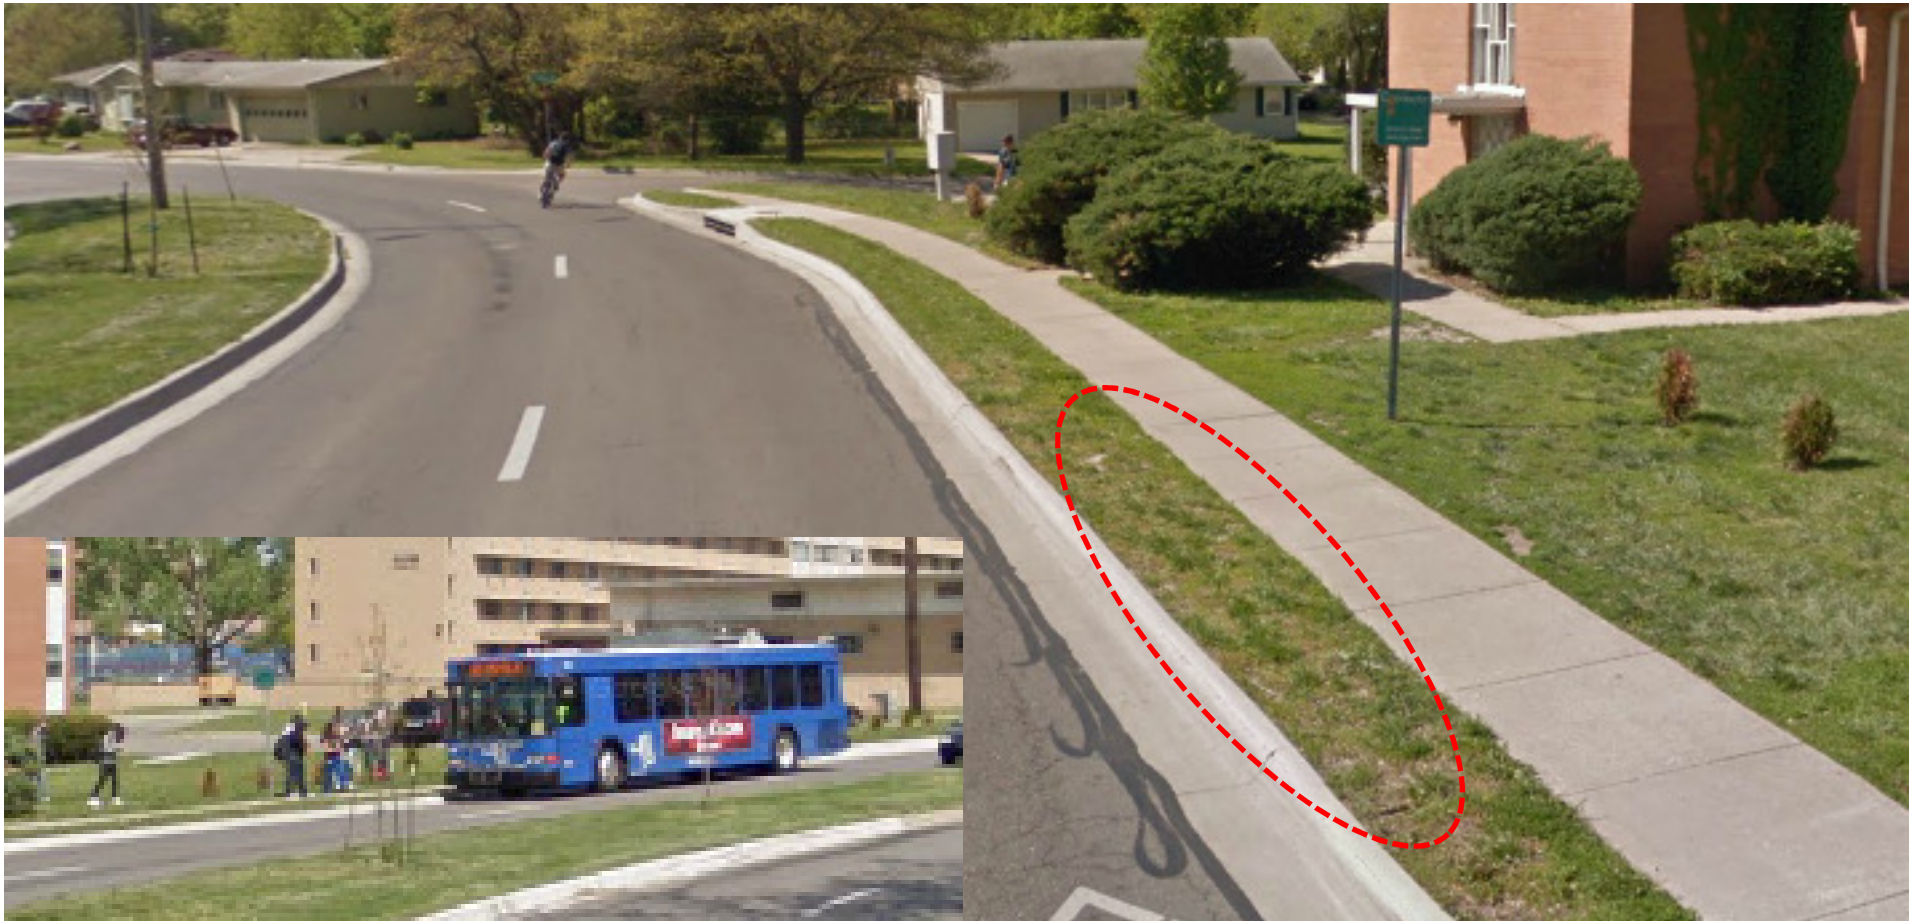
SB Naismith Drive south of 19th Street

- Highly used(?) bus stops with no rider amenities
 - Concrete pad and shelter could be installed (shelter if r-o-w available)
 - Estimated cost to add 3' x 6' concrete pad ~ \$200
 - Estimated cost to install simple shelter (with concrete foundation) ~ \$5,000 - \$8,000
