Appendices

- A. Preparer & Qualifications
- B. Agencies/Tribes Consulted
- C. Public Involvement
- D. Sponsor Land Use Letter
- E. Section 106 Consultation
- F. Wetland Delineation, Consultation and Preliminary JD
- G. Affected Environment and Area Photography

Environmental Assessment Projects; Purpose/Need Aerial Background

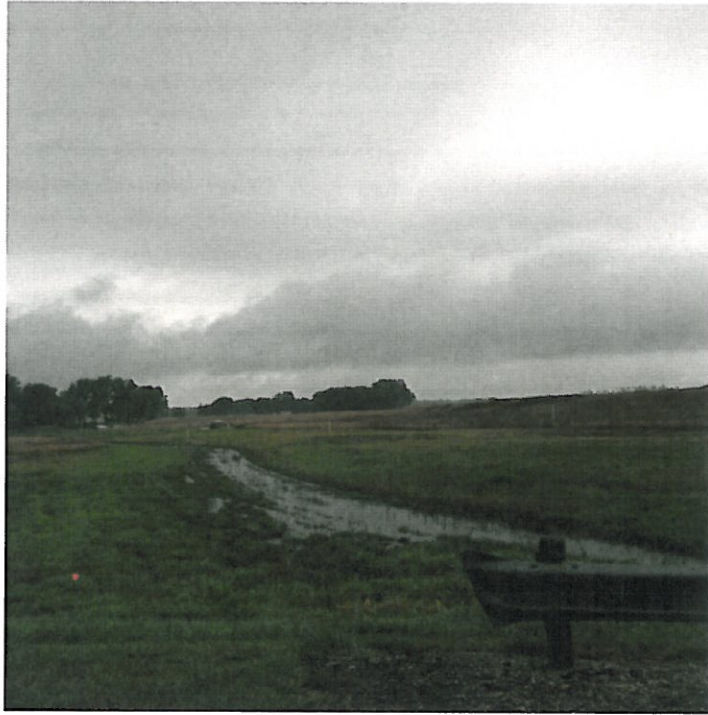
Photo 1 – Drainage adjacent to agricultural fields with K31 fescue

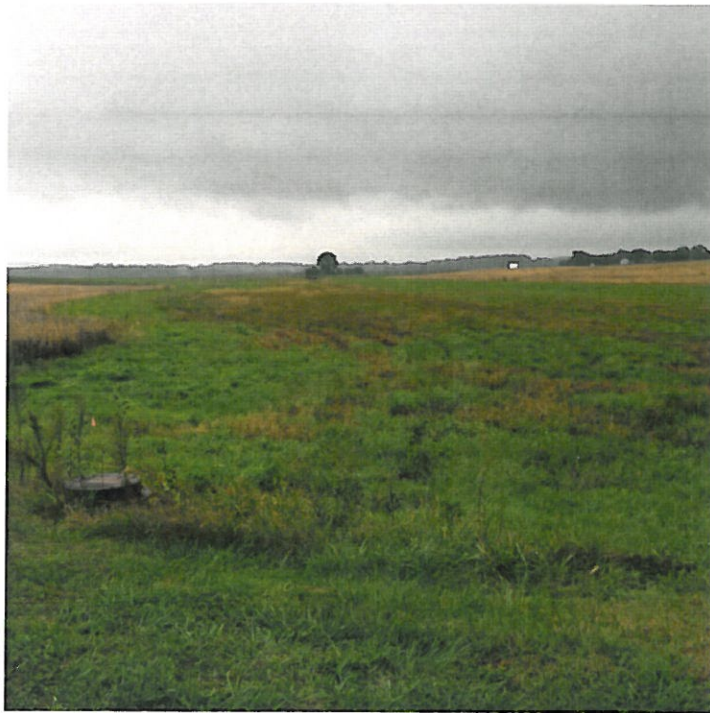
Photo 2 – Drainage area showing K31 cool season grass and agricultural field

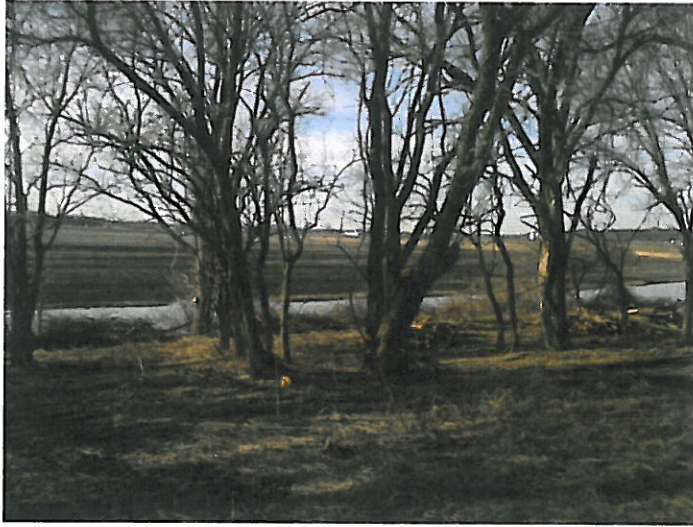
Photo 3 – Area of cottonwood trees and Osage orange above oxbow drainage (note- the stacks of woody material are underbrush and not trimmings from the trees.)

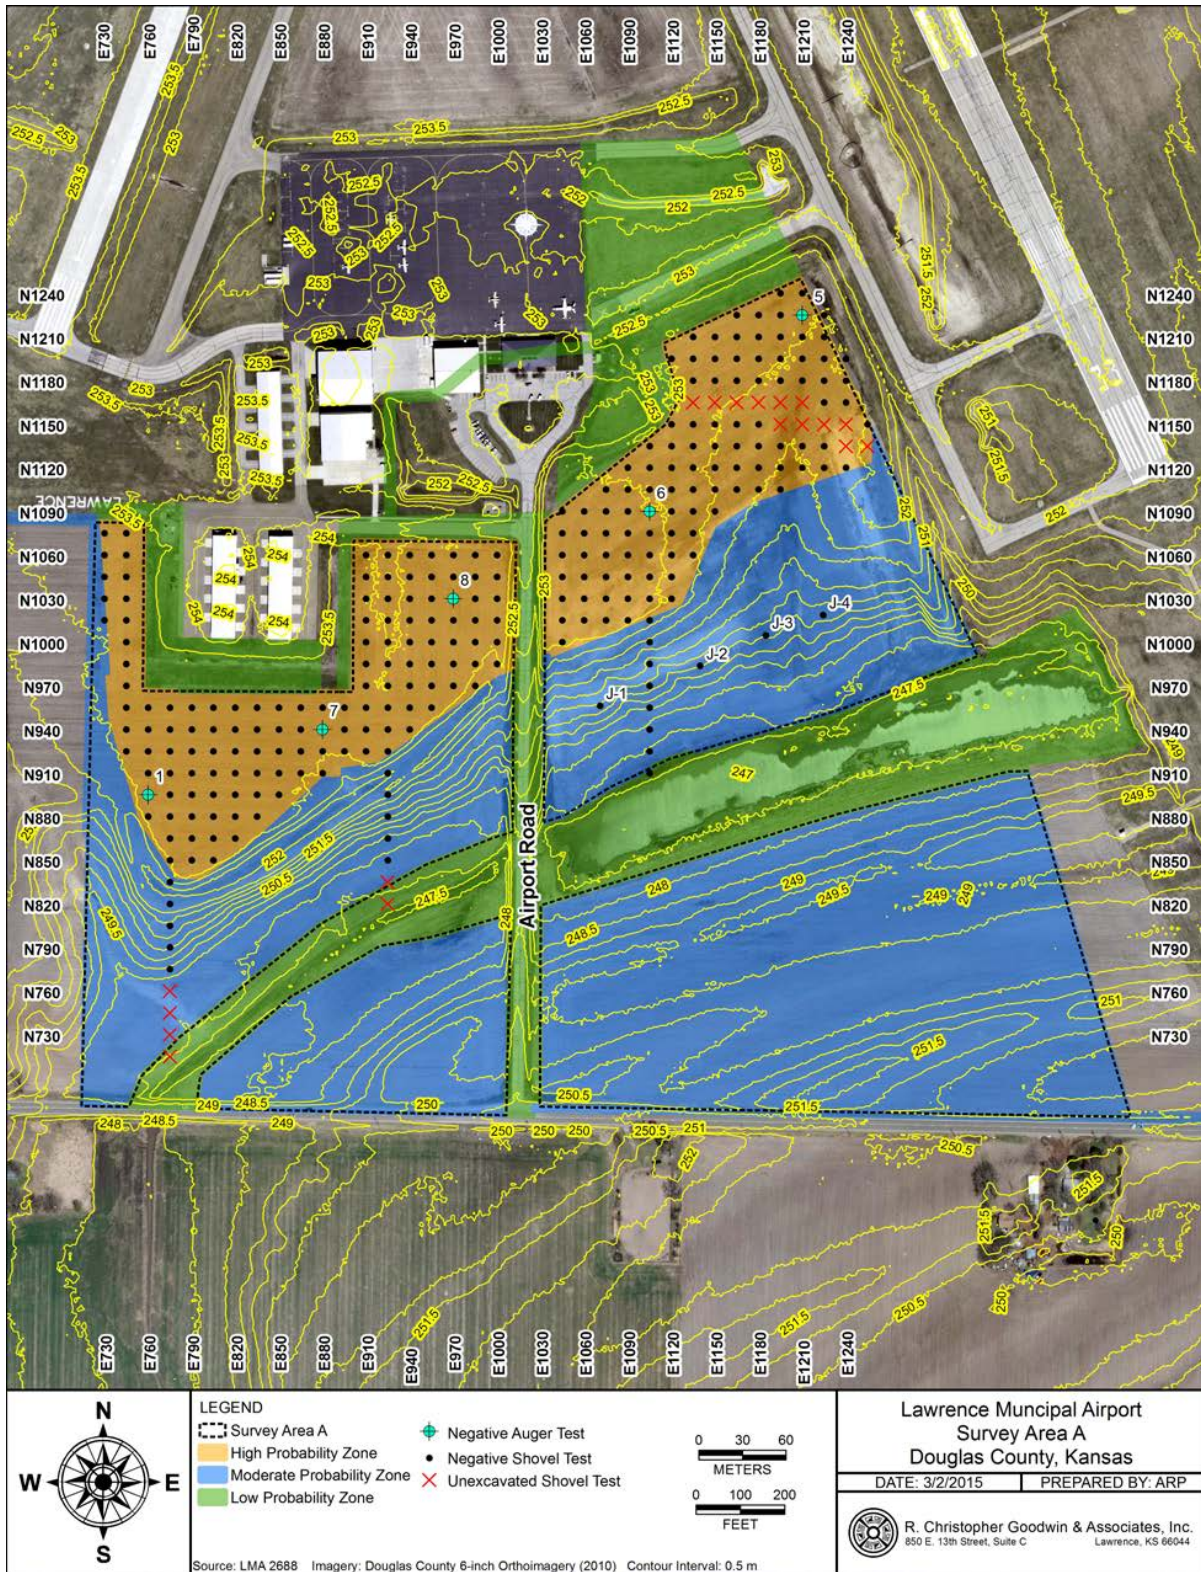
Figure 6.1. Phase II investigations of Area A.

In Area A, the geoaarcheological investigation consisted of the excavation of five auger tests: 1, 5, 6, 7, and 8 (Figure 6.1). Appendix B provides detailed stratigraphic profiles for each of these auger tests, none of which yielded cultural materials. The typical observed soil profile in all of the auger tests at Area A consisted of an Ap horizon and thick mollic epipedon (A1 and A2 horizons) with an average depth of 76 cm (30 in), followed by a weakly developed B horizon (Figure 6.4). In Area A, the top of a buried soil (Soil 2) was located approximately 205 cm (81 in) bgs (Figure 6.4). The buried soil at Area A consists of an A horizon with very dark brown to dark brown silty clay loam and a well-developed Bt horizon with clay films and redoximorphic concentrations. Two auger tests (5 and 6) excavated east of Airport Road revealed a nearly two meter-thick homogenous package of very fine sand between 128-300 cm (50-118 in); no buried soil was detected. The results of auger tests 5 & 6 more closely resemble the typical pedons for the Bismarckgrove or Eudora series than the Rossville series (Soil Survey Staff 2015). Given the proximity of the Eudora-Bismarckgrove series, it is probable that the Rossville soil series simply was misplotted in the portion of Area A to the east of Airport Road.

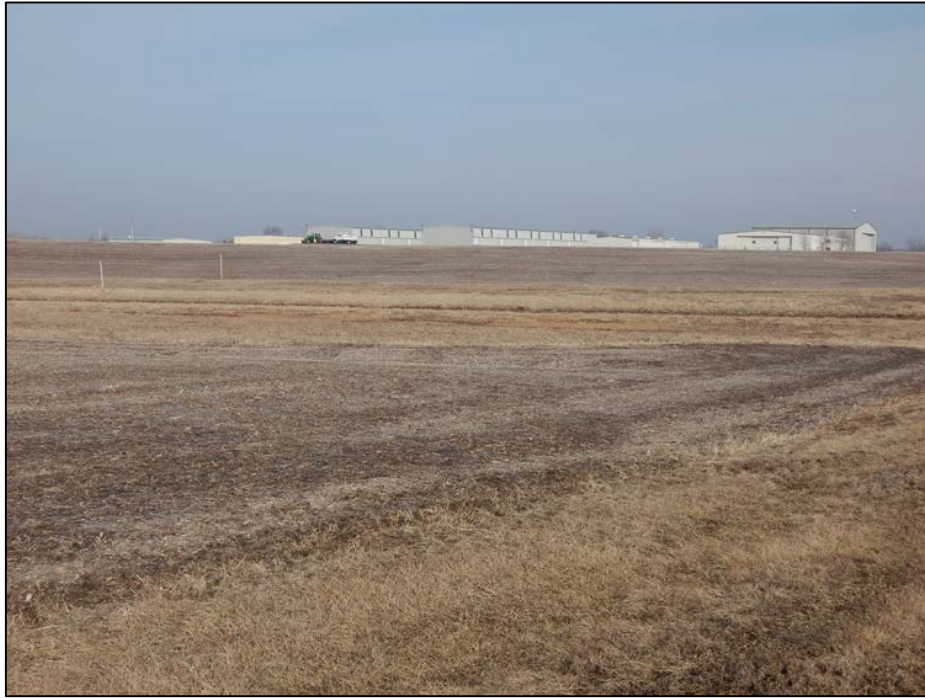
Figure 6.2. Area A west of Airport Road: overview of the drainage channel (mid-ground) and the Newman terrace escarpment and tread (background); view is to the northwest towards Item 2.

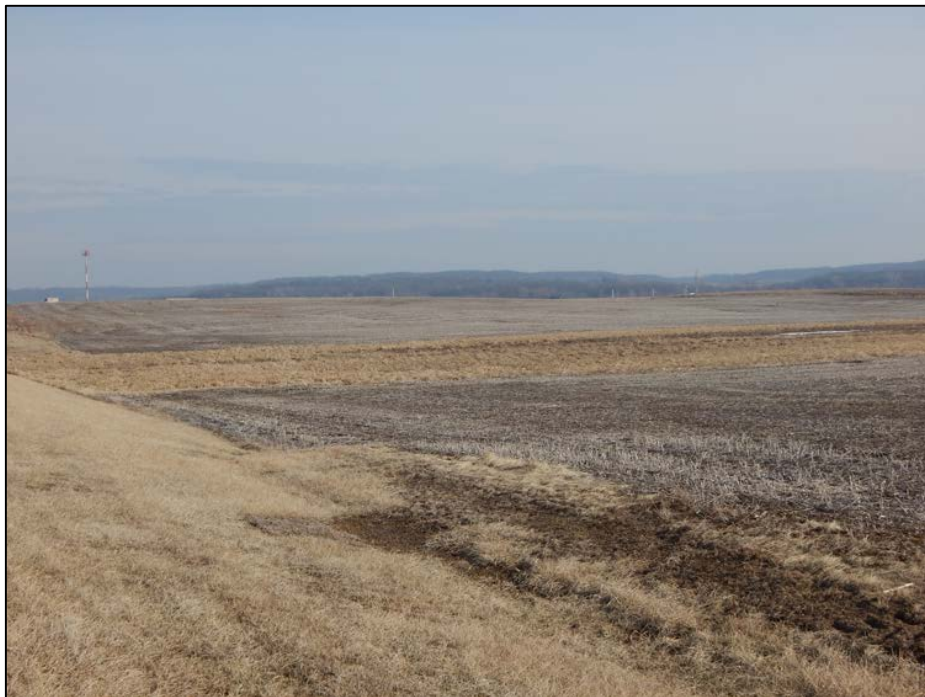
Figure 6.3. Area A east of Airport Road: overview of the drainage channel (mid-ground) and the Newman terrace escarpment and tread (background); view is to the northeast.

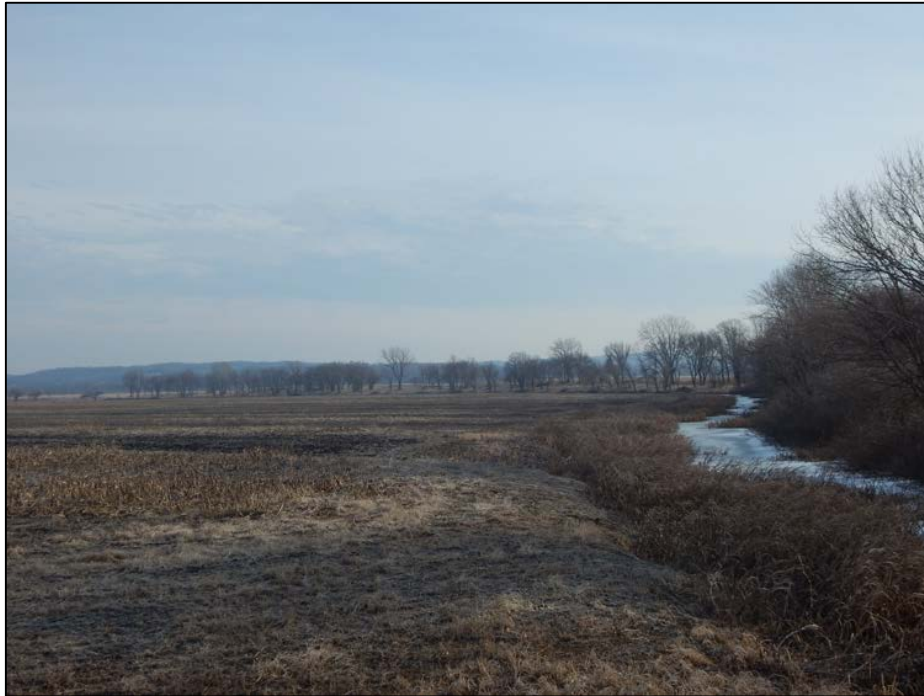
Figure 6.6. Overview of Area C from E1500 Road, view is to the northeast.

Area C corresponds to the intersection of Item 4 with a wooded escarpment of the Newman terrace along an oxbow lake at the western periphery of LWC property (Figure 6.6). The soil series mapped for this area include the Kimo silty clay loam and Rossville silt loam soil series, both of alluvial origin (Soil Survey Staff 2015). The Kimo silty clay loam is mapped along the meander scar, and the Rossville silt loam is mapped atop the tread of the Newman terrace (Figure 2.4).

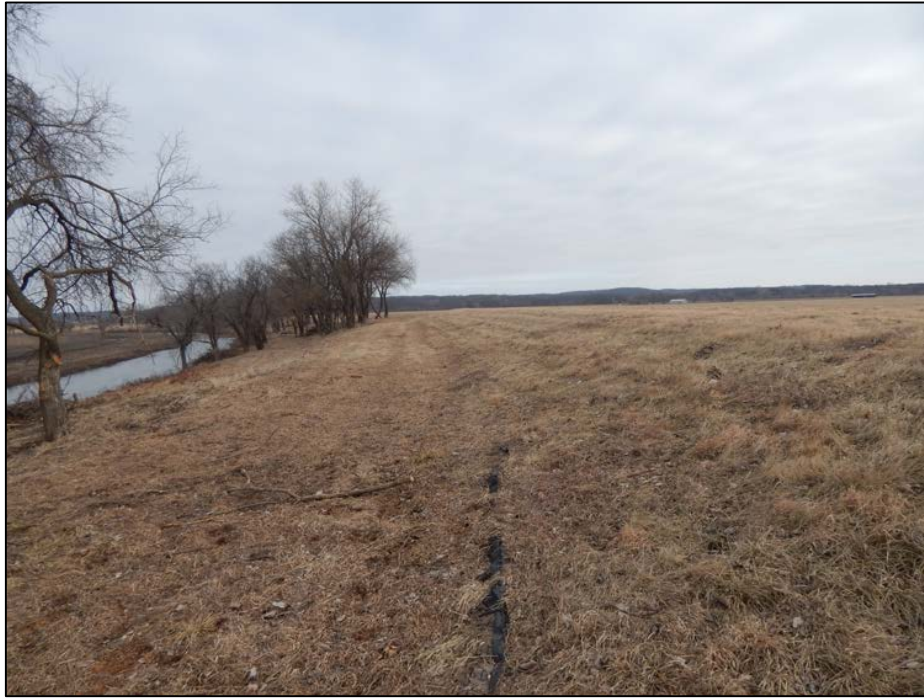
Figure 6.7. Area C: artificial berm on the Newman terrace tread with black landscape cloth exposed at its base; view is to the north.

In Area C, the surface of the Newman terrace has been impacted by runway construction activities. An artificial earthen berm was constructed in circa 2008 to provide erosion control and stabilization (Dale Mooney and Rick Bryant, personal communication, Jan 2015). This berm parallels the edge of the terrace along a large section of the oxbow lake in the central portion of the Item 4, and is bisected by a stormwater drain (Figure 6.7). Other disturbances include two natural gas pipelines that intersect the oxbow to the north of the levee, and a KU building complex at the southern end of the oxbow (Figure 6.8).

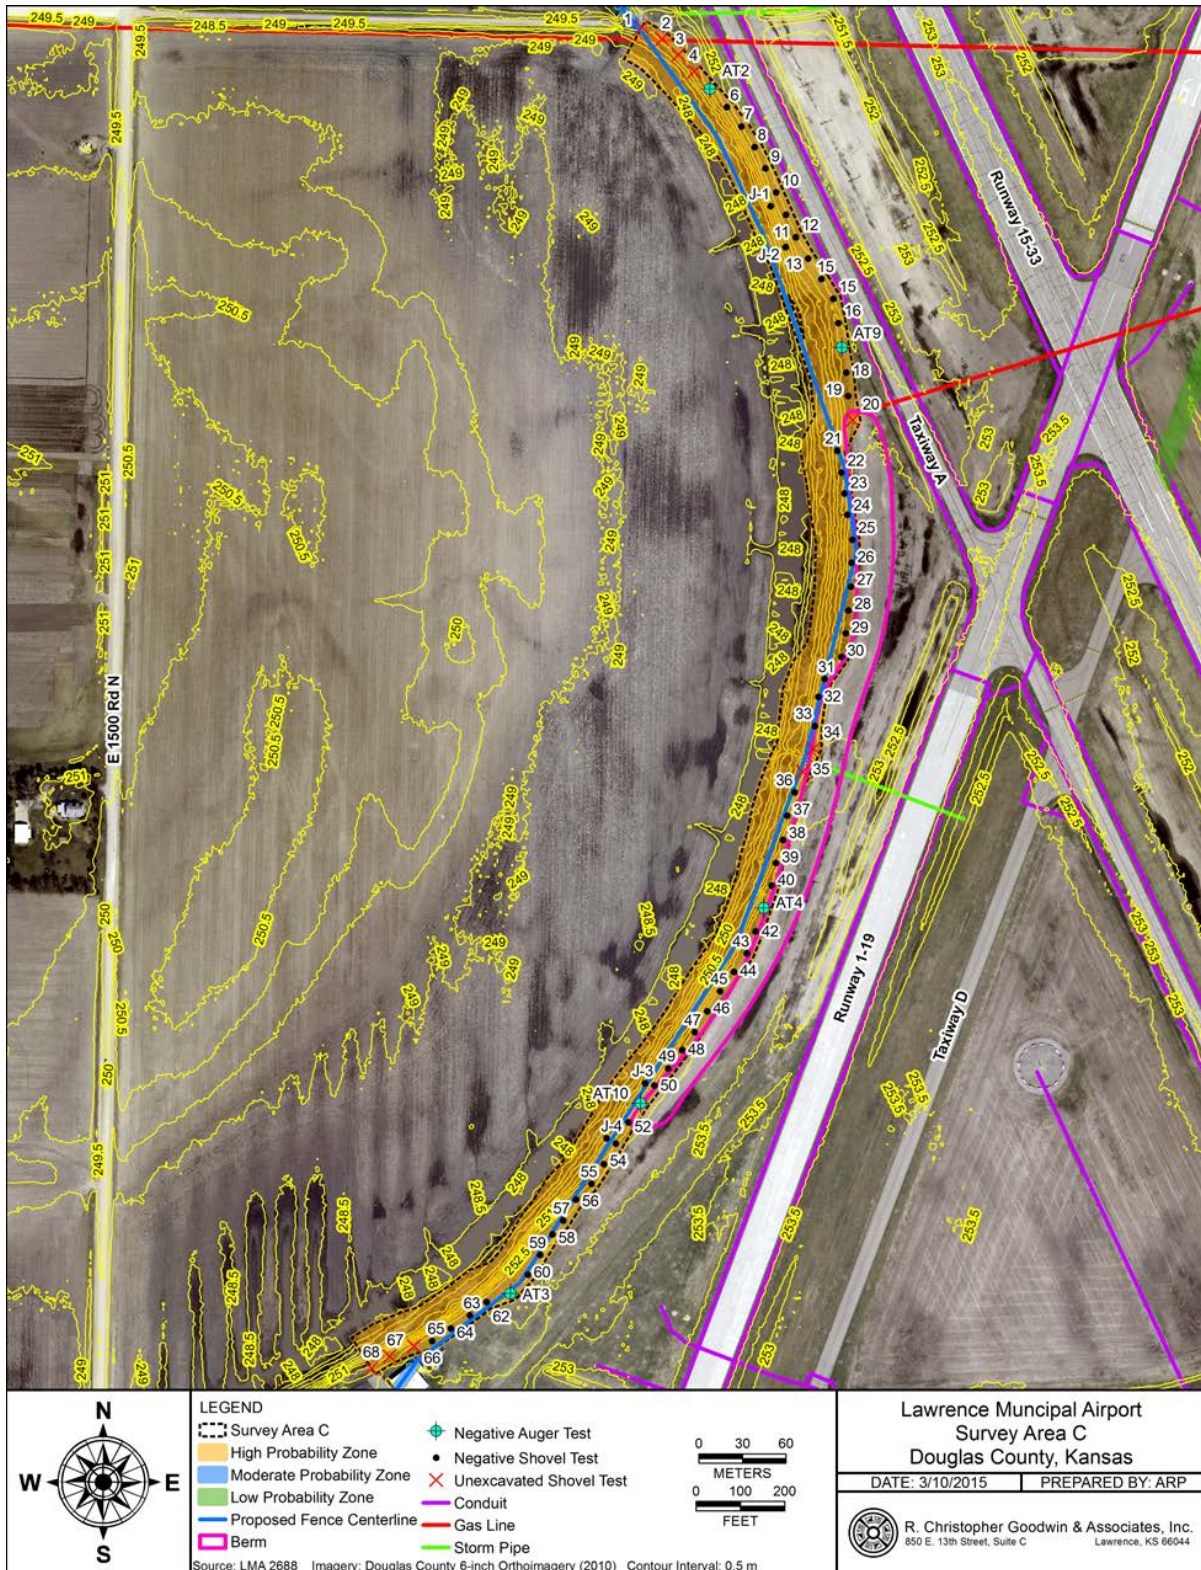
Figure 6.8. Phase II investigations of Area C.

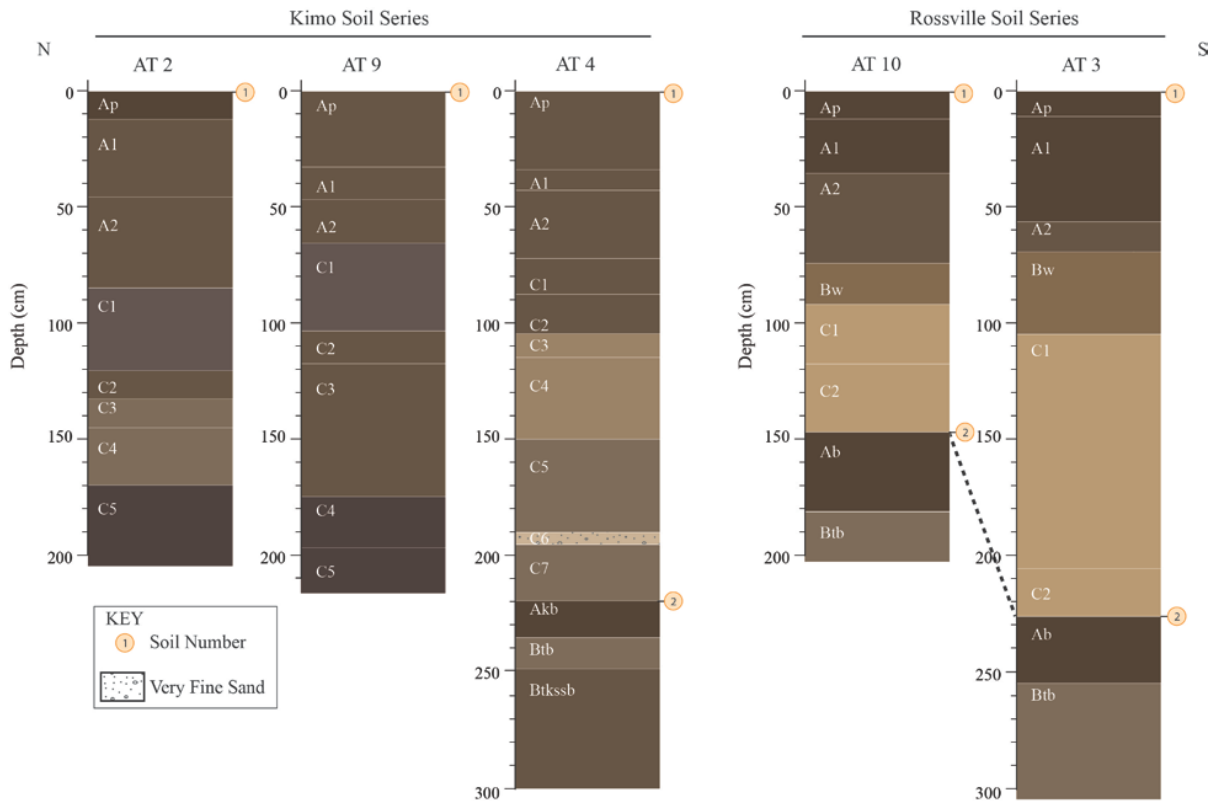
Figure 6.9. Soil stratigraphy from auger tests at Area C (north to south).

Three auger tests were placed on the northern portion of the terrace mapped as Kimo silty clay loam. Consistent with that soil series, auger tests 2, and 9 revealed an Ap horizon, a mollic epipedon (A1 and A2 horizons) averaging 76 cm (30 in) in thickness, and a series of organic-rich C horizons from fluvial deposition (Figure 6.9). In auger test 4, a buried soil was identified at 220 cm (87 in) bgs in an area mapped as Kimo series. The buried soil is a hard, silty clay loam with carbonates in the A horizon, followed by Bt and Btss horizons. Two additional auger tests (3 and 10) were placed at Area C south of auger tests 2, 4, and 9. These were placed at higher elevation on the Newman terrace tread. Auger tests 3 and 10 revealed a surface soil and buried soil development similar to Area A; a buried soil was encountered at depths of 148 cm (58 in) and 226 cm (89 in) bgs (Figure 6.9).

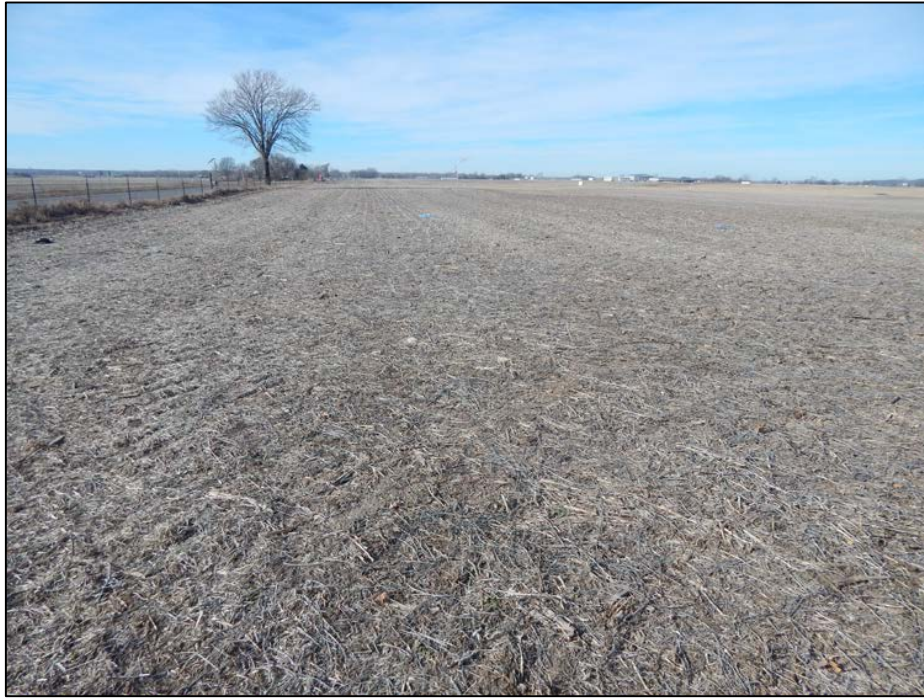
Figure 6.11. Overview of Site 14DO1014 looking west. U.S. Hwy 24/40 is at photo left and the airport terminal complex is visible in the distance.

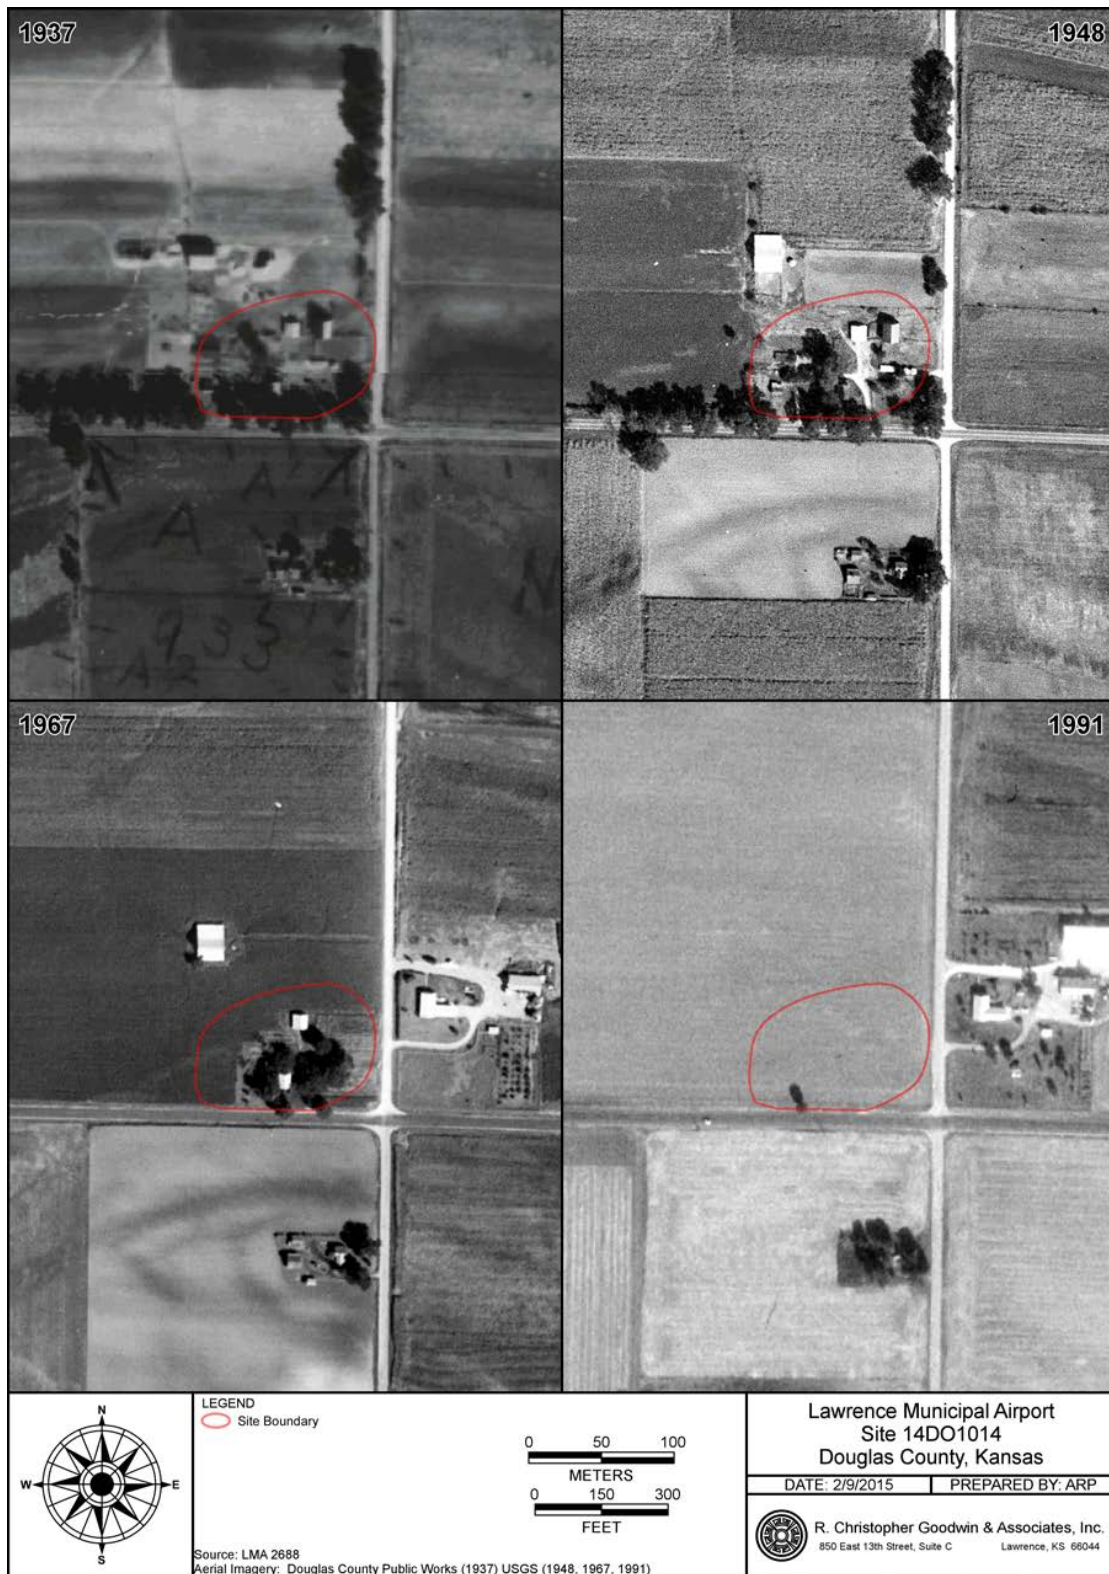
Figure 6.14. Historic aerial images showing the location of 14DO1014 through time. Farmstead structures are visible in the 1937, 1948, and 1967 images; by 1985, the former farmstead was an agricultural field.

and a one-story house also was present (construction date unknown). Other structures at this farmstead included a hayshed north of the houses, the blacksmith shop, and a well with an associated windmill (Personal Communication, Kent Nunemaker, January 19, 2015). These buildings and others are visible on aerial imagery from the first half of the twentieth century (Figure 6.14).

Historic cartographic research revealed a single structure was depicted on the property in the 1873 and 1902 plat atlases (F.W. Beers & Co. 1873; George A. Ogle & Co. 1902). The 1909 plat (Armstrong and Soudea 1909) does not show a structure on the property; however, several buildings depicted on earlier and later maps are not depicted on this map so it is not considered a reliable resource. Structures, two this time, are depicted at 14DO1014 on a 1921 plat by George A. Ogle & Co. (Figure 6.12). The 1948 aerial photograph shows at least six structures (Figure 6.14). By 1967, several of the structures had been removed, and portions of the property have been converted to an agricultural field. Mr. Nunemaker reported the last building at the site was demolished in the late 1970s and aerial photograph shows the entire property had been converted to an agricultural field by 1985.

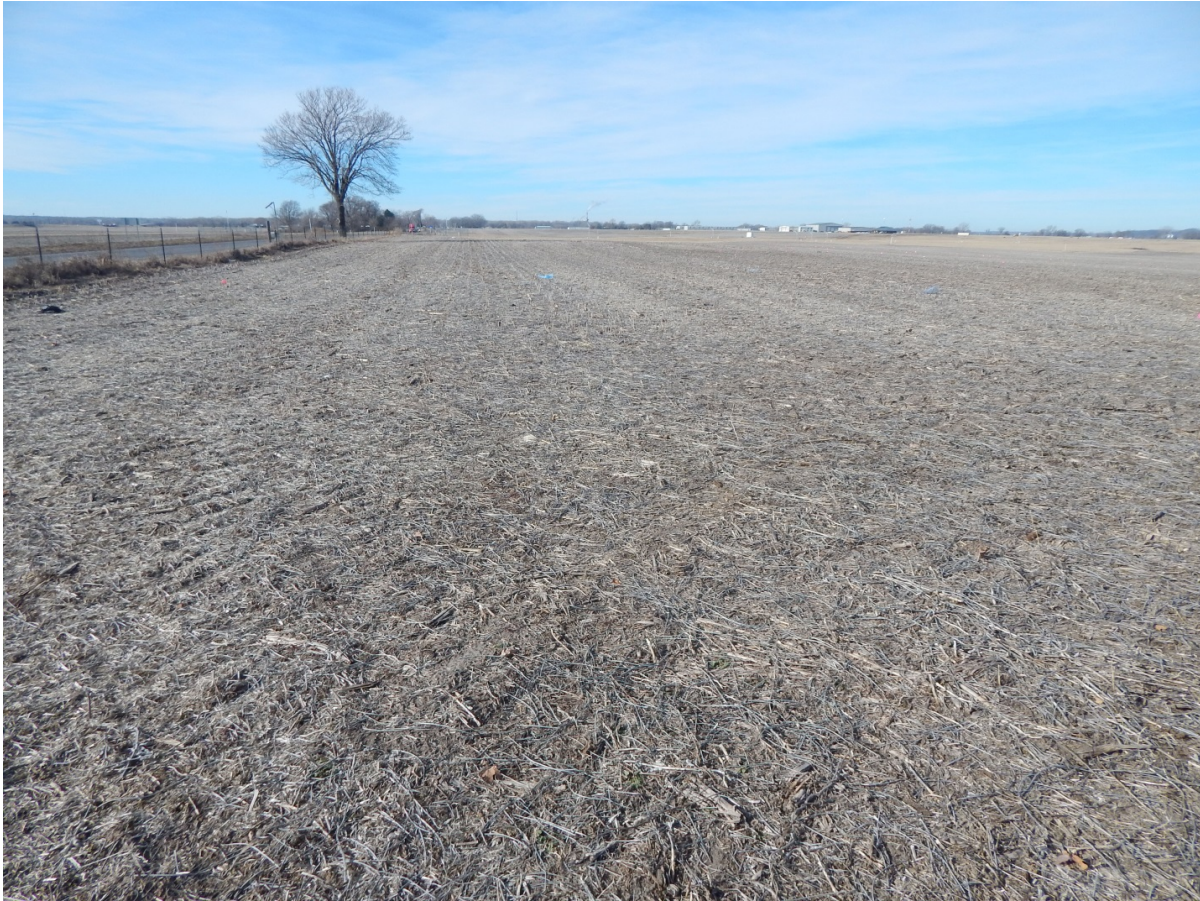
Figure 3. Overview of Site 14DO1014 looking west. U.S. Hwy 24/40 is visible at photo left and the airport buildings can be seen in the distance.

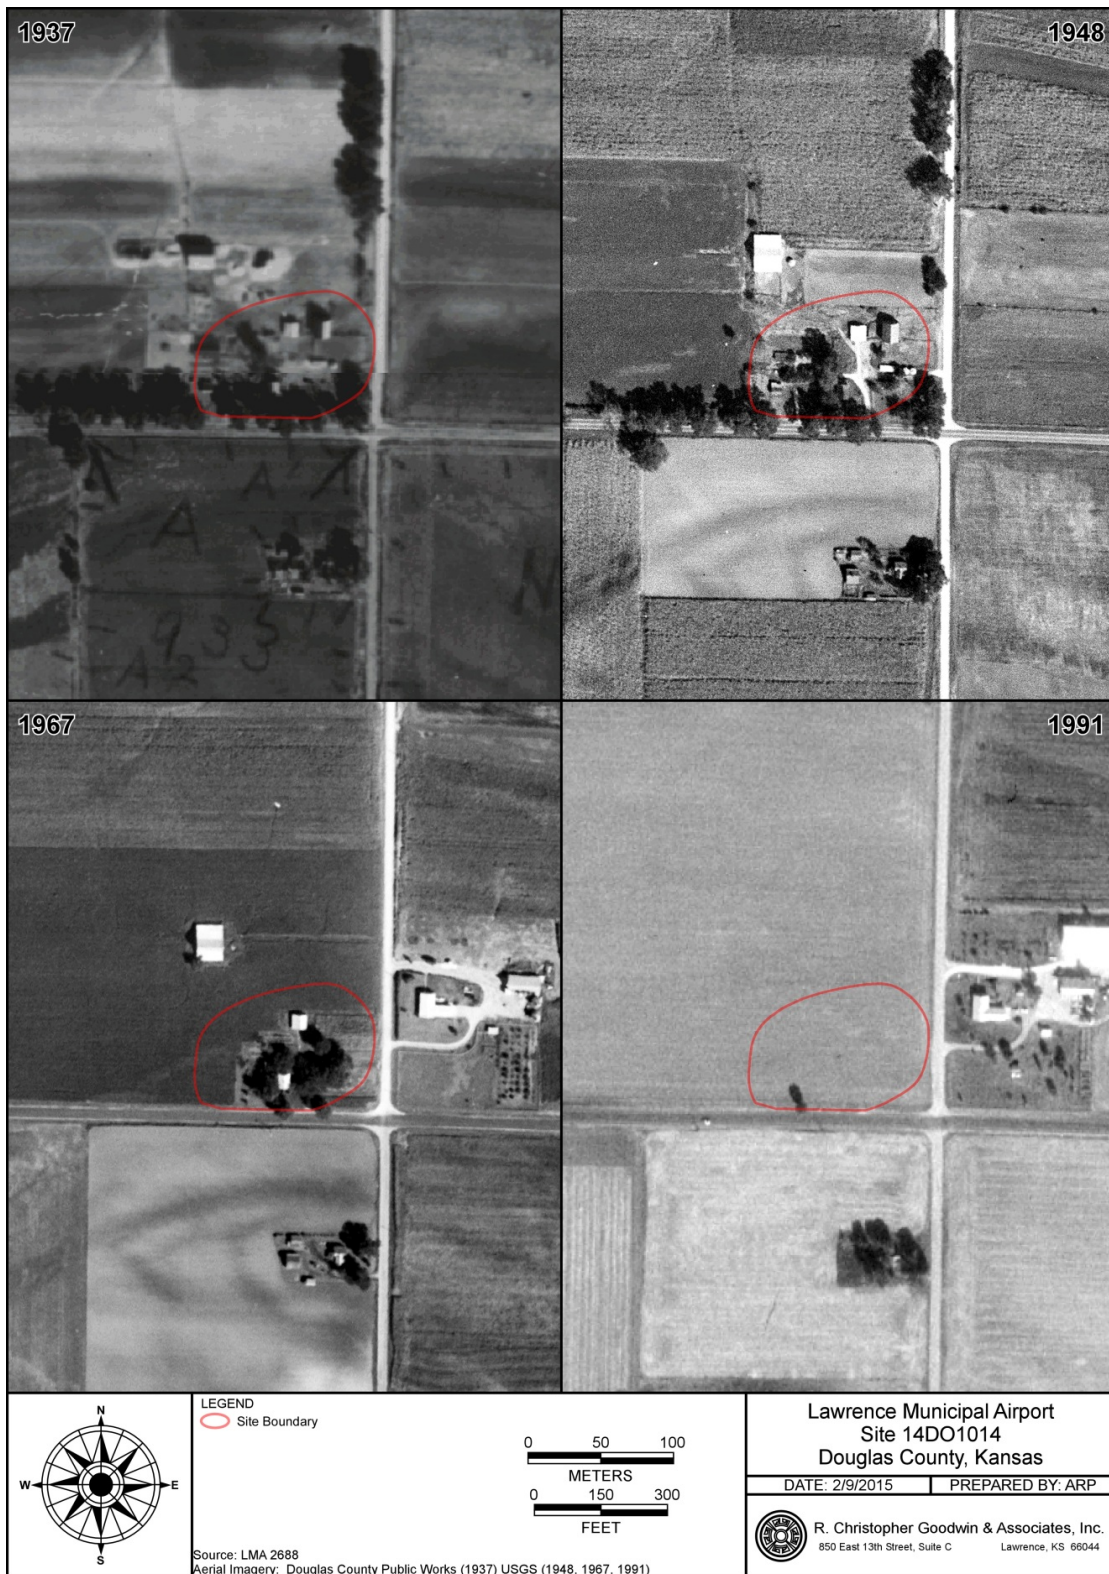
Figure 5. Historic aerial images showing the location of 14DO1014. Farmstead structures are visible in the 1937, 1948, and 1967 images; by 1991 the area has been incorporated into the agricultural field.

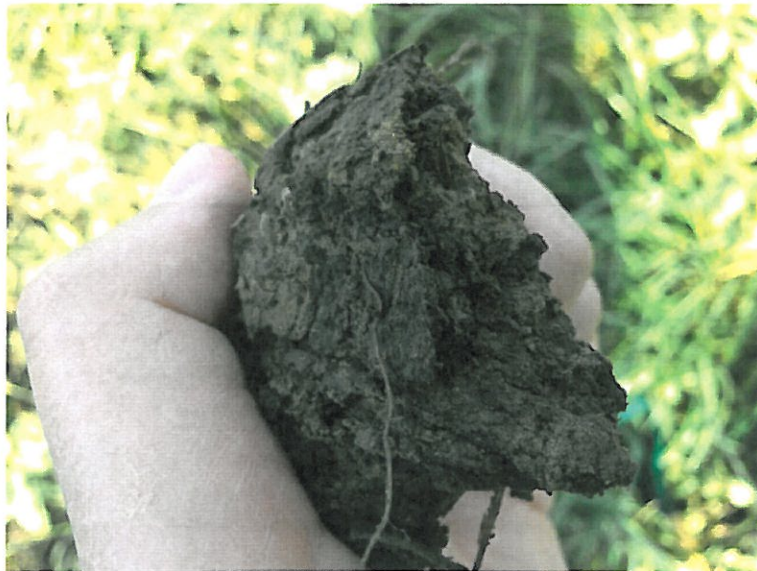
Photo 2: Kimo series soil from A-01, thick dark surface indicator

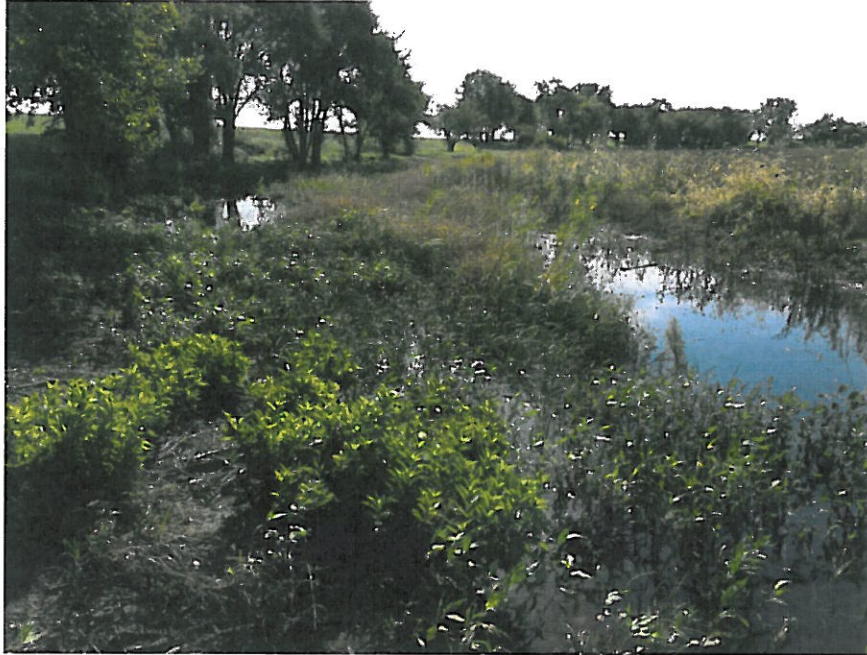
Photo 3: Polygon A, oxbow drainage, looking SSW

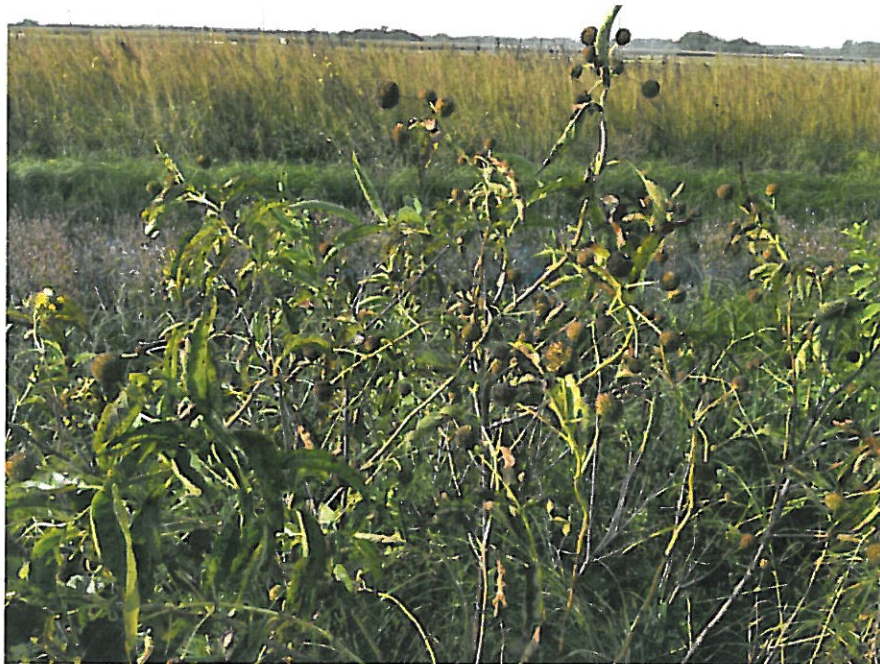
Photo 4: Common buttonbush (*Cephalanthus occidentalis*) along edge of drainage in polygon A.

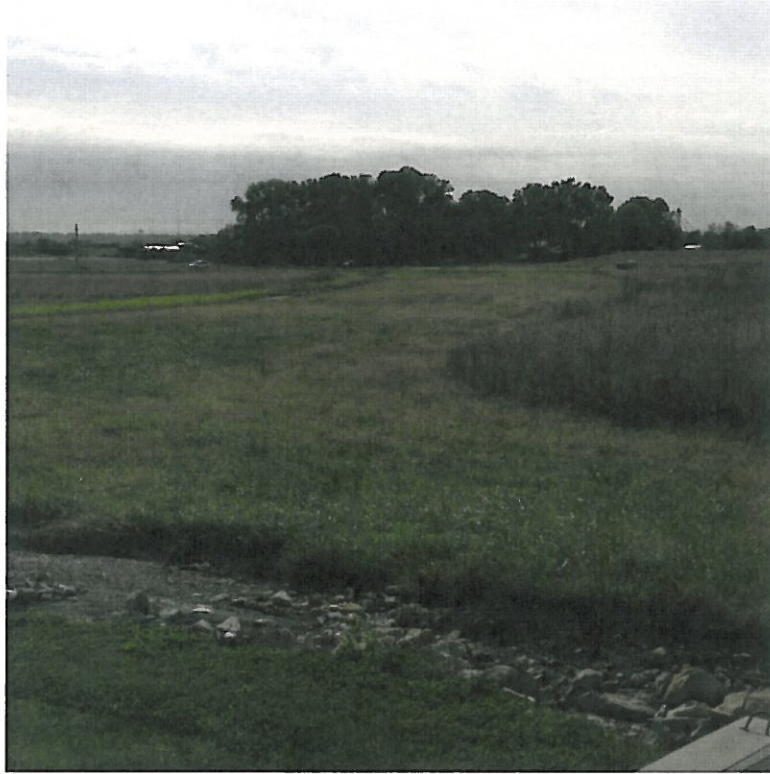
Photo 5: Polygon B area beyond the rip/rap drainage

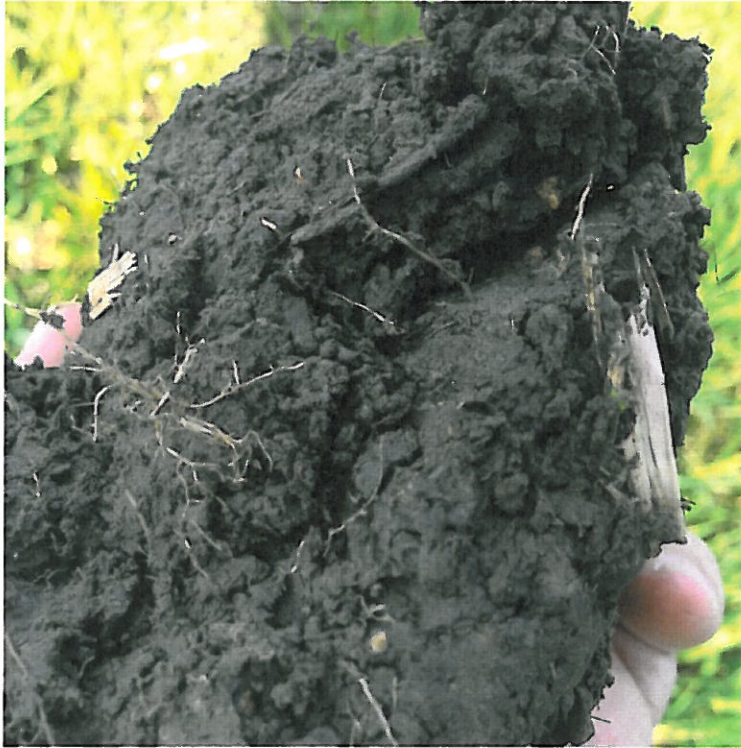
Photo 6: Example of Kimo series soil with thick dark surface indicator, Polygon B

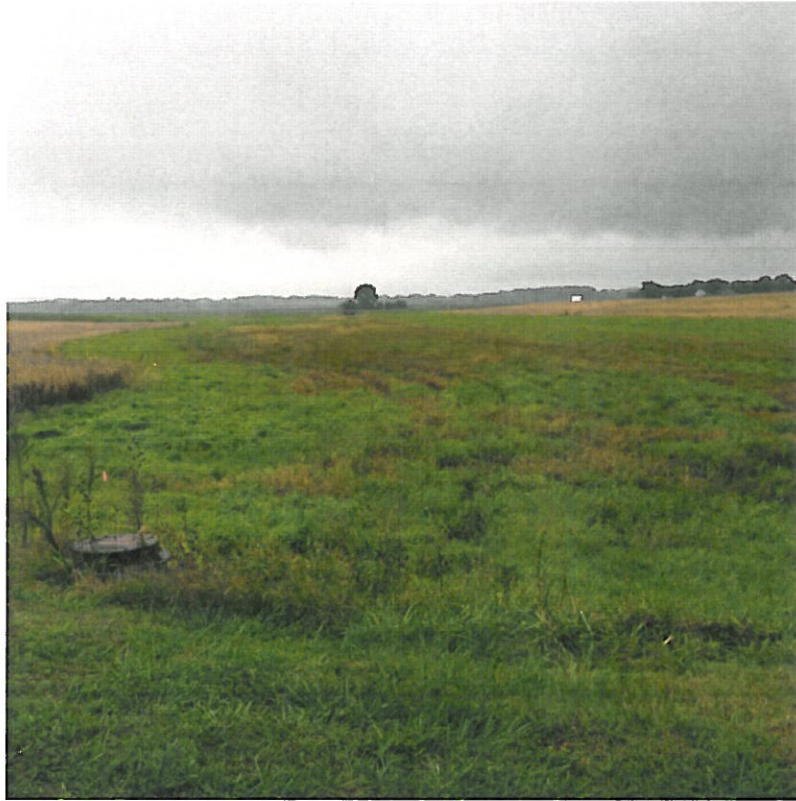
Photo 7: Polygon C area looking east from Airport Rd., water sedge, meadow foxtail and Polygonum are dominant. K31 fescue is also present near field edges.

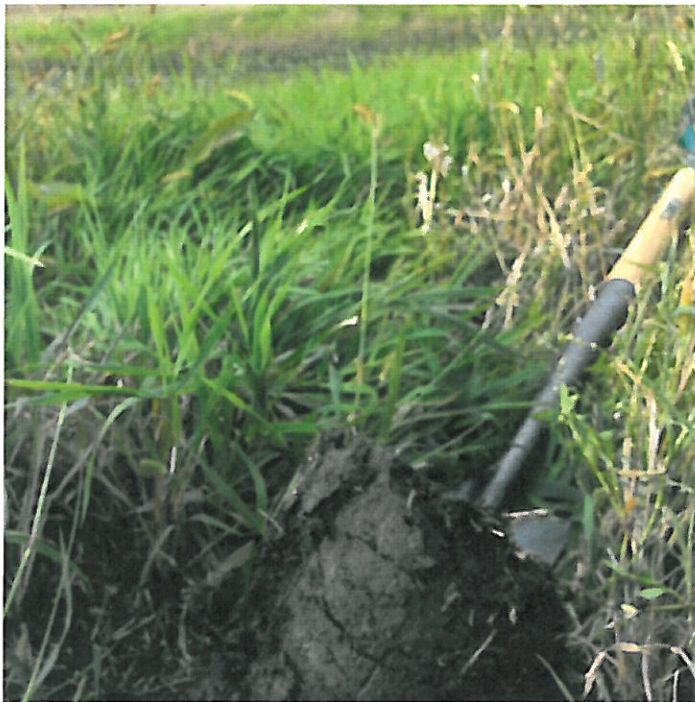
Photo 8: Kimo series soil in polygon c is consistent with other areas sampled.

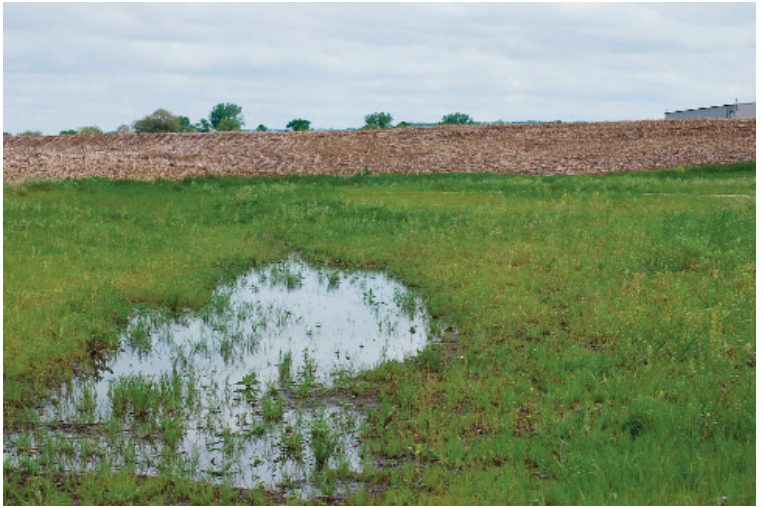
Photo 7: Looking North from airport septic system pump station off Hwy 40.

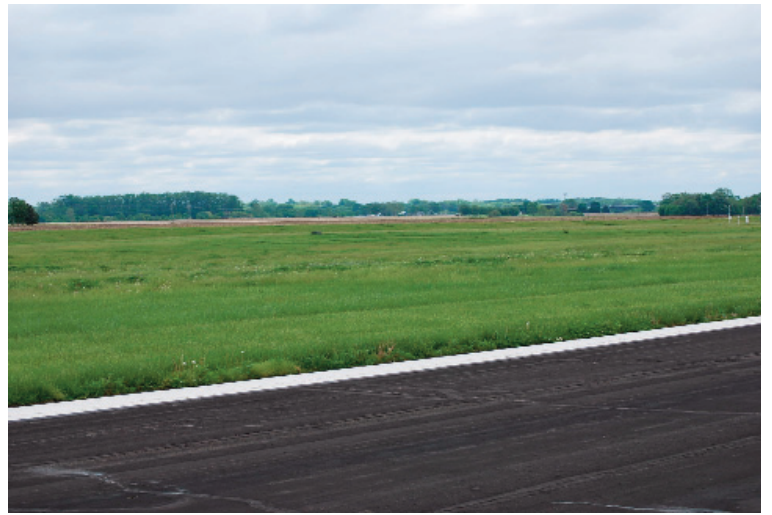
Photo 62: View south, off east edge of Runway 15/33. AWOS is visible at right edge.

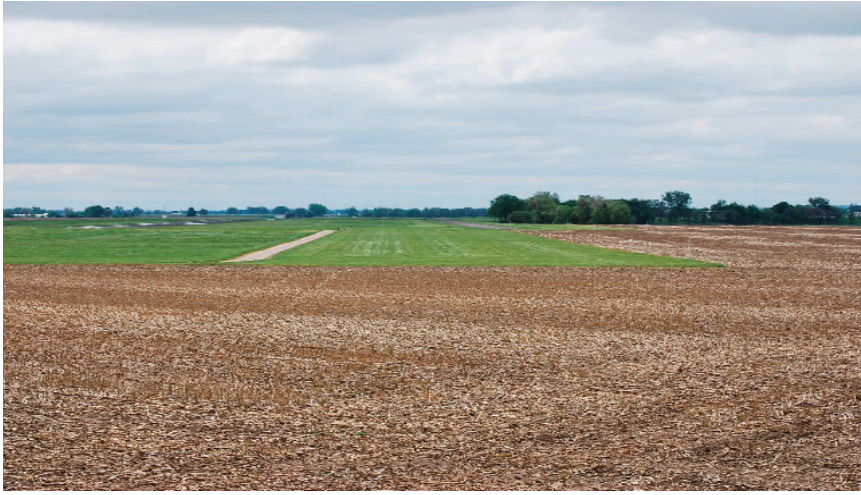
Photo 81: View south toward Runway 15/33 from top of Mud Creek levee and North 1500 Road.

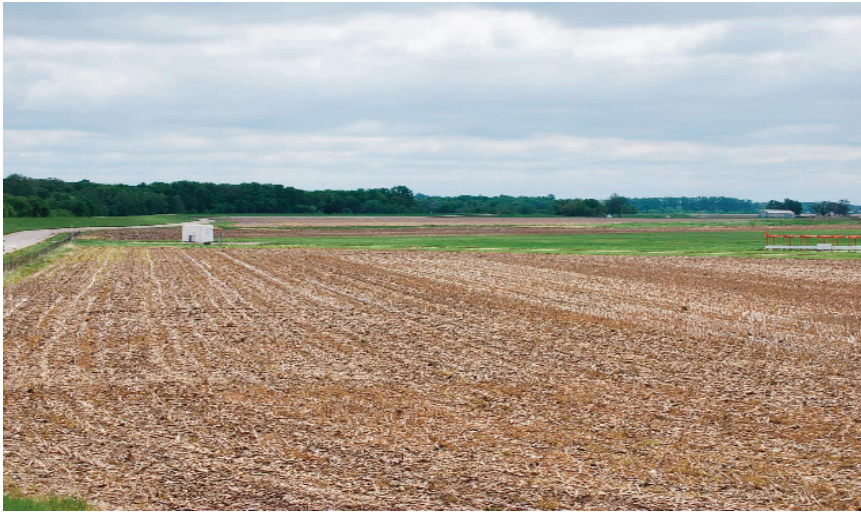
Photo 83: View southeast toward Runway 15/33 showing localizer and doghouse along North 1950 Road at bottom of Mud Creek levee.

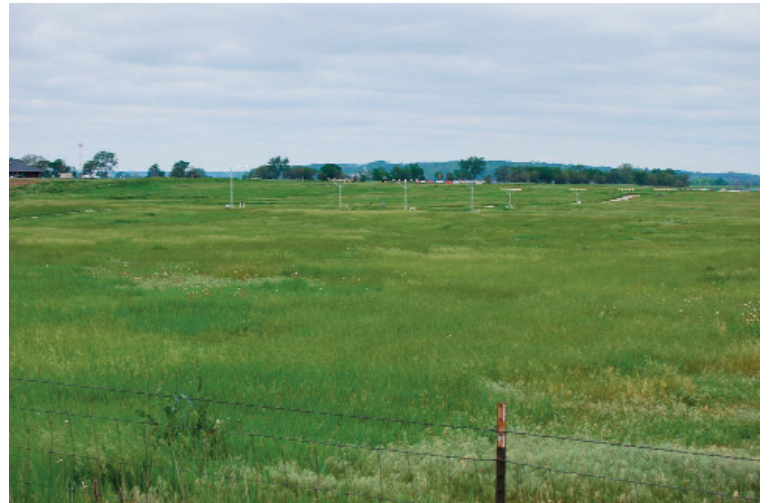
Photo 100: View north toward Runway 15/33 from Hwy 40 across the safety area covering the drainage creek.

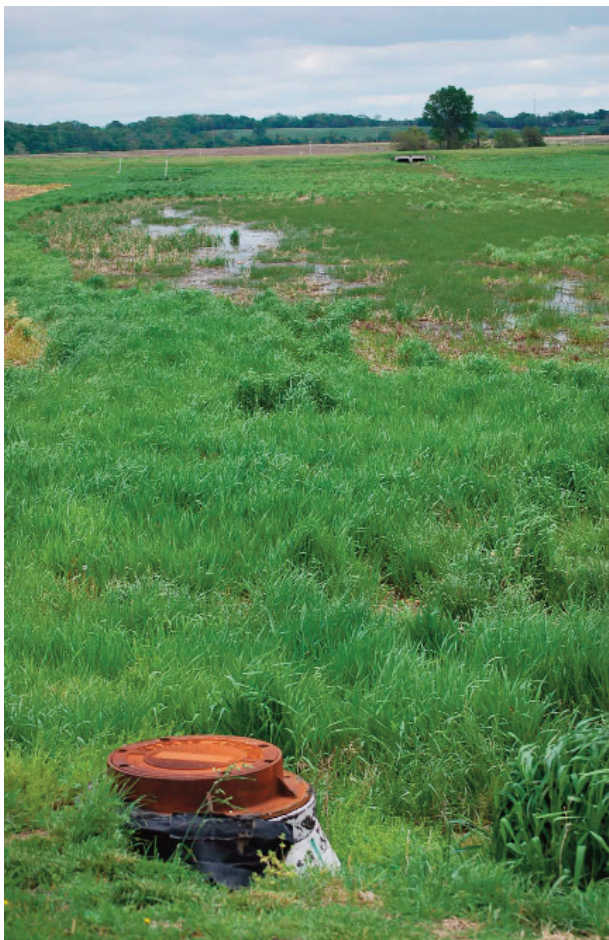
Photo 112: View west off Airport Road culvert span showing water volume after heavy running through property toward Hwy 40. This area was noted as avian habitat in 2012 WHA.
