DGM Consultants, P.A.

November 24, 2009

Re: Historic Structures Report - Structural and Masonry
Sante Fe Station
413 East 7th Street
Lawrence, Kansas
DGM PN 2009014

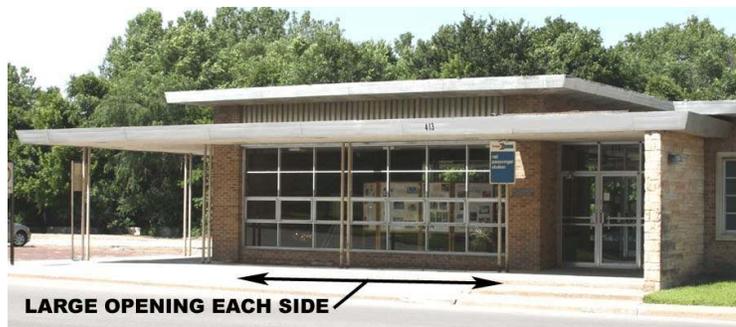
1. The waiting room consist of an exterior wall on the northwest side and glass window walls on the front and back walls. A canopy surrounds the waiting room.

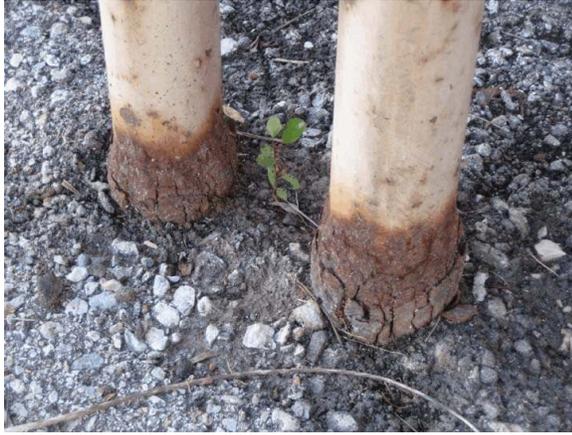
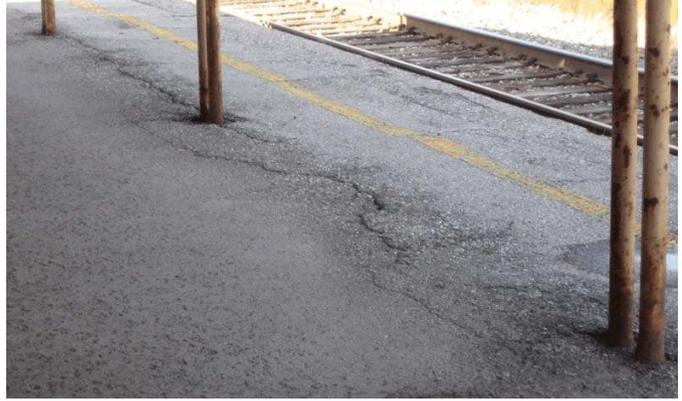
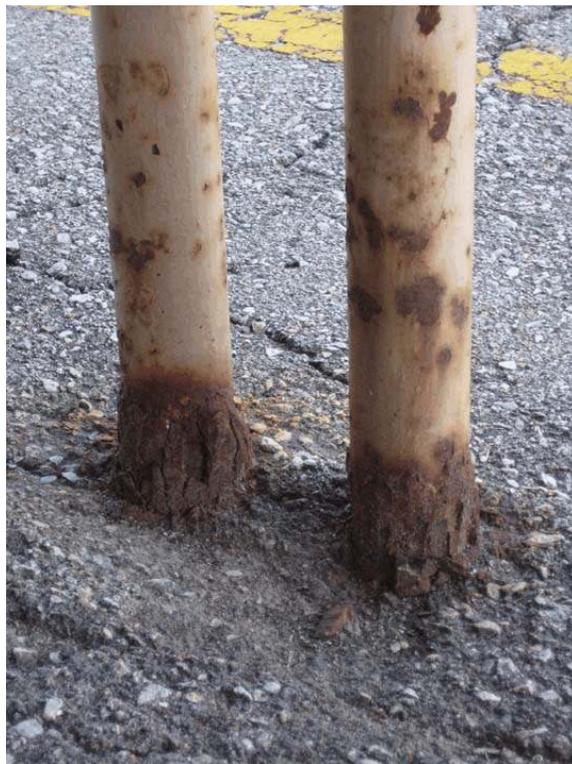
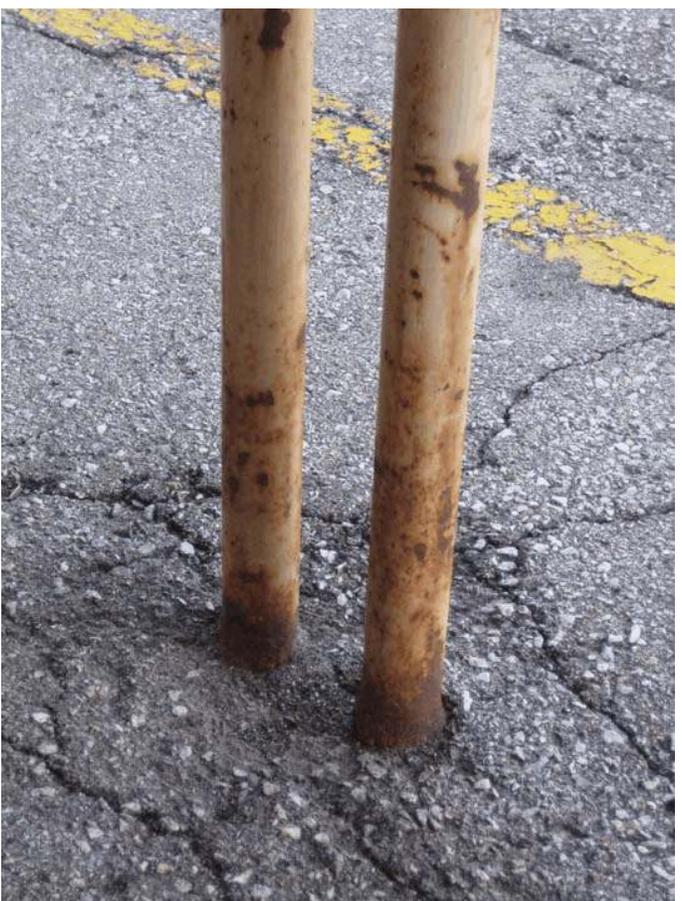
5. Canopy that wraps around the waiting room also extends another 42 feet northeast of the waiting room, parallel to the track.
- The columns for the canopy are constructed from two 2.5-inch diameter steel pipe.
 - The bases of these columns are embedded in the cementitious or asphaltic concrete walks.
 - The bases of some columns are severely corroded. Other columns are corroded the full length of the column or barely corroded at all.
 - Refer to the pictures on the following pages for the various conditions noted.

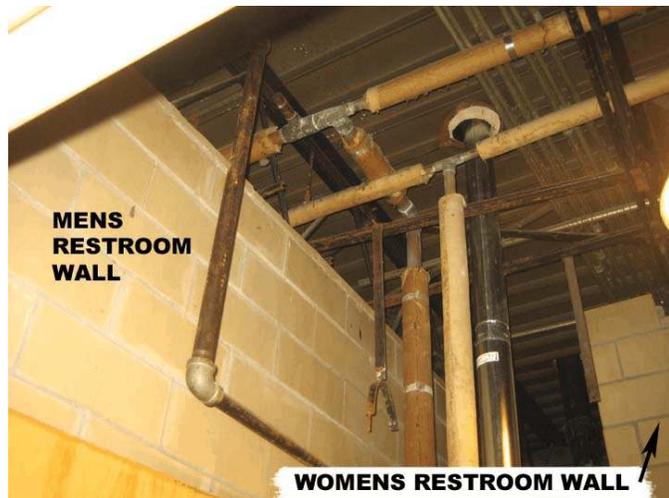
- i. Janitor room:
- (1) This room occurs between the two restrooms and is enclosed with the 4" partition walls.
- (2) The 4" partition walls set on the concrete floor and extend to just above the ceiling. There is 2 feet between the two walls at the stalls to allow room for the plumbing chase.
- (3) We understand, from discussions on site, that at one time there was a plumbing leak in this area.

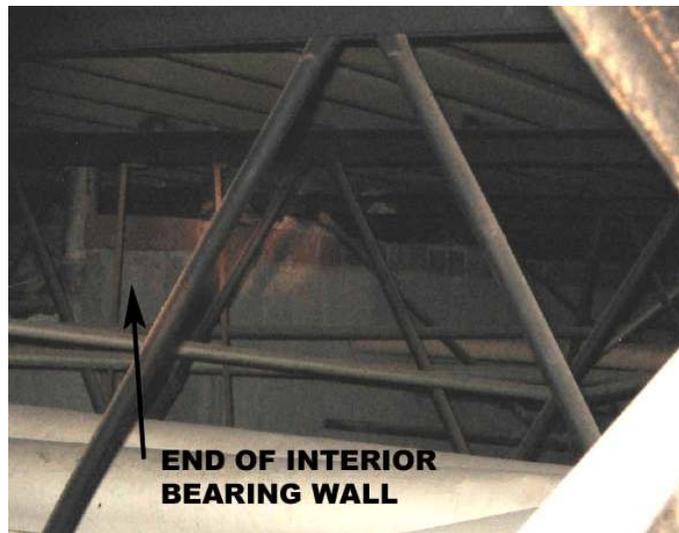
(5) The boiler room wall along the corridor was verified to be load bearing as shown on the drawings.

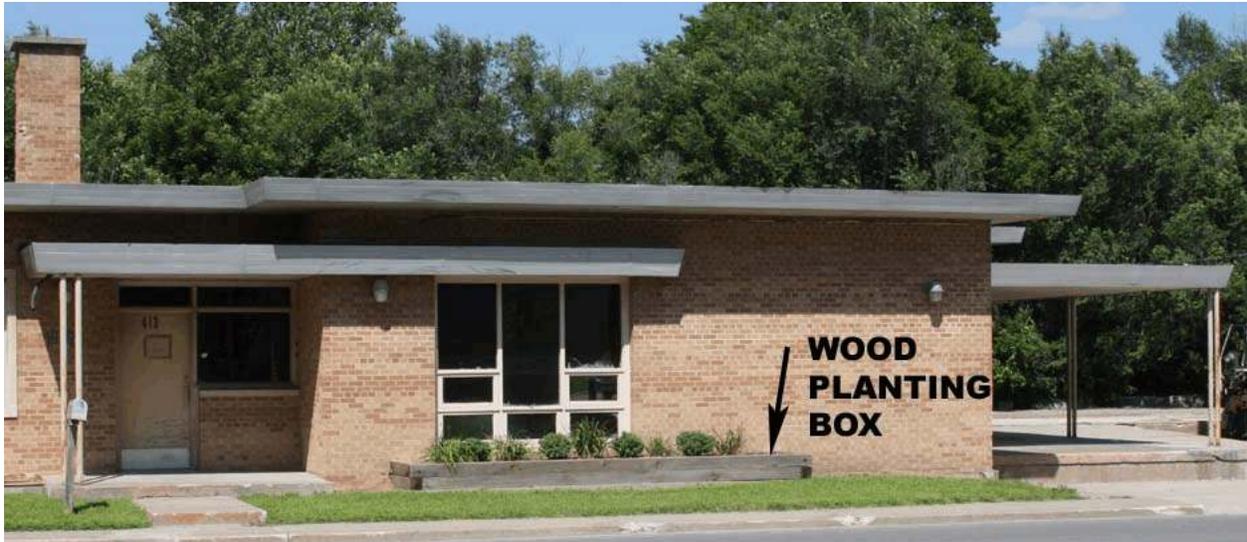
- (1) The southwest wall along the street was reviewed first.
- (2) The wood planter box along this wall is apparently a replacement for the original brick planter noted on the drawings and similar to the one on the track side of the building.

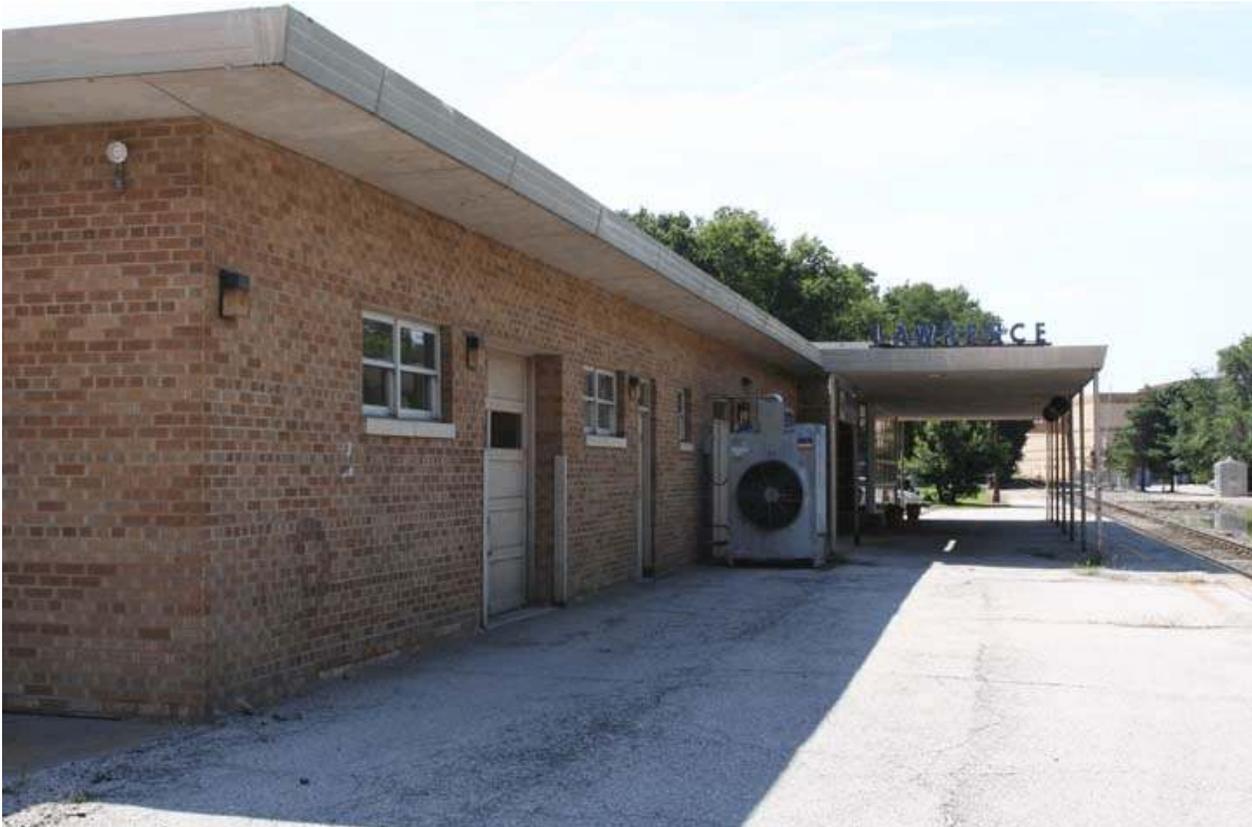
- n. Northeast wall:
(1) This wall encloses the baggage room, the file room, boiler room, and the ticket office.

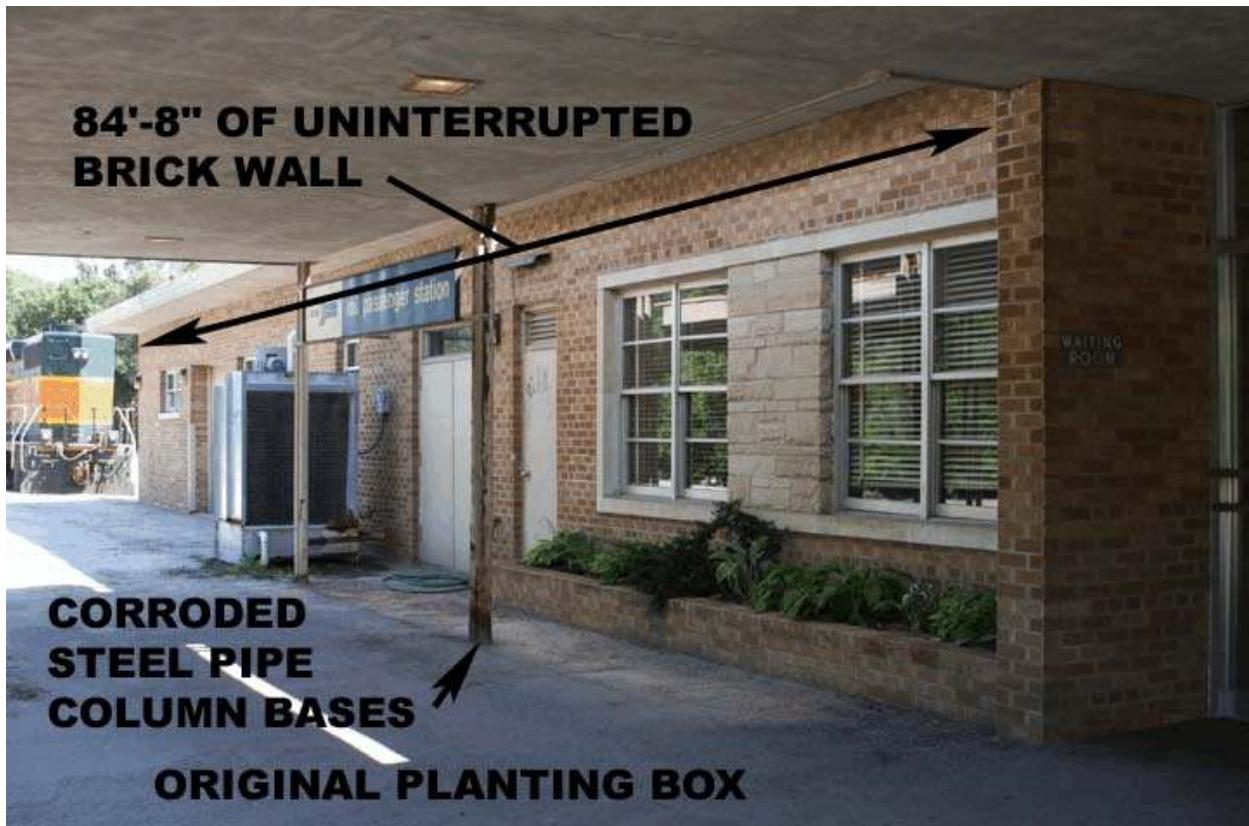
- (9) The northeast wall is an uninterrupted wall over the 84'-8" length above the openings.

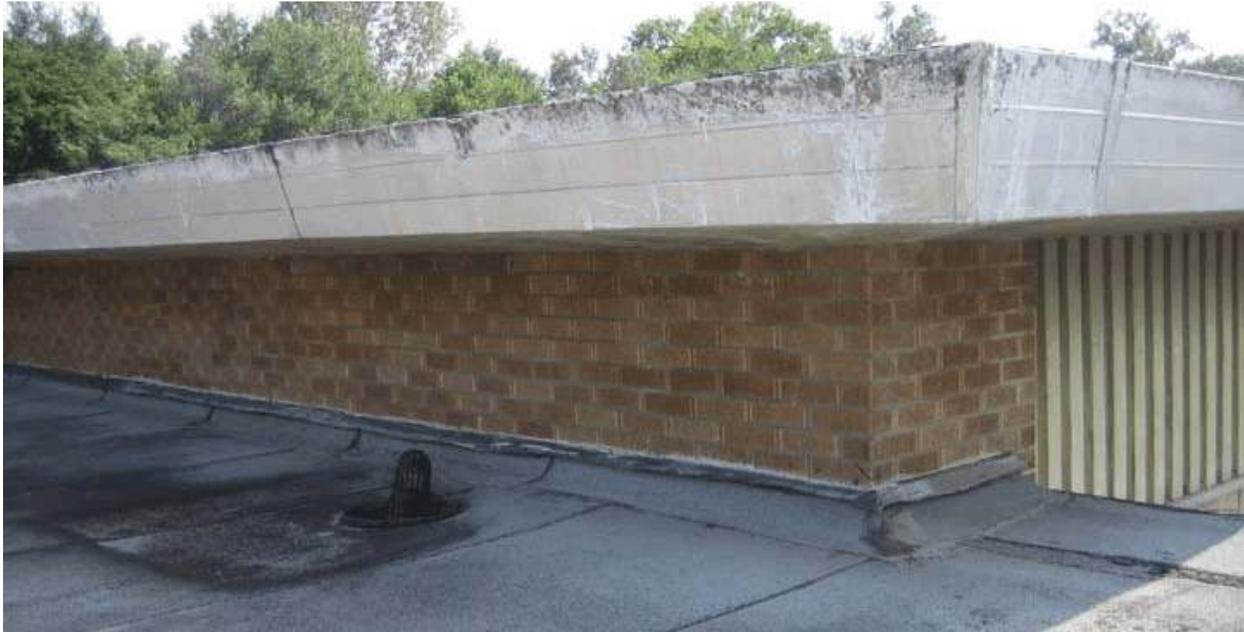
- b. The masonry wall above the low roof at the vestibule are appears to be in good condition.
