Architectural Condition Survey

Santa Fe Railroad / AMTRAK Depot, Lawrence. Kansas

for the City of Lawrence, 2002

Survey: Lindsay Marion (student)

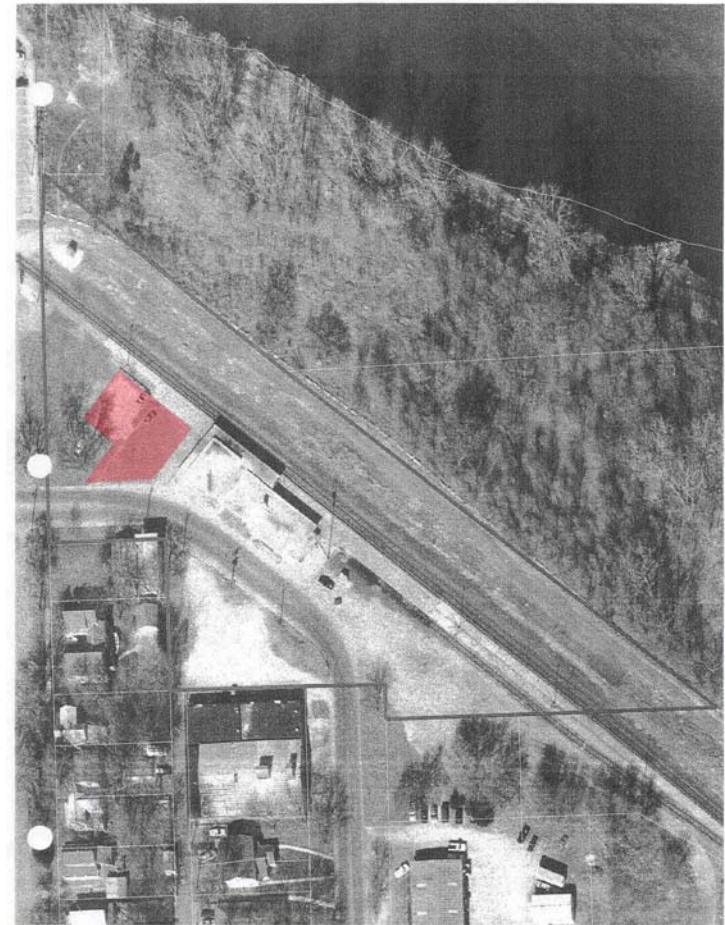
Northwest
Parking

- Two parking lots on Northwest side of the building.
- The farthest from the station is asphalt with several cracks that run the length of the lot but do not show a great amount of deterioration.
 - This lot has room for approximately eight cars
 - The curb along the Northeastern half of the lot is deteriorated or missing
 - Bordered by wooden rail on the Northeast side that shows some deterioration of the wood
- The lot bordering the station is of brick and shows significant deterioration to the surface. The majority of the brick has some sand on it, and a strip along the Southeast side of the lot varying in width from 5-10ft. is almost entirely covered in sand.

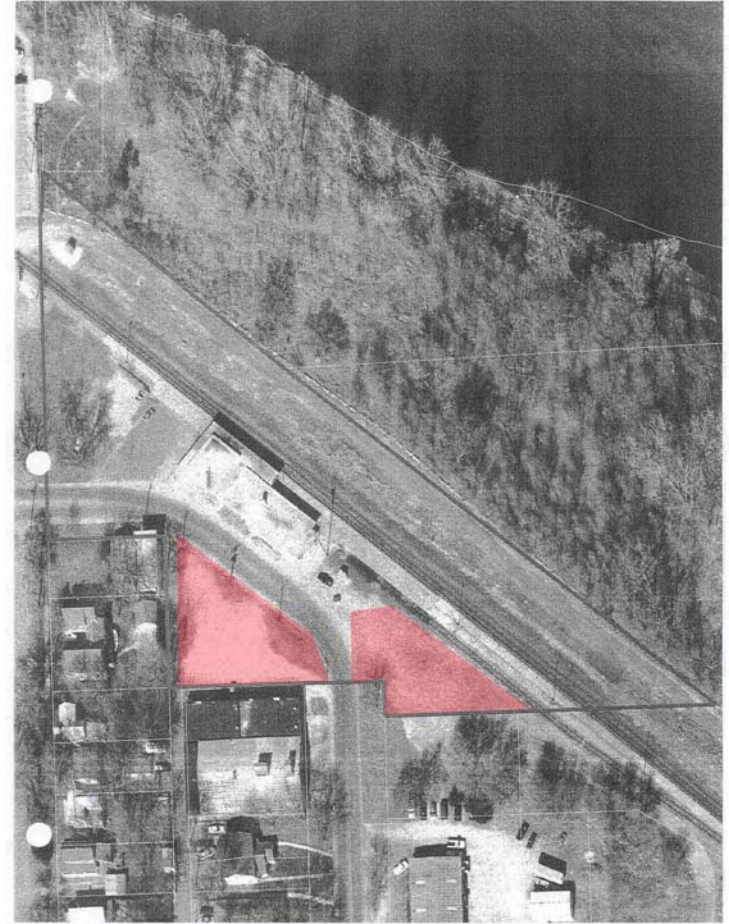
**Southwest
Parking**

- Gravel lot on the opposite side of 7th St., currently used by Van GO Mobile Arts. The triangular lot borders the street on the Northeast, and alley on the West, and the arts building on the South. In addition to the gravel, there are areas of weeds and grass around each telephone pole.
