Airport Community Hanger Executive Summary 2014 1925 Airport Road

Executive Summary 2014

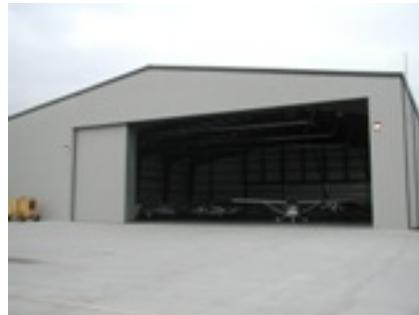
The Hanger is in good overall condition.

- Install occupancy sensors for lighting
- As lighting needed repaired replace with more energy efficient fixtures

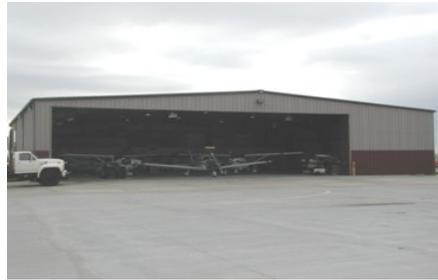
Maintenance Hanger is in overall good condition.

- Install motion sensor lighting
- Replace Outside AC condenser with energy efficient model

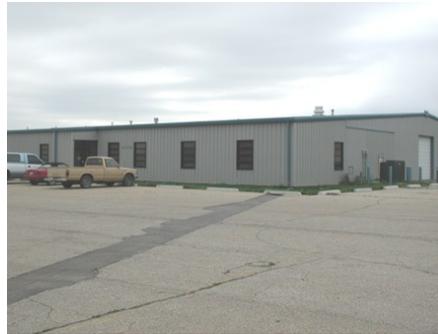
The building is in good overall condition.

- Replace or repair surrounding asphalt

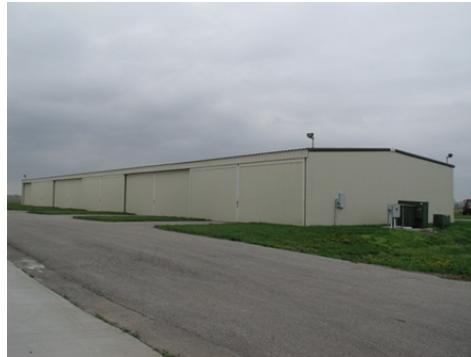
Building is in good overall condition.

- Replace or repair Asphalt around hangers
- Insulate and heat B-7 airport shop

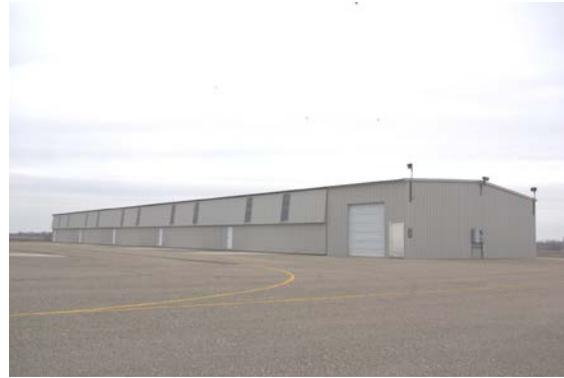
Building is in good overall condition.

- Replace or repair asphalt around the hanger

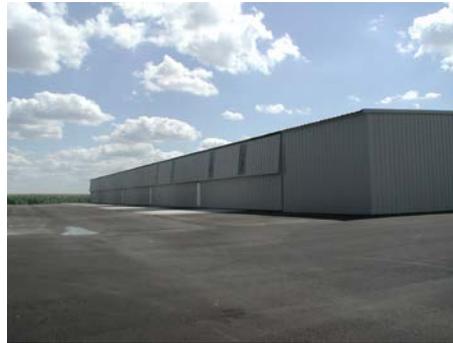
Building is in good overall condition.

- Replace or repair asphalt around the building

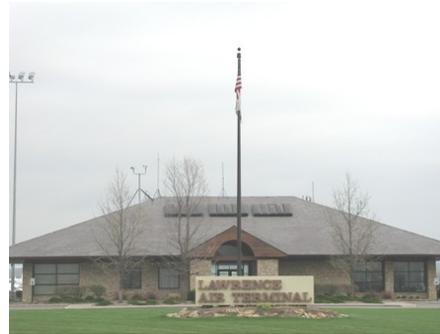
- Restroom floors need recoated within the next 5 years
- Exterior wood will need to be sealed.
- Carpet needs replaced

- Replacement of 2 furnaces with energy efficient one

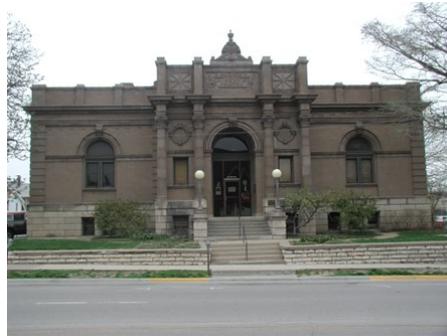
- Replace or repair roof parifin walls. Brick regraded. Sealed during roof replacement, but not enough money to repair correctly
- Interior electrical needs replaced
- Plumbing need replaced
- ADA upgrades

- All interior finished need repaired or replaced
- HVAC equipment and controls need upgraded

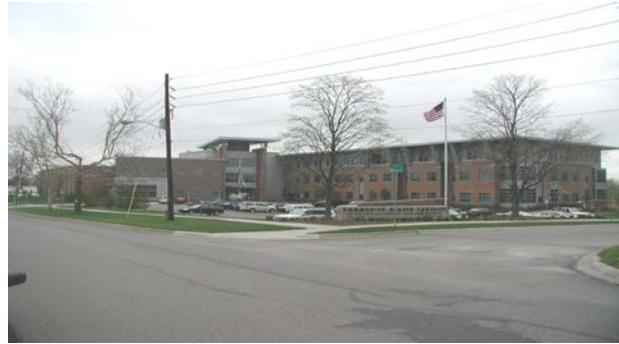
The Community Health Building is in good overall condition. Parking lot shows signs of deterioration.

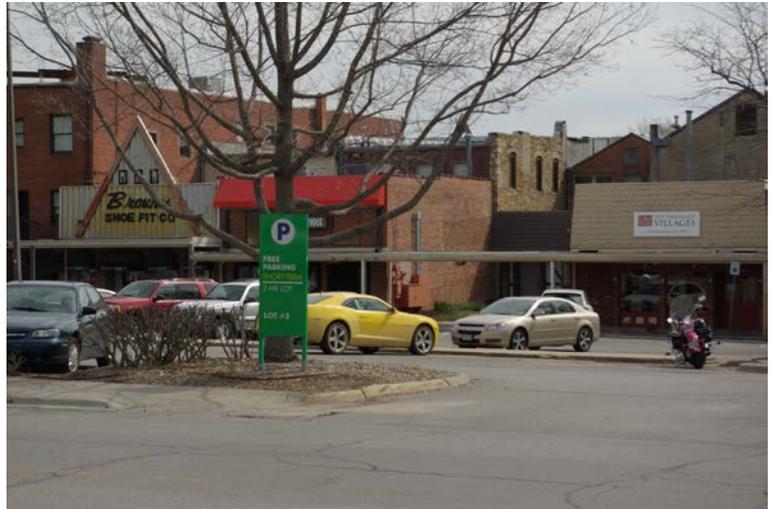
Parking Lot 3

Needs painted

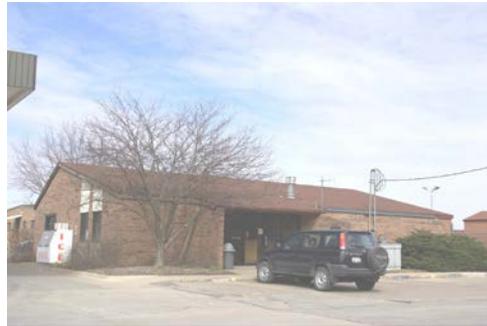
Solid Waste Division Executive Summary 2014 1140 Haskell

Building structure is in very poor condition. The slab is dropping in the middle of the building. Walls are separating from the ceiling. Metal doors have been replaced with wood to be able to keep cutting them so they can close.

Replace roof and soffits	30,000.00
Building needs stabilized	30,000.00
New Building

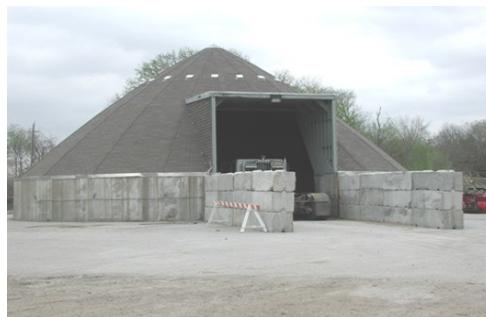
Street Division Salt Dome #1 Executive Summary 2014 1128 Haskell

Good condition except for roof

- Roof needs replaced. 60,000.00
- New electrical panel 10,000.00

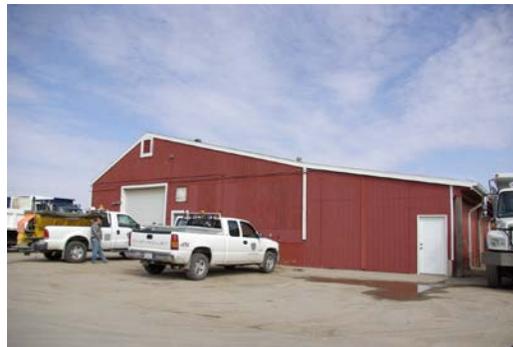
Street Division Maintenance Building Executive Summary 2014 1120 Haskell

Structure is in Poor condition, North and west wall had to be stabilized. It is off the foundation, being held in place by supports and winch straps.

Rebuild North exterior wall, building needs replaced.

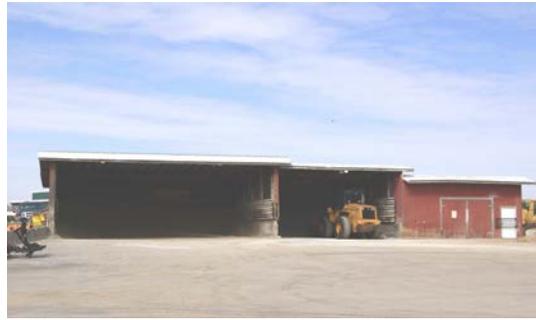
Street Division Sand/Carpenter Building Executive Summary 2014 1120 Haskell

Structure has been reinforced with steel to keep it in place. Termite damage is a big problem.

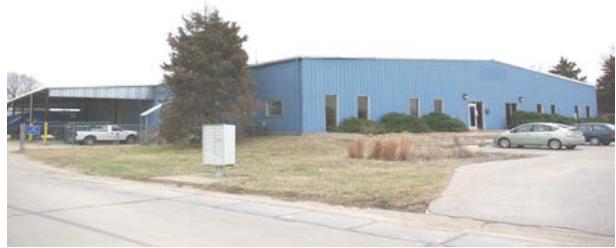
Building is in good condition. Mechanical systems need replaced.

- Replace HVAC system

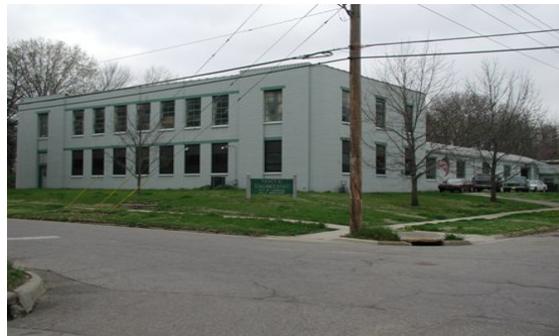
Traffic Division Executive Summary 2014 455 Mississippi

The structure needs many improvements. The roof needs replaced over the two story side of the building. An effort was made to keep the cost of a new roof down and the new roof was installed over the old roof. The exterior needs painted, windows and lighting need upgraded. Heat is the inefficient ceiling mounted, gas fired units.

Replace roof ASAP

Exterior windows need to be replaced	300,000.00
Lighting needs upgrade	
Equipment storage area heaters need upgraded heating units, lighting, and roof	20,000.00
Barrel roof needs coated	80,000.00
