From: Justin E. Burgoon, P.E., S.E. - BSE
To: Ernie Shaw – City of Lawrence Park & Rec.
RE: Lawrence Sports Pavilion Concrete Crack Assessment

Date: 7/3/2017
Project No: 17-236

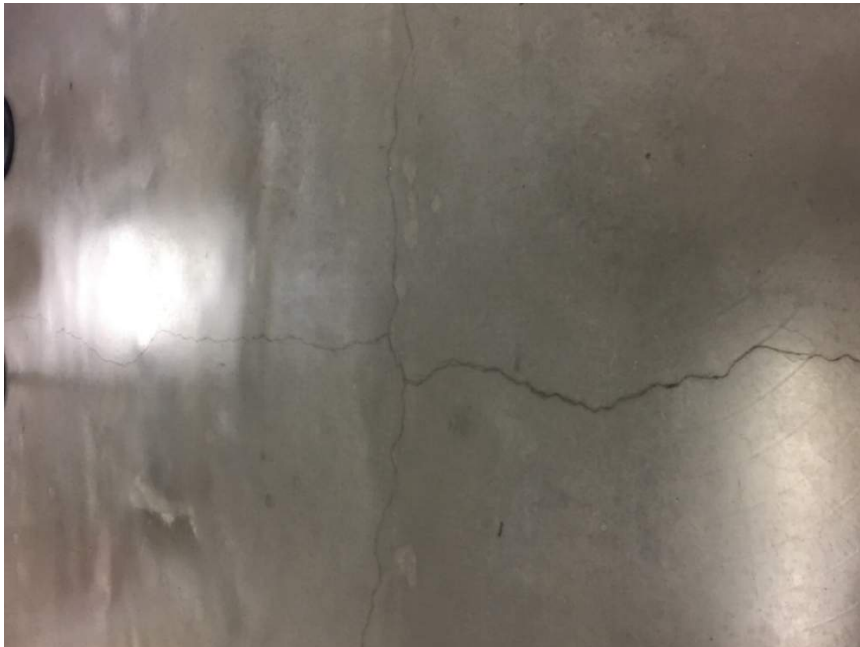
Photo 11 – 2017

Focusing on the mezzanine slab cracks and comparing photos 5 through 7 (from 2014) with photos 8 and 9 (from 2017) it appears that the cracks have occurred in areas in which random shrinkage cracks are common. These areas include corners of floor openings (duct penetrations and stairwells) and points of floor support (column locations and girder lines). The photos from 2014 show that cracks immediately showed in these areas. In addition to the cracks mentioned above, several transverse cracks have occurred in an 8 foot to 16 foot spacing with a longitudinal crack running in the perpendicular direction along the length of the mezzanine. See attached photo 10. These cracks have occurred in a pattern that is similar to the control joint pattern sawn into the concrete slab on grade. See attached photo 11. The difference between the cracks in photo 10 and photo 11 is that the cracks were controlled in the slab on grade with sawn control joints. The cracks in the mezzanine slab were not controlled because sawn control joints were not sawn into the mezzanine slab. The pattern and spacings of these cracks are consistent with temperature and shrinkage cracking. BSE's conclusions and recommendations from the November 17, 2014 letter are still accurate.
