# Roof Inspection Report

City of Lawrence  
Mr. Jason Stowe  
PO Box 708  
Lawrence, KS 66044

Roofing Solutions, Inc.  
6728 W. 153<sup>rd</sup> Street  
Overland Park, KS 66223

Arts Center  
940 New Hampshire Street  
Lawrence, KS 66044

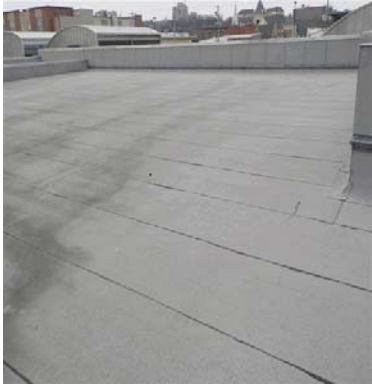
| Photo | Section /<br>Name / Year<br>Installed | Size /<br>Height | Roof Type | Condition<br>Index/<br>*RCI/<br>ASLR(Yrs) | Estimated<br>Replacement<br>Value |
|---|---|---|---|---|---|
| | Roof A<br>A1 - A7<br>2002 | 15,528 sq. ft.<br>30 ft. | (SBS) Modified<br>Bituminous<br>Membrane<br>Roofing | Poor<br>33<br>0(Yrs) | \$232,920.00 |

Roof Section A refers to the low slope roof which includes A1-A7 over Arts Center in Lawrence, KS. The roof is accessed by an internal hatch at A1. The membrane is a sixteen (16) year old 2-ply modified bitumen. The parapet walls separating the different A sections are flashed up terminating under stainless steel coping cap or counter flashing. The decks slope in multiple directions to internal drains, external mounted gutters and thru wall scuppers. A large chiller is supported by a steel platform on A1.

- Random areas of deteriorated sealant - No. 1 (A1, A2)
- Random areas of ridging membrane - No. 5 (A3)
- Random areas of membrane deterioration - No. 8 (A2)
- Blocked gutter - No. 16 (A7)
- Twelve (12) areas physical damage to the membrane - No. 23 (A4)
- Random areas of repairs - No. 24 (A2, A4, A5, A6)
- Random areas of low flashing heights - No. 40 (A4, A6)
- Random areas of deteriorated flashing - No. 43 (A4, A6)
- Random areas of open flashing laps - No. 45 (A1, A2, A3, A4, A6)
- Two (2) areas of rusted pitch pan bases - No. 86 - (A1)

Overall, the roof is in poor working condition and is nearing the end of its design life expectancy. Given the deteriorated flashing at the base of the wall, the onset of ridging membrane, and physical damage to the membrane additional comprehensive repairs in an effort to extend the life of the system would not be feasible or cost effective. RSI recommends a retrofit of the existing roof system and installation of a new twenty (20) year design life gray fleeceback TPO roof system utilizing the existing coping cap and terminating at new slip counter flashing.

| Budget Year | Activity Type | Action Item ? | Allocation | Urgency | Quotation \$ |
|---|---|---|---|---|---|
| RSI recommends retrofit of the existing roof system with a twenty (20) year design life system. | | | | | |

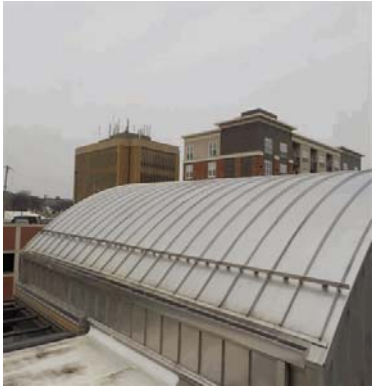
| Photo | Section /<br>Name / Year<br>Installed | Size /<br>Height | Roof Type | Condition<br>Index/<br>*RCI/<br>ASLR(Yrs) | Estimated<br>Replacement<br>Value |
|---|---|---|---|---|---|
| | Roof B<br>B, B1, B2<br>2002 | 2,848 sq. ft.<br>40 ft. | Standing Seam<br>Sheet Metal<br>Roofing | Very Good<br>92<br>14(Yrs) | \$56,960.00 |

| Date | Inspection Type | Inspecting Company | Inspector |
|---|---|---|---|
| <p>Roof Section B refers to the sloped metal roofs which includes B1 and B2 over Arts Center in Lawrence, KS. The roof is accessed by ladder. The membrane is a sixteen (16) year old stainless steel standing seam panel at B, flat panel at B1 and standing seam galvalume at B2.</p> <p>No defects were identified at the time of the inspection.</p> <p>Overall, the roof is very good working condition. With regular inspections and routine maintenance, the roof system should remain effective for the duration of its assessed service life.</p> <p>No warranty information was available at the time of the inspection.</p> | | | |

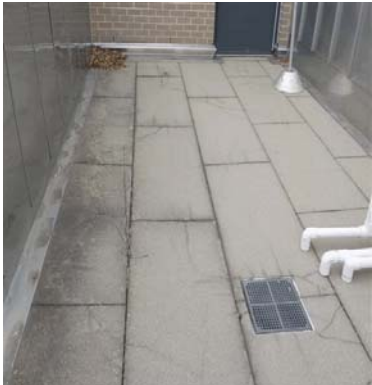
| Photo | Section /<br>Name / Year<br>Installed | Size /<br>Height | Roof Type | Condition<br>Index/<br>*RCI/<br>ASLR(Yrs) | Estimated<br>Replacement<br>Value |
|---|---|---|---|---|---|
| | Roof C<br>C<br>2002 | 670 sq. ft.<br>18 ft. | Concrete Roof<br>Tiles | Good<br>78<br>9(Yrs) | \$13,400.00 |

| Date | Inspection Type | Inspecting Company | Inspector |
|---|---|---|---|
| <p>Roof Section C refers to the paver patio areas at Arts Center in Lawrence, KS. The roof is accessed by door. The membrane is a sixteen (16) year old paver.</p> <p>Defects identified at the time of the inspection include the following:</p> <ul style="list-style-type: none"> <li>- Minor cracks in the pavers</li> </ul> <p>Overall, the roof is very good working condition. With regular inspections and routine maintenance, the roof system should remain effective for the duration of its assessed service life.</p> <p>No warranty information was available at the time of the inspection.</p> | | | |
