# TURNHALLE

## Historic Structure Report

*Lawrence, Kansas*

*JULY 25, 2013*

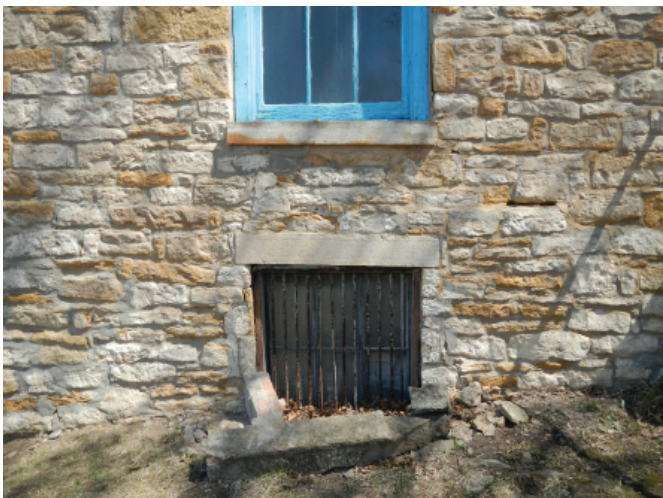
*Typical Stone Construction Surrounding Basement and First Floor Windows*

This may have been the desire for more space or it may have been to provide an alternative venue to the outdoor beer garden as a result of prohibition, which began in Kansas in 1880. The windows and masonry ties would likely have been installed at the same time. The current stone stairs to the west entry have not been dated.

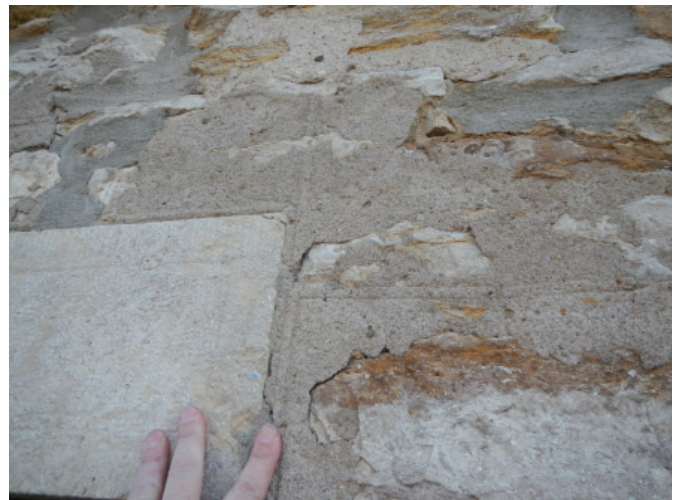
*Evidence of Stucco Layer*

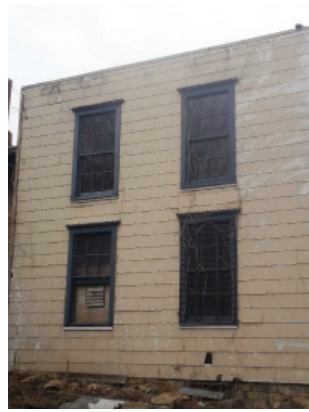
The rear wood-framed addition is clad with wood lap siding that is in fair condition. On the south elevation, twenty-six rows of cement siding boards conceal or replace the original wood siding. These boards are in poor condition. Seven equally-spaced brackets at the roofline of the north elevation of the rear addition highlight this elevation as the primary façade of the rear addition. The brackets are in fair condition.

*Cement Siding on South Elevation*

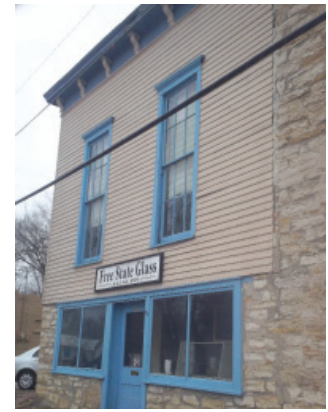
Architectural woodwork composed of 2x6s, 2x8s and moldings typical of the mid-nineteenth century trims the eaves of the gabled roof. The eaves extend approximately 3'-0" beyond the face of the stone walls. The woodwork is in good to fair condition with some visible rot, delaminated paint and missing features.

*Original Bracketed Eave and Wood Siding on North Elevation*

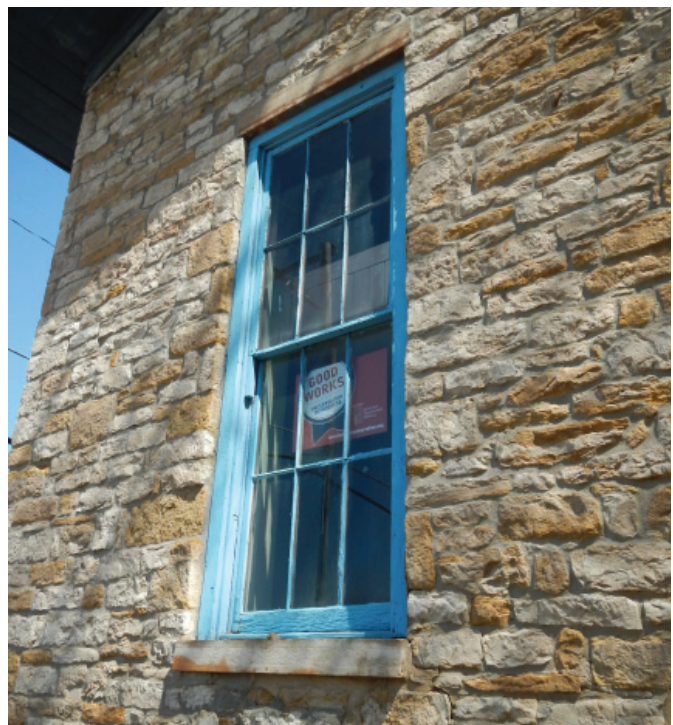
*Original Wood Window on West Elevation*

The wood-framed, double-hung first floor windows of the main 1869 building are in good to fair condition. The sash are approximately 3'-5" wide by 10'-6" tall. Many of the glass panes have been replaced, however, much of the remaining components of the windows are original and are intact. The south elevation features original exterior screens. Exterior sills are dressed limestone and interior sills are wood. The jambs are also composed of wood with an interior casing that is slightly canted towards the interior. Window conditions include missing screens, wood rot, deteriorated glazing, cracked glazing units, broken ropes, missing hardware, and damaged components.

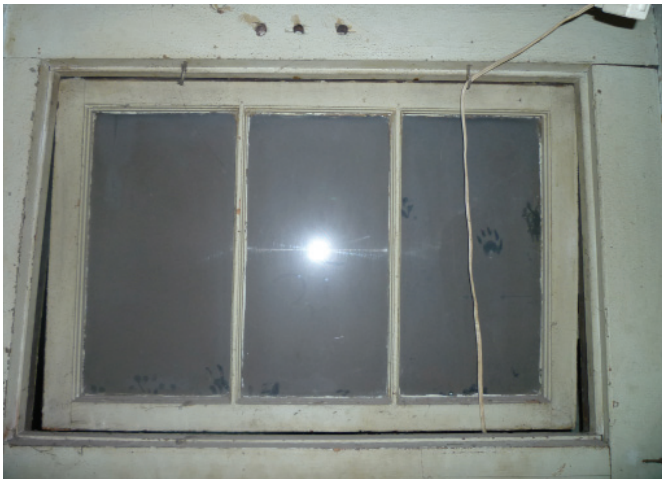
*Interior Awning Sash of Basement Window*

The wood-framed awning basement windows are in fair to poor condition. The sash are approximately 3'-6" wide by 3'-10 1/2" tall with a six-paneled configuration. Many openings include a secondary interior awning sash of the same size and configuration as the exterior sash, as well as original wood-framed exterior screens.

Exterior sills are dressed limestone and interior sills are wood. Wood beadboard finishes out the window heads. Basement window conditions include missing interior sash, missing exterior screens, wood rot, deteriorated glazing, missing paint, termite damage, missing hardware and missing components.

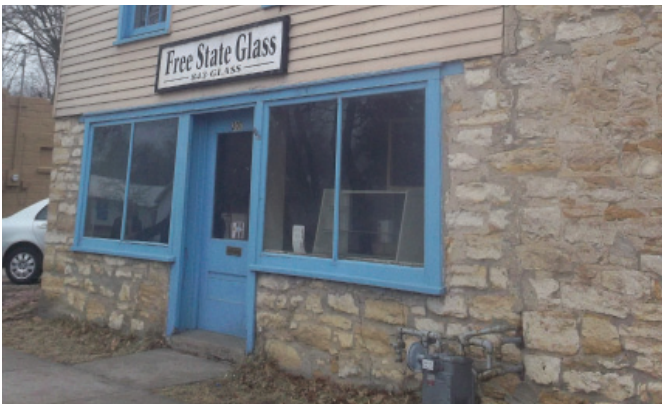
*Basement Entrance Doors on North Elevation*

The basement entrance door on the north elevation was installed at a later date. This door is paneled with a light and is flanked by wood-framed storefront windows. The door and storefronts are in good condition.

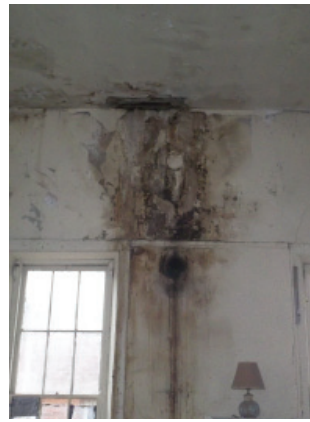
*Water Damage at Flat Plasterwork*

Smooth plaster comprises the majority of the ceiling and wall finishes on the first and second floors. The flat plasterwork has a traditional base coat, intermediate coat and finish coat applied directly to the masonry walls at the main building and applied to wood lath at the rear addition. The plaster is in poor condition due to structural settlement and the lack of interior conditioning. Existing conditions include vertical, horizontal and diagonal cracking, full-depth delamination from the substrate, delamination of the finish coat, wholesale missing plaster and water saturation. Evidence of a painted twelve inch high frieze exists at the balcony level. A previous alteration replaced the smooth plaster at the walls and ceilings of the first floor office of the rear addition with gypsum board.

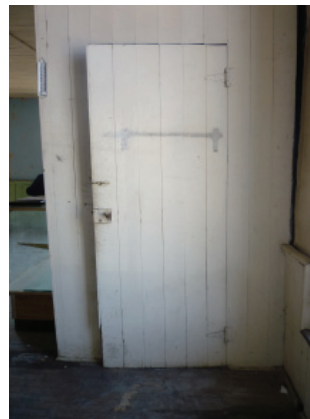
*Board-and-Batten Door at Stair No. 1 to Basement and Original Hardware*

The interior doors are primarily four-paneled wood doors with wood frames, with the exception of a two-paneled door with a light at the second floor office. The door leading to the basement from the main hall is a board-and-batten door with diagonal strapping and strap hinges. The basement and second floor bathroom doors of the addition are also board-and-batten doors with bead-board verticals and one-by battens with strap hinges.

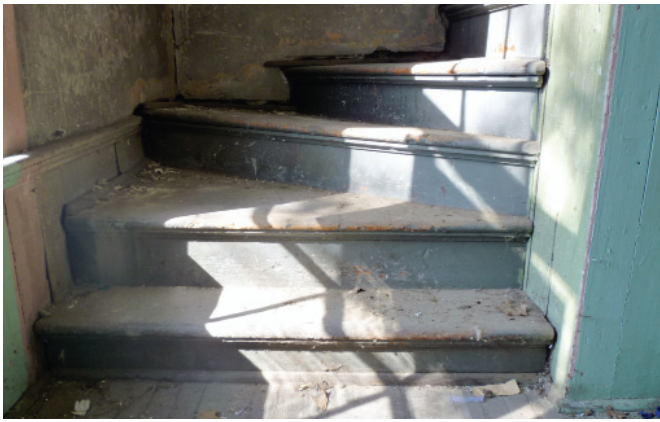
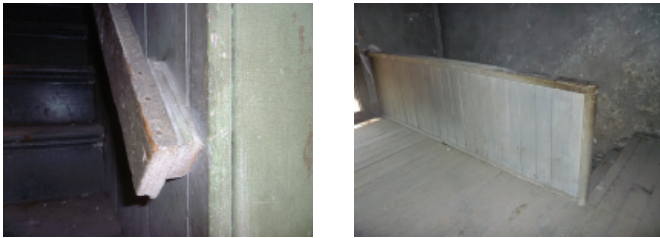
*Stair No. 1 from First Floor to Balcony*

The staircase in the main building is in fair to poor condition. The staircase is pulling away from the north wall at both the basement to first floor and first floor to balcony level runs. The structure of the intermediate landing of the basement to first floor run is deteriorated and unsafe. The components of the staircase, including the treads, risers, nosing trim, base and handrails, are intact and in good condition.

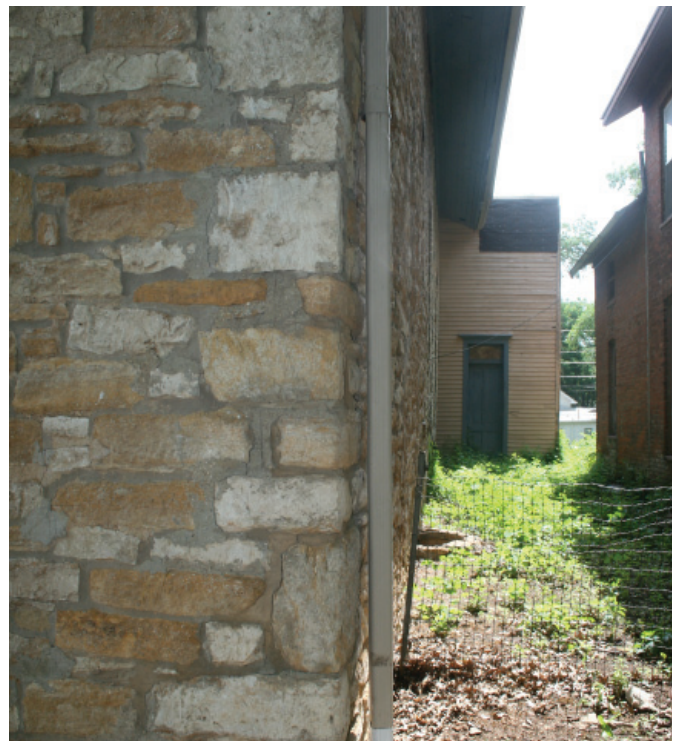
The most critical structural component in need of attention is the stabilization of the exterior limestone walls. The most significant of this outward bowing of the walls occurs at the far west end of the building. Preliminary measurements indicate that the west end of the southern wall has bowed out 2½" while the west end of the north wall has bowed out 2". The bowing in these walls appears to decrease moving eastward, due to the presence of the existing tie rods. The movement of these walls has also led to the development of cracks that are most prevalent on the west end of the building.

*West Limestone Exterior Walls Bowing*

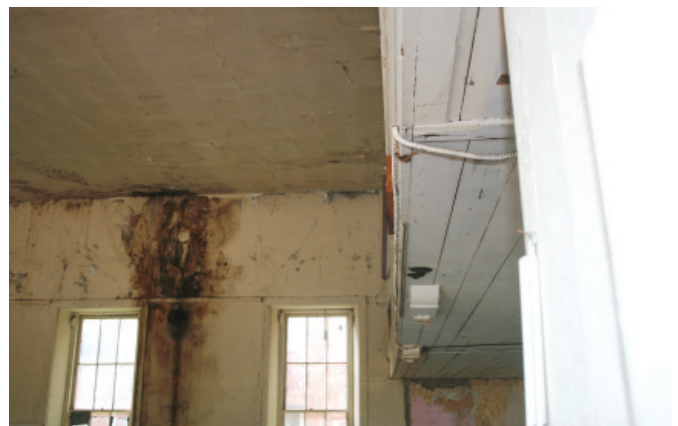
As an extension of the bowed west wall described above, the balcony framing has bowed in a horizontal plane to the west. This is most readily evidence by the bow observed in the north-south running beam along the east side of the balcony. As the west exterior wall has bowed out, the balcony diaphragm was not rigid enough to resist this outward movement and has translated westward with the exterior wall.

*Bowing Balcony Framing*

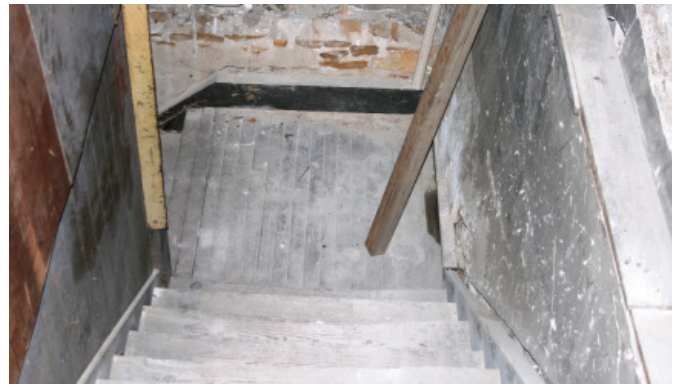
*Unsupported Northwest Stair Landing*

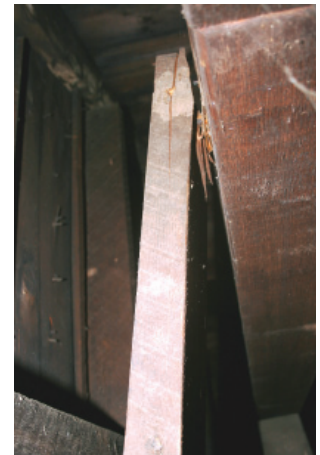
The ledger that supports the west end of the 2x12 ceiling rafters is hung from the easternmost 1869 roof truss as described above. The truss is approximately 16" west of the ledger. As a result, the bottom of the 2x6 hangers that support the ledger are skewed 16" east of the top of the hangers. These hangers are simply nailed to the truss and ledger and the skew has placed an eccentric load on these nailed connections. Additionally, the connection between the 2x12 joists and the ledger consists of a 2x5 nailed to the bottom of the ledger with each 2x12 partially notched around the 2x5. Each member is connected with nails that exhibit some signs of withdrawal. Finally, the 2x12 ledger bears on a wood bearing wall on the south end of the stage opening that is badly deteriorated.

*2x6 Hanger Supporting Ledger is Skewed 16"*

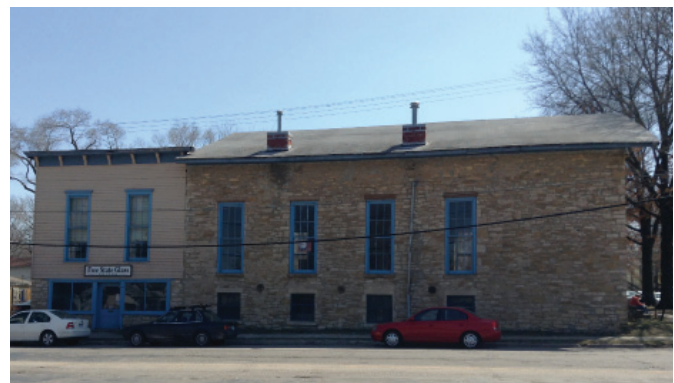
*Gutter and Downspout for the North Roof Edge – Downspout is Disconnected from the Gutter*

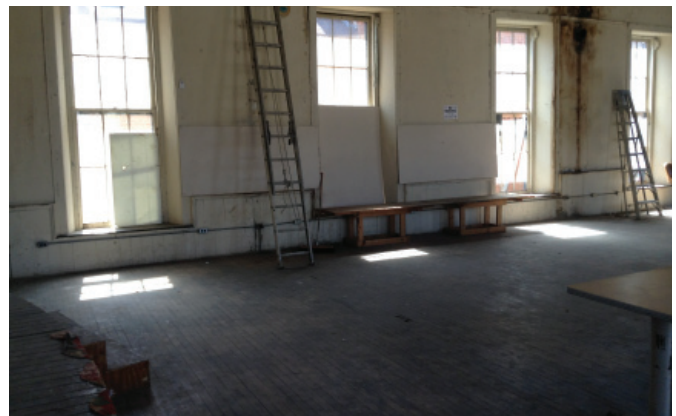
Surface Mounted Convenience Receptacles in 1st Floor Auditorium

Convenience receptacles are located throughout the building. These receptacles are surface mounted with required conductors run in electrical metallic conduit.

Convenience electrical outlets and associated conduit and conductors should also be replaced.

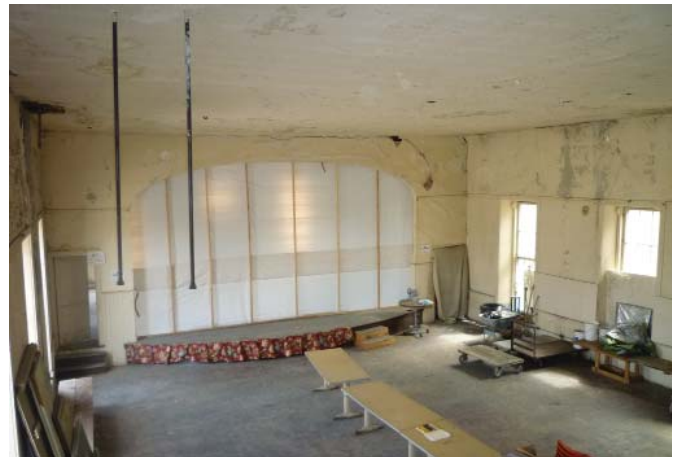
*While the Main Hall exhibits minimal detailing, the architectural features that do exist are significant and help define this highly significant space. As such, the wood wainscot, window and door surrounds (woodwork), plasterwork and wood floors should be retained and restored, as well as the open space of the main hall.*

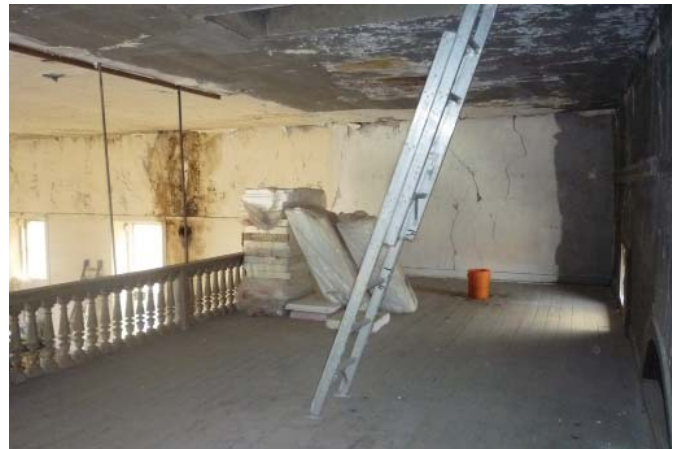
*The architectural features of the balcony, including the wood balustrades, plasterwork and wood floor are significant features that should be retained and restored. Further investigations should be made into the decorative frieze on the west wall.*

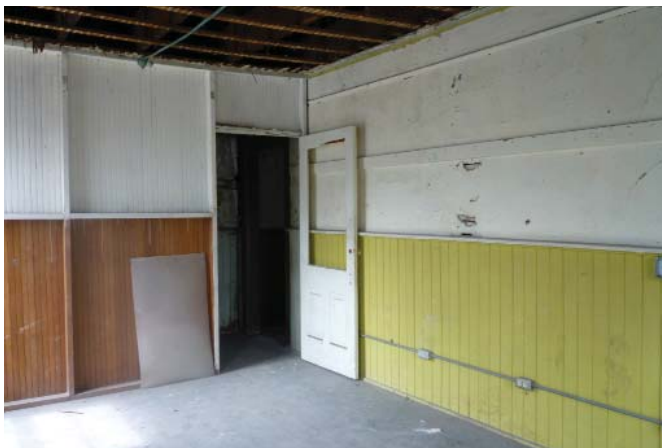
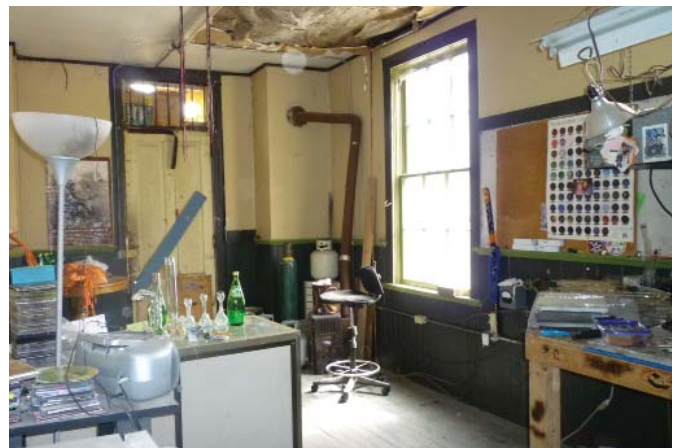
*The first and second floor offices in the addition support the main function of the building. While somewhat utilitarian in nature, these spaces also retain significant features that are in good condition that should be preserved. Examples include the wood floors, plasterwork, wainscot and doors.*

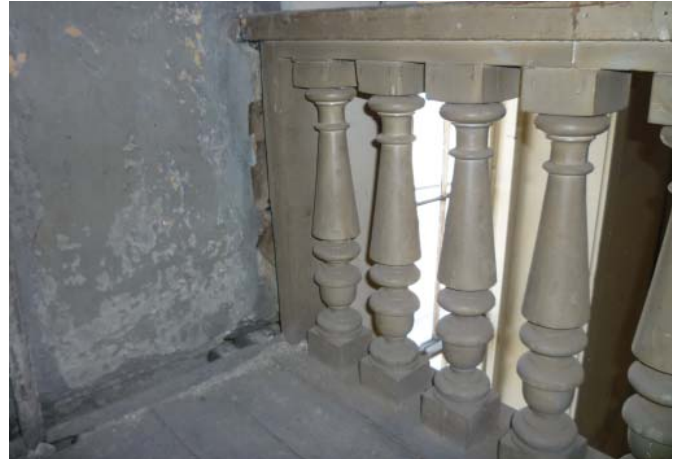
*The original balustrade at the balcony level has high integrity as it is in excellent condition and has had no alterations.*

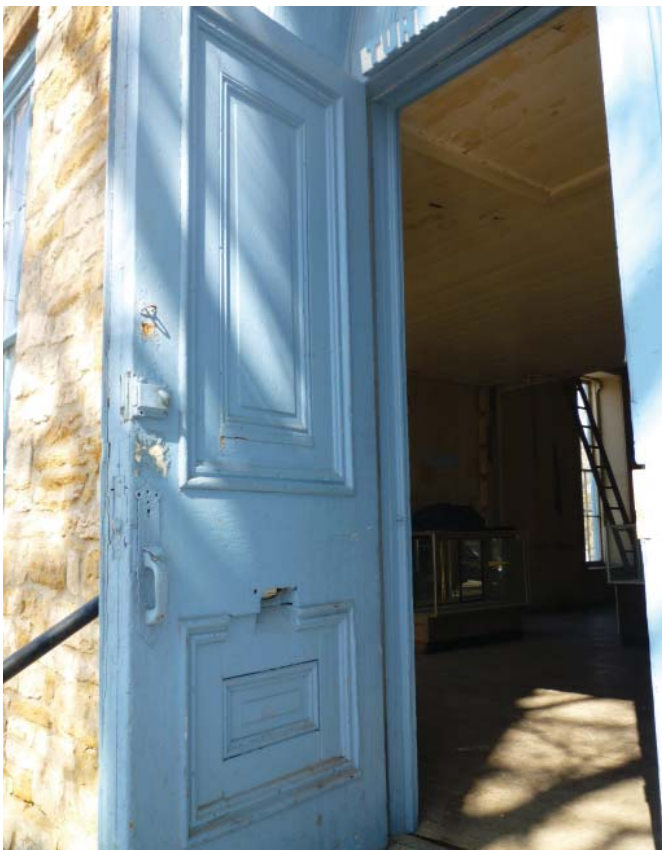
*The main entrance doors exhibit moderate integrity. There have been several alterations made to the doors over the years, but these changes may be reversed and the doors restored.*

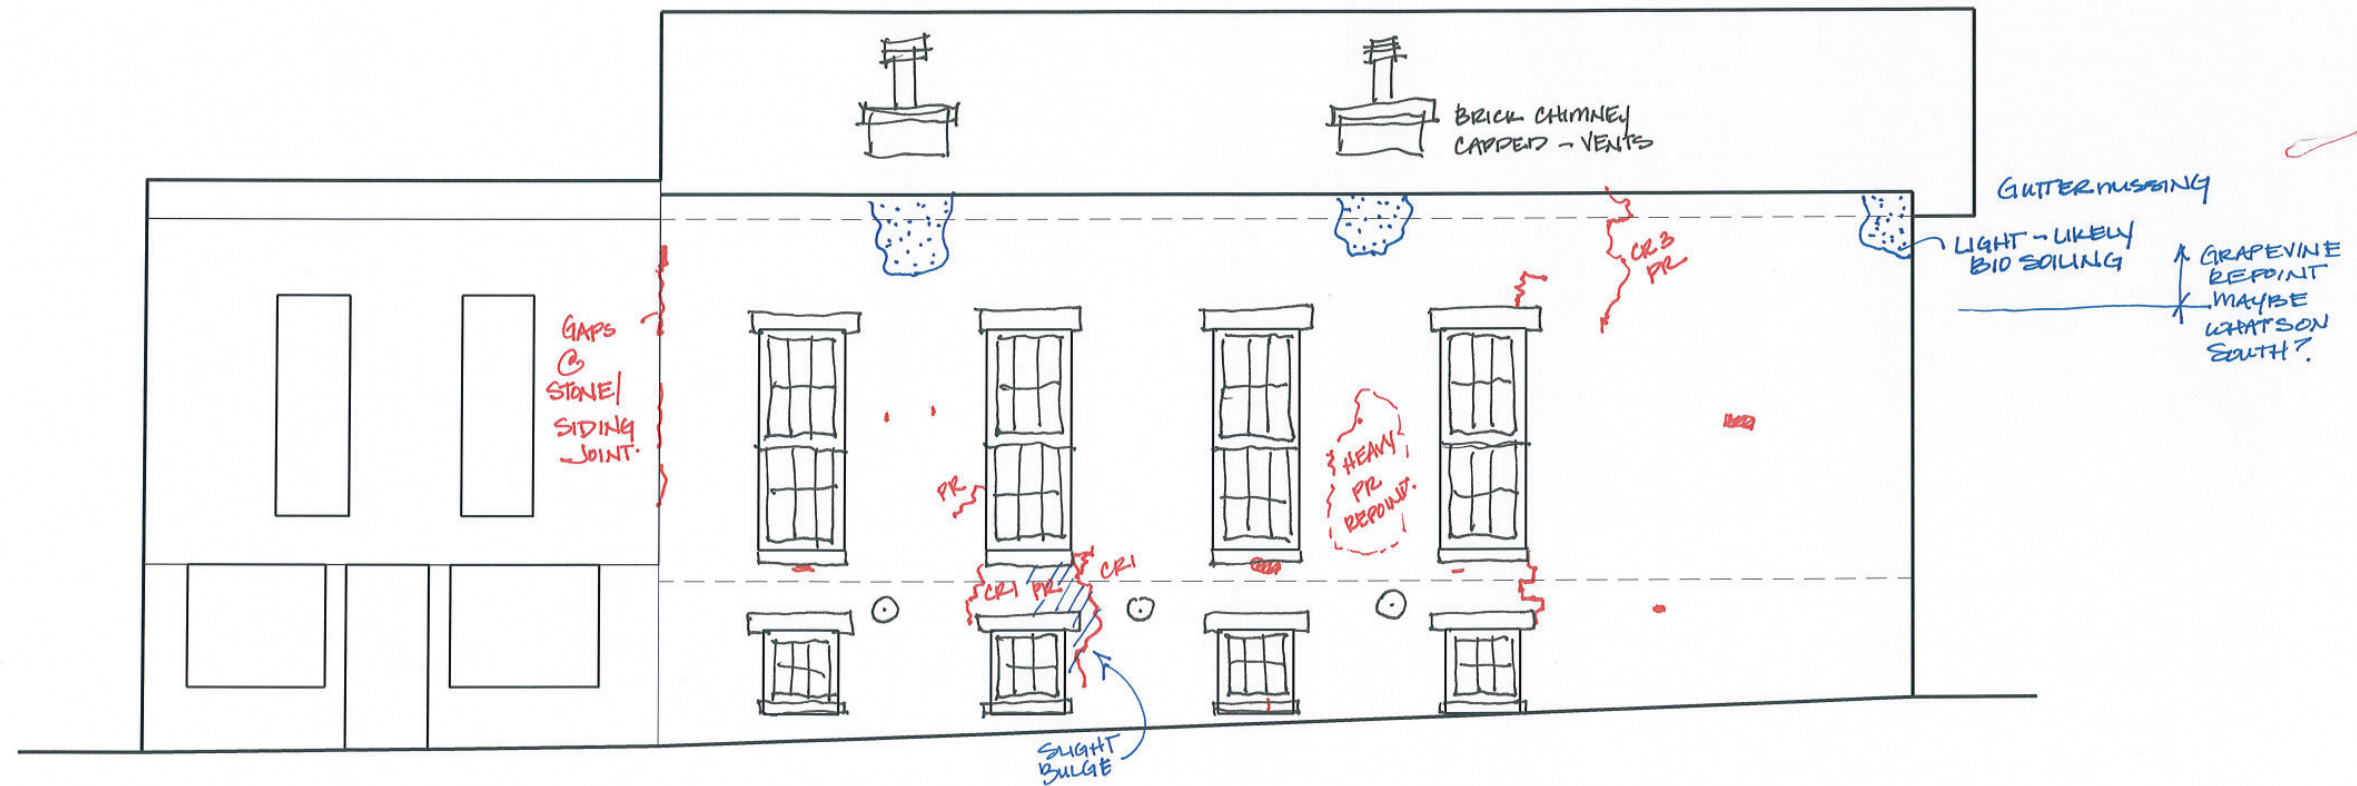
North Elevation **A1**  
 1/8" = 1'-0"

- BASEMENT LINTELS: LIMESTONE  
NOT THE SAME AS 1<sup>ST</sup> FLOOR
- 3 REPOINT REPAIRS (AT LEAST) SAND IS MUCH FINER THAN ORIG
  - UMBER - MOST PREVALENT
  - OCHRE
  - GRAY
- LINTELS & SILLS HAVE DRESSED MARGINS & BUSHED FIELD
- KEystone IS DRESSED & DATED - DATE IS FADING/ERODED
- TURNHALLE SIGN IS VERY FINELY DONE SCRIPT - MIGHT BE SANDSTONE.
- FEW CRACKED STONES BUT UNITS ARE IN GOOD CONDITION
- CRACKS ARE PRIMARILY AT JTS.
- OPEN & DET. JTS.
- ORIG. MORTAR BEHIND REPOINT IS SOFT, CRUMBLES TO TOUCH, SLIGHTLY HARDER THAN FOUND INSIDE  
LARGE SAND GRAINS.
- SOILING IS LIGHT - EXCEPT FOR SIGN  
BLACK BIO OR GYP CRUSTS -
- FRONTS OF STEPS LOOK LIKE THEY WERE DRESSED LIKE LINTELS TOPS SMOOTH

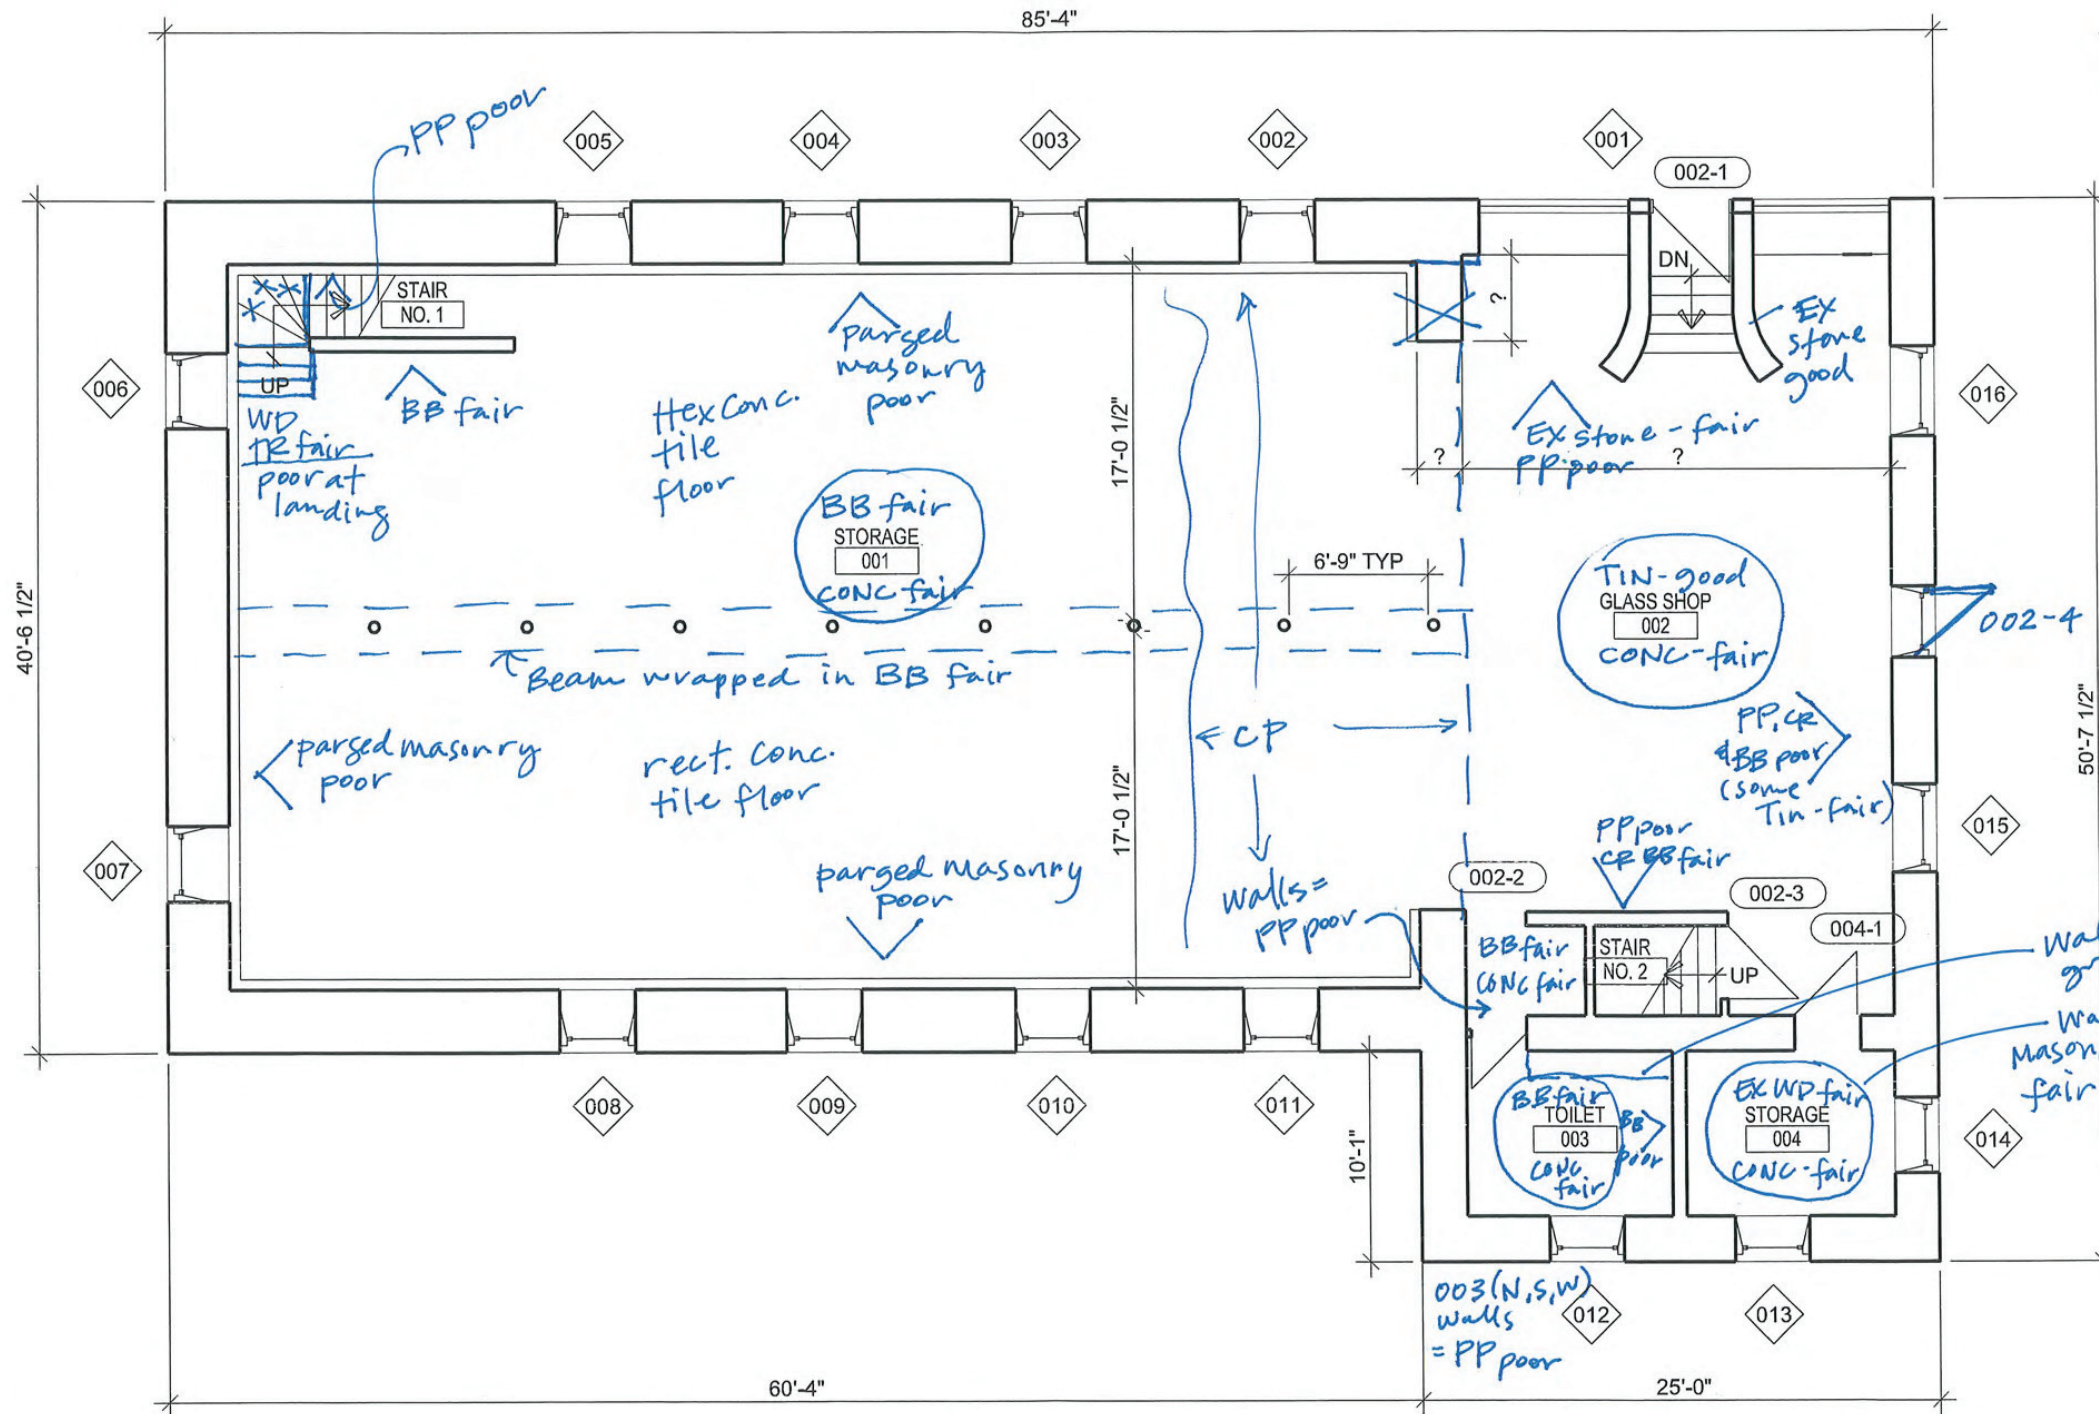
Basement Floor **A1**  
1/8" = 1'-0"

002 floor is combination of flat conc. slab and parer sized hex pattern

Wall gets thicker gradually down to floor  
Walls masonry fair?

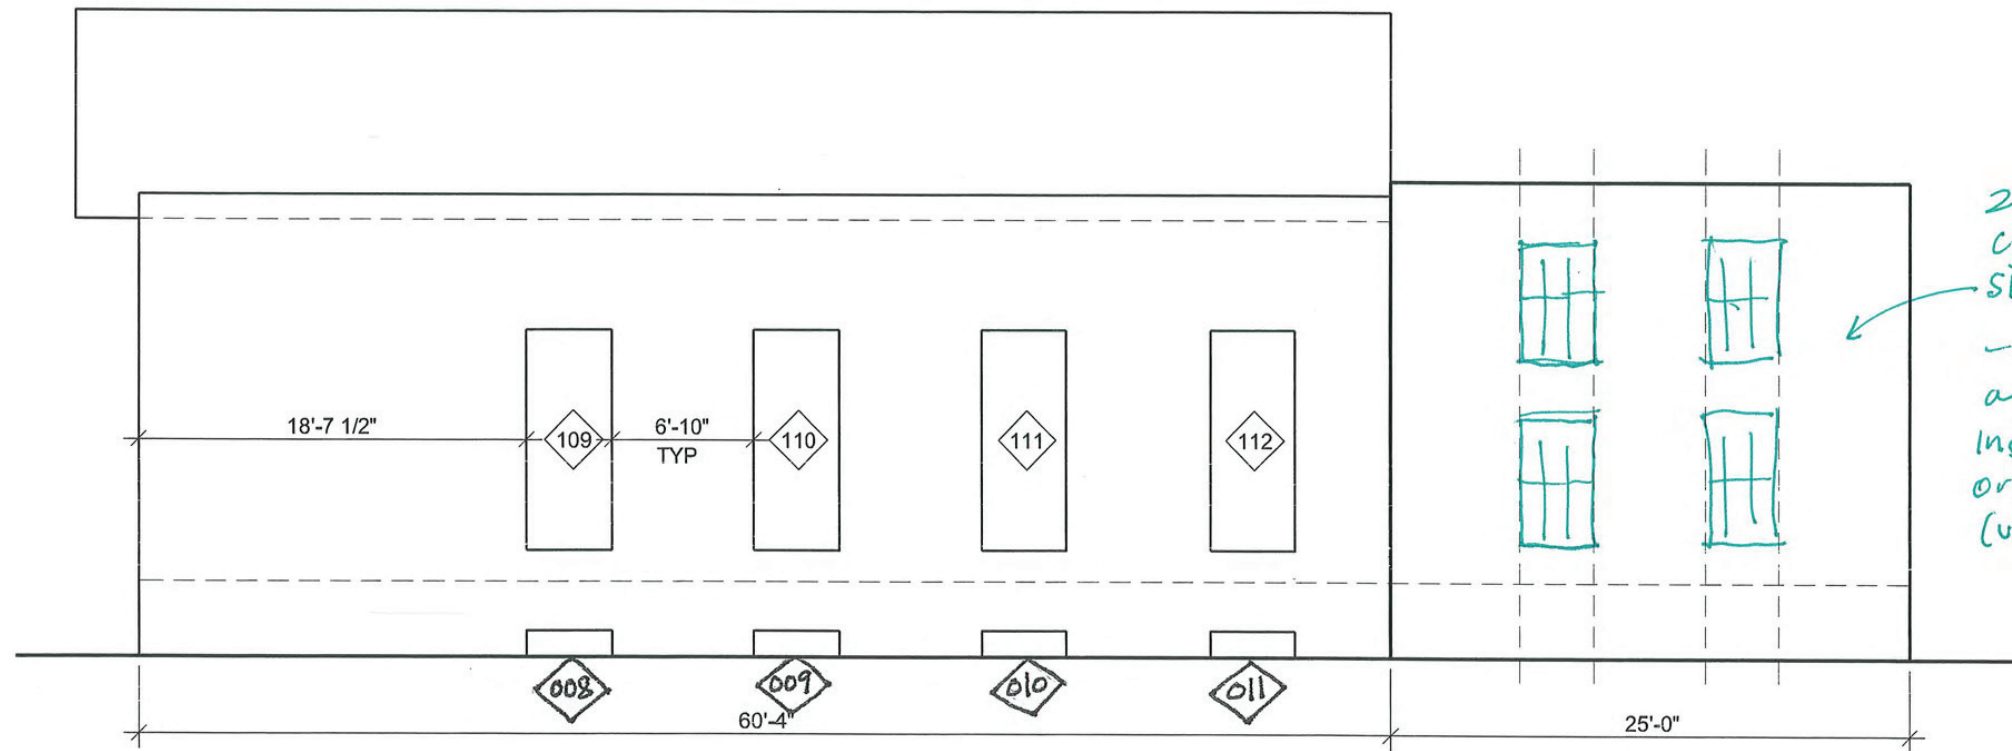
South Elevation **A3**  
1/8" = 1'-0"

26 rows  
cement  
siding boards  
- poor  
appear to be  
installed over  
original wd siding  
(unconfirmed)

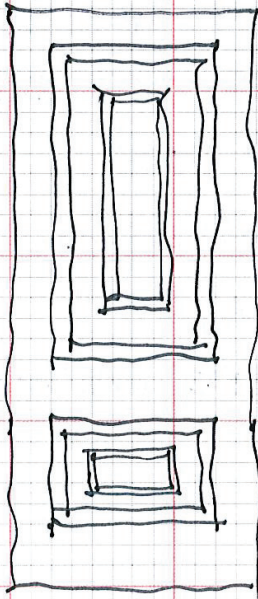
FIRST FLOOR DOORS:  
MAIN DOOR 1012-1

- ▷ PAIR OF ORIGINAL, HIGHLY ORNATE, W/D DOORS
- ▷ ORIGINALLY HAD 2ND SET OF INTERIOR SWINGING DOORS W/ 3 HINGES EA. SOUTH SET HINGES ARE INTACT
- ▷ DO-ORIG. DOOR LATCH HARDWARE INTACT - 2 ADD'L SETS LOCKS
- ▷ MAIL SLOT CUT INTO NORTH LEAF
- ▷ HARDWARE: (1) BOTTOM LOCKS (INTO FLOOR) MISSING @ N. LEAF
- (2) 3 HINGES EA. INTACT
- (3) LATCHES/LOCKS: LOCKS - SEE ABOVE
- (4) LOCK @ S. LEAF HEAD

DOORS: FRAME IN FAIR CONDITION:

- SEVERAL LAYERS PAINT
- EXTERNAL PARTING BEAD DAMAGED
- EXTRA STRAP HINGE @ BOTTOM OF N. LEAF
- BEEN REPAIRED SEVERAL TIMES BEFORE

- CRACKED / CHECKERED W/D THRESHOLD
- THRESHOLD HAS MAJOR CRACK.

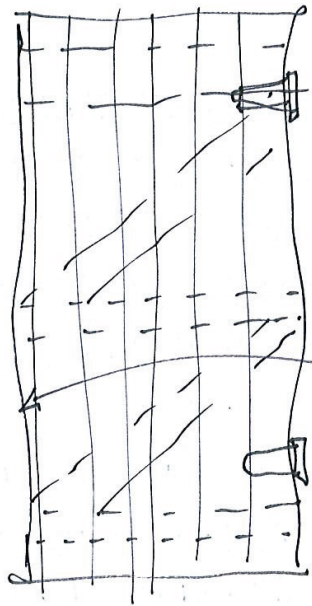
DOOR 101-1 - TO STAIR NO. 1 TO BASEMENT

- guc.
- ▷ 2 STRAP HINGES AND LOCK/LEVER INTACT, MISSING BOTH KNOBS
  - ▷ WD PANELLED DOOR
  - ▷  $\frac{3}{4}$ " THICK W/  $\frac{3}{4}$ " ZIG-ZAG FRAMING ON BACK
  - ▷ OUTER EDGE PIECE DAMAGED BOTTOM

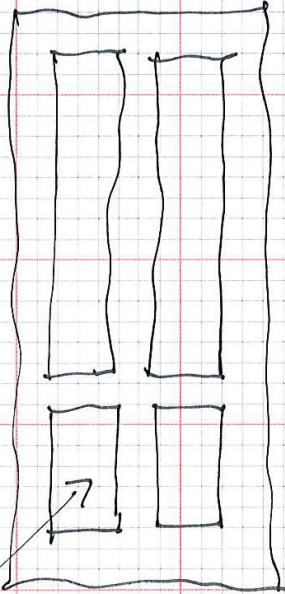
DOOR 102-1 , DOOR 102-2 (MISSING DOOR, BECAUSE INTACT)  
GOOD DOOR (W/C MISSING DOOR)

- ▷ GOOD CONDITION
- ▷ RETAINS ORIG. LOCKSET HORN & 2 HINGERS, PORCELAIN KNOBS
- ▷ WOOD THRESHOLD

- ▷ SAME TYPE AS 102-1
- ▷ MISSING BOTTOM PANEL
- ▷ RETAINS ORIG. LOCKSET HORN; 2 HINGERS ARE NEW  
 LOCKSET RETURN MISSING

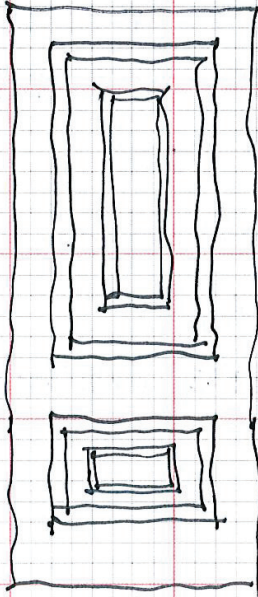
FIRST FLOOR DOORS:  
MAIN DOOR 1012-1

- ▷ PAIR OF ORIGINAL, HIGHLY ORNATE, W/D DOORS
- ▷ ORIGINALLY HAD 2ND SET OF INTERIOR SWINGING DOORS W/ 3 HINGES EA. SOUTH SET HINGES ARE INTACT
- ▷ DO-ORIG. DOOR LATCH HARDWARE INTACT - 2 ADD'L SETS LOCKS
- ▷ MAIL SLOT CUT INTO NORTH LEAF
- ▷ HARDWARE: (1) BOTTOM LOCKS (INTO FLOOR) MISSING @ N. LEAF
- (2) 3 HINGES EA. INTACT
- (3) LATCHES/LOCKS: LOCKS - SEE ABOVE
- (4) LOCK @ S. LEAF HEAD

DOORS: FRAME IN FAIR CONDITION:

- SEVERAL LAYERS PAINT
- EXTERNAL PARTING BEAD DAMAGED
- EXTRA STRAP HINGE @ BOTTOM OF N. LEAF
- BEEN REPAIRED SEVERAL TIMES BEFORE

- CRACKED / CHECKED W/D THRESHOLD
- THRESHOLD HAS MAJOR CRACK.

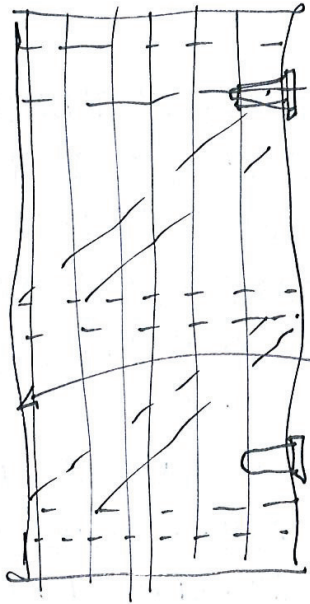
DOOR 101-1 - TO STAIR NO. 1 TO BASEMENT

- guc.
- ▷ 2 STRAP HINGES AND LOCK/LEVER INTACT, MISSING BOTH KNOBS
- ▷ WD PANELED DOOR
- ▷  $\frac{3}{4}$ " THICK W/  $\frac{3}{4}$ " ZIG-ZAG FRAMING ON BACK
- ▷ OUTER EDGE PIECE DAMAGED BOTTOM

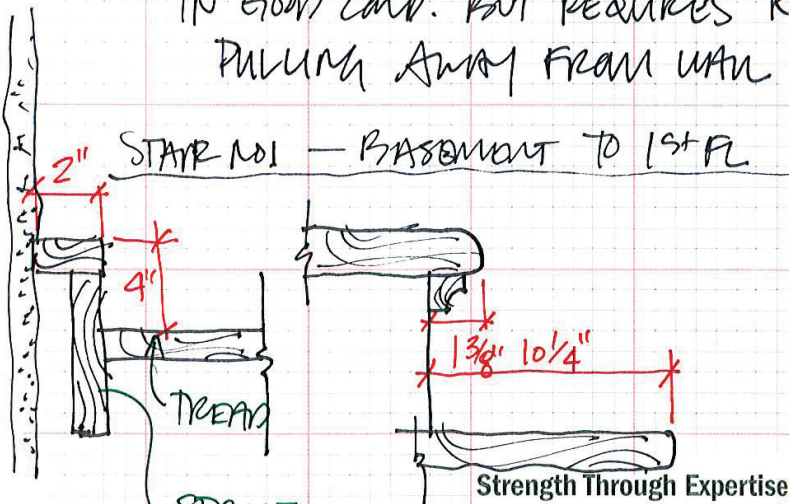
STAIR NO. 1 - BASEMENT TO 1st FL (SAME)

TOP 5 TREAD NOSINGS WORN; MAY NEED REPLACEMENT

IN GOOD COND. BUT REQUIRES REBUILDING @ WINDER  
 PULLING AWAY FROM WALL

\* MANY NOSINGS HAVE  
 BEEN DAMAGED OR  
 ARE MISSING

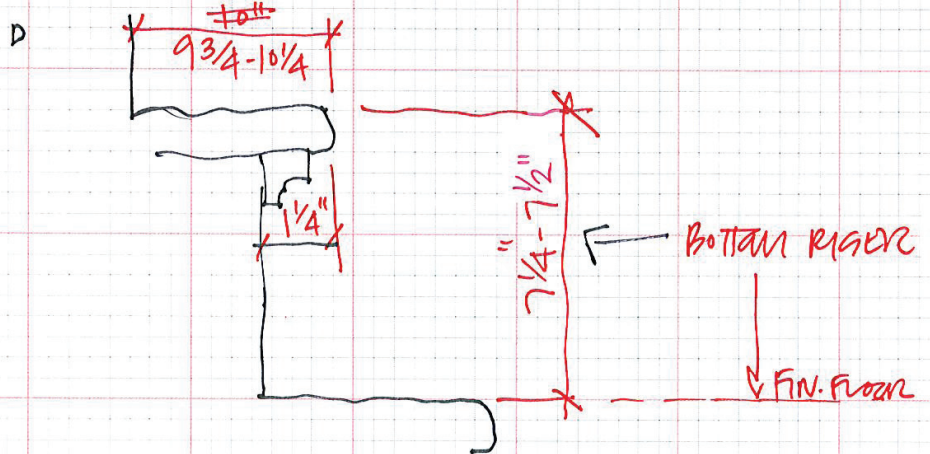
STAIR NO. 2 — 1st — 2nd FLOORS

▷ TREAD / RISER PROFILE SAME AS STAIR NO. 1

▷ NON-HISTORIC RAILING: 29 1/2" ABOVE NOSING

▷ ~~THE~~ BAMBINO WAINSCOT ON EACH SIDE STAIR

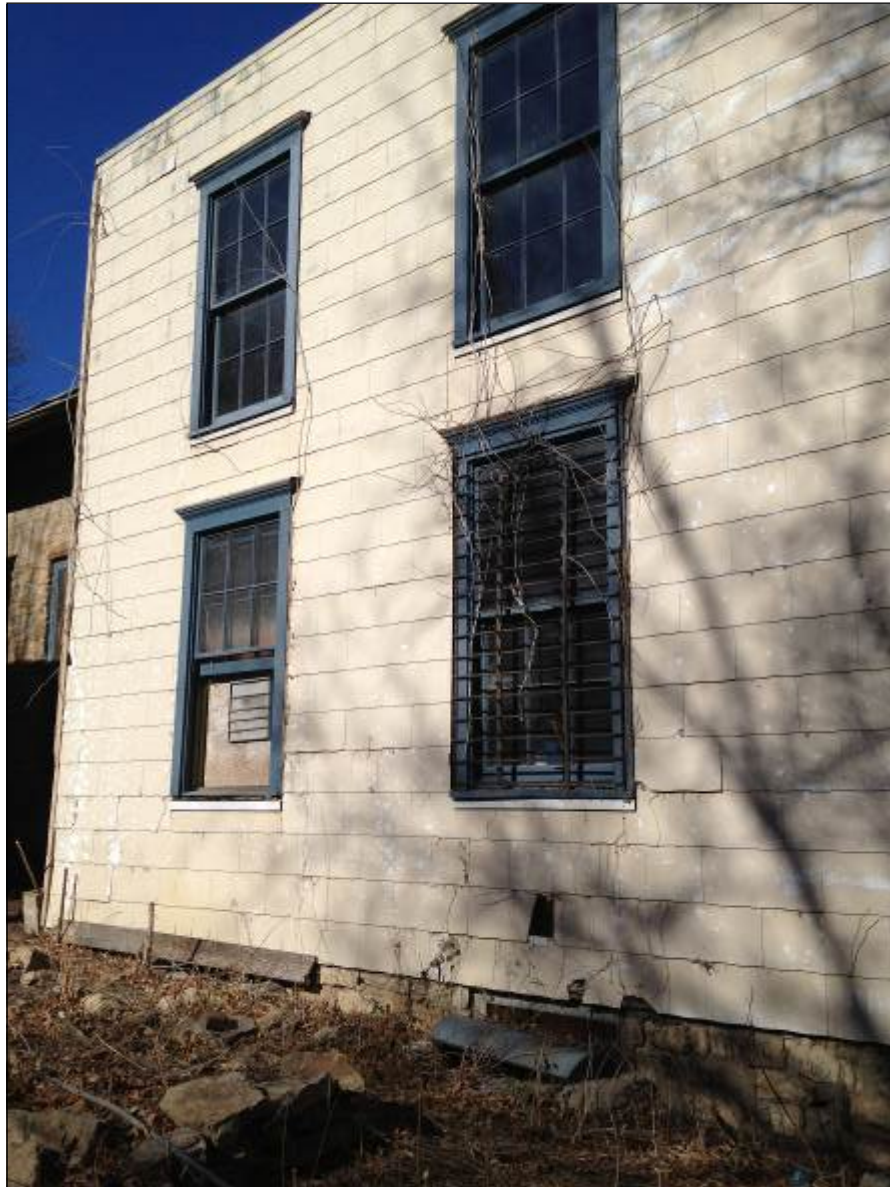
Asbestos containing siding on south rear side of building

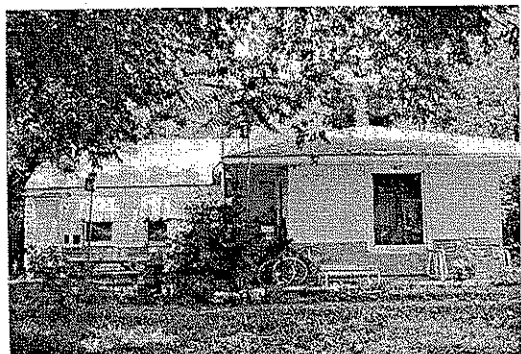
*Inappropriate Addition and Windows,  
822 Rhode Island (Photo # 80)*

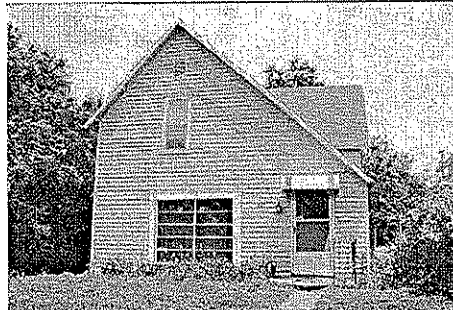
*Inappropriate Porch and  
Window Alterations,  
826 Rhode Island (Photo # 81)*

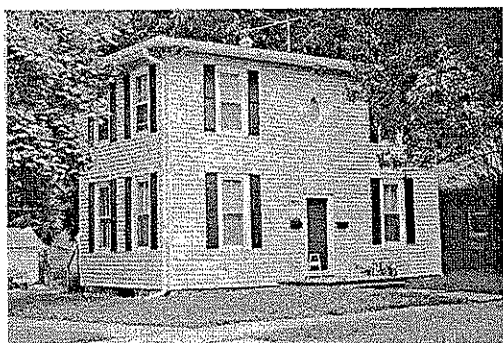
*Vinyl Siding and  
Inappropriate Window Replacement,  
1000 Rhode Island (Photo # 6)*

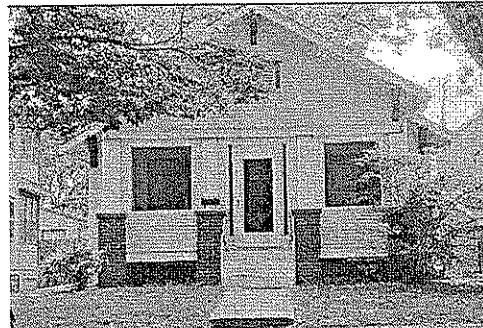
*Porch Infill,  
1025 Rhode Island Street,  
Looking West (Photo # 3)*
