Carnegie Building Roof Rehabilitation Phasing Plan

**THE CARNEGIE BUILDING
PARAPET WALL REHABILITATION**

200 West 9th Street
Lawrence, KS 66044

DGM Consultants, P.A.

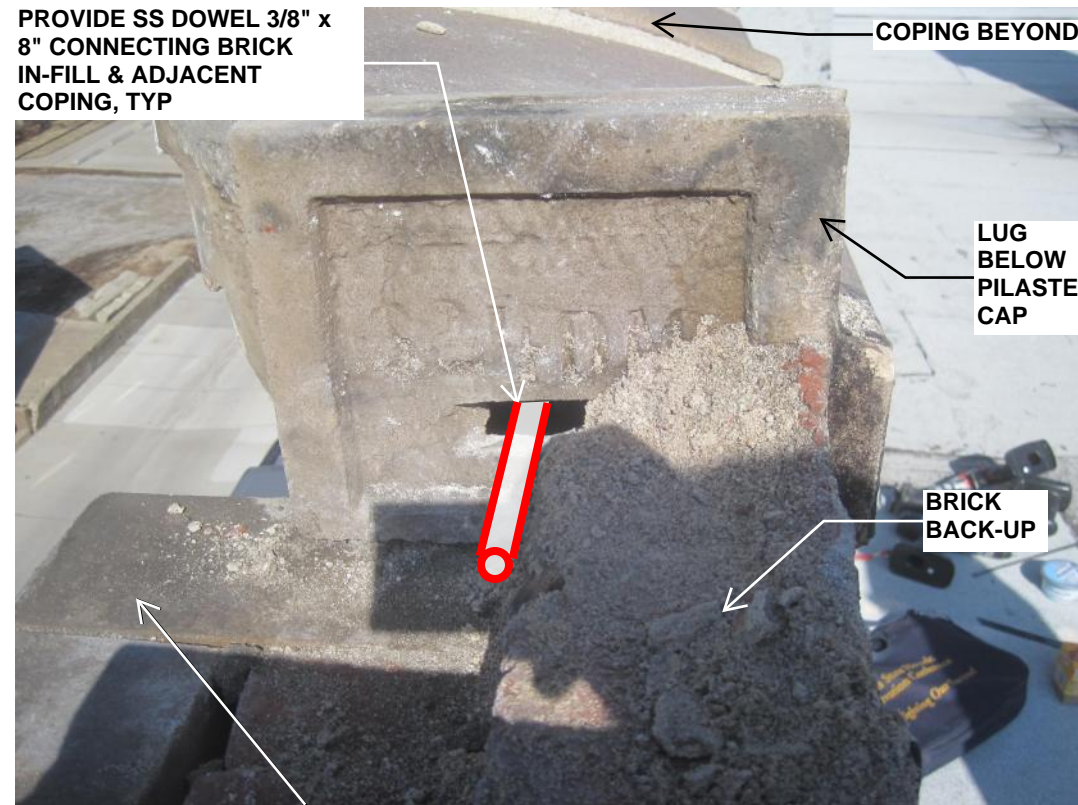
4 COPING ADJ. TO PILASTER
PHOTO

BRICK PILASTER BELOW REMOVED PILASTER NOSING

PROVIDE SS DOWEL 3/8" x 8" CONNECTING BRICK IN-FILL & ADJACENT COPING, TYP

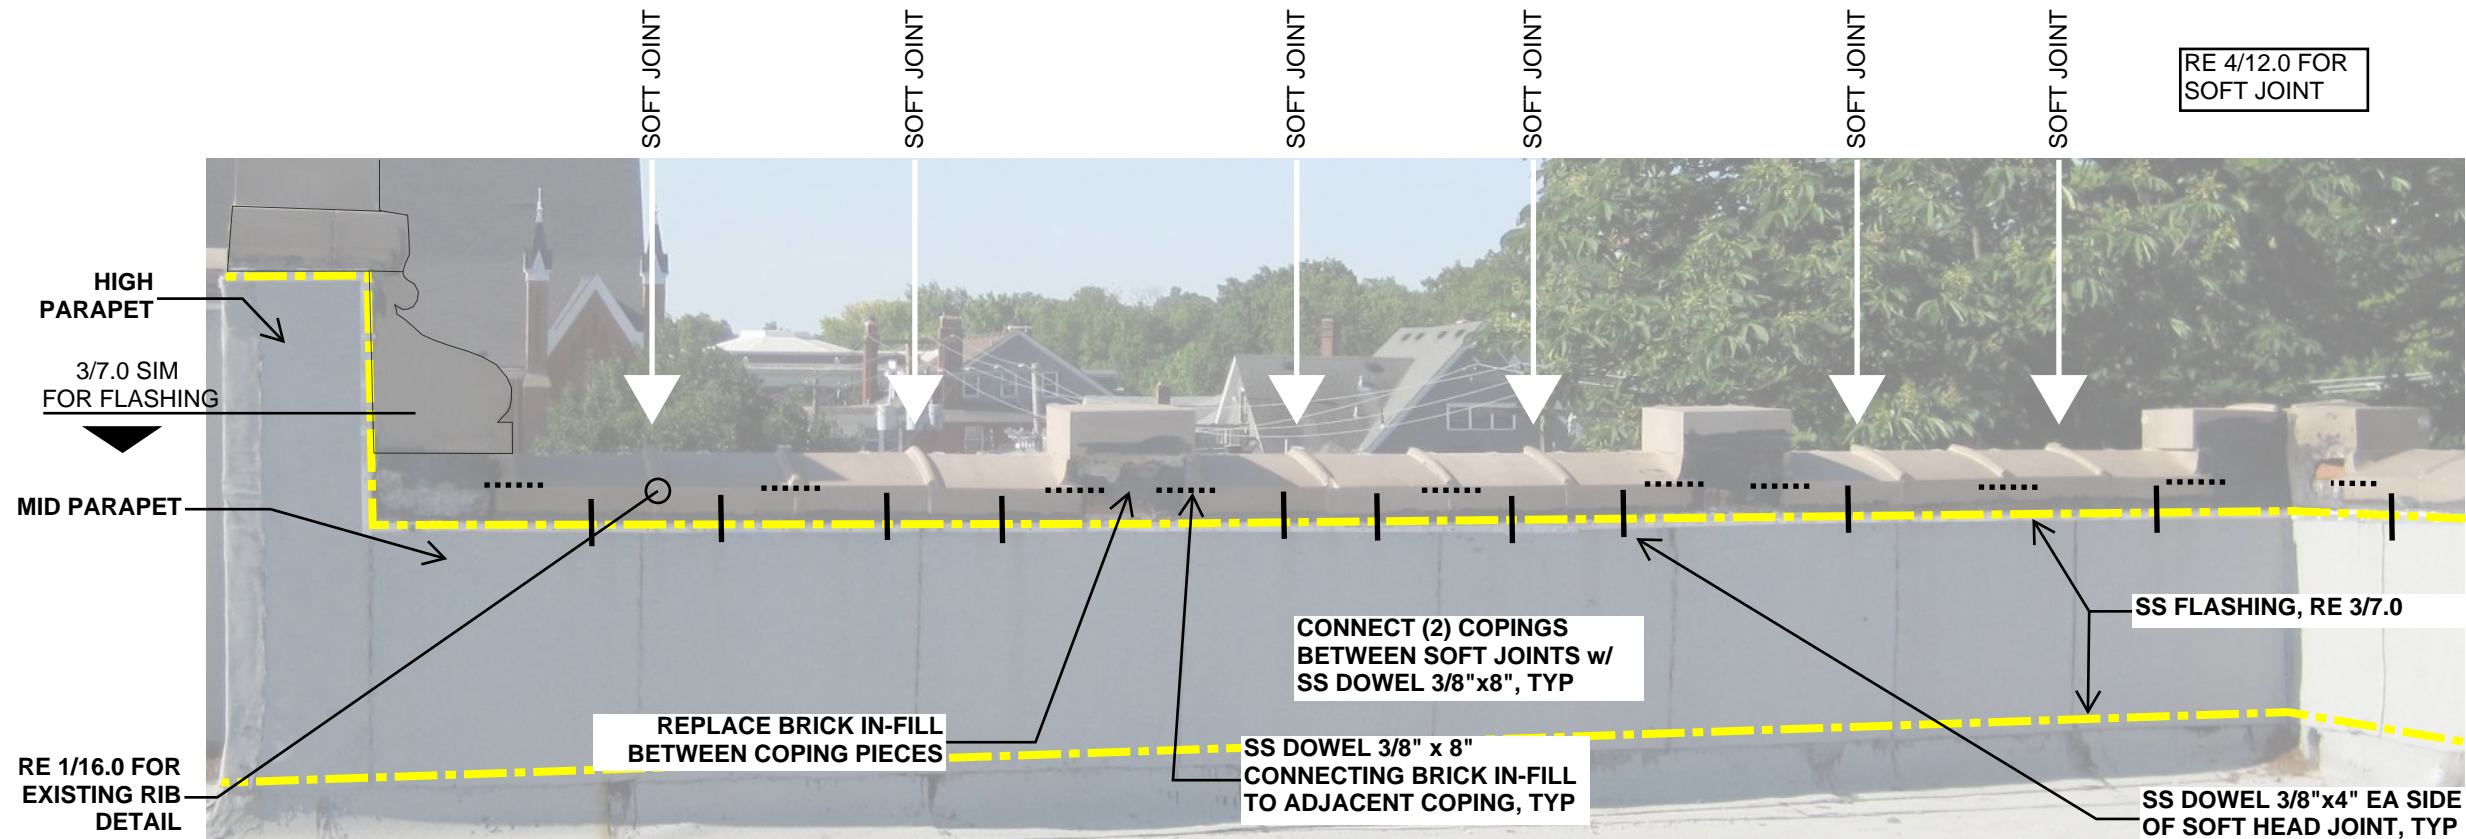
2 MID PARAPET COPINGS - S WALL
 PHOTO

WEST PARAPET OF SOUTH WALL SHOWN, EAST PARAPET SIMILAR

RE 1/7.0 FOR FURTHER INFORMATION

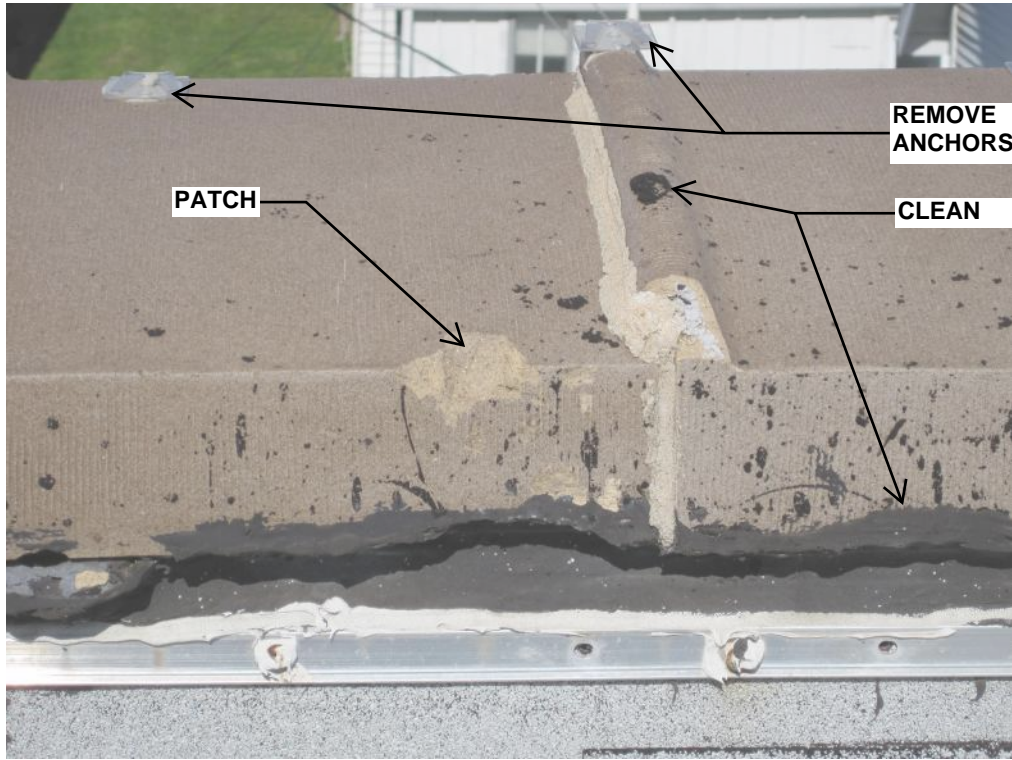
4 TERRA COTTA PATCH EXAMPLE
PHOTO

DAMAGE SHOWN ON SHEET IS NOT ALL INCLUSIVE, IT IS PROVIDED TO SHOW EXAMPLES OF THE TYPE OF DAMAGE ON THE TERRA COTTA COPINGS & CAPS

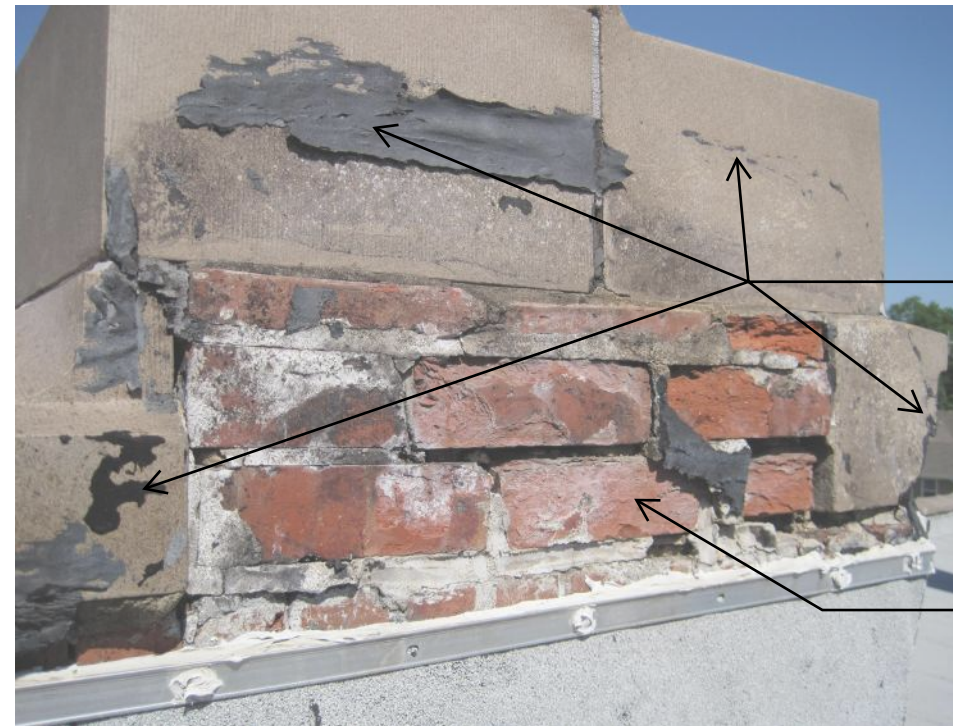
1 BACK OF TYPICAL PILASTER
PHOTO

CLEANING SHOWN ON SHEET IS NOT ALL INCLUSIVE, IT IS PROVIDED TO SHOW EXAMPLES OF THE TYPE OF MATERIAL ON THE TERRA COTTA COPINGS & CAPS TO BE REMOVED

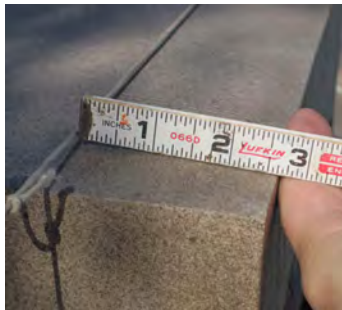
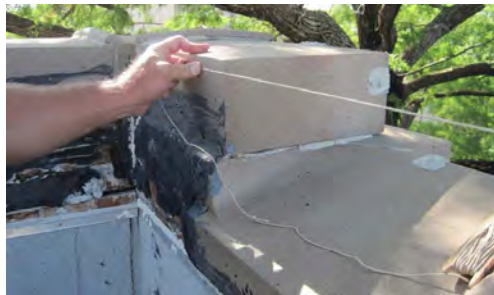
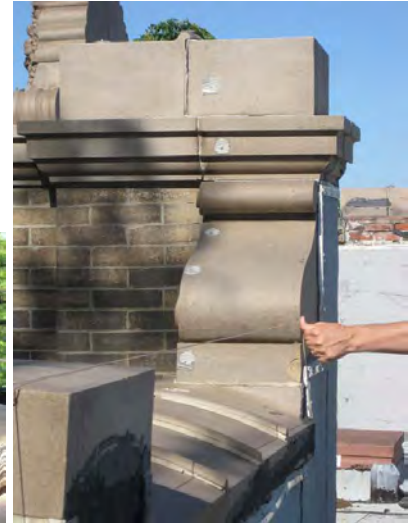
- b. Inward leaning south parapet walls
- (1) The most concerning condition is the two inward leaning parapet walls along the south wall.
 - (2) We pulled a string line along the left section (east) and measured the intermediate conditions to get a relative offset measurement (repeated at west section). We determined that both parapet walls were leaning inward about 2.625".

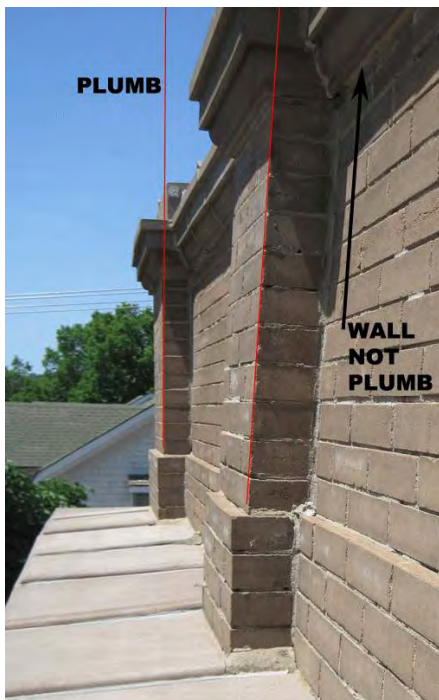
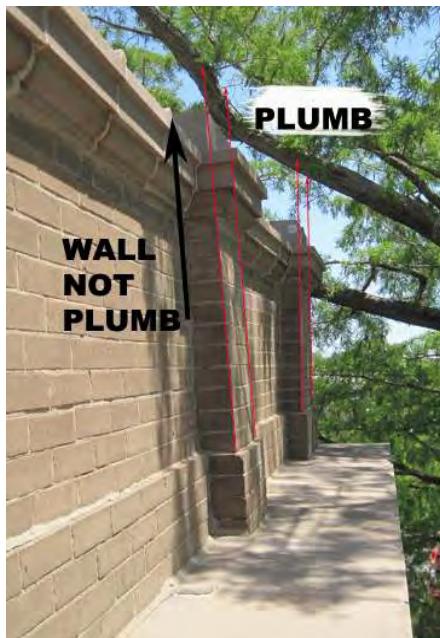
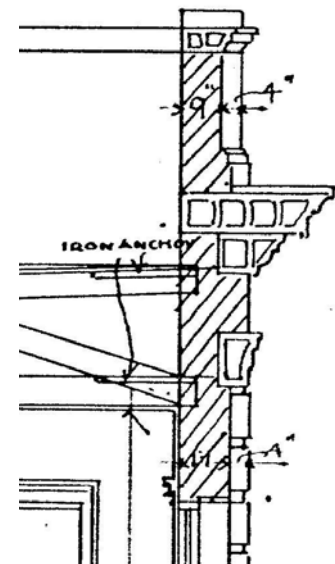
- (3) We later accessed the exterior south face of the south parapet walls, that flank each side of the area above the south porch. Both sections were noticeably out of plumb. (Portion of original drawing #5 below).

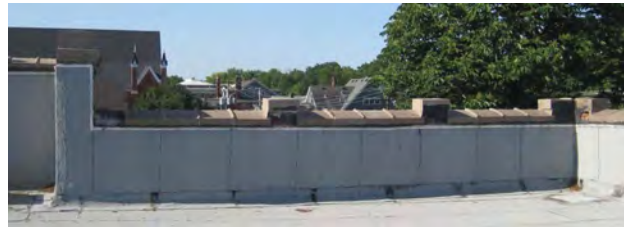
above the rest of the cap stones. The back of the pilasters are brick between the upturned terra cotta cap stone edges. The brick is partially exposed from behind an asphalt coating that was applied over the masonry. The bricks are deteriorated to varying degrees. West parapet series of pilaster caps shown below.

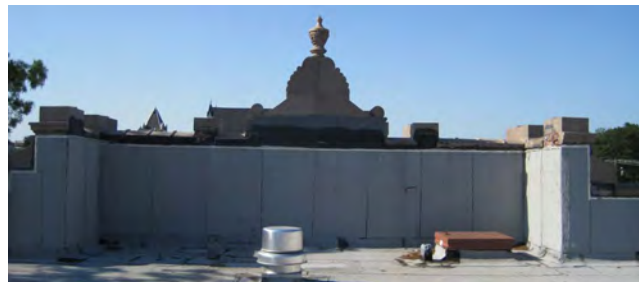
(c) The center section (27'-8") above the south entrance is taller and consists of a west wall, a south wall, and an east wall.

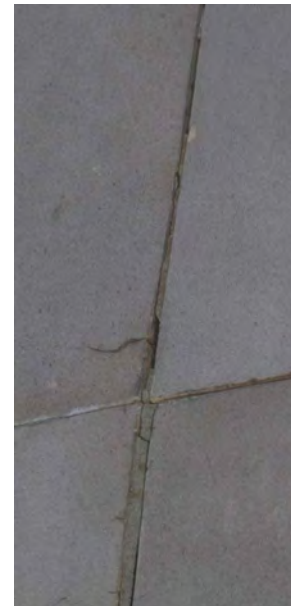
Back side is covered with a weathered asphalt coating above the termination bar to “seal” the exposed brick. The joints above in the back of the terra cotta finial are displaced and open. One crack was noted along the vertical joint.

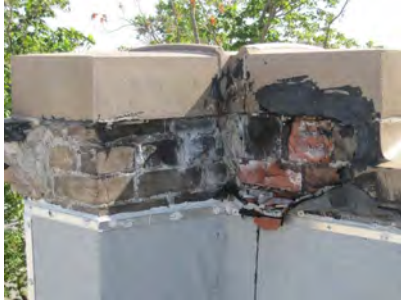
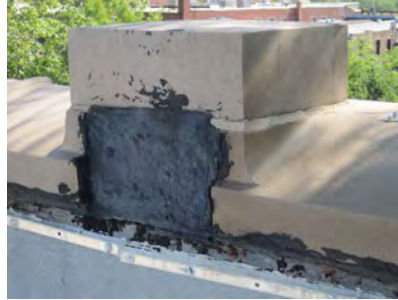
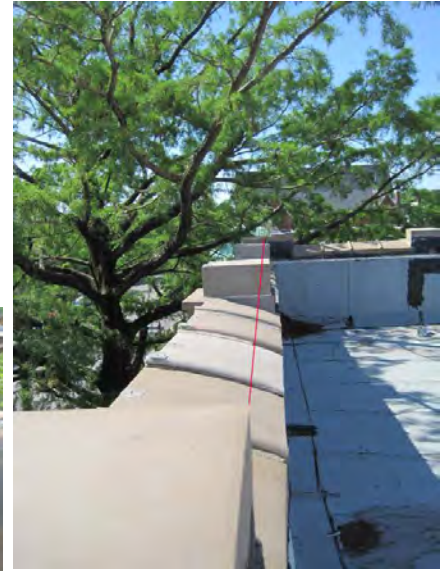
- (d) East parapet wall (31'-4")
 - i) Starting at the north end of this wall we noted a slight inward lean (bow) in this wall.
 - ii) The north end of the wall has similar covered brick issues and gaps above the

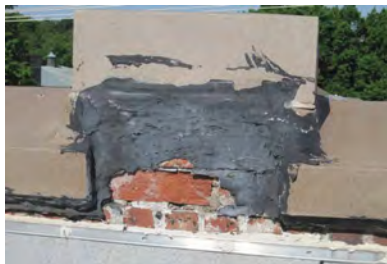
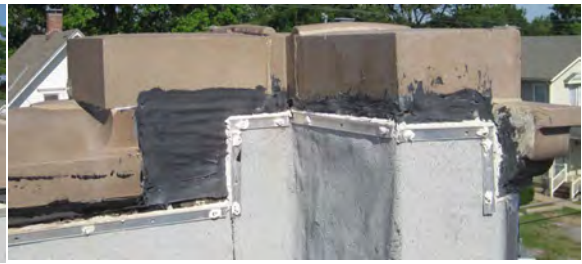
- (3) West parapet wall (31'-4"): The deteriorated conditions along this wall are

similar to the other walls.

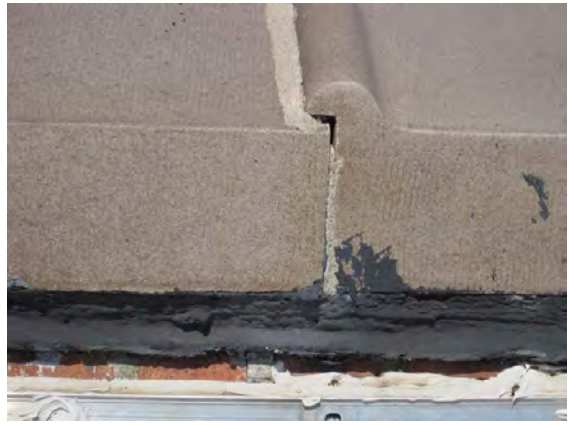
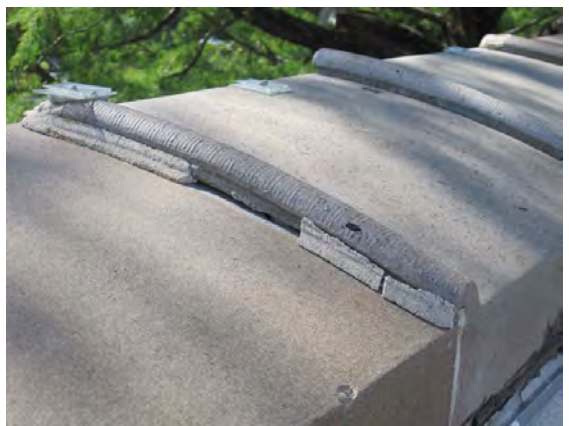
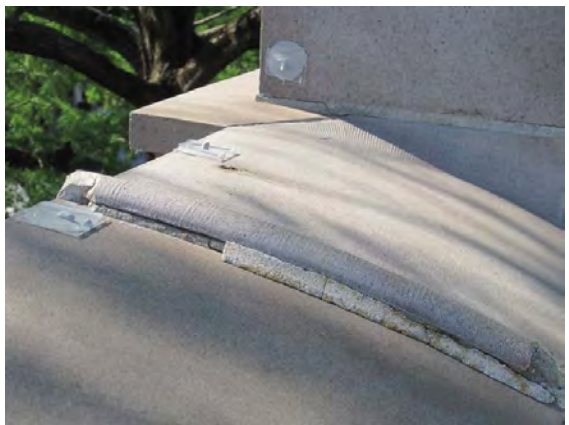
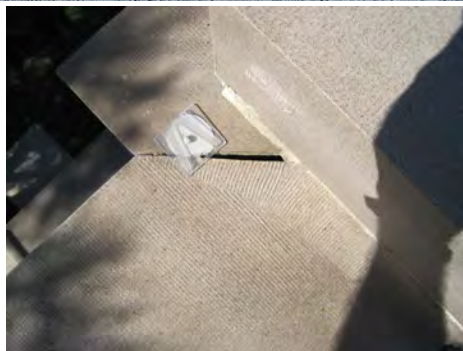
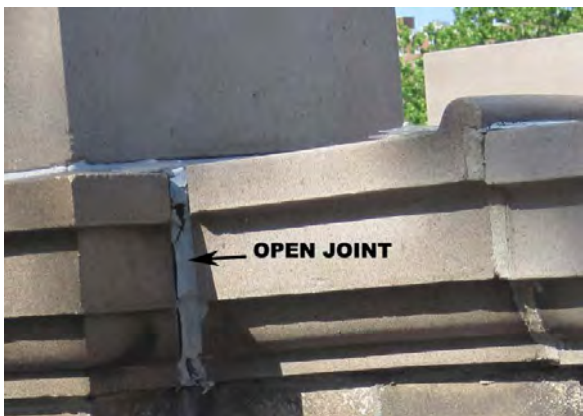
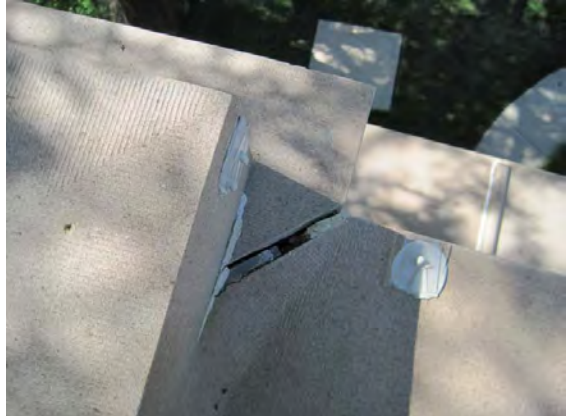
- (4) Terra cotta coping: Copings appear to be a very durable material, based on the noted condition in most locations. We noted several chips, open joints, and gaps under the coping. Several of the open joints noted were a direct result of the leaning walls. Refer to pictures on next page.

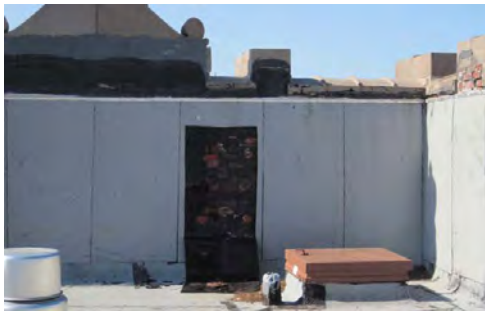
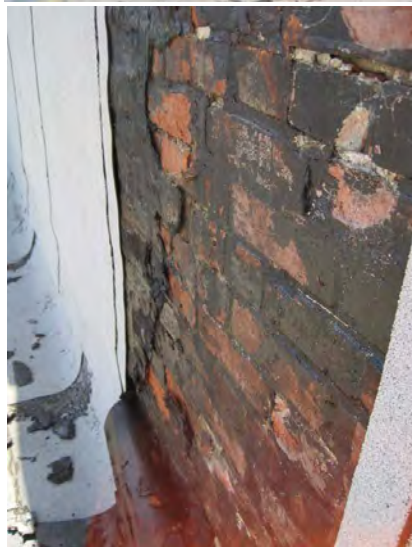
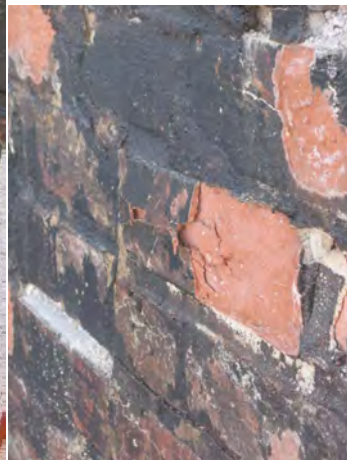
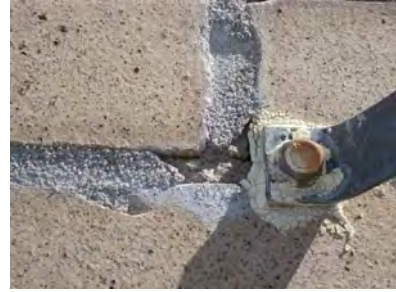
- (1) The first was at the center section. After folding the roofing down we noted the wall to be visibly wet from the glistening surface moisture. The brick backup wall had been coated with an asphalt coating subsequent to some pointing and the bricks were spalling.

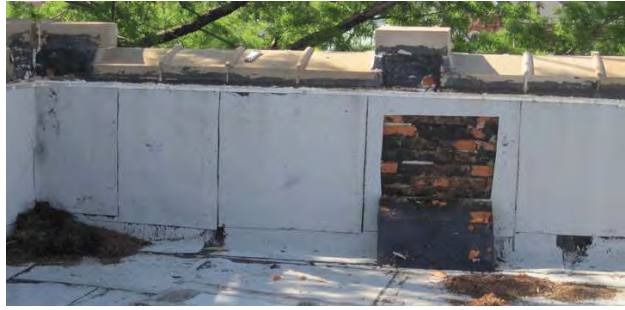
- (2) The second was the east parapet section.
- (3) The mortar original mortar joints were wider than the exterior joints and they were severely deteriorated. Previous pointing attempts appeared to be just shallow joint fills that were not

bonded to the brick well or deep enough.

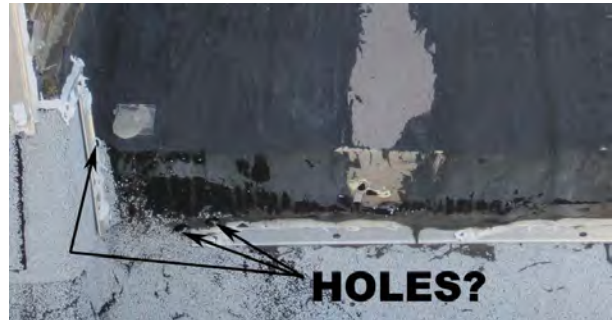
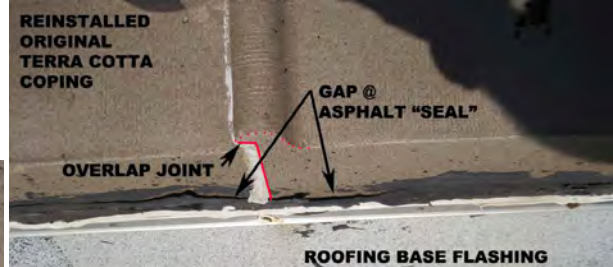
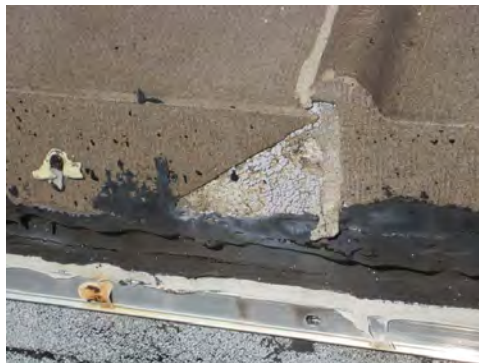
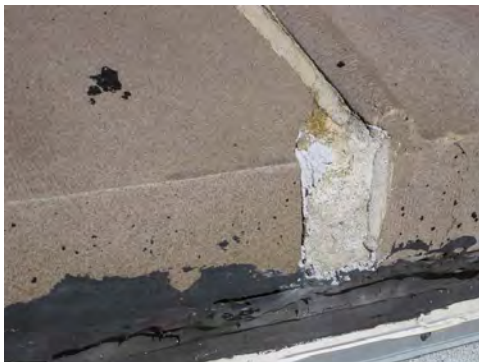
- c. West wall (36'-5"): Wall is capped with 25 terra cotta coping units, plus three pieces at the corner, from the original building that was replaced by this addition. These terra cotta coping units are in good condition, except for several chipped units and open joints.

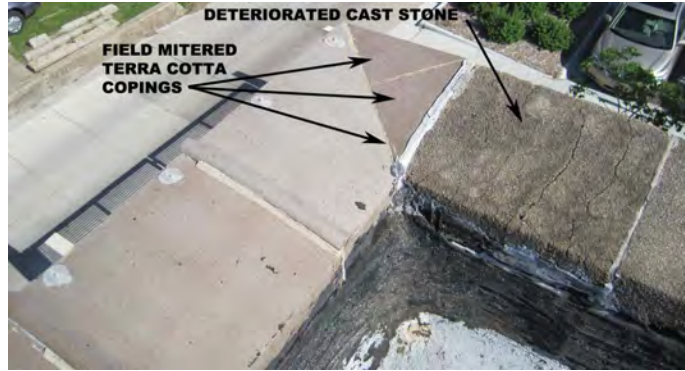
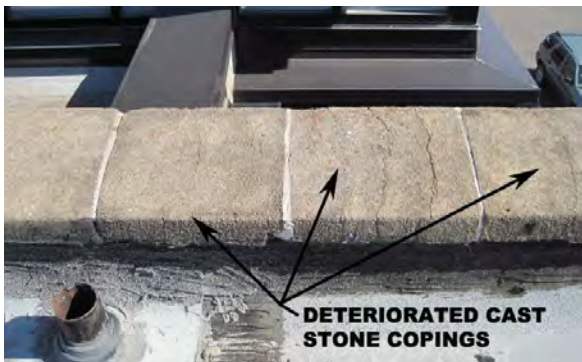
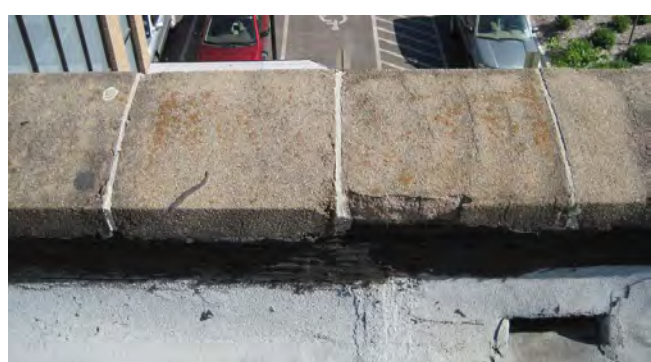
(1) The copings on the north wall are cast stone units that are of a similar cross section as the original, but 24 of the 47 units are severely deteriorated and joints are cracked.

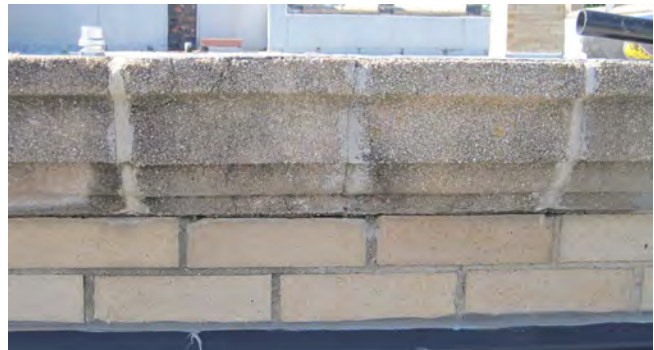
(2) The north face of this coping wall was reviewed from the 2011 Addition roof. Cracked units and gaps in brick wall below were noted.

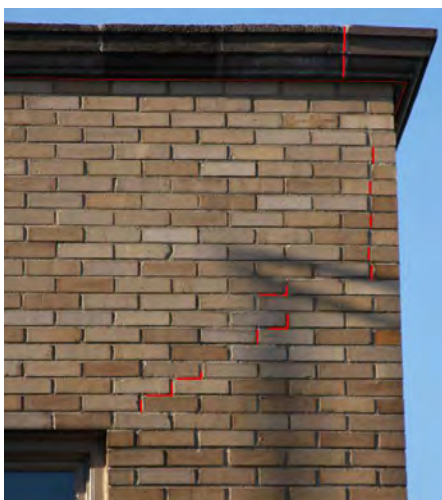
- (3) At the northwest corner (from the ground), we noted that the coping was being pushed off the wall in both direction but more toward the west since the north wall is twice as long. The expansion toward the west has also cracked the brick wall below.

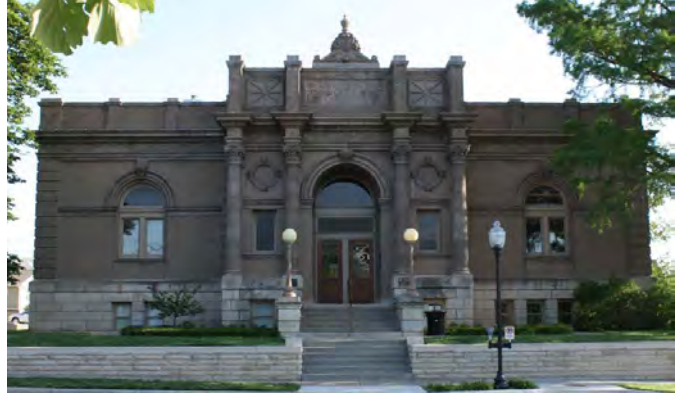
- (1) General: This elevation is the front of the original building. Discussions will include the east and west portions of the entrance.

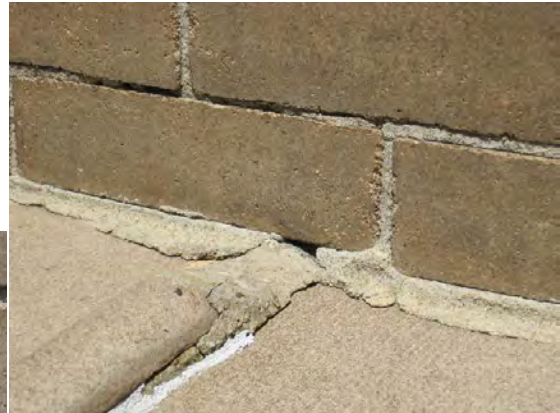
- iii) Pointing at base of parapet wall (at watertable) appears to be installed

improperly and holes were noted in mortar joints.

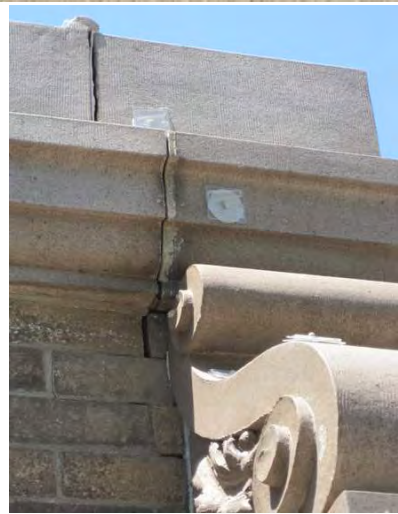
At top of wall (east central portion), open joints were noted from ladder.

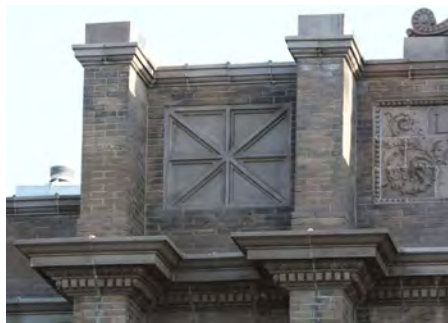
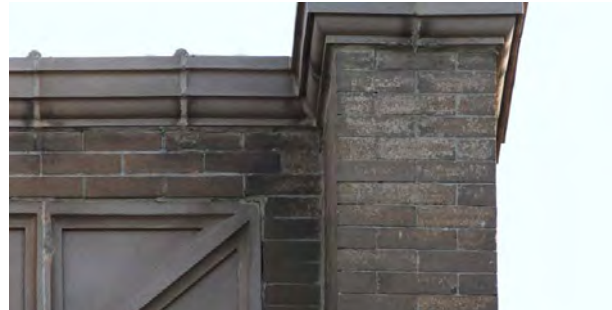
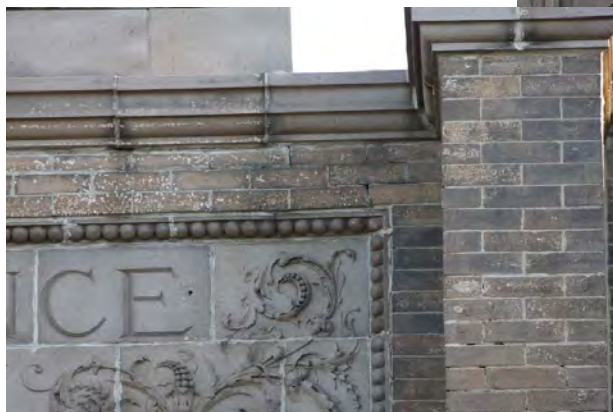
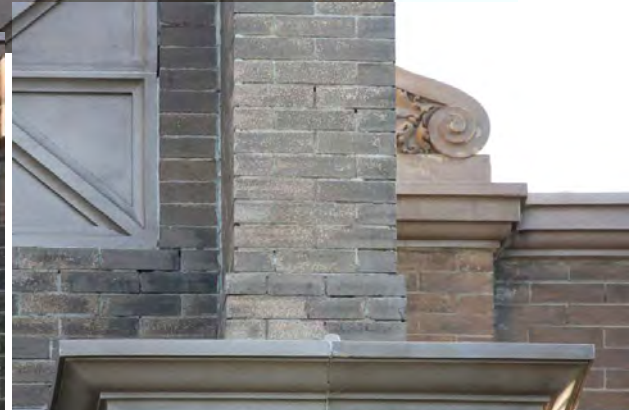
- (c) Center section: Masonry appears to be in good condition, except for some open joints between the bricks and the inlaid panels and mortar joints.

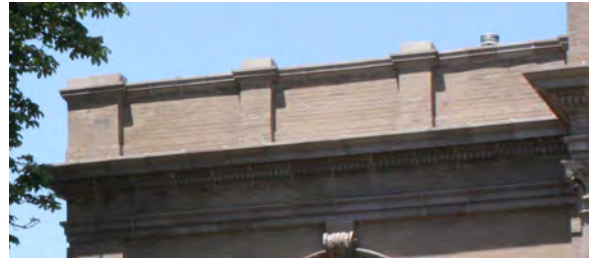
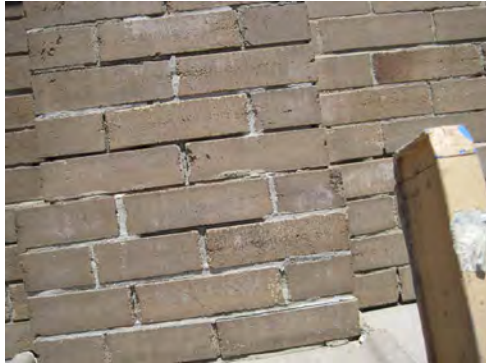
- (d) Western parapet
 - i) Accessed with a ladder
 - ii) Narrow mortar joints are weathered.

Some pointing has failed. Watertable is in good condition, but some open joints were noted. Pointing at base of parapet wall (at watertable) appears to be installed improperly and holes were noted in mortar joints.

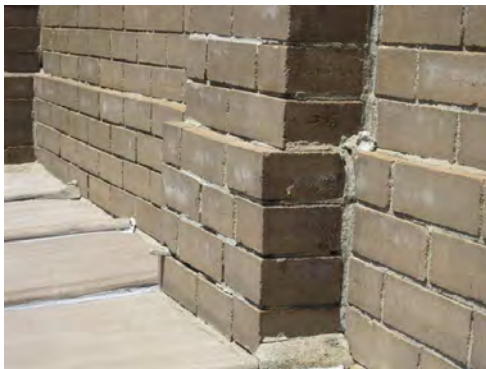
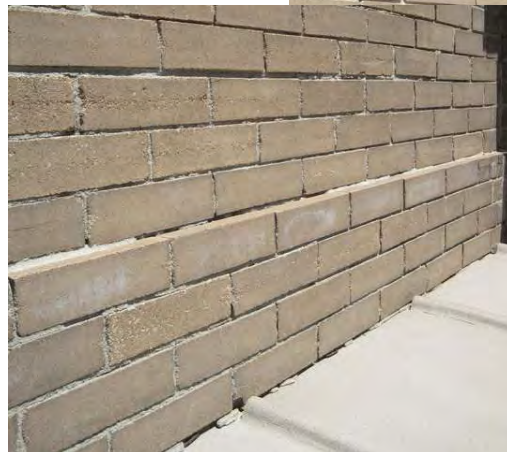
- iii) Displaced units were noted near the top of wall (photo right).

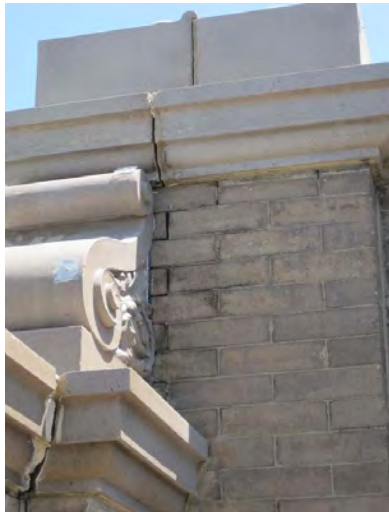
- iv) At top of wall (west central portion), open joints were noted from ladder (photo left).

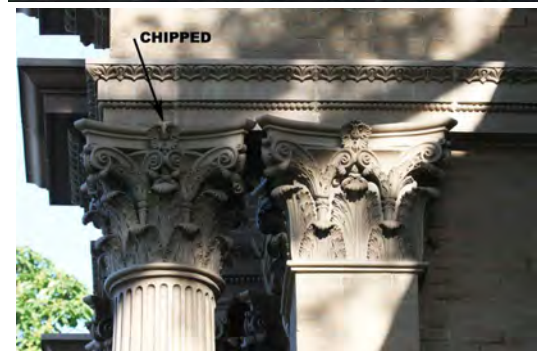
- (4) South Entrance
 - (a) The right terra cotta column capitals appear to be in excellent condition. One slightly chipped detail was noted.
 - (b) The base of the left wall corner is cracked on the west and south faces. Previous repairs have addressed the older cracks, but some cracks appear to be newer than the last repairs.

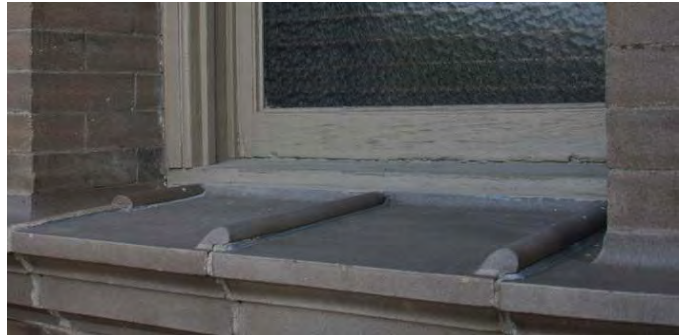
(c) The sills are also in good condition, except for a few broken terra cotta joint laps.

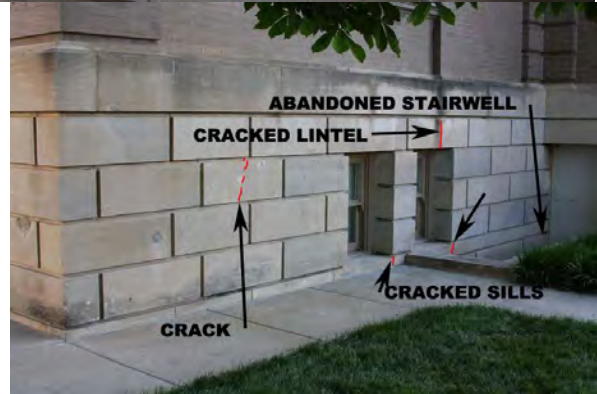
(5) Western wall
(a) Noted a few cracked joints and

cracked stones in the foundation wall. Biological staining was also noted along the top of the foundation wall.

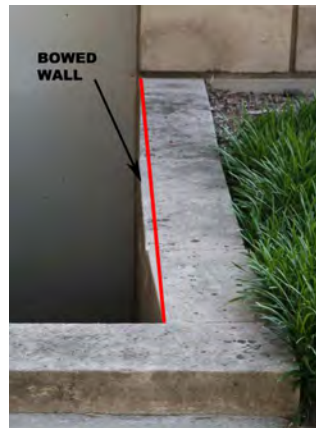
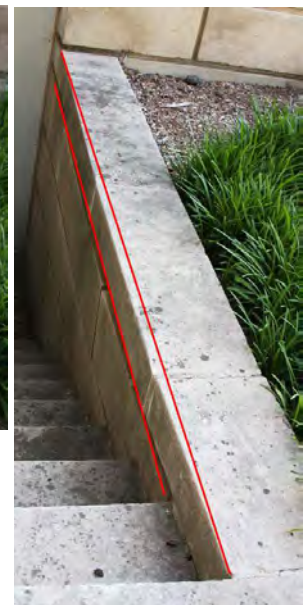
(b) Abandoned stairwell on the west side of the entrance has a bowed foundation wall. The top two courses are displaced and cracked. No guardrail at lower level stairwell.

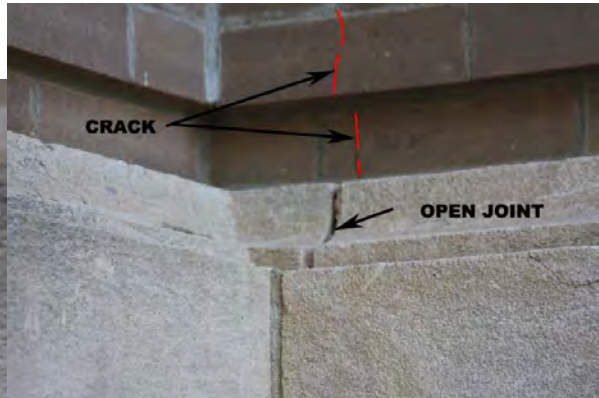
(c) Cracks and open

joints were noted at the inside corner.

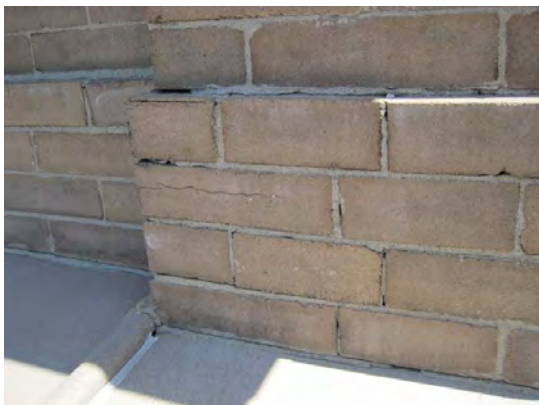
(a) The parapet was accessed with a ladder
(b) Mortar joints appears to be deteriorated in several locations.

1. The original building mortar joints are thin and have weathered the 108 plus years of exposure well. The severely weathered locations (especially the parapet walls) allow moisture to enter the walls and contribute to further deterioration of the masonry walls and possibly interior finishes.
2. The 1937 Addition has a few areas that need to be pointed to address holes and weathered joints.
3. Repairs: Point all deteriorated or improperly pointed mortar joints with the appropriate mortar according to Preservation Brief No. 2.

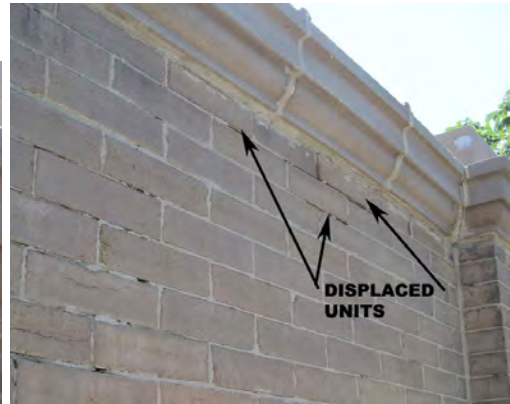
(c) Displaced bricks were

noted at another location.

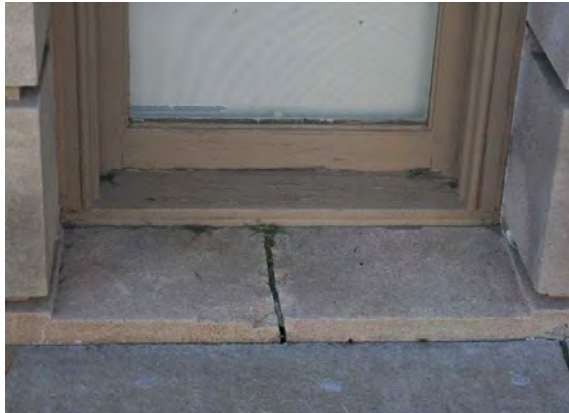
- (d) Cracks in foundation wall near corner and at basement window.

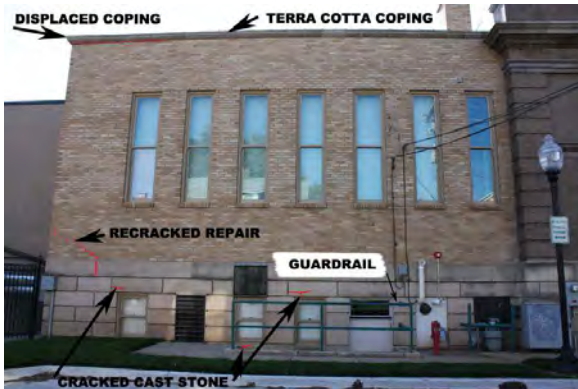
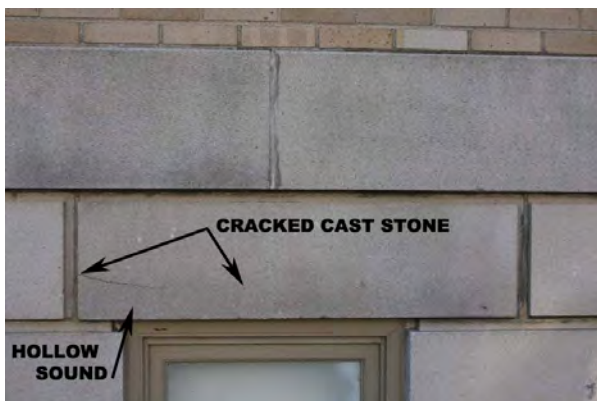
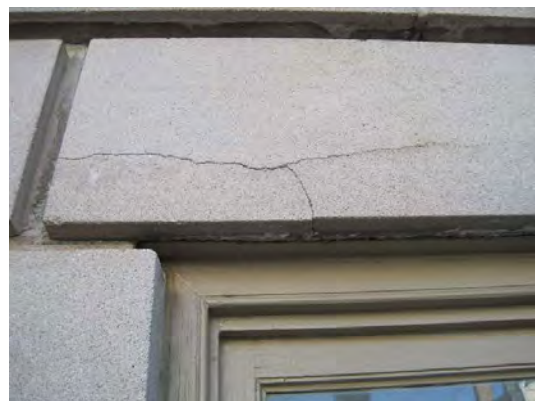
- (a) Cracks noted at northwest corner
(b) Foundation was made with cast stone units. Two cast stone lintels are cracked and one of them sounds hollow (noted in photo).

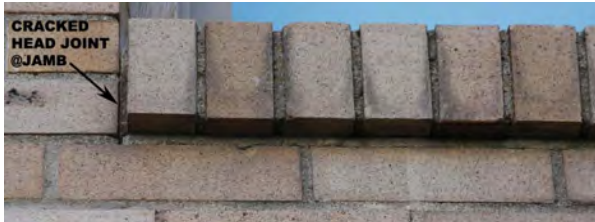
- (c) Open mortar joints were noted in brick wall near original building's northwest corner. The mortar joint, at the lintel bearing, is cracked.
- (d) Deteriorated

rowlock window sill and cracked joint at jamb were noted.

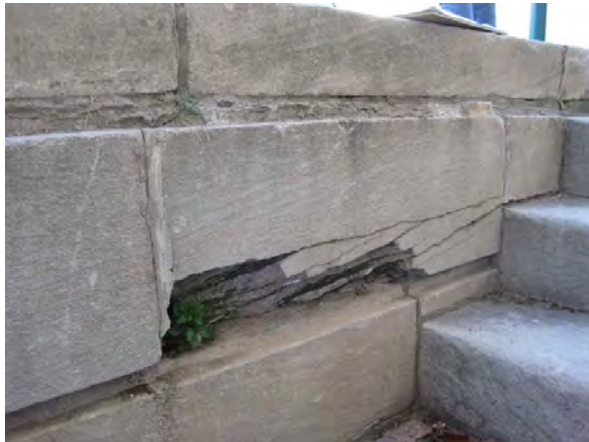
- (e) Cracked cast stone sill, at head of basement stair, is cracked
- (f) A stones in the stairwell

foundation wall is severely deteriorated.

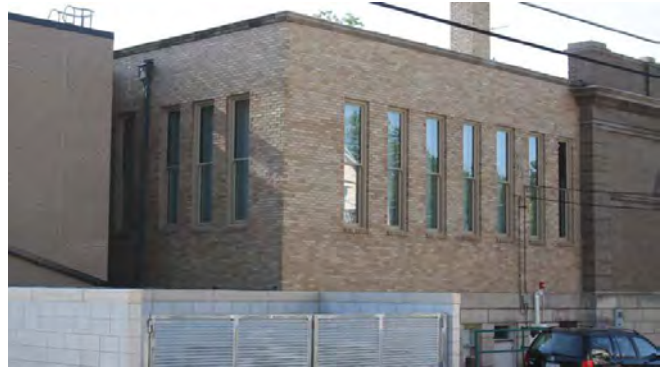
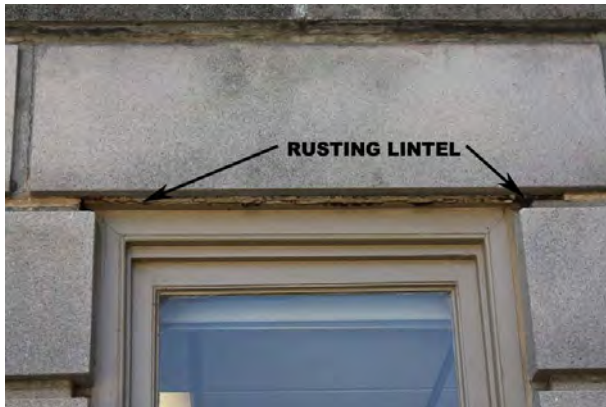
- d. North elevation
 - (1) 1937 Addition
 - (a) Western portion of elevation is partially visible from the northwest. Noted concerns were previously discussed.
 - (b) Eastern portion of north elevation is more visible from the northeast. Lintels were noted to be rusted along this elevation.

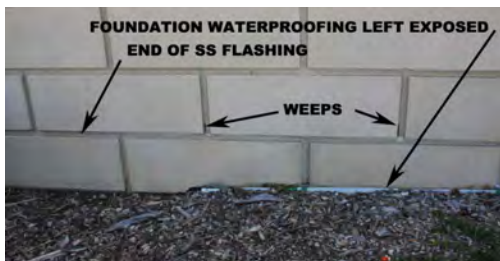
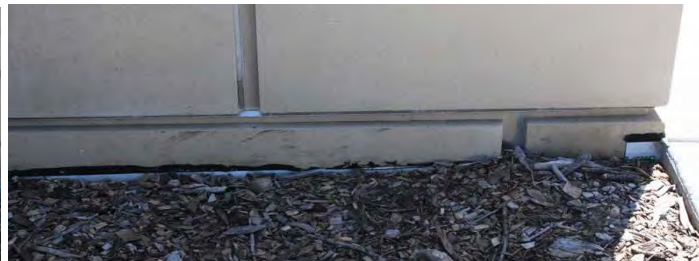
- (2) 2011 Addition: The foundation waterproofing has been improperly terminated above grade. This material will degrade with UV exposure.

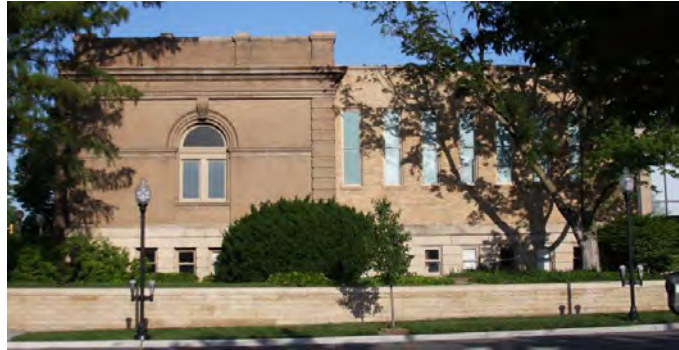
- e. East Elevation
 - (1) General: This elevation is right side of the remaining original building and the east elevation of the 1937 Addition.

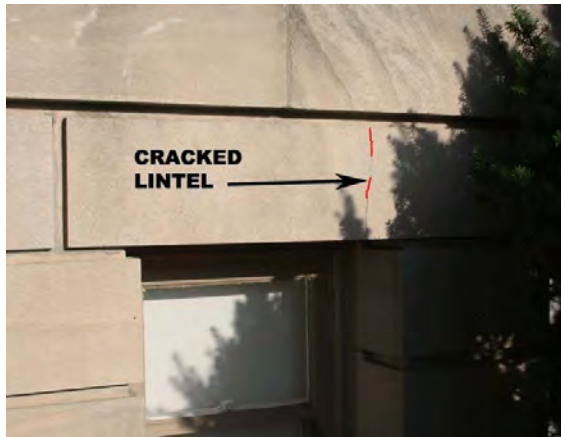
- (2) Original building
 - (a) Cracked lintel was noted in the stone foundation wall.

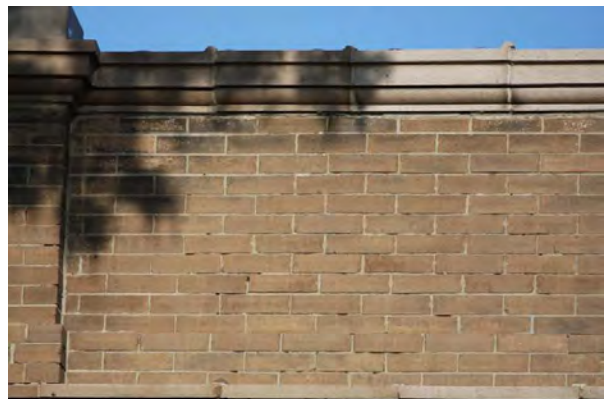
- (b) Repaired jamb conditions were reviewed and previous repairs are cracked.
 - (c) Parapet wall is like the others, except only open mortar joints were noted.

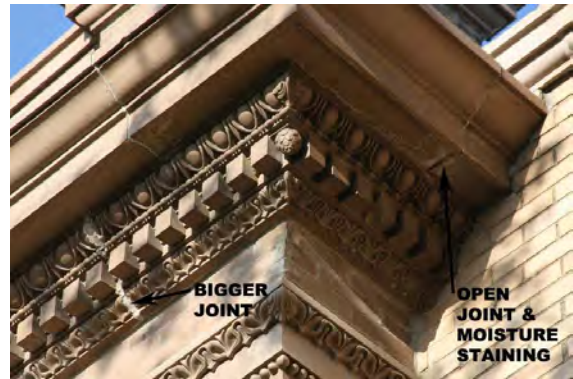
- (d) Signs of moisture coming through terra cotta joints were noted at the inside corner below the watertable. Joints above need to be reviewed and repaired.

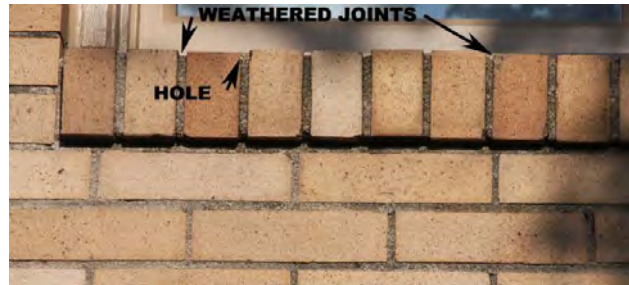
- (3) 1937 Addition: Deteriorated mortar joints at rowlock window sills and a cracked joint next to jamb were noted.

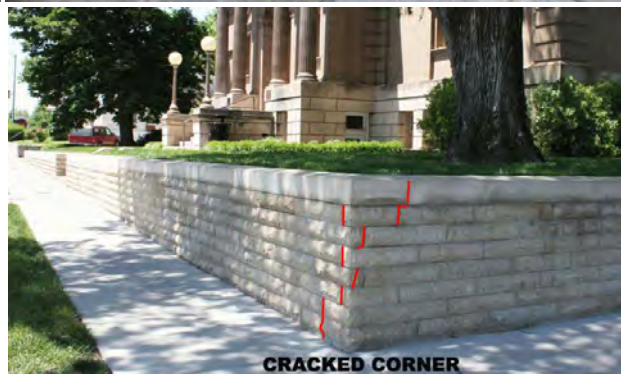
- b. Stone wall along walk at southeast corner.
(1) The wall extends a long ways to the corners beyond. No movement joints were noted, except for a resulting crack at the southeast corner.

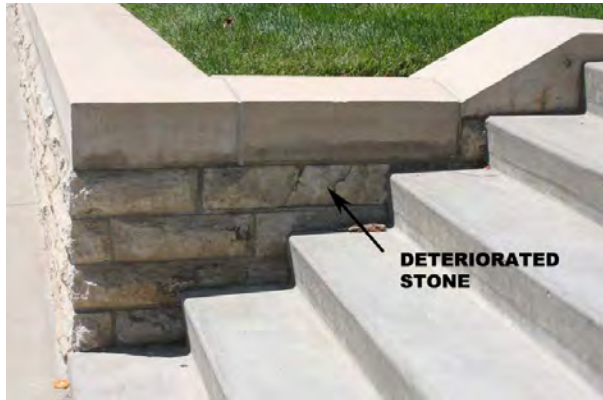
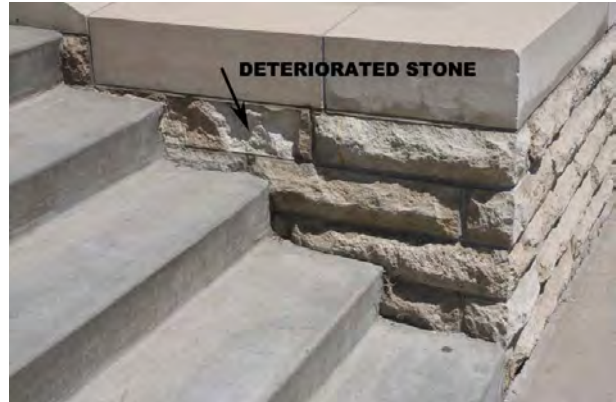
- (2) South entrance stair walls: Some stones are deteriorated.
