LAWRENCE  
DOUGLAS  
COUNTY

## MULTIMODAL STUDY FIELD OBSERVATION

Eudora & Baldwin City, Kansas Primary and Middle Schools

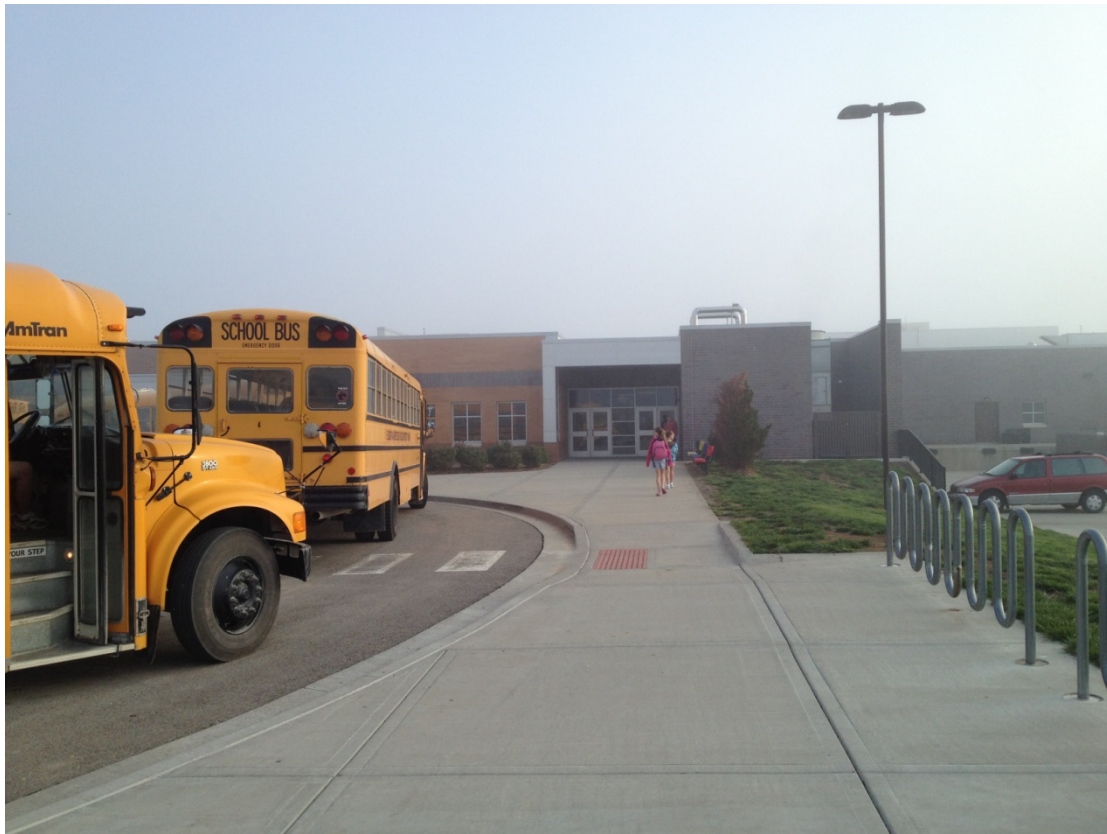
Figure 1. Eudora Elementary School's south entrance accommodates walkers, bicyclists, bus riders, and students dropped off by car and walked inside by parents.

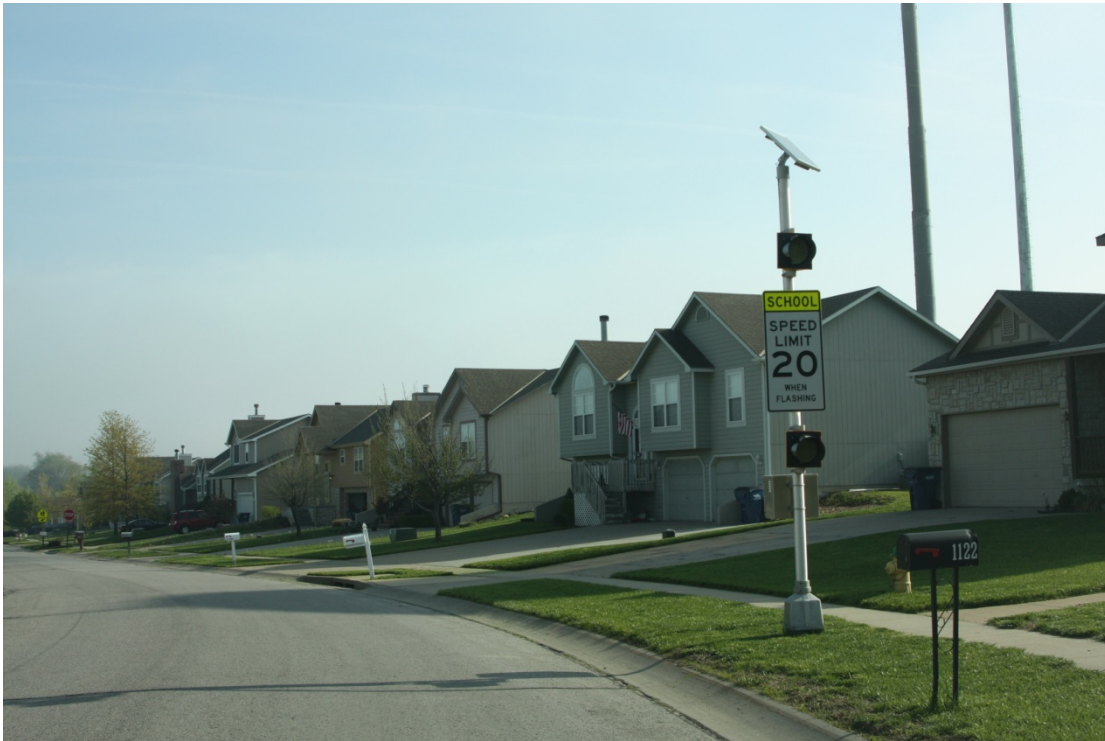
Figure 3. Peach Street, to the east of Eudora Elementary School includes a fully connected sidewalk along one side of the street, and is well-signed to inform drivers of the nearby school and pedestrian crossings.

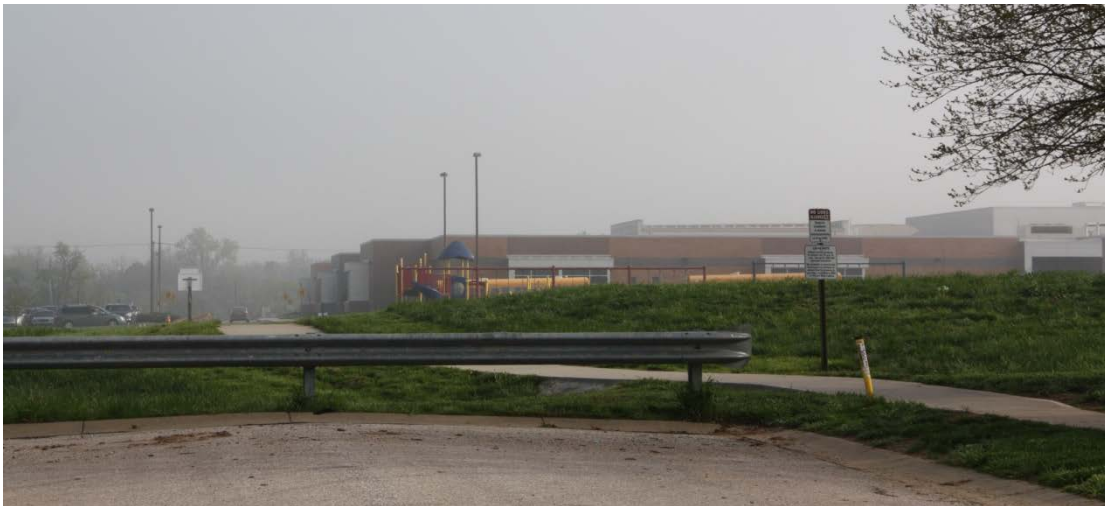
Figure 4. South pedestrian walk from the neighborhood to the school.

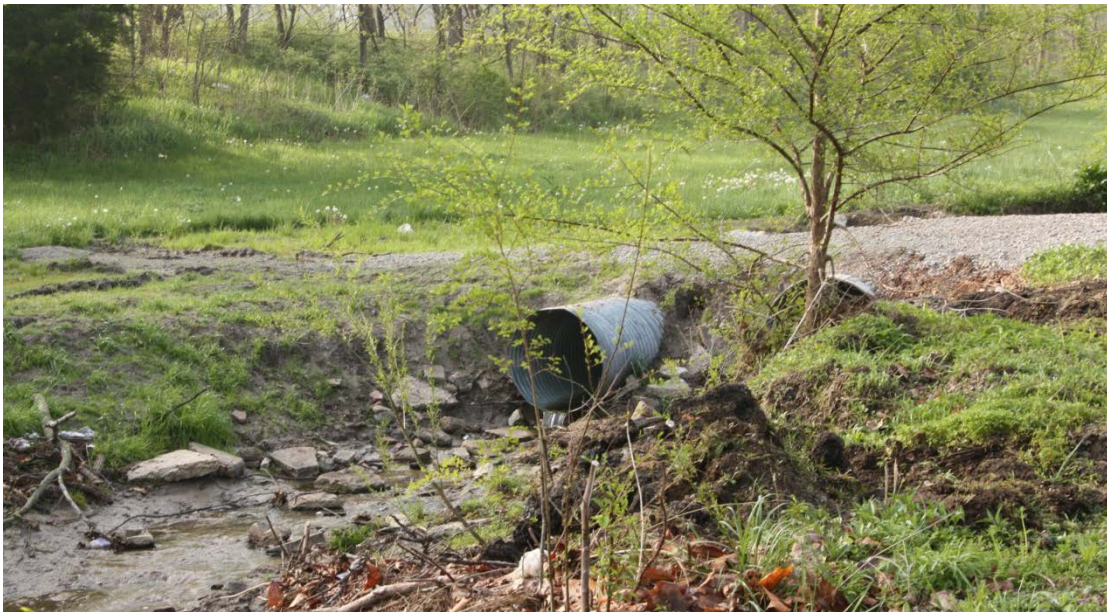
A culverted driveway across the stream approximately one block south provides better access across the stream, but does not appear to be used as frequently as the straight jump across the water near Lane C. The primary purpose of the driveway is unapparent, as it doesn't appear to connect to a home, though it is contained within the private ownership of the Grandview Trailer Park neighborhood.

Figure 6. Newer culverted drive across the creek on the west side of the school property.

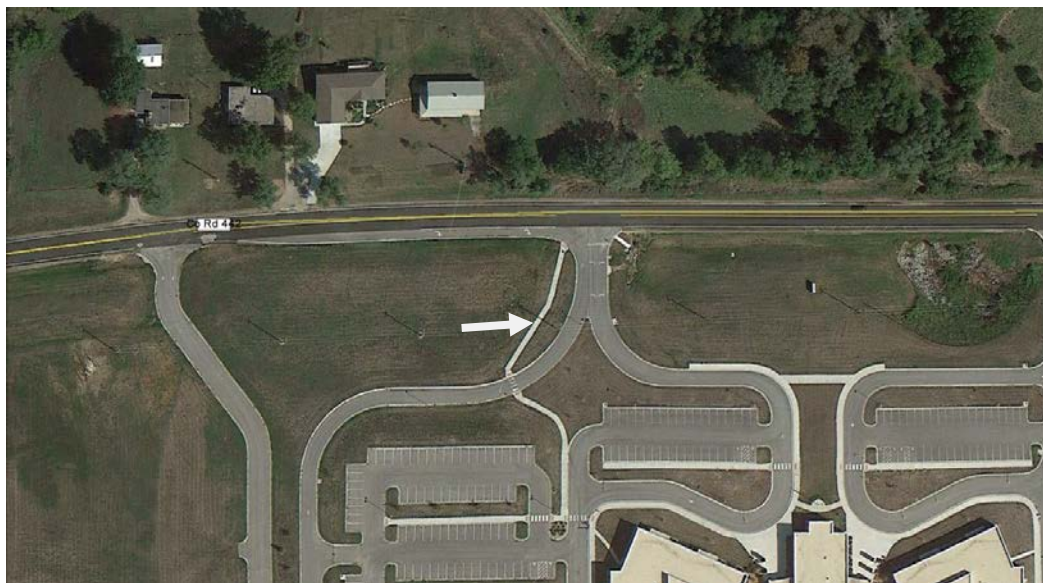
**North:** No children were observed travelling to or from the school by foot to the north. Northern travel is discouraged, however, due to the location of the walk/bike entrance on the south end of the building, and observation occurring near the south entrance, if any children did actually walk to or from the north, they would not have been seen.

Figure 12. North sidewalk to Eudora Elementary's front entrance.

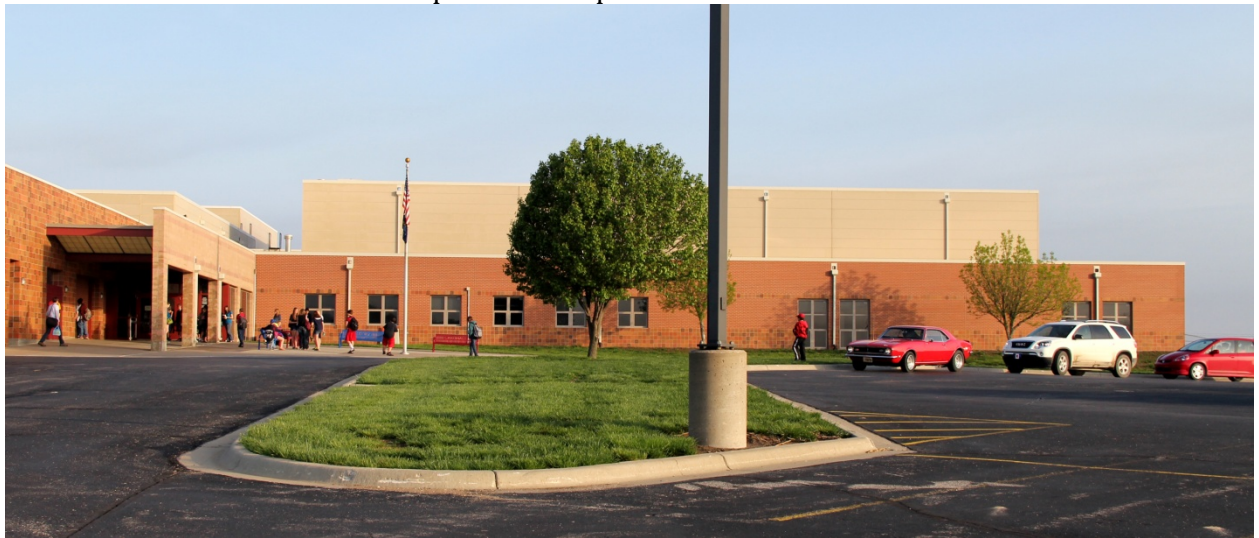
Figure 13. Eudora Middle School's south entrance accommodates walkers, bicyclists, bus riders, and students dropped off by car.

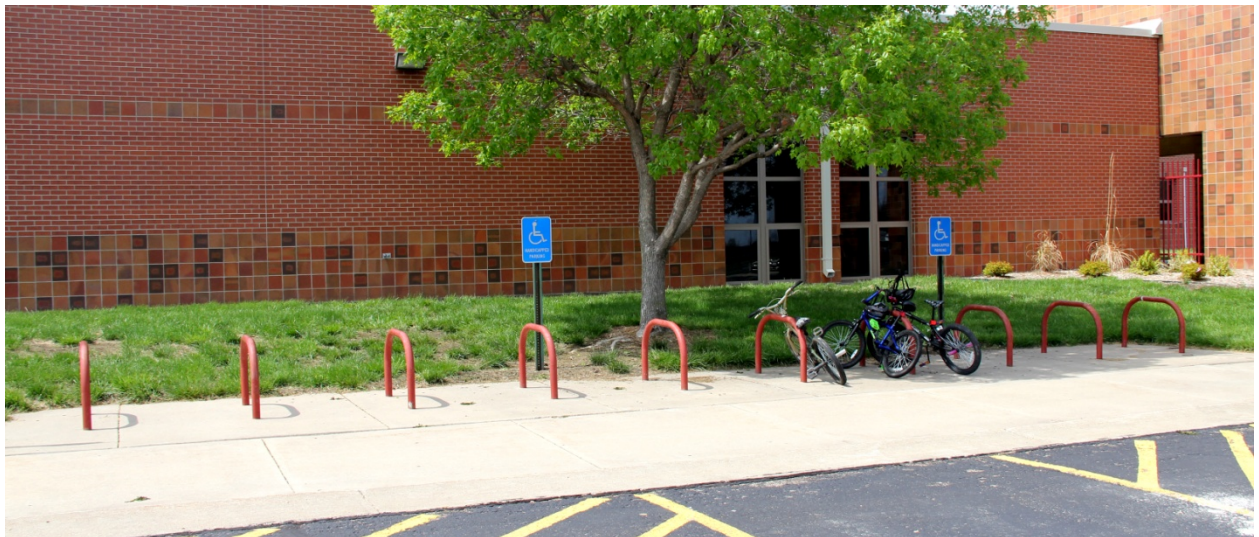
Figure 14. Half "H" style bike racks are provided on the east side of the school, next to the staff parking lot.

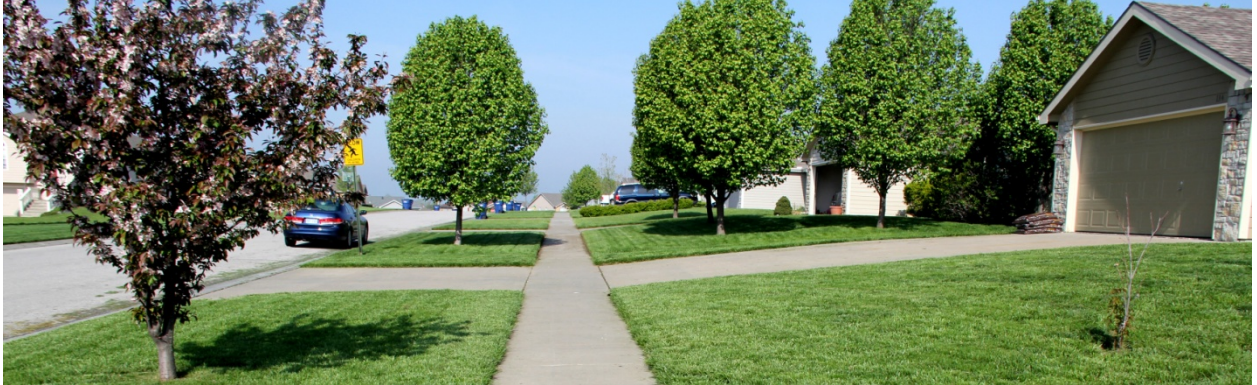
Figure 15. Typical sidewalk in Shadow Ridge subdivision.

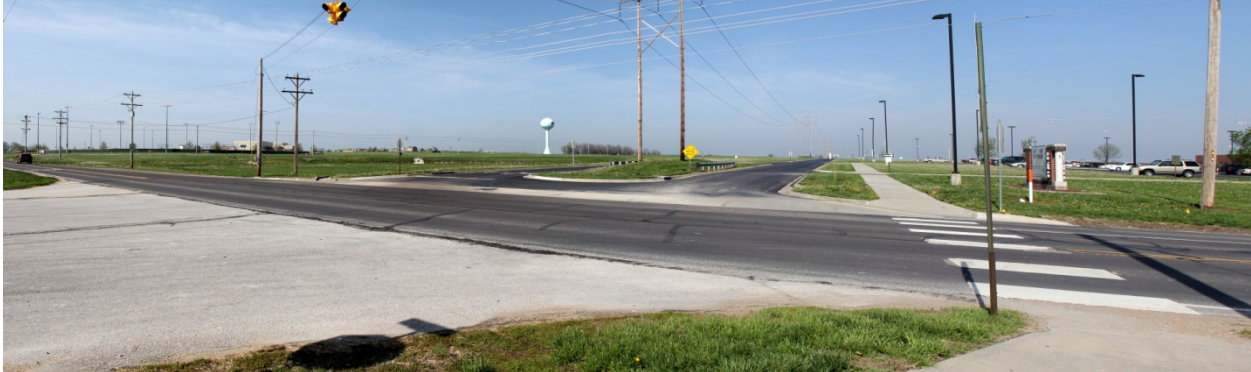
A concrete walk from Eudora Middle School to Eudora High School ties into a signed and painted crosswalk located at the intersection of E 2200 Road and 23<sup>rd</sup> Street. This crosswalk provides the only safe connection to the east. A school crossing guard is stationed here during morning arrival and afternoon pick-up.

Figure 19. Crosswalk at E 2200 Road and 23<sup>rd</sup> Street.

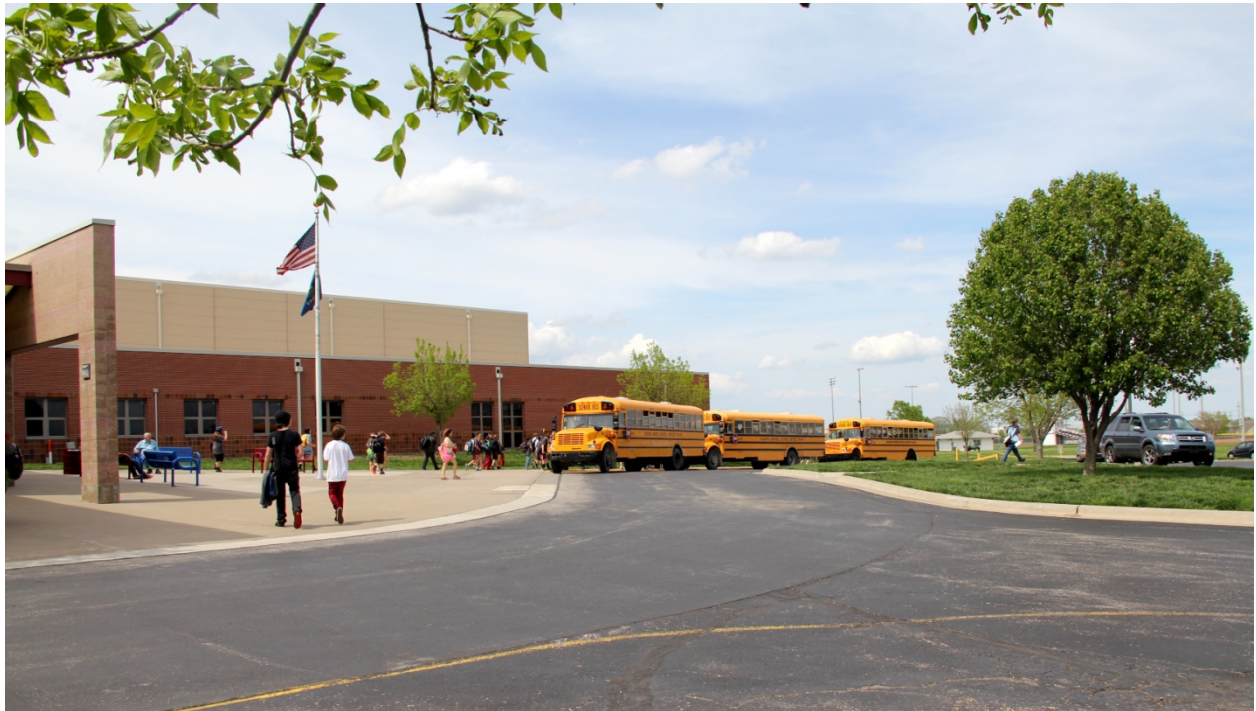
Figure 20. Buses pick-up and drop-off students on the south side of Eudora Middle School.

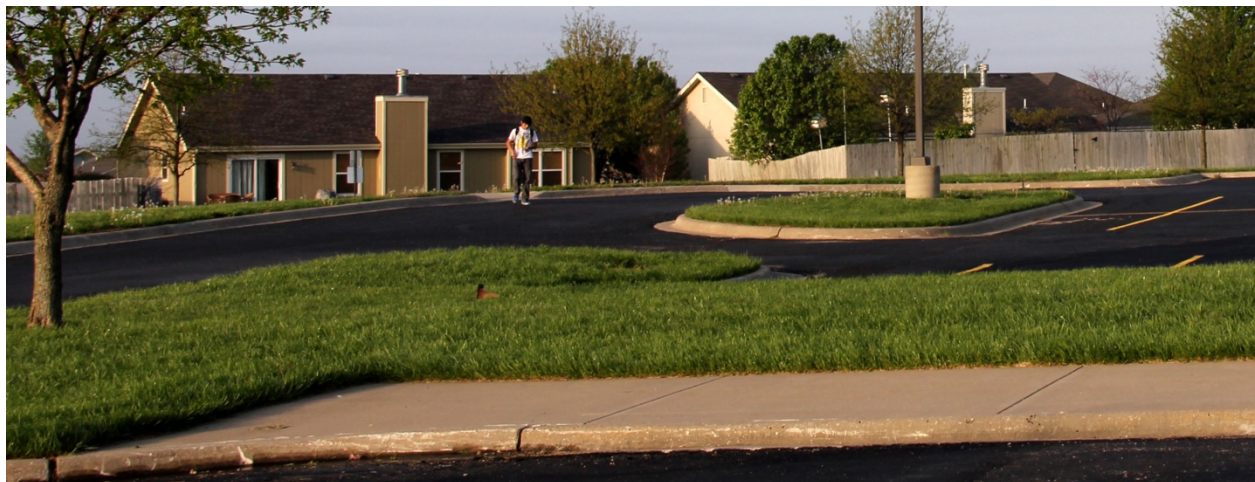
**South:** Students walking to and from the neighborhood to the south were observed using the provided concrete walk connecting Shadow Ridge Drive to the staff parking lot. Because this is not a continuous sidewalk to the building entrance, students must walk through the staff parking lot. Fortunately, most of the staff is parked before walkers arrive.

Figure 22. A Middle School student taking the Saddle Ridge Drive cut-through.

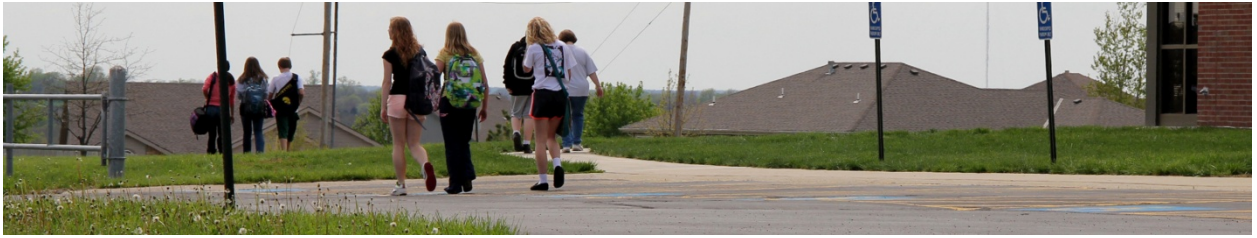
**West:** A concrete sidewalk from Elm Street ends at the school property boundary, forcing students to travel through a grassy field. Since no clear walk to and from the neighborhood is delineated, students were observed crossing to the west and southwest through grassy open space and private backyards.

Figure 23. Middle school students walking home to the west.

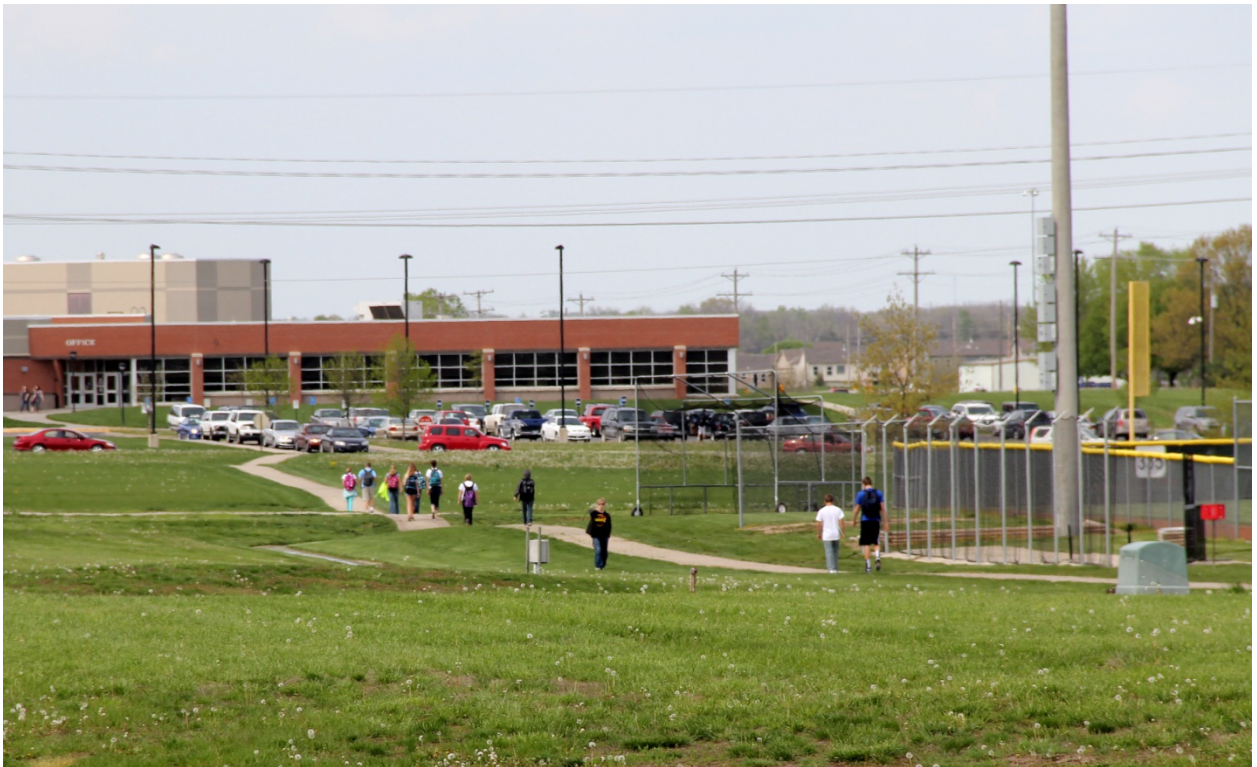
**North:** Students walking to and from the north were observed using the provided concrete sidewalk connecting Eudora High School and Eudora Middle School.

Figure 24. Students walking on the sidewalk between the Middle School and High School.

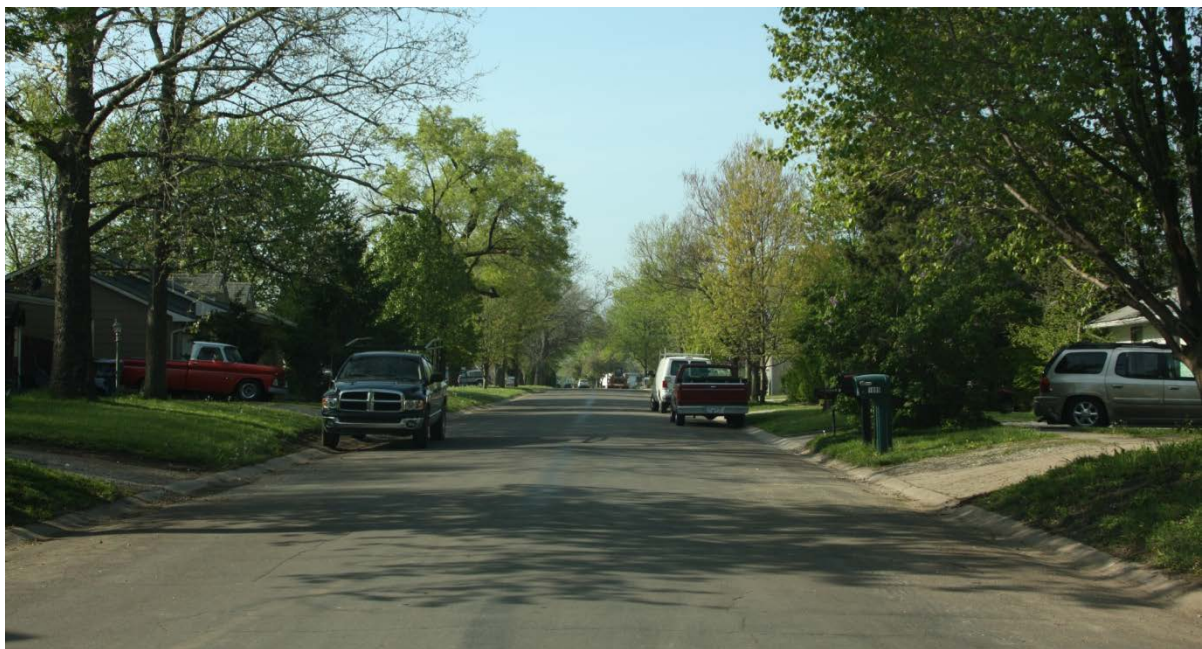
Figure 25. Established road rights-of-way offer potential for better connectivity by simply adding interconnected sidewalks.

include interconnected, ADA appropriate, pedestrian sidewalks and trails is the simplest, best solution to making Eudora more walkable and bicycle friendly.

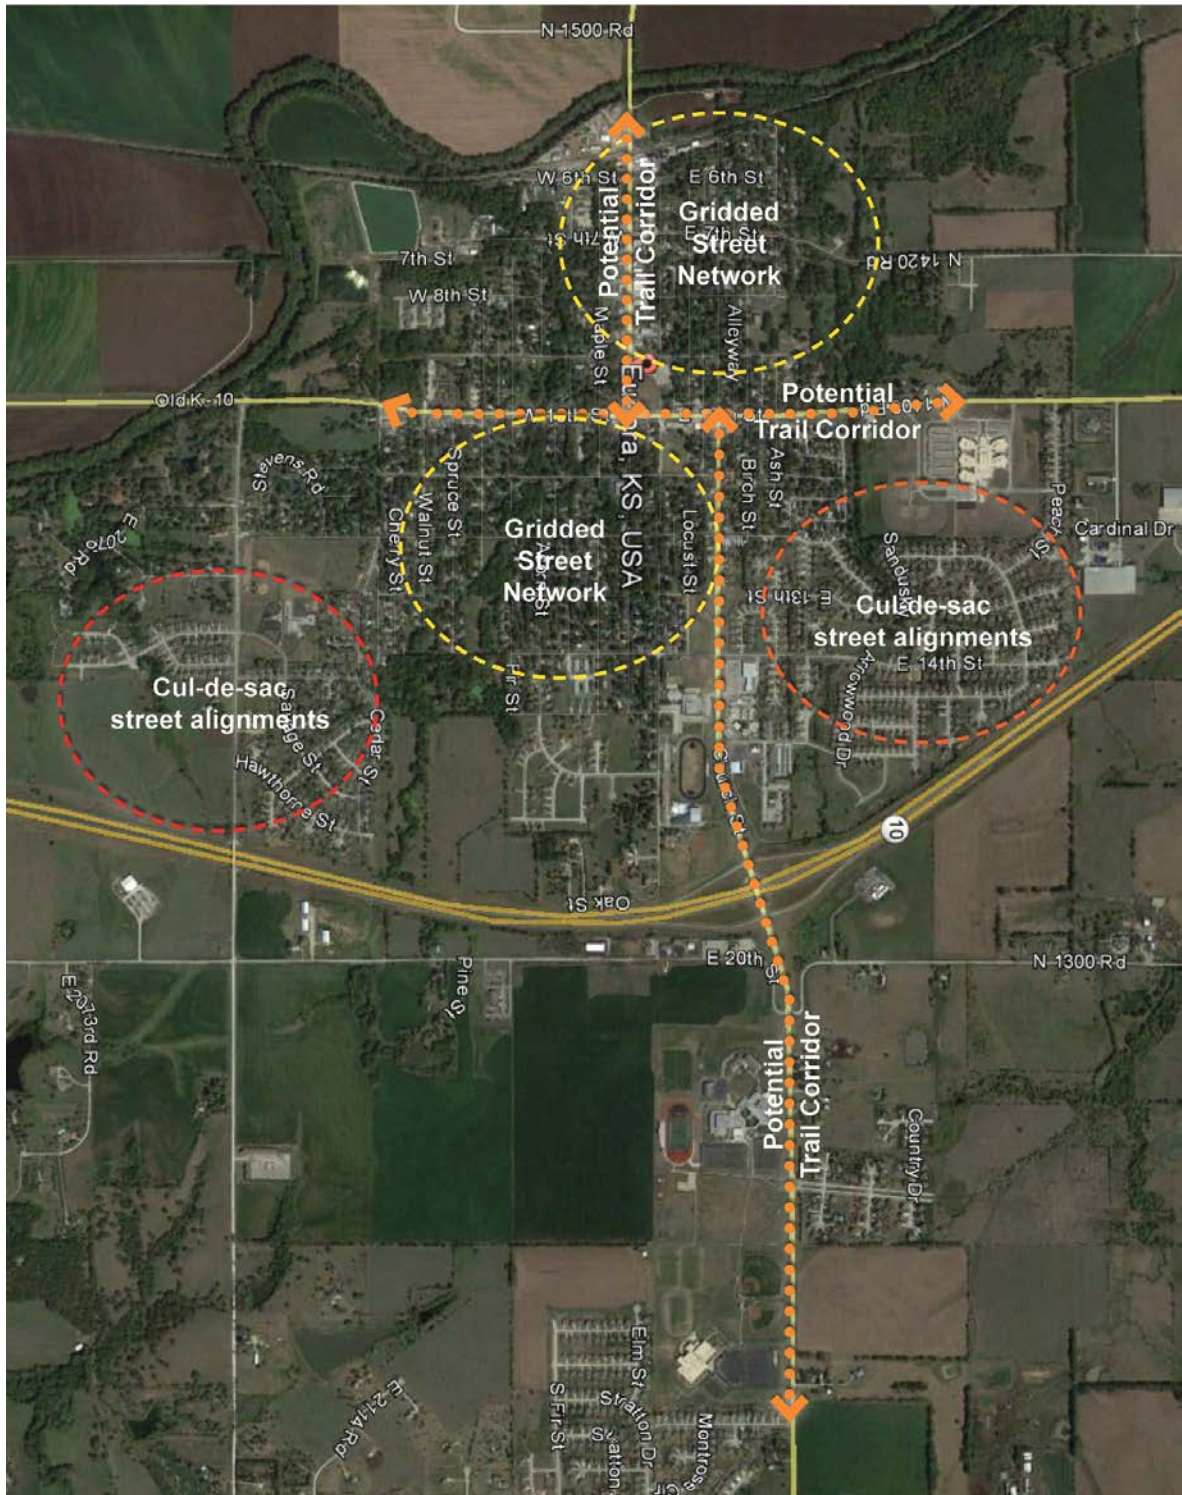
Figure 26. Gridded street areas vs. cul-de-sac street areas of Eudora and the proposed trail corridors to tie the north, south east and west ends of the community together, opening up access to downtown.

It is recommended that a trail within the East 10th Street/North 1400 Road right-of-way be added to tie the elementary school safely to the neighborhoods to the west and north, and to facilitate walking/bicycling from neighborhoods into the commercial districts.

Also, a north-south trail spine should be considered along Church Street from East 10th Street to the Middle School south of K-10. There is an existing sidewalk that runs along the east side of Church Street from East 10th Street to the commercial district near K-10 Highway with some minor discontinuity at both ends. This would serve well as a trail with some widening. South of K-10 Highway, the trail would serve the schools well to run along the west side of Church Street.

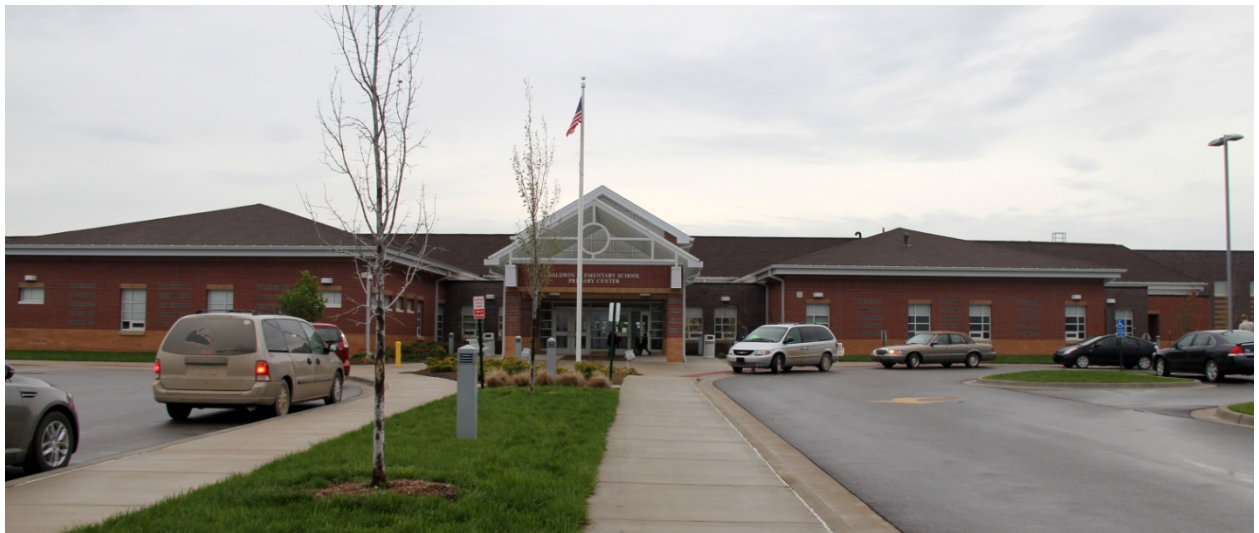
Figure 27. Baldwin Primary Center's west entrance accommodates walkers, bicyclists and students dropped off by car.

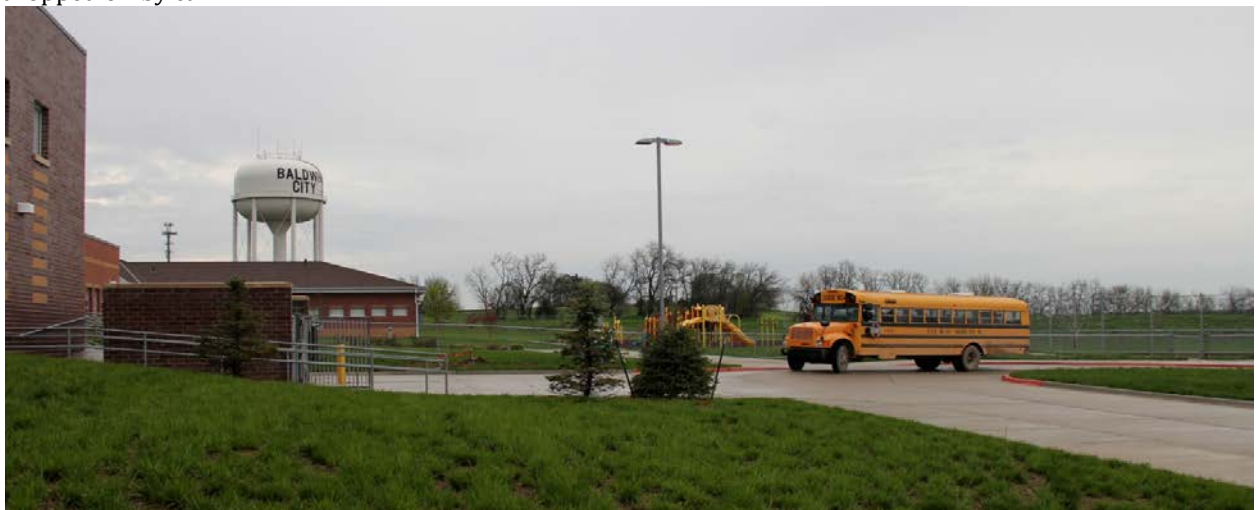
Figure 28. Baldwin Primary Center's east entrance accommodates bus riders.

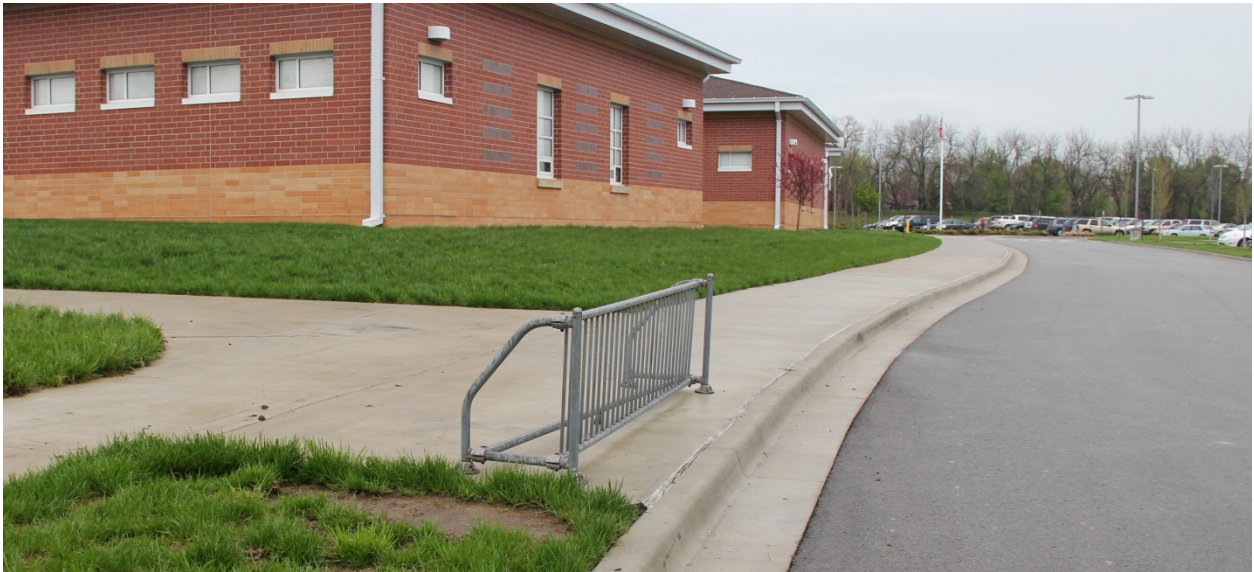
Figure 29. A comb style bike rack is provided north of Baldwin Primary Center, adjacent to the car entrance and exit.

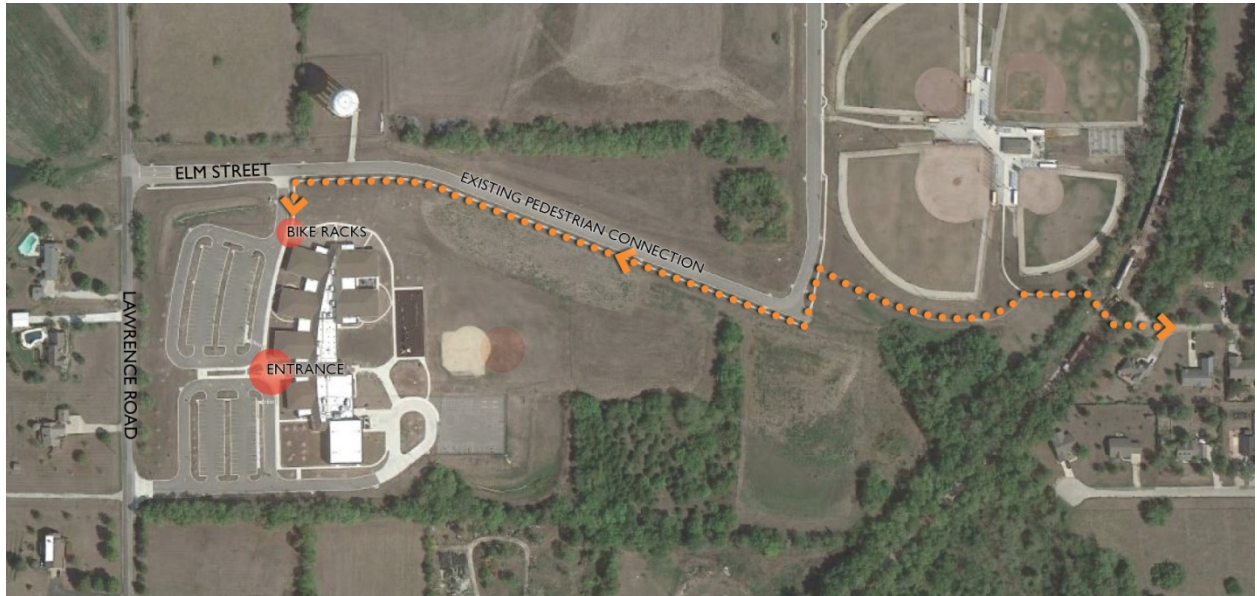
The location of the Primary Center poses a problem for students walking or bicycling. The only pedestrian connection to surrounding neighborhoods is a sidewalk along Elm Street which connects to a concrete sidewalk northeast of the Primary Center. This trail routes walkers and bicyclists across abandoned railroad tracks to Elm Street and neighborhoods to the east.

Figure 31. Existing pedestrian connection to Baldwin Primary Center

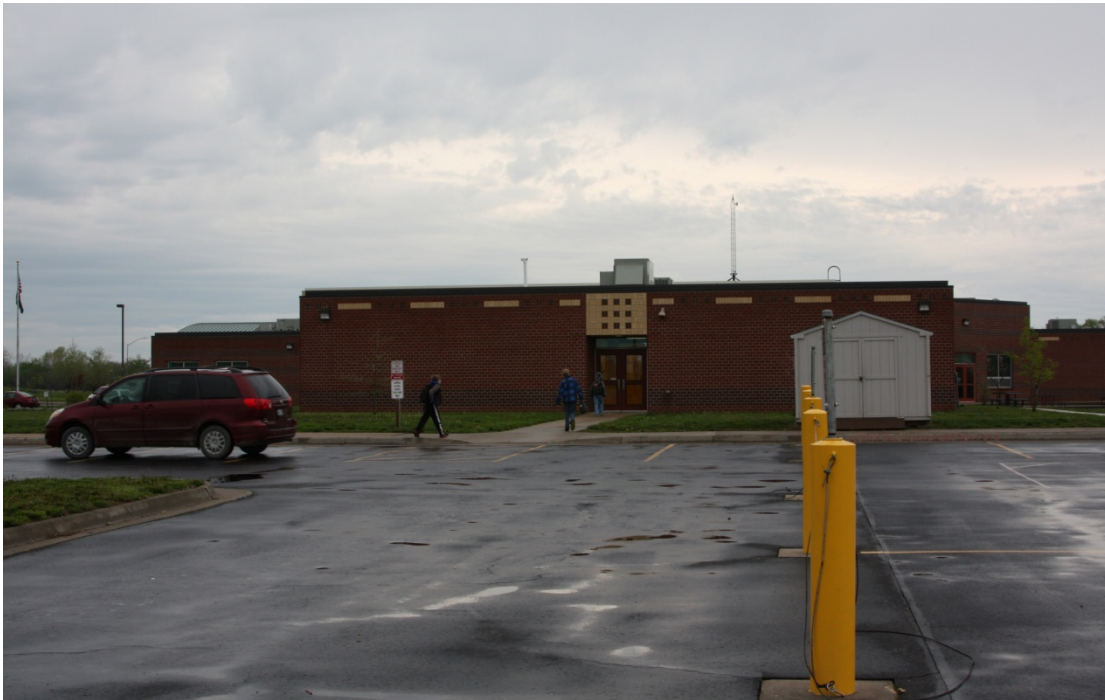
Figure 35. Baldwin City Intermediate School's south entrance accommodates walkers, bicyclists and students dropped off by car.

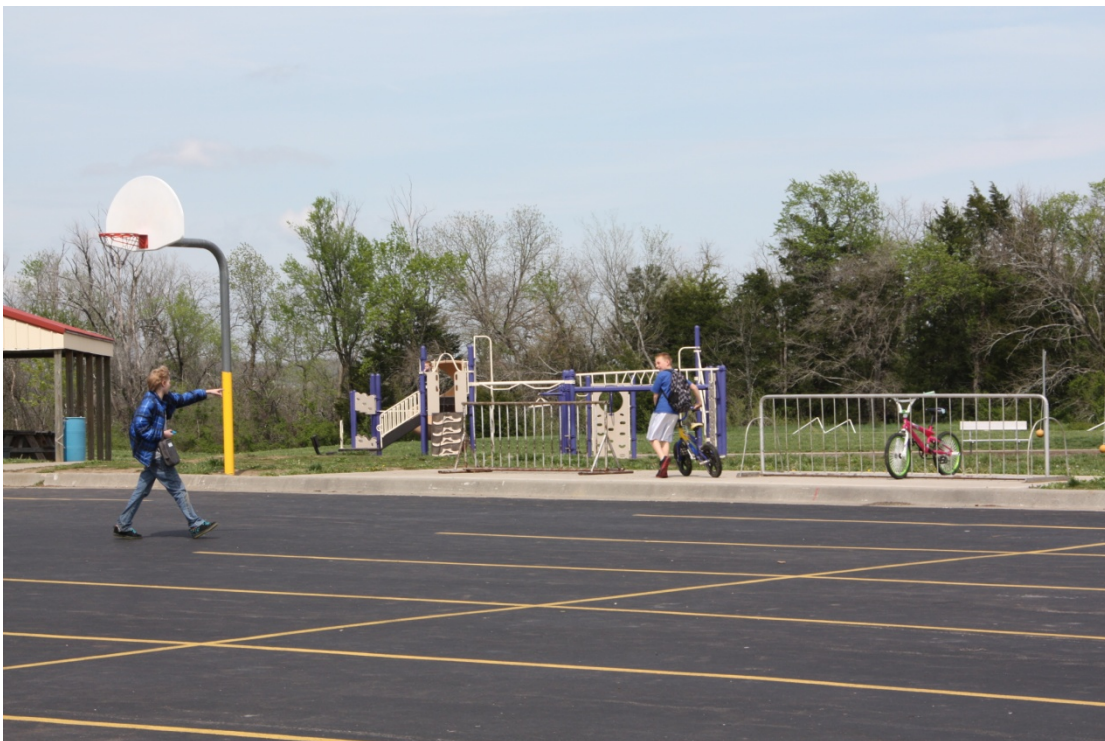
Figure 36. Bike racks are placed conveniently for students arriving from the south sidewalk.

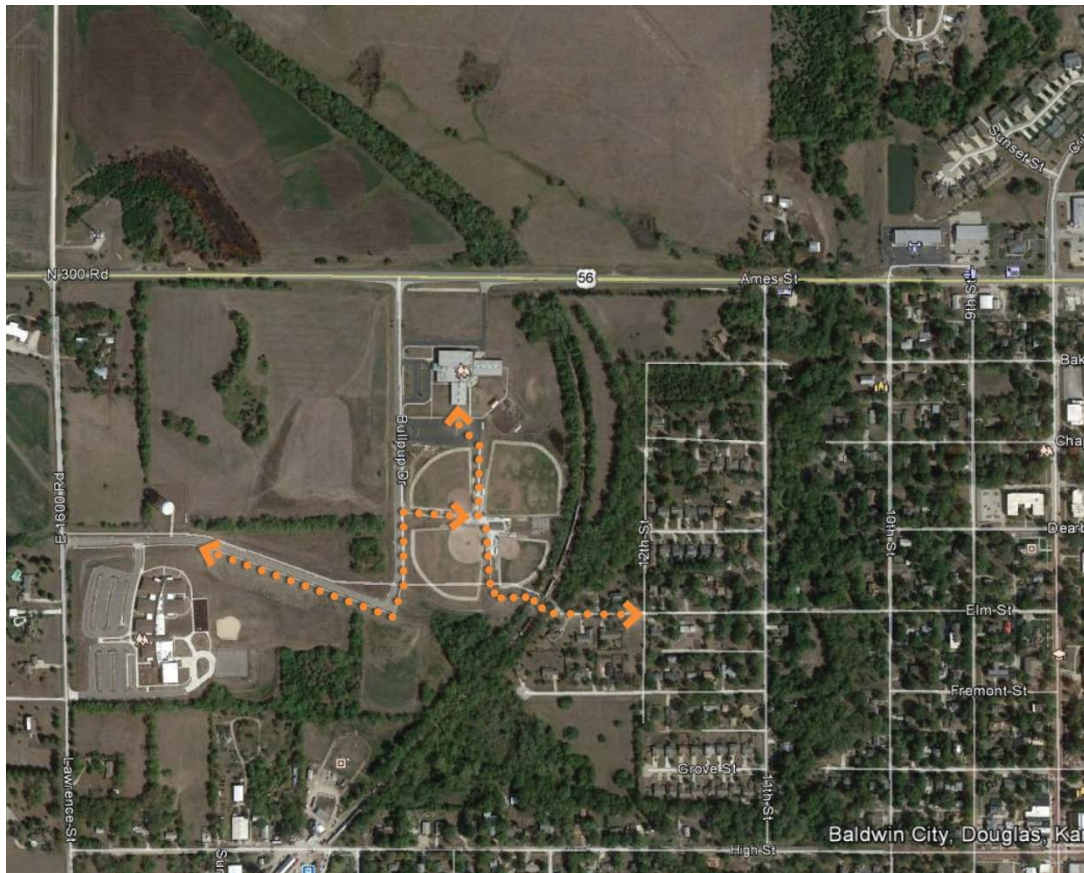
Figure 38. Development is focused to the southeast of the school, yet lack of railroad crossings, streets and sidewalks means the school has limited connection points. The orange arrows indicate walking/biking patterns around the intermediate school.

Bicycle and pedestrian traffic is confined to two possible directions, east over the railroad tracks at Elm or west along Elm toward the Elementary School. The majority of housing lies to the east, making the railroad crossing the most travelled route. (Figure 38)

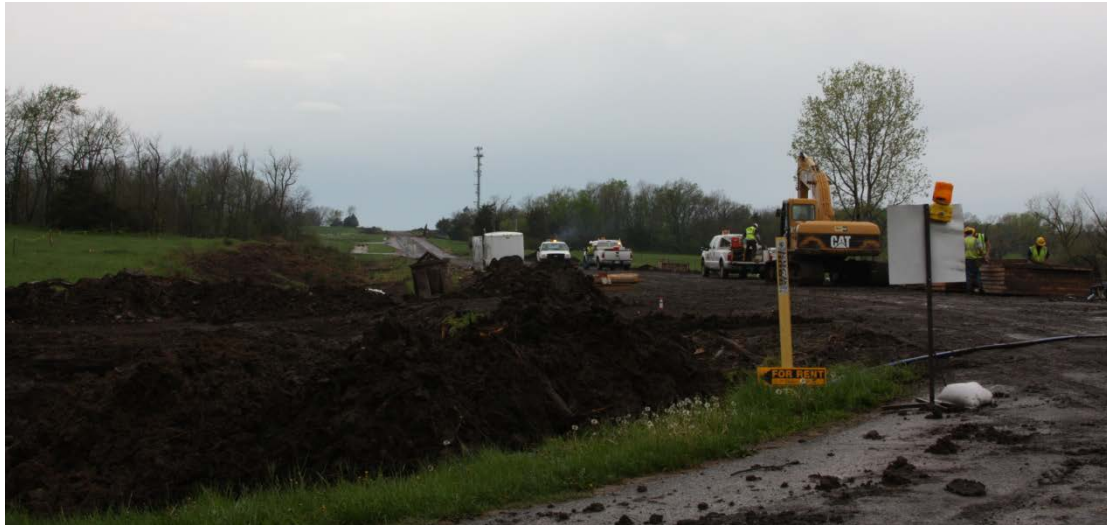
Figure 41. KDOT in the process of widening the middle box culvert on US Highway 56 at 11th Street. According to the inspector on-site, the cross section here (near 11th Street) will also include a 5 foot sidewalk on each side of the highway.

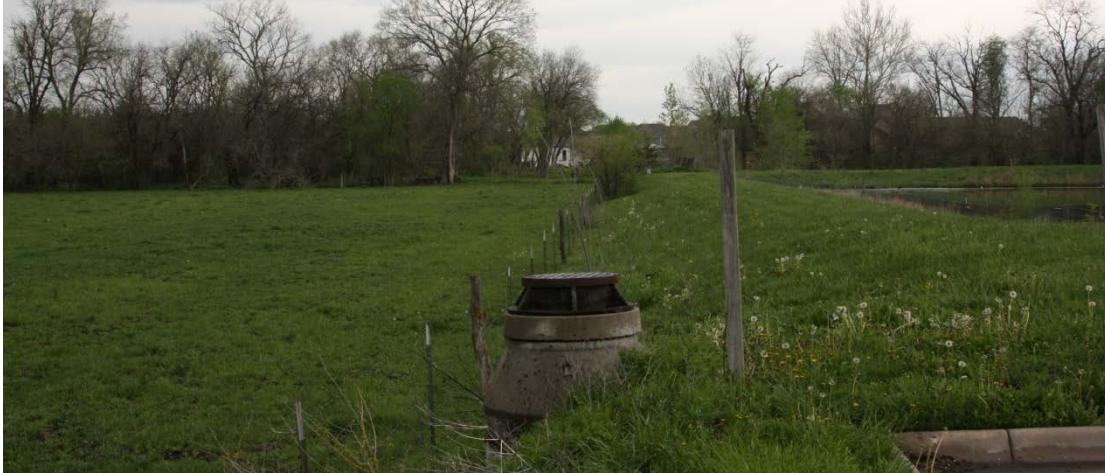
Figure 42. Potential walk/trail connection from Firetree Estates

An open area from the newer subdivisions to the northeast offers a safe alternative and shorter route to the Primary and Intermediate Schools. A walk or trail could connect the walk at Blaze Boulevard/Flame Way in Firetree Estates to the sidewalks near the retail area along Highway 56. A spur could connect over to Silver Leaf Lane as well (Figures 42, 43). Because of the presence of manholes in this corridor, this appears to be a sewer easement, yet exact alignment of the pipe is unclear.

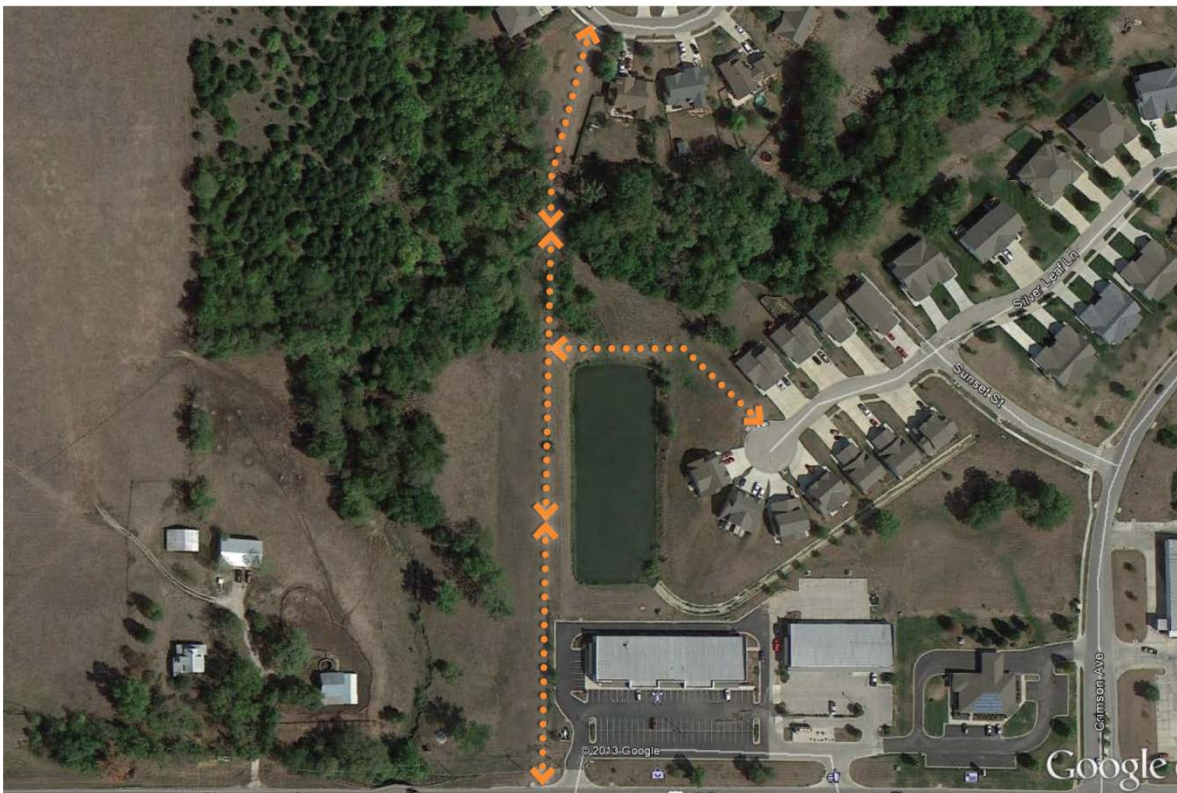
Figure 43. Potential Firetree connection.
