GEOBLOCK® POROUS PAVEMENT SYSTEM

GEOBLOCK®

fire access system

CASE STUDY SUMMARY 1

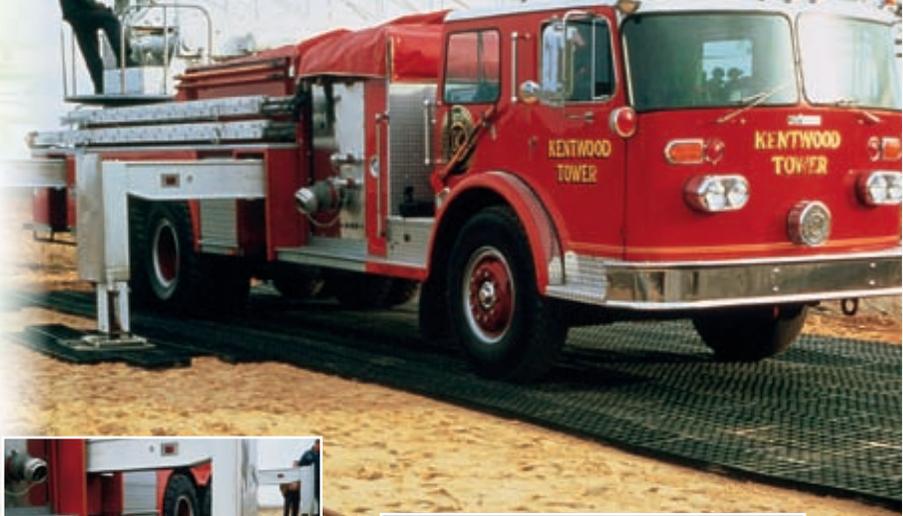
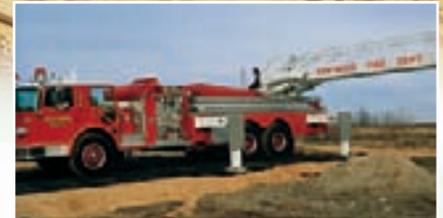
The fire marshal directed a 22,400 kg (60,000 lb) ladder/pumper to drive onto the unfilled 3.9 m x 14.6 m (13 ft x 48 ft) Geoblock test pad, drop its outriggers and begin tests while geotechnical engineers monitored the system performance.

After a series of rigorous tests, the ladder/pumper stayed on the Geoblock pavement for a full hour.

Under loading, inspection revealed only a 13 mm (1/2 in) deflection in the pavement system. After removal of the load, the Geoblock pavement rebounded to its original condition in less than one hour and the units were recovered for future use. As a result of this test and the system's performance, the City of Kentwood approved the Geoblock system for use on its fire access lanes.

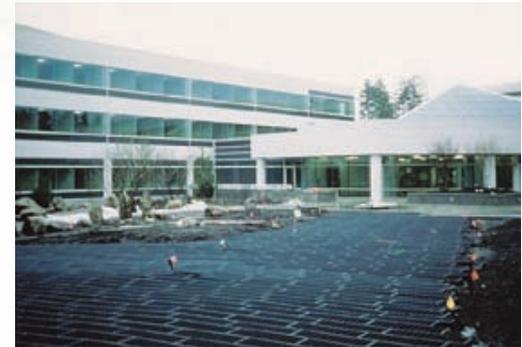
At their Washington State Campus, 800 m² (8,600 ft²) of the Geoblock system was installed for permeable, grass fire access lanes around nine campus buildings.

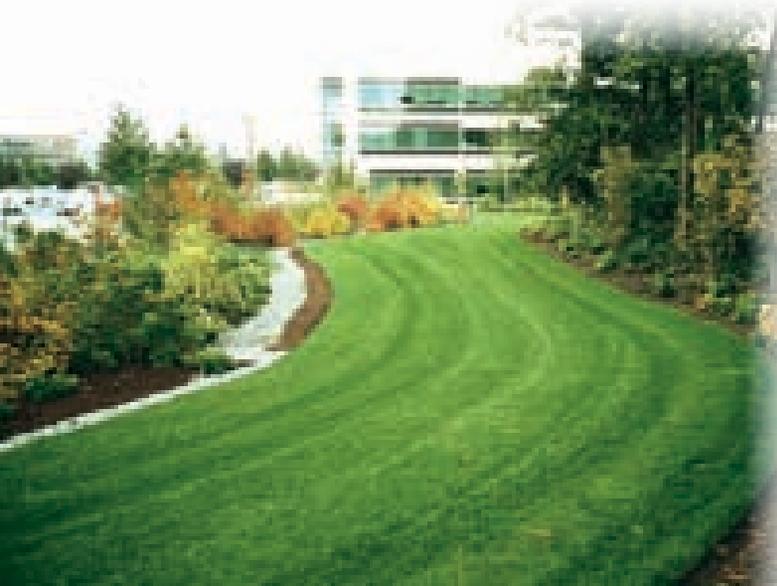
Implementation of the Geoblock system helps preserve the campus' natural look while providing the load support necessary to accommodate all emergency vehicles.

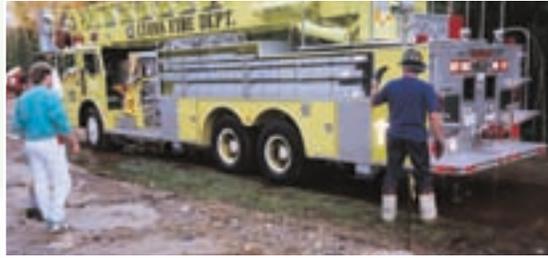
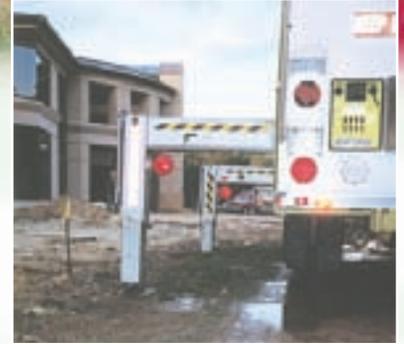
A test pad was installed in front of the facility adjacent to a concrete block entrance-drive. Side restraints, sometimes used to anchor the pavement system, were purposely omitted. A few weeks later with only light grass established, the Lyons Township Fire Department was ready to begin the testing.

Under full pressure, firemen turned the hose directly on the Geoblock platform and proceeded to saturate the test pad. With water still standing on the pad, a 29,900 kg (80,000 lb) fire engine was backed over the saturated area, and with the outriggers lowered, was lifted off its tires. A series of tests was performed under full load and less-than-ideal conditions to determine the capabilities of the Geoblock system.

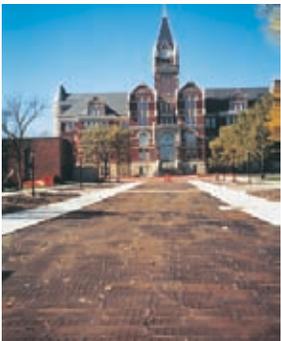
Removing the frontage road and circle drive left the mall with diminished emergency vehicle access. The university sought an alternative to hard surface paving that would blend naturally with the green look of the campus while providing the necessary load support for maintenance and emergency vehicles.

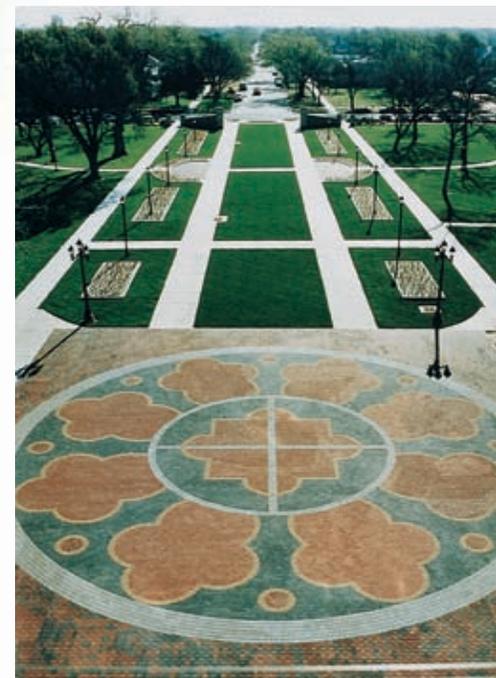
The Geoblock® load support solution was chosen to best complement the new pedestrian mall and paving stone design work. About 840 m² (9,000 ft²) of the Geoblock system was installed with an engineered base of sand and topsoil. Topsoil and a hearty bluegrass and fescue blend sod were placed in the cells of the Geoblock units.

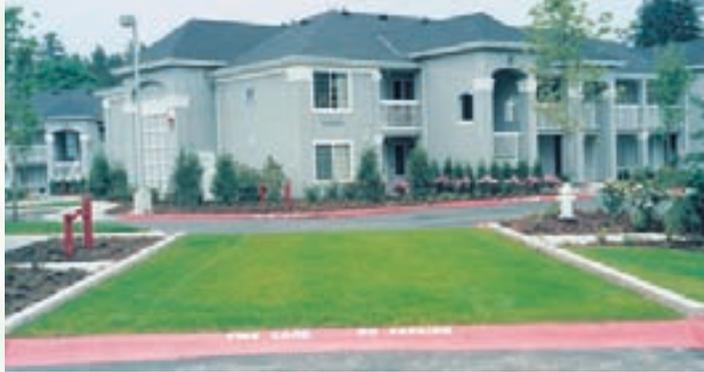
Faced with the common problem of providing emergency vehicle access while maintaining desirable green space, architects and contractors building the Homestead Village Complex rejected traditional paving materials in favor of a permeable system.

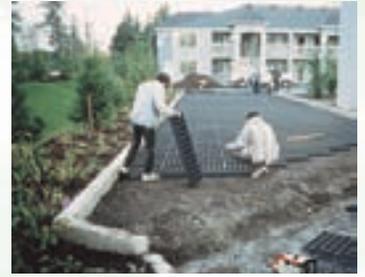
The Geoblock® system was utilized in three areas at the apartment complex—two fire access lanes and one access road to the complex's water detention pond. In all, three areas totaling 280 m² (3,000 ft²) were installed in less than three days starting from site preparation through seeding.

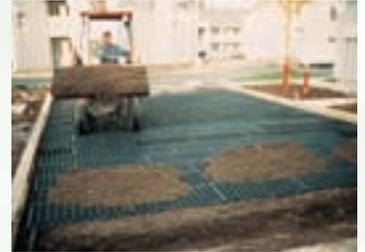
After the system was fully vegetated, tests were performed by the local fire department and the Geoblock system was approved for use.

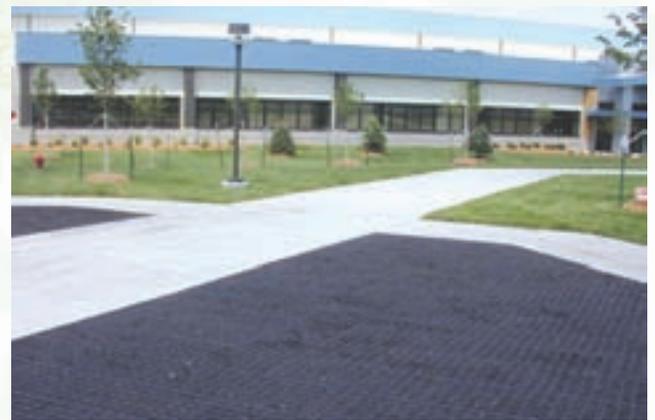
The Geoblock system was chosen for its aesthetic appeal, ease of installation, and load support capabilities. The Geoblock units were placed on a prepared base such that their tops were flush with the adjacent concrete roadways. Units were set in place, cut as needed to conform to site irregularities, infilled with topsoil, and seeded.

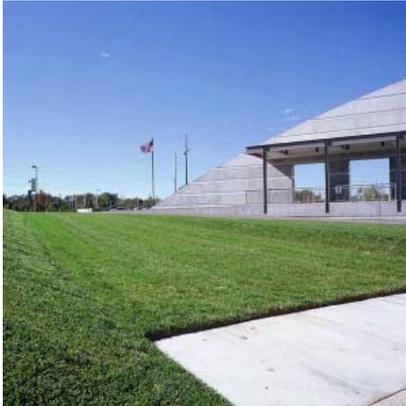
View from far side of curved wall, the fire lane is nicely marked with a slope on the left.

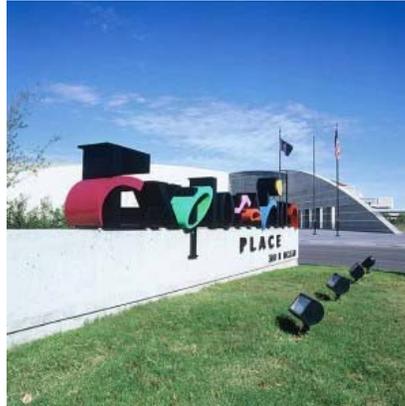
Multicolored signage marks the entrance. Our fire lane is located around the backside of the vertical curved wall to the right.

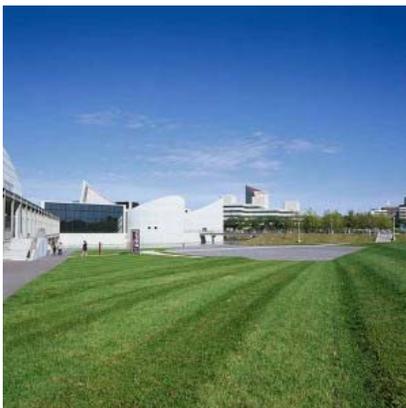
Fire lane can also be used as an event access drive. Notice the hard-surfaced plaza in the background, the edge of which is also shown in the above photo.

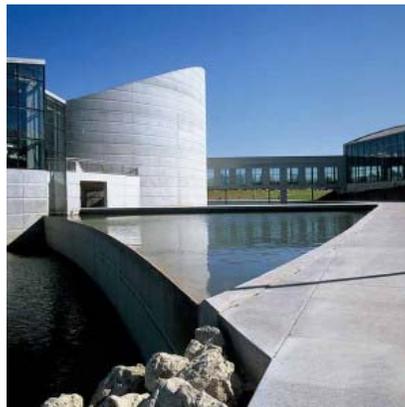
Architecture view showing river level on left, moat, pedestrian river trail, and overhead walkway
