## **Analysis of Environs of 1000 New York Street, German Methodist Episcopal Church**

# Environs of 1000 New York Street

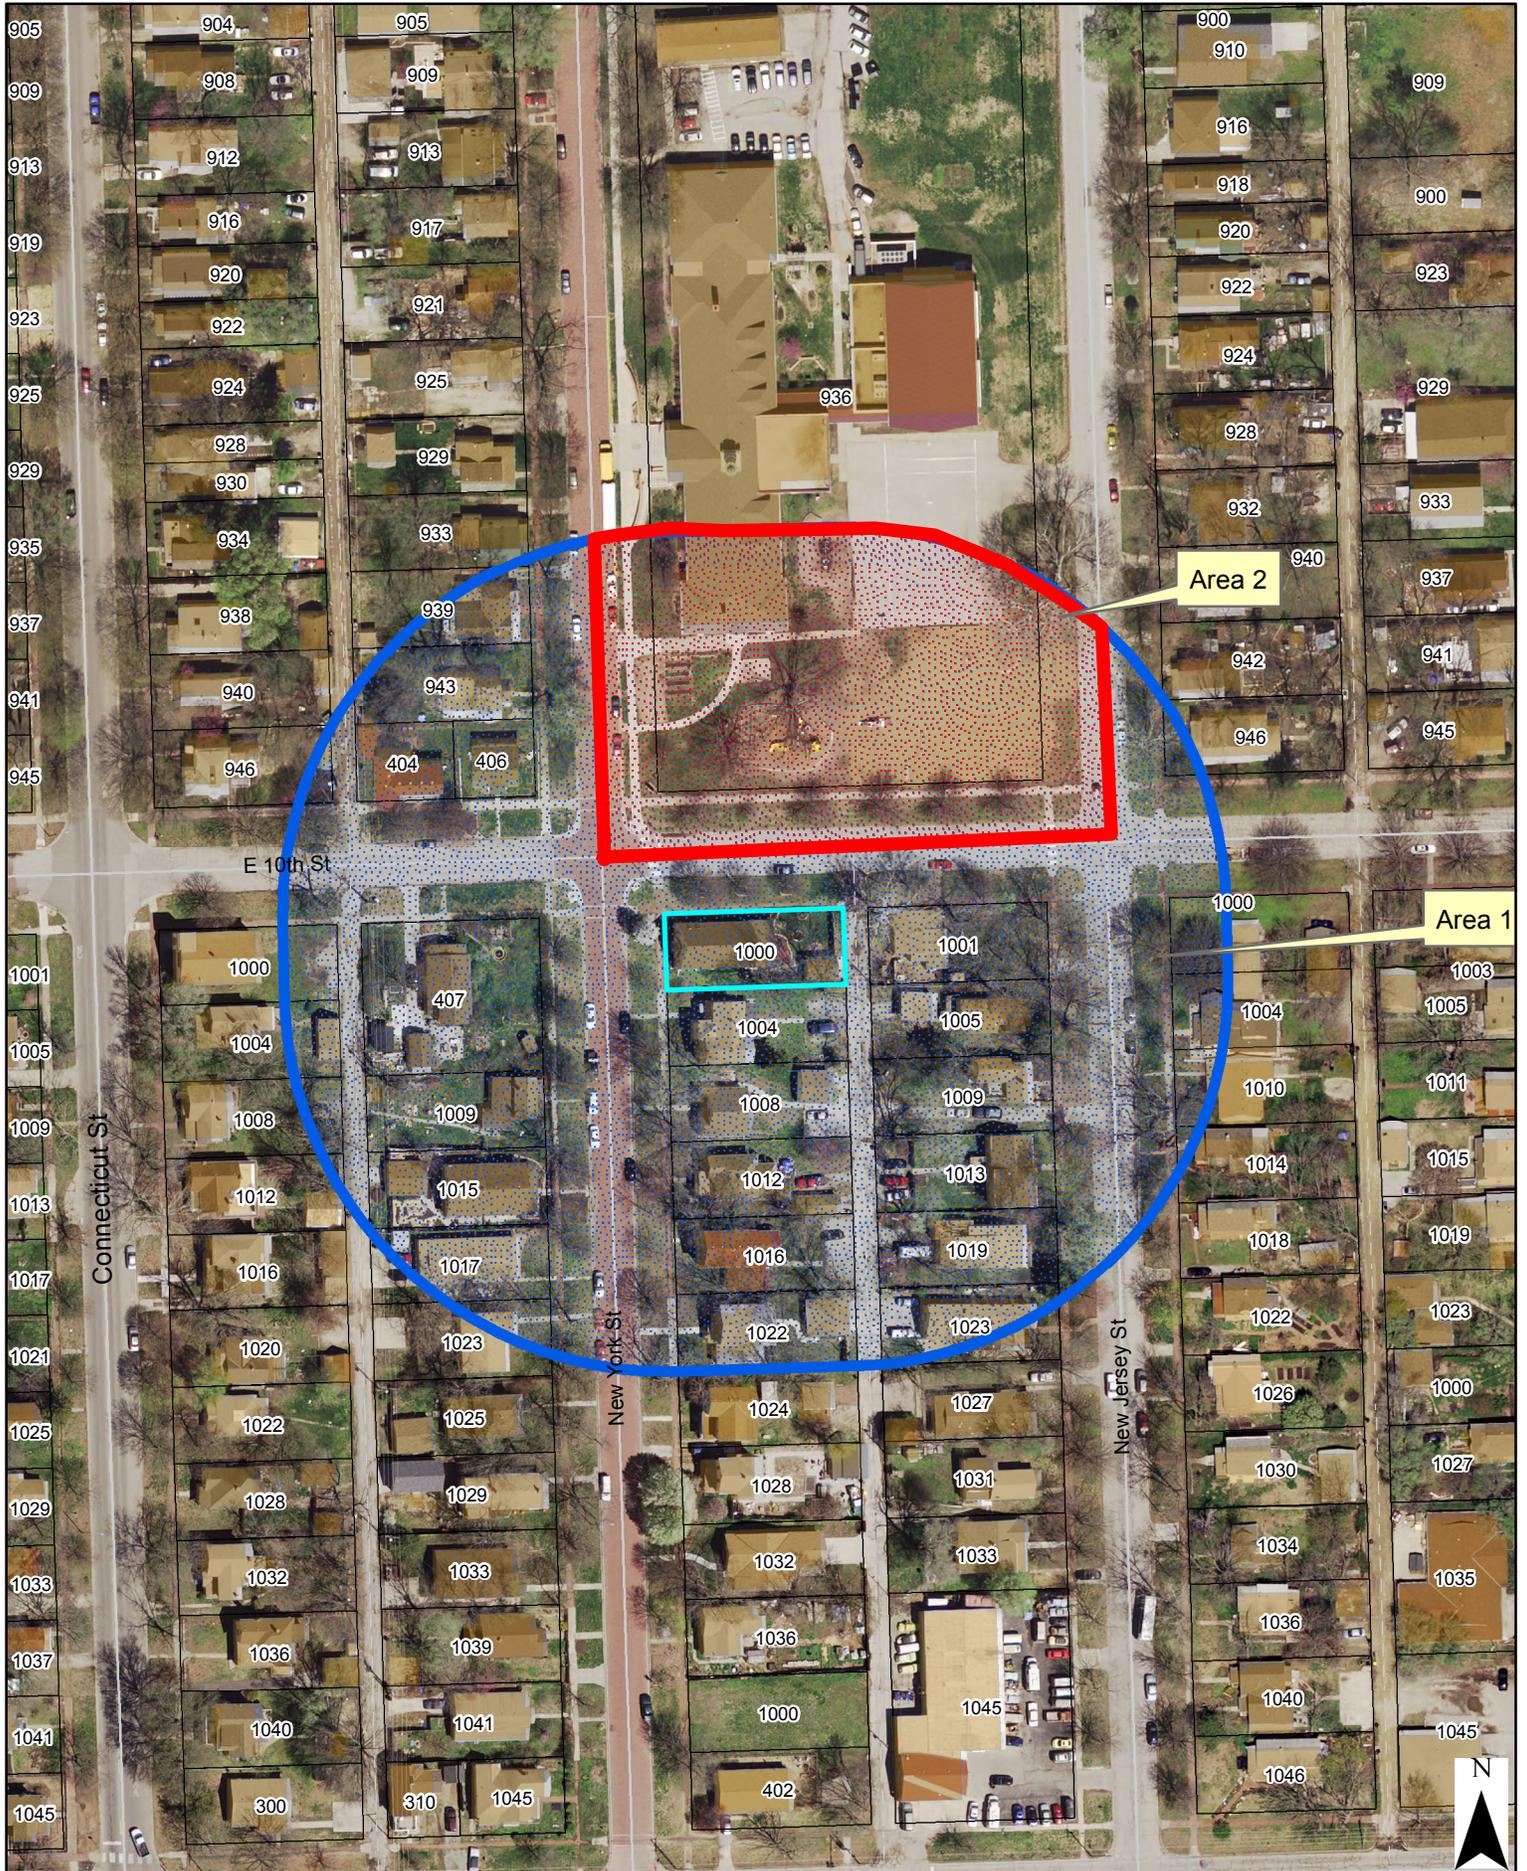
The Environs for 1000 New York Street, the German Methodist Episcopal Church, should be reviewed in the following manner. The Environs should be divided into two areas (see attached map) and the following standards applied to each of the areas:

**Area 1:** Maintaining the residential character, existing historic structures and visual appearance of the environs is the primary focus of review. Main structure demolitions of historic structures would be approved only if documentation was provided that indicated that the structure was unsound and/or a certificate of economic hardship was approved.

**Area 2:** Because the area no longer reflects the residential character of the historic environs, the area should reflect the development pattern established for New York Elementary School. The proposed alteration or construction should meet the intent of the Criteria set forth in 22-505. Design elements that are important are scale, massing, site placement, height, directional expression, percentage of building coverage to site, setback, roof shapes, rhythm of openings and sense of entry. Demolition of properties shall be approved if a compatible structure is proposed on the site. Maintaining views to the listed property and maintaining the rhythm and pattern in the environs are the primary focus of review.
