Lawrence, Kansas
Bowersock Dam Inspection 2006

B&V Project 146136
B&V File B-1.1
February 14, 2007

On October 30, 2006 an inspection of the Bowersock Dam in Lawrence, Kansas was performed to assess the condition of the dam. This report summarizes the visual observations made of the dam's condition and provides a phased recommendation for corrective actions for the City of Lawrence's consideration.

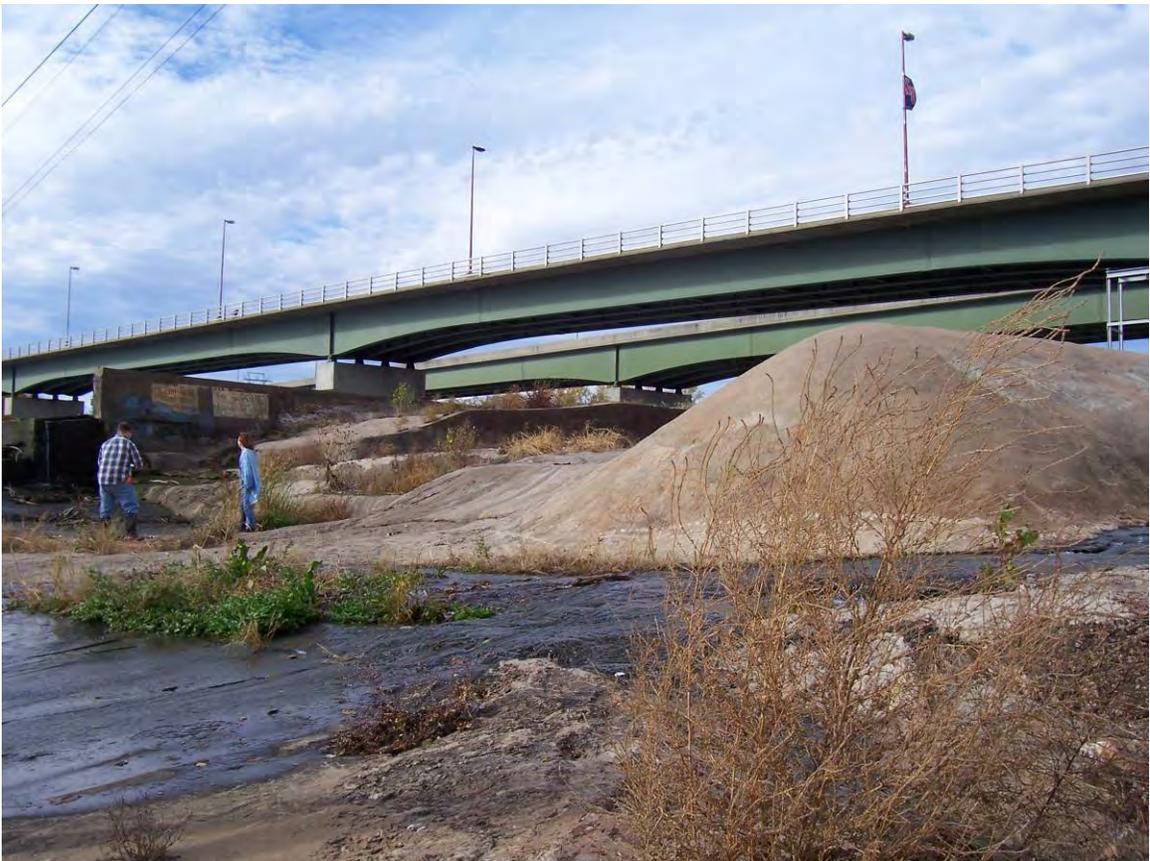
3. North Spillway

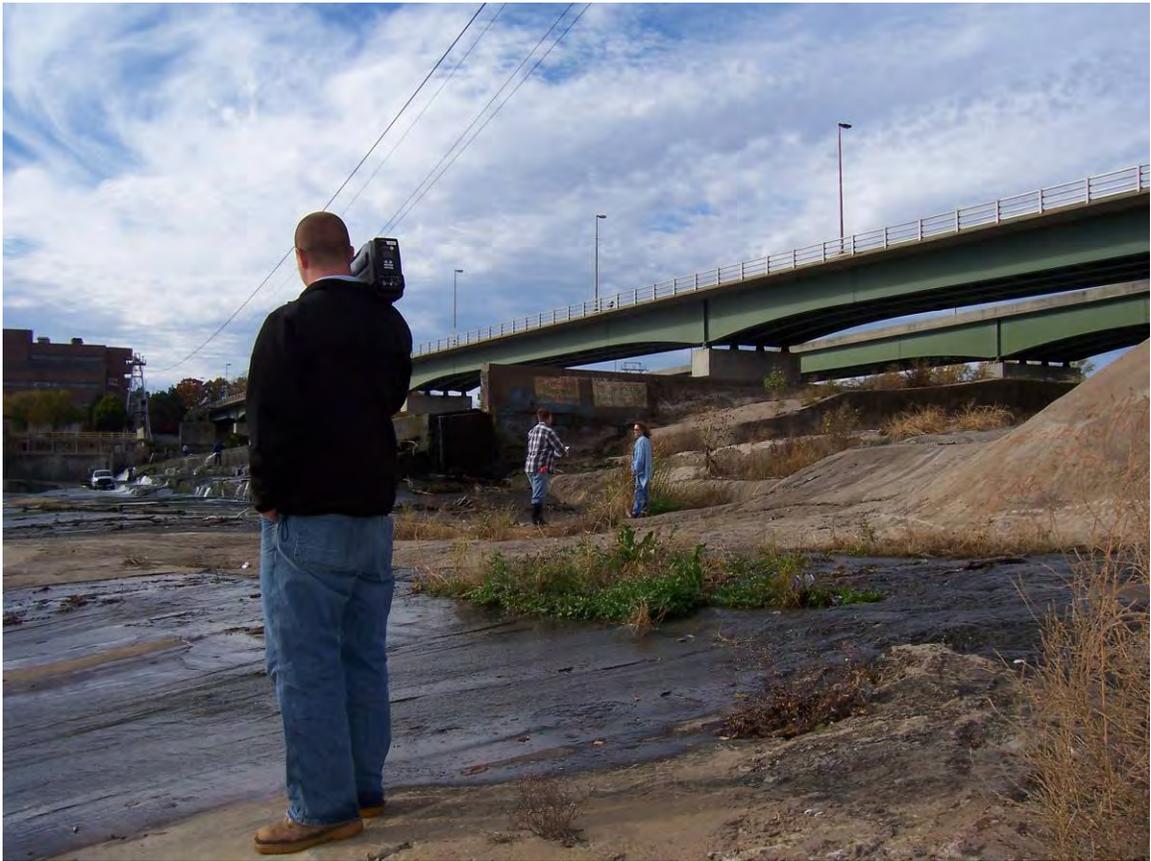
4. North spillway looking south from station 0+00

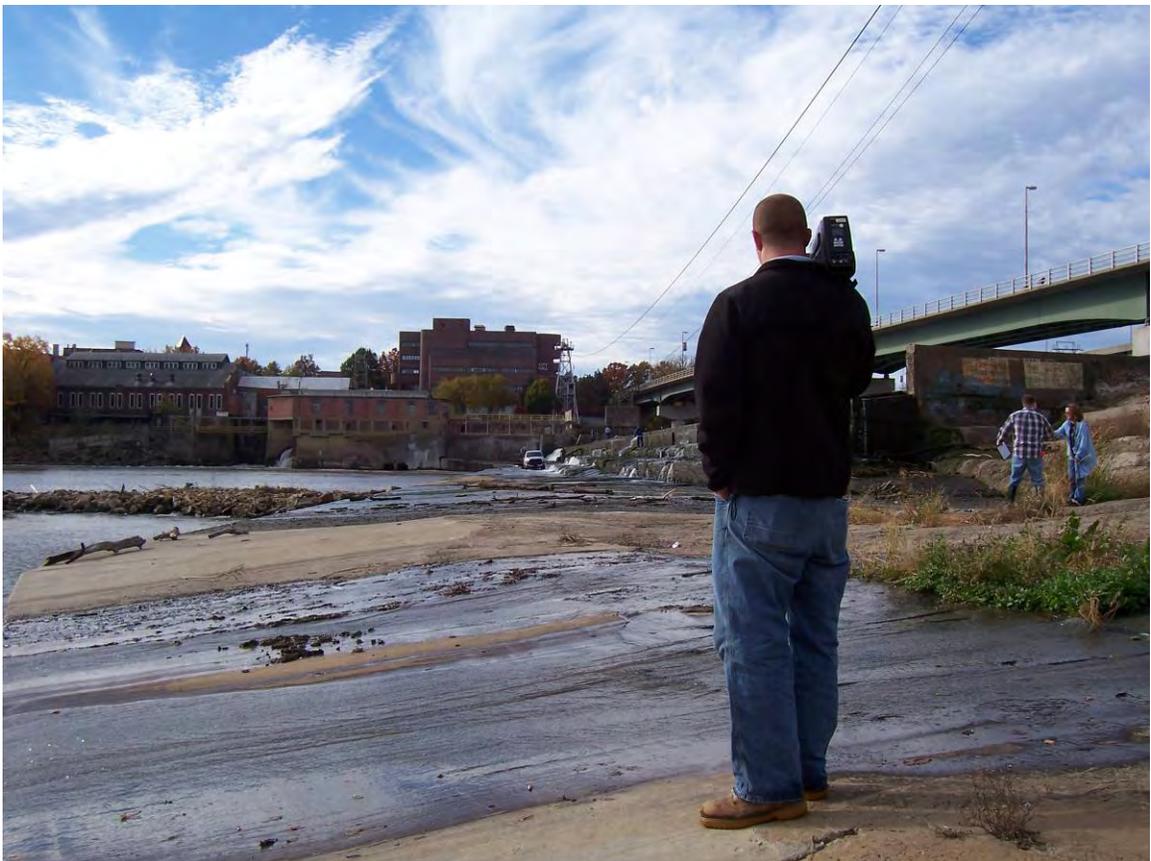
5. View of dam from station 0+00

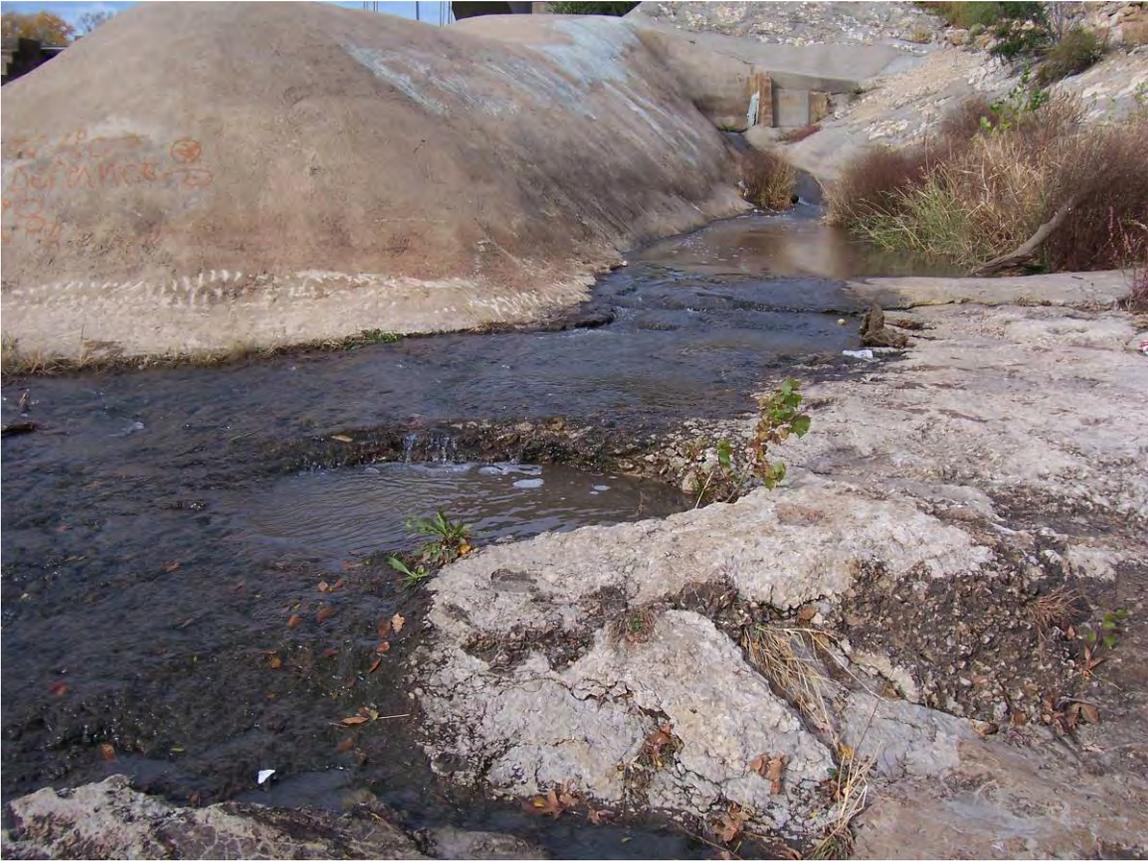
6. Sta 0+25±. Storm drainage flume north of spillway, eroded concrete

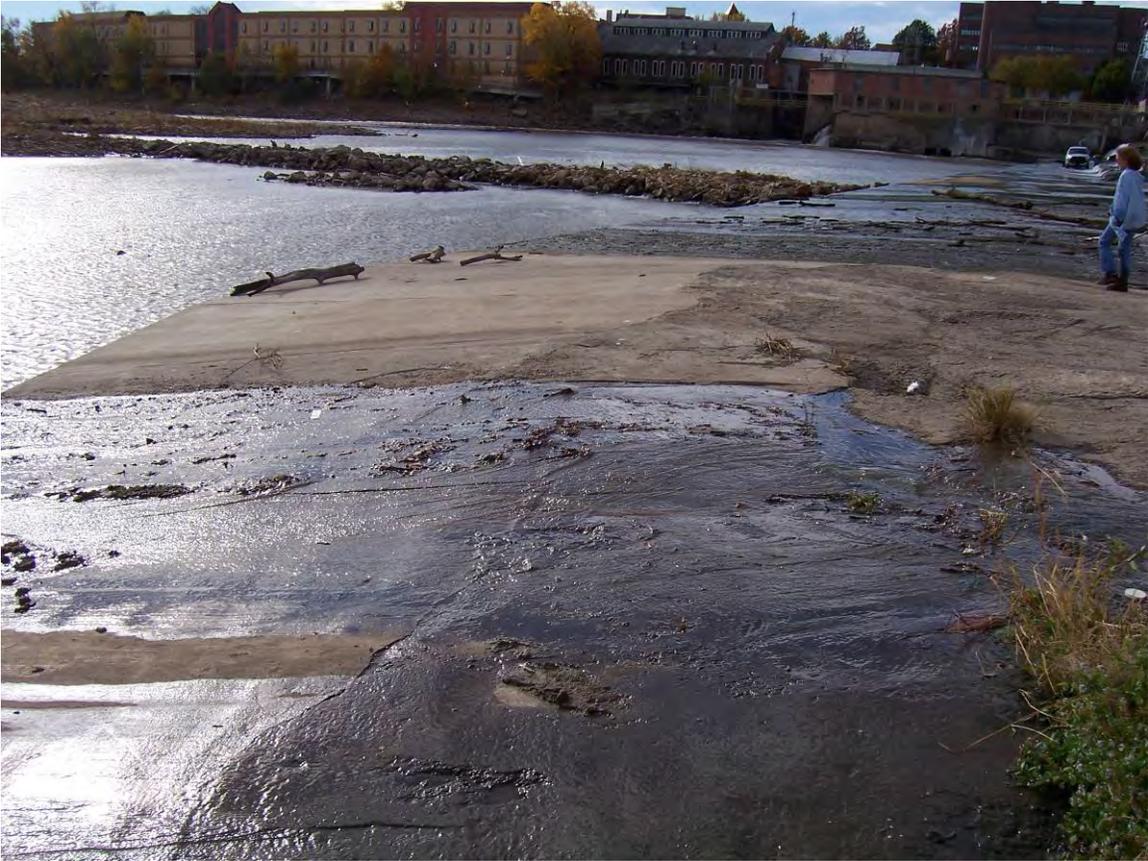
7. Sta 0+40±. Apron downstream of spillway. Flow from storm drain.

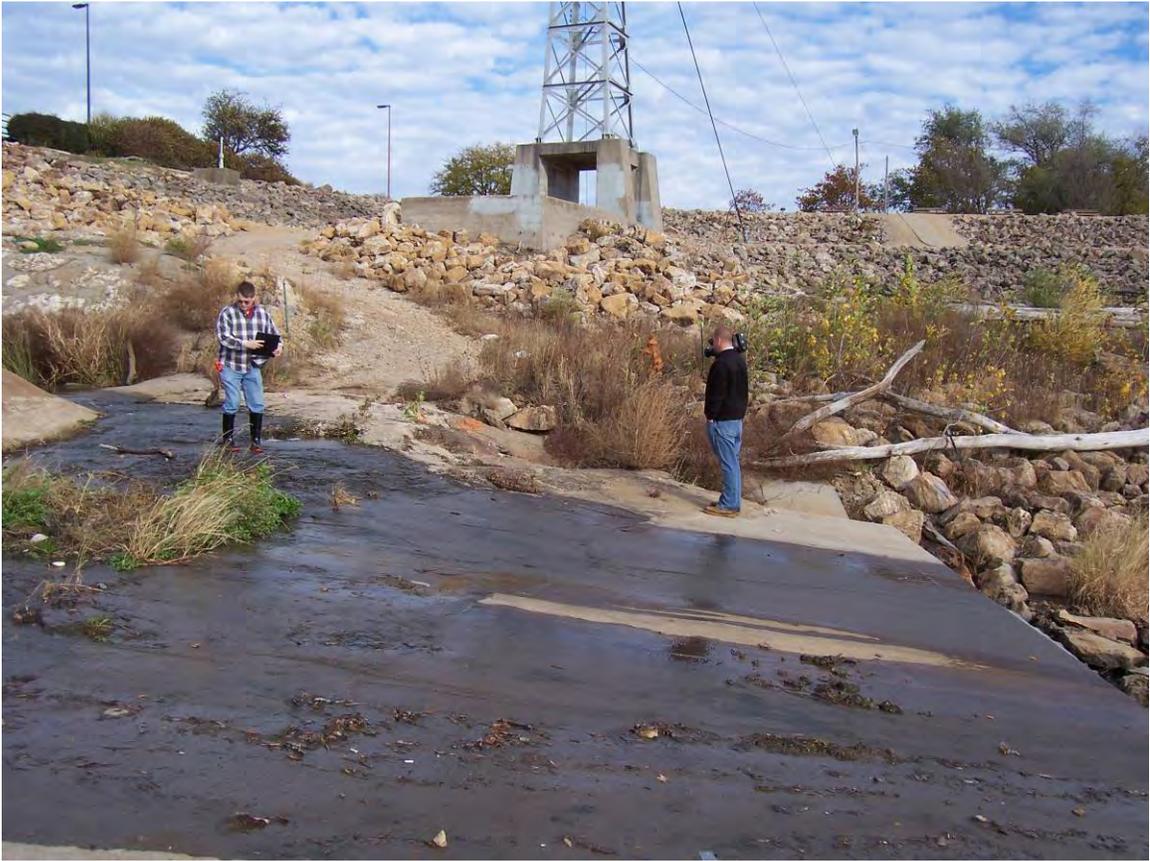
8. Sta 0+50±. Looking north to Sta 0+00 access road to dam apron.

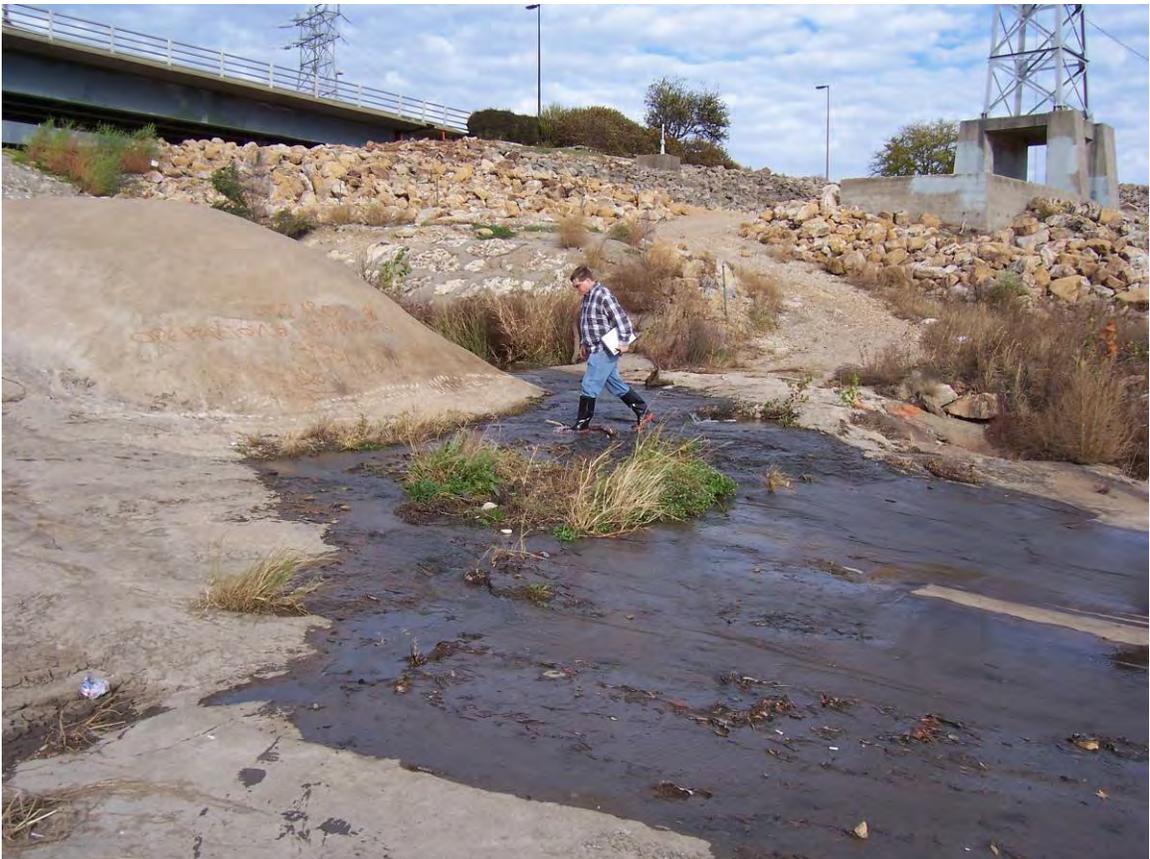
9. Sta 0+50±. Storm drainage flume and north wall of spillway

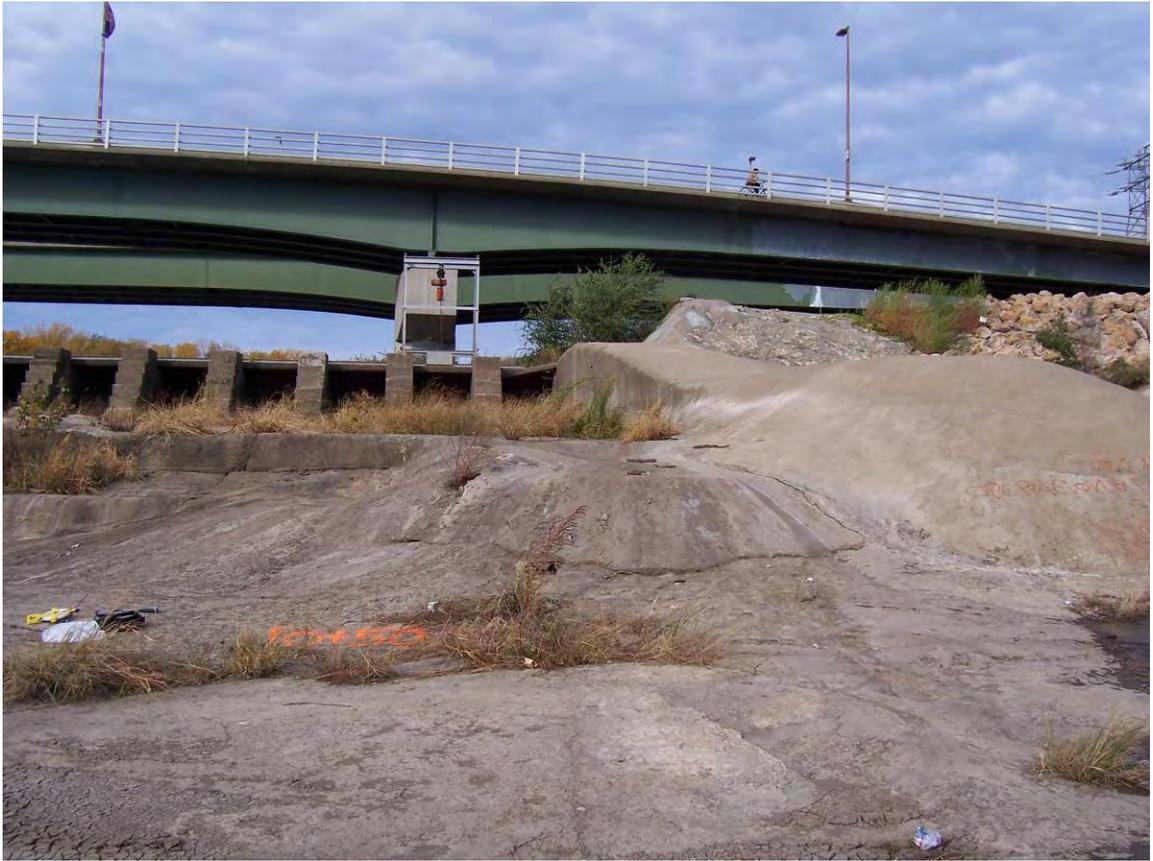
10. Sta 0+50. Spillway

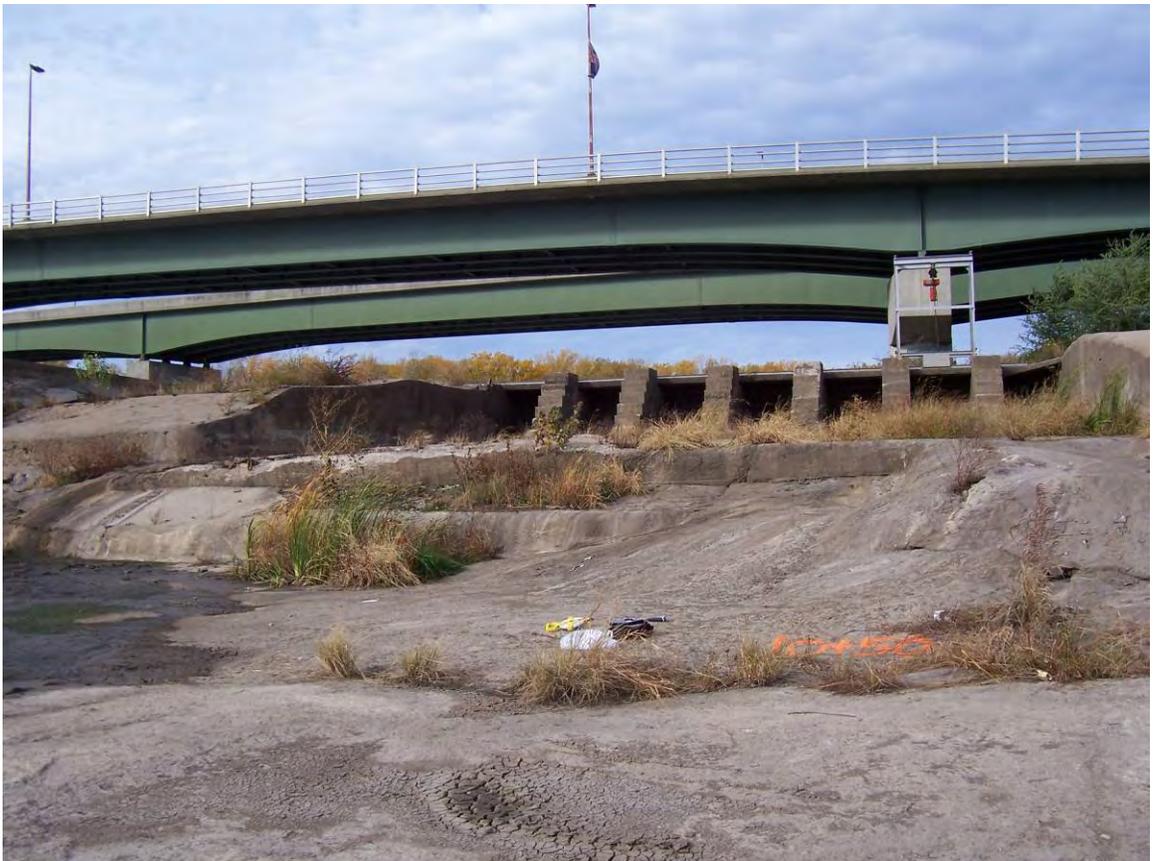
11. Sta 0+50. Spillway

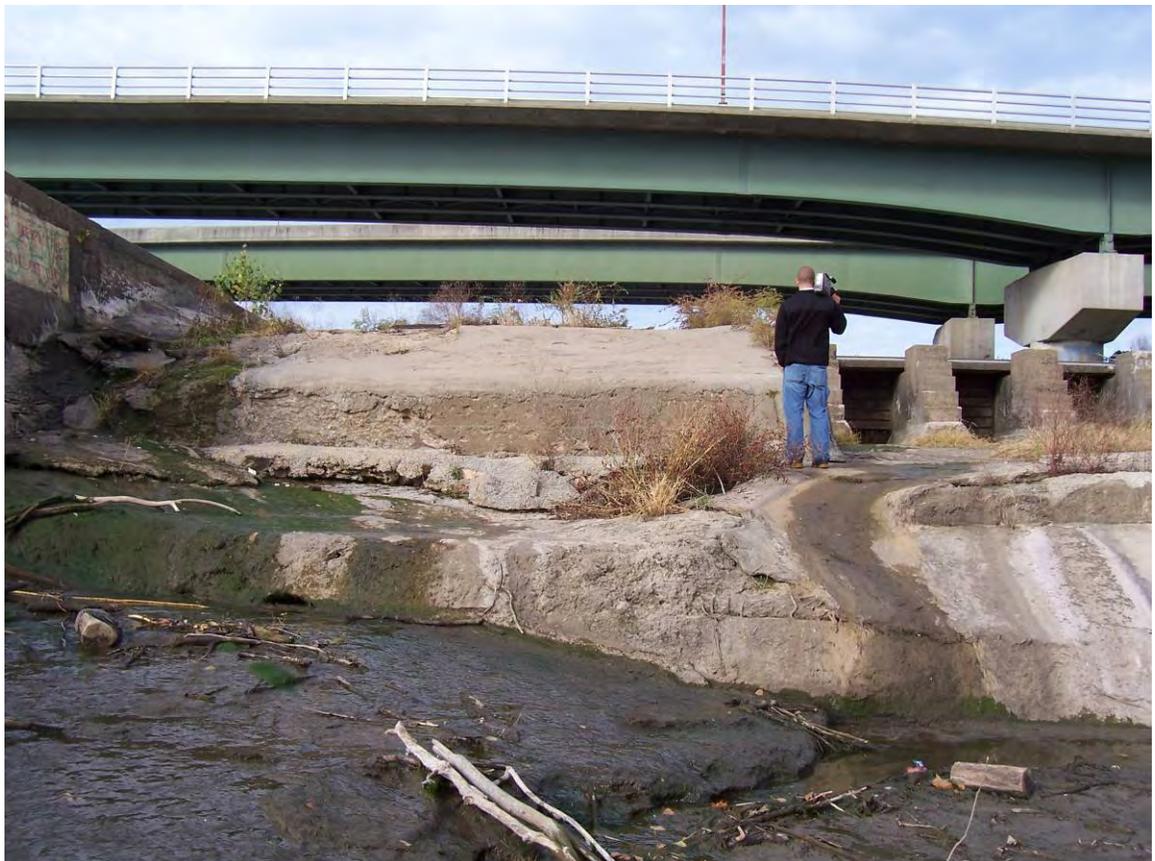
15. Sta 0+00. Eroded concrete and exposed joints in spillway.

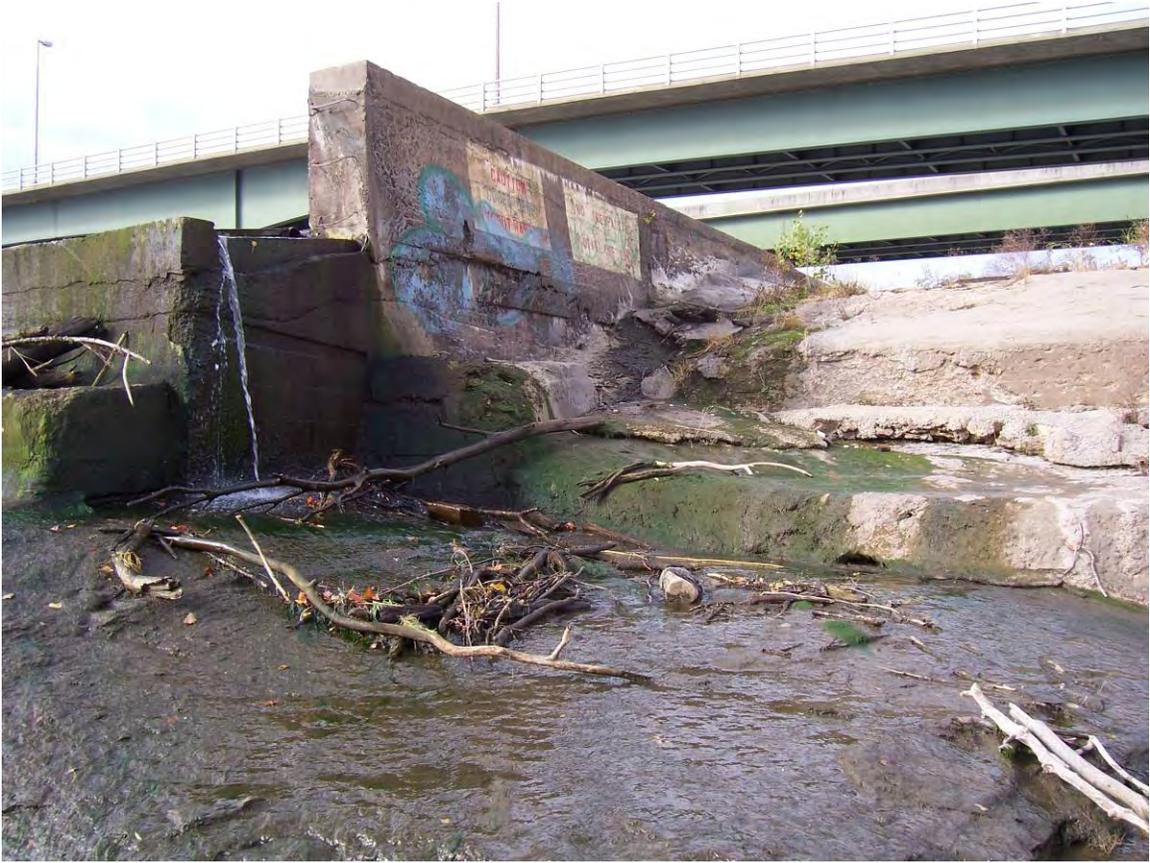
16. Sta 1+10. North wall of dam. Eroded concrete and exposed joints in spillway.

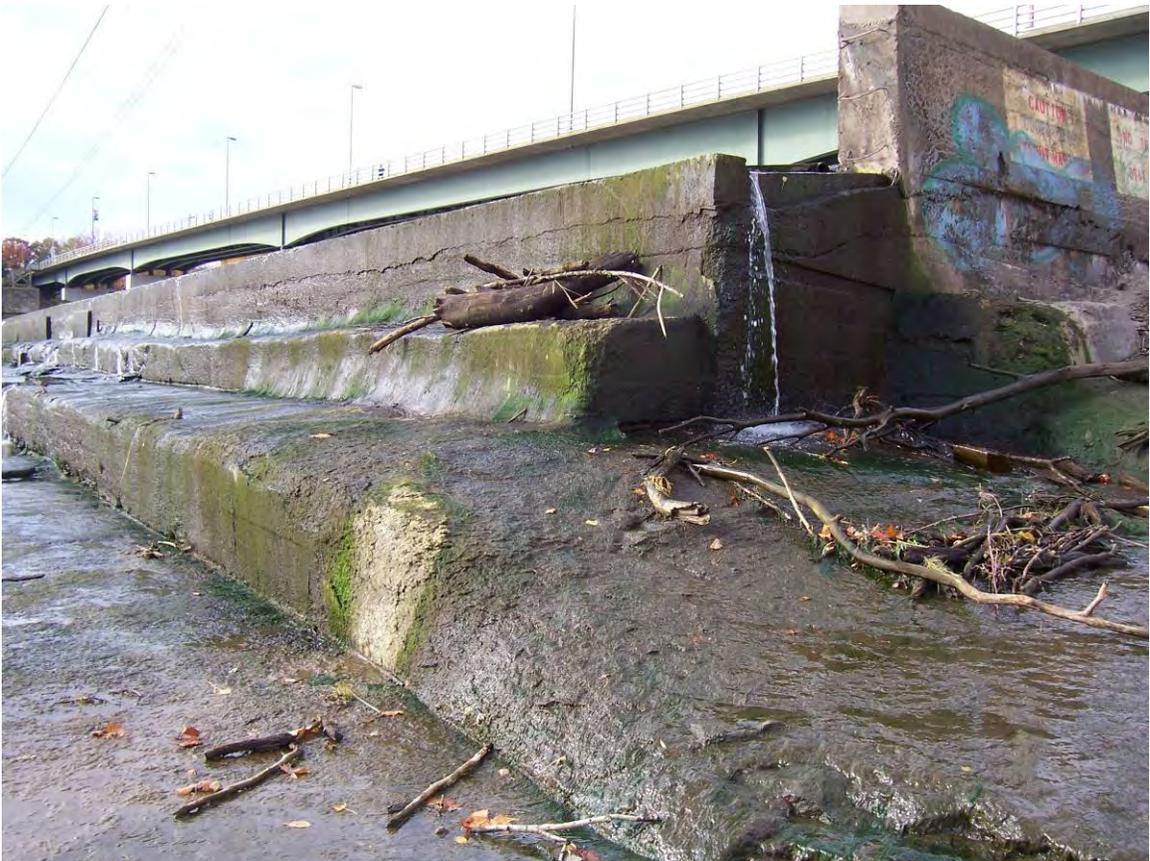
17. Sta 1+25. Eroded concrete at north end of dam.

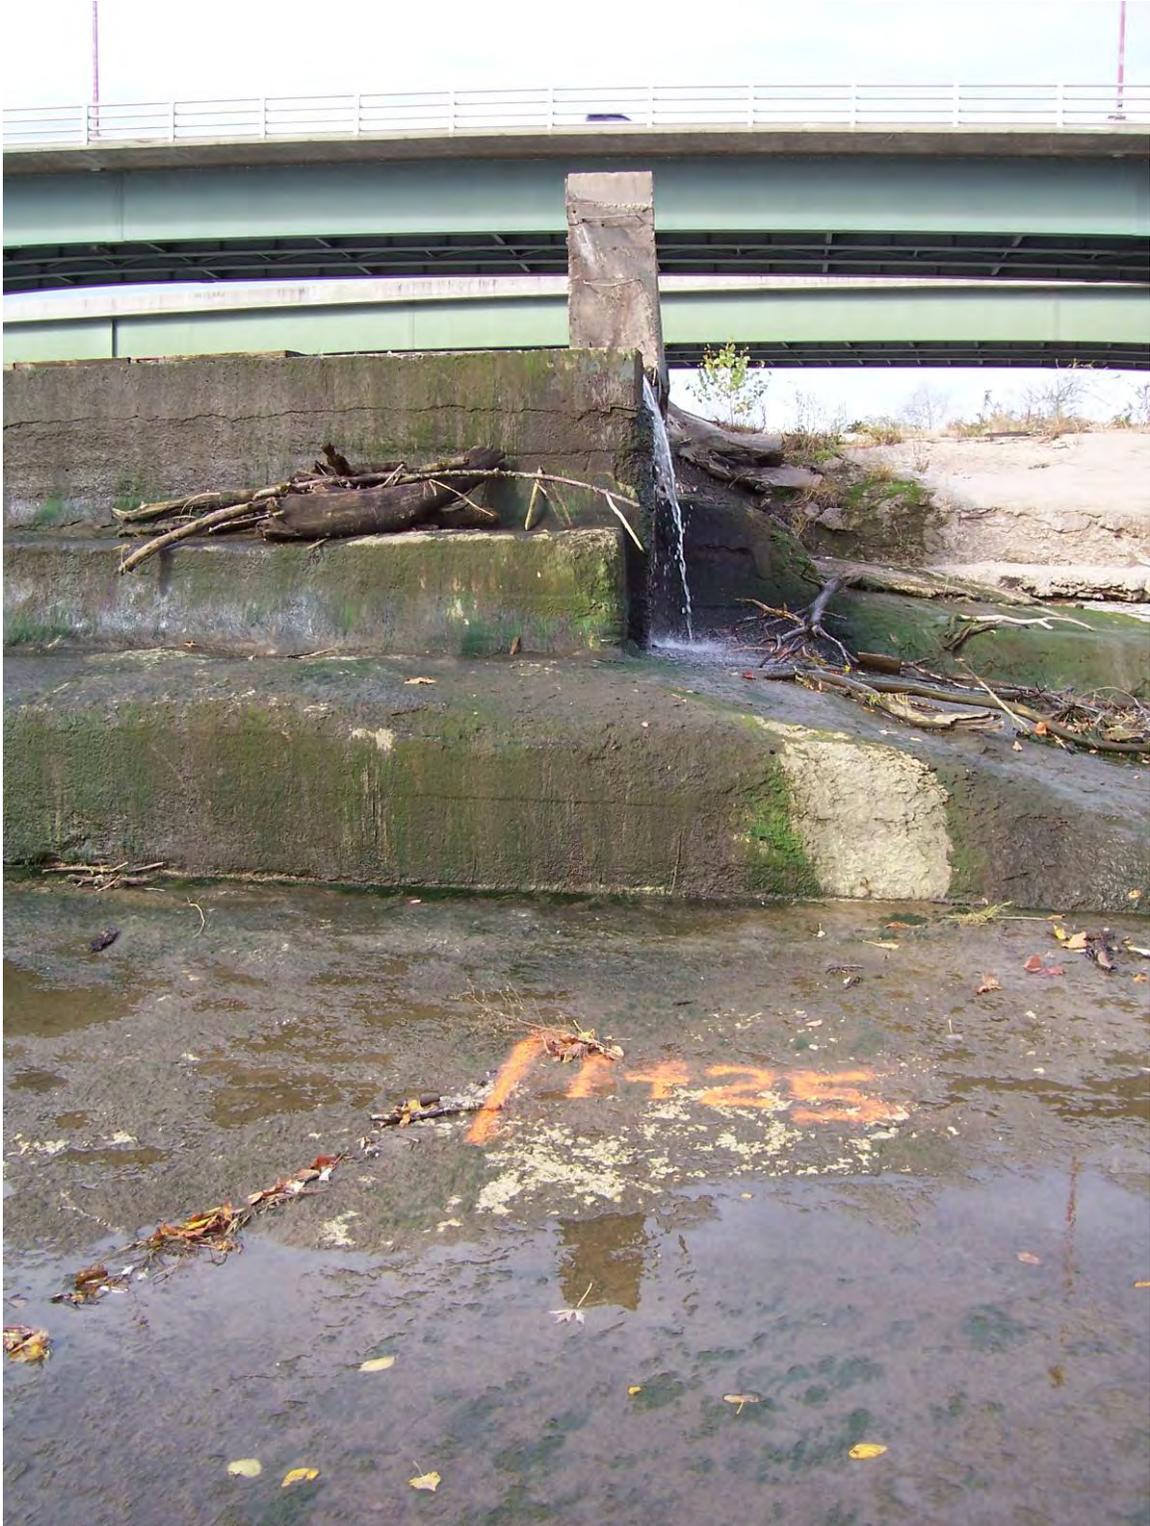
18. Sta 1+25. Eroded concrete at north end of dam. Exposed joints at bottom of dam steps. Eroded shotcrete near top of dam.

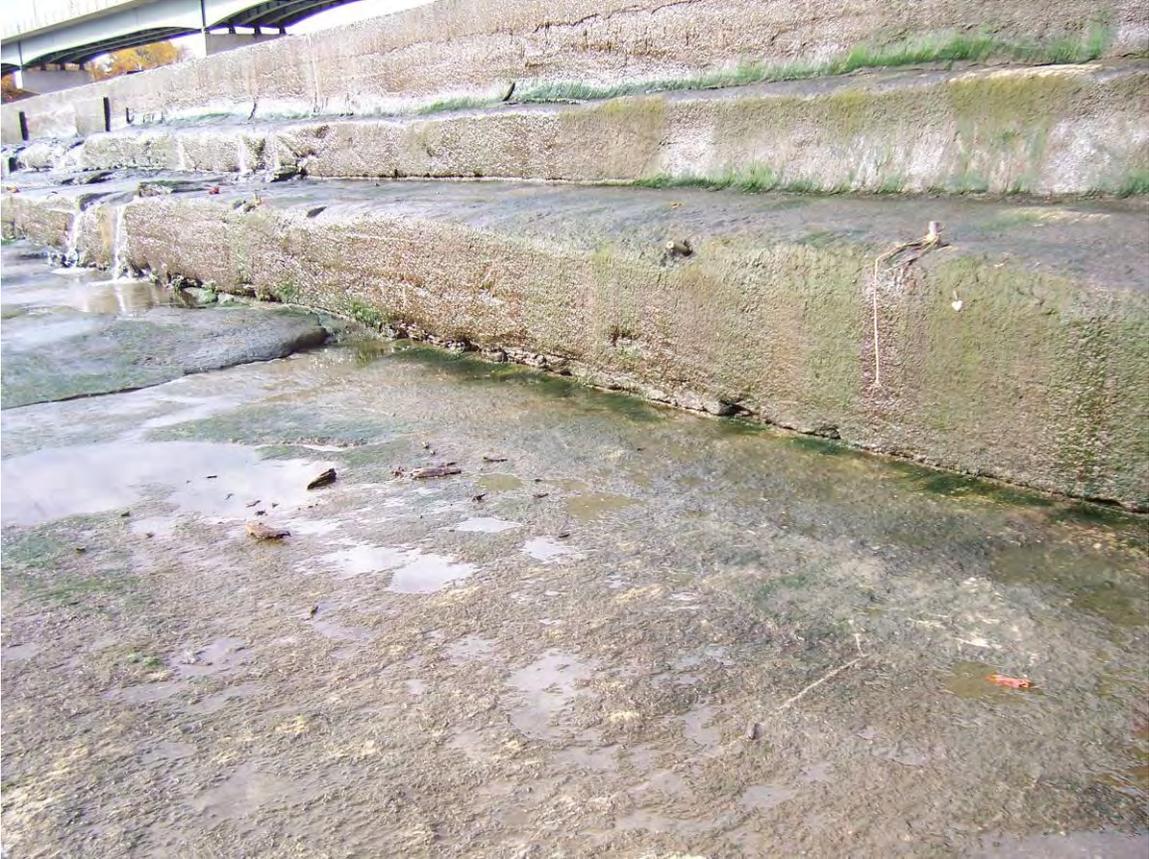
19. Sta 1+25 to 1+50. Exposed joints at bottom of dam steps. Eroded shotcrete at top step.

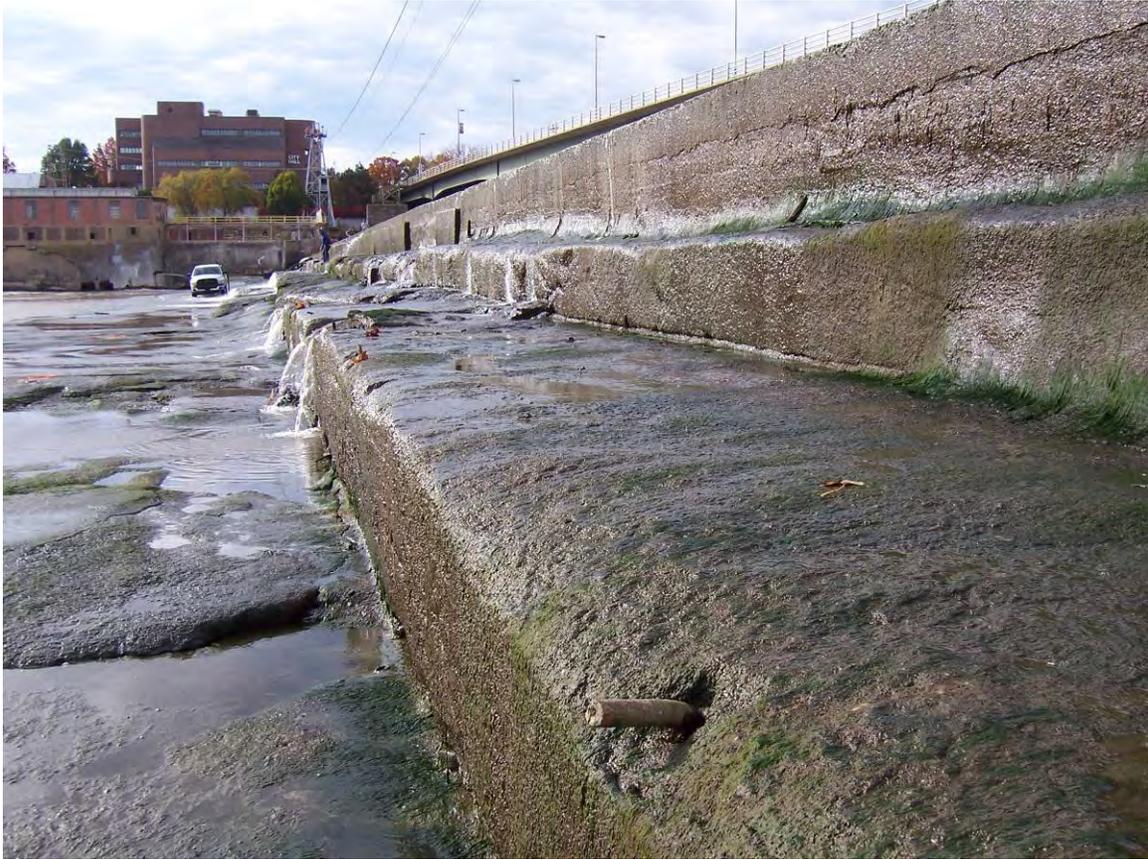
21. Sta 1+50 to Sta 2+00. Eroded concrete steps and shotcrete. Exposed reinforcing bar.

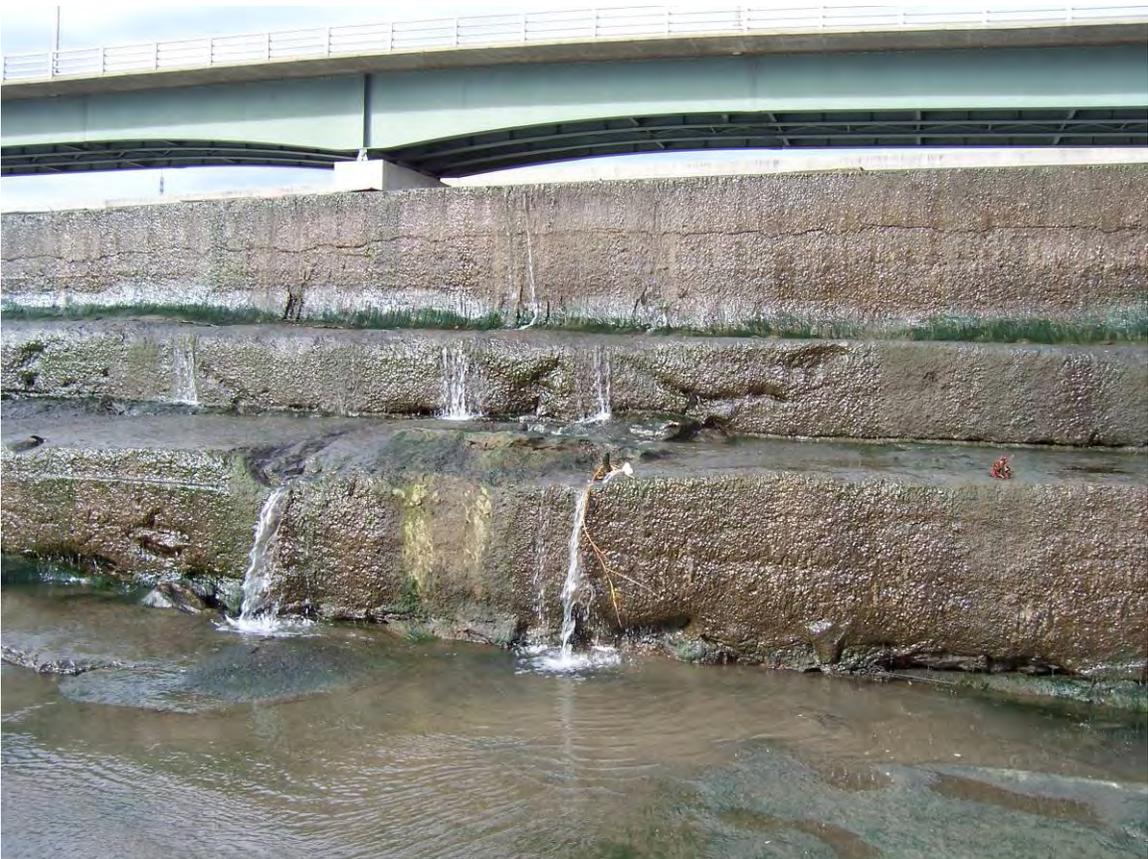
22. Sta 1+80. Eroded bottom step. Depression with 2 ft deep hole at bottom step. Eroded shotcrete.

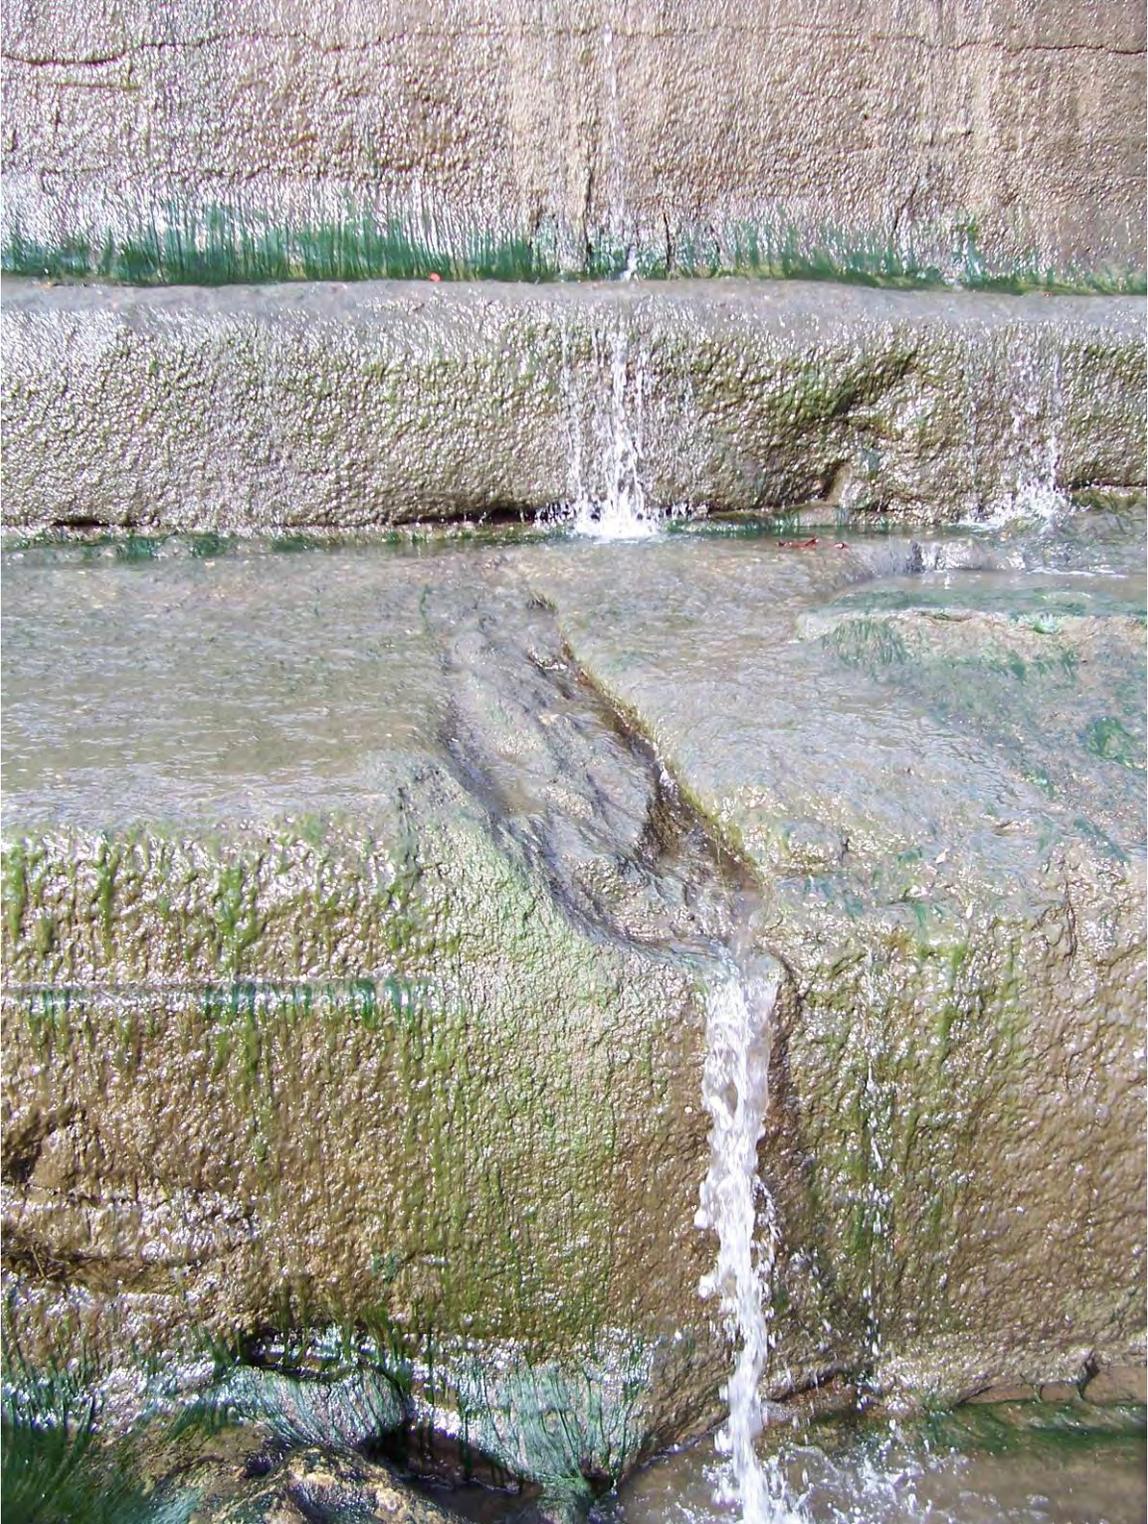
23. Sta 1+80. Eroded concrete on bottom step. Exposed joints between steps. Eroded shotcrete on top step.

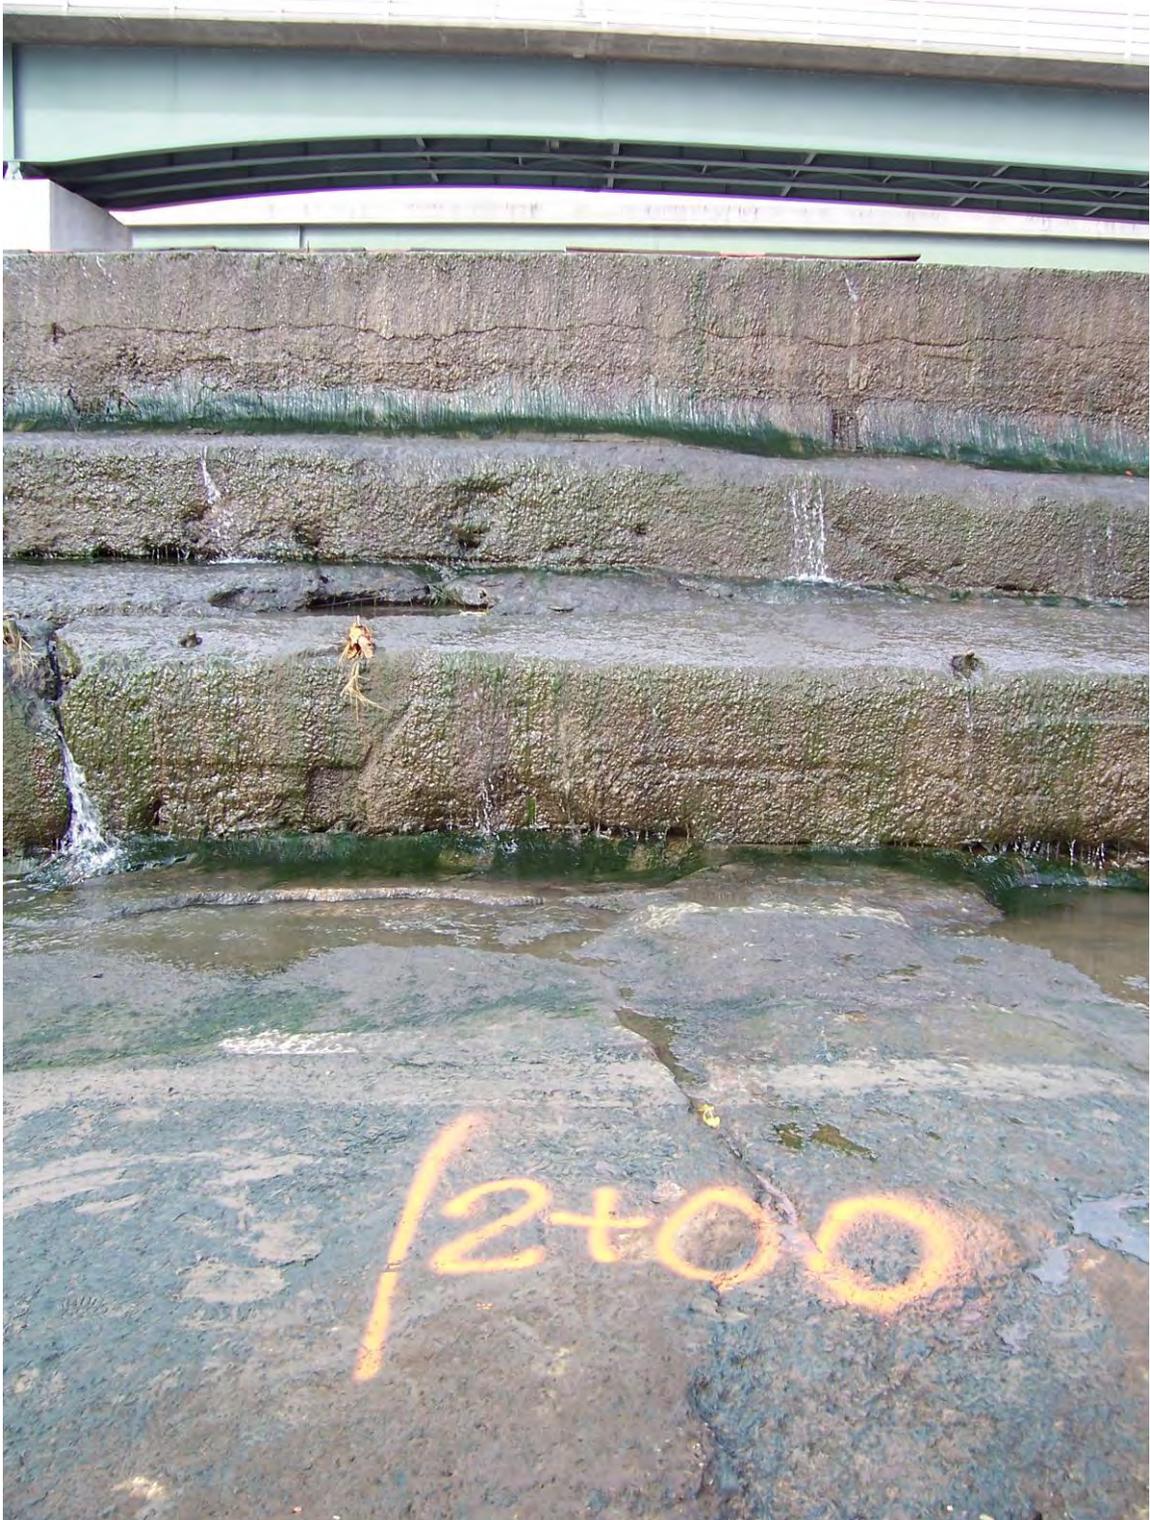
24. Sta 2+00. Eroded concrete on top of bottom step. Exposed joints at bottom of steps. Beginning of separated triangular section in bottom step.

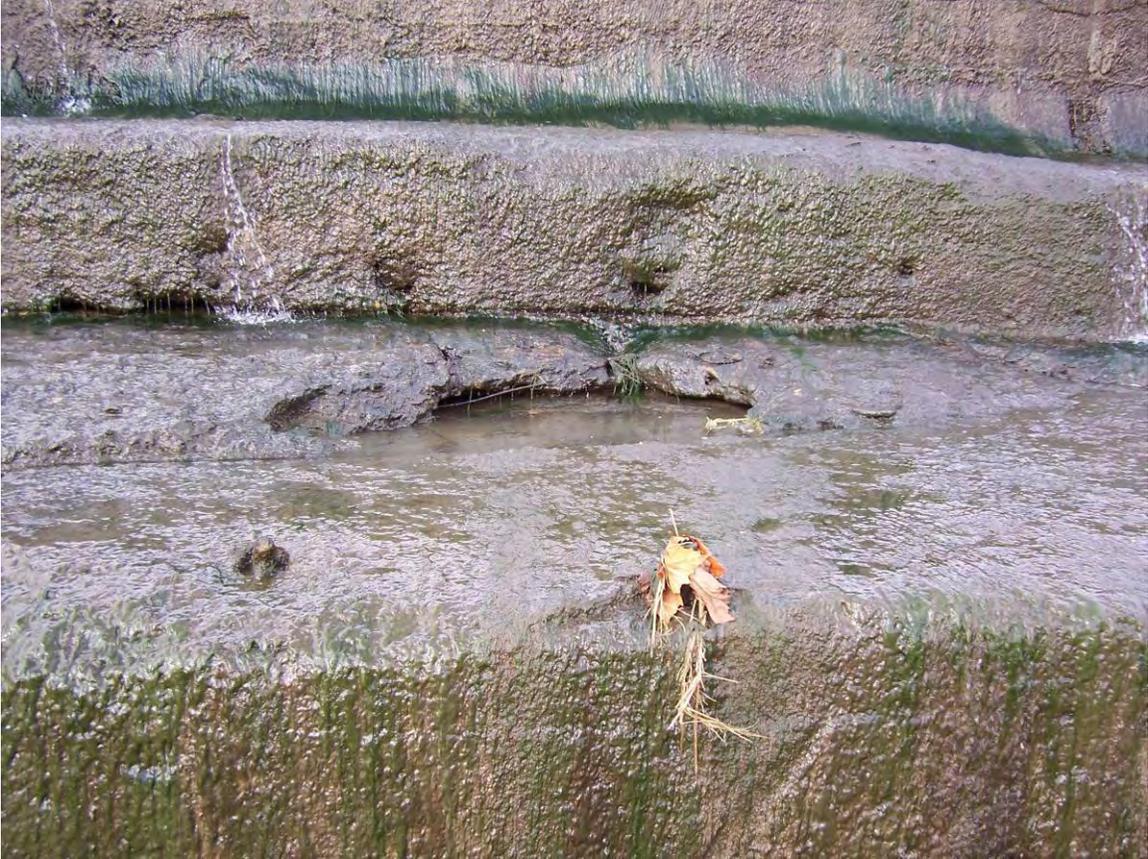
25. Sta 2+05. Top of bottom step. Eroded concrete with exposed reinforcing mesh. Exposed joint between 2nd and 1st step. Eroded shotcrete with exposed mesh on top step.

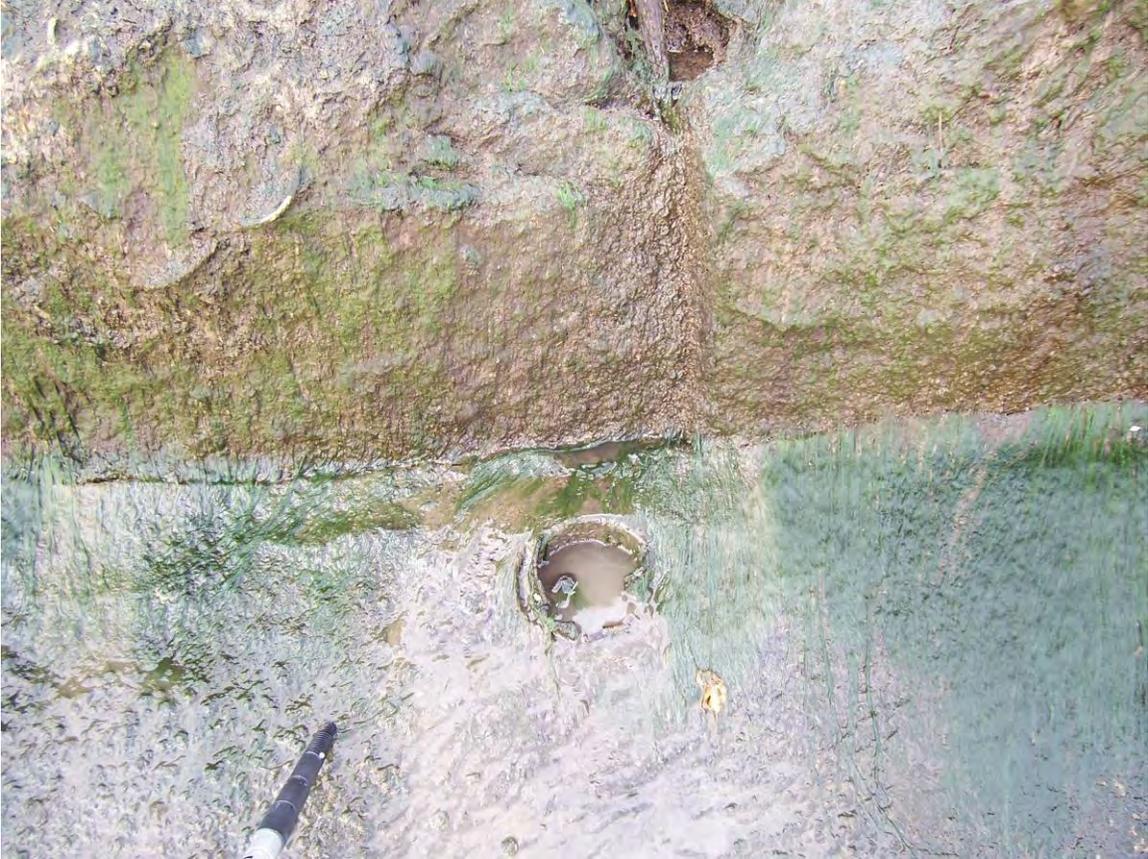
34. Sta 2+65±. Exposed eroded timber at top of bottom step. Cast-In-Place weep hole at bottom of bottom step.
