Lawrence, Kansas
Bowersock Dam Inspection 2006

B&V Project 146136
B&V File B-1.1
February 14, 2007

On October 30, 2006 an inspection of the Bowersock Dam in Lawrence, Kansas was performed to assess the condition of the dam. This report summarizes the visual observations made of the dam's condition and provides a phased recommendation for corrective actions for the City of Lawrence's consideration.

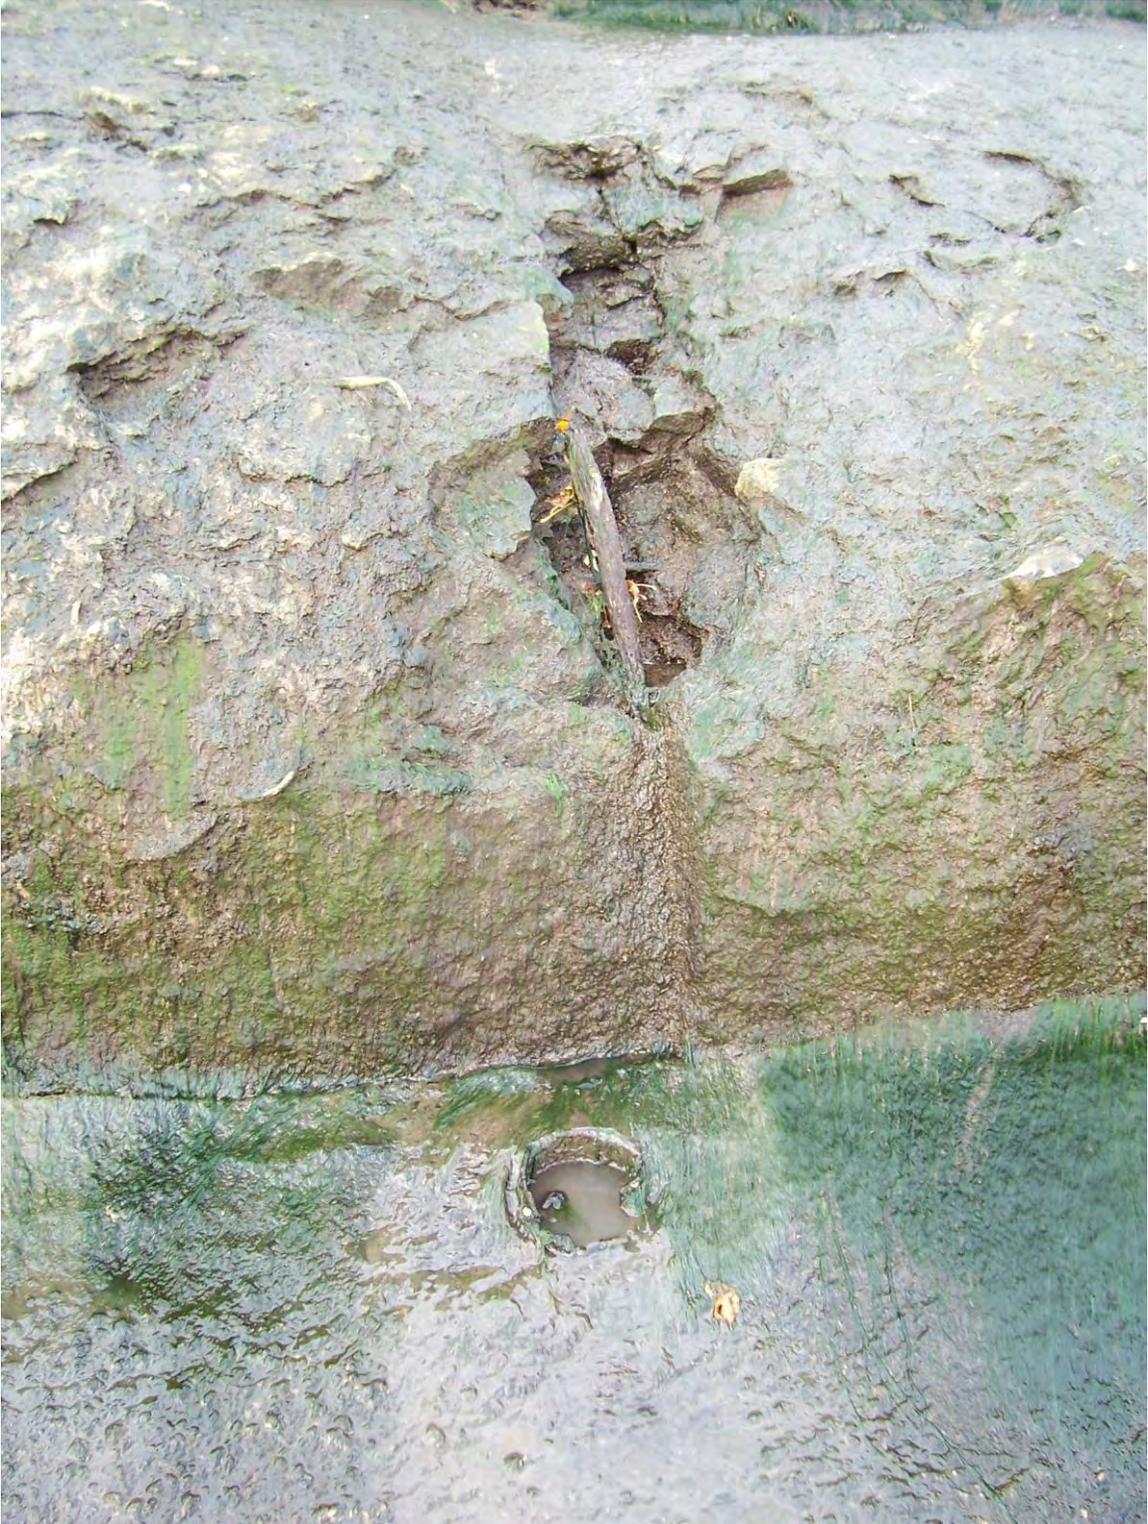
35. Sta 2+65. Exposed eroded timber at top of bottom step. Cast-In-Place weep hole at bottom of bottom step.

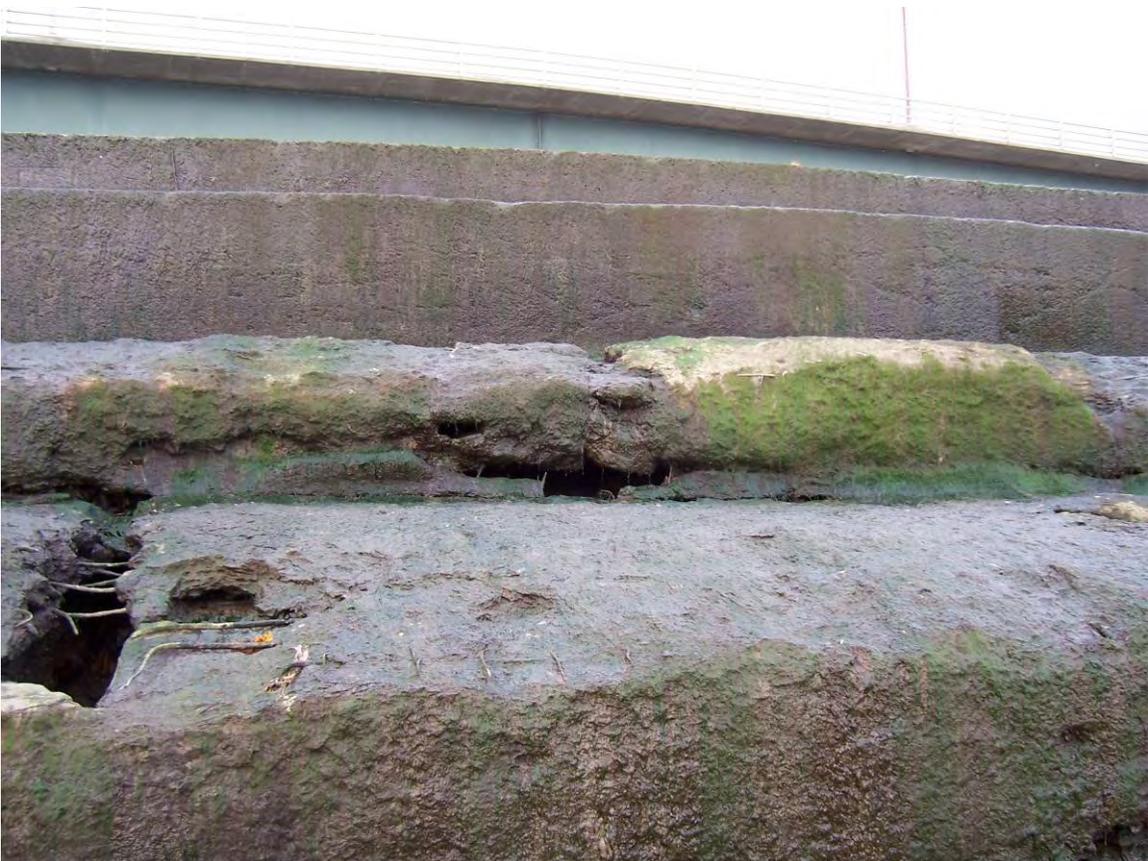
41. Sta 3+00. Eroded timber hole with exposed rebar. Exposed joint between steps.

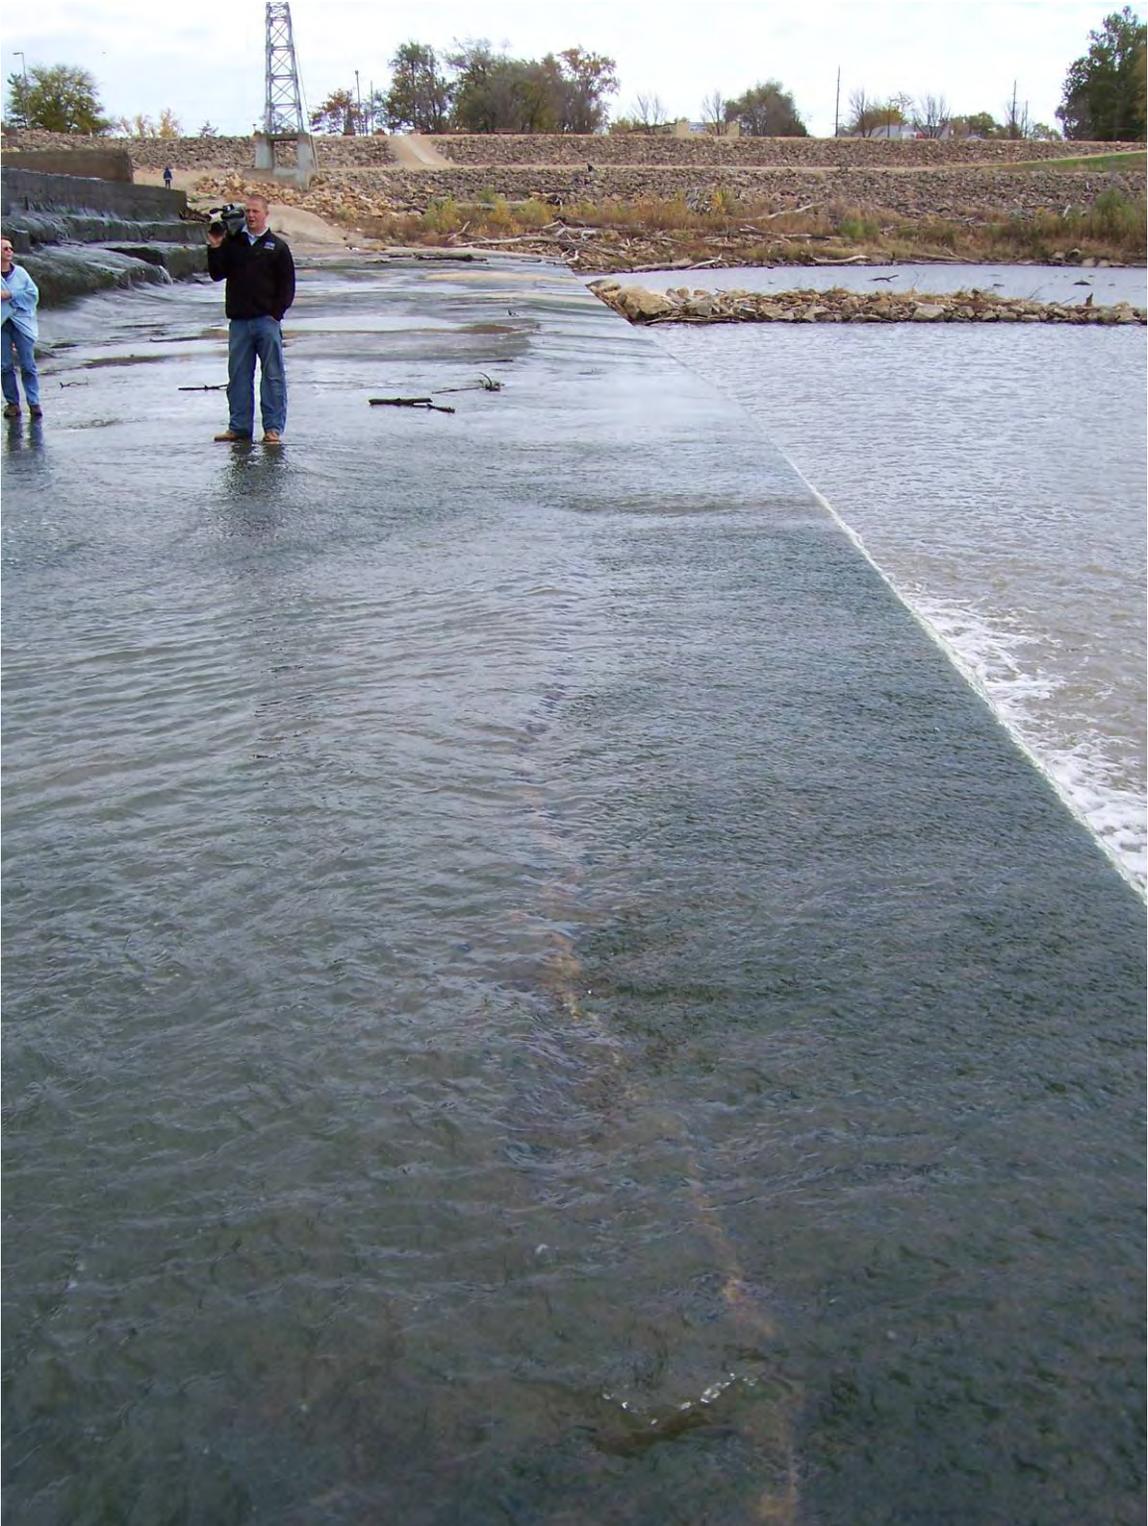
51. Sta 3+75±. Construction joint between old and new apron.

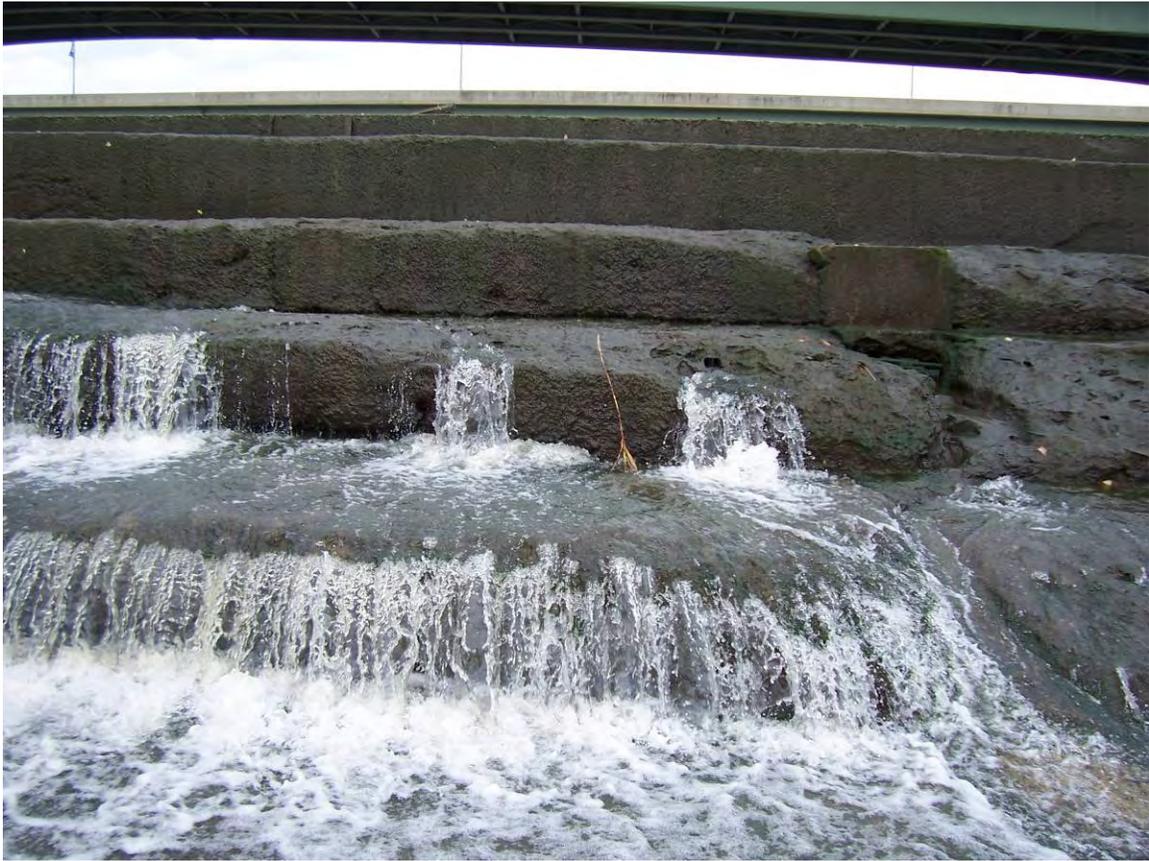
52. Sta 3+75±. Significant flow through Dam in numerous locations.

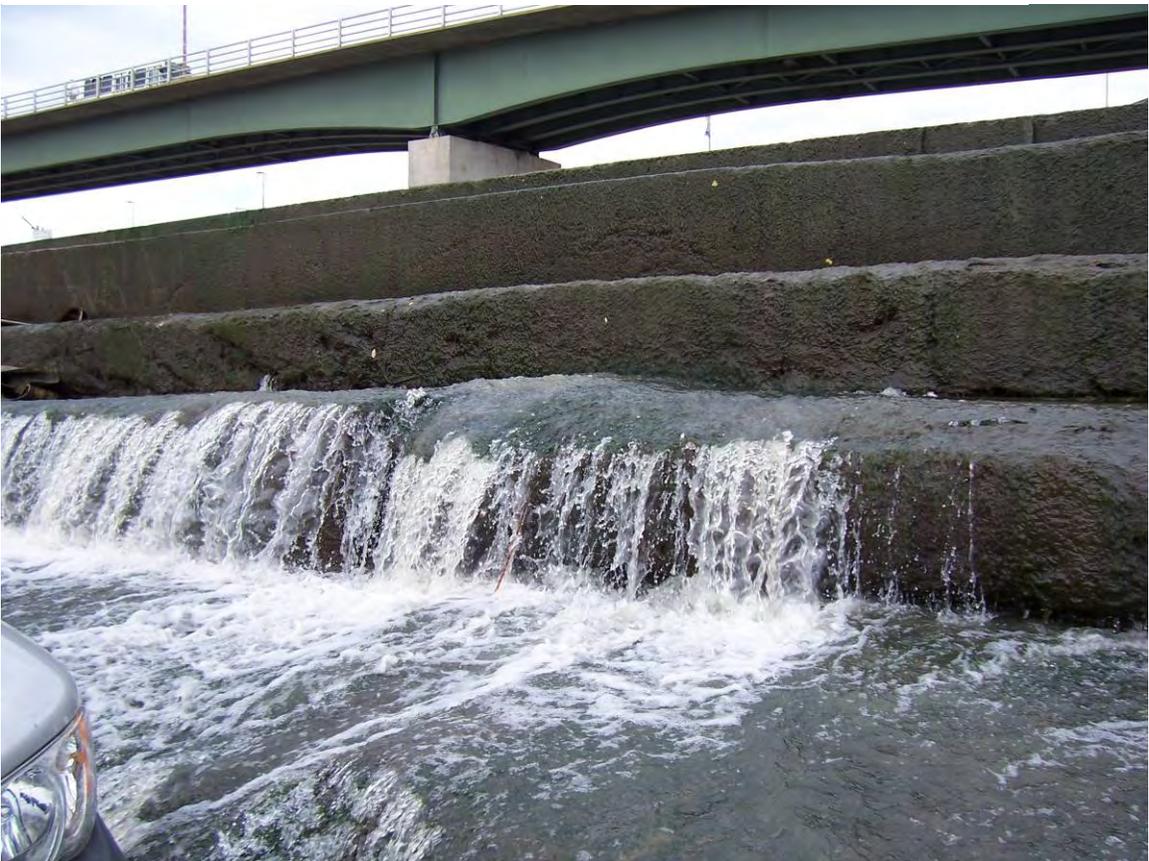
53. Sta 3+80±. Significant flow through Dam in numerous locations.

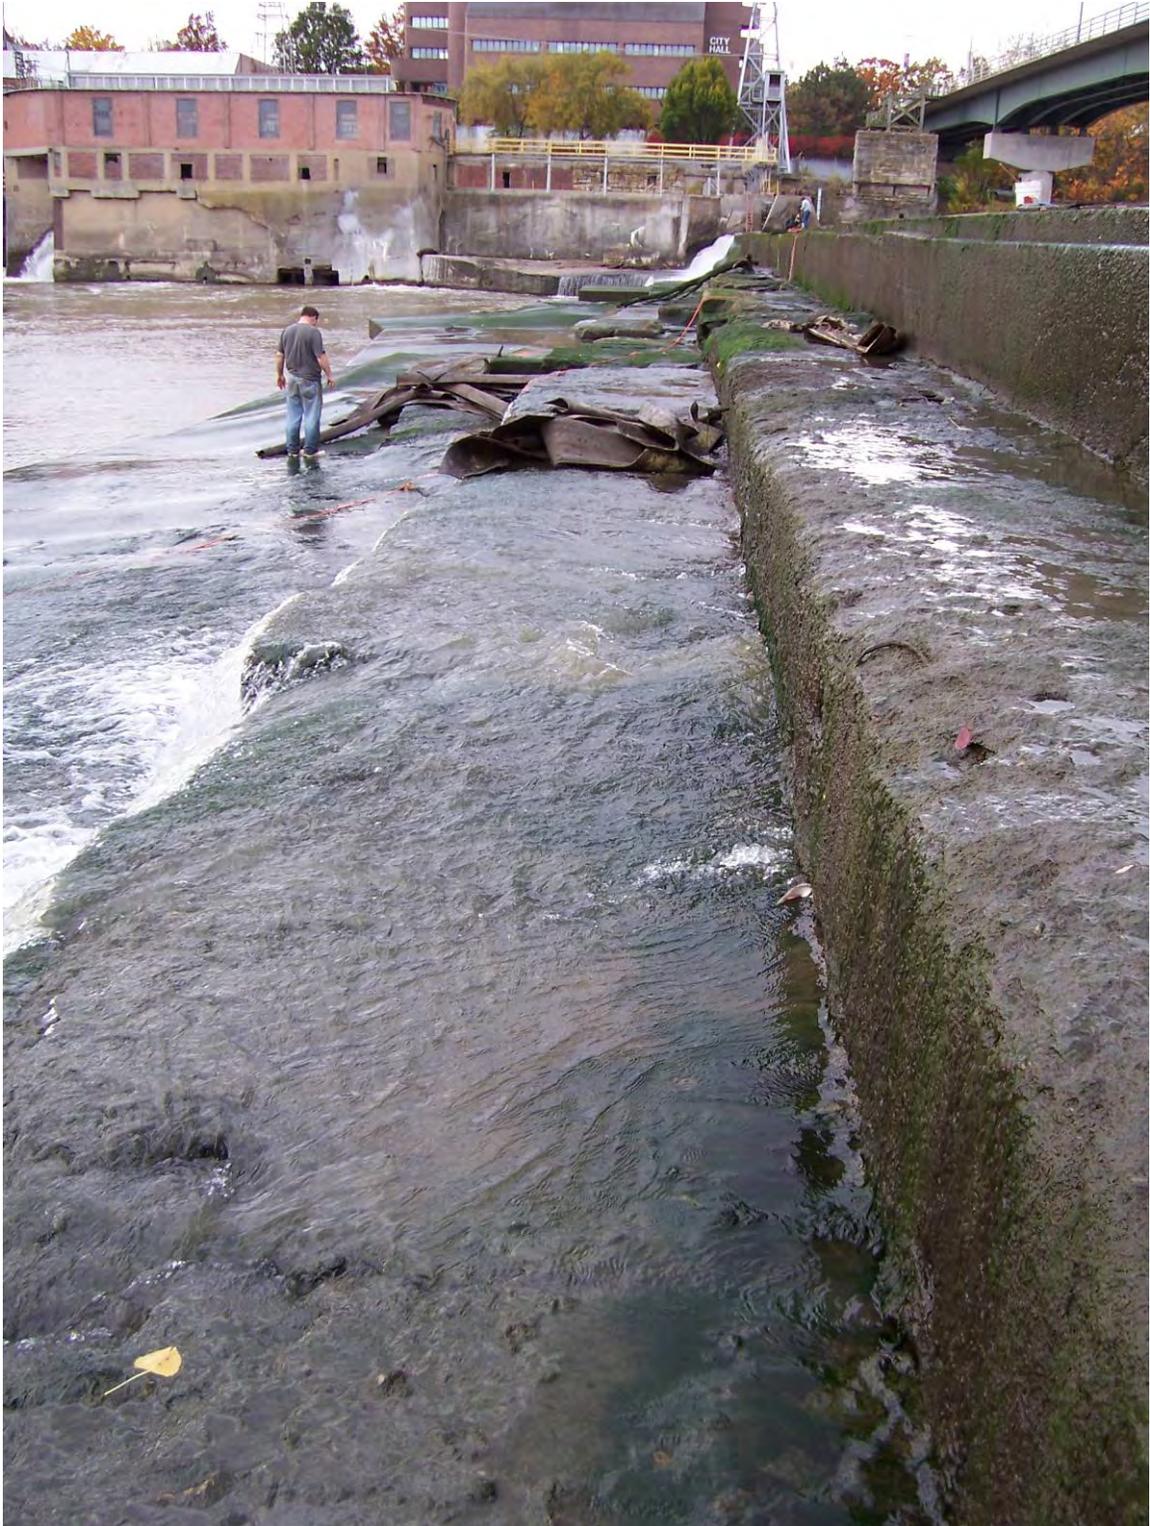
54. Sta 3+90. Looking south. Main flow point through dam. 4 ft deep hole at flow point.

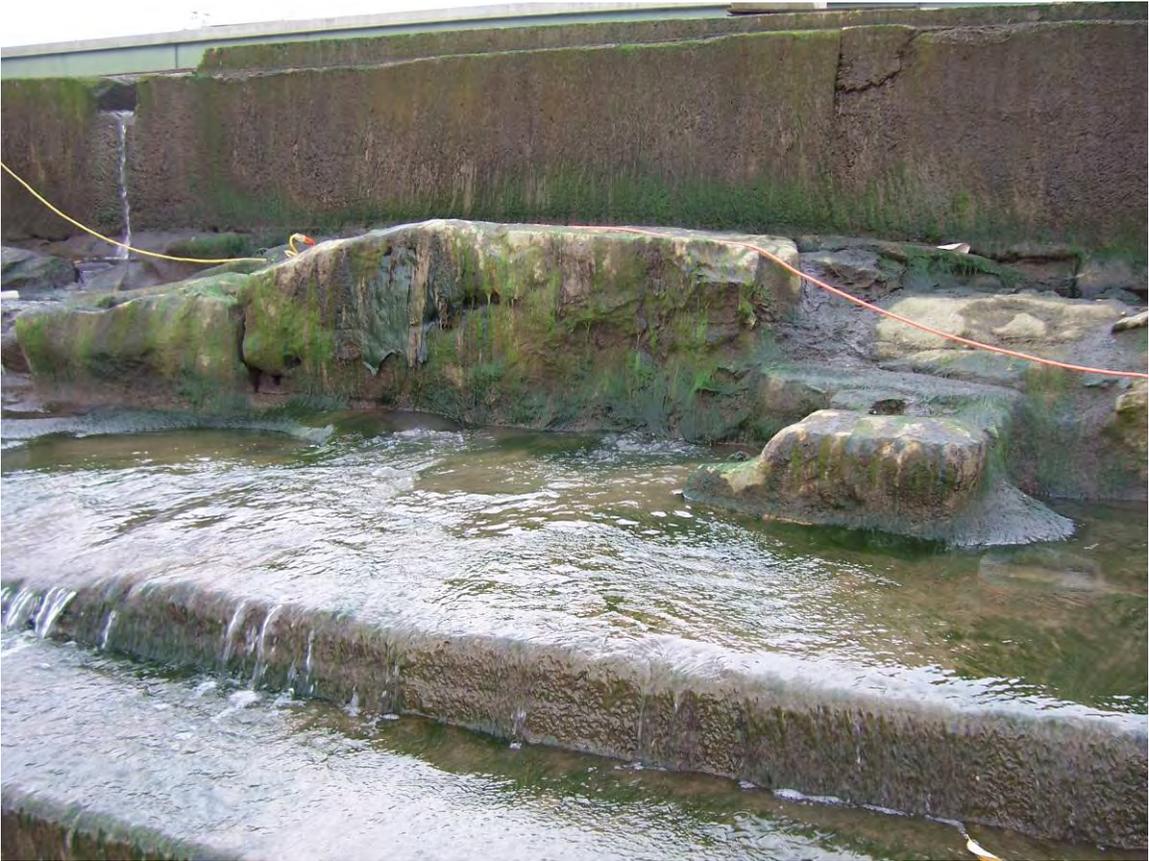
62. Sta 4+75±. Eroded and irregular steps with exposed joint and flow through joint.

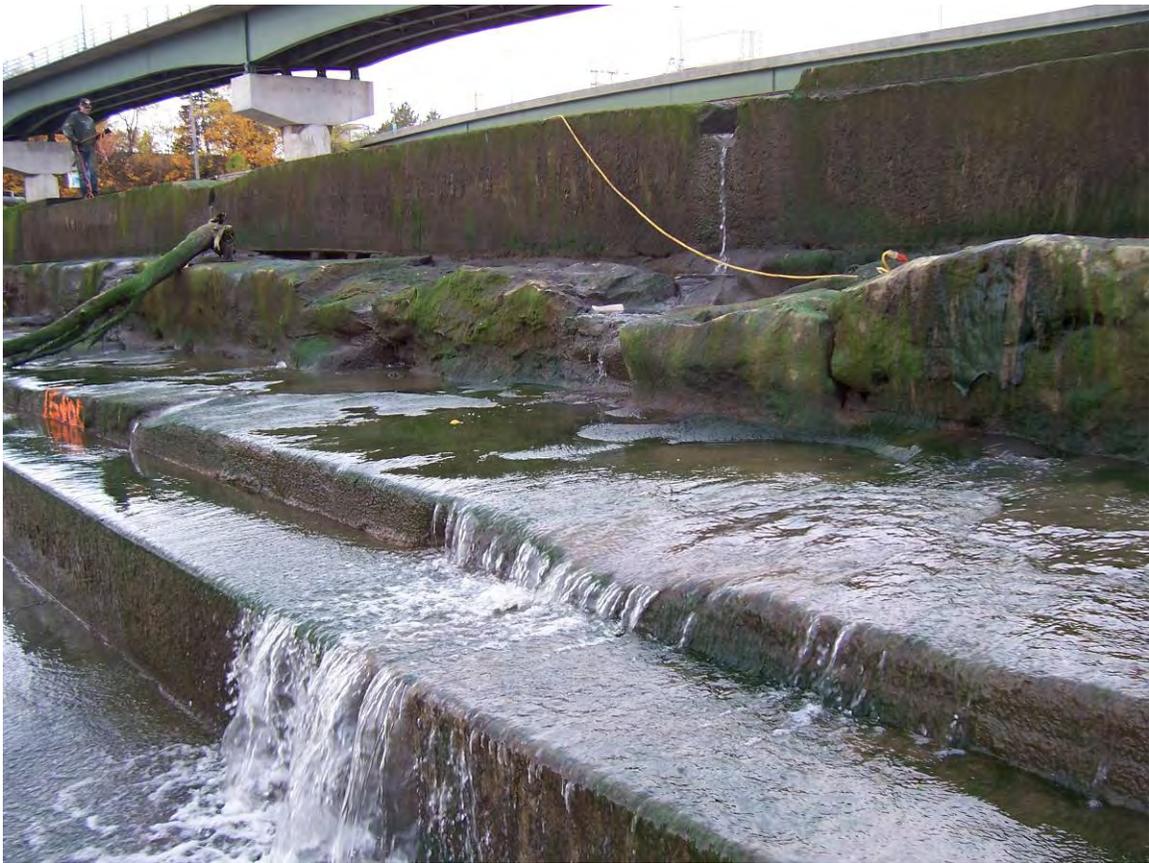
63. Sta 4+75 to 5+00. Severely eroded top step with flow through joint in step.

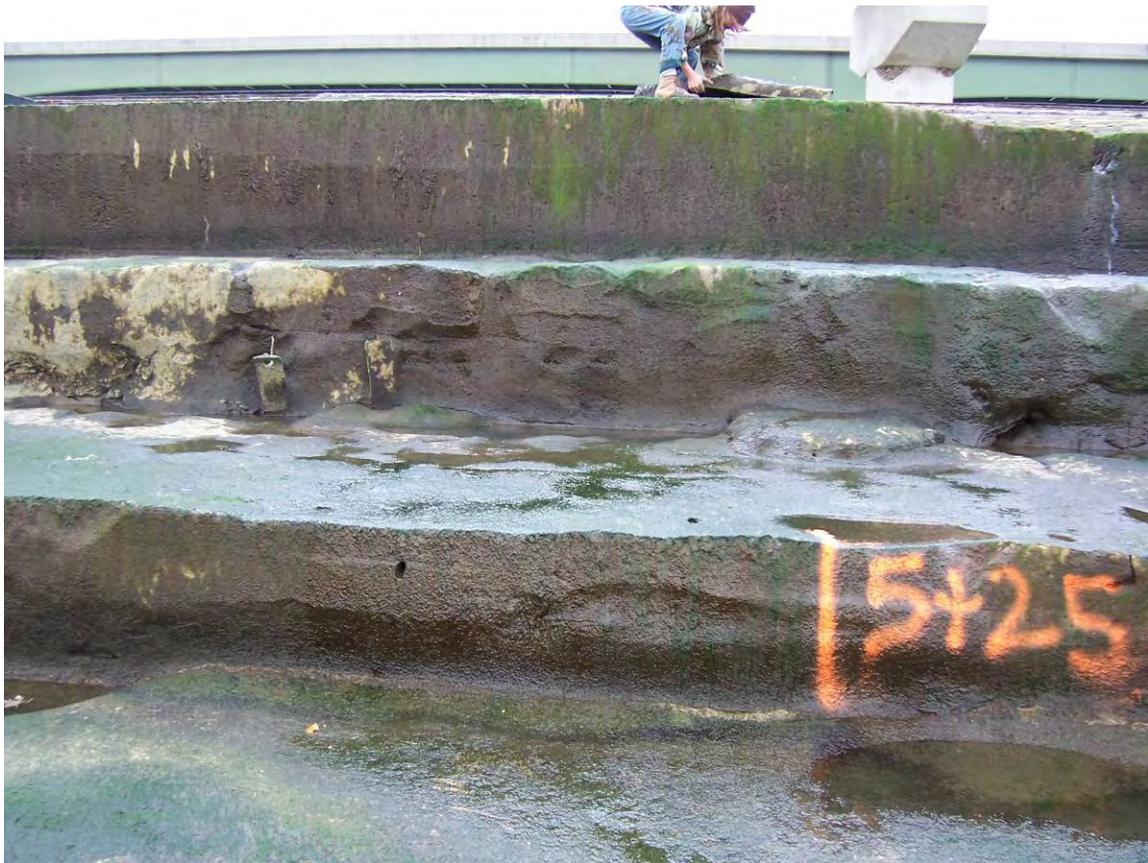
67. Sta 5+25 to 5+35. Exposed I-beam piling at Sta 5+35. Eroded shotcrete exposed joint at step.

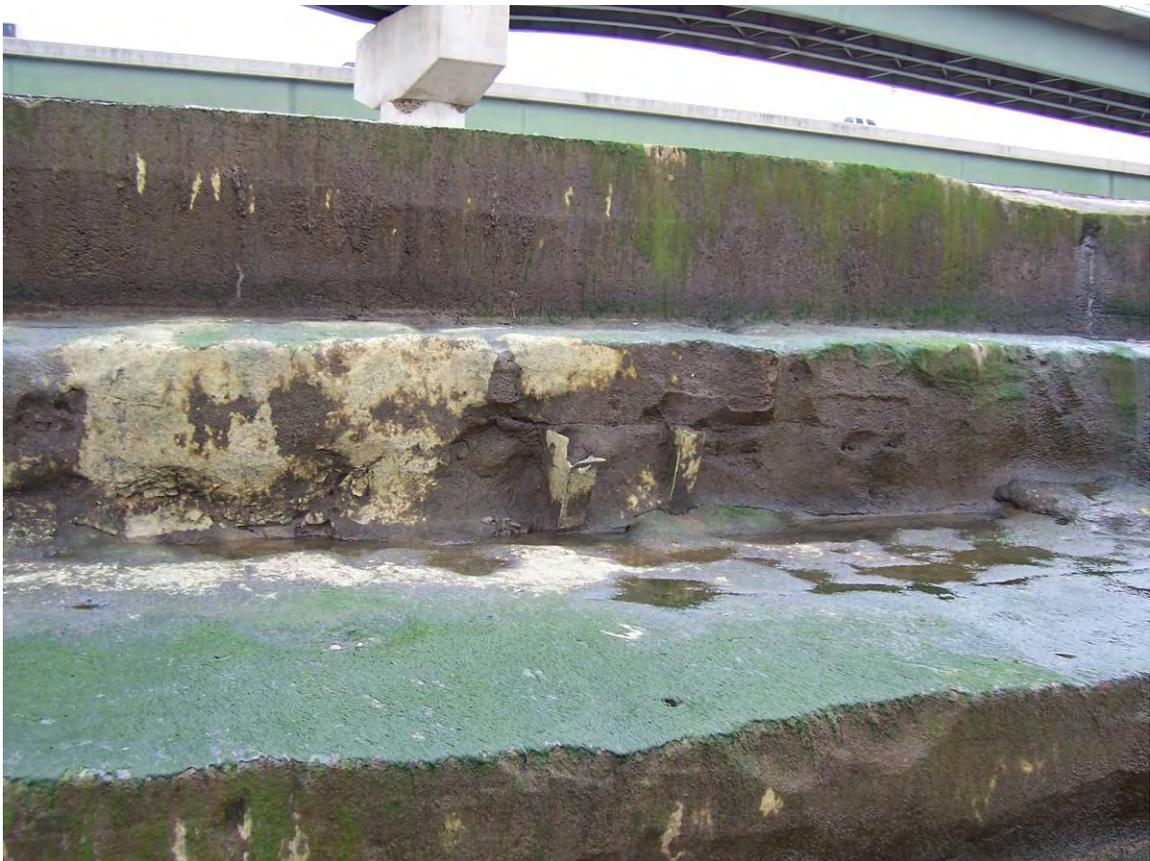
68. Sta 5+35. Exposed I-beam pilings.

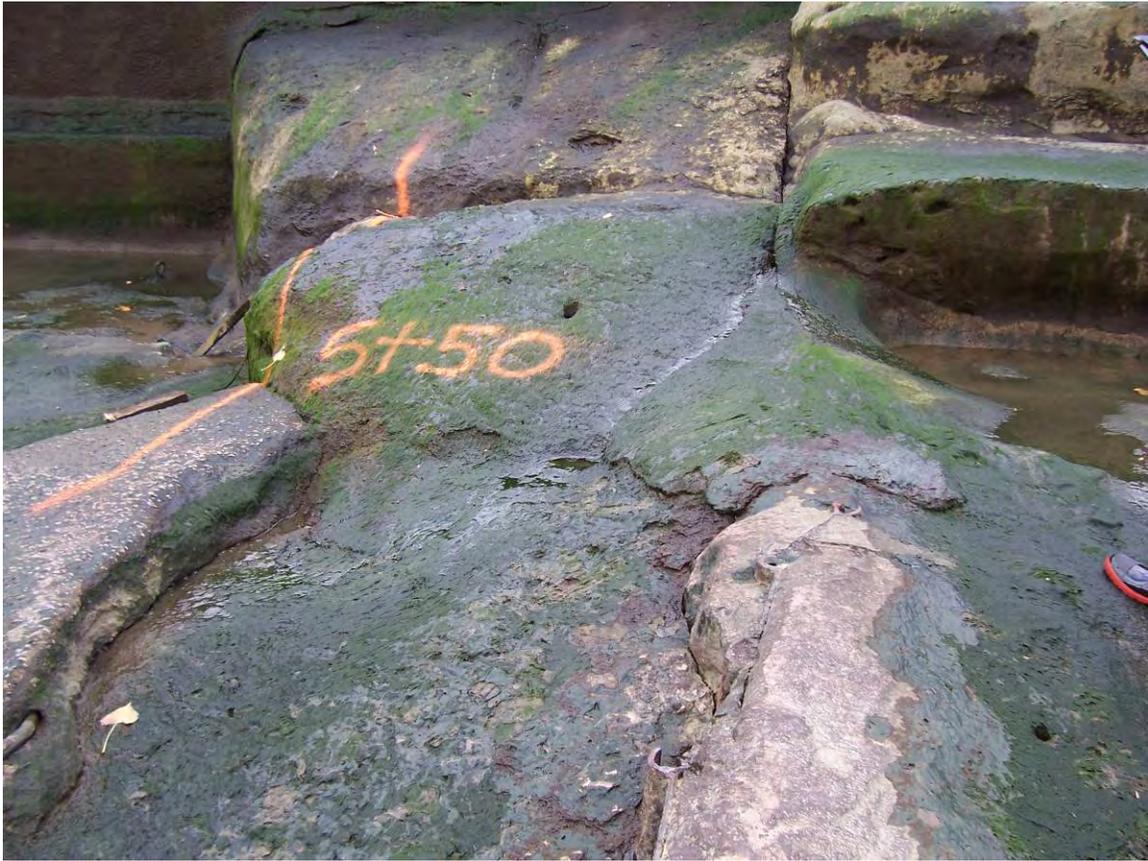
69. Sta 5+50. South end of steps. Eroded concrete exposed joints.

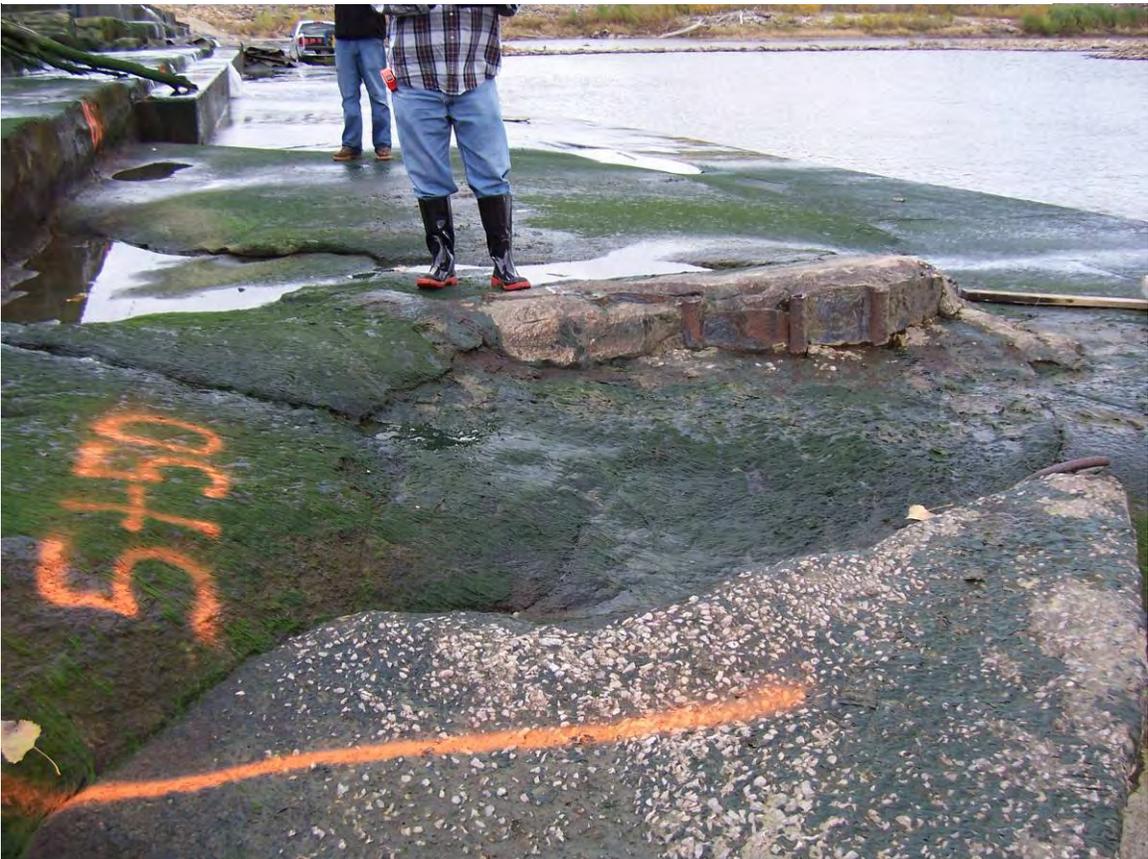
70. Sta 5+50. South end of steps. Exposed old sheet piling encased in apron. Eroded concrete with numerous exposed joints.

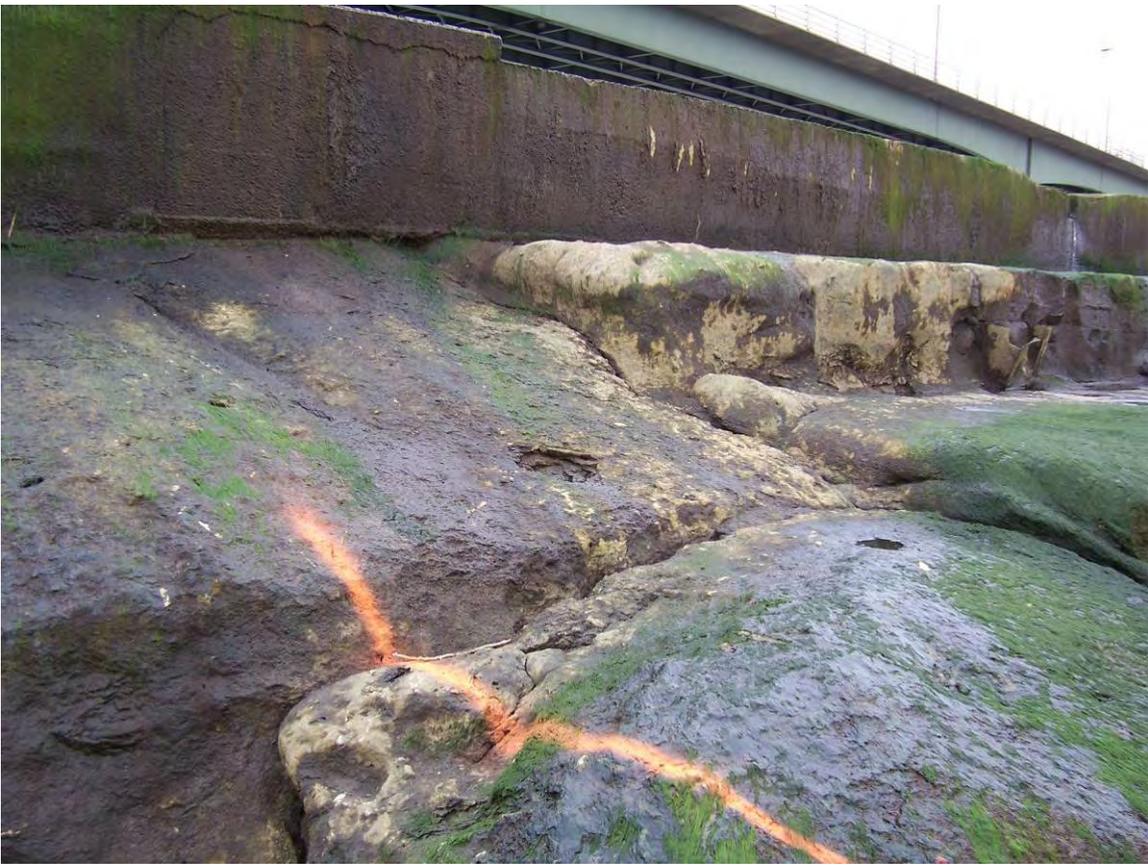
71. Sta 5+50. South end of steps. Eroded concrete exposed joints.

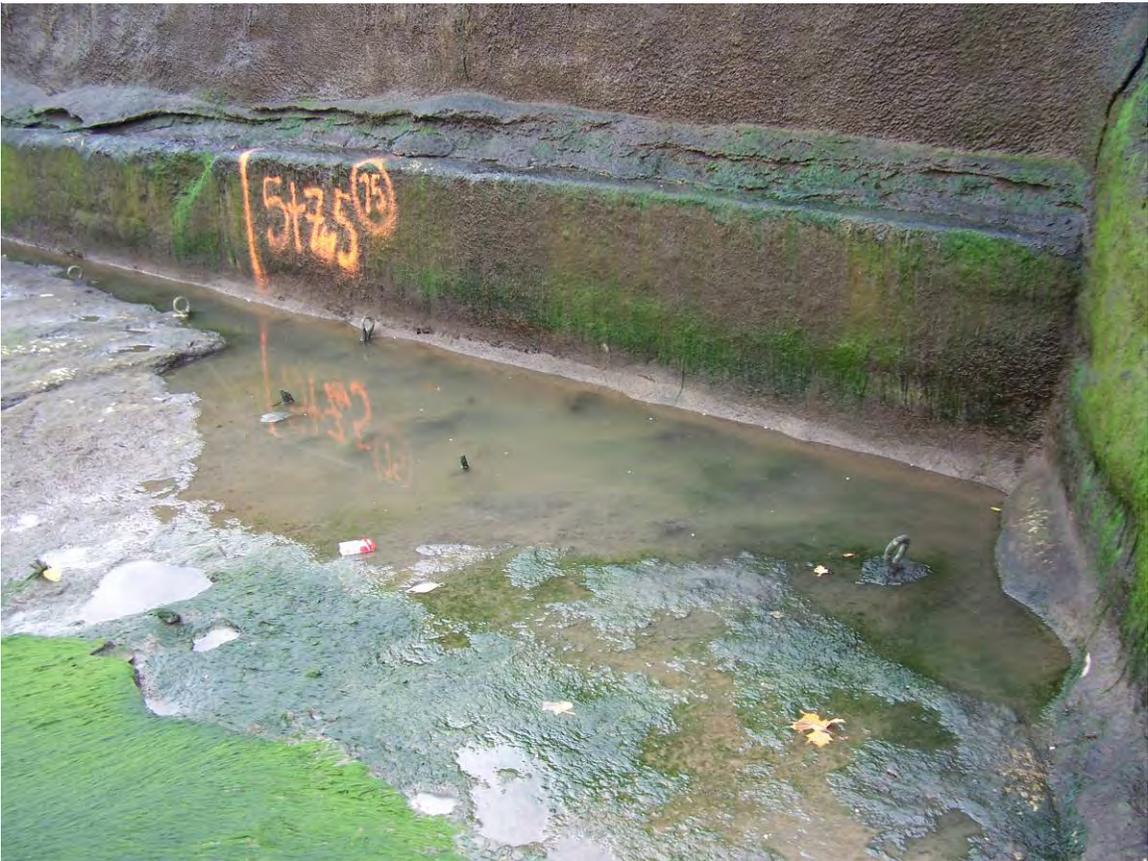
72. Sta 5+75. Eroded shotcrete. Depression with exposed spikes and tie-rings.

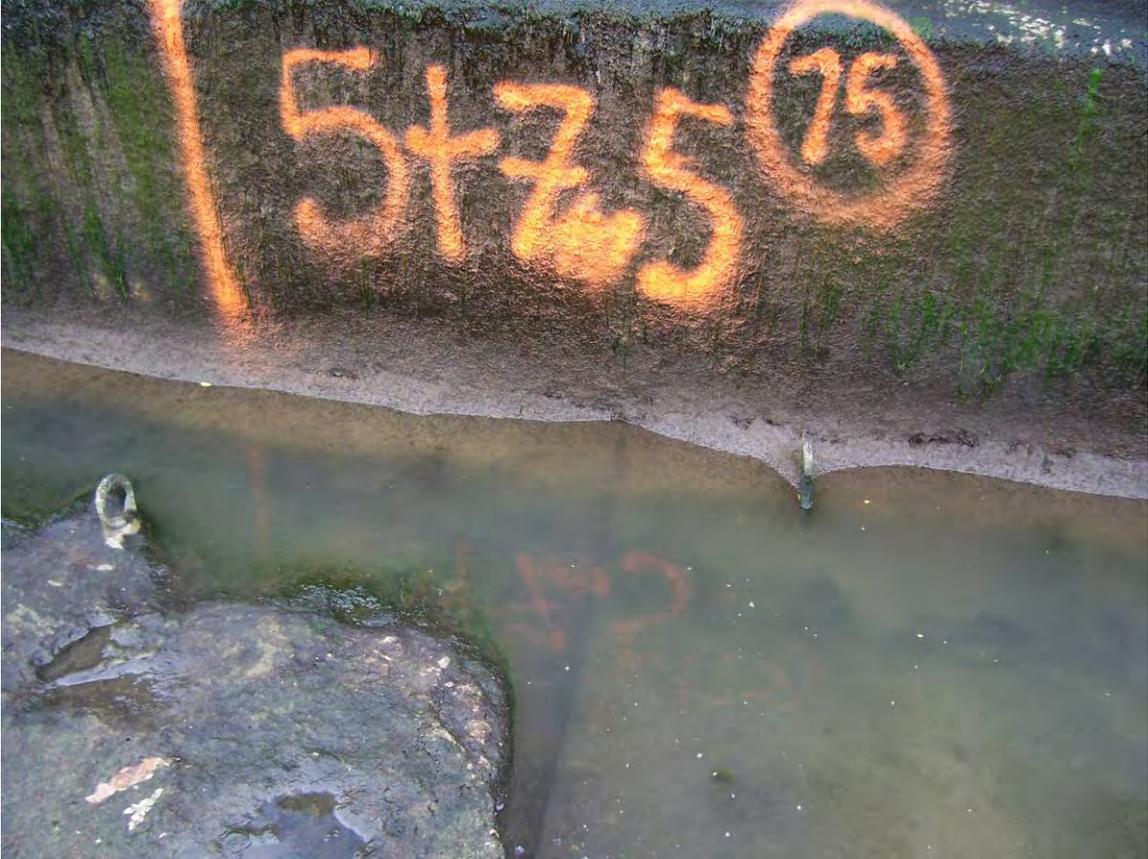
73. Sta 5+75. Eroded shotcrete. Depression with exposed spikes and tie-rings.

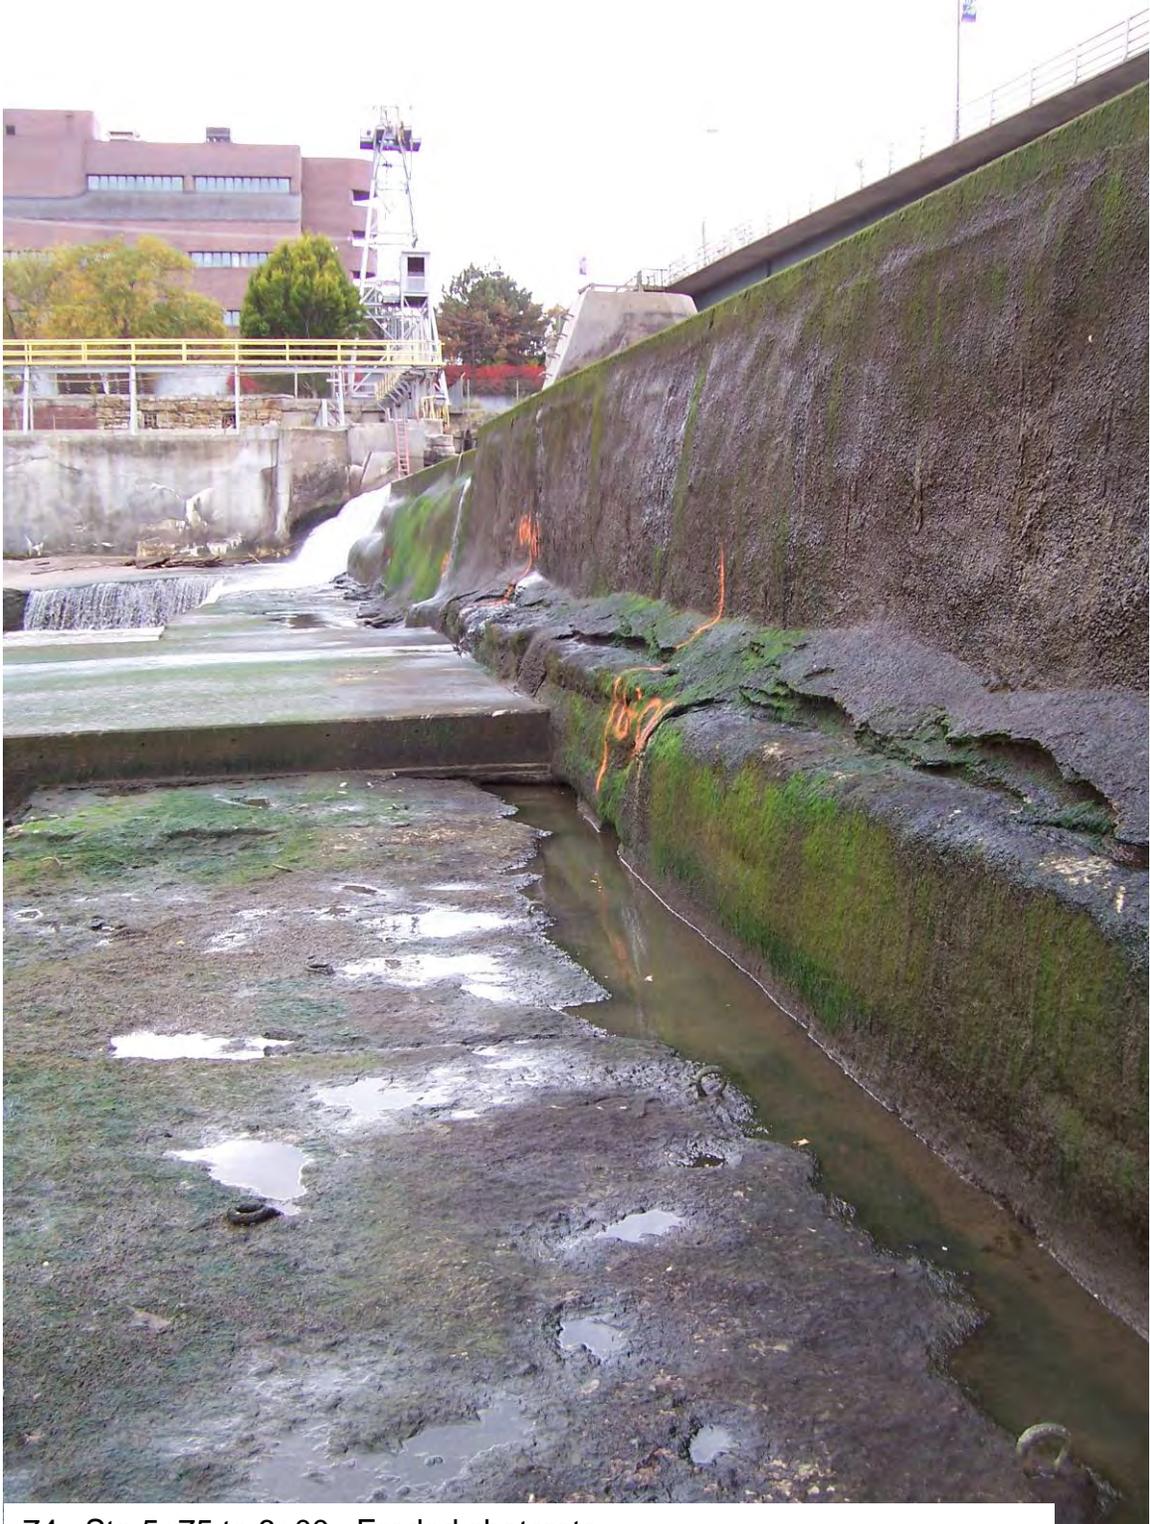
74. Sta 5+75 to 6+00. Eroded shotcrete.

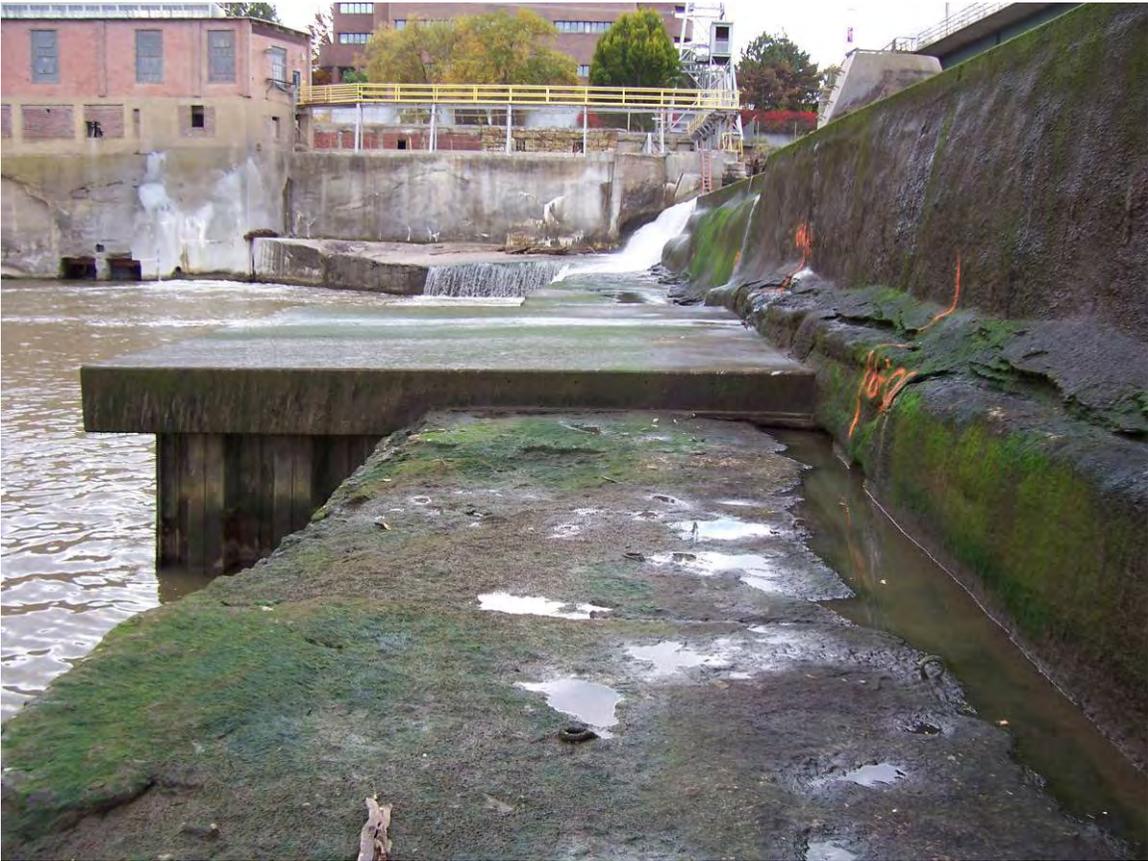
75. Sta 5+75 to Sta 6+00 South. Eroded shotcrete. Short section of piling and new apron.

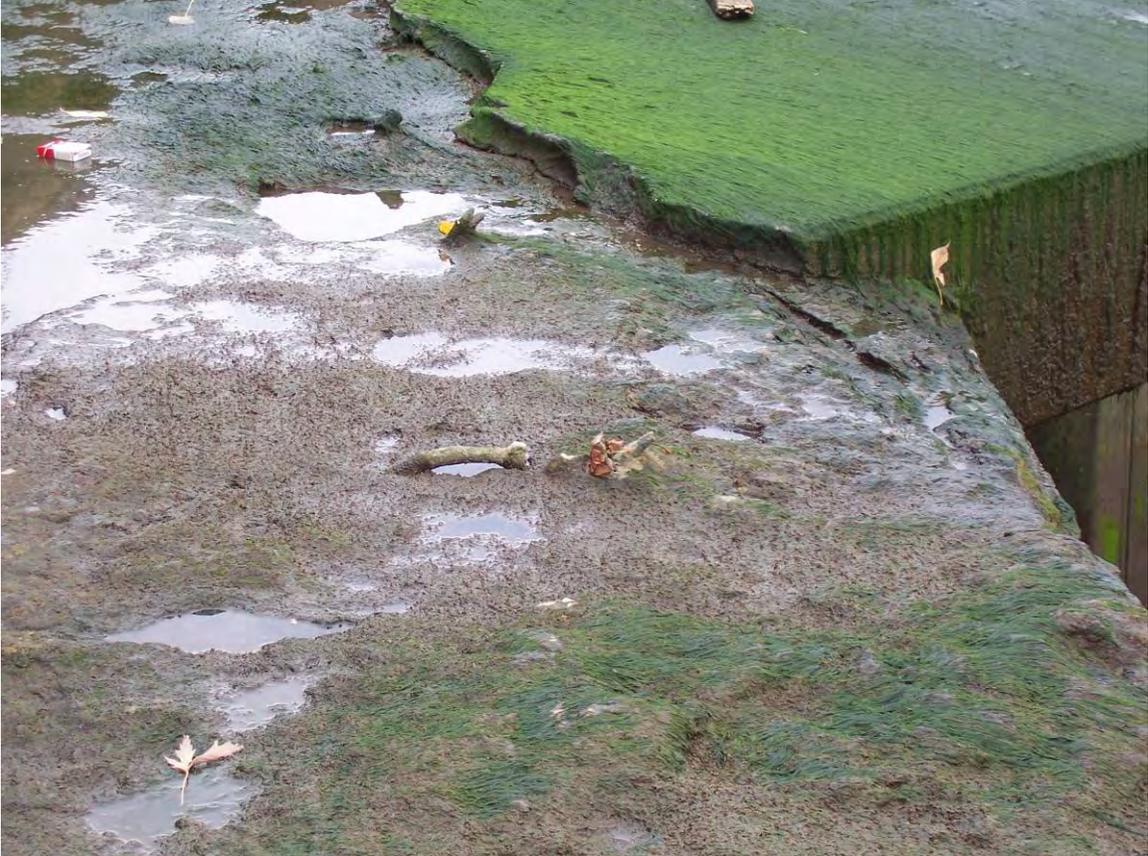
76. Sta 5+75 to 5+60 North. Eroded portion of new apron. Exposed spike in old apron.

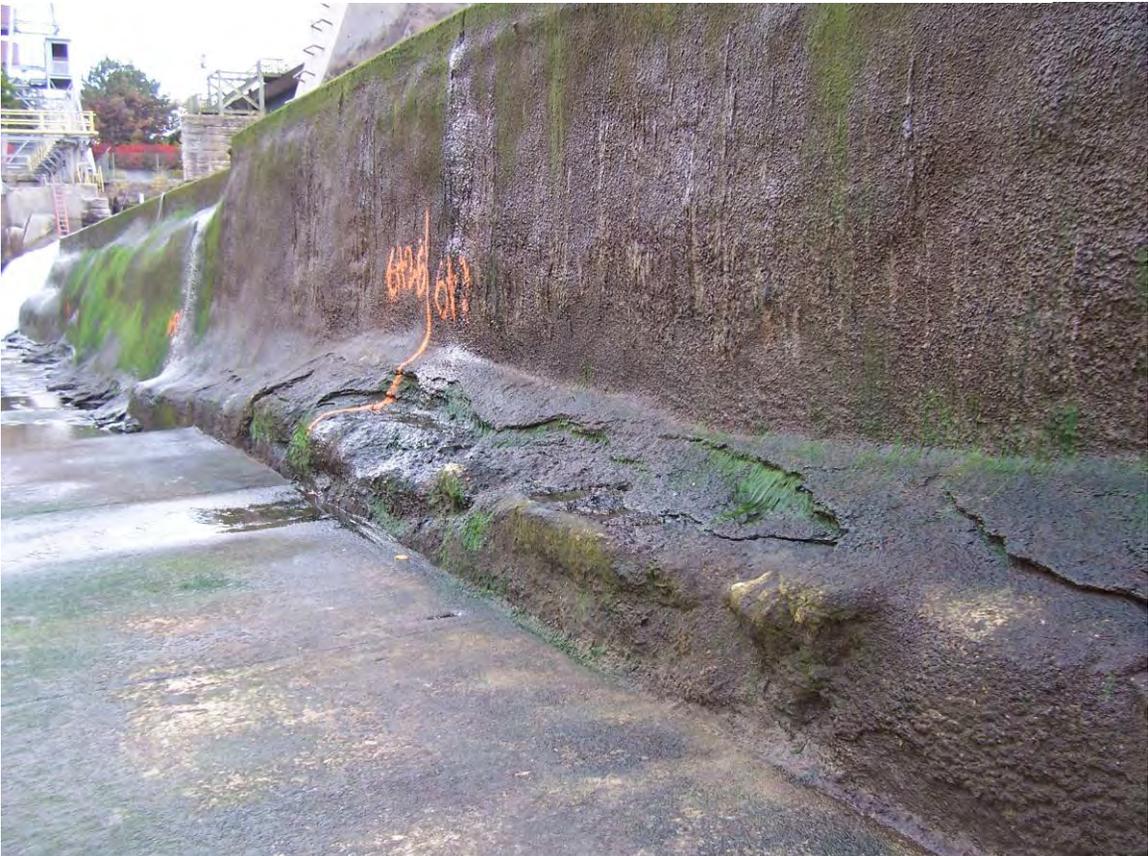
77. Sta 6+00 to 5+75 North. Eroded shotcrete.

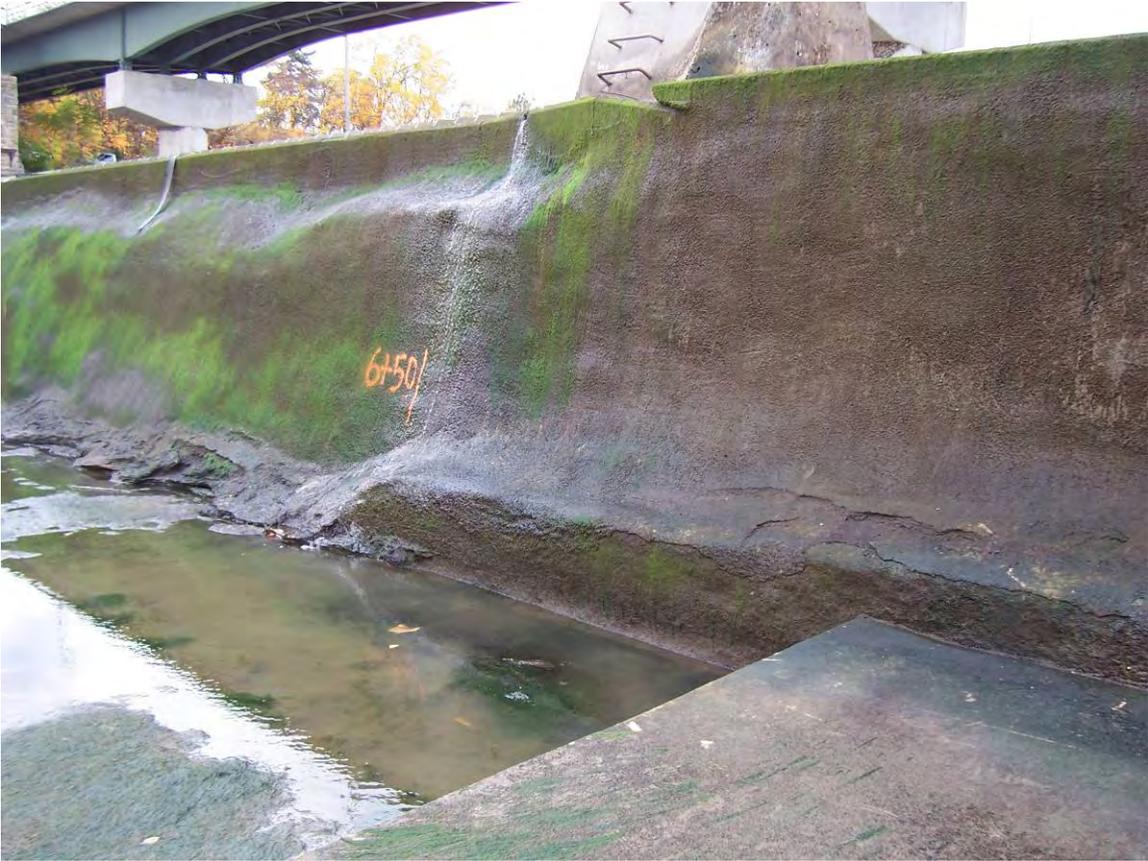
78. Sta 6+25. Eroded shotcrete.
