Lawrence, Kansas
Bowersock Dam Inspection 2006

B&V Project 146136
B&V File B-1.1
February 14, 2007

On October 30, 2006 an inspection of the Bowersock Dam in Lawrence, Kansas was performed to assess the condition of the dam. This report summarizes the visual observations made of the dam's condition and provides a phased recommendation for corrective actions for the City of Lawrence's consideration.

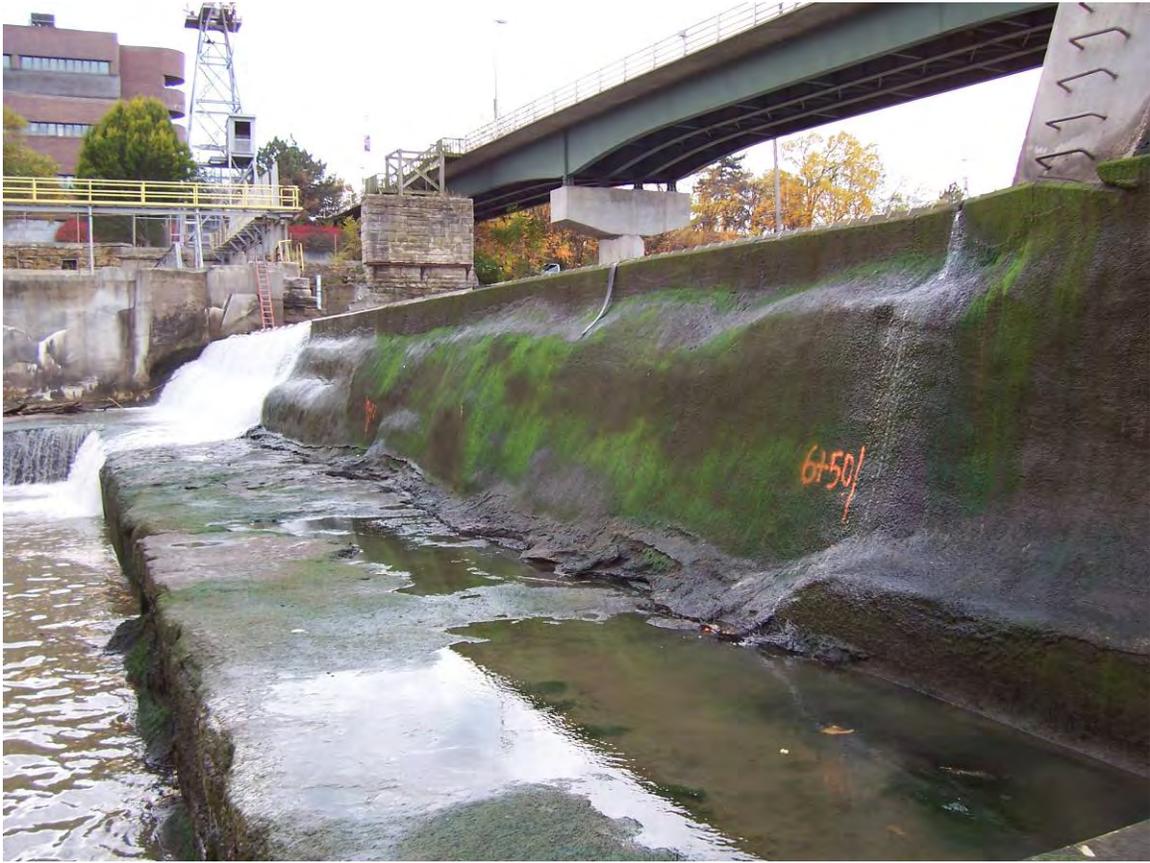
79. Sta 6+50 to south pneumatic flashboards. Eroded shotcrete.

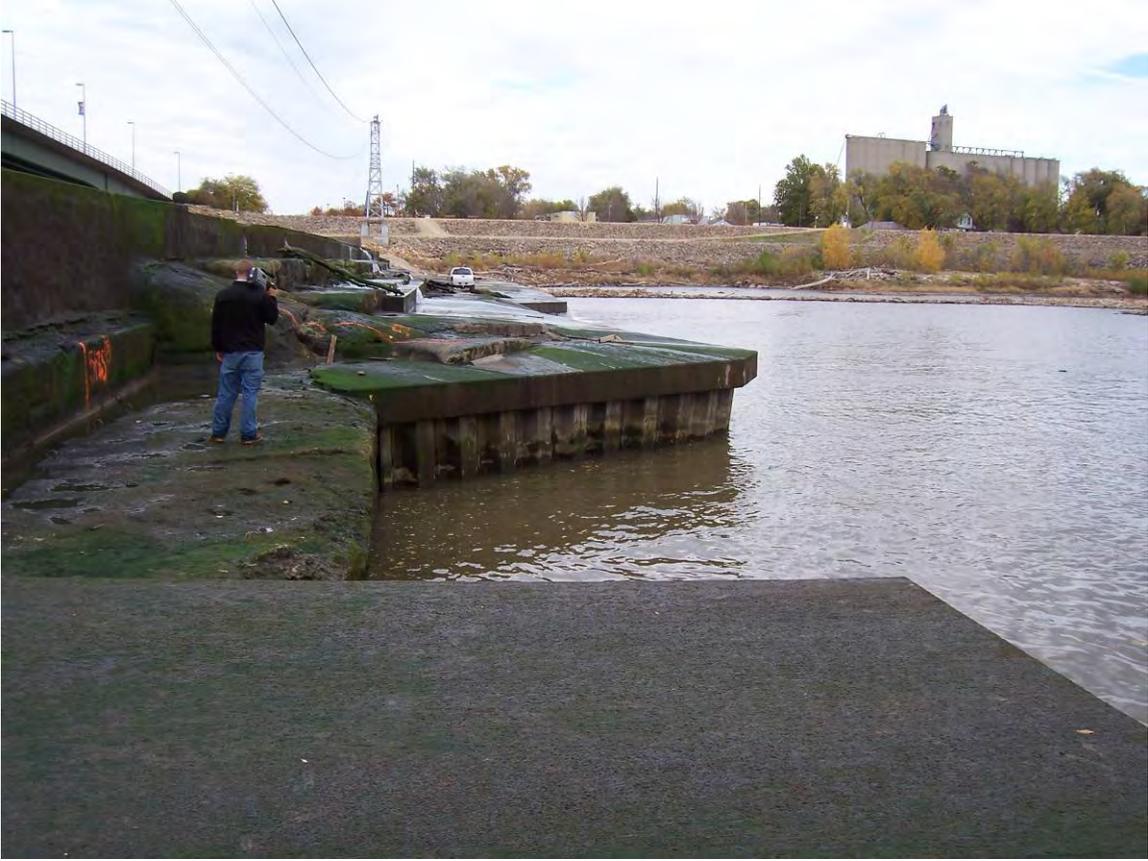
83. Sta 6+50 to south pneumatic flashboards. Eroded shotcrete.

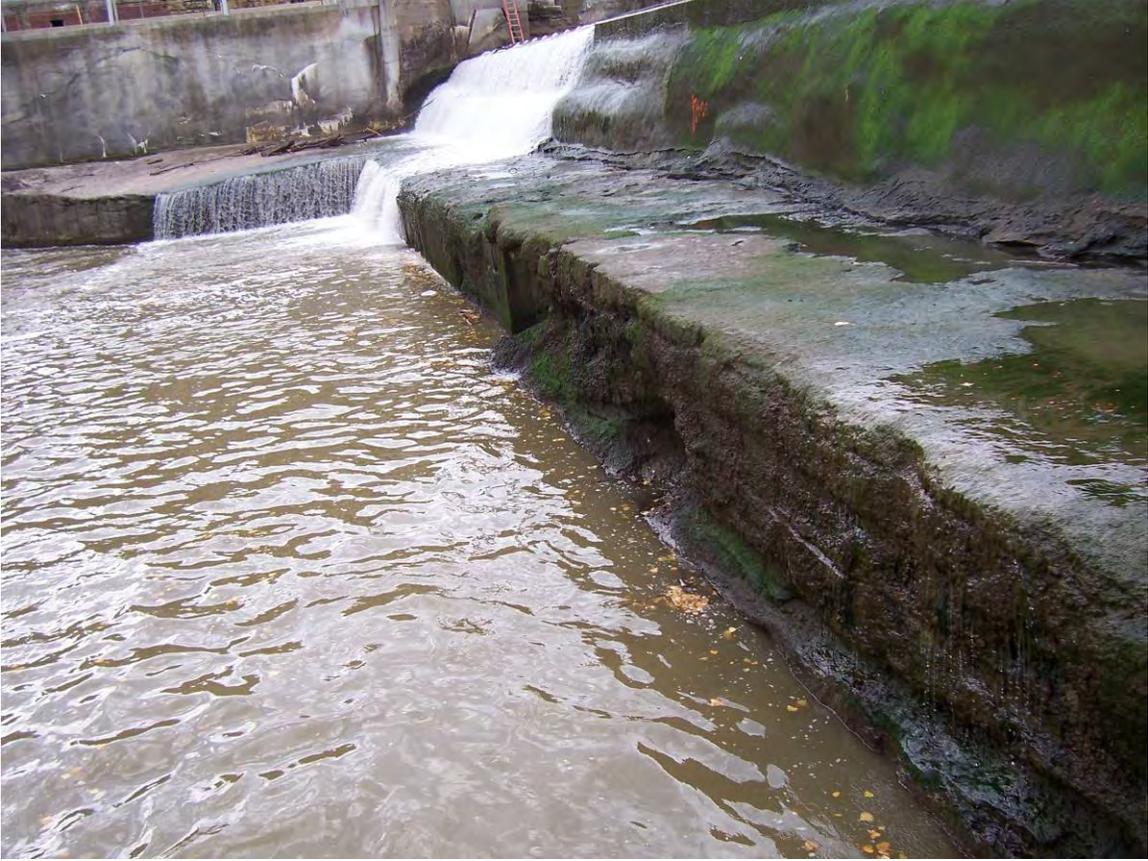
85. Sta 5+80 to 6+00. Hole below old apron.

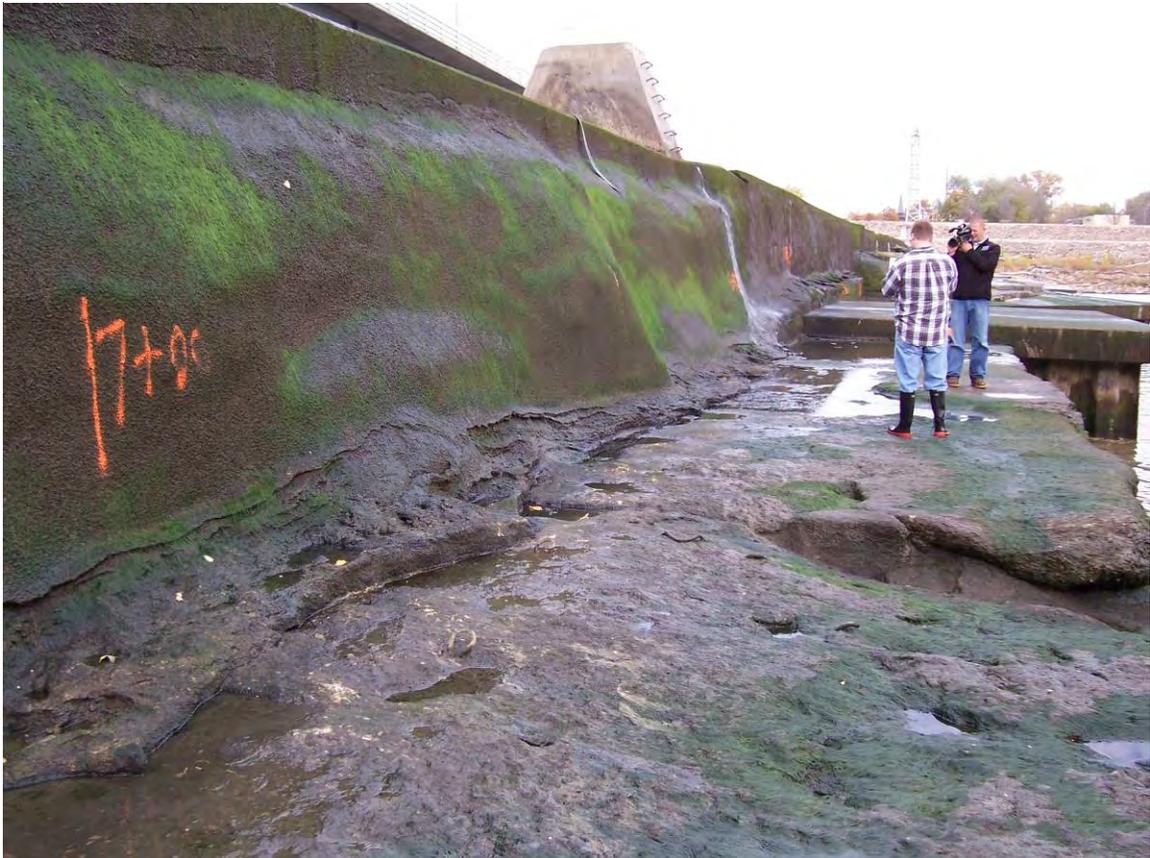
88. Sta 6+80 to north. Severely eroded apron and shotcrete.

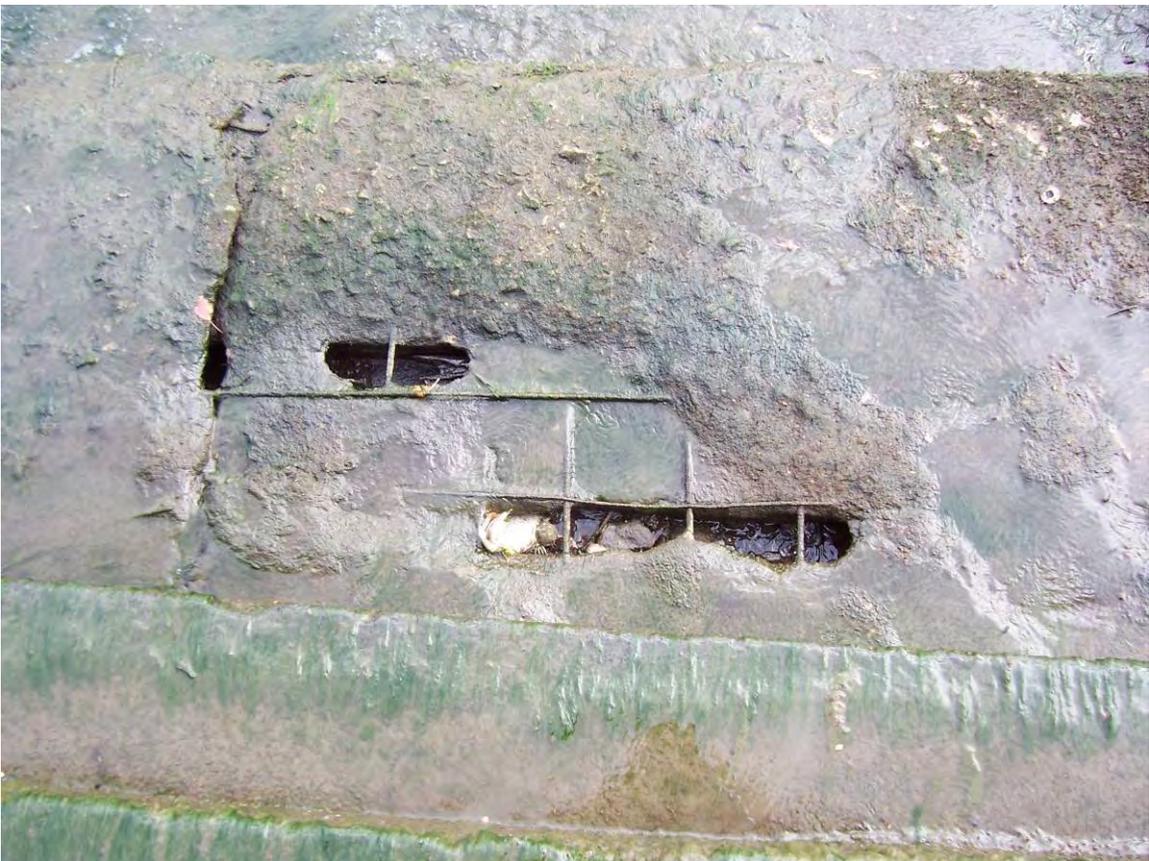
98. Sta 4+40±. Eroded concrete with exposed timber in top step.

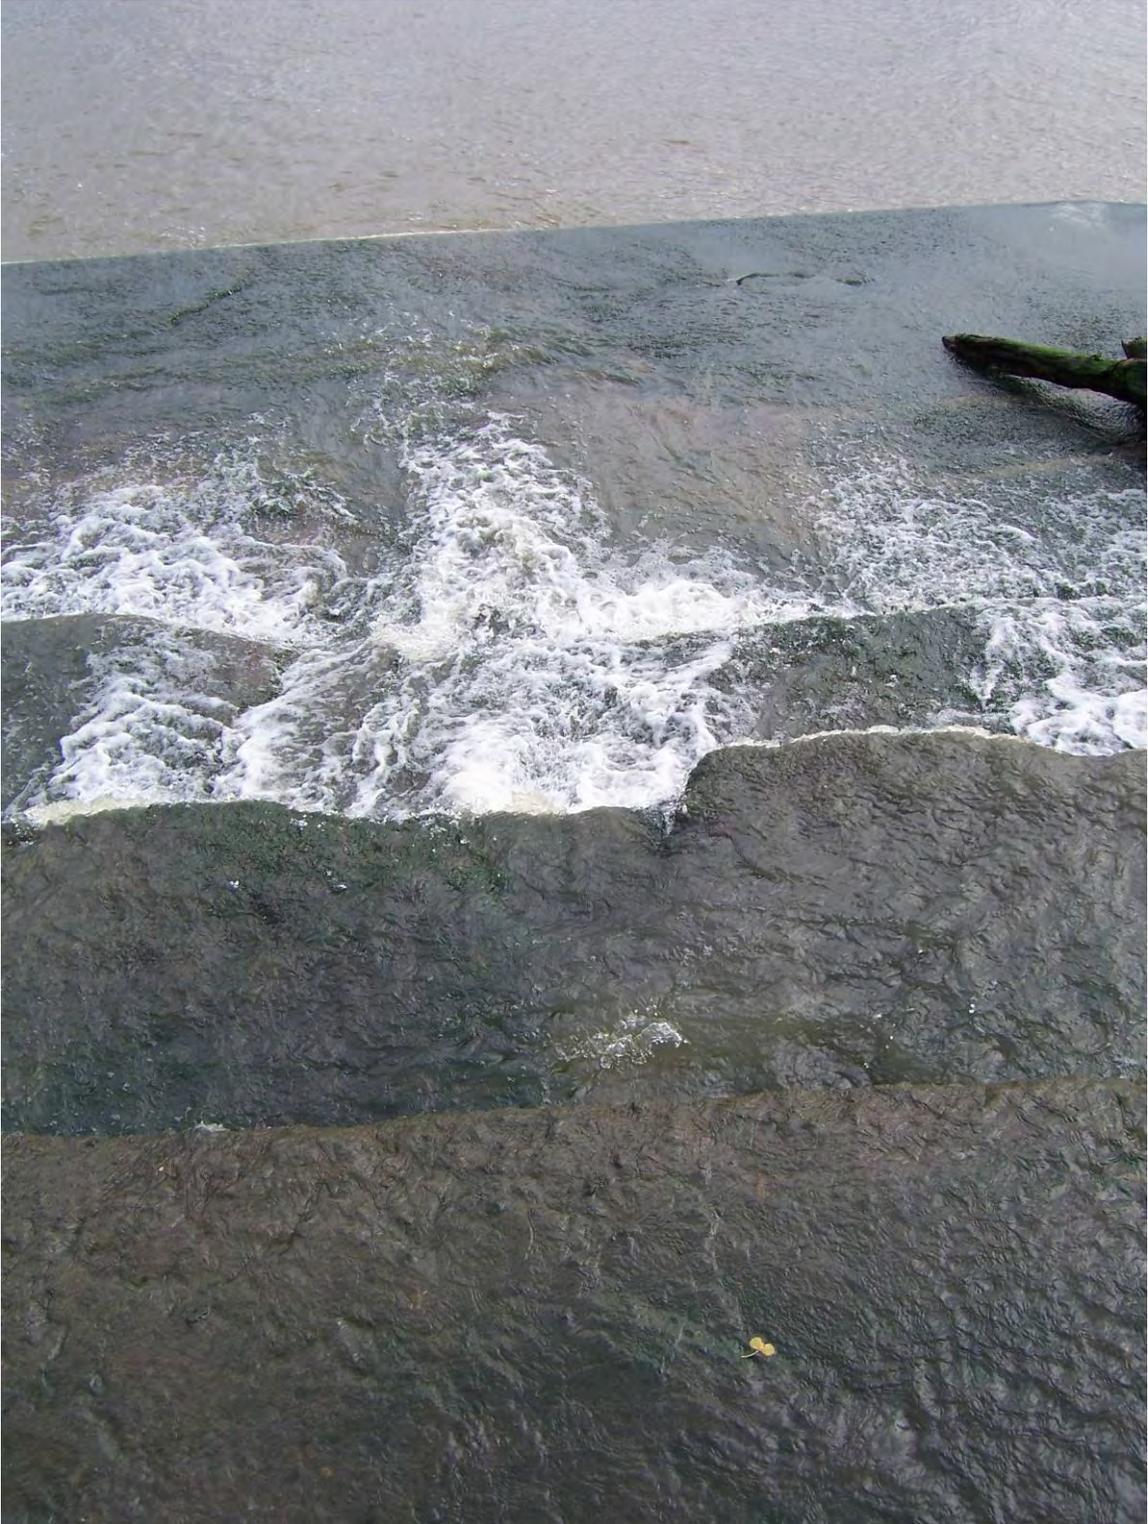
99. Sta 3+90±. Eroded concrete with exposed wire mesh in top step.

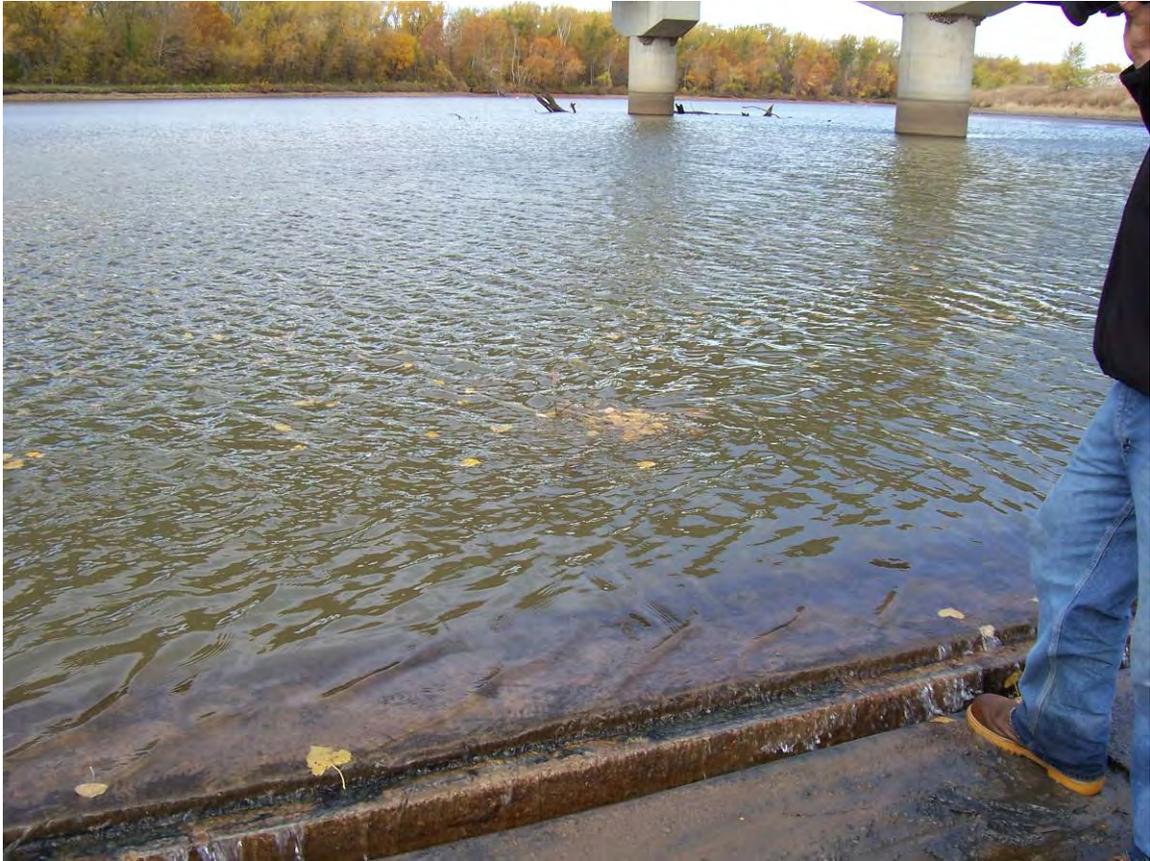
100. Sta 3+80± from top. Severe flow through dam.

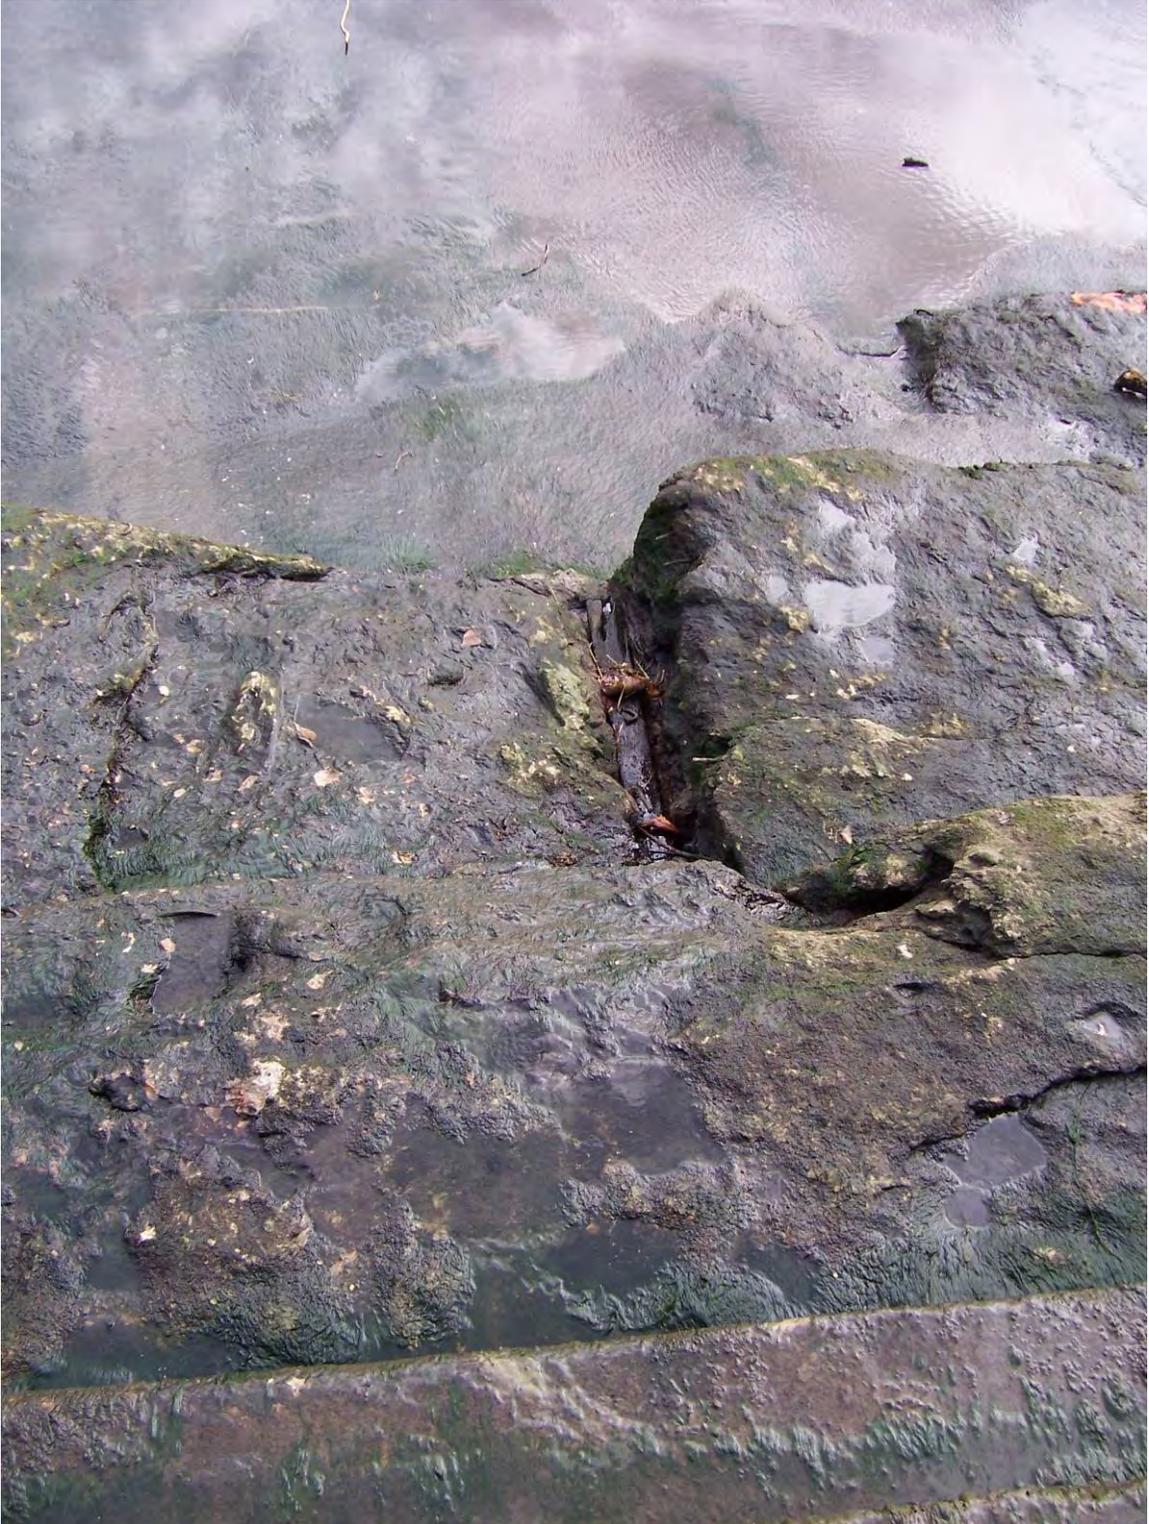
104. Sta 3+00 from top. Eroded timber hole with exposed rebar.

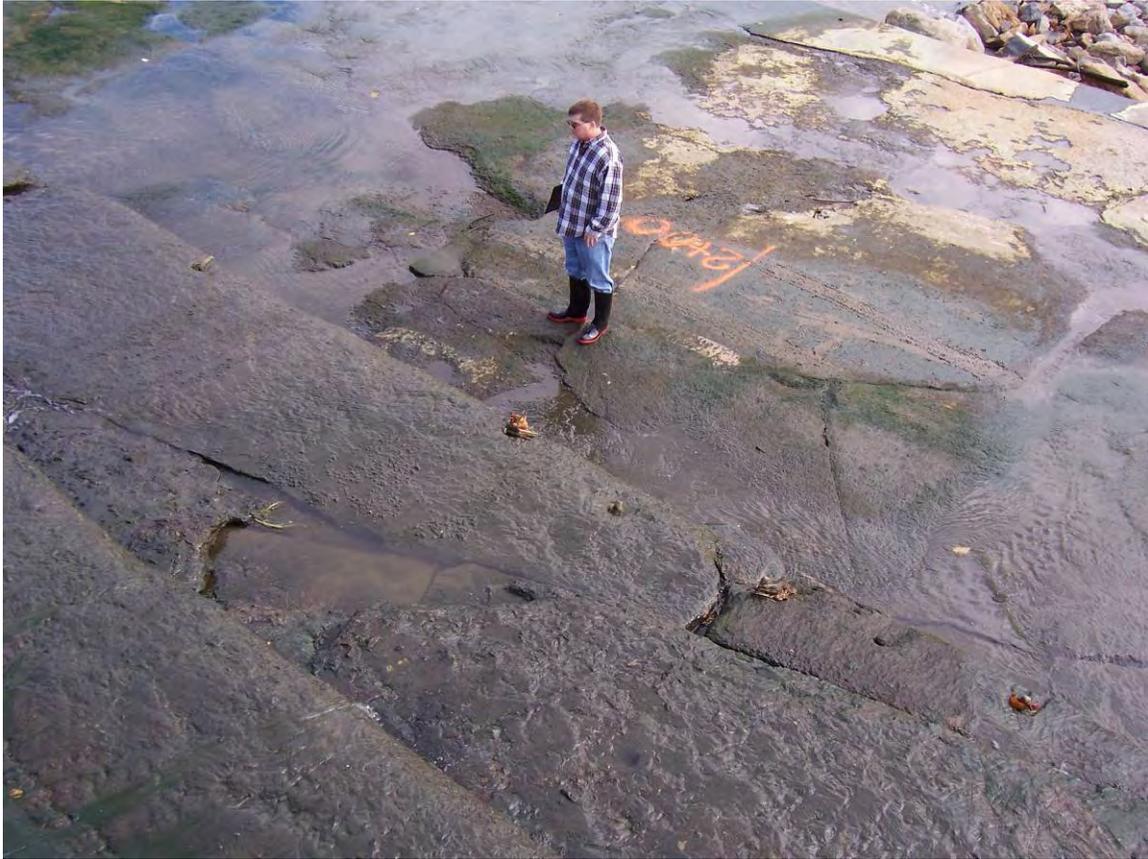
105. Sta 2+80 from top. Eroded timber and concrete.

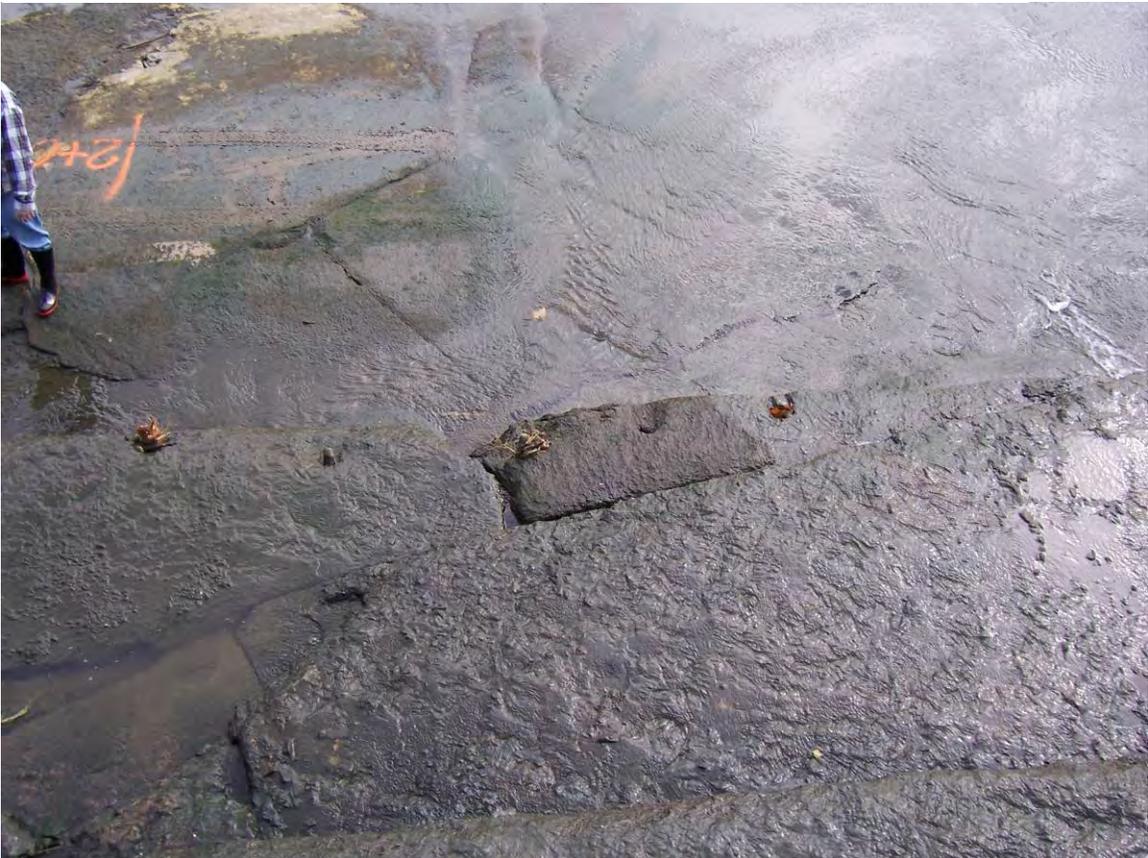
106. Sta 2+00 from top. Separated triangular section in bottom step.

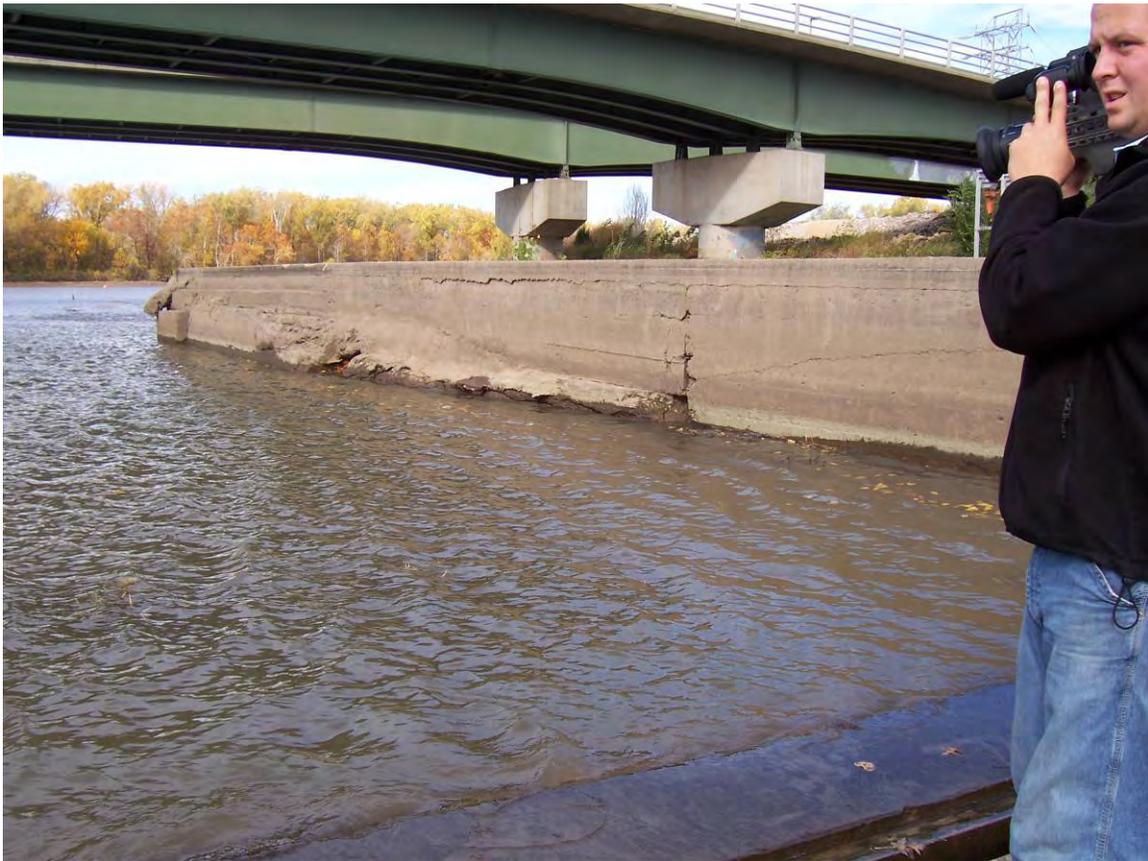
108. Sta 1+75 to south. Separated triangular section in bottom step. Eroded concrete steps.

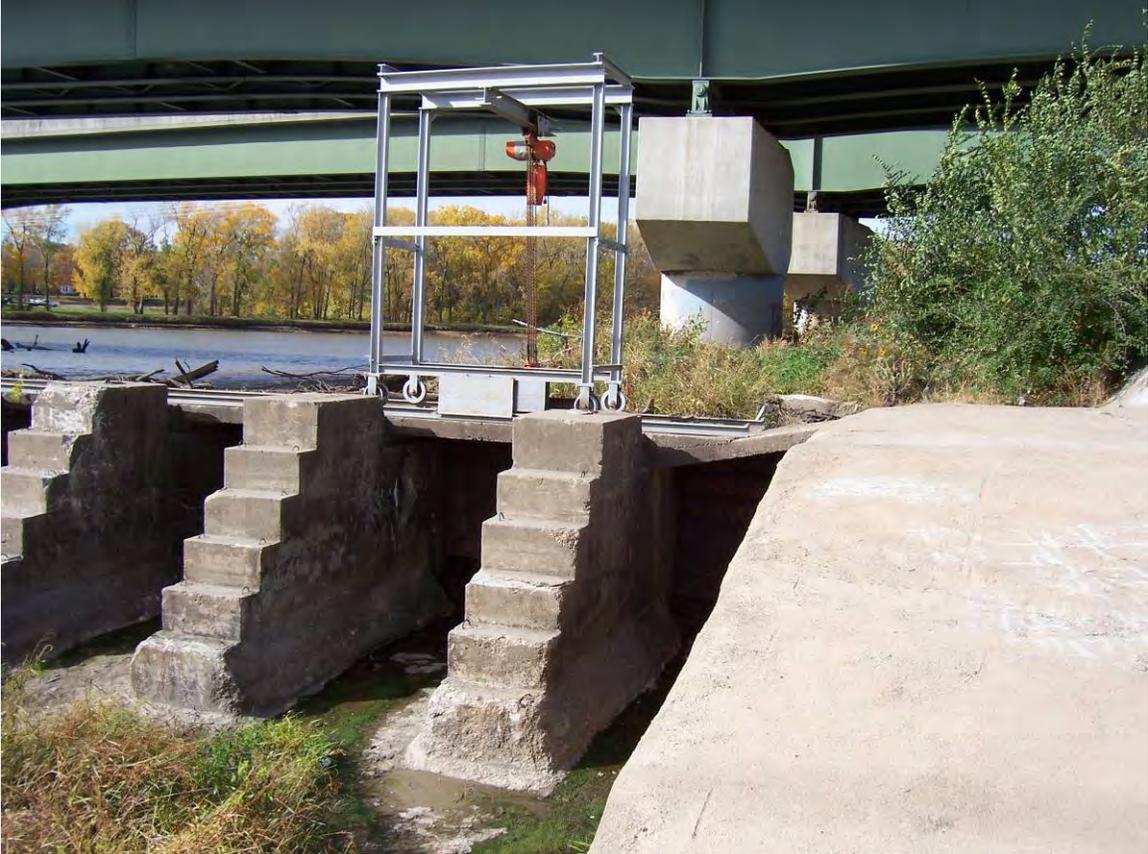
109. Sta 1+75 top of dam to north dam wall. Eroded concrete and open joints.

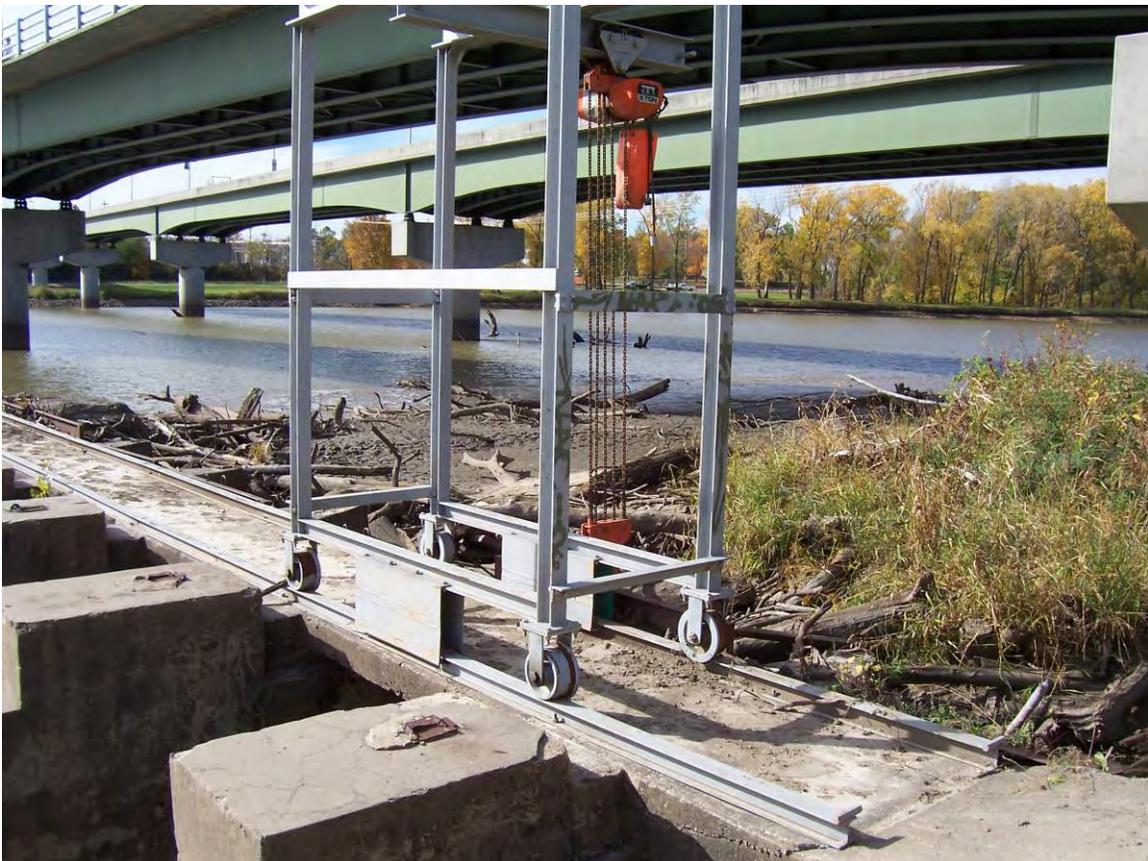
113. North end of spillway, accumulated debris ahead of spillway inlet.

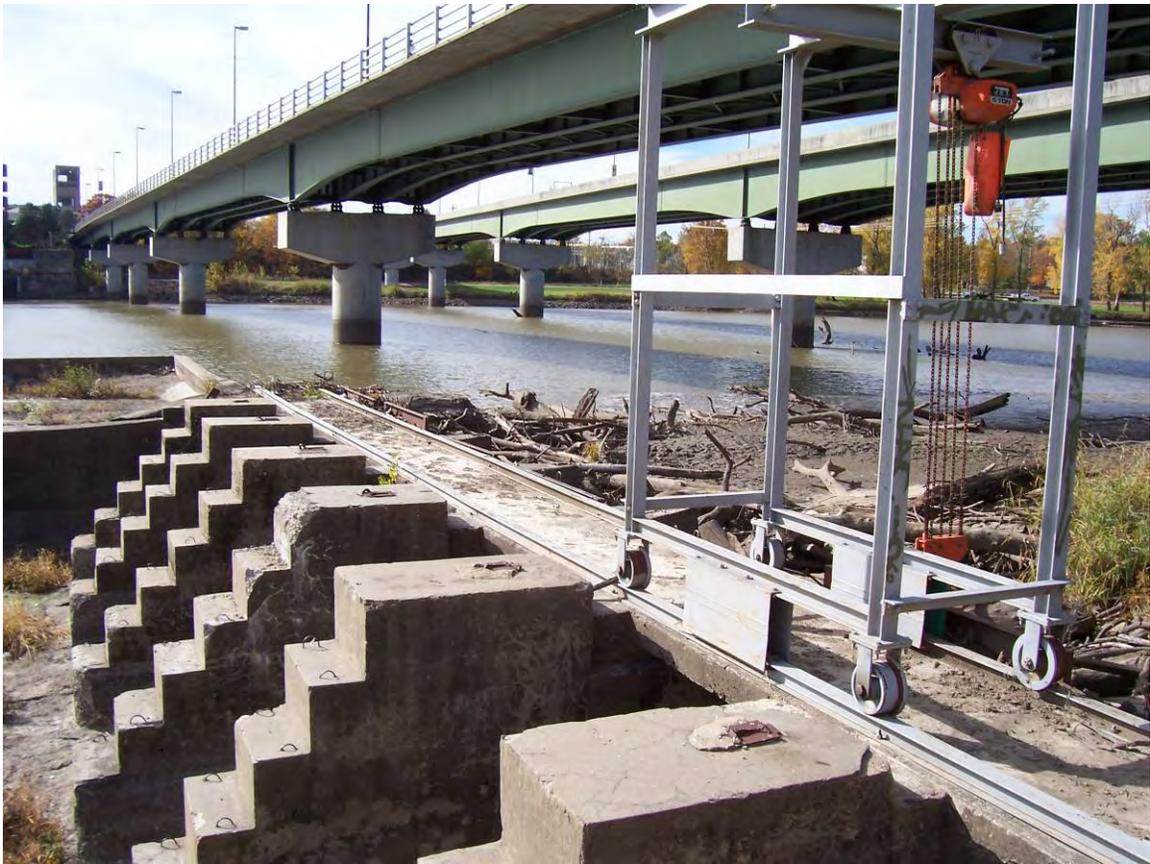
114. North end of spillway, accumulated debris ahead of spillway inlet.

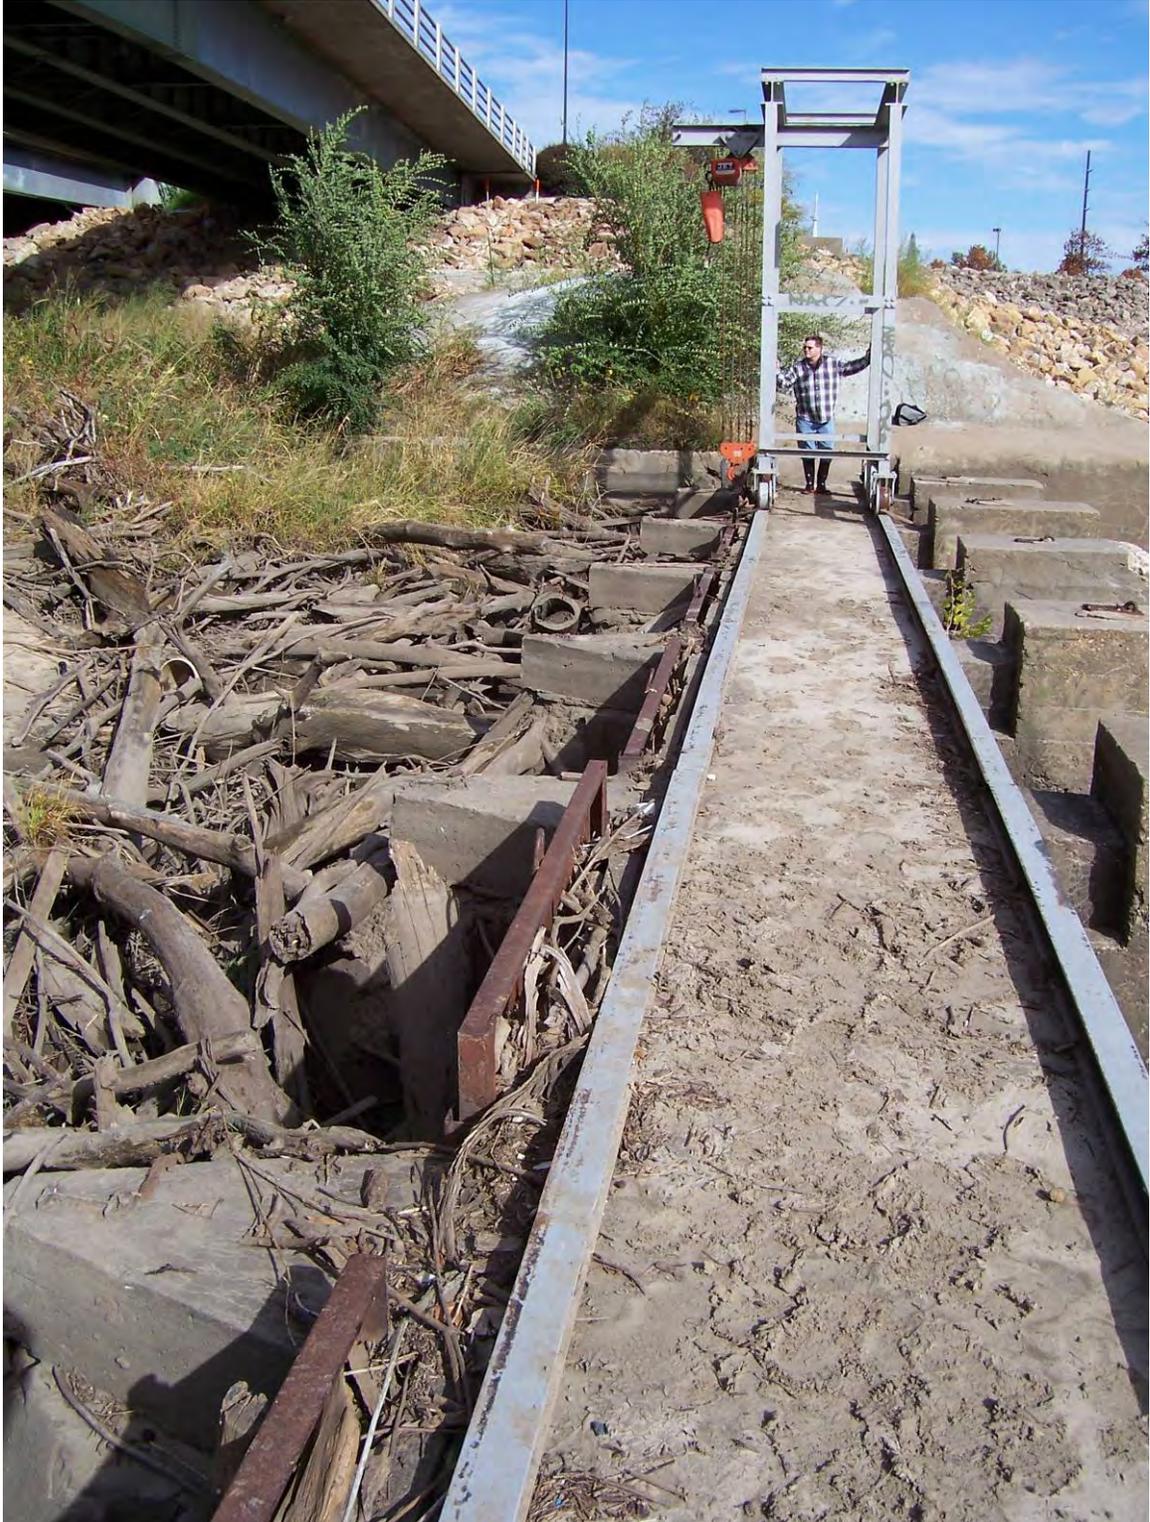
115. North end of spillway, accumulated debris ahead of spillway inlet.

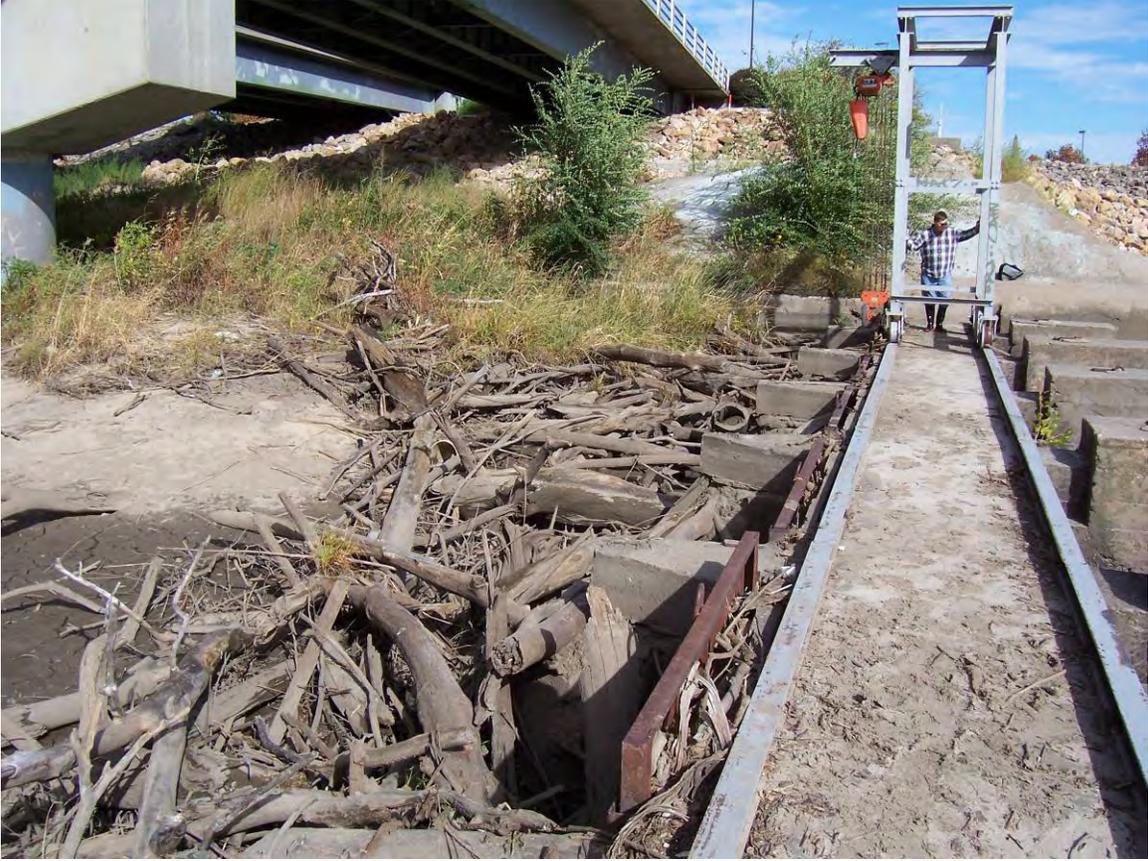
116. Top of spillway to north. Accumulated debris in front of gates.

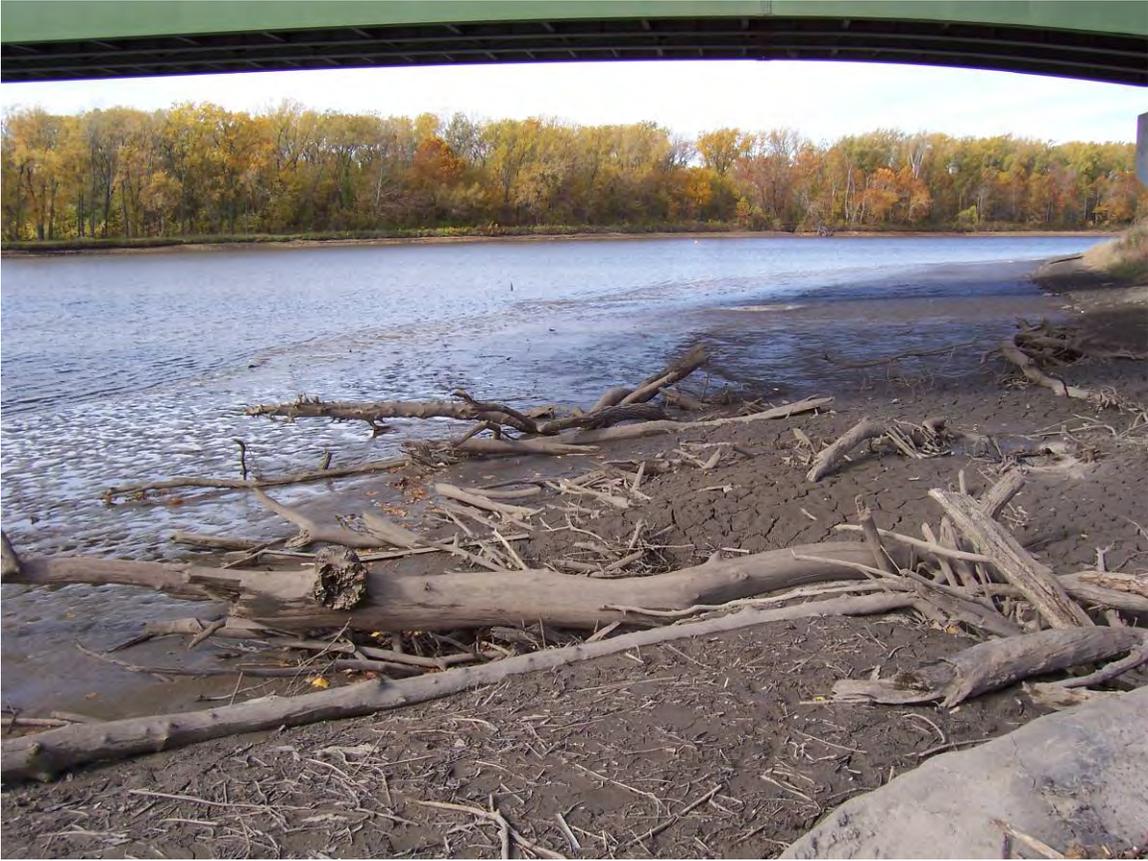
126. Accumulated debris in front of spillway gates.

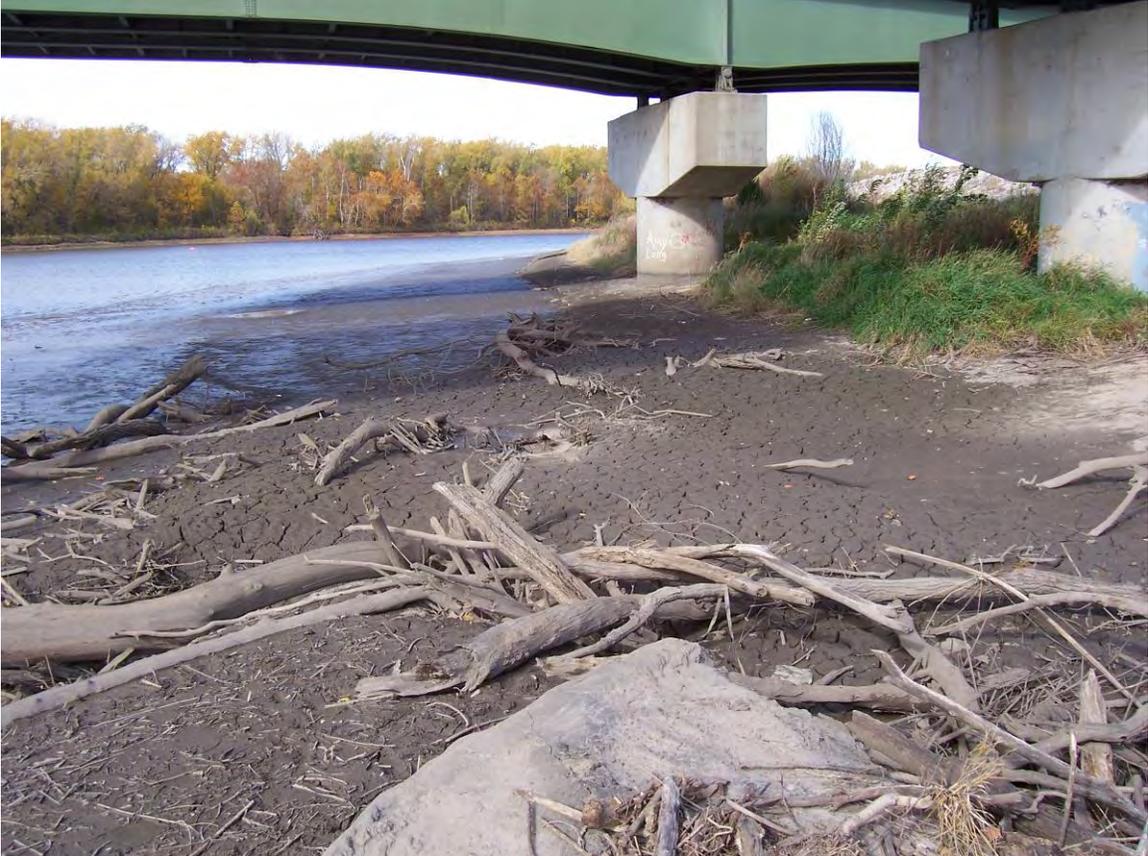
127. Accumulated debris in front of spillway gates.

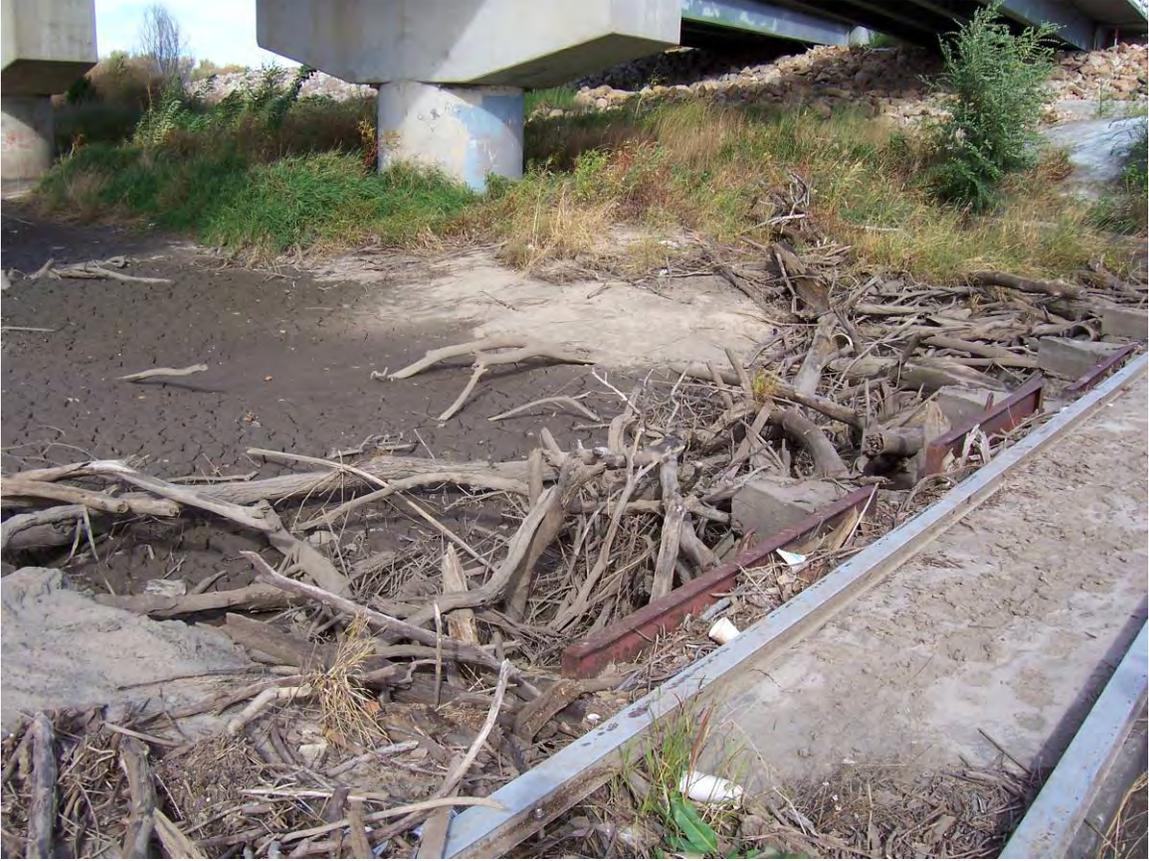
128. Accumulated debris in front of spillway gates.

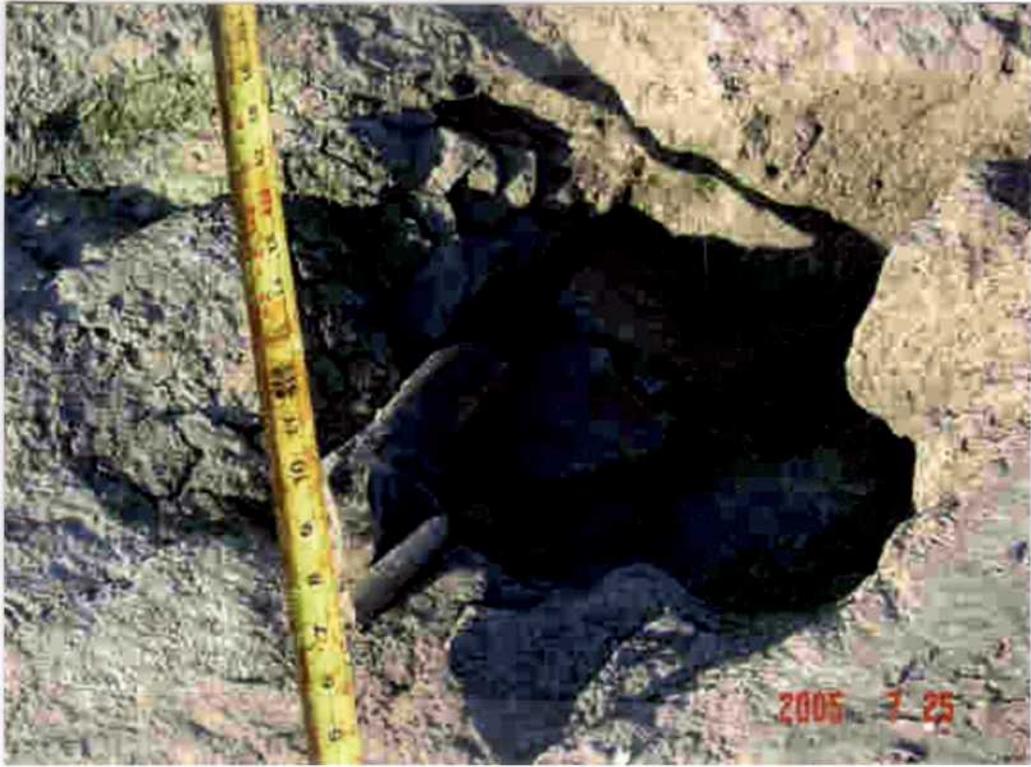
Photo #1

Ty and I used the low flows to inspect the condition of the spillway and top of the dam after the high flows we experienced during June. You will notice in photo #1 and photo #2 that the apron in front of the spillway has developed two holes and in photo #3 a crack has developed as well. Unfortunately the river level was not below the top of the dam, so there was flowing water. This flowing water does seem to follow the path that it has already eroded into the top of the dam which means it will continue to remove material and cut those channels deeper as time goes on. There are three places where water is being forced through the dam and is acting like a geyser when it exits the dam—see photos #7 and #8. There are also several cracks along the upper “step” that will become even bigger and we may lose several large chunks of concrete after this winter's freeze/thaw.
